RE: Ingleside, Parkfield Road, Liverpool L17 8UH

Ingleside, Parkfield Road, Liverpool L17 8UH

REPORT RE TREES and DAMAGE TO BOUNDARY WALL

Report Ref EBC00191-TR01-PD – 29 February 2016

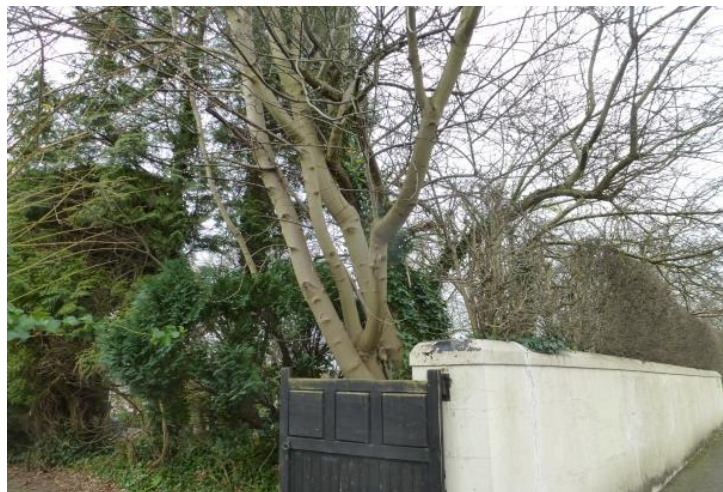
The photo below shows the locations of the small group of trees immediately behind the right hand gatepost/front boundary wall, when viewed from the street:

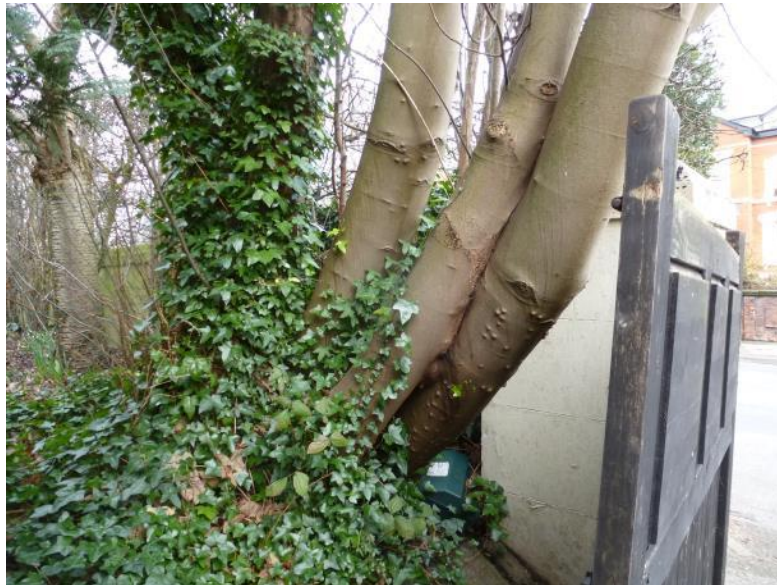
....and a similar view but from withing the property:

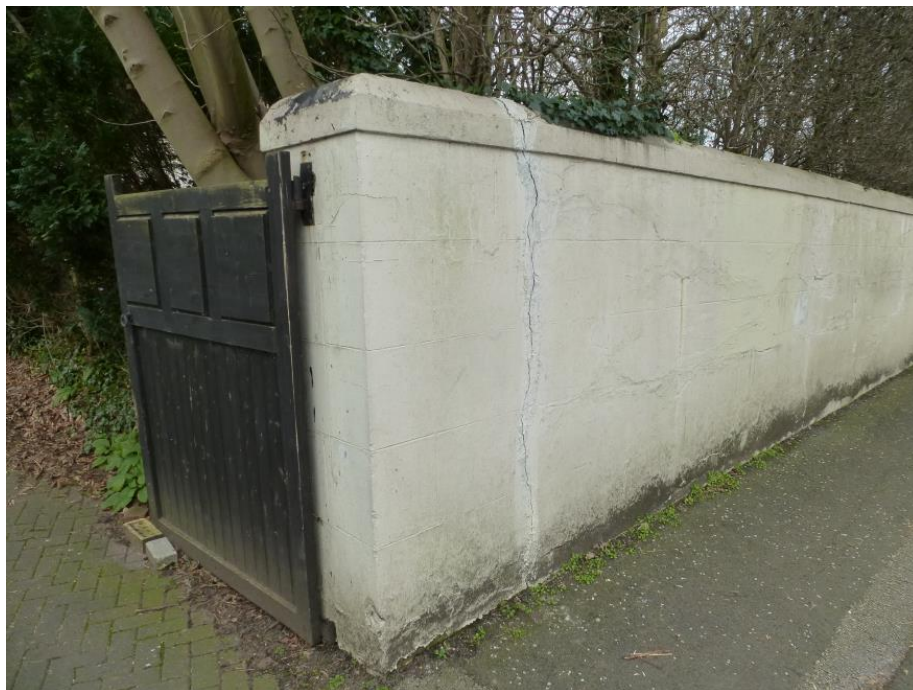
The photo below shows the cracking in the wall. This movement is ongoing/active(evidenced by previous repairs):

The presence of the trees T1 and T2 (the locations of which are shown on the sketch plan), in close proximity to the wall, are causing movements in the clay soil at the foundation level of the wall. Removal of the trees will prevent or minimise seasonal variations in the moisture content of the soil, and this will prevent further significant movement and damage to the wall. Following removal of the trees, the cracks in the wall can be stitch-repaired and the wall re-rendered.

The trees are of low amenity value, and are possibly self-seeded. They have grown in an inappropriate location and have reached a size whereby damage is being caused to the adjacent boundary wall.
