Galkoff Extension

Design Options

May 2014

Condition Report

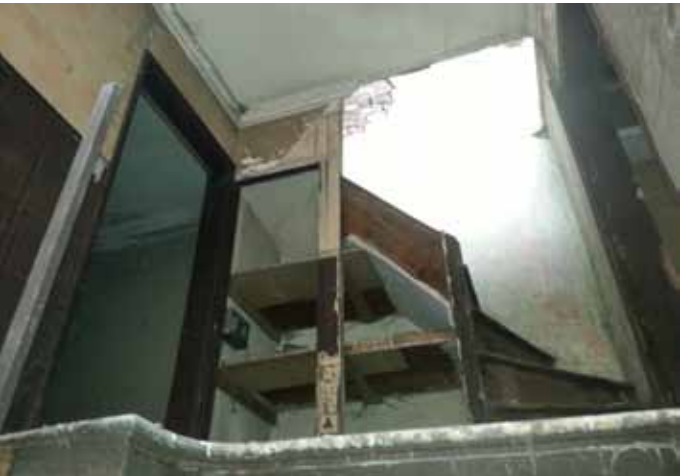
Second Floor - Stair landing / Stair to 3rd Floor

The staircase between the first and second floors is timber and in poor structural condition due to water ingress from the skylight at the roof level. Water has been clearly entering this area for some time causing damage to the finishes and saturating the timber

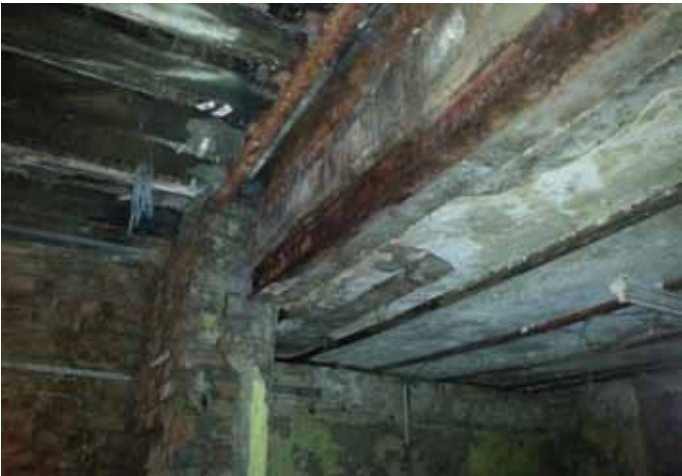
Ground Floor - Damaged structural beam

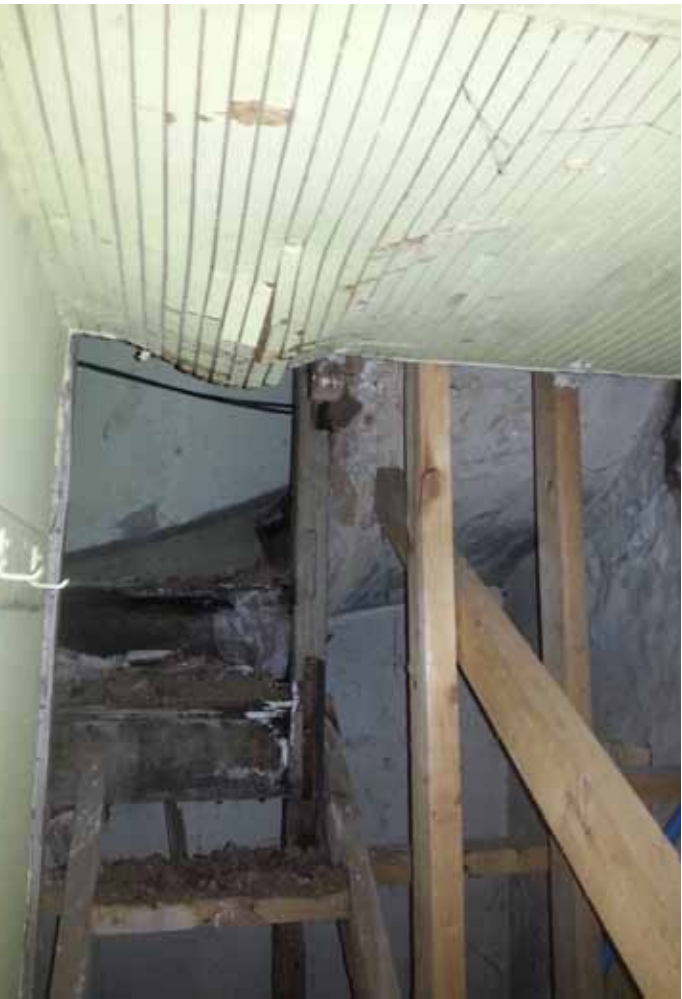
Ground Floor to First Floor Stair - Blocked/Damaged

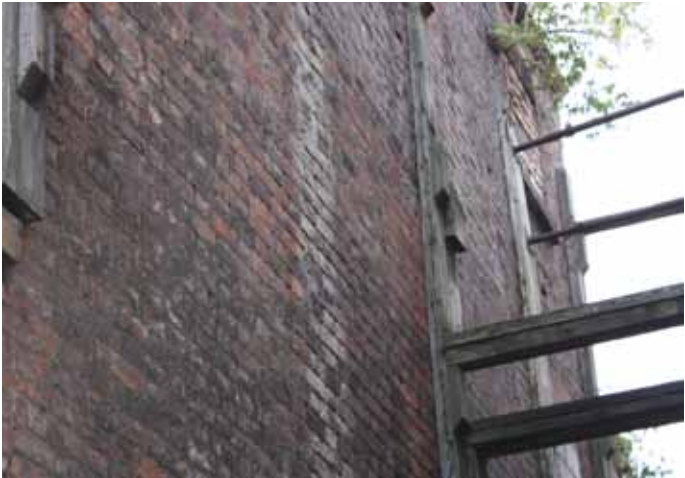
Flying shoring between No. 35 and 37

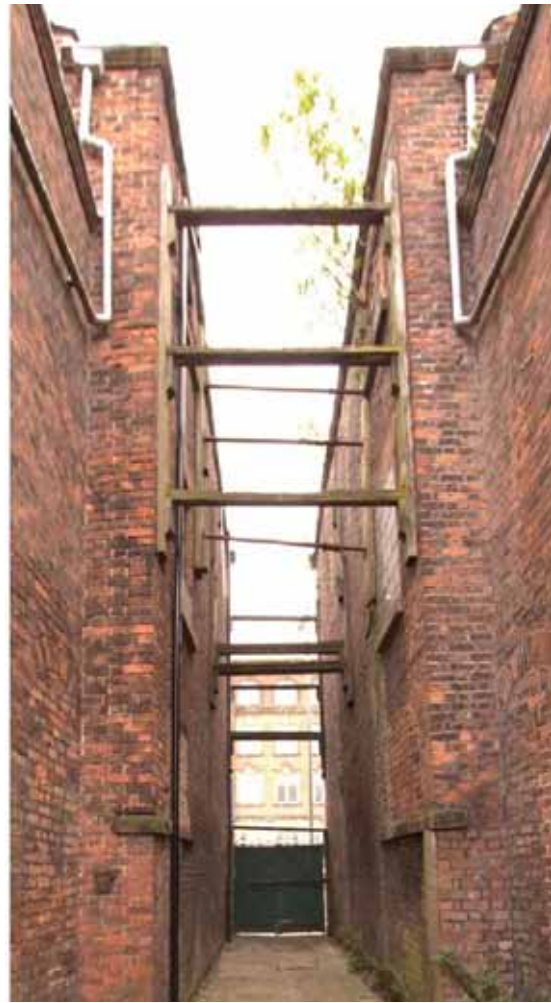
The gable wall fronts onto the alley that would have led to the rear court. Flying shores have been erected between No 35 and No 37 (Male clothing store) at 1st and 2nd floor levels. Photographs 1 and 2 shows the details. A visual inspection of both walls showed that the masonry was out of plumb. A detailed assessment of the lateral stability of this building will be needed. The shores are old and will need repair. They will also need to be retained irrespective of any strengthening as No 37 will rely on them being in place. We would recommend that LSTM seek further legal advice regarding these shores. The gable wall has been altered over the years although the original

Photograph 1
View looking along the alley between the Bookshop and No 39. Note the flying shores are timber and are relatively simple in form. The walls on both sides appear to be out of plumb.

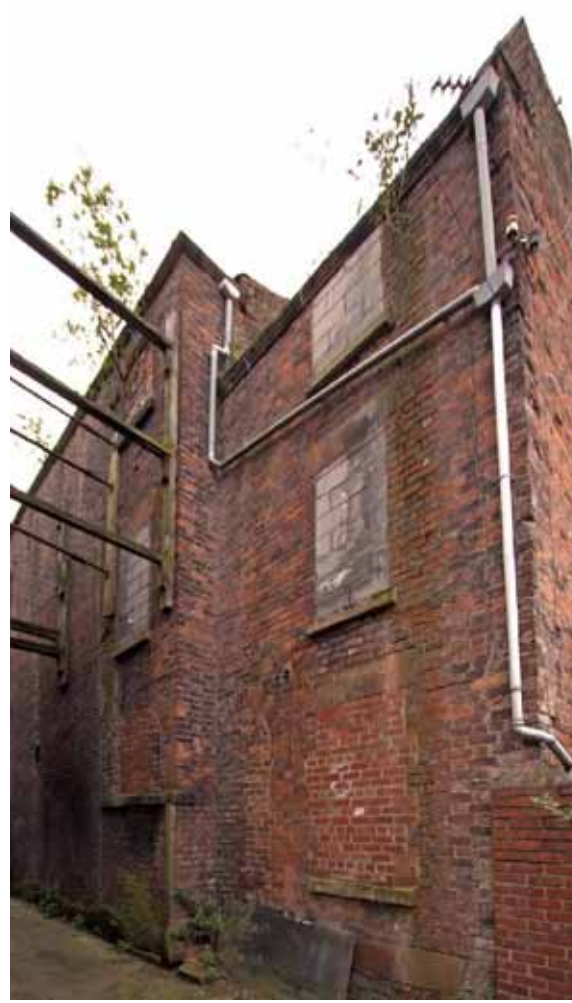
entrance and arch over is intact and the doorway infilled. Two stone sills are evident.

Photograph 2
View looking onto the side wall of the Bookshop showing the original entrance doorway (now infilled), the flying shores, areas where brickwork appear to have been modified, vegetation at roof level and replacement guttering.

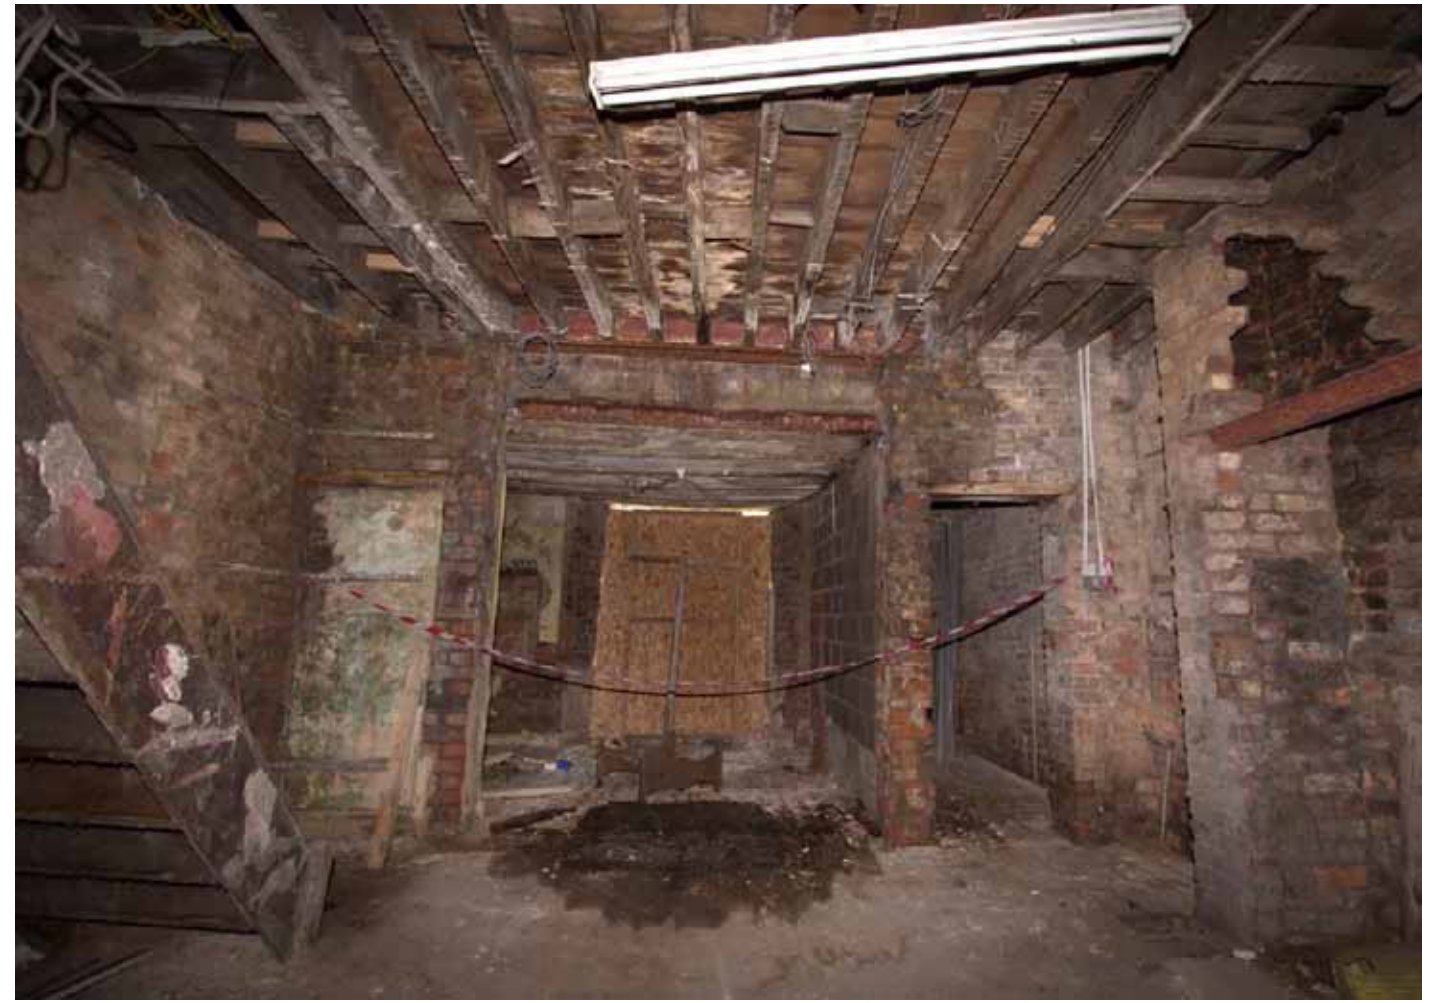
Towards the rear of the ground floor on the upper area the floor joists are saturated as can be seen on photograph 3. The floor in this area was considered to be too dangerous to access. Above there is a wide opening in the original rear wall leading to a modern outrigger beyond the line of the rear wall.

Steel beams have been installed to trim the opening and also to support the concrete flat roof. The beams are severely corroded on the top and bottom flanges and sections of the web. The beams appear shallow for the span and load that would be applied. We have not undertaken any design checks on these beams but suspect that they would not meet the current British Standard recommendations. Externally further steelwork is visible that helps support the concrete ground floor and outrigger brickwork walls. The steel is corroded and all priming coats have been lost. There is some damage to the concrete which we presume is due to lack of cover and carbonation.

There are areas of poorly bonded brickwork to the gable / party wall at ground floor level. Some of this is due to past alterations and removal of the former staircase walls and chimney stack. This can be seen on photograph 3. These areas will require local rebuilding to repair the damage. Stitch lintels will be required to bridge the crack and prevent shear failure. The stack is apparent at roof where no terracotta pots can be seen. It is possible that the stack has been sealed. At first floor level the fireplace opening within the wall has been infilled and much of the plaster appears intact with minor cracking.

Photograph 3
View on the inside of the upper level of Galkoffs showing saturated floors, corroded steel beams, concrete roof slab to outrigger extension; replacement staircase, modified chimney breast and water staining on the first floor.

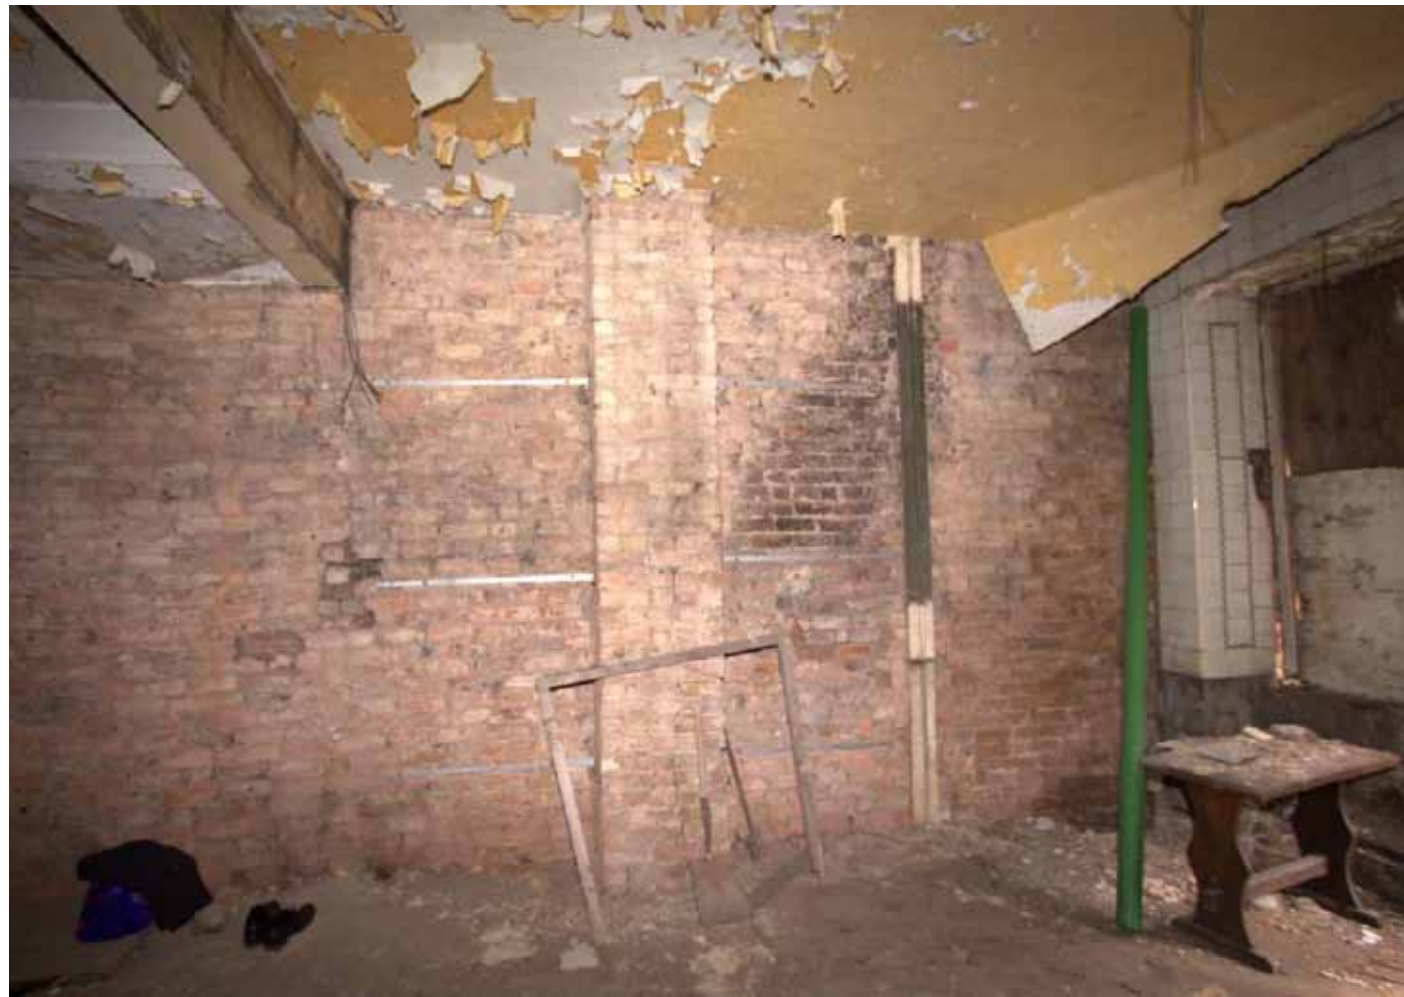
Photograph 4

View looking onto party wall of Galkoffs and No 29 Pembroke Place. Note the isolated cast iron column, removal scars of old brickwork cross walls, the bearing of the flitched beam; attempts to stabilise vertical movement in the wall by the installation of galvanised mild steel straps and other areas of poor brickwork.

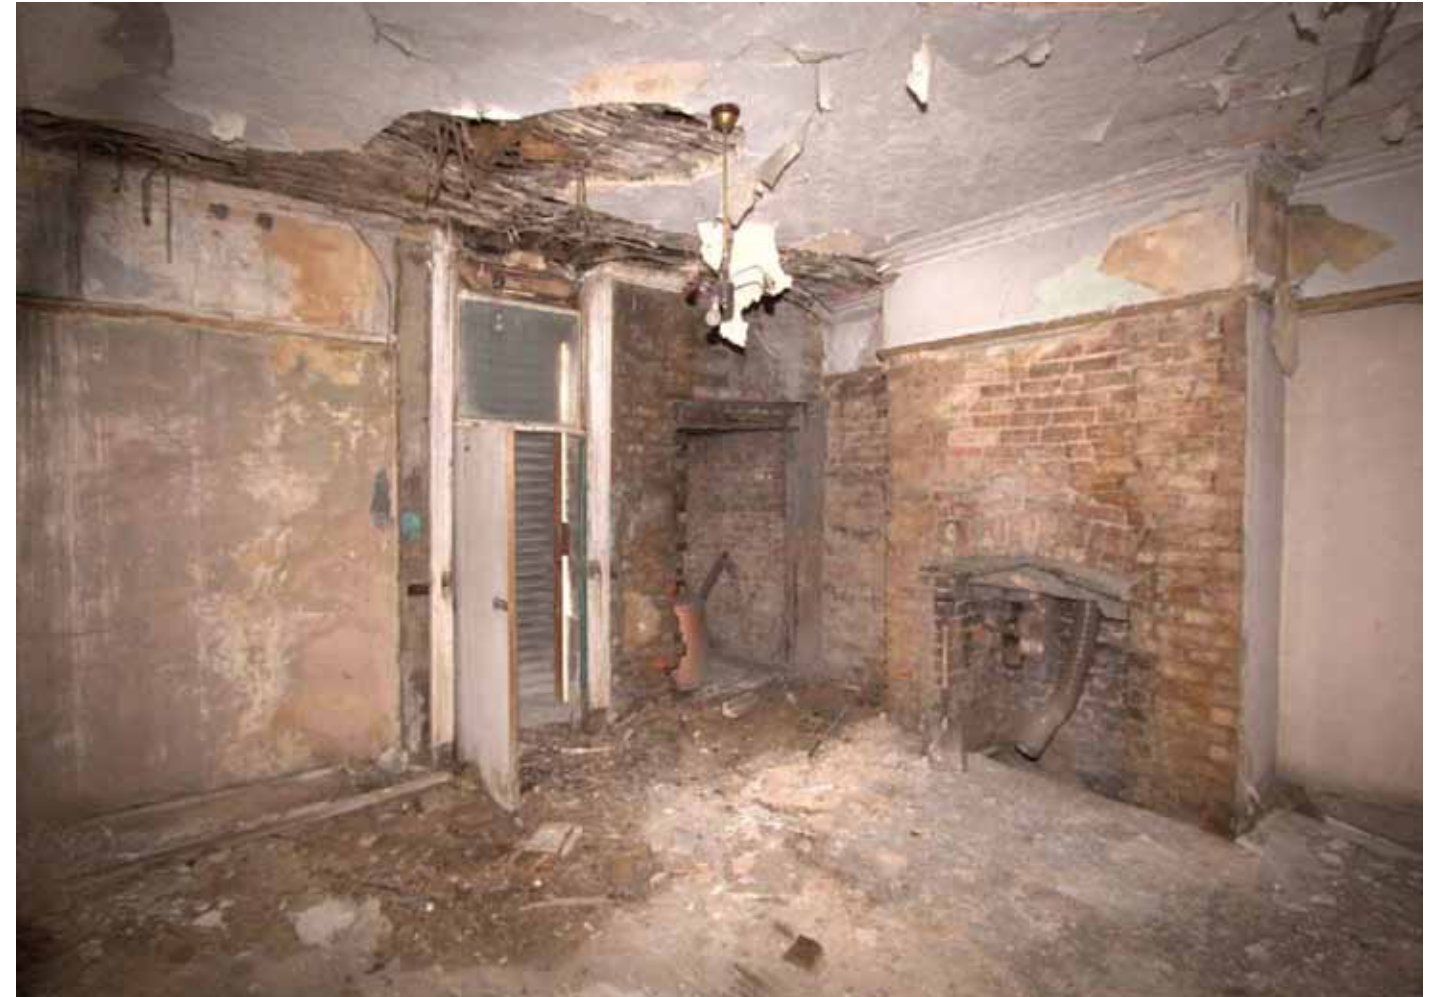
Photograph 5

View of basement showing water ingress from the flat roof at first floor on the extension outrigger.

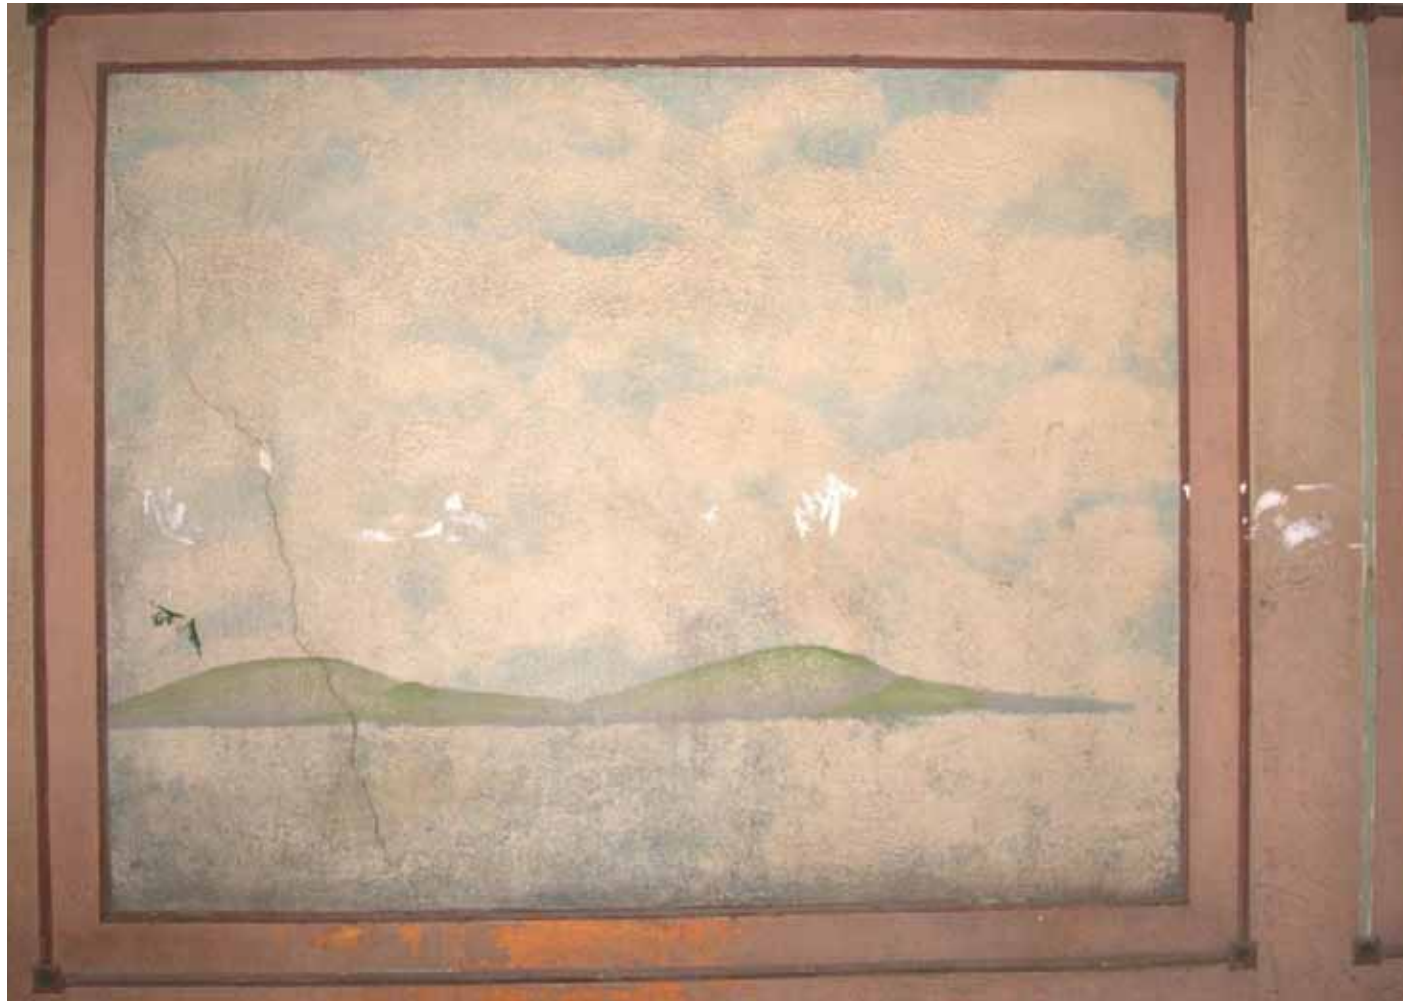
At the first floor there is diagonal cracking that extends in the gable / party wall to Anson House. At high level due to the alteration work currently being undertaken on Anson House it can be seen that there are two walls. A block lining wall to the modern building and an old solid bonded brick wall estimated to be one full brick width. This cracking cuts across

the plasterwork of two of the paintings. Photograph 6 shows one such crack. This form of cracking is likely to be due to one or a combination of the following:

- Outward movement of the façade facing Pembroke Place due to a lack of lateral restraint at the floor / roof level.
- Possible movement associated with the original installation of the shop front beams and columns.

Photograph 6
View at 1st floor showing cracking across the painting which is a result of outward movement of the gable front elevation with respect to the flank wall.

At first floor level there is a gap between the floor boards and the plaster indicating outward movement of the wall with respect to the floor. This will require the boards to be locally removed, noggin timbers inserting, straps fixed between the wall and the floor and the boards replacing. We would recommend that all the other walls are strapped back to the floors in a similar manner. Although some straps are visible at the underside of the 1st floor, these will need alteration / replacement and additional work. If the repairs to the cracked masonry are undertaken internally this will cause significant damage to the painting. If undertaken externally it will be visible.

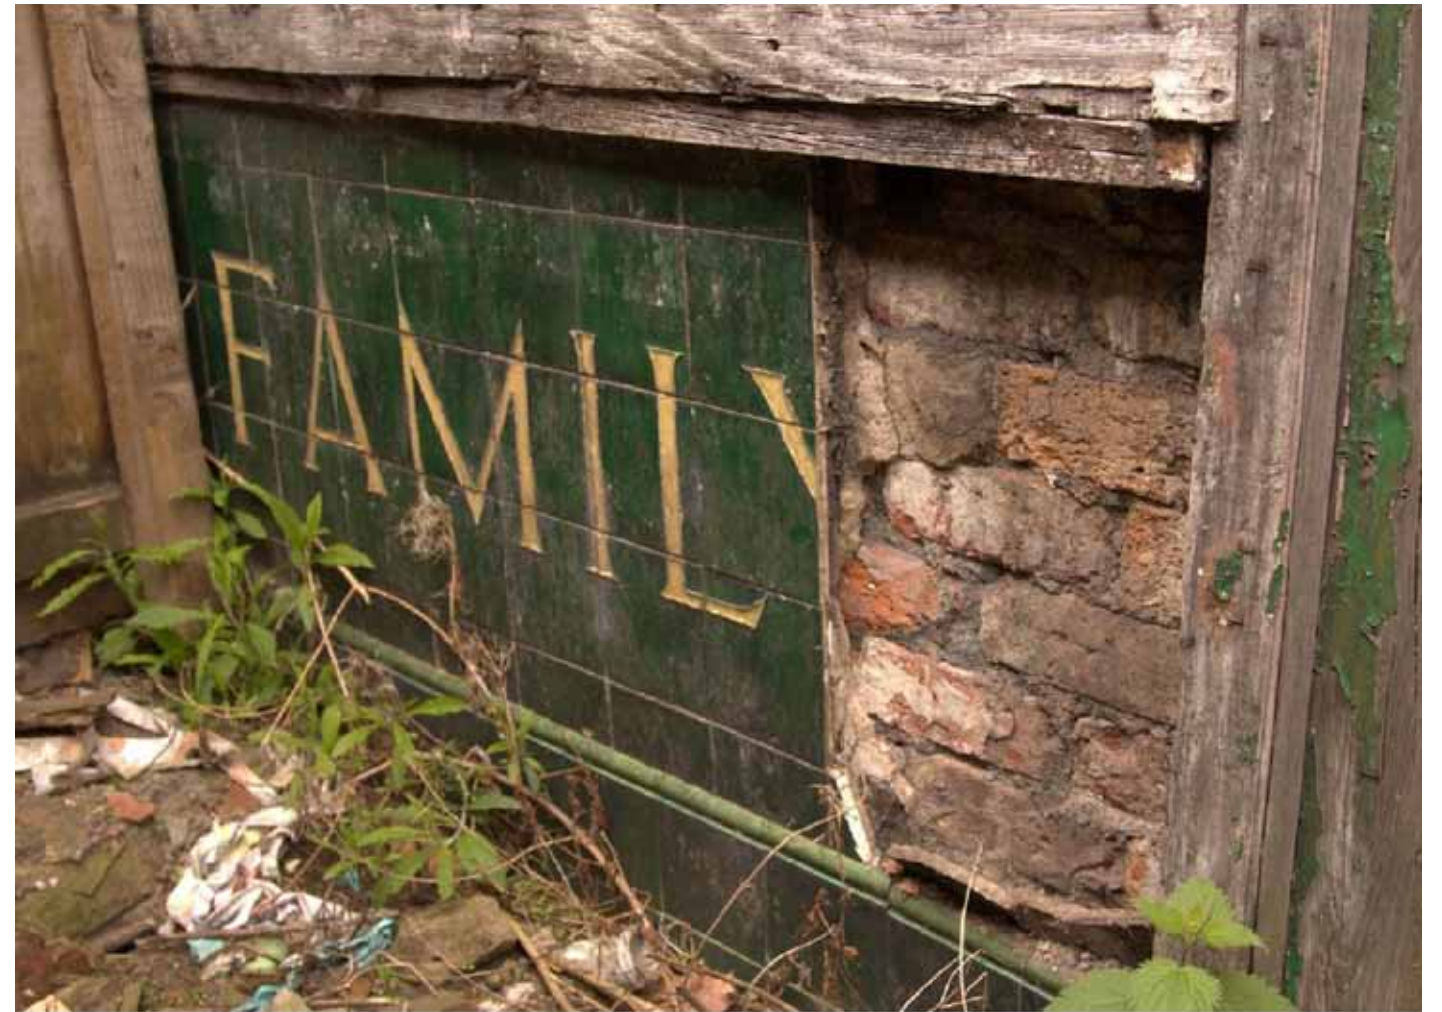
The front wall is constructed in Flemish bond with alternating header stretcher bricks and alternating on adjacent courses. The mortar is probably lime based and there is evidence of some cement repointing to the return gable corner to No 27 (Anson House). Galvanised straps are visible on the external corner adjacent to the shop front beam. There has been some movement of the brickwork around the bearing to the main shop front support beam. If retained the beam will need propping, blast cleaning, treating with priming coats and the brickwork locally rebuilt.

Photograph 7
View showing the condition of the brickwork behind the tile finish.
