1 Summary 4

1 Summary

This report advises on the findings of an intrusive investigation to determine the building fabric and general condition at the above. Aspects of the premises were inspected by BDI at the time of investigations. This report does not constitute a structural survey or building condition survey.

It is proposed to convert the existing synagogue into residential apartments with internal amenity space.

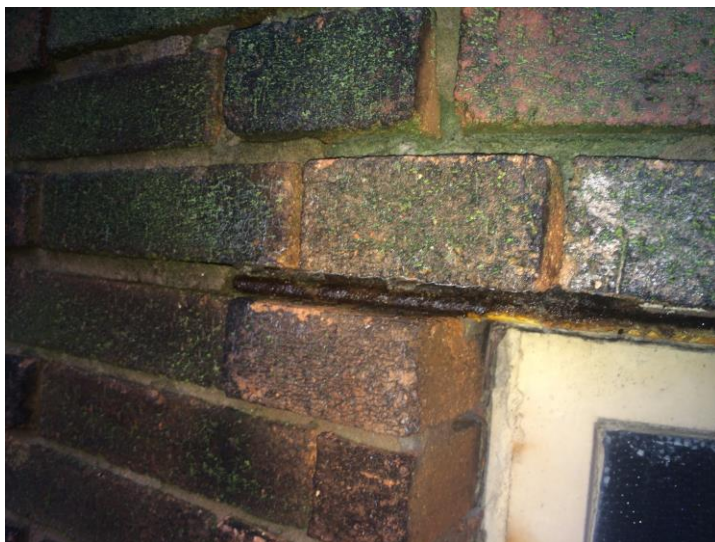
In the instances where the window have flat horizontal heads lintels within the outer leaf brickwork have been formed with either flat steel plate or steel bars built into the bed joints either side of the window reveal. In many instances these flat plate or bar mild steel lintels have corroded resulting in rust expansion causing cracking in the bed joints at the reveals.

Figure 3 Corroding window lintel

It is apparent that to preserve the building existing mild steel lintels should be removed and replaced with proprietary galvanised steel angle lintels.

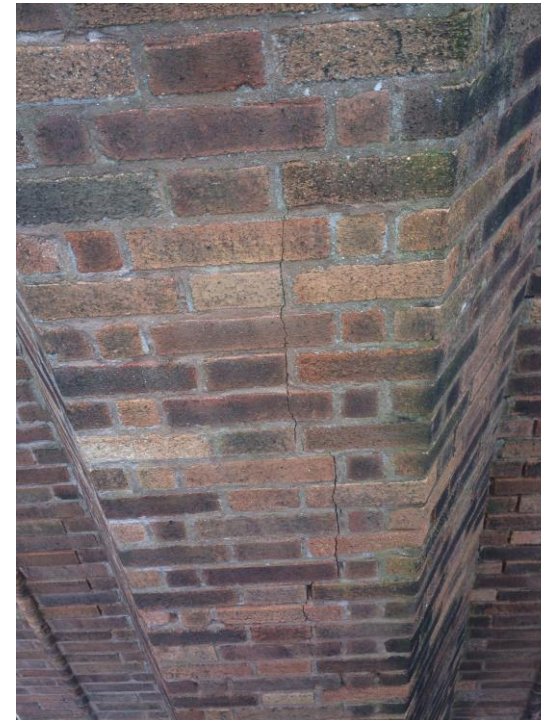
Many of these brick columns have vertical cracking at high level.

Figure 4 Cracking to external masonry columns

The cracking to the external columns has been caused by corrosion and rust expansion of the encased steel channels.

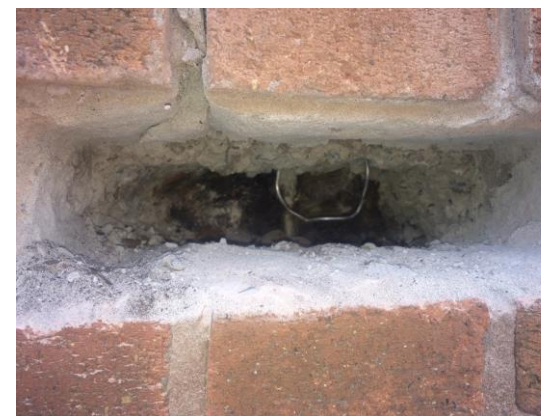
Figure 5 Exposed Steel Channel Columns to external masonry columns

A section of encased steel channel column was exposed to the left elevation. We established that the upper section of the masonry has been rebuilt in the past and the columns have in their upper section been encased in concrete. Corrosion where observed was noted to be relatively minor.

The corrosion however is clearly progressive as cracking has been caused within the concrete encased and rebuilt sections of the brick piers.

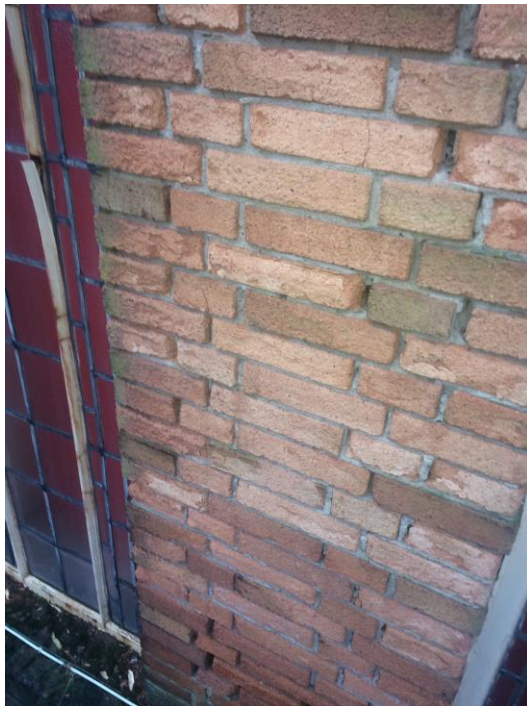
Generally the masonry to the elevations are in reasonable condition there are some areas where bricks have locally spalled due to frost damage and water damage due to leaking rainwater good and poor roof edge drips.

Spalling and deterioration of the mortar joint and brickwork is particularly prevalent to the rear elevation. Local rebuilding will be required to restore the brickwork to this façade.

Figure 6 Eroded and frost damaged masonry

Generally all elevations will require repointing with localised brickwork repairs.

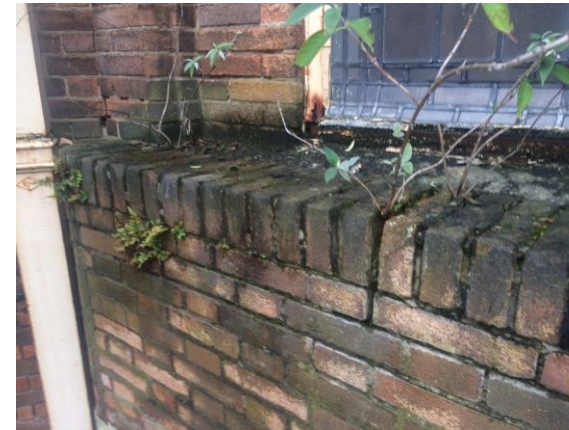
Water and vegetation root ingress into these masonry window features has created significant damage and movement and many of these features to the left, rear and right elevation require repairs and local/total rebuilding.

Figure 7 Masonry window box feature note damage and concrete infill to top.

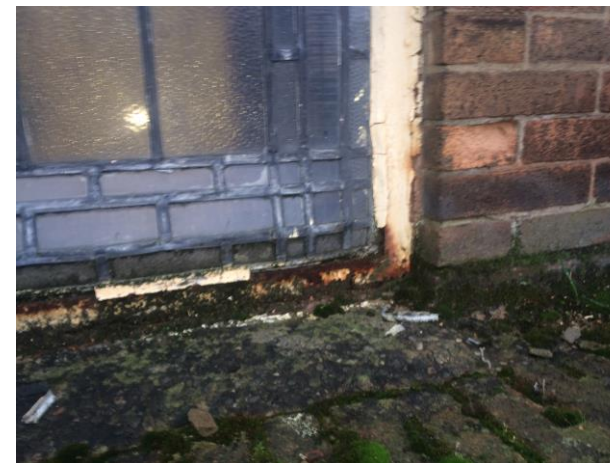
Whilst not a structural defect the window frames are seated directly above the window box features. The window frames are steel and have significant corrosion. This appears in part due to the concrete infill of the window box being at the same level as the bottom of the frame.

In addition the glazing in the leaded windows appears to have dropped over time resulting in bulging to the glass at the bottom of the frame.

Figure 8 Corrosion to window frame and bulging of leaded window glazing.

Repairs will be required to the window frames and the glazing and the detail between concrete infill/brick window box and window frame needs improving for future durability.

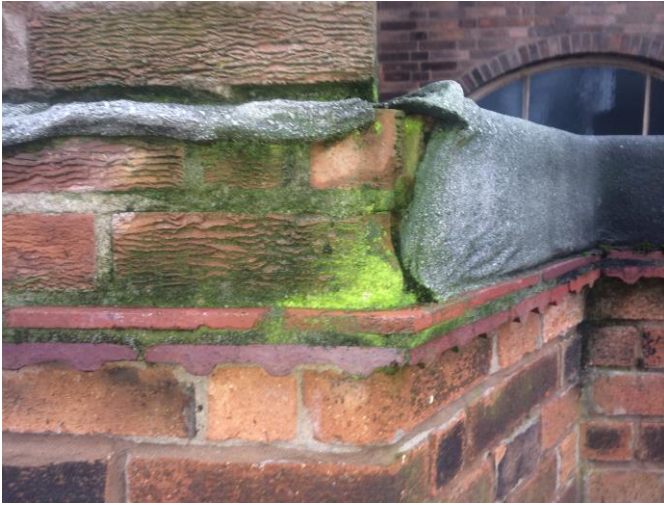
The detailing of the asphalt roofing is poor where the coverings abut parapet and upstand walls and as such leakage of water into the structure is occurring.

Figure 9 Failed or poor detailing of roof coverings leading to water ingress.

The refurbishment of the building should include and anticipate new roof coverings to flat roofs.

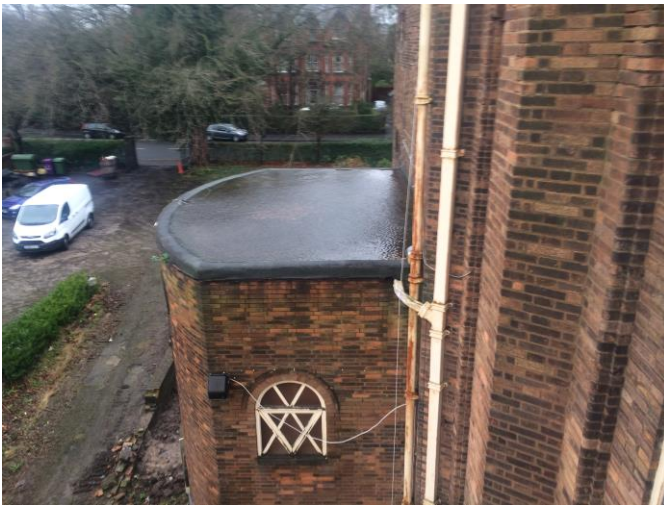
The flat roof coverings generally are of concern there are a number of flat roofs to all elevations which have an asphalt finish, most of these appear to hold water and in one instance the outlet has been roofed over.

Figure 10 Ponding of water on flat roofs.

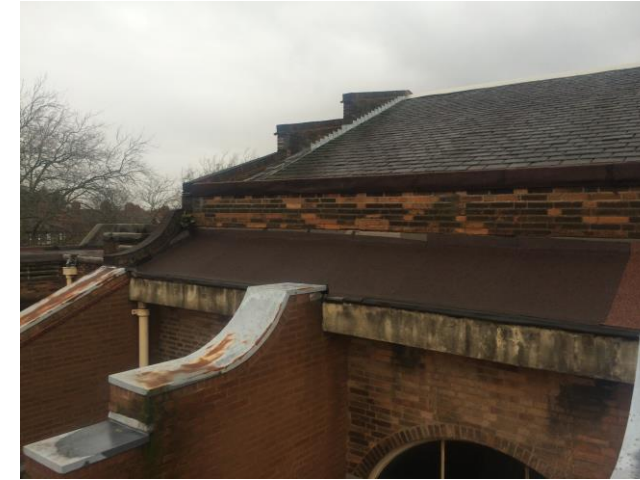
The ridge has been formed with a folded plastic or tin flashing which appears to be poorly fitted.

Flashings between the tiled pitched roof and the end gables are formed with a mixture of lead flashings and flash bands. New flashings are likely to be required.

Figure 11 Flashings in lead and flash band. Note ridge formed in folded plastic or metal sheet.

We would suggest that it would appropriate to install a new tiled ridge to this roof.

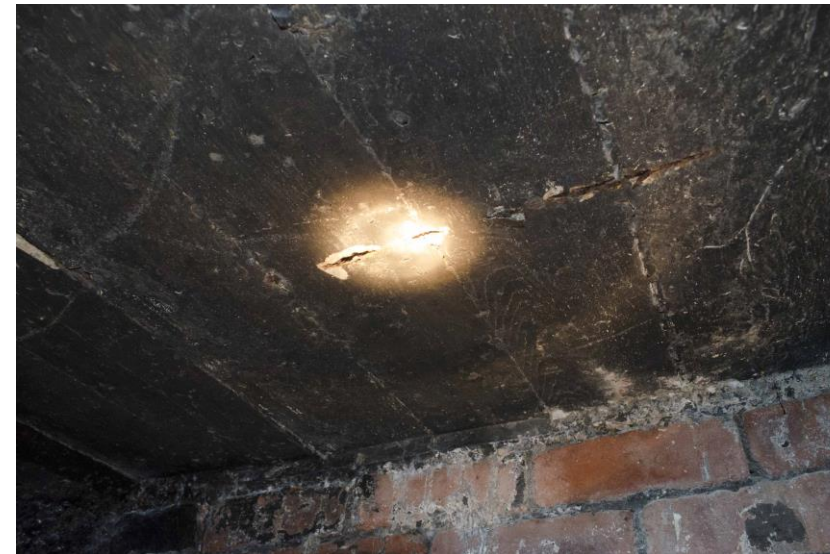
The underside of the ground floor slab was inspected from the room below. A cast in-situ slab was identified. Whilst the slab appeared serviceable, reinforcement was exposed and deteriorating in some areas. The surface to the slab also appeared to be covered in smoke residue. The slab was supported on load bearing masonry walls.

Figure 11 Reinforcement exposed

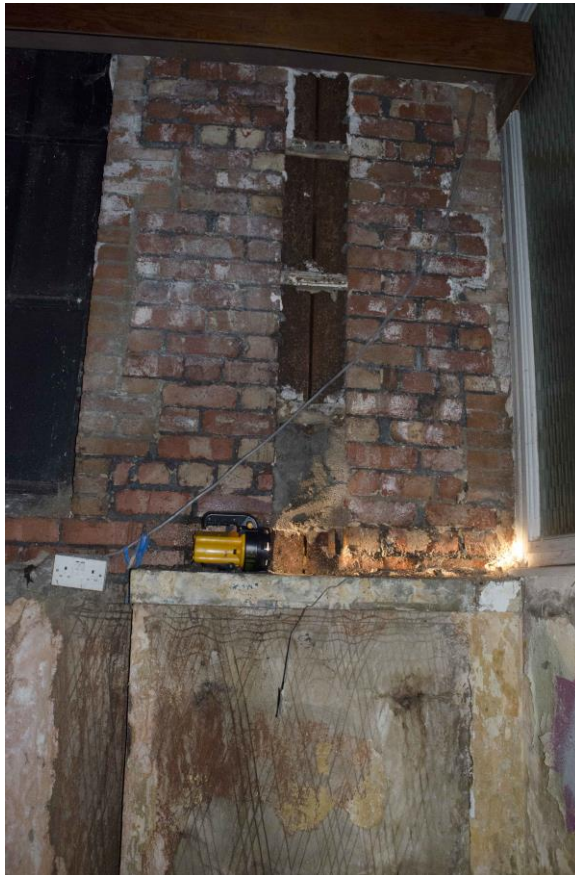
The level of corrosion of the packer plate was significant. The columns had surface rust present to all surfaces.

Figure 12 Exposed External Column

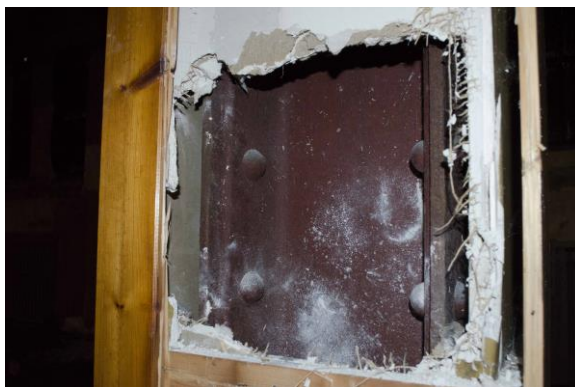
Internal columns were exposed. Steel I beams with riveted plates on both the top and bottom flange were identified. Column dimensions are indicated within the appendix.

Figure 12 Exposed Internal Column

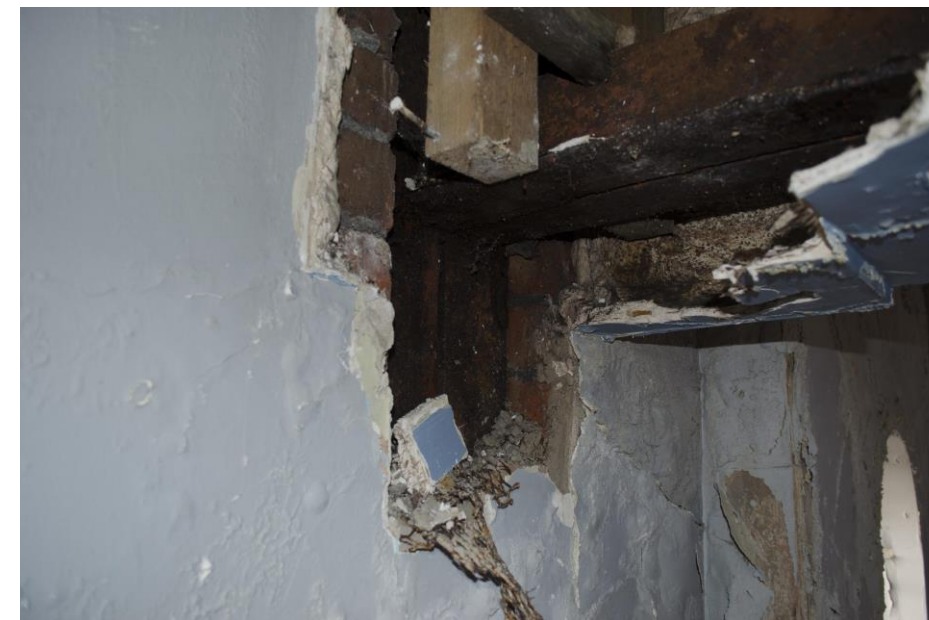
Truss ends were exposed internally by removing boxing and plaster. Upon removal of plaster significant rust was present on the inside face of plaster. Water was also present on the face of the steel.

The bottom chord of the truss runs through a concrete flat roof. It was clear from inspection that some of the original concrete had been cut back and replaced. Retrofitted welded steel plate strengthening was also visible.

Figure 14 Exposed internal truss end

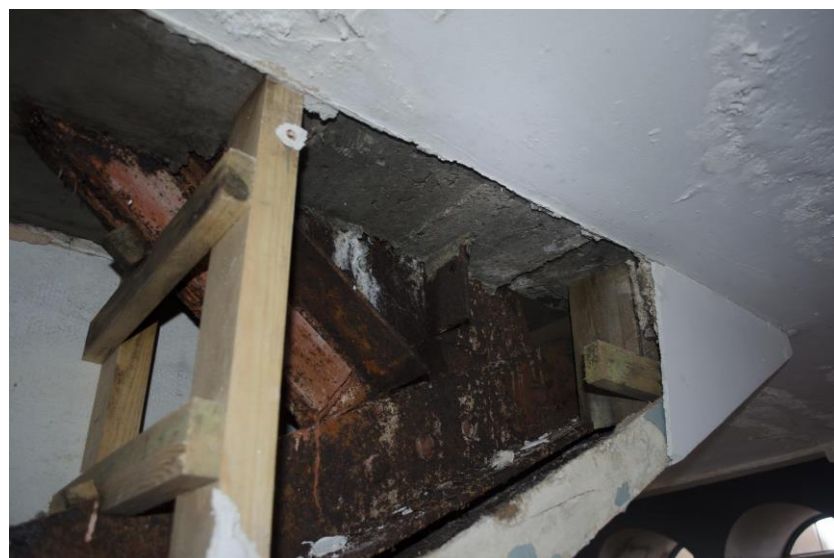
Our visual inspection suggests that the fixings from the columns to bottom chord of the truss have been historically removed. Significant corrosion has occurred with the steel at the bottom chord end on both the column and truss delaminating.

Figure 15 Exposed internal truss end showing retrofitted steel

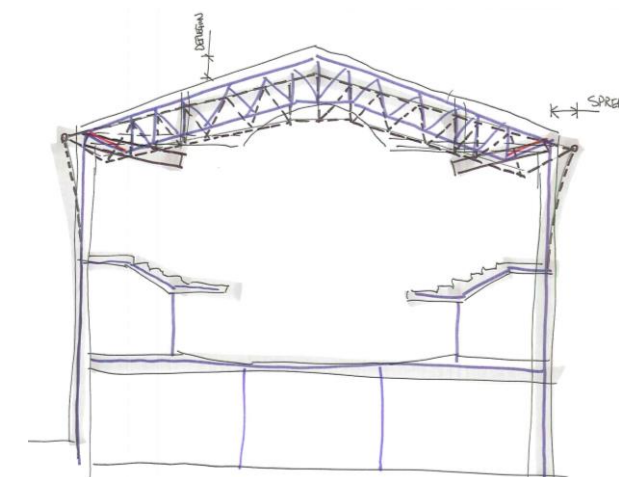
In its original support condition the trusses would have provided lateral stability to the columns and masonry walls through stiffness in the connection. The decrease in stiffness has led the truss connection to act as a pin; this has led the fundamental support conditions to the columns to change, now acting as a cantilever. This has resulted in the truss being more susceptible to deflection and the columns more susceptible to lateral loads causing sway. This is observed in the significant cracking identified to the internal ceiling and the external masonry piers.

Truss elevation indicating spread of truss and vertical deflection owing to amended end configuration
