Simpson Playing Fields

Arboricultural Report

December 2015

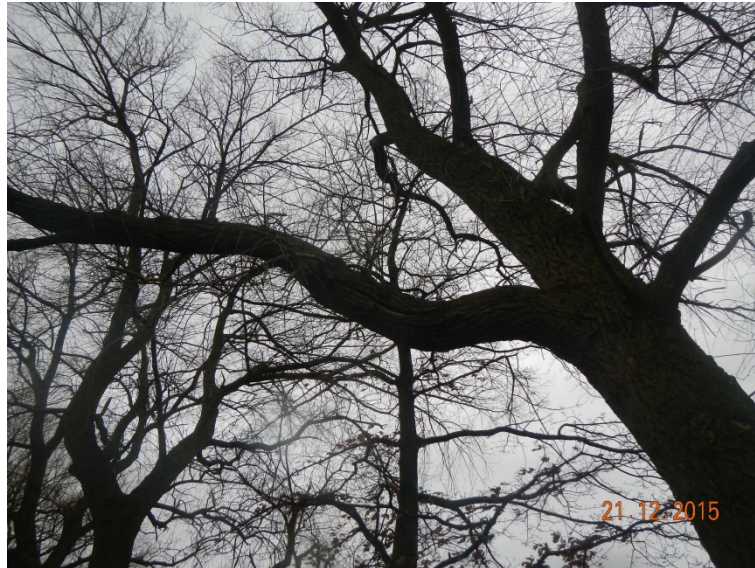
3.05 The poplars (5850 – 5854 and 5856 – 5862) are visually significant specimens located on the site's southern boundary with Springwood Cemetery. They are fully mature trees as a linear group in the landscape. A number of trees have features that compromise their retention without remedial tree surgery. Trees 5851 and 5852 have significant wounds/cavities where the residual walls are currently outside acknowledged scientific parameters. Thus they require pruning, through conventional crown reduction, to allow them to be retained.

Failed limb on Tree 5856

5854	Poplar	Crown clean.	
5856	Poplar	Crown clean.	
5857	Poplar	Crown clean.	
5858	Poplar	Crown clean.	
5859	Poplar	Crown clean.	
5860	Poplar	Reduce first main limb to north at 5m and second limb to the north by up to 3m, cutting back to suitable lateral branches, creating wounds of no more than 100mmØ. Crown clean.
