Memorandum

ARUP

19 August 2010

Subject Korean House Site Condition Survey

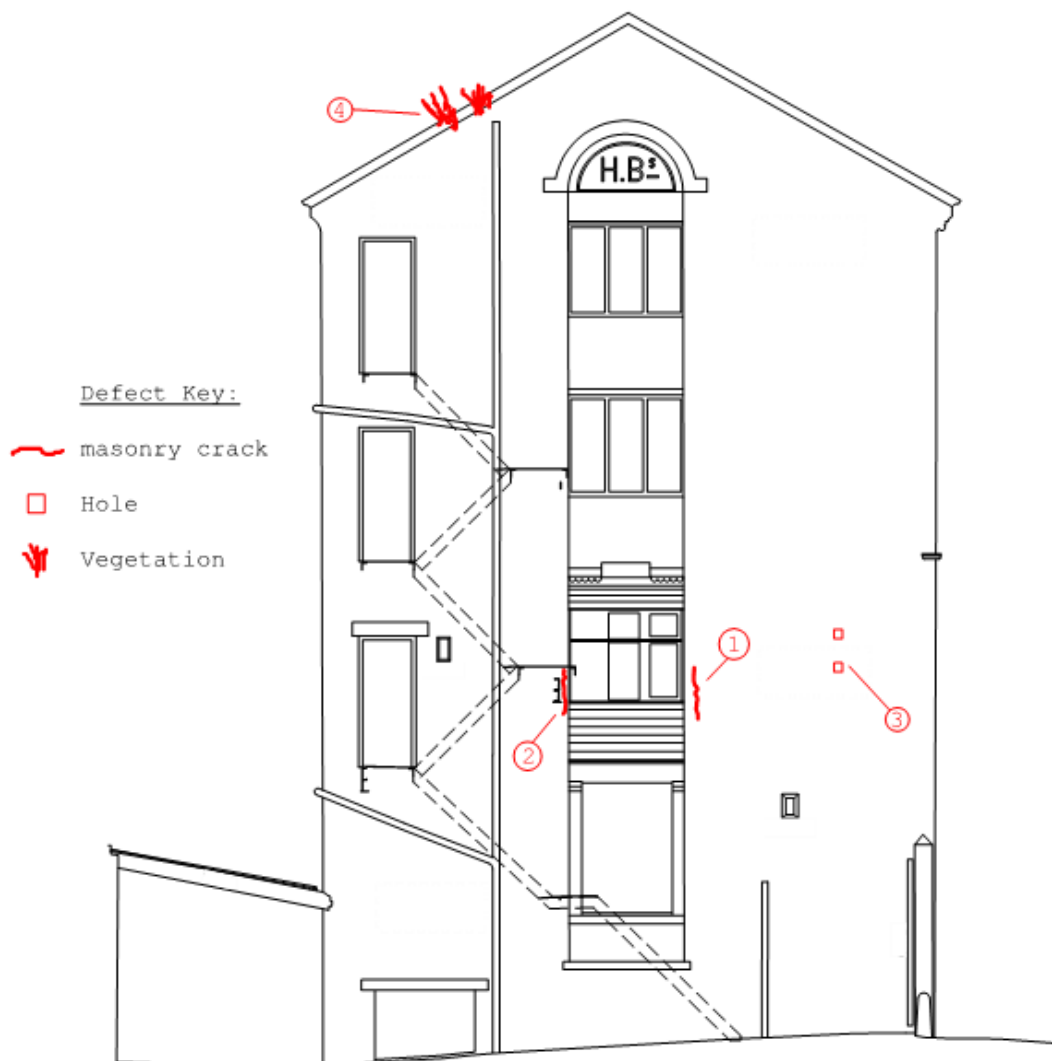
Figure 2 – Frendsons Building East Façade Elevation Defects

Generally the east façade masonry wall is in fair condition with no visible signs of movement from subsidence nor bowing. Generally the brickwork and joints are in good condition with minimal loss of mortar. A number of defects were identified and these are shown in figure 2 below and in more detail on photographs 1 to 4.

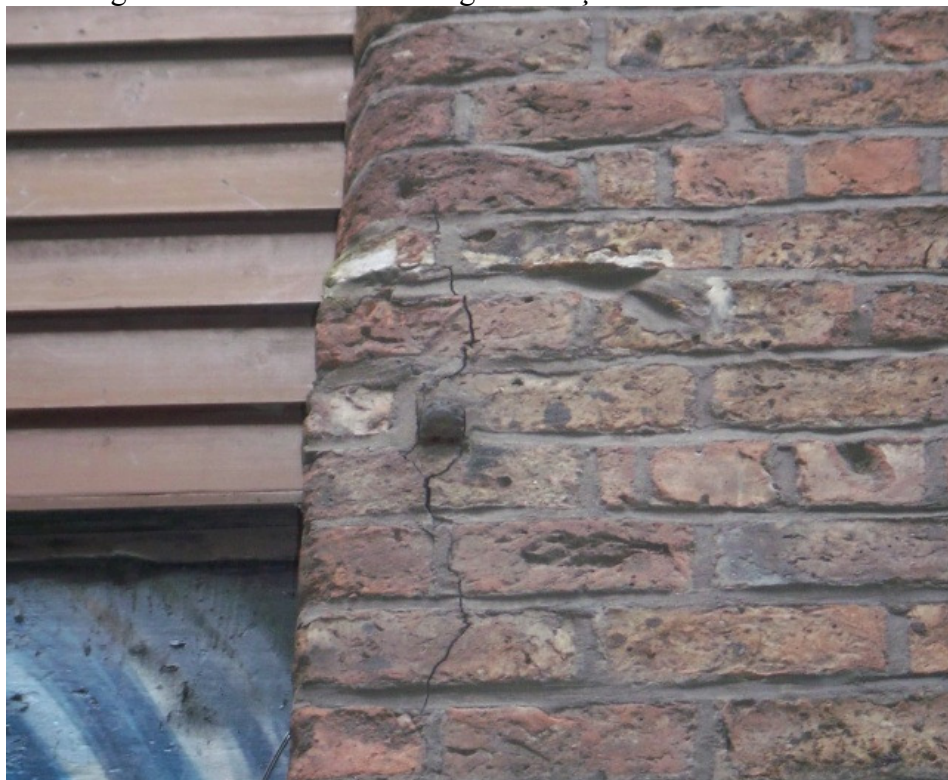
Photograph 1 – Defect 1, crack in the masonry external wall

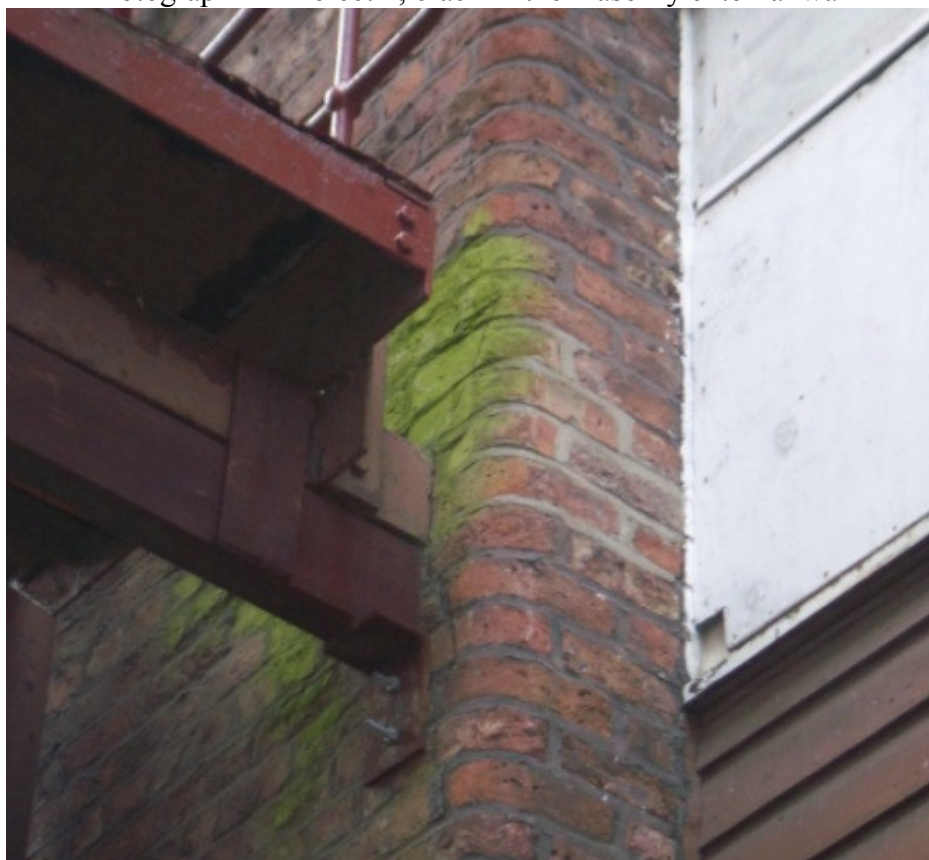
Photograph 2 – Defect 2, crack in the masonry external wall

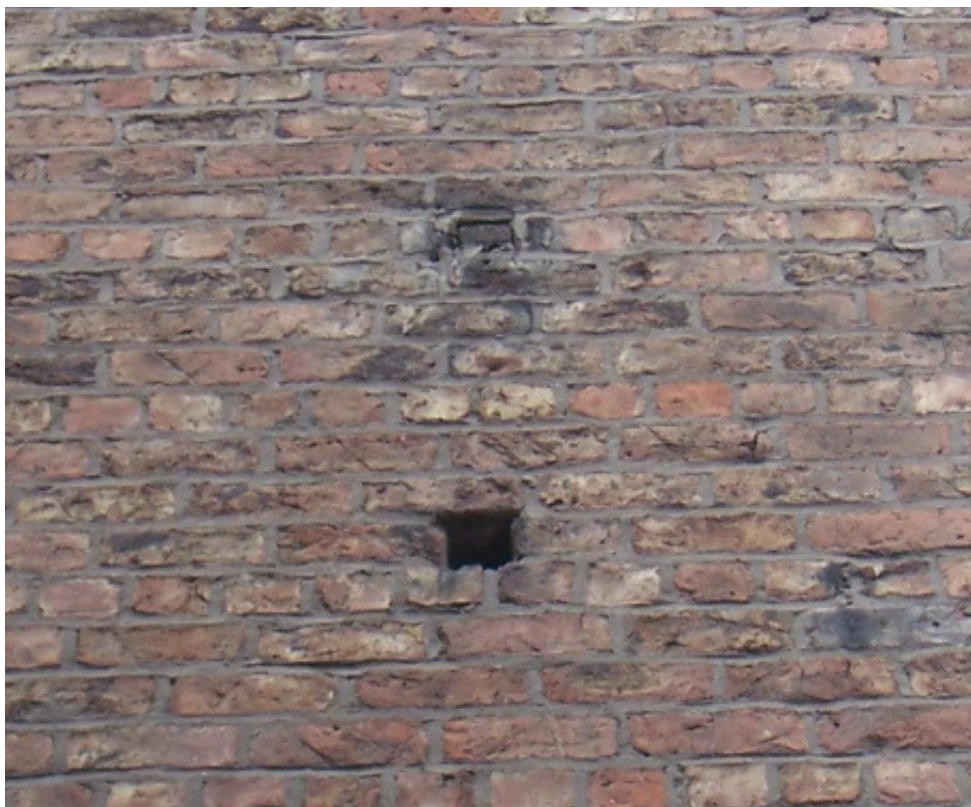
Photograph 3 – Defect 3, two holes in the masonry wall

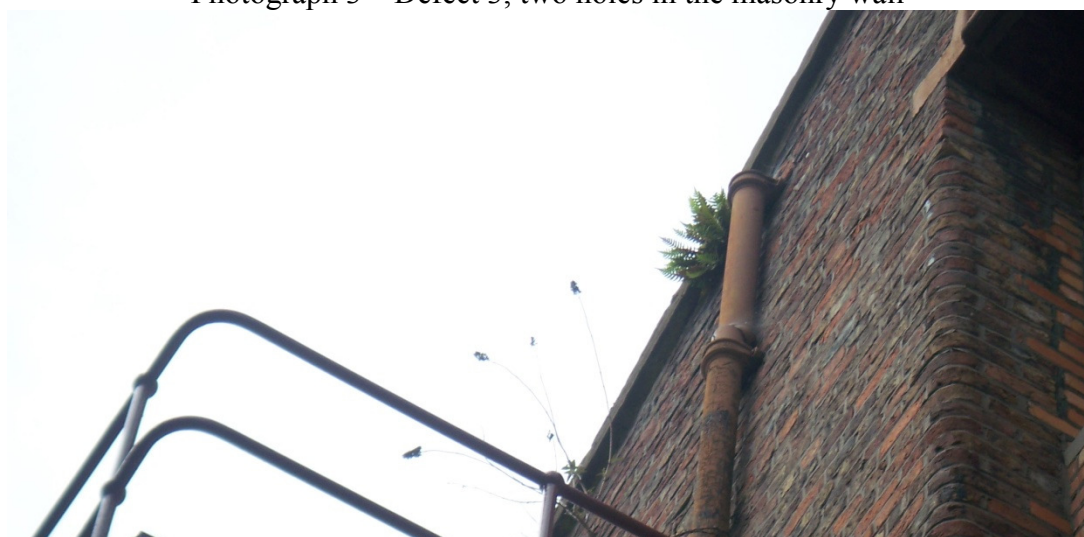
Photograph 4 – Defect 4, Vegetation Growth

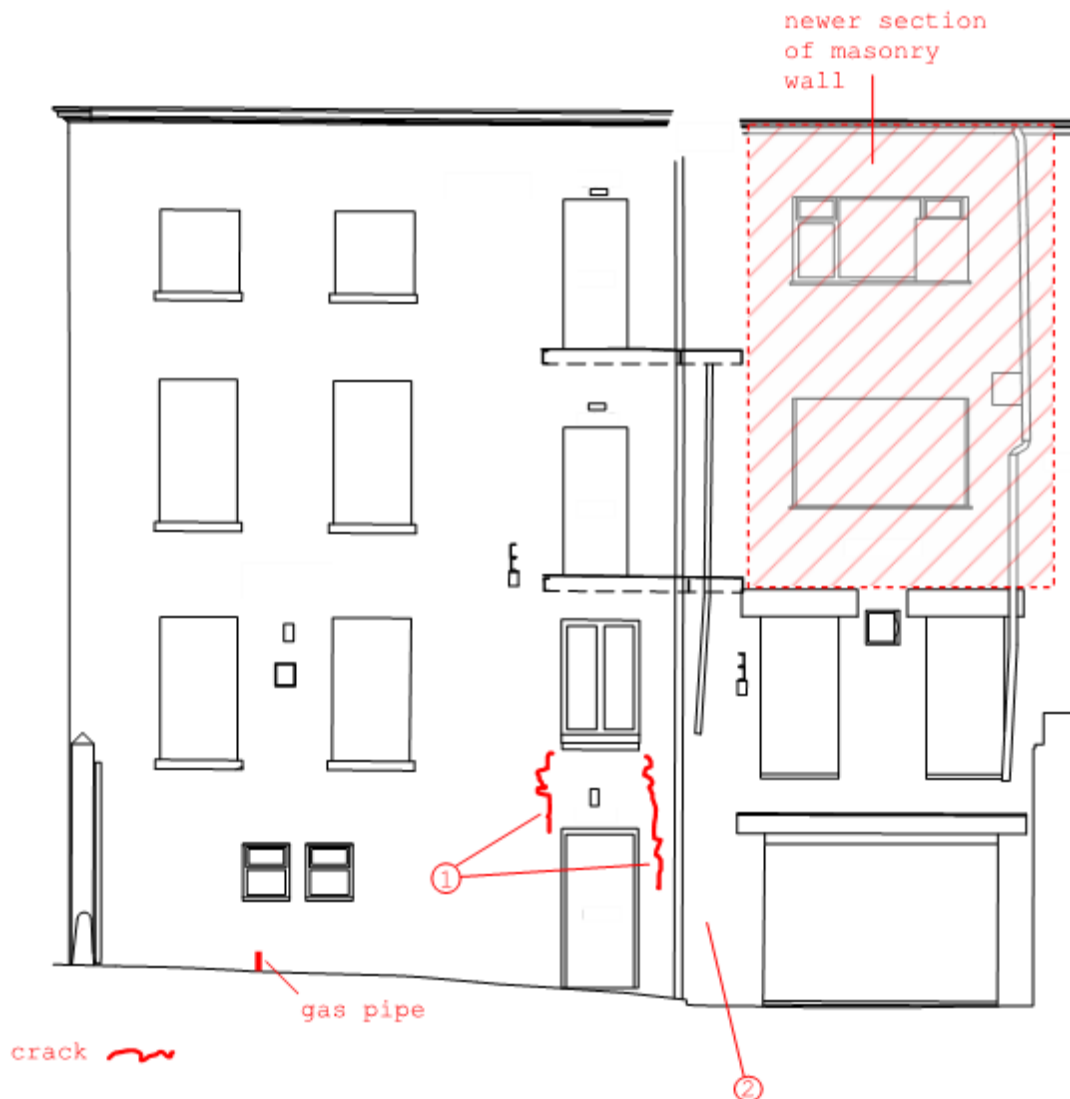
Figure 3 – EP building West Façade Elevation Defects

Generally the east façade masonry wall is in poor condition with loss of mortar in the joints identified. In the areas adjacent to the rain water pipes vegetation growth on the brickwork was noted. No visible signs of movement from subsidence nor bowing was noted in the wall. A number of defects were identified and these are shown in figure 3 below and in more detail on photographs 5 and 6.

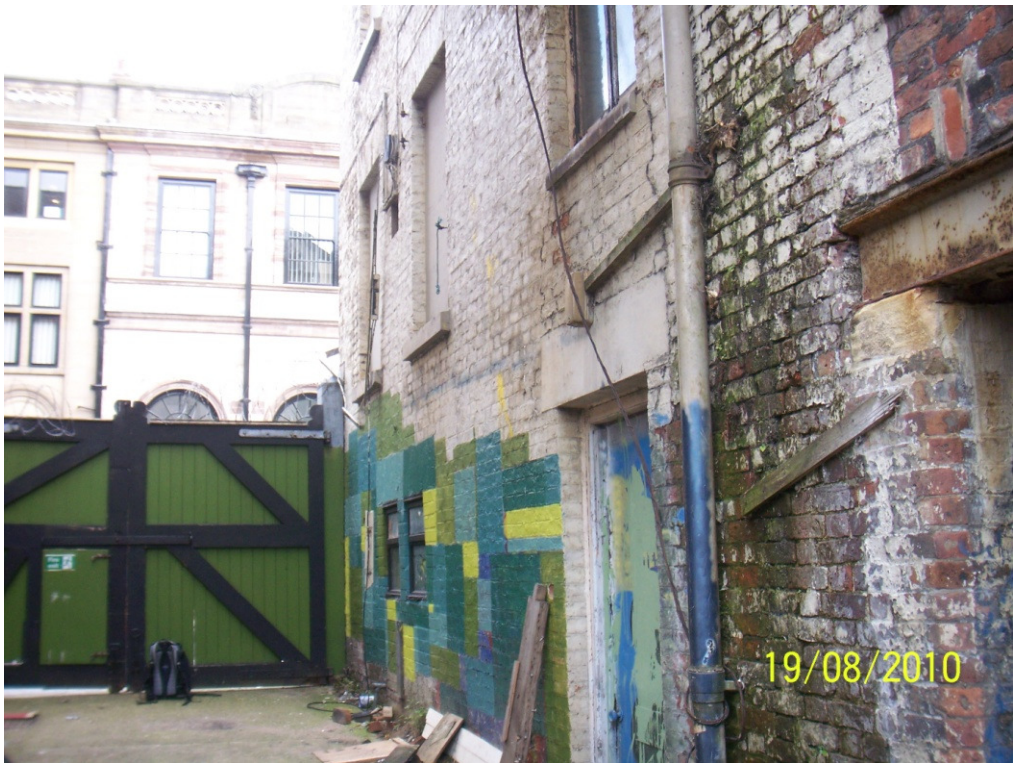
Photograph 5 – Defect 1, masonry cracks from window frame to concrete lintel

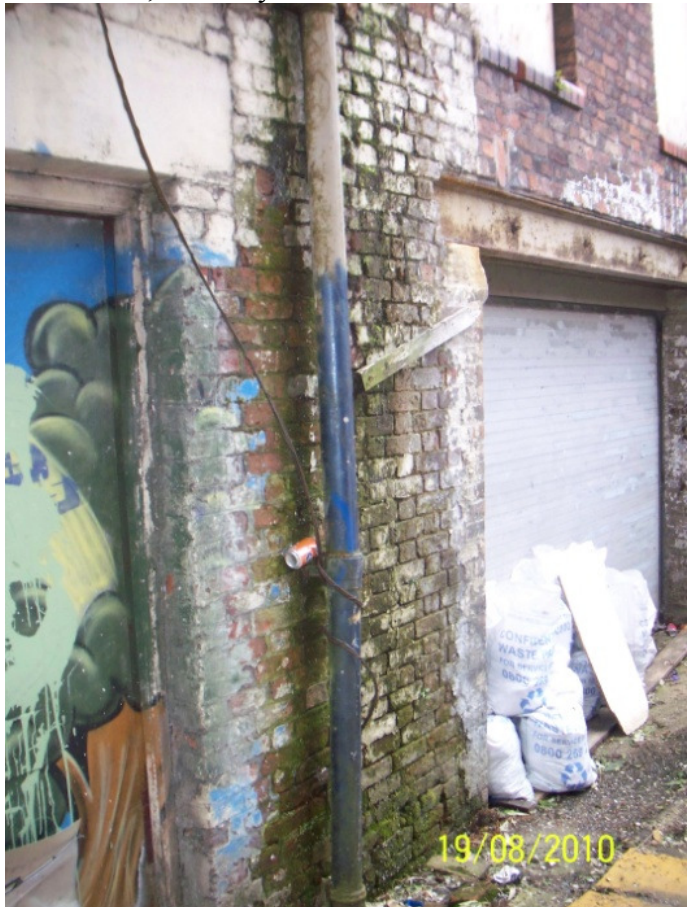
Photograph 6 – Defect 2, Loss of mortar in joints and vegetation growth

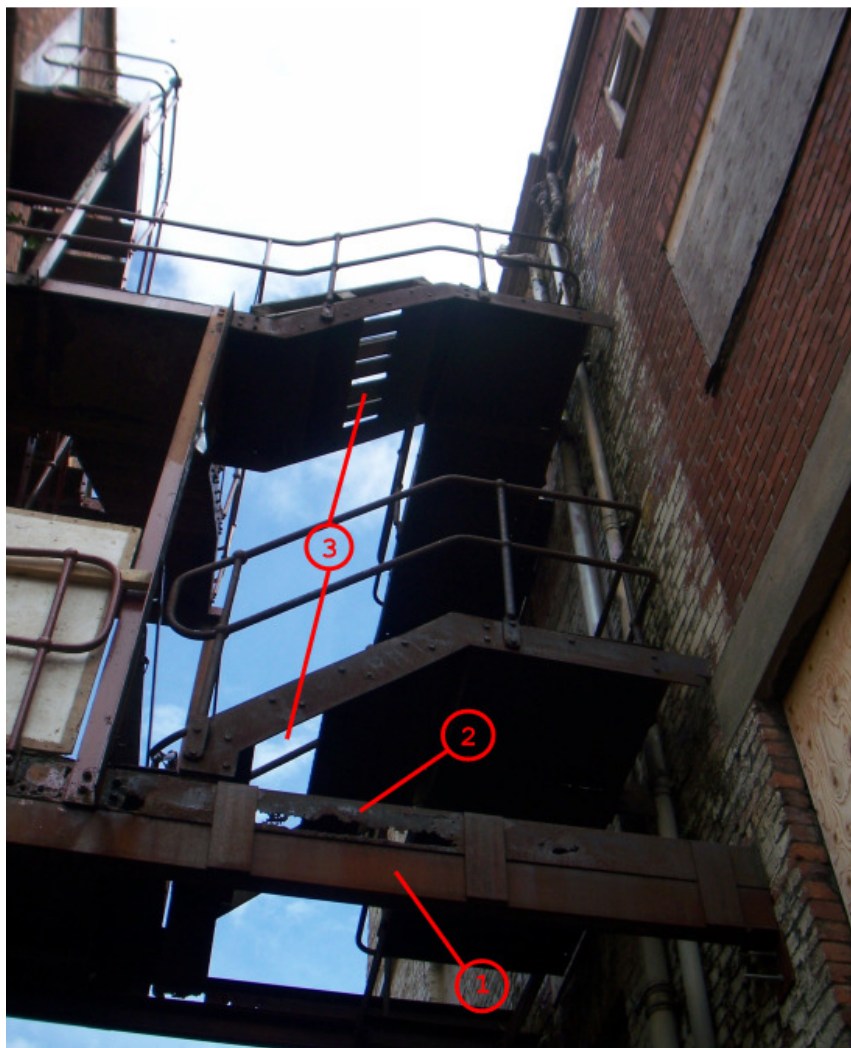
Photograph 7 – Steel Fire Escape

3. **Fire Escape** - The steel stair structure provides means of fire escape to both the Frendsons Building and the EP Building. The steel stairs and landings are supported by a steel beam spanning between the buildings. Evidence of structural strengthening to the support beams was noted and indicated by a Number 1 on Photograph 7 below.

The steel beams, stairs and steel plates forming the landing are in poor condition with the following defects noted:

- Visible signs of loss of sections in the support beams and steel landing plates. Indicated by a Number 2 on Photograph 7 below.
- Corrosion of all steel elements except those painted on the ground to first floor flight.
- Missing steel plates forming the landings and stairs. Indicated by a Number 3 on Photograph 7 below.

It should be noted that Arup has instructed all Contractors undertaking work for the Korean House that the fire escape is an unsafe structure and it is not to be used.

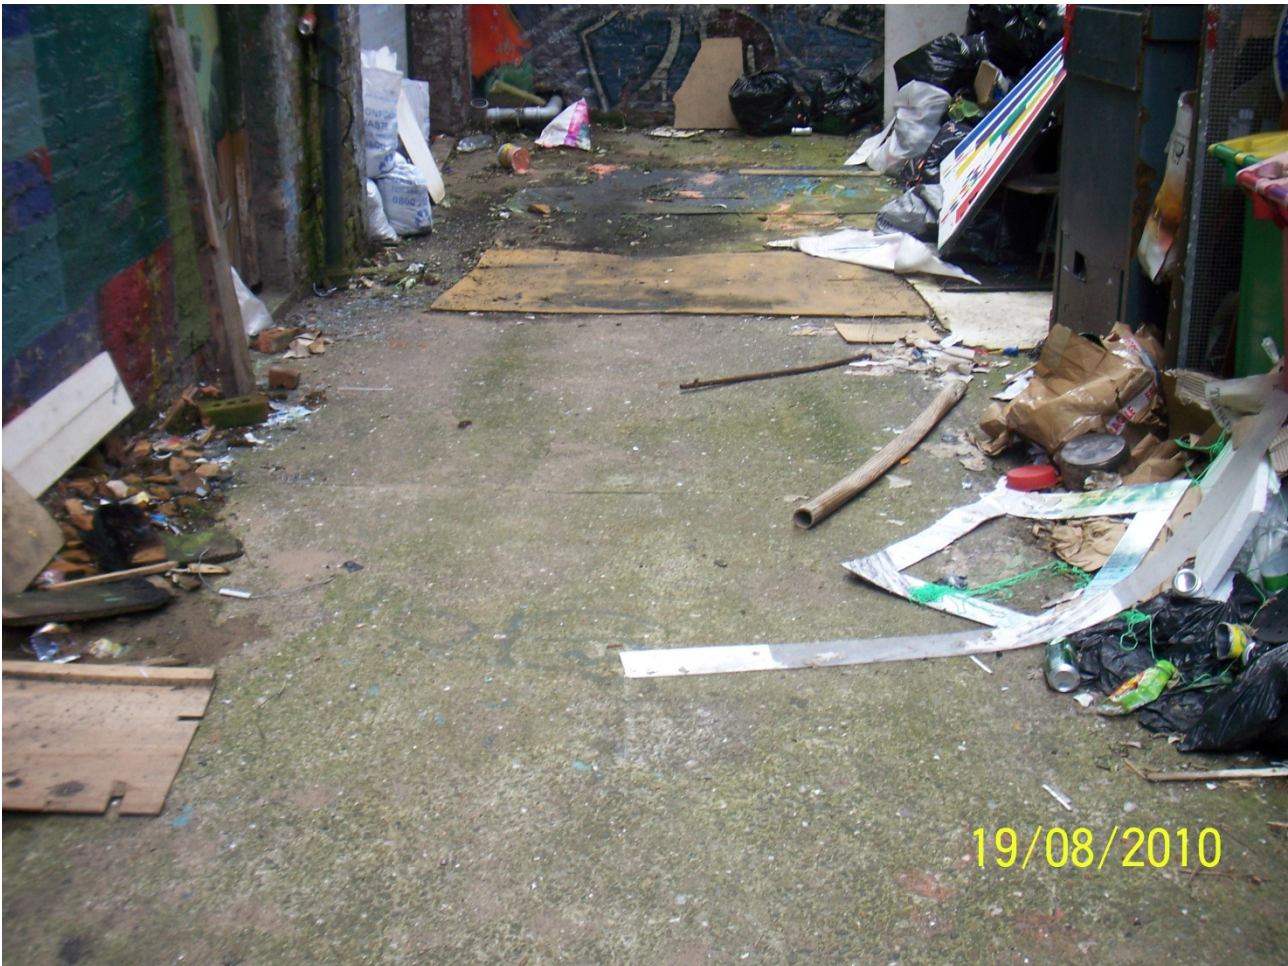
Photograph 8 – Site floor and debris

4. **Floor** – The floor of the site is a concrete slab. There was a large amount of debris on site at the time of the site visit, therefore the full extent of the floor area could not be assessed. The floor is generally in fair condition with no significant signs of cracking, spalling or movement. Photograph 8 below shows the site floor and debris.

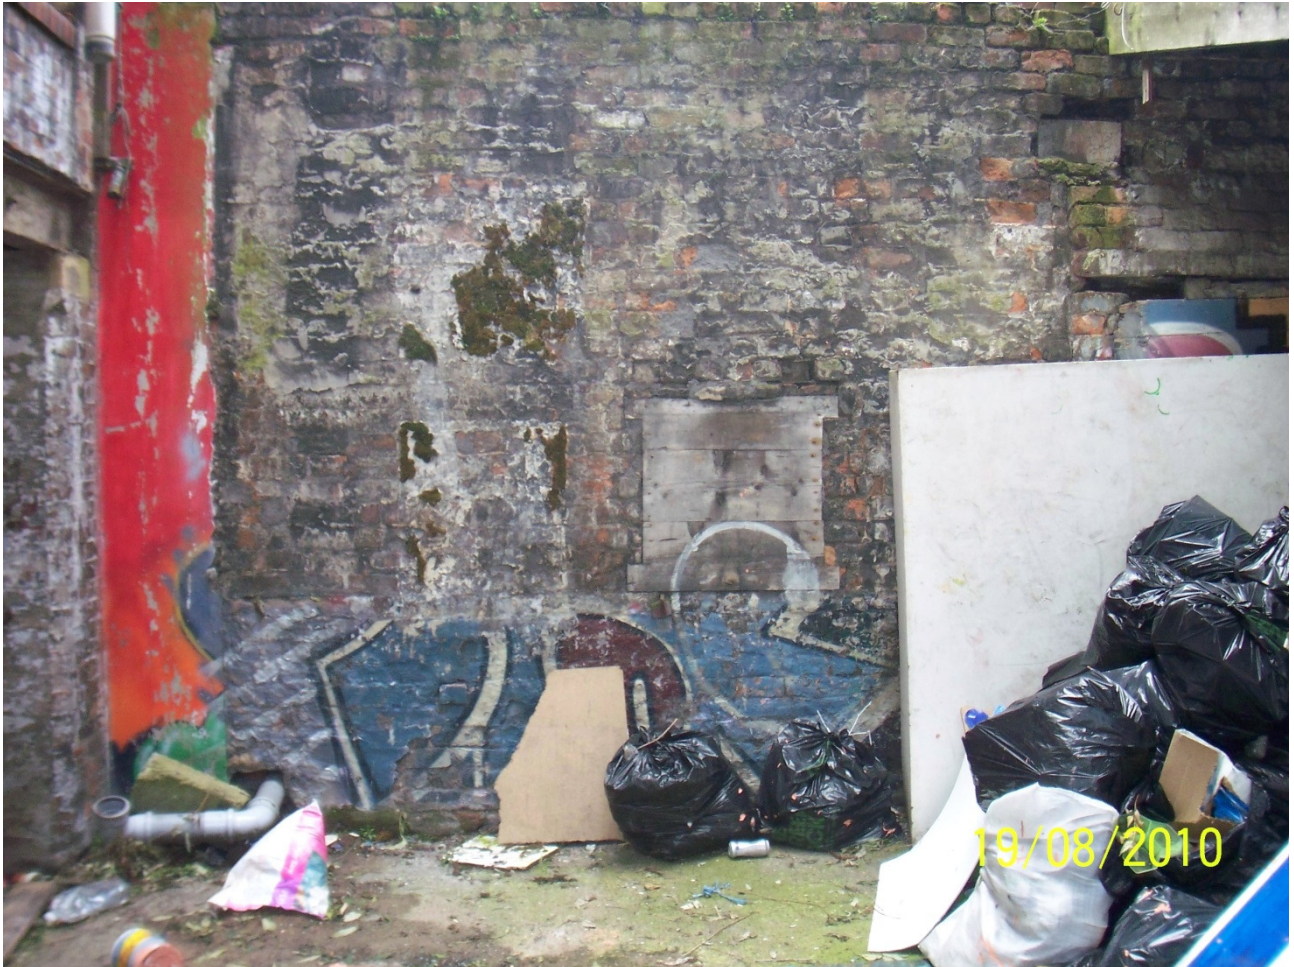
Photograph 9 – Masonry wall at the rear of the site.

5. **Yard Rear Wall** – The rear wall of the site is in poor condition with areas of loose brickwork and substantial mortar loss in the joints. There is a hole in the wall that has been in filled with timber. Photograph 9 below shows the in filled hole and loose brickwork (top right of Photograph 9).

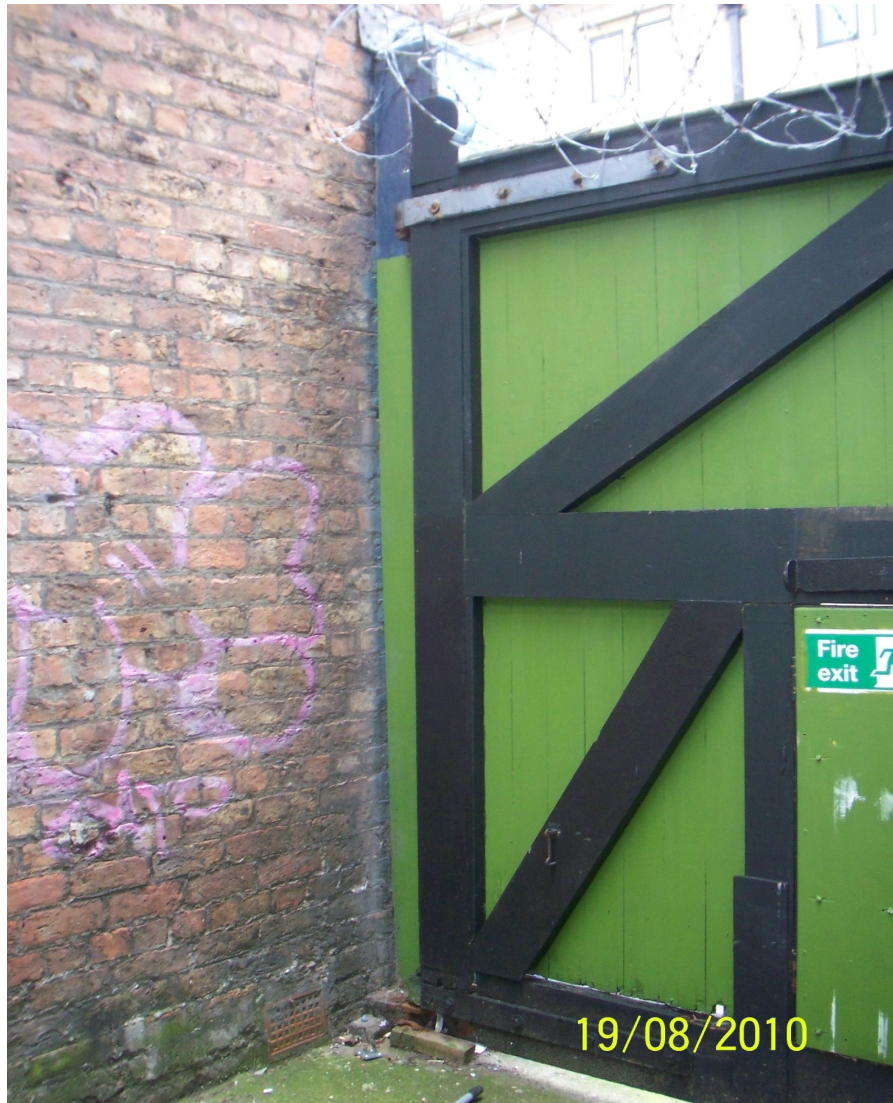
Photograph 10 – Site Front Entrance Timber Gate

6. **Site Front Entrance Gate** – The front entrance gate is constructed from timber supported off timber posts via steel hinges. The timber gate has been painted with a hatch opening for human access. The top half of the gate appeared to be in acceptable condition with no major defects noticed. The bottom half of the gate is in poorer condition with rotten timber boards which have become loose from the main frame. The timber frame around the bottom hinge is also rotten. Photograph 10 below shows the gate and the loose rotten timber around the bottom.
