# **HYDRAULIC TOWER CONDITION**

# Hydraulic Accumulation Tower at Bramley-Moore Dock Liverpool

## Stage 1 Visual Structural Condition Appraisal (2020 Update)

Curtins Ref: BMD01-CUR-Y0-ZZ-RP-S-000001

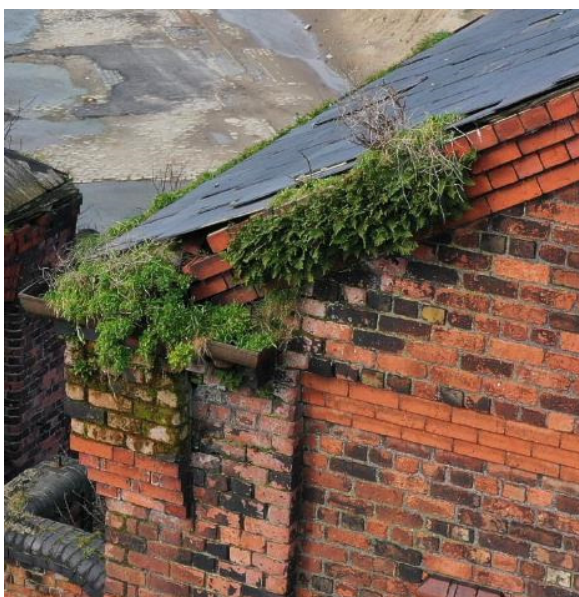
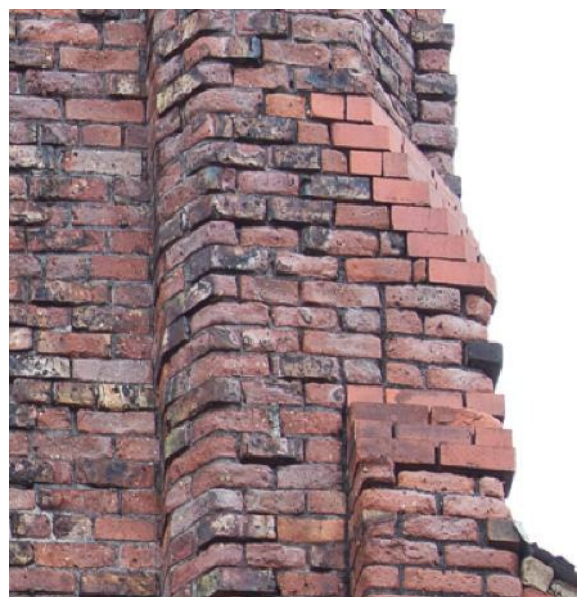
- 4.3 The exposed setting of the building renders it particularly liable to masonry decay processes, especially salt weathering. By and large, the fabric appears to be in fair condition with the exception of exposed elements such as piered corners and projecting architectural detailing which attract the wind, and particularly saturated areas of masonry, which exhibit pronounced fabric decay.

Figure 3: Fabric decay and vegetation particularly prevalent at structural elements which attract the wind

- 4.4 Mortar joints exhibit particularly weathered states at exposed locations, and where the masonry is saturated, the weathering of the mortar is extensive. This has the potential (and is already evident sporadically across the building) for the masonry units to drop out, leading to local instability of discrete elements e.g. corbelled wall head detailing, arches etc. The deep weathering also gives water a deeper foothold, accelerating salt and frost-induced decay.

- 4.5 The weathering of high-level masonry has allowed vegetative growth to take hold and it appears to be disrupting the masonry: the mass coping stones at the top of the tower are becoming displaced, and wall heads generally are loosened where vegetation is observed.

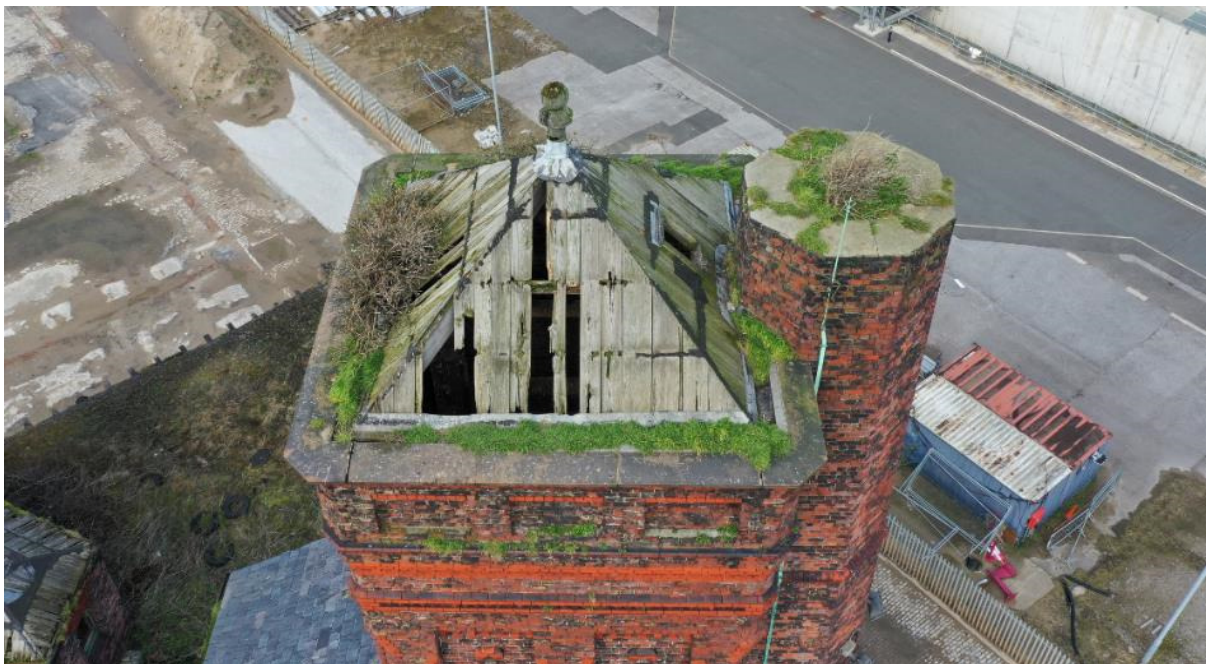
- 4.6 The timber roofs over the various elements of the overall building within the overall complex are in very poor condition and are ineffective for protecting the masonry wall-head from water ingress. Rainwater handling goods are practically non-existent. Sustained wall head water ingress significantly accelerates decay processes and can quickly give rise to local instability. Where the timber roofs bear onto the wet masonry significant decay is anticipated. The consequence of this is that their effectiveness as diaphragm restraints to the masonry wall head is significantly impaired, and the potential for local collapse is significant.

Figure 4: Drone survey image from 2020 condition appraisal. Timber boarding deterioration and vegetation growth appears to have progressed and the mass coping stones appear to have moved further.

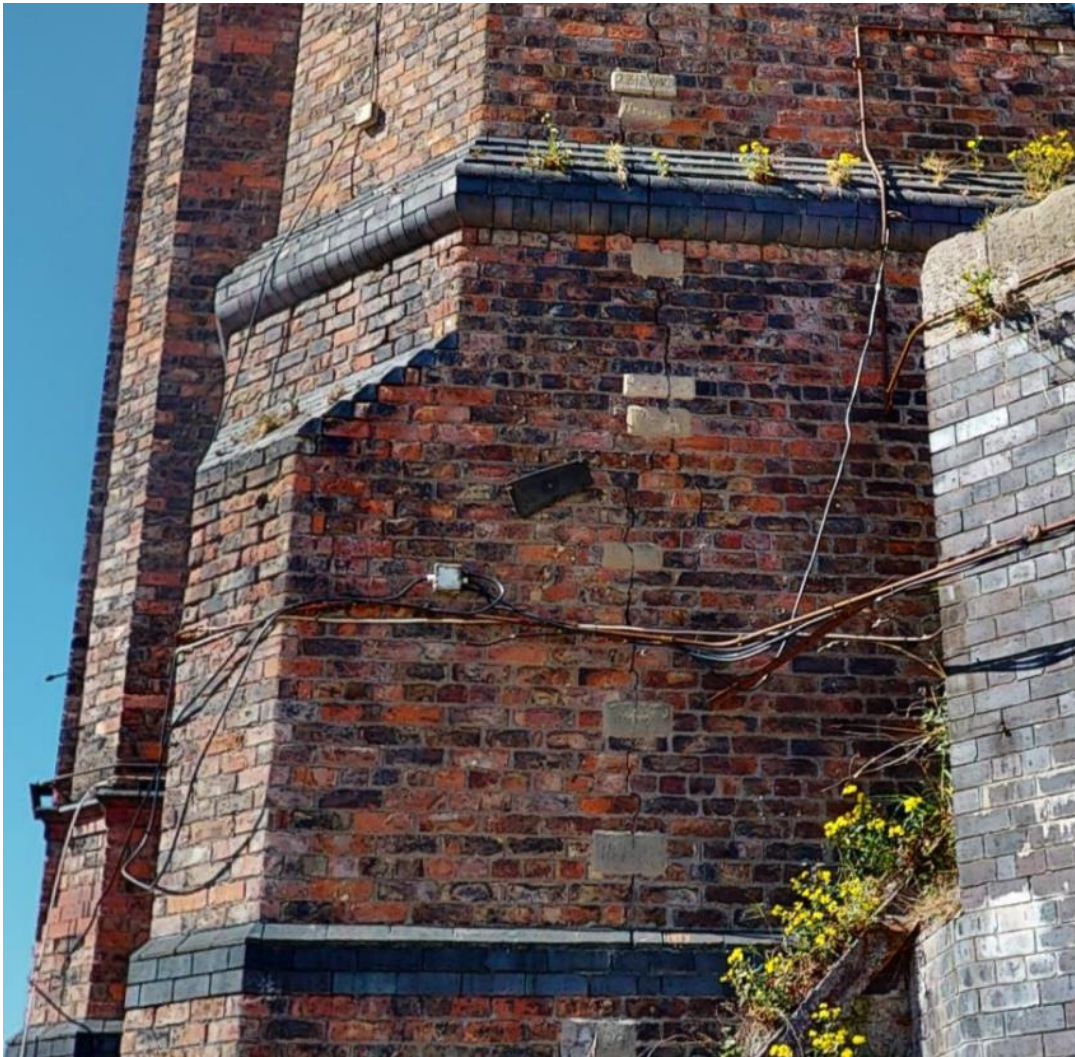
4.7 The root cause of the cracking observed in the Chimney to the Tower is believed to be thermal, arisen during operation of the Tower, for the following reasons:

- The crack is coarsest within the bottom 5m of the chimney, reducing in severity with height (by implication, worst at close proximity to the furnace, best at cooler areas).
- The crack is vertical and follows the centreline of the facet panels finding the thinnest point in the flue (the outer corners of the octagonal external face are the thickest points vs the circular inner face).
- This defect is characteristic of chimney towers of this nature.

Figure 5: Coarse vertical cracking following the centreline of the facet panels of the chimney

4.8 Given this suspected cause, the issue is likely dormant i.e. inactive and not progressive. The old tell-tales indicate a longstanding history and appear to have been monitored since 1979. Cement tell-tales

do not give reliable information so the fact that they have cracked does not necessarily mean the crack is getting worse.

- 4.9 The propagation extent and severity of the crack are not considered to be at a stage whereby they impair the Chimney to the point of instability, although it does represent a structural weakening which warrants remedial work in the medium term.
- 4.10 The half-height extension to the Accumulator Tower, apparently being a retrospective addition to the original Main Tower, is in essence butt-jointed to the Main Tower. The header teeth (visible to the outer face) have snapped, indicating some relative vertical movement between the two parts of the Tower. However, by and large the mortar bed joints and brick courses line through, so the relative movement is minor and not considered structurally significant. In any case the extension appears well bonded at the top, appears plumb, stable: the defect can be recorded, repaired if desired and resolved.

- 6.6 The crack pattern observed on the Tower appears to be consistent with the thermal cracking associated with the function of the Chimney flue. This defect appears to have a relatively longstanding history and does not present cause for immediate concern, however we recommend it be monitored as part of the immediate works, and it would also be prudent to consider installing more permanent designed and approved repair works (most likely using stainless steel embedded crack stitch bars), subject to agreement with the LCC Conservation Officer.

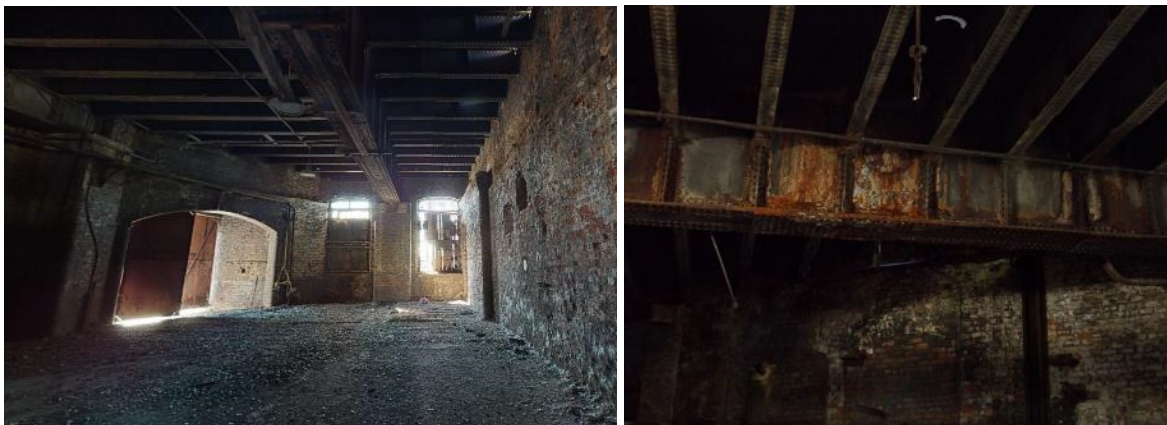
Figure 6: Internal images of the heavy-engineered roof deck over the Boiler House.

- 4.12 Active water ingress through the roof deck is noted, and associated corrosion of the roof structure is observed, particularly on the primary girders. Given their stocky shape they may be twin-web and the actual extent of the corrosion may not be informed by that visible on the outer faces. This applies also to the compression flange which is likely in direct contact with the (leaking) solid decking and may be of more pronounced extent of decay.
- 4.13 No evidence of significant movement or distress was noted to the Boiler House structure; however, the lighting is poor internally within the space, which impeded detailed visual inspection of the roof structure. This, plus the structural movement observed to the office block overhead (discussed below), suggests that the beam grillage and solid roof deck to the Boiler House do warrant further investigation.

- 6.11 The structural condition of the Boiler House roof could not be properly appraised during this survey owing to access constraints and poor lighting; however, we know that there are roof leaks and the beam grillage exhibits corrosion. The extent of structurally relevant corrosion is unknown and should be investigated further. Removal of the pigeons and associated guano will need to be undertaken first however, and the open fenestrations will need to be covered with a suitable mesh to prevent pigeons from re-entering the building.

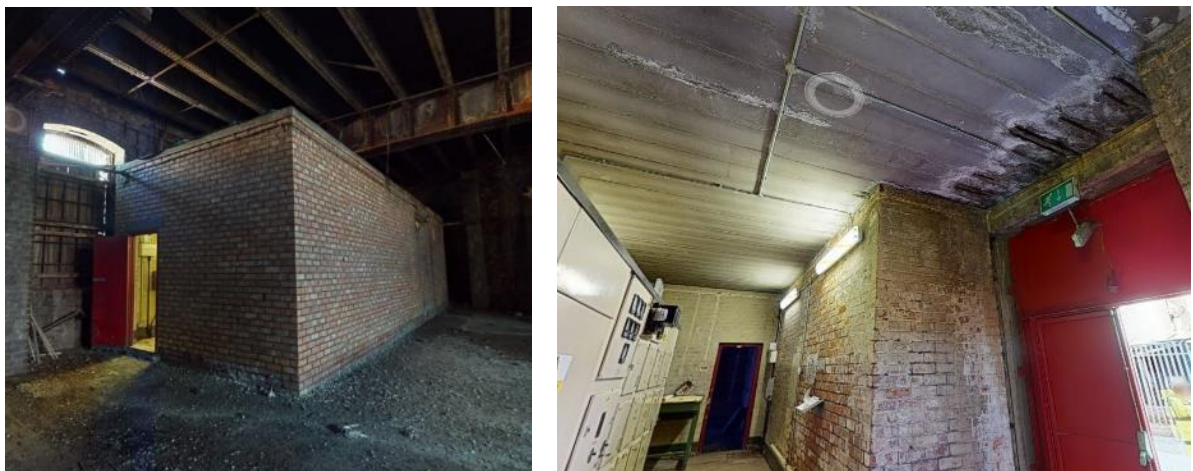
Figure 7: Internal images of the later Switch Room constructed within the Boiler House.
