| BRAMLEY-MOORE HYDRAULIC ACCUMULATION TOWER | | |

**Bramley Moore Dock  
Hydraulic Accumulation Tower  
Visual Condition Appraisal - Update**  
Drawing: 75808-CUR-00-XX-DR-S-101  
Date Prepared: 15/05/2020

**Bramley Moore Dock  
Hydraulic Accumulation Tower  
Visual Condition Appraisal - Update**  
Drawing: 75808-CUR-00-XX-DR-S-102  
Date Prepared: 15/05/2020

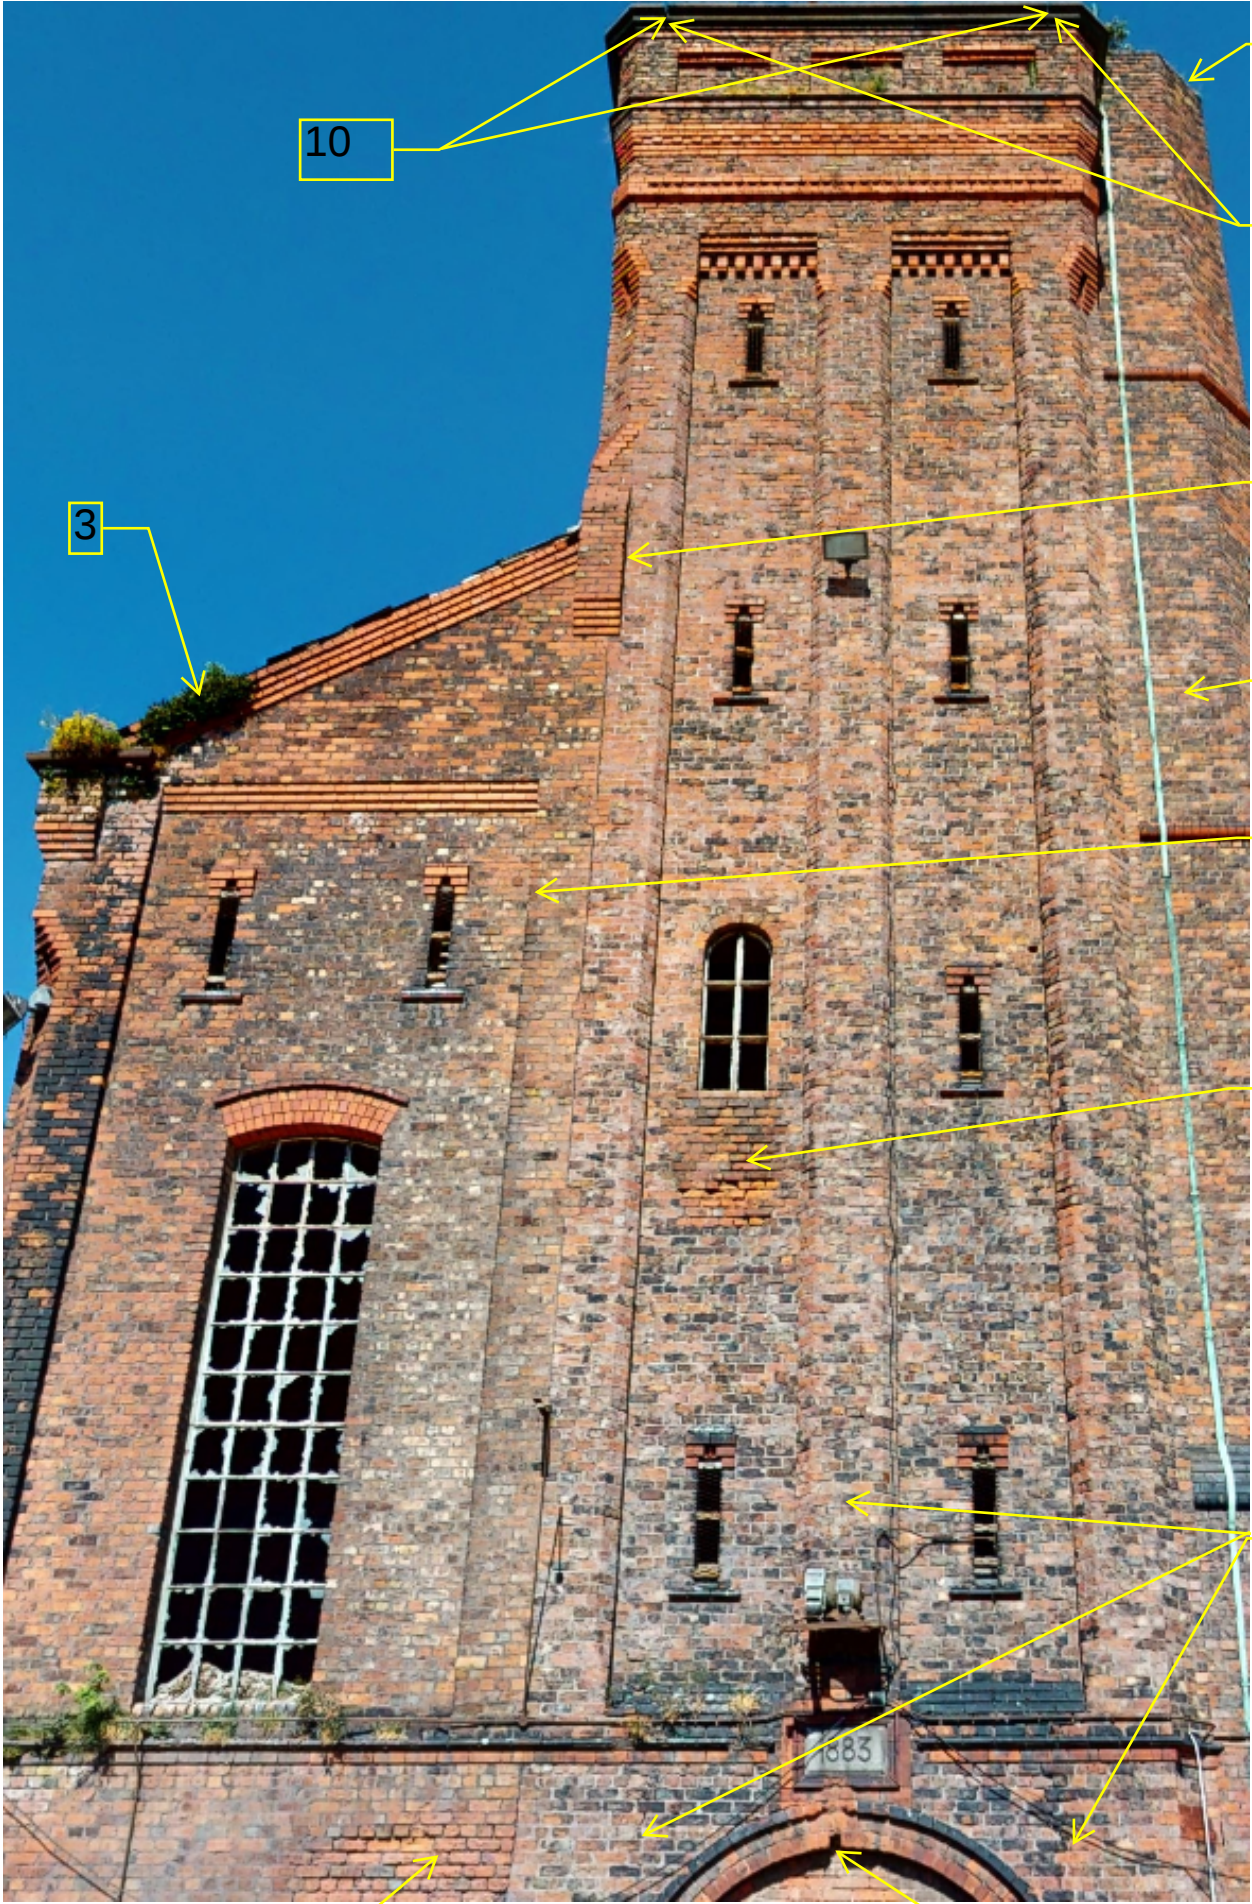
| BRAMLEY-MOORE HYDRAULIC ACCUMULATION TOWER | | |
|---|---|---|
| SE | (GEN NB) | RH chimney appears to widen towards base, built with slight batter towards main tower. LH lower rise on this elev appears to be a retrospectively bonded addition to the core tower. |
| | 1 | Vertical butt-joint between lh lower rise and core tower slightly open; appears to be locally bonded with 3 courses every few metres, however these have sheared through the units and lost bond. Crack closes at top where it receives bonding preload from pier and superstructure construction above (1b). |
| | 2 | Mass coping stones at lh/rh corners of roof appear to be moving slightly outwards, perpends visibly open, although no referred cracking below observed, suggesting weathered mortar perpends propagating ratchet mechanism. Appear stable, minor movement. |
| | 3 | LH skew course along verge exhibits some missing units, weathering of perpends and persistent wall-head water penetration through defective roof. Moss and vegetation noted. |
| | 4 | Main archway geometry appears in good condition with no major distortion. Very slight downward movement in arch at crown (slight 'flattening'. Missing unit at crown appears to be mechanical damage. Weathering of mortar joints appears to exceed 25mm. |
| | 5 | Minor vertical cracking up from both springing points at each end of the main archway, consistent with the slight 'flattening' of the arch under high compressive load down through central pier. |
| | 6 | Deep weathering observed to this area of masonry, progressed since 2016 inspection |
| | 7 | Deep weathering observed to this area of masonry, mortar joints and scaling /spalling of brick units, progressed since 2016 inspection |
| | 8 | Fine vertical crack observed this face of the chimney tower when sighted with powerful binoculars. Crack width estimated to range from H/L to c.5mm, largely following the mortar joints up the centreline of the panel. Some split units observed. Appears to have a longstanding history (does not appear to be a "new" crack) |
| | 9 | Weathering of chimney tower at high level appears to have worsened/progressed since 2016 inspection |
| | 10 | Displacement of coping stones appears to have worsened since 2016 inspection. |

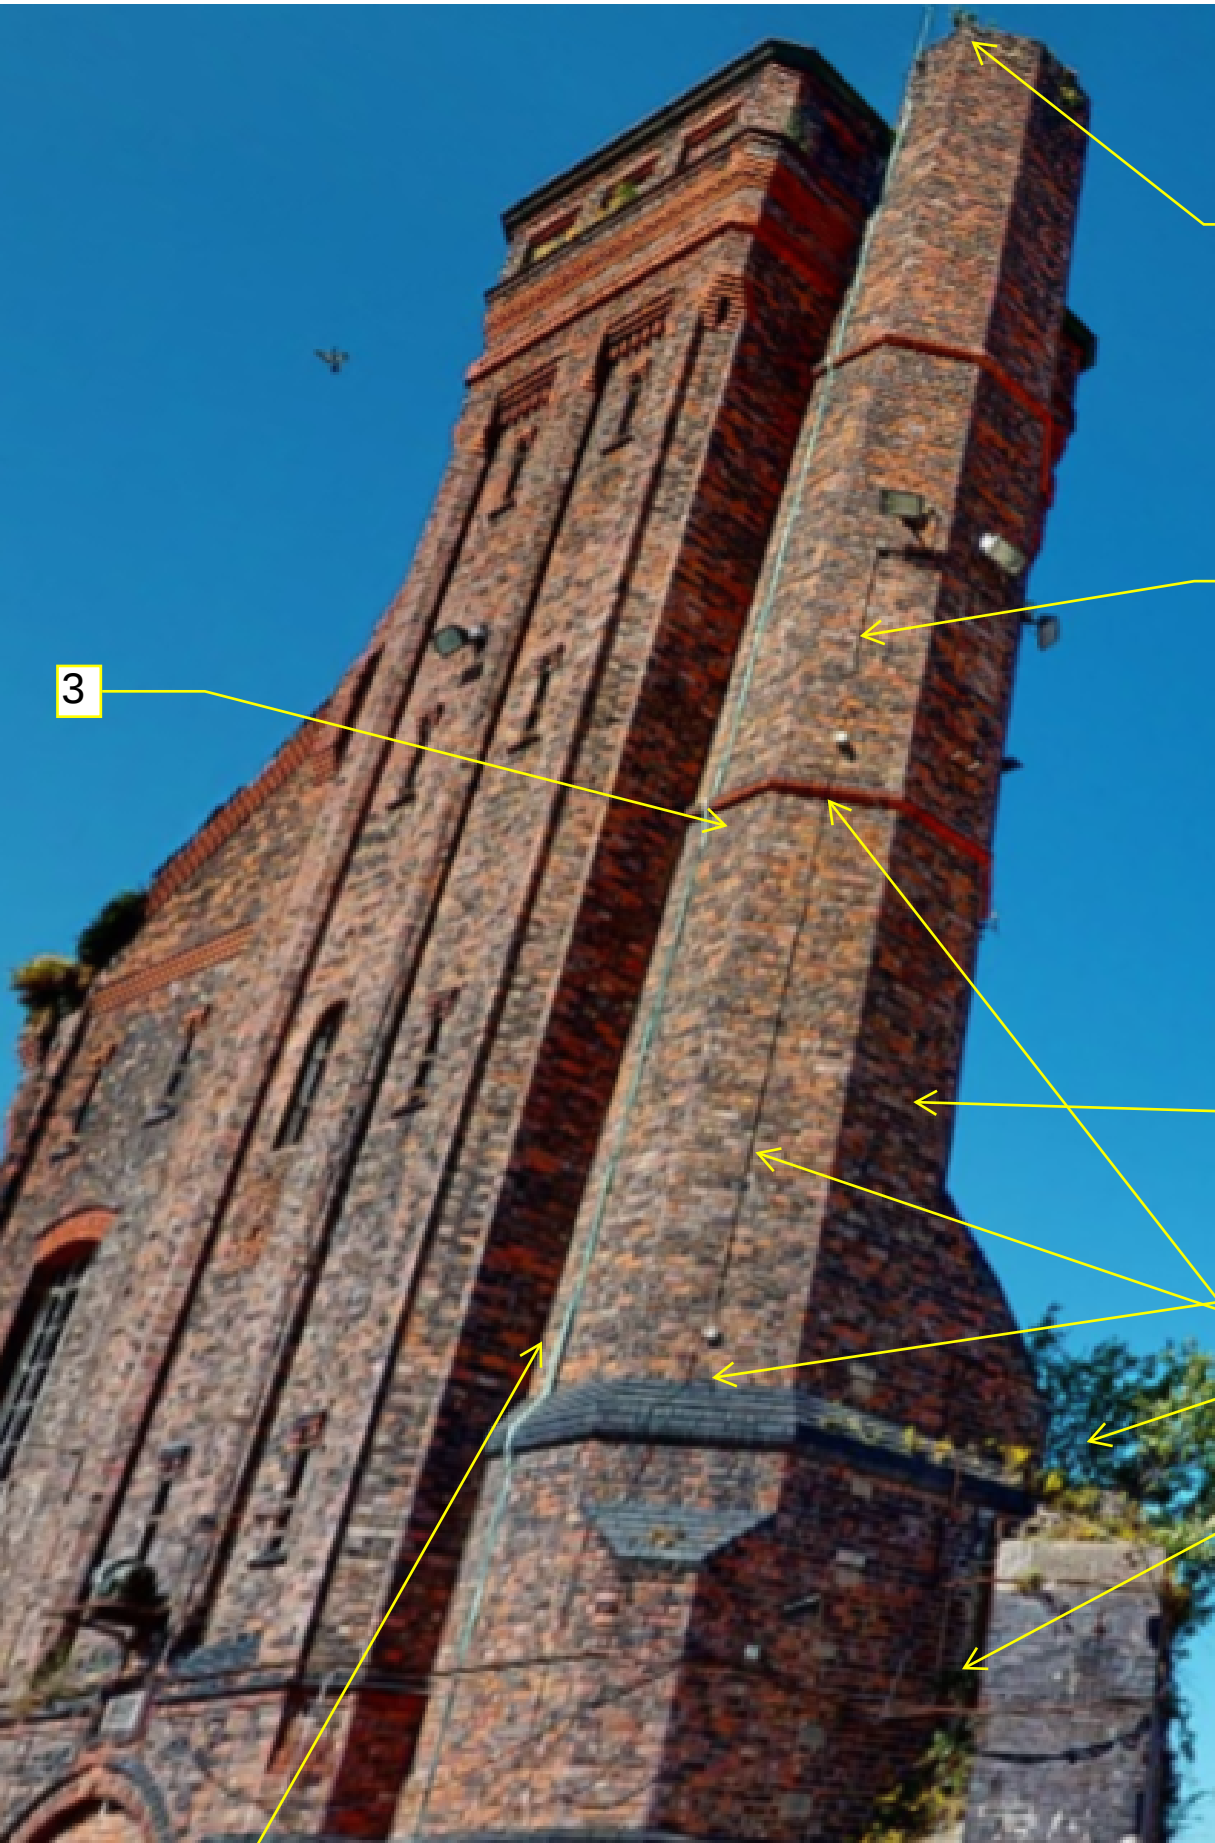
| BRAMLEY-MOORE HYDRAULIC ACCUMULATION TOWER | | |
|---|---|---|
| NE | NB 1 | Chimney construction appears to widen towards base |
| | 2 | Weathering generally exacerbates with height. Possibly no coping to chimney element. |
| | 3 | Minor vert crack down centreline of se face, just below middle string course, diminishing towards lower string course. |
| | 4 | Weathering of mortar joints (see photos) |
| | 5 | Significant vert crack down from middle string course to diminish at btm stiffening pier head on ne face. Both string courses appear level to the eye. Refer to report for narrative re mechanisms. |
| | 6 | Minor/moderate vert crack down centreline of n face diminishing at thickening pier below |
| | 7 | Very minor vert crack as N face, much less pronounced. |
| | 8 | Defective and corroding rainwater handling goods with associated accelerated weathering of masonry and possibly corrosion-related mechanical expansion. |
| | 9 | Vegetation associated with points of water ingress |
| | 10 | Chimney tower well bonded integral with hydraulic tower up full height both returns |
| | 11 | Thermal vertical crack up this panel similar as previous 2016 inspection |
| | 12 | Coarse crack tracks roughly up centreline this panel, wandering off C/L occasionally. Similar extent of propagation to condition observed 2016. |
