**Bramley Moore Dock
Hydraulic Accumulation Tower
Visual Condition Appraisal - Update**
Drawing: 75808-CUR-00-XX-DR-S-103
Date Prepared: 15/05/2020

**Bramley Moore Dock
Hydraulic Accumulation Tower
Visual Condition Appraisal - Update**
Drawing: 75808-CUR-00-XX-DR-S-104
Date Prepared: 15/05/2020

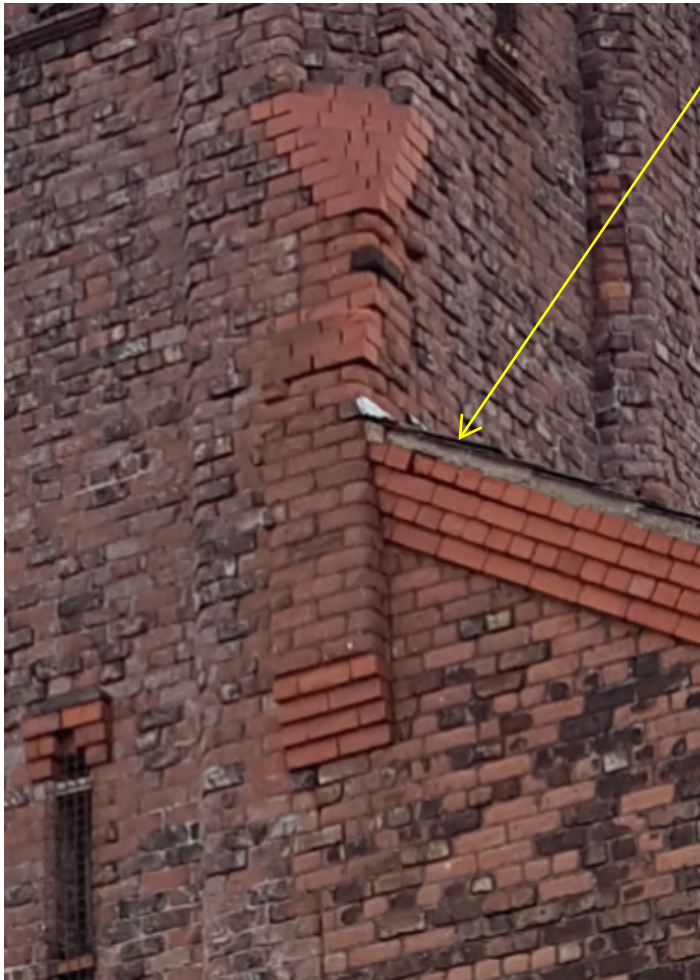
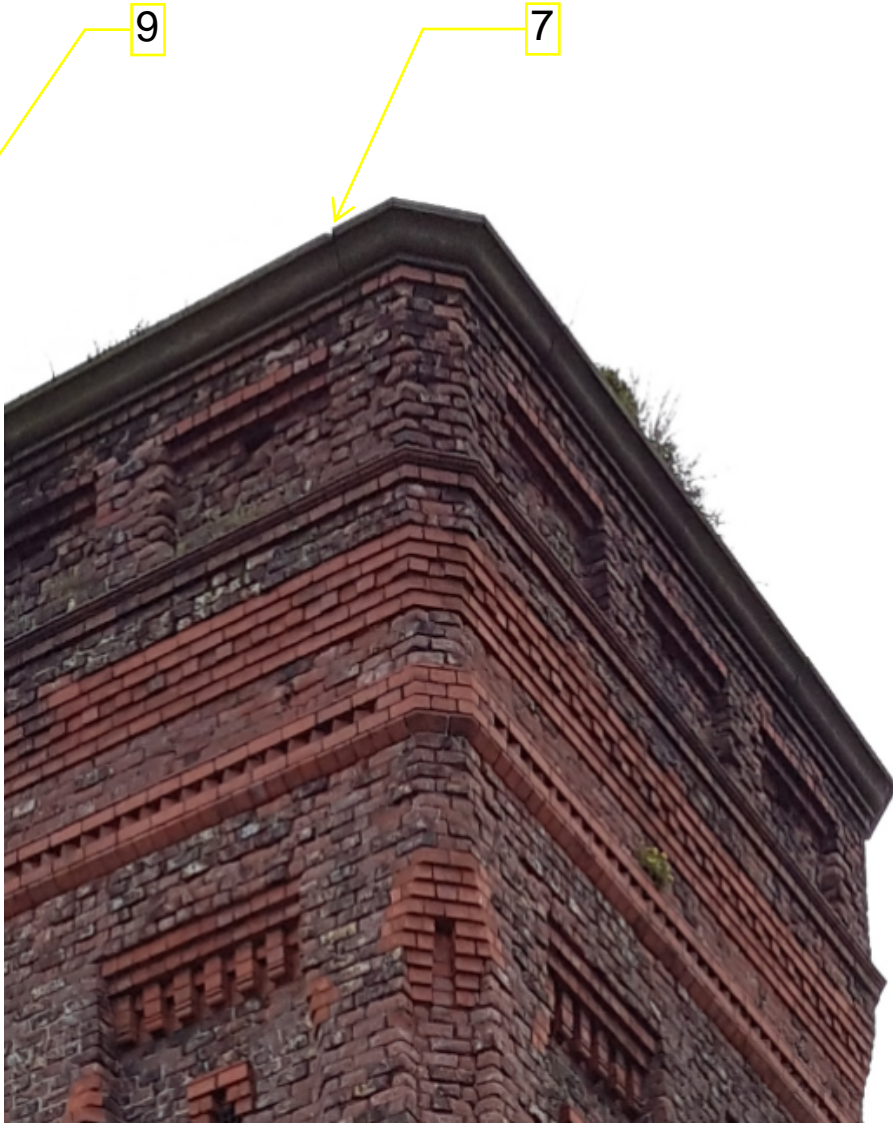
BRAMLEY-MOORE HYDRAULIC ACCUMULATION TOWER		
FACE	DEFECT #	DEFECT DESCRIPTION
NW	1	Butt-joint between low-rise retrospectively bonded tower and main core tower, joint visibly open as SE elev, again closing at point of cross-bonding with preload from superstructure of main core tower. Inspection this side limited owing to vantage points.
	2	Weathering of masonry & extensive opening of mortar joints (weathering-related) at corner corbeled piers.
	3	Mass coping stones exhibit minor movement as se elev, perpends visibly open.
	4	Extensive vegetation on roof at top of main core tower indicates failing roof.
	5	Weathering, exposed corroding girders of flat low-rise roof with extensive wallhead penetration, related vegetation and displacement to wall-head masonry.
	6	Skew course at verge exhibits open perpends indicating wallhead penetration.
	7	Coping stones at tower wallhead appear to have been displaced slightly since the April 2016 inspection. Suspected ratchet mechanism whereby vegetative growth is widening the perpends and debris accumulates in crack.

8	Verge terracotta detailing at wallhead, headers are loosened and several have dropped out. Progressed since the 2016 inspection.
	9	Verge terracotta detailing at wallhead, headers are loosened and several have dropped out. Progressed since the 2016 inspection.

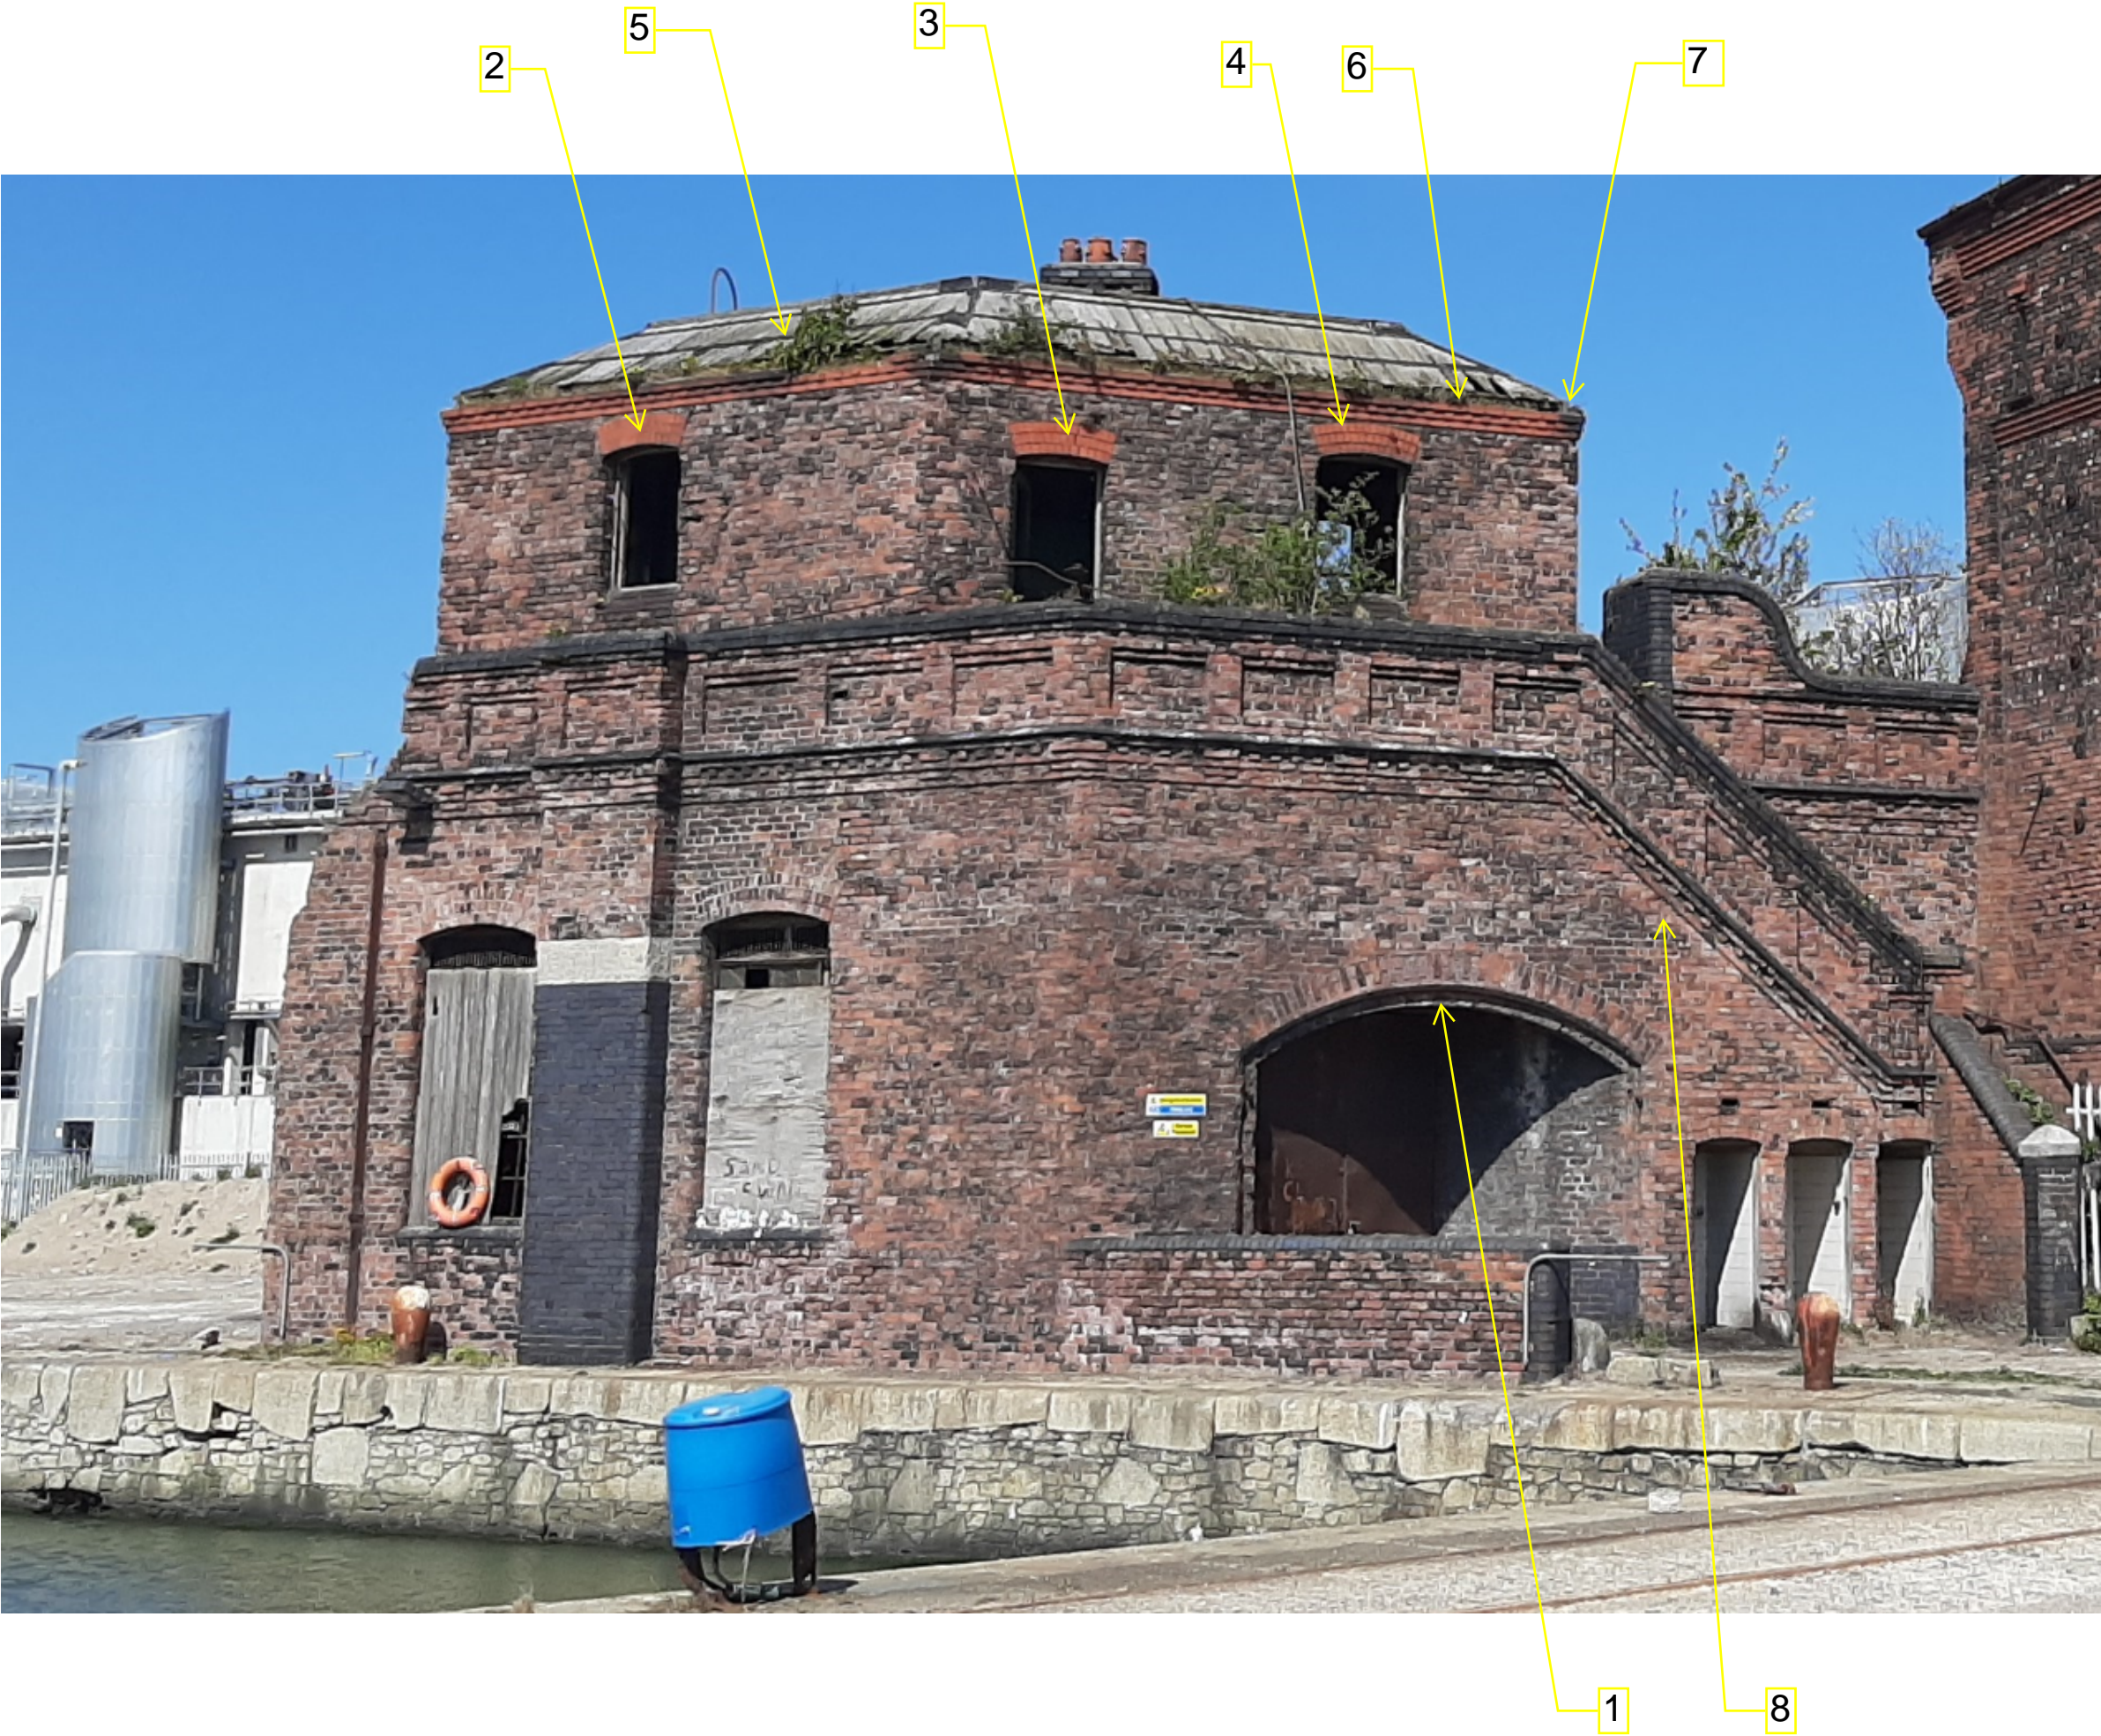
BRAMLEY-MOORE HYDRAULIC ACCUMULATION TOWER		
LOC'N	DEFECT #	DEFECT DESCRIPTION
BOILER HOUSE S / SE ELEV	1	Ground floor level arches exhibit no structural defect of note, good condition, no change in geometry or distress movement in overhead masonry. Main archway into workshop exhibits historic 'bashing' damage to face voussoirs and some mortar weathering / recessed joints over crown. No movement overhead. Toilet entrance arches sound. Exhibit no structural defect of note.
	2	First floor accommodation / office. South facing arched window over engineering brick pier (receiving internal girder) appears to be in sound condition.
	3	Left-hand arch on S/E face exhibits coarse vertical crack through arch up into masonry over, tucked to the right-hand-side of the crown. Crack reduces to hairline width at verge / wallhead.
	4	Right-hand arch on S/E face exhibits good condition, no structural defect of note.

5	South facing wallhead verge exhibits extensive vegetation on wallhead and failed roof. Several units on wallhead lost, several loose.
	6	South-east facing wallhead masonry units appear sound, although extensive vegetation on wallhead and failed roof jeopardise long-term condition.
	7	Right-hand (east) corner on the south-east face very weathered towards the wallhead and loss of units evident. Left-hand corner of wall bonded to return on surface.
	8	Staircase and pierced parapet structurally sound. External face weathered fabric.
