**Bramley Moore Dock
Hydraulic Accumulation Tower
Visual Condition Appraisal - Update**
Drawing: 75808-CUR-00-XX-DR-S-106
Date Prepared: 15/05/2020

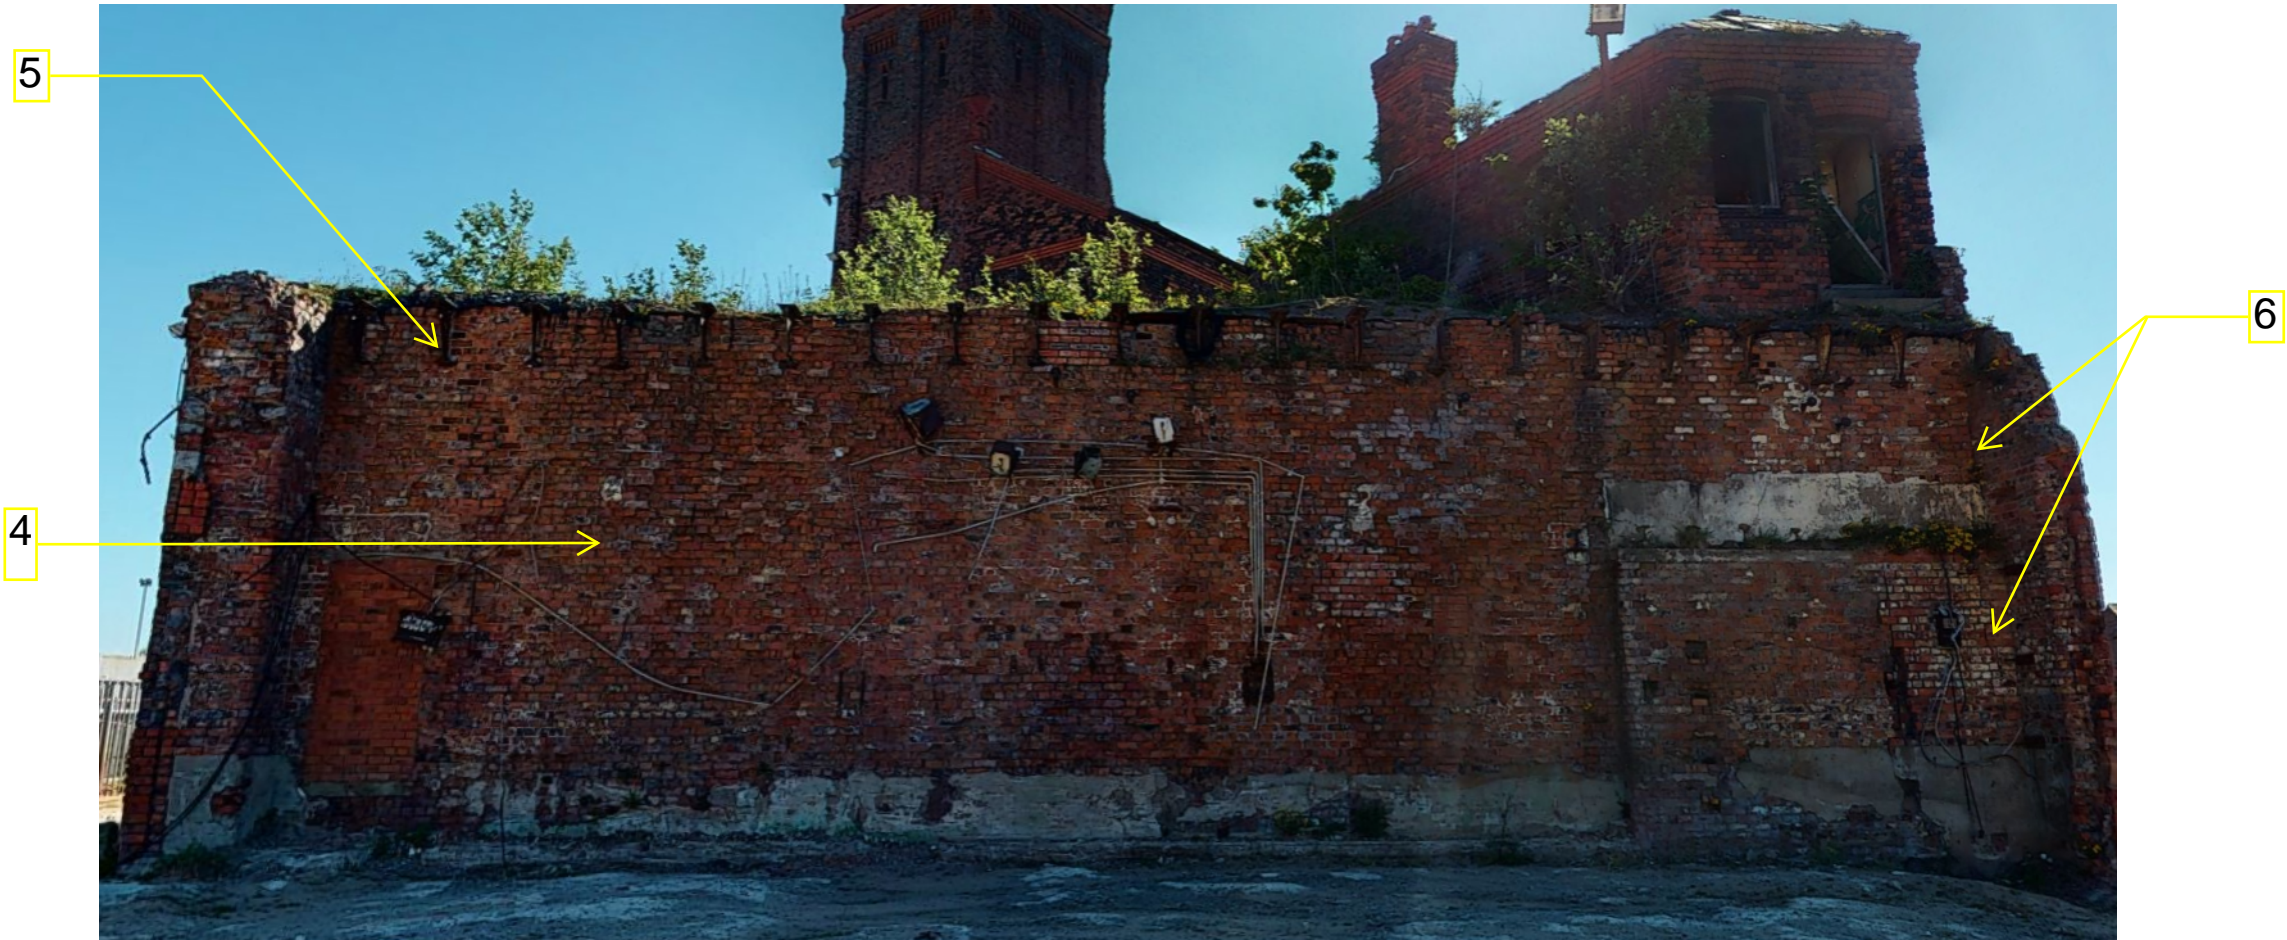
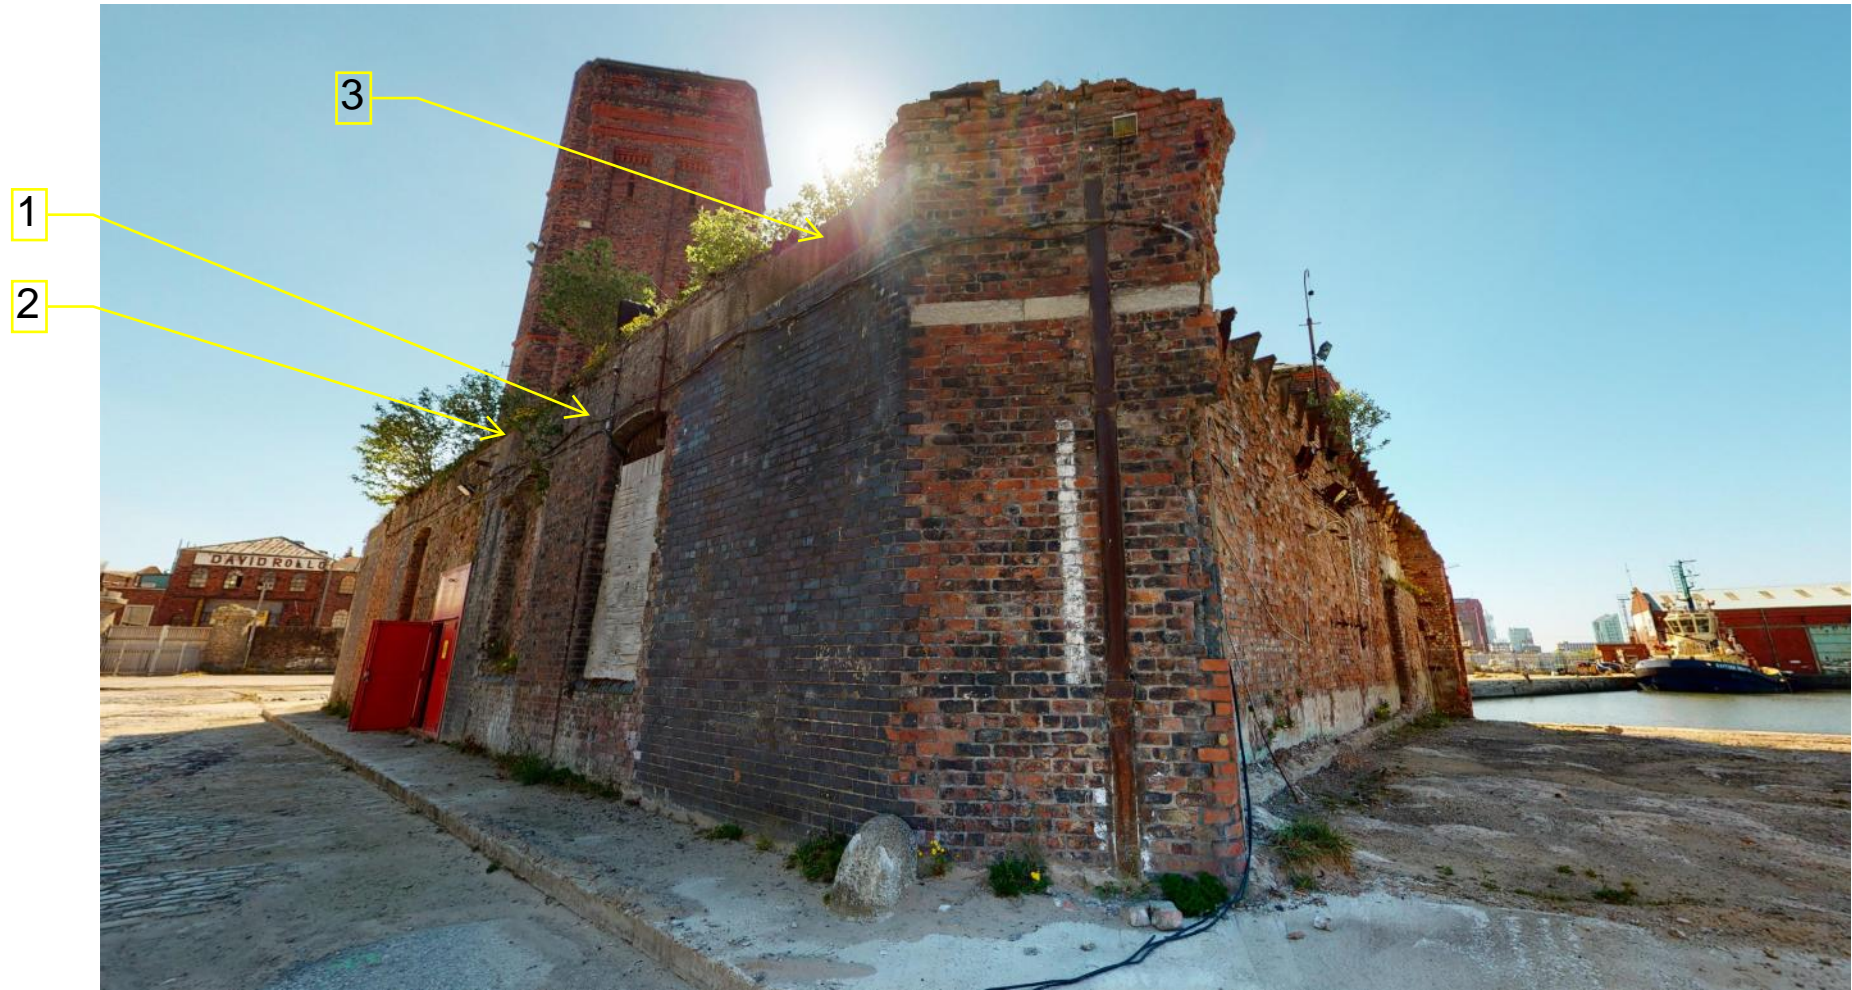
BRAMLEY-MOORE HYDRAULIC ACCUMULATION TOWER		
LOC'N	DEFECT #	DEFECT DESCRIPTION
BOILER HOUSE N & W ELEVS	1	N Elev. Engineering brick piers exhibit good condition. Common bricks heavily weathered by contrast, especially towards wallhead which is subject to active water penetration and supports vegetative growth.
	2	Iron/steel roof structure exposed to the elements, active corrosion visible
	3	Common brick masonry at wallhead (where it thins to accept the built-in roof structure beams) os displaced, loose, disrupted by vegetation.
	4	W Elev. This wall originally was internal (the engine house demolished) It comprises common brick of lesser durability than facing or engineering bricks and is heavily decayed accordingly
	5	Iron/steel roof structure exposed to the elements, active corrosion visible
	6	Vertical gap evident to upper half of wall junction at corner of Boiler House. Also, lower half while appearing bonded around corner is weakened by adjacent in-filled opening
