Bramley Moore Dock
Hydraulic Accumulation Tower
Visual Condition Appraisal - Update
Drawing: 75808-CUR-00-XX-DR-S-107
Date Prepared: 15/05/2020

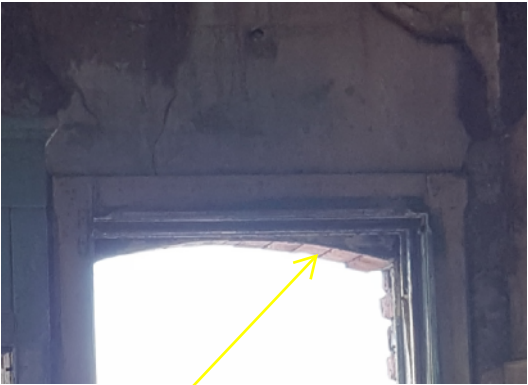
BRAMLEY-MOORE HYDRAULIC ACCUMULATION TOWER		
LOC'N	DEFECT #	DEFECT DESCRIPTION
OFFICE OVER BOILER	1	West elevation drop in arch validated from loss of mortar not move in abutments (see photo)
	2	North elevation drop in arch validated. Coarse cracking up both sides internally, including spandrel below
	3	East elevation drop in arch validated. Coarse cracking up both sides internally, including spandrel below
	4	Window on chamfer at roof access coarsely cracked masonry spandrels below & overhead
	5	South face openings exhibit no structural defect of note internally
	6	Floor rotting, loss of boards. Joists appear adequate but will continue to rot. Roof failed
