**Sisters of Notre Dame
266 Woolton Road
Childwall
Liverpool
L16 8NF**

Arboricultural Assessment

16T/0685
14/3/16

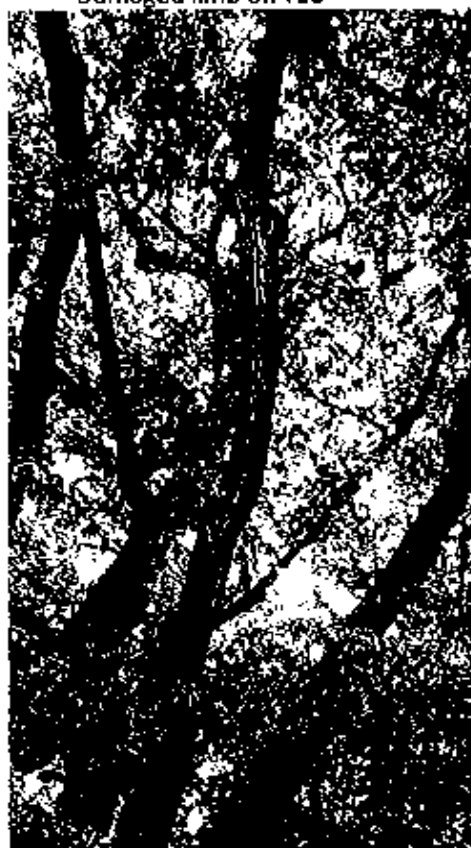
T28	Beech	21-25	M	A/B	A large co-dominant specimen with good form but has a damaged limb over the car park.	Remove damaged limb.	2
T29	Beech	11-15	EM	B	A minor suppressed specimen with poor form.	n/a	-
T30	Lime	6-10	SM	A	A young specimen with good form.	n/a	-
T31	No tree found						
T32	Sycamore	11-15	EM	B	A co-dominant specimen forked at approx 1m with reasonable overall form. Close to property.	Reduce from property by approx 2m.	3

Damaged limb on T28

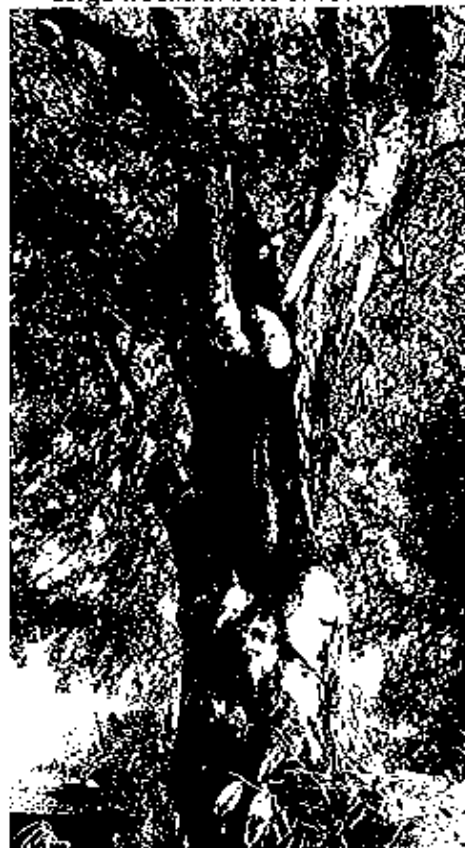
Large wound in bole of T39
