# **Asbestos Refurbishment/Demolition Survey Report**

### **Worley Parsons/National Grid**

**At  
Former Gasworks  
Bank Road  
Garston  
Merseyside  
L19 8HZ**

Report Reference Number: AP000464-02

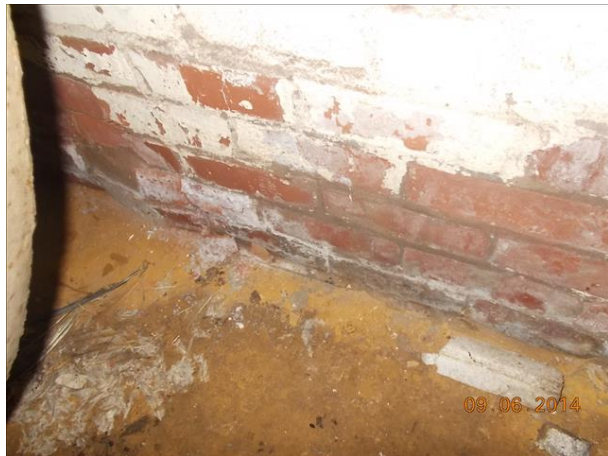
Sample Information	
Site Name/Building Name	Former Gasworks / Former Gasworks
Location	Boiler Room
Floor	Ground
Position	Low level to wall internal and external
Int/Ext	Int
Description	Bitumen Damp Proof Course
Product Type	Bitumen
Extent (actual)	20.0 m Run
Identification	Sampled
Sample Ref	AP000464-02/0007
Visually Similar to Sample

Material Risk Assessment	As Per HSG 264
Product Category	1 - Bitumen
Damage/Deterioration	1 - Low
Surface Treatment	0 - Reinforced - Composite Materials
Asbestos Type(s)	1 - Chrysotile
Material Score	3
Material Risk Category	Very Low

Room/ Location	Position	Building	Floor/ Level	Sample Number	Description	Extent	Comment	Recommended Removal Method
Boiler Room	Low level to wall internal and external	Former Gasworks	Ground	AP000464-02/0007	Bitumen Damp Proof Course	20.0 m Run		Remove asbestos containing bituminous products as per HSG 210-A21
Boiler Room	To pipework flanges	Former Gasworks	Ground	AP000464-02/0008	Gasket	10 Items		Remove compressed asbestos fibre (CAF) gasket as per HSG 210-A25
Boiler Room	To the floor and ledge	Former Gasworks	Ground	AP000464-02/0009	Gasket Debris	4.00 m <sup>2</sup>		Remove compressed asbestos fibre (CAF) gasket debris as per HSG 210-A25
Boiler Room	To the pipework flanges	Former Gasworks	Ground	AP000464-02/0010	Gaskets	10 Items		Remove compressed asbestos fibre (CAF) gasket as per HSG 210-A25
Boiler Room	To the floor and ledges	Former Gasworks	Ground	AP000464-02/0011	Gasket Debris	4.00 m <sup>2</sup>		Remove compressed asbestos fibre (CAF) gasket debris as per HSG 210-A25

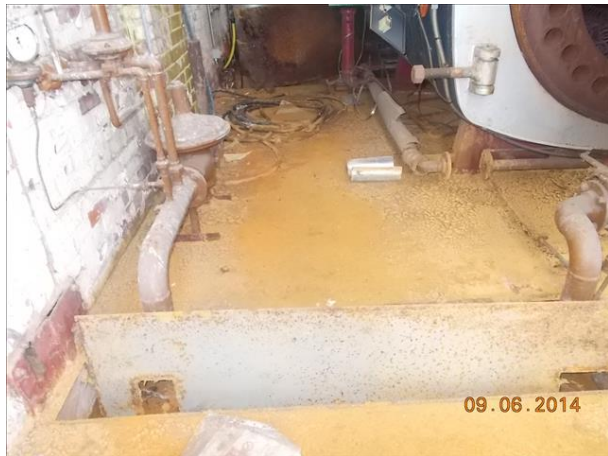
Sample Information	
Site Name/Building Name	Former Gasworks / Former Gasworks
Location	Boiler Room
Floor	Ground
Position	To the floor ducts
Int/Ext	Int
Description	Dust and Debris
Product Type	Debris
Extent (actual)	10.00 m <sup>2</sup>
Identification	Sampled
Sample Ref	AP000464-02/0014
Visually Similar to Sample

Material Risk Assessment	As Per HSG 264
Product Category	3 - Debris
Damage/Deterioration	3 - High
Surface Treatment	3 - Debris
Asbestos Type(s)	0 - No Asbestos Detected
Material Score	0
Material Risk Category	Non asbestos

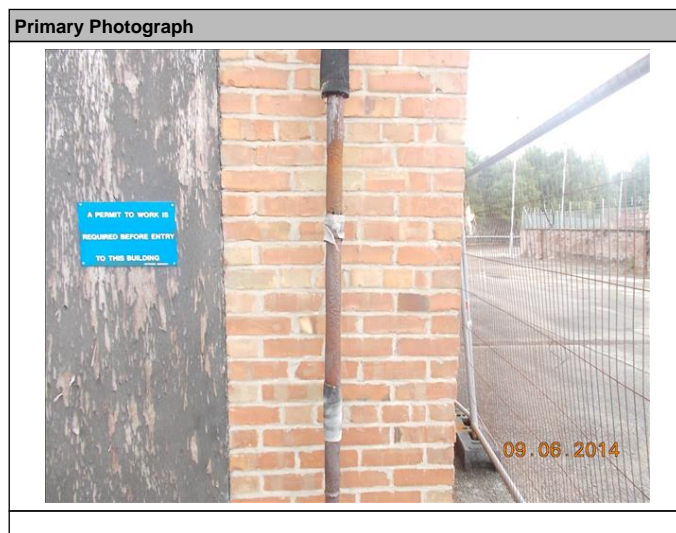
Sample Information	
Site Name/Building Name	Former Gasworks / Former Gasworks
Location	Boiler Room
Floor	External
Position	To the external pipe
Int/Ext	Ext
Description	Bitumen Wrap
Product Type	Bitumen
Extent (actual)	Small Amounts
Identification	Sampled
Sample Ref	AP000464-02/0015
Visually Similar to Sample	AP000464-02/0007

Material Risk Assessment	As Per HSG 264
Product Category	1 - Bitumen
Damage/Deterioration	1 - Low
Surface Treatment	0 - Reinforced - Composite Materials
Asbestos Type(s)	0 - No Asbestos Detected
Material Score	0
Material Risk Category	Non asbestos

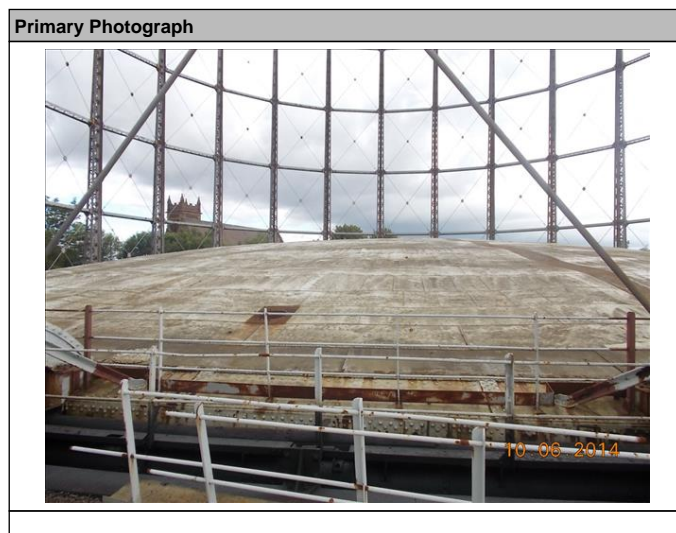
Sample Information	
Site Name/Building Name	Former Gasworks / Former Gasworks
Location	Gas Holder 1
Floor	External
Position	Coating to surfaces around around dome and structure
Int/Ext	Int
Description	Paint Coating
Product Type	Bitumen
Extent (actual)	500.00 m <sup>2</sup>
Identification	Sampled
Sample Ref	AP000464-02/0020
Visually Similar to Sample

Material Risk Assessment	As Per HSG 264
Product Category	1 - Bitumen
Damage/Deterioration	2 - Medium
Surface Treatment	0 - Reinforced - Composite Materials
Asbestos Type(s)	0 - No Asbestos Detected
Material Score	0
Material Risk Category	Non asbestos

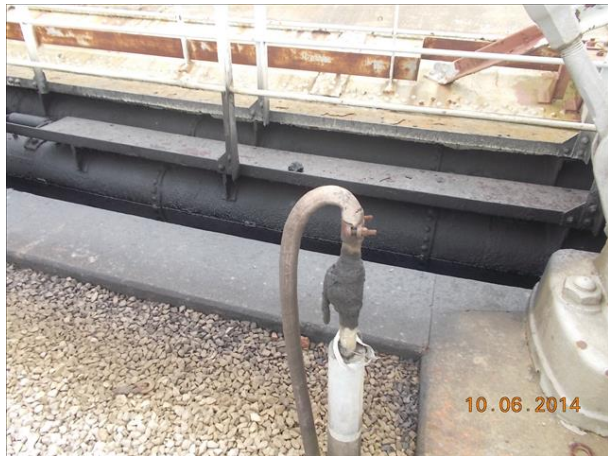
Sample Information	
Site Name/Building Name	Former Gasworks / Former Gasworks
Location	Gas Holder 1
Floor	External
Position	To pipe valve end
Int/Ext	Int
Description	Bitumen
Product Type	Bitumen
Extent (actual)	Small Amounts
Identification	Sampled
Sample Ref	AP000464-02/0021
Visually Similar to Sample

Material Risk Assessment	As Per HSG 264
Product Category	1 - Bitumen
Damage/Deterioration	1 - Low
Surface Treatment	0 - Reinforced - Composite Materials
Asbestos Type(s)	1 - Chrysotile
Material Score	3
Material Risk Category	Very Low

Priority Risk Assessment	Mean Scores Only, Calculated as per HSG 227.
Normal Occ Activity	2
Likelihood Disturbance	0
Human Exposure Potential	1
Maintenance Activity	1
Priority Score	4
