**A165 Chainage 800 to 805m**

**Figure A165 - Bramley Moore: Chainage 800 to 805m**

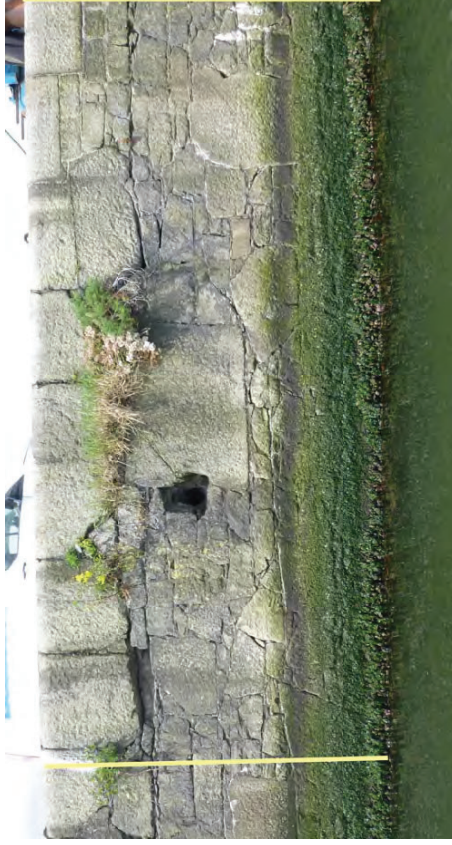
| Overall Assessment | 2 | Good |

| Chainage (m) | Feature | Level (m from top) | Dimensions (m) | Description |
|---|---|---|---|---|
| 800 to 805 | Coping | 0 to 0.5 | - | Good - Minor cracks created by minor movement. Surface defects in coping or limited mortar loss from joints |
| 800 to 805 | Brickwork / Masonry | 0.5 to 1.8 | - | Good - Minor cracks created by minor movement. Surface defects in bricks or limited mortar loss from joints |
| 800 to 805 | Marine Growth | 1.5 to 1.8 | - | Minor growth. Features partially obscured |
| 801 to 803.5 | Vegetation | 0.3 to 0.5 | - | Minor growth. Features partially obscured. Onset of structural degradation by root growth |
| 802 | Weephole / Outfall | 0.8 | D = 0.2m | Circular weephole/outfall. Fair condition, some deterioration of material surrounding weephole/outfall. Any fixings have minor damage |
| 800 to 805 | Concrete | 0 (coping) | - | Good - Structurally sound but with minor cracks and localised honeycombing/flaking with no significant defects |

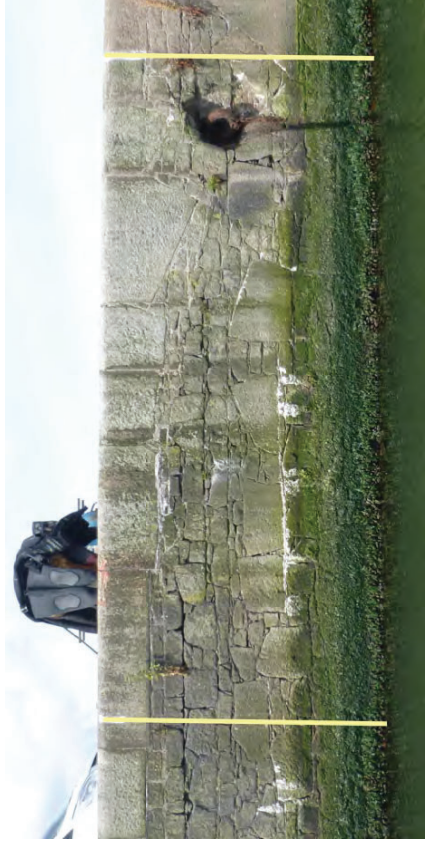
**Figure A166 - Bramley Moore: Chainage 805 to 810m**

| Overall Assessment | 2 | Good |

| Chainage (m) | Feature | Level (m from top) | Dimensions (m) | Description |
|---|---|---|---|---|
| 805 to 810 | Coping | 0 to 0.5 | - | Very Good - No sign of movement. Joints are sound with no loss of mortar |
| 805 to 810 | Brickwork / Masonry | 0.5 to 1.8 | - | Good - Minor cracks created by minor movement. Surface defects in bricks or limited mortar loss from joints |
| 805 to 810 | Marine Growth | 1.5 to 1.8 | - | Minor growth. Features partially obscured |
| 809 | Mooring Chain | 0.8 to 1.8 | - | Fixed within recess. Fair condition, extensive corrosion with minor thickness loss and/or minor damage to links |
| 805 to 810 | Concrete | 0 (coping) | - | Good - Structurally sound but with minor cracks and localised honeycombing/flaking with no significant defects |
| 806 | Mooring Bollard | 0 (coping) | H = 0.8m | T-shaped bollard embedded into coping. Good condition, localised surface corrosion |

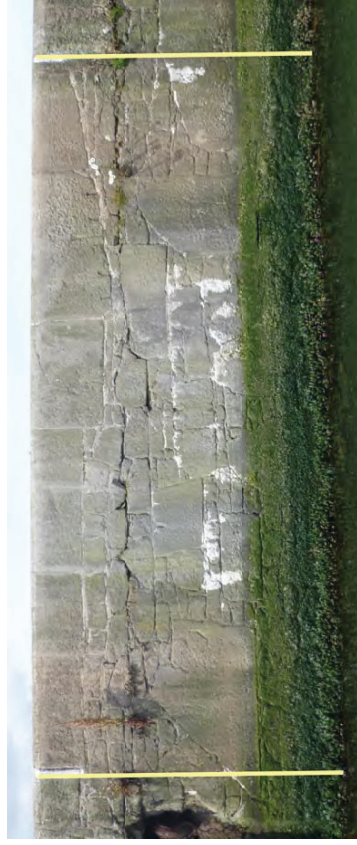
**Figure A167 - Bramley Moore: Chainage 810 to 815m**

| Overall Assessment | 1 | Very Good |

| Chainage (m) | Feature | Level (m from top) | Dimensions (m) | Description |
|---|---|---|---|---|
| 810 to 815 | Coping | 0 to 0.5 | - | Very Good - No sign of movement. Joints are sound with no loss of mortar |
| 810 to 815 | Brickwork / Masonry | 0.5 to 1.8 | - | Very Good - No sign of movement. Joints are sound with no loss of mortar |
| 810 to 815 | Marine Growth | 1.5 to 1.8 | - | Minor growth. Features partially obscured |
| 810 to 815 | Concrete | 0 (coping) | - | Good - Structurally sound but with minor cracks and localised honeycombing/flaking with no significant defects |
| 810.5 | Metalwork | 0 (coping) | 0.1 x 0.1m | Metal fixing. Good condition, localised surface corrosion |

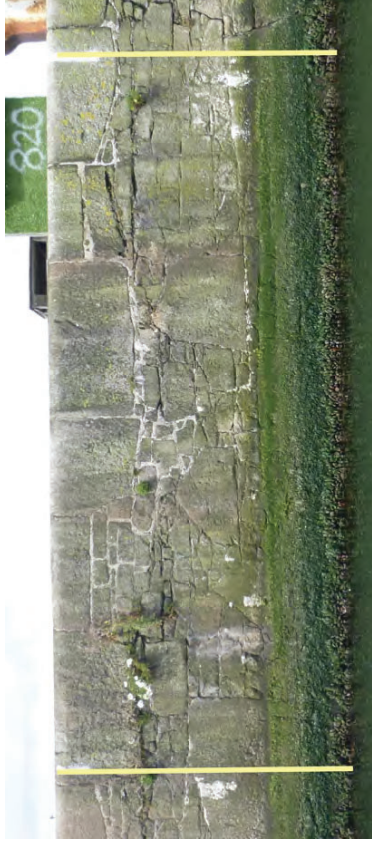
**Figure A168 - Bramley Moore: Chainage 815 to 820m**

| Overall Condition Rating | | |
|---|---|---|
| Overall Assessment | 2 | Good |

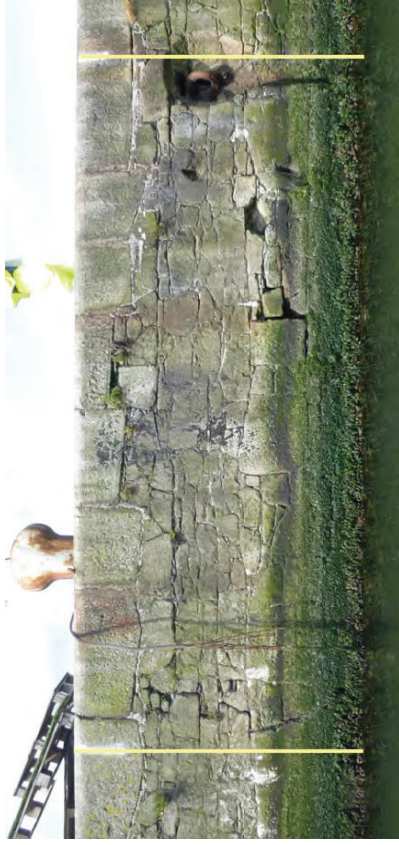
**Figure A169 - Bramley Moore: Chainage 820 to 825m**

| Overall Assessment | 2 | Good |

| Chainage (m) | Feature | Level (m from top) | Dimensions (m) | Description |
|---|---|---|---|---|
| 820 to 825 | Coping | 0 to 0.5 | - | Good - Minor cracks created by minor movement. Surface defects in coping or limited mortar loss from joints |
| 820 to 825 | Brickwork / Masonry | 0.5 to 1.8 | - | Good - Minor cracks created by minor movement. Surface defects in bricks or limited mortar loss from joints |
| 820 to 825 | Marine Growth | 1.5 to 1.8 | - | Minor growth. Features partially obscured |
| 821 | Miscellaneous | 0 to 1.5 | - | Steel cable fixed to mooring bollard. Significant corrosion |
| 824.5 | Mooring Chain | 0.8 to 1.8 | - | Fixed within recess. Fair condition, extensive corrosion with minor thickness loss and/or minor damage to links |
| 820 to 825 | Concrete | 0 (coping) | - | Good - Structurally sound but with minor cracks and localised honeycombing/flaking with no significant defects |
| 821.5 | Mooring Bollard | 0 (coping) | H = 0.8m | T-Shaped bollard embedded into coping. Good condition, localised surface corrosion |

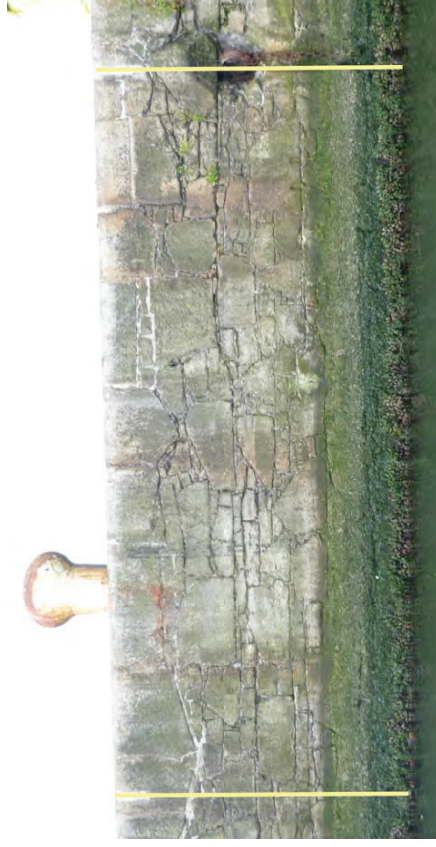
**Figure A172 - Bramley Moore: Chainage 835 to 840m**

| Chainage (m) | Feature | Level (m from top) | Dimensions (m) | Description |
|---|---|---|---|---|
| 835 to 840 | Concrete | 0 (coping) | - | Good - Structurally sound but with minor cracks and localised honeycombing/flaking with no significant defects |
| 836.5 | Mooring Bollard | 0 (coping) | H = 0.8m | T-Shaped bollard embedded into coping. Good condition, localised surface corrosion |

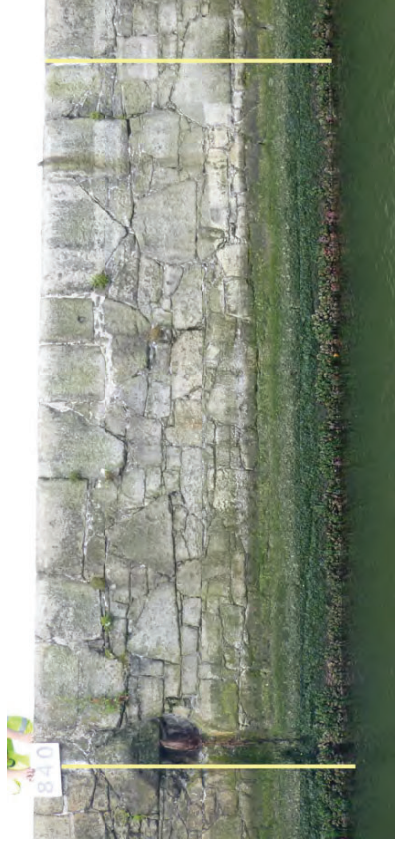
**Figure A173 - Bramley Moore: Chainage 840 to 845m**

| Chainage (m) | Feature | Level (m from top) | Dimensions (m) | Description |
|---|---|---|---|---|
| 840 | Mooring Chain | 0.7 to 1.8 | - | Fixed within recess. Fair condition, extensive corrosion with minor thickness loss and/or minor damage to links |
| 840 to 845 | Concrete | 0 (coping) | - | Good - Structurally sound but with minor cracks and localised honeycombing/flaking with no significant defects |
| 841 | Metalwork | 0 (coping) | 0.1 x 0.1m | Metal fixing. Good condition, localised surface corrosion |

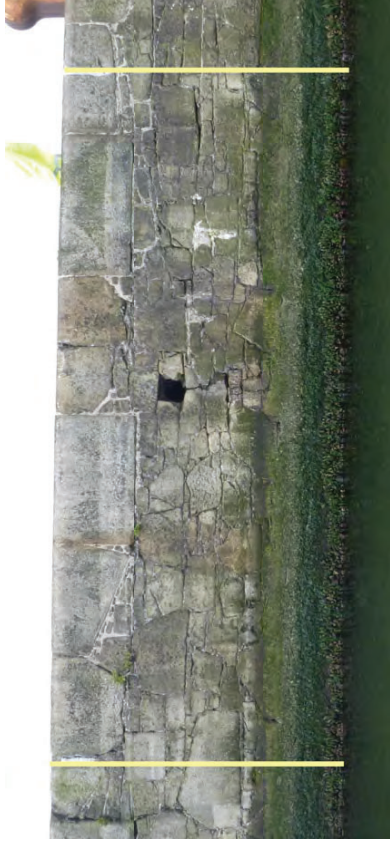
**Figure A174 - Bramley Moore: Chainage 845 to 850m**

| Chainage (m) | Feature | Level (m from top) | Dimensions (m) | Description |
|---|---|---|---|---|
| 848 | Weephole / Outfall | 0.6 | D = 0.3m | Rectangular weephole/outfall. Good condition, some degradation but fully operable |
| 845 to 850 | Concrete | 0 (coping) | - | Good - Structurally sound but with minor cracks and localised honeycombing/flaking with no significant defects |
| 847 | Metalwork | 0 (coping) | 0.1 x 0.1m | Metal fixing. Good condition, localised surface corrosion |

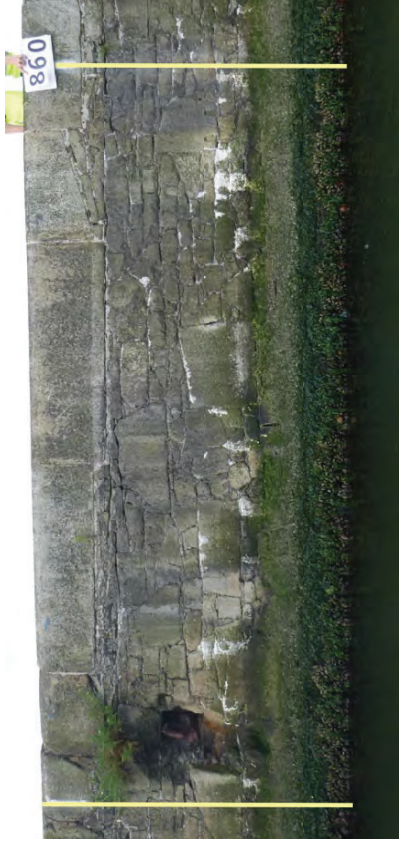
**Figure A176 - Bramley Moore: Chainage 855 to 860m**

| Chainage (m) | Feature | Level (m from top) | Dimensions (m) | Description |
|---|---|---|---|---|
| 855 to 856 | Vegetation | 0.4 | - | Minor growth. Features partially obscured. Onset of structural degradation by root growth |
| 855 to 856 | Mooring Chain | 0.5 to 1.5 | - | Fixed within recess. Fair condition, extensive corrosion with minor thickness loss and/or minor damage to links |
| 855 to 860 | Concrete | 0 (coping) | - | Good - Structurally sound but with minor cracks and localised honeycombing/flaking with no significant defects |
| 856 and 859 | Metalwork | 0 (coping) | 0.1 x 0.1m | Metal fixing. Good condition, localised surface corrosion |

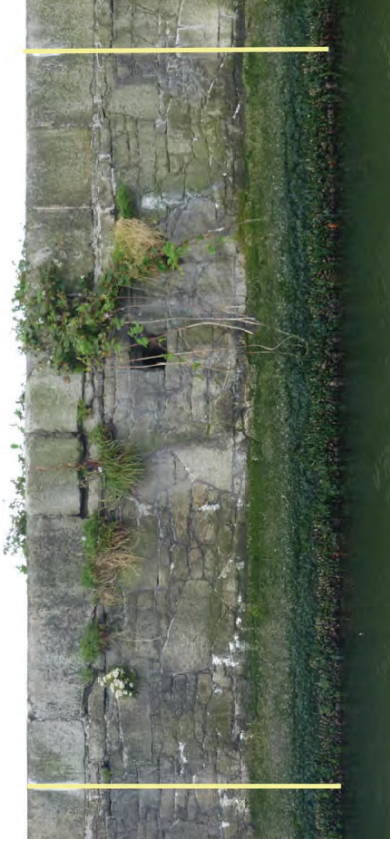
**Figure A177 - Bramley Moore: Chainage 860 to 865m**

| Chainage (m) | Feature | Level (m from top) | Dimensions (m) | Description |
|---|---|---|---|---|
| 860 to 865 | Coping | 0 to 0.4 | - | Fair - Slight coping displacement created by movement. Mortar loss from joints and joints/coping cracking. Rounding/chipping of coping edges |
| 860 to 865 | Brickwork / Masonry | 0.4 to 1.8 | - | Good - Minor cracks created by minor movement. Surface defects in bricks or limited mortar loss from joints |
| 861 to 864 | Vegetation | 0 to 0.6 | - | Minor growth. Features partially obscured. Onset of structural degradation by root growth |
| 863 | Weephole / Outfall | 0.6 | D = 0.3m | Rectangular weephole/outfall. Good condition, some degradation but fully operable |
| 860 to 865 | Concrete | 0 (coping) | - | Good - Structurally sound but with minor cracks and localised honeycombing/flaking with no significant defects |
| 863 | Metalwork | 0 (coping) | 0.1 x 0.1m | Metal fixing. Good condition, localised surface corrosion |

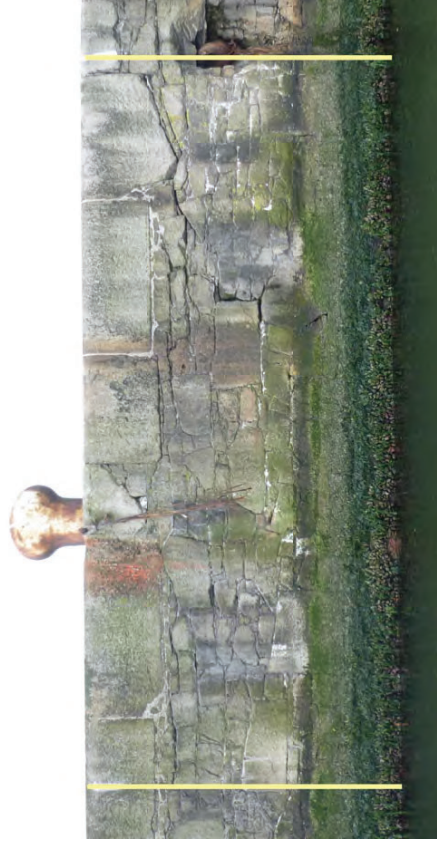
**Figure A178 - Bramley Moore: Chainage 865 to 870m**

| <b>Overall Condition Rating</b> | <b>2</b> | <b>Good</b> |

| Chainage (m) | Feature | Level (m from top) | Dimensions (m) | Description |
|---|---|---|---|---|
| 865 to 870 | Brickwork / Masonry | 0.5 to 1.8 | - | Good - Minor cracks created by minor movement. Surface defects in bricks or limited mortar loss from joints |
| 867 | Mooring Ring | 0 | - | Fixed to coping. Fair condition, extensive corrosion with minor thickness loss and/or minor damage to ring/fixing |
| 865 to 870 | Concrete | 0 (coping) | - | Good - Structurally sound but with minor cracks and localised honeycombing/flaking with no significant defects |
| 865 and 869 | Metalwork | 0 (coping) | 0.1 x 0.1m | Metal fixing. Good condition, localised surface corrosion |
| 867 | Mooring Bollard | 0 (coping) | H = 0.8m | T-Shaped bollard embedded into coping. Good condition, localised surface corrosion |

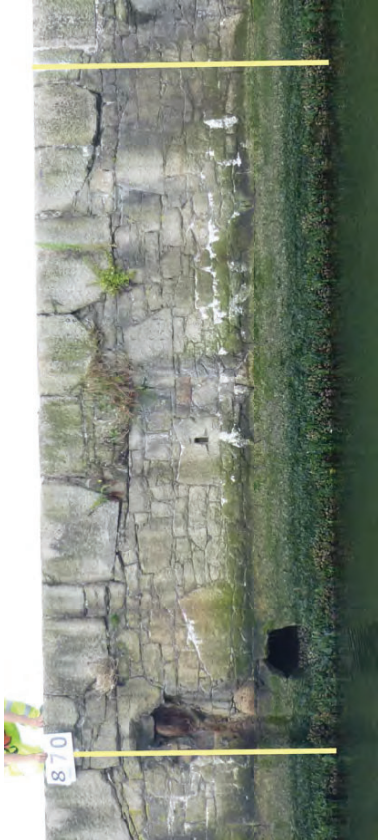
A179 Chainage 870 to 875m

| Chainage (m) | Feature | Level (m from top) | Dimensions (m) | Description |
|---|---|---|---|---|
| 870 to 875 | Coping | 0 to 0.4 | - | Good - Minor cracks created by minor movement. Surface defects in coping or limited mortar loss from joints |
| 870 to 875 | Brickwork / Masonry | 0.4 to 1.8 | - | Good - Minor cracks created by minor movement. Surface defects in bricks or limited mortar loss from joints |
| 870 to 870.5 | Mooring Chain | 0.5 to 1.2 | - | Fixed within recess. Fair condition, extensive corrosion with minor thickness loss and/or minor damage to links |
| 870.5 | Weephole / Outfall | 1.3 to 1.6 | D = 0.4m | Rectangular weephole/outfall. Good condition, some degradation but fully operable |
| 870 to 875 | Concrete | 0 (coping) | - | Good - Structurally sound but with minor cracks and localised honeycombing/flaking with no significant defects |

| Defects | | | | |
|---|---|---|---|---|
| 870.5 to 874 | Brickwork / Masonry | Vegetation Damage | 0.4 to 0.6 | Small and shallow rooted vegetation resulting in surface cracks and the early onset of mortar degradation |
| 872 to 874.5 | Brickwork / Masonry | Staining / Calcification | 1.4 to 1.3 | White staining concentrated around mortar joints indicative of early sulphate attack. May lead to future spalling and deterioration of mortar |
| 870 to 870.5 | Mooring Chain | Corrosion | 0.7 to 0.9 | Progressive corrosion has lead to deep pitting and loss of thickness weakening the metal |

| Overall Assessment | 2 | Good |

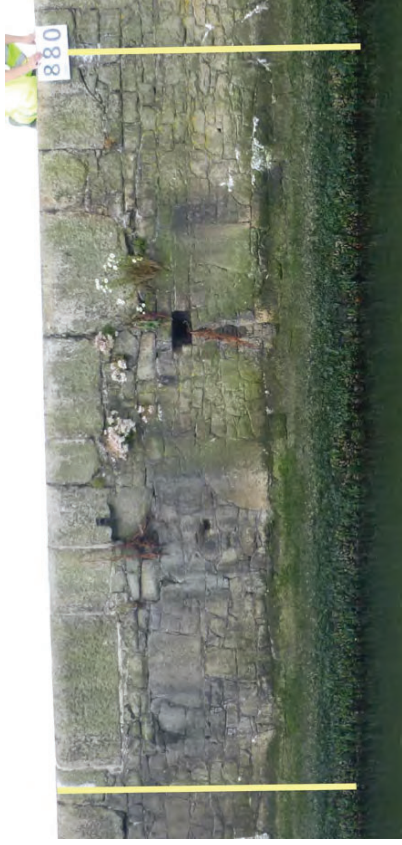
**Figure A180 - Bramley Moore: Chainage 875 to 880m**

| Chainage (m) | Feature | Level (m from top) | Dimensions (m) | Description |
|---|---|---|---|---|
| 875 to 880 | Concrete | 0.6 to 1.8 | - | Good - Structurally sound but with minor cracks and localised honeycombing/flaking with no significant defects |
| 875 to 880 | Concrete | 0 (coping) | - | Good - Structurally sound but with minor cracks and localised honeycombing/flaking with no significant defects |
| 878 | Metalwork | 0 (coping) | 0.1 x 0.1m | Metal fixing. Good condition, localised surface corrosion |

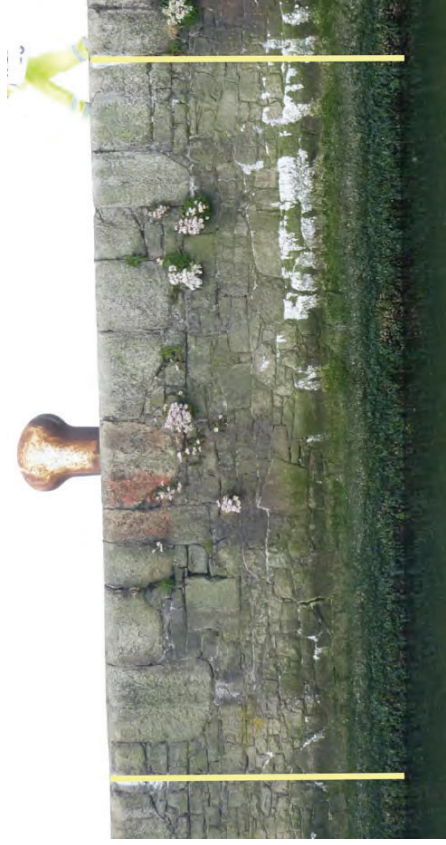
**Figure A181 - Bramley Moore: Chainage 880 to 885m**

| Chainage (m) | Feature | Level (m from top) | Dimensions (m) | Description |
|---|---|---|---|---|
| 880 to 885 | Concrete | 0 (coping) | - | Good - Structurally sound but with minor cracks and localised honeycombing/flaking with no significant defects |
| 880.5 and 884 | Metalwork | 0 (coping) | 0.1 x 0.1m | Metal fixing. Good condition, localised surface corrosion |
| 882.5 | Mooring Bollard | 0 (coping) | H = 0.8m | T-Shaped bollard embedded into coping. Good condition, localised surface corrosion |
