Figure A181a - Bramley Moore: Coping Chainage 880 to 885m

A182 Chainage 885 to 890m

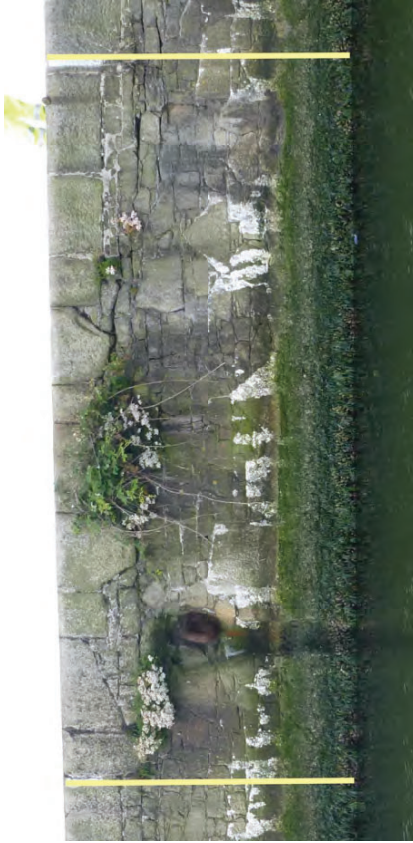
Figure A182 - Bramley Moore: Chainage 885 to 890m

| Chainage (m) | Feature | Level (m from top) | Dimensions (m) | Description |
|---|---|---|---|---|
| 885 to 890 | Coping | 0 to 0.4 | - | Good - Minor cracks created by minor movement. Surface defects in coping or limited mortar loss from joints |
| 885 to 890 | Brickwork / Masonry | 0.4 to 1.8 | - | Very Good - No sign of movement. Joints are sound with no loss of mortar |
| 885 to 890 | Marine Growth | 1.5 to 1.8 | - | Minor growth. Features partially obscured |
| 885 to 888 | Vegetation | 0.2 to 0.5 | - | Minor growth. Features partially obscured. Onset of structural degradation by root growth |
| 886 | Mooring Chain | 0.5 to 1.8 | - | Fixed within recess. Fair condition, extensive corrosion with minor thickness loss and/or minor damage to links |
| 885 to 890 | Concrete | 0 (coping) | - | Good - Structurally sound but with minor cracks and localised honeycombing/flaking with no significant defects |
| 886 and 889 | Metalwork | 0 (coping) | 0.1 x 0.1m | Metal fixing. Good condition, localised surface corrosion |

| Chainage (m) | Feature | Defect | Level (m from top) | Description |
|---|---|---|---|---|
| 885 to 888 | Coping | Vegetation Damage | 0.2 | Small and shallow rooted vegetation resulting in surface cracks and the early onset of mortar degradation |
| 885 to 889 | Brickwork / Masonry | Staining / Calcification | 0.9 to 1.5 | White staining concentrated around mortar joints indicative of early sulphate attack. May lead to future spalling and deterioration of mortar |
| 887 to 888 | Brickwork / Masonry | Vegetation Damage | 0.2 to 0.5 | Established vegetation with deep roots. Roots have cracked mortar with the potential to displace bricks/blocks |
| 886 | Mooring Chain | Corrosion | 0.6 to 0.8 | Progressive corrosion has lead to deep pitting and loss of thickness weakening the metal |

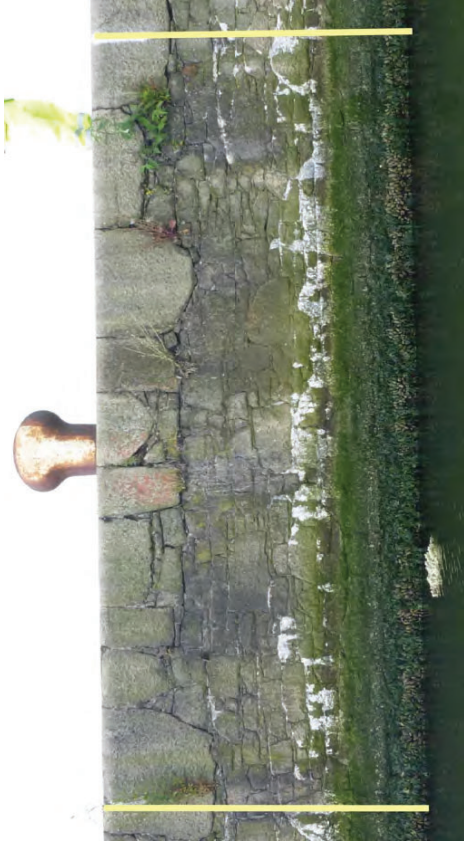
Figure A184 - Bramley Moore: Chainage 895 to 900m

| Chainage (m) | Feature | Level (m from top) | Dimensions (m) | Description |
|---|---|---|---|---|
| 895 to 900 | Coping | 0 to 0.6 | - | Good - Minor cracks created by minor movement. Surface defects in coping or limited mortar loss from joints |
| 895 to 900 | Brickwork / Masonry | 0.6 to 1.8 | - | Good - Minor cracks created by minor movement. Surface defects in bricks or limited mortar loss from joints |
| 895 to 900 | Marine Growth | 1.5 to 1.8 | - | Minor growth. Features partially obscured |
| 899 to 900 | Vegetation | 0.3 to 0.5 | - | Minor growth. Features partially obscured. Vegetation does not affect structural integrity |
| 895 to 900 | Concrete | 0 (coping) | - | Good - Structurally sound but with minor cracks and localised honeycombing/flaking with no significant defects |
| 896 and 899 | Metalwork | 0 (coping) | 0.1 x 0.1m | Metal fixing. Good condition, localised surface corrosion |
| 897.5 | Mooring Bollard | 0 (coping) | H = 0.8m | T-Shaped bollard embedded into coping. Good condition, localised surface corrosion |

| Defects | | | | |
|---|---|---|---|---|
| 895 to 900 | Brickwork / Masonry | Staining / Calcification | 1 to 1.3 | White staining concentrated around mortar joints indicative of early sulphate attack. May lead to future spalling and deterioration of mortar |
| 897.5 | Coping | Loss of Mortar | 0.2 to 0.4 | Mortar loss to coping stone is limited to the surface. Defects are cosmetic only |
| 899 to 900 | Coping | Vegetation Damage | 0.3 | Small and shallow rooted vegetation resulting in surface cracks and the early onset of mortar degradation |

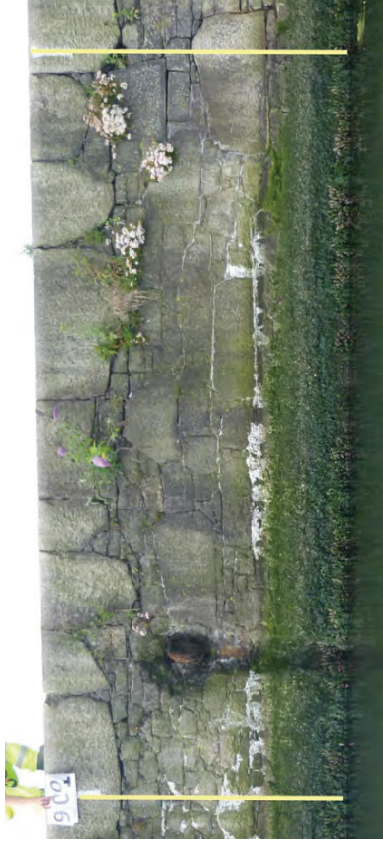
**Figure A185 - Bramley Moore: Chainage 900 to 905m**

| Chainage (m) | Feature | Level (m from top) | Dimensions (m) | Description |
|---|---|---|---|---|
| 900 to 905 | Coping | 0 to 0.5 | - | Good - Minor cracks created by minor movement. Surface defects in coping or limited mortar loss from joints |
| 900 to 905 | Brickwork / Masonry | 0.5 to 1.8 | - | Good - Minor cracks created by minor movement. Surface defects in bricks or limited mortar loss from joints |
| 900 to 905 | Marine Growth | 1.5 to 1.8 | - | Minor growth. Features partially obscured |
| 901 | Mooring Chain | 0.6 to 1.8 | - | Fixed within recess. Fair condition, extensive corrosion with minor thickness loss and/or minor damage to links |
| 900 to 905 | Concrete | 0 (coping) | - | Good - Structurally sound but with minor cracks and localised honeycombing/flaking with no significant defects |

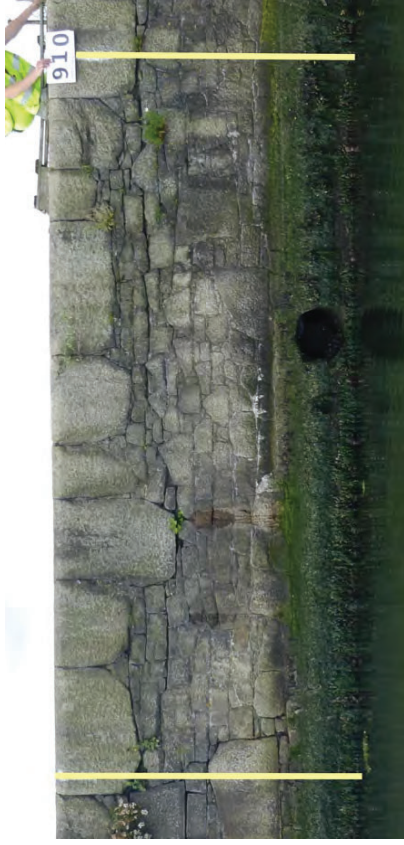
**Figure A186 - Bramley Moore: Chainage 905 to 910m**

| Chainage (m) | Feature | Level (m from top) | Dimensions (m) | Description |
|---|---|---|---|---|
| 905 to 910 | Brickwork / Masonry | 0.3 to 1.8 | - | Good - Minor cracks created by minor movement. Surface defects in bricks or limited mortar loss from joints |
| 908 | Weephole / Outfall | 1.6 to 1.8 | D = 0.4m | Rectangular weephole/outfall. Good condition, some degradation but fully operable |
| 905 to 910 | Concrete | 0 (coping) | - | Good - Structurally sound but with minor cracks and localised honeycombing/flaking with no significant defects |

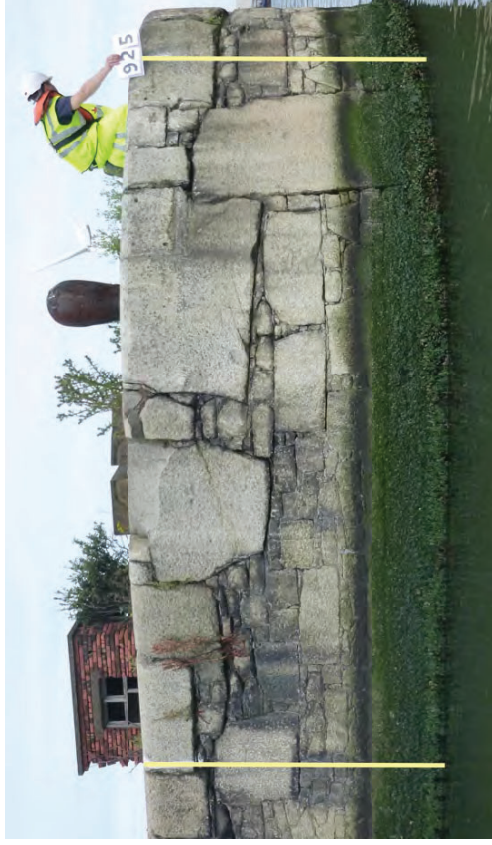
**Figure A189 - Bramley Moore: Chainage 920 to 925m**

| Chainage (m) | Feature | Level (m from top) | Dimensions (m) | Description |
|---|---|---|---|---|
| 920 to 925 | Coping | 0 to 0.8 | - | Fair - Slight coping displacement created by movement. Mortar loss from joints and joints/coping cracking. Rounding/chipping of coping edges |
| 920 to 925 | Brickwork / Masonry | 0.3 to 1.8 | - | Good - Minor cracks created by minor movement. Surface defects in bricks or limited mortar loss from joints |
| 920 to 925 | Cobbles | 0 (coping) | - | Good - Minor cracks created by settlement/heave. Surface defects in cobbles or limited mortar loss from joints |
| 925 | Mooring Bollard | 0 (coping) | - | Single bitt bollard. Fair condition, extensive corrosion with minor thickness loss and/or minor movement to bollard |

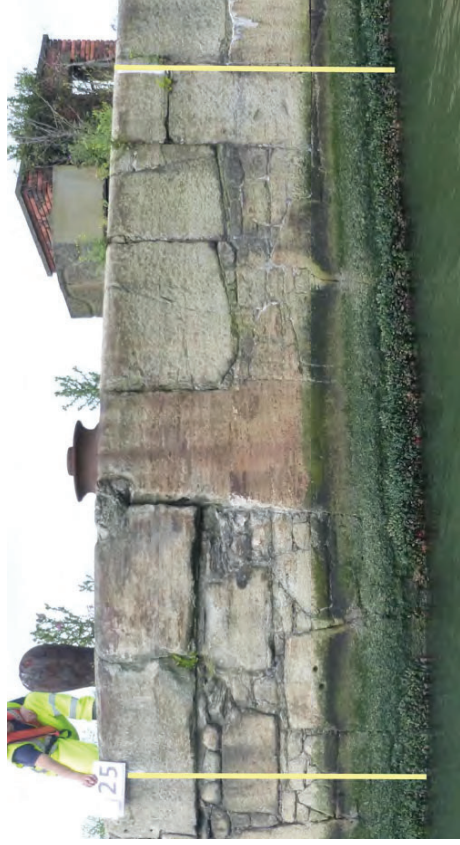
**Figure A190 - Bramley Moore: Chainage 925 to 930m**

| Chainage (m) | Feature | Level (m from top) | Dimensions (m) | Description |
|---|---|---|---|---|
| 925 to 930 | Coping | 0 to 0.8 | - | Good - Minor cracks created by minor movement. Surface defects in coping or limited mortar loss from joints |
| 925 to 930 | Brickwork / Masonry | 0.5 to 1.9 | - | Good - Minor cracks created by minor movement. Surface defects in bricks or limited mortar loss from joints |
| 927 | Mooring Bollard | 0 (coping) | H = 0.2m | Short pillar bollard. Good condition, localised surface corrosion |

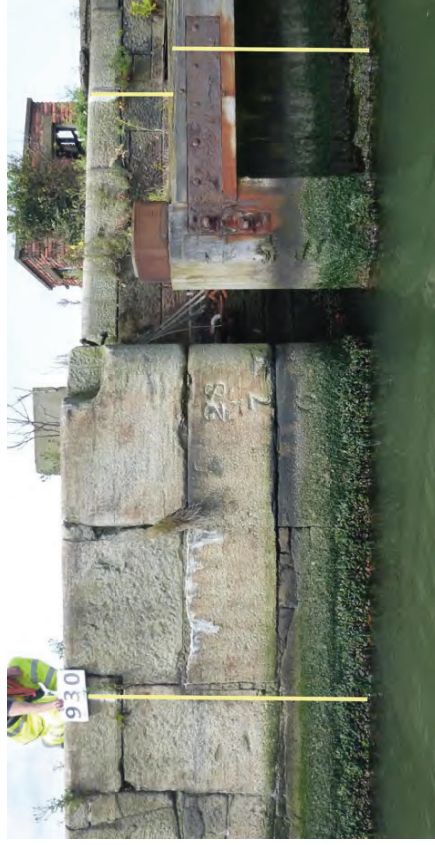
**Figure A191 - Bramley Moore: Chainage 930 to 935m**

| Chainage (m) | Feature | Level (m from top) | Dimensions (m) | Description |
|---|---|---|---|---|
| 930 to 935 | Coping | 0 to 1 | - | Good - Minor cracks created by minor movement. Surface defects in coping or limited mortar loss from joints |
| 930 to 935 | Brickwork / Masonry | 0.3 to 1.9 | - | Good - Minor cracks created by minor movement. Surface defects in blocks or limited mortar loss from joints |
| 932 to 935 | Lock Gate | 0.5 to 1.9 | - | Fair - Minor cracks or split timbers. Established fungal decay, corrosion to fixings and gaps/misaligned timber joints. Some movement in gates |
| 932 to 935 | Obstruction | 0.5 to 1.9 | - | Significant obstruction. Features obscured. Condition cannot be assessed |
| 932 | Metalwork | 0.2 | - | Metal fixing. Poor condition, extensive corrosion with major thickness loss and/or significantly bent and deformed |
| 932 | Miscellaneous | 0 to 1 | - | Steel cable to secure the gates in the open position. Minor corrosion. |
| 930 to 935 | Vegetation | 0 to 0.5 | - | Minor growth. Features partially obscured. Onset of structural degradation by root growth |
| 930 to 935 | Cobbles | 0 (coping) | - | Good - Minor cracks created by settlement/heave. Surface defects in cobbles or limited mortar loss from joints |

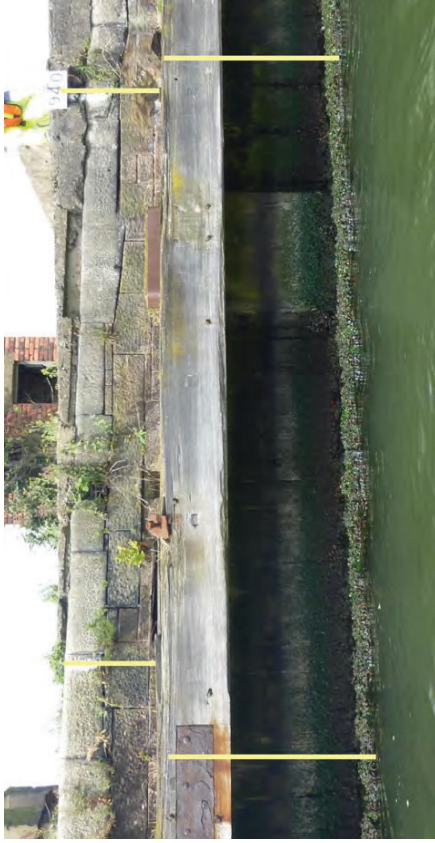
A192 Chainage 935 to 940m

| Chainage (m) | Feature | Level (m from top) | Dimensions (m) | Description |
|---|---|---|---|---|
| 935 to 940 | Coping | 0 to 0.3 | - | Good - Minor cracks created by minor movement. Surface defects in coping or limited mortar loss from joints |
| 935 to 940 | Brickwork / Masonry | 0.3 to 1 | - | Good - Minor cracks created by minor movement. Surface defects in bricks or limited mortar loss from joints |
| 935 to 940 | Lock Gate | 1 to 2.1 | - | Fair - Minor cracks or split timbers. Established fungal decay, corrosion to fixings and gaps/misaligned timber joints. Some movement in gates |
| 935 to 940 | Obstruction | 1 to 2.1 | - | Significant obstruction. Features obscured. Condition cannot be assessed |
| 935 to 940 | Vegetation | 0 to 1 | - | Minor growth. Features partially obscured. Onset of structural degradation by root growth |
| 935 to 940 | Vegetation | 0 (coping) | - | Minor growth. Features partially obscured. Onset of structural degradation by root growth |
| 937 | Metalwork | 0 (coping) | 0.1 x 0.1m | Metal fixing. Good condition, localised surface corrosion |

| Chainage (m) | Feature | Defect | Level (m from top) | Description |
|---|---|---|---|---|
| 935 to 940 | Lock Gate | Decay | 1 to 2.1 | Decay is throughout intertidal zone leading to weakening of timber elements and localised section loss |
| 935 to 940 | Lock Gate | Corrosion | 1 to 2.1 | Onset of corrosion to surface layers which may include pitting and/or flaking of the surface metal. Defects are cosmetic only |
| 935 to 940 | Coping | Loss of Mortar | 0.3 to 0.6 | Mortar loss to coping stones extends below surface and has the potential to weaken/loosen surrounding bricks/blocks |
| 935 to 940 | Concrete | Flaking / Spalling | 0 (coping) | Flaking of surface concrete. Flaking likely due to impact damage or freeze thaw action |
| 937 | Metalwork | Corrosion | 0 (coping) | Onset of corrosion to surface layers which may include pitting and/or flaking of the surface metal. Defects are cosmetic only |

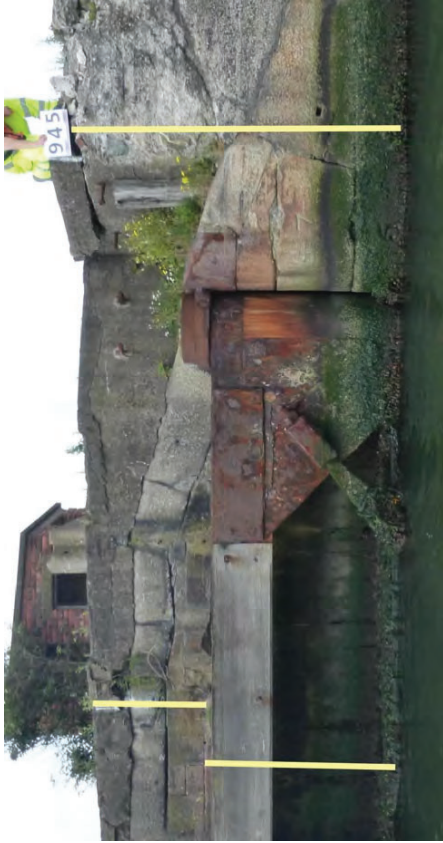
A193 Chainage 940 to 945m

| Chainage (m) | Feature | Level (m from top) | Dimensions (m) | Description |
|---|---|---|---|---|
| 940 to 945 | Coping | 0.3 to 1 | - | Good - Minor cracks created by minor movement. Surface defects in coping or limited mortar loss from joints |
| 940 to 945 | Brickwork / Masonry | 0.3 to 2.1 | - | Good - Minor cracks created by minor movement. Surface defects in blocks or limited mortar loss from joints |
| 940 to 944 | Lock Gate | 1 to 2.1 | - | Fair - Minor cracks or split timbers. Established fungal decay, corrosion to fixings and gaps/misaligned timber joints. Some movement in gates |
| 940 to 944 | Obstruction | 1 to 2.1 | - | Significant obstruction. Features obscured. Condition cannot be assessed |
| 944 to 945 | Metalwork | 0.3 | - | Metal fixing. Fair condition, extensive corrosion with minor thickness loss and/or partially bent and deformed |
| 944.5 | Timber | 0.5 to 1 | - | Fair - Minor cracks or split timbers. Established insect or fungal decay with loss of timber. Gaps at joints, misalignment of timber or bulging |
| 940 to 945 | Vegetation | 0 to 2.1 | - | Minor growth. Features partially obscured. Onset of structural degradation by root growth |
| 940 to 945 | Concrete | 0 (coping) | - | Good - Structurally sound but with minor cracks and localised honeycombing/flaking with no significant defects |

| Chainage (m) | Feature | Defect | Level (m from top) | Description |
|---|---|---|---|---|
| 940 to 944 | Lock Gate | Decay | 1 to 2.1 | Decay is throughout intertidal zone leading to weakening of timber elements and localised section loss |
| 940 to 944 | Lock Gate | Corrosion | 1 to 2.1 | Progressive corrosion has lead to deep pitting and loss of thickness weakening the metal |
| 944 to 945 | Concrete | Cracking | 0 to 0.5 | Severe cracking of concrete. Indicates significant wall movement likely through overloading |
| 940 to 945 | Coping | Loss of Mortar | 0 to 1 | Mortar loss to coping stones extends below surface and has the potential to weaken/loosen surrounding bricks/blocks |
| 944 to 945 | Metalwork | Corrosion | 0.3 | Progressive corrosion has lead to deep pitting and loss of thickness weakening the metal |
| 940 to 945 | Brickwork / Masonry | Loss of Mortar | 0.3 to 2.1 | Mortar loss to bricks/blocks is limited to the surface. Defects are cosmetic only |
| 940 to 945 | Concrete | Cracking | 0 (coping) | Significant cracking of concrete surfacing. |

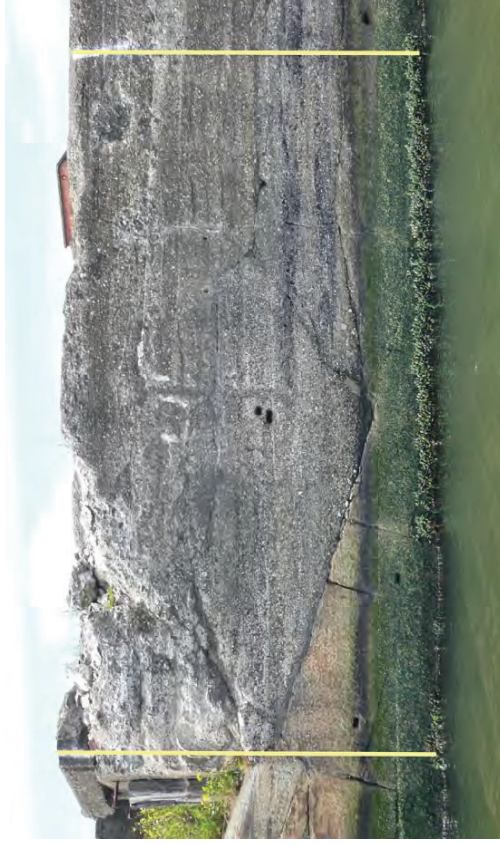
**Figure A194 - Bramley Moore: Chainage 945 to 950m**

| Chainage (m) | Feature | Level (m from top) | Dimensions (m) | Description |
|---|---|---|---|---|
| 945 to 950 | Concrete | 0 to 2.3 | - | Fair - Rust staining, localised spalling, lengthy cracking and some movement or extensive honeycombing |
| 945 to 947 | Brickwork / Masonry | 1 to 2.3 | - | Good - Minor cracks created by minor movement. Surface defects in bricks or limited mortar loss from joints |
| 945 to 950 | Vegetation | 0 (coping) | - | Minor growth. Features partially obscured. Onset of structural degradation by root growth |
| 945 to 950 | Concrete | 0 (coping) | - | Good - Structurally sound but with minor cracks and localised honeycombing/flaking with no significant defects |

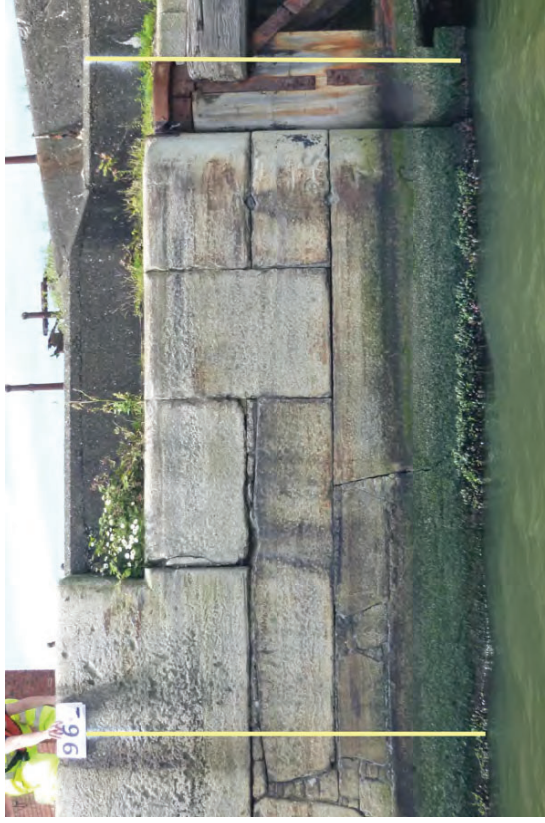
**Figure A197 - Bramley Moore: Chainage 960 to 965m**

| Chainage (m) | Feature | Level (m from top) | Dimensions (m) | Description |
|---|---|---|---|---|
| 960 to 964 | Brickwork / Masonry | 0 to 2.2 | - | Good - Minor cracks created by minor movement. Surface defects in blocks or limited mortar loss from joints |
| 964 | Lock Gate | 0.5 to 2.2 | - | Very poor condition. Metalwork rusted. Timber rotted and large sections missing |
| 960 to 963 | Metalwork | 0 (coping) | - | Metal fixing. Good condition, localised surface corrosion |
| 964 | Manhole | 0 (coping) | - | Fair - Extensive corrosion and minor damage but manhole housing remains sound. Some deterioration to material surrounding manhole |

| Chainage<br>(m) | Feature | Defect | Level (m<br>from top) | Description |
|---|---|---|---|---|
| 961 to 965 | Concrete | Flaking /<br>Spalling | 0 (coping) | Minor spalling or surface concrete at a construction joint |
| 964 | Lock Gate | Decay | 0.5 to 2.2 | Decay is throughout intertidal zone leading to weakening of timber elements and localised section loss |
| 964 | Lock Gate | Corrosion | 0.5 to 2.2 | Onset of corrosion to surface layers which may include pitting and/or flaking of the surface metal. Defects are cosmetic only |
| 960 to 964 | Brickwork /<br>Masonry | Loss of Mortar | 0.5 to 2.2 | Mortar loss to bricks/blocks extends below surface and has the potential to weaken/loosen surrounding bricks/blocks |
