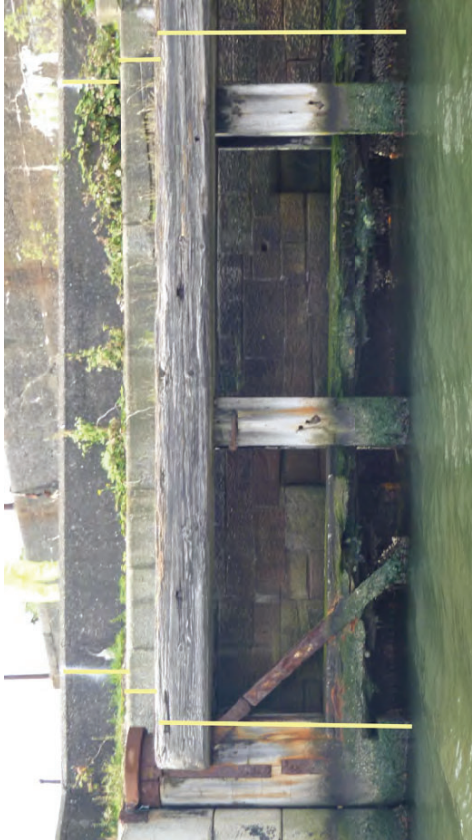
Figure A198 - Bramley Moore: Chainage 965 to 970m

Overall Assessment	3	Fair
--------------------	---	------

Chainage (m)	Feature	Level (m from top)	Dimensions (m)	Description
965 to 970	Coping	0 to 0.3	-	Good - Minor cracks created by minor movement. Surface defects in coping or limited mortar loss from joints
965 to 970	Brickwork / Masonry	0.3 to 2.6	-	Good - Minor cracks created by minor movement. Surface defects in bricks or limited mortar loss from joints
965 to 970	Marine Growth	2 to 2.6	-	Minor growth. Features partially obscured
965 to 970	Lock Gate	0.3 to 2.6	-	Gate within recess. Very Poor condition, gate is broken, derelict and beyond repair. Full thickness decay, missing fixings or dislodged gate
968	Miscellaneous	2	-	Holes within the wall possibly from historical fixings no longer present.
965 to 970	Concrete	0 (coping)	H = 0.5m	Concrete capping/platform above coping stone
965 to 970	Vegetation	0 (coping)	-	Very good condition. Minimal defects.
965, 968 and 970	Recess	1.6 to 2.6	-	Good - Surface defects in blocks/bricks, minor cracks and/or limited mortar loss from joints

Chainage (m)	Feature	Defect	Level (m from top)	Description
965 to 970	Concrete	Flaking / Spalling	0 (coping)	Minor spalling or surface concrete at a construction joint
965 to 970	Lock Gate	Decay	1 to 2.6	Decay is extensive throughout intertidal zone and has resulted in the loss of whole sections of timber
965 to 970	Lock Gate	Corrosion	1 to 2.6	Severe corrosion has lead to full thickness loss and failure of the element
965 to 970	Brickwork / Masonry	Loss of Mortar	0.5 to 0.8	Mortar loss to coping stones extends below surface and has the potential to weaken/loosen surrounding bricks/blocks
969	Brickwork / Masonry	Cracking	0.5 to 2.6	Significant vertical cracking of mortar joints and/or bricks/blocks. Indicates wall movement/settlement

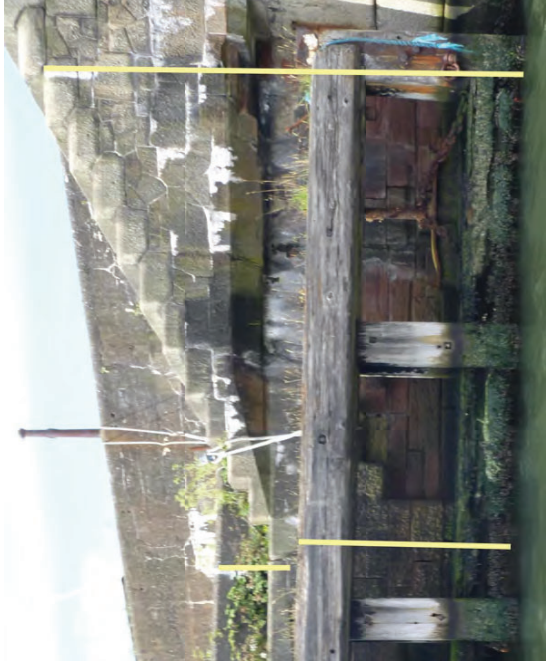
Figure A199 - Bramley Moore: Chainage 970 to 975m

Overall Assessment	3	Fair
--------------------	---	------

Chainage (m)	Feature	Level (m from top)	Dimensions (m)	Description
970 to 971	Coping	0.5 to 0.8	-	Good - Minor cracks created by minor movement. Surface defects in coping or limited mortar loss from joints
970 to 975	Brickwork / Masonry	0.8 to 4.2	-	Good - Minor cracks created by minor movement. Surface defects in bricks or limited mortar loss from joints
970 to 975	Marine Growth	2 to 4.2	-	Minor growth. Features partially obscured

970.5 to 975	Steps	0 to 2.3	-	Fair - Cracking, spalling and rounding/chipping of step edges
970 to 975	Recess	0.5 to 4.2	-	Good - Surface defects in blocks/bricks, minor cracks and/or limited mortar loss from joints
970 to 975	Lock Gate	0.8 to 4.2	-	Gate within recess. Very Poor condition, gate is broken, derelict and beyond repair. Full thickness decay, missing fixings or dislodged gate
971	Miscellaneous	0 to 0.8	-	Steel cable to secure the gates in the open position. Minor corrosion.
970 to 975	Vegetation	0 (coping)	-	Minor growth. Features partially obscured. Vegetation does not affect structural integrity
970 to 971	Concrete	0 (coping)	H = 0.5	Concrete capping/platform above coping stone

Chainage (m)	Feature	Defect	Level (m from top)	Description
970 to 975	Lock Gate	Decay	0.8 to 4.2	Decay is extensive throughout intertidal zone and has resulted in the loss of whole sections of timber
970 to 975	Lock Gate	Corrosion	0.8 to 4.2	Severe corrosion has lead to full thickness loss and failure of the element
970.5 to 975	Steps	Flaking / Spalling	0 to 2.3	Significant spalling of concrete
970.5 to 975	Brickwork / Masonry	Staining / Calcification	0 to 2.3	White staining concentrated around mortar joints indicative of early sulphate attack. May lead to future spalling and deterioration of mortar
975	Recess	Loss of Bricks/Blocks	2	Loss of singular bricks/blocks. Defects are cosmetic only
970 to 975	Brickwork / Masonry	Loss of Mortar	0.8 to 4.2	Mortar loss to bricks/blocks extends below surface and has the potential to weaken/loosen surrounding bricks/blocks

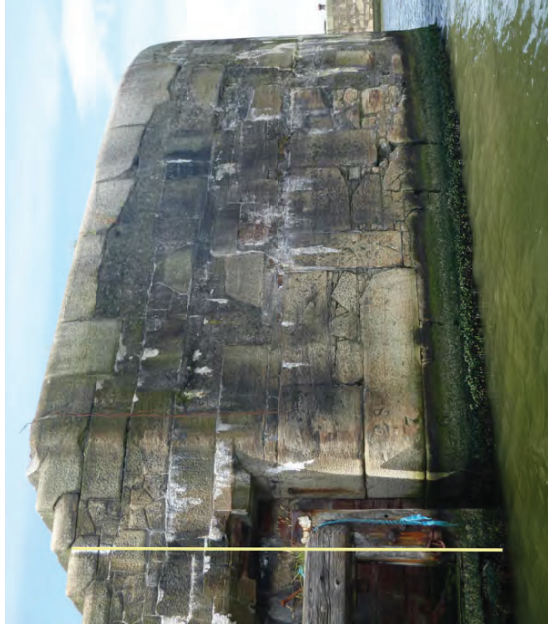
Figure A200 - Bramley Moore: Chainage 975 to 980m

Overall Assessment	2	Good
--------------------	---	------

Chainage (m)	Feature	Level (m from top)	Dimensions (m)	Description
975 to 980	Coping	0 to 0.5	-	Very Good - No sign of movement. Joints are sound with no loss of mortar
975 to 980	Brickwork / Masonry	0.5 to 4.5	-	Good - Minor cracks created by minor movement. Surface defects in bricks or limited mortar loss from joints
975 to 980	Marine Growth	4 to 4.5	-	Minor growth. Features partially obscured
975 to 976	Steps	0 to 1	-	Good - Minor cracks and surface defects/blemishes visible. Steps remain structurally sound
975 to 976	Recess	1.5	-	Good - Surface defects in blocks/bricks, minor cracks and/or limited mortar loss from joints
975 to 976	Lock Gate	1.5	-	Very Poor - Structural failure, derelict and beyond repair. Full thickness decay and missing fixings.
976	Miscellaneous	2	-	Steel cable fixed to mooring bollard. Significant corrosion
976 to 980	Concrete	0 (coping)	-	Good - Structurally sound but with minor cracks and localised honeycombing/flaking with no significant defects

976	Metalwork	0 (coping)	0.1 x 0.1m	Metal fixing. Good condition, localised surface corrosion
977	Mooring Bollard	0 (coping)	H = 0.2m	Short pillar bollard. Good condition, localised surface corrosion
