Bramley-Moore Dock  
Bramley-Moore Dock Wall Visual  
Condition Report  
December 2019

**Bramley-Moore Dock Wall  
Visual Condition Report**

**Document Ref: 170701-01-200 - Rev. C**

**Bramley–Moore Dock Wall**

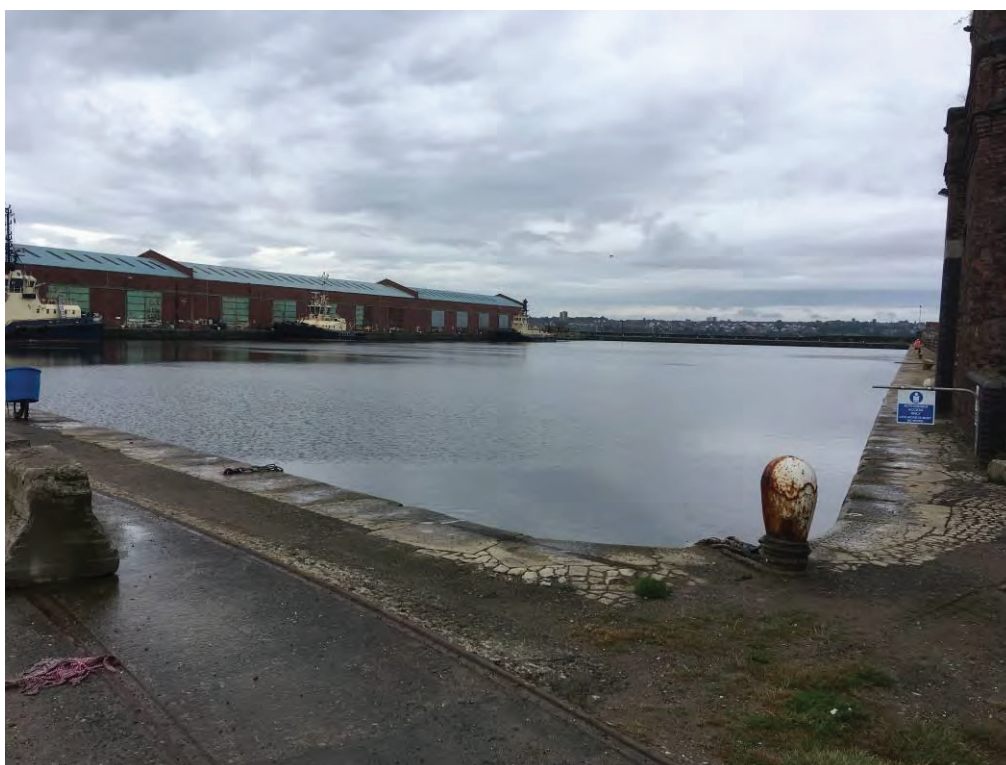
General View of Bramley-Moore Dock

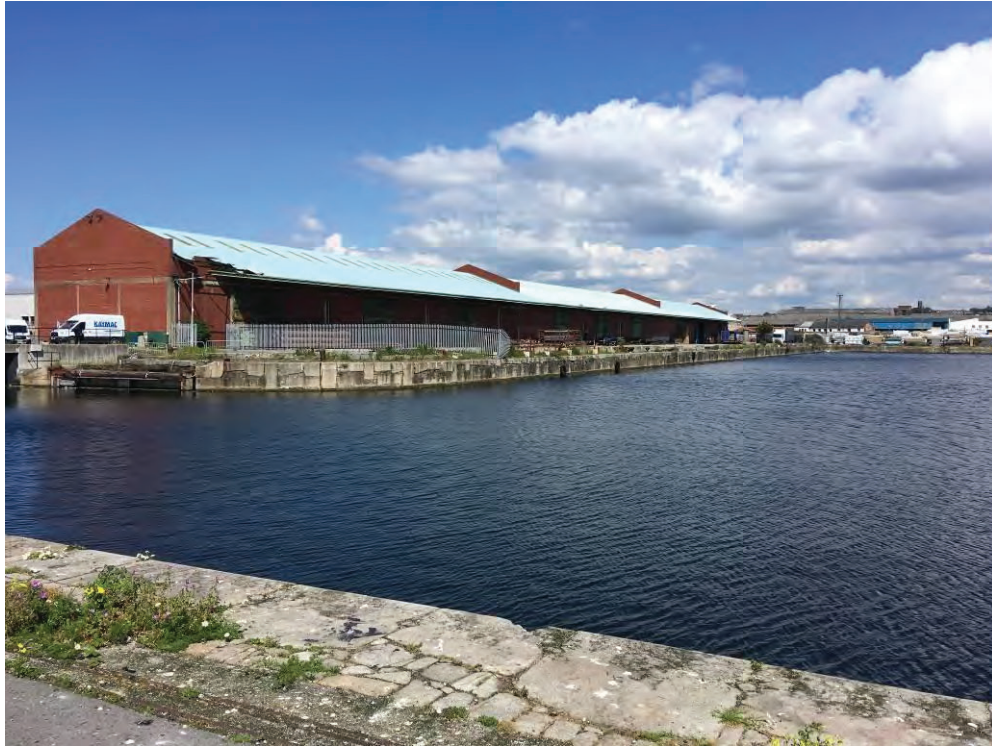
View of North Wall to Nelson Dock

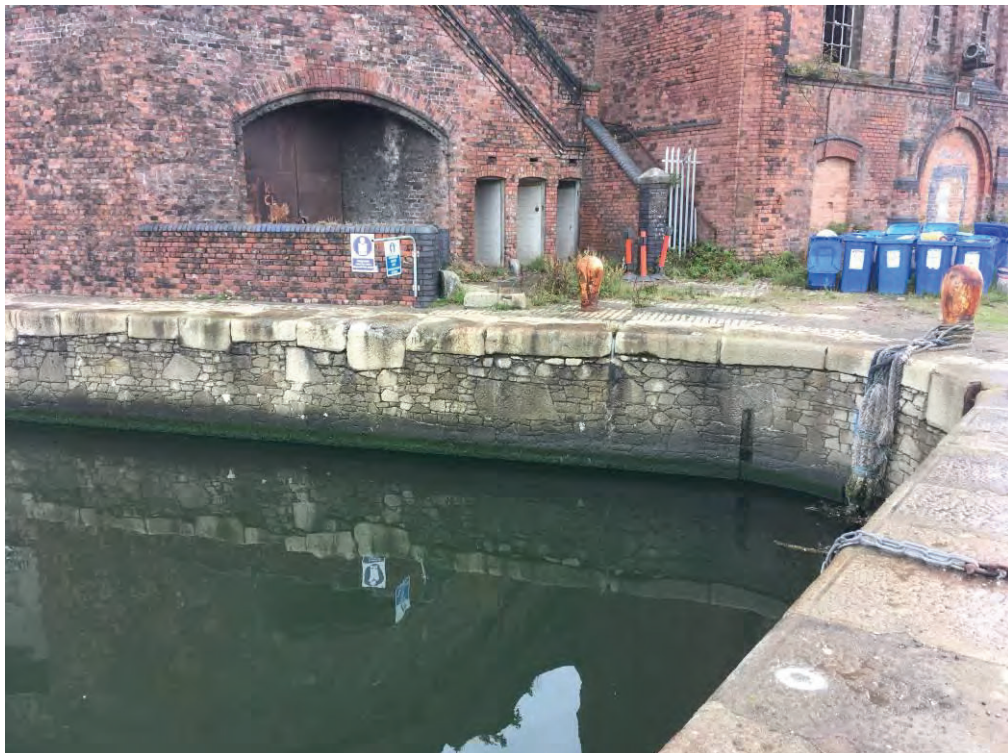
Typical Wall Construction

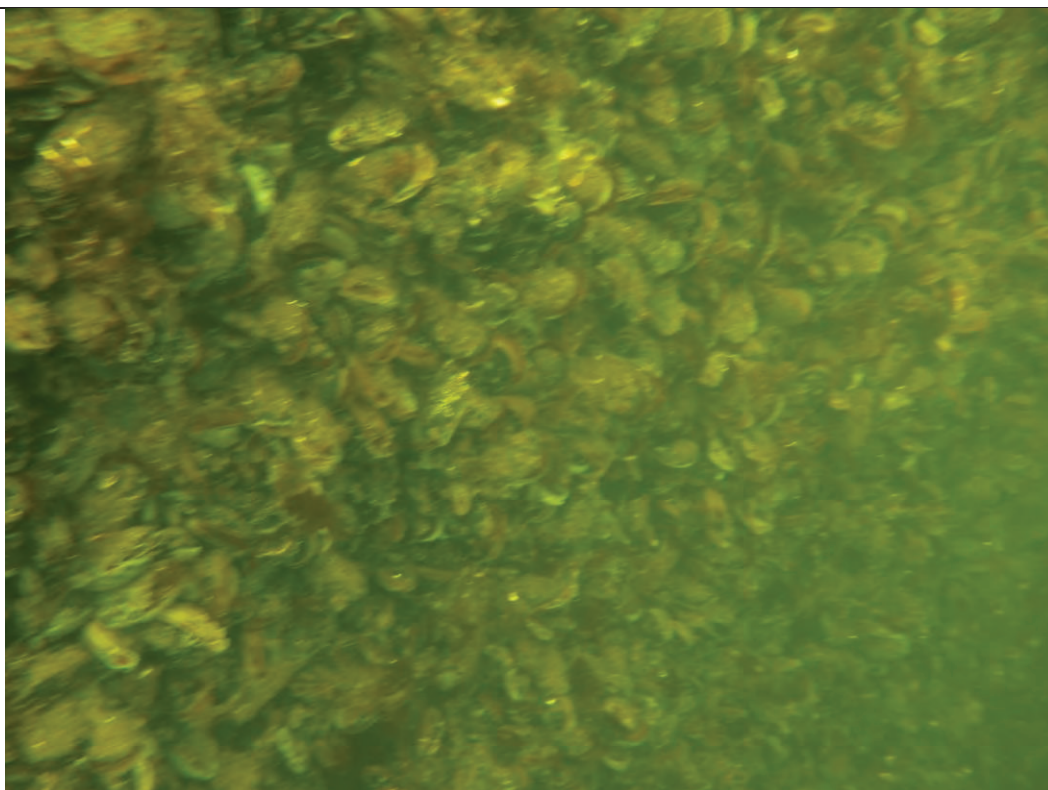
**Photograph 1.** General view of the wall

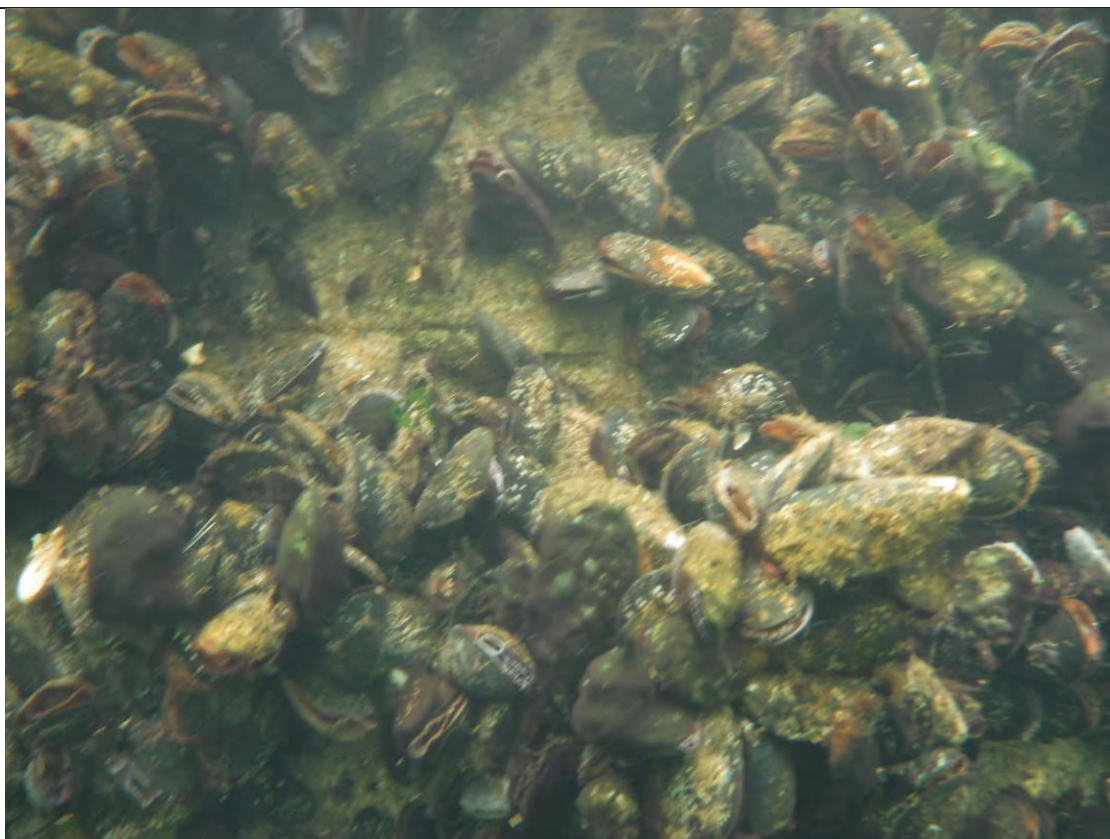
**Photograph 2.** General view of the wall

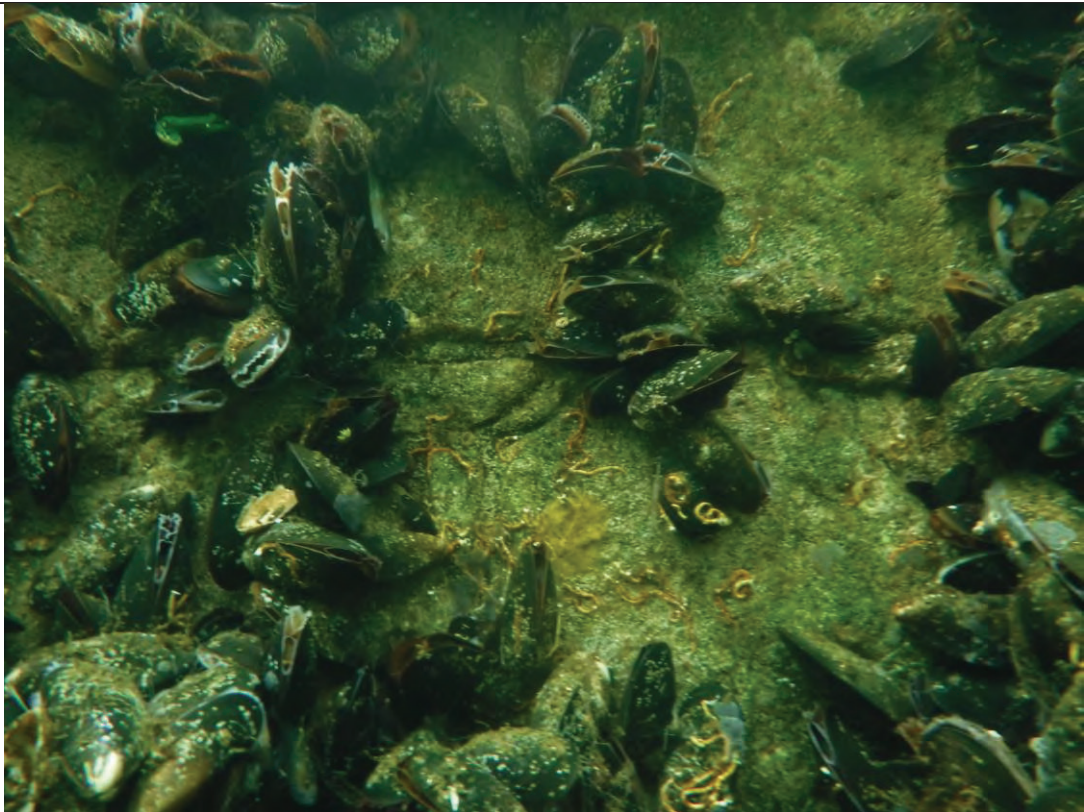
**Photograph 3.** General view of the wall

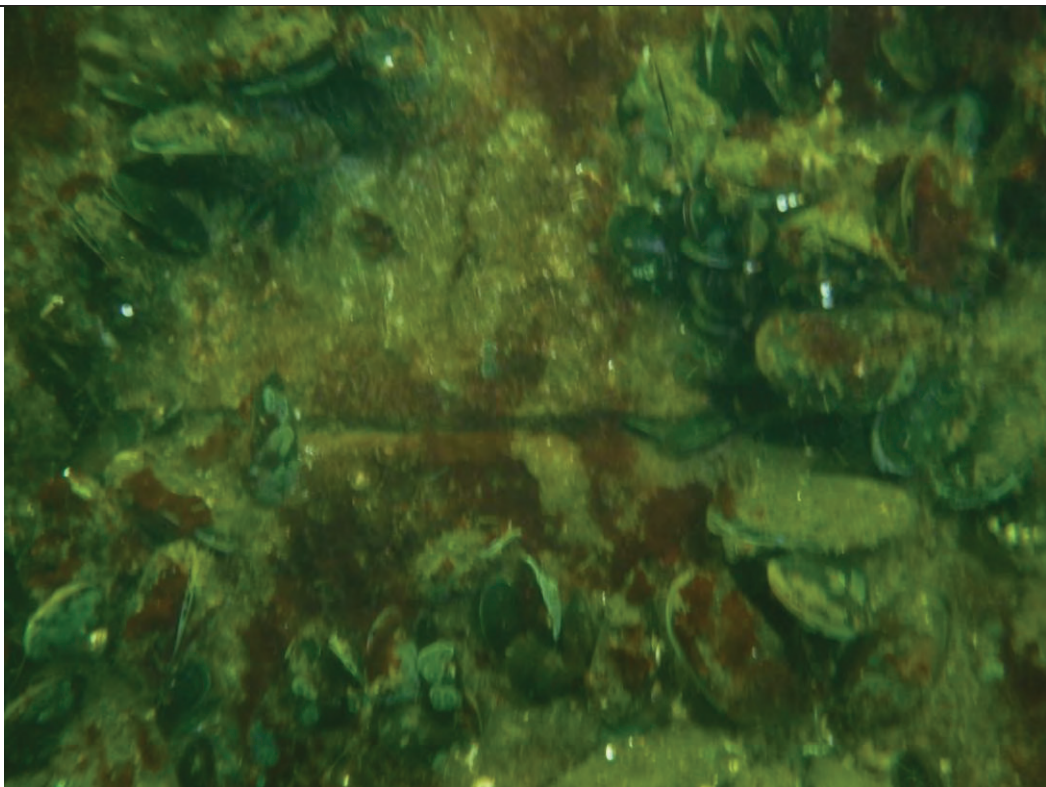
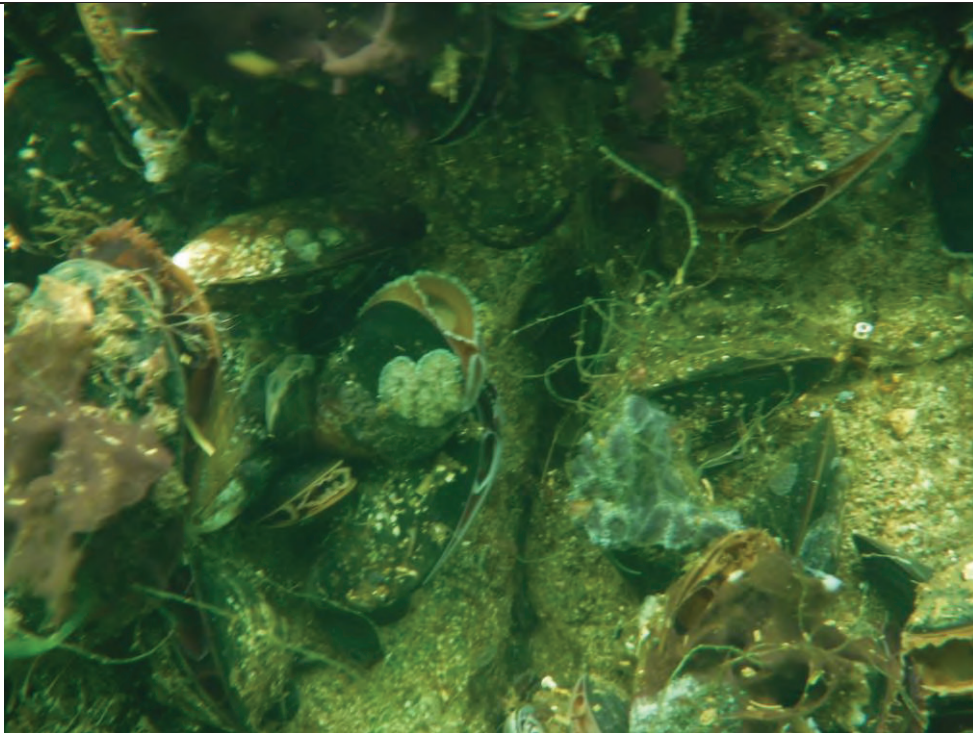
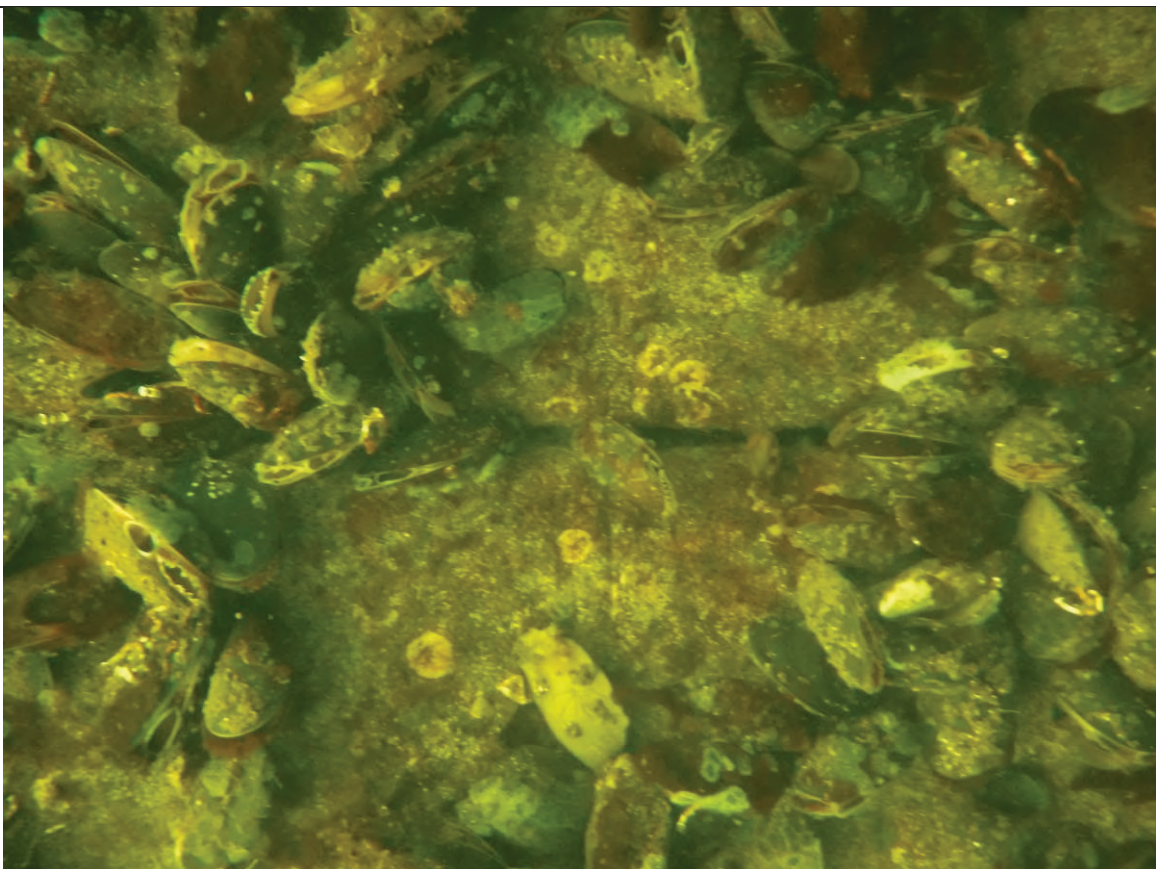
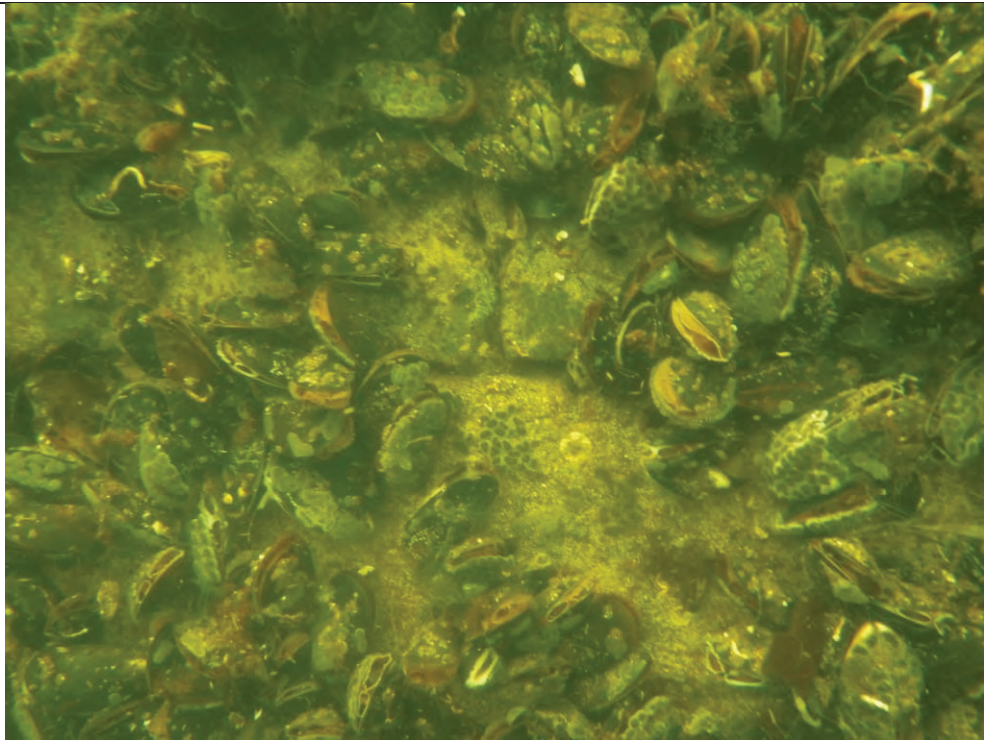
Ref. No.	Defect
i.	Numerous areas of open jointing were recorded throughout the structure.
ii.	Voids between masonry block work varying in size and penetration.
iii.	One vertical crack through number of the masonry courses was located with only a minimal penetration.

**Photograph 4.** Typical open jointing found throughout

**Photograph 5.** Typical open jointing found throughout

**Photograph 6.** Typical open jointing found throughout

**Photograph 7.** Typical open jointing found throughout

Ref. No.	Suggested Remedial Work	Priority
i.	All the open jointing will need to be repointed in order to reduce further open jointing and potential masonry loss.	L
ii.	Voids found need to be filled with an underwater cement/grout with the larger voids shuttering work will be required.	L
iii.	Crack to be monitored and further investigated.	L

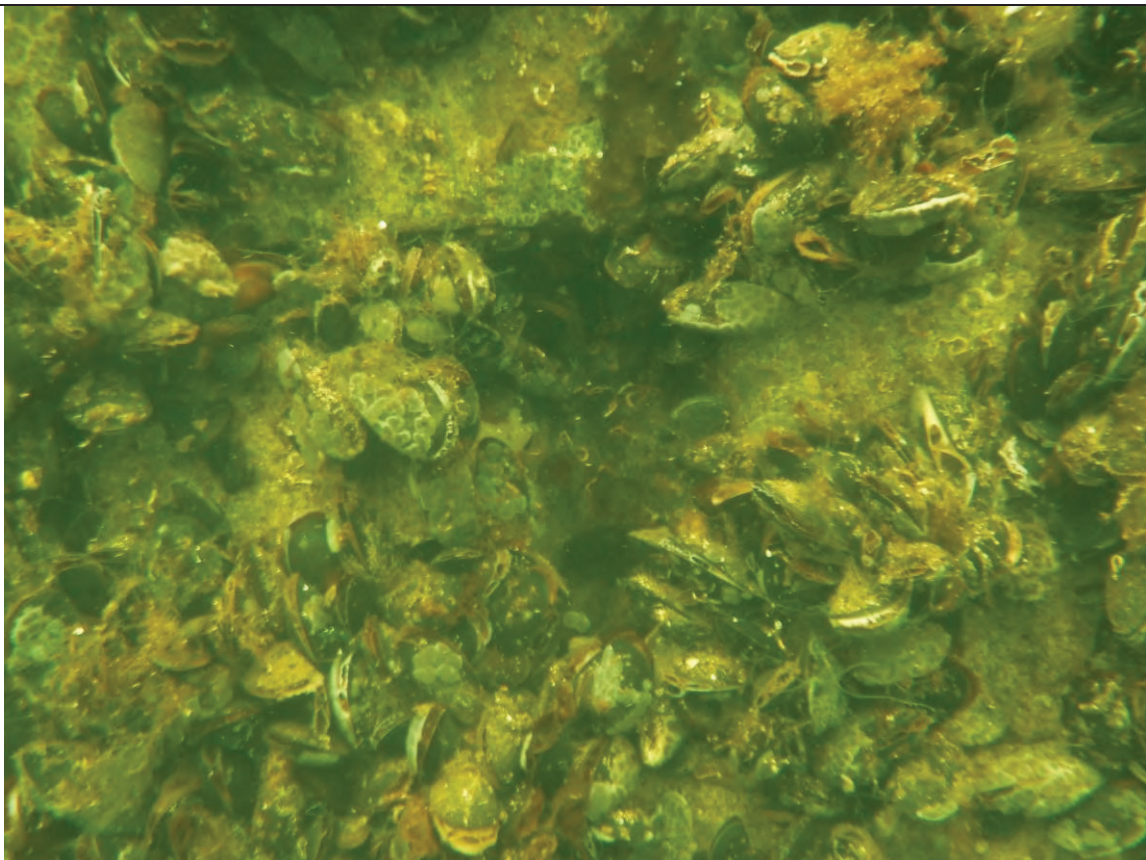
**Photograph 8.** Large open jointing

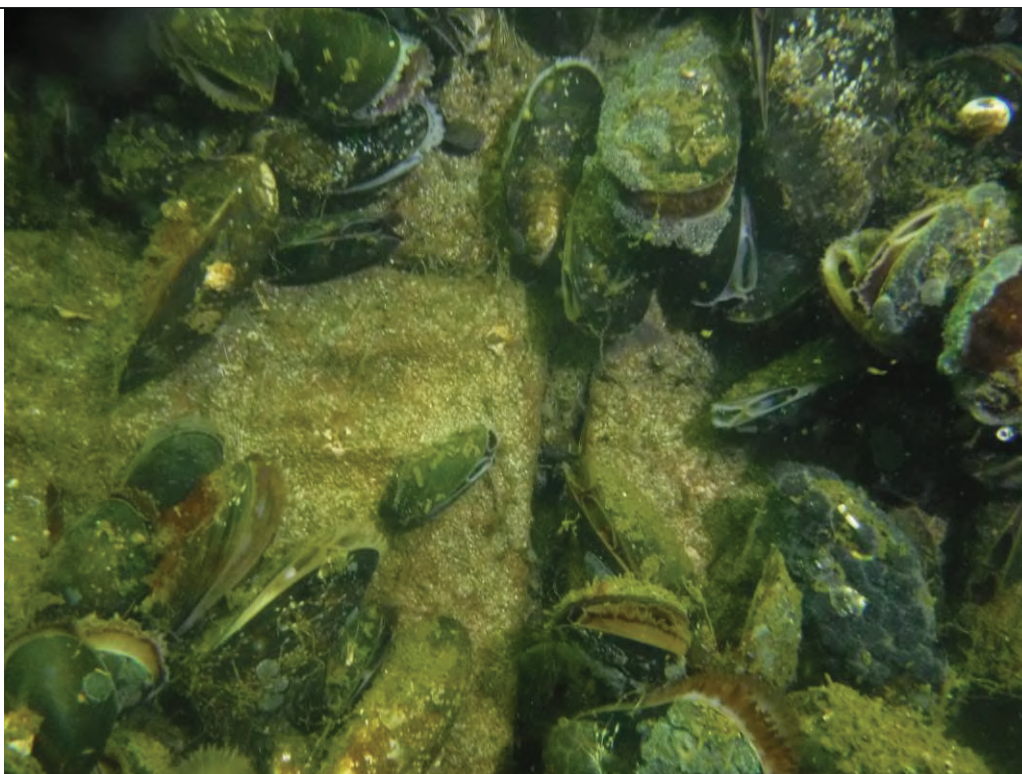
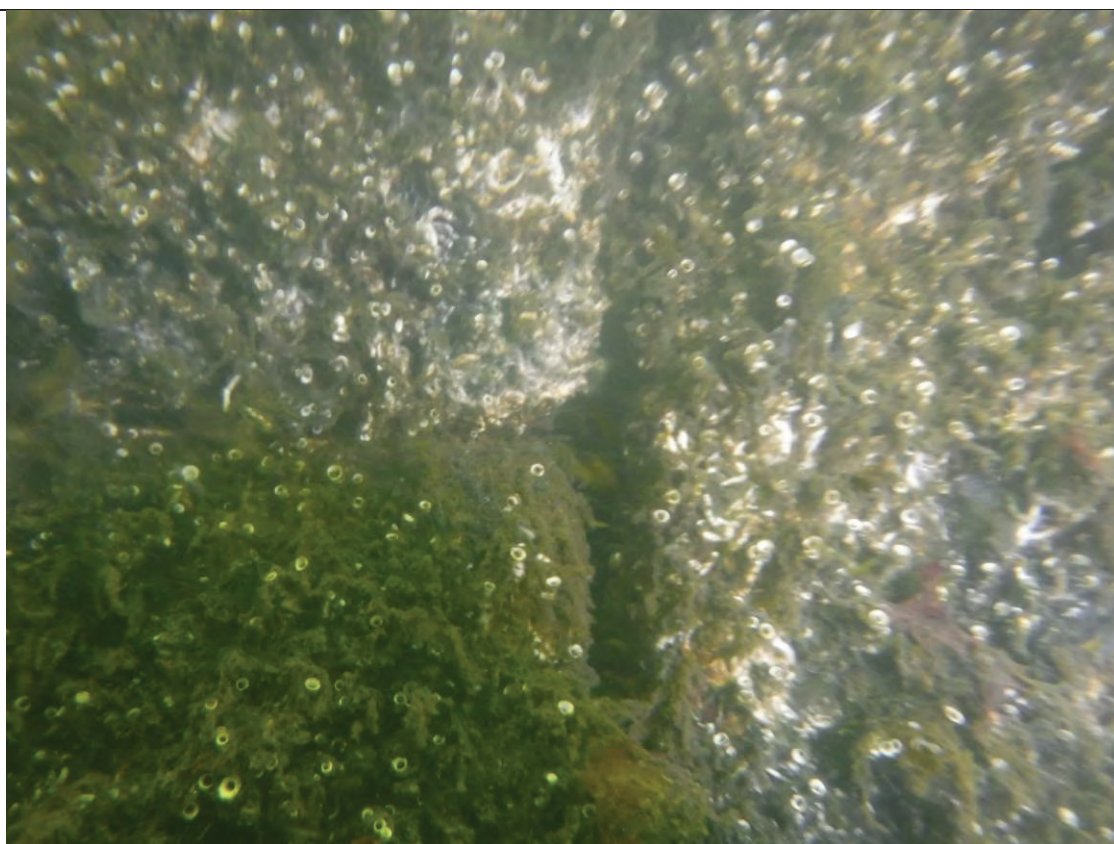
**Photograph 9.** Close up of open jointing

**Photograph 10.** Close up of open jointing

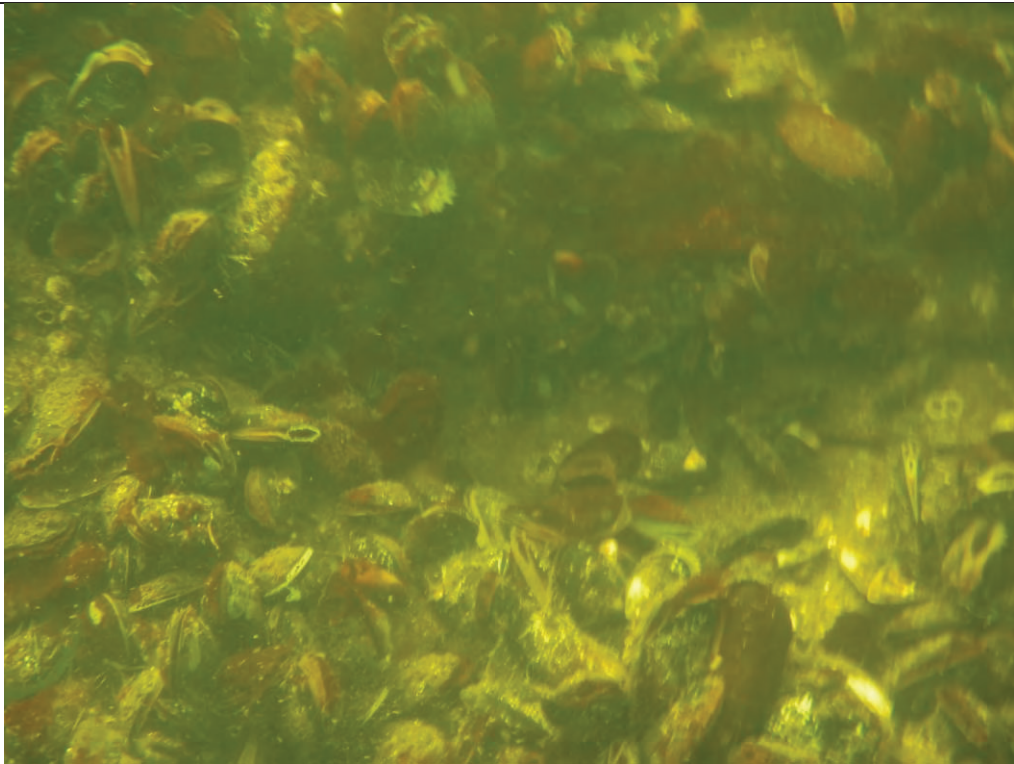
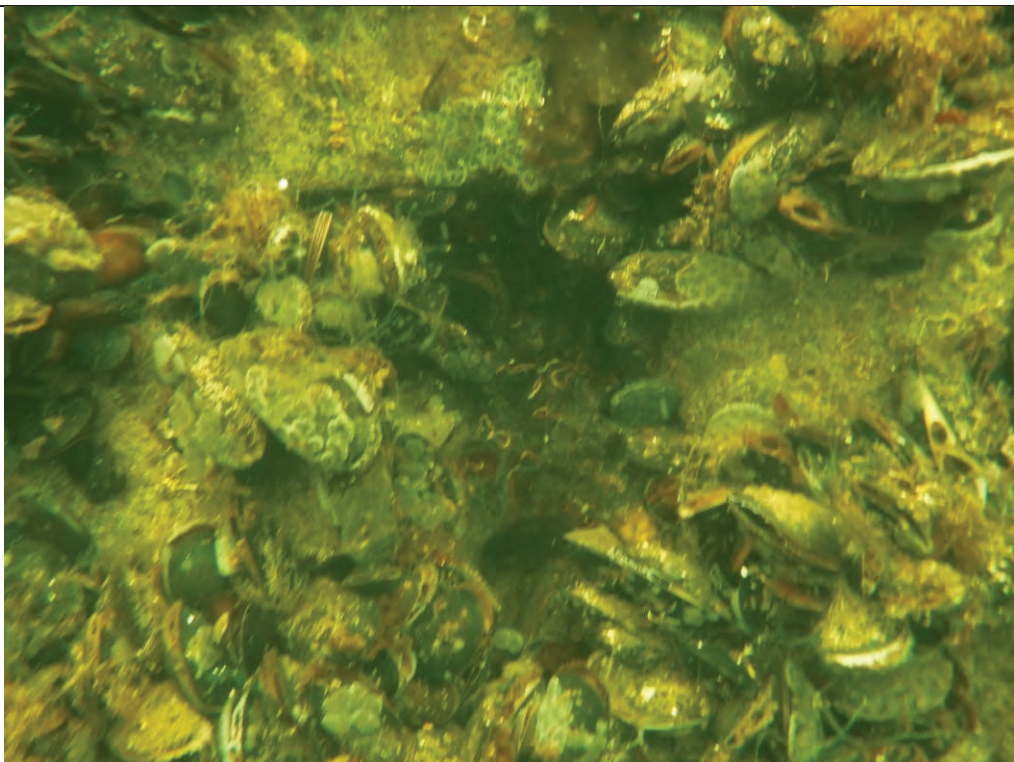
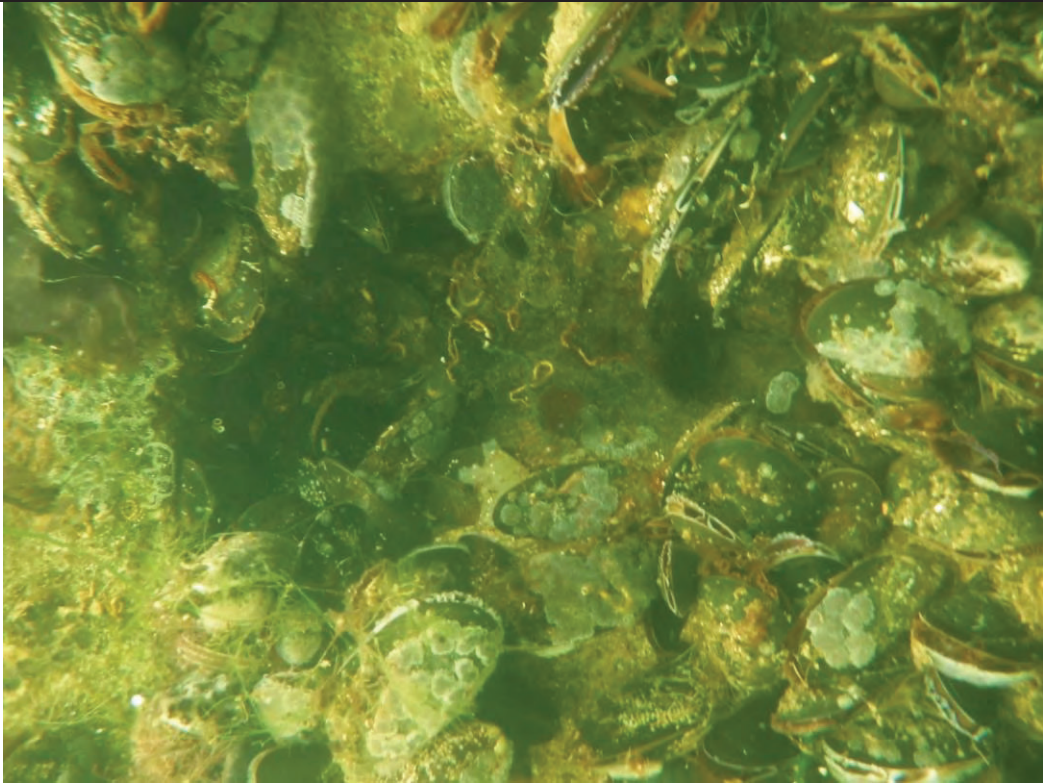
**Photograph 11.** Void found in the wall

**Photograph 12.** Void found in the wall

**Photograph 13.** Void found in the wall

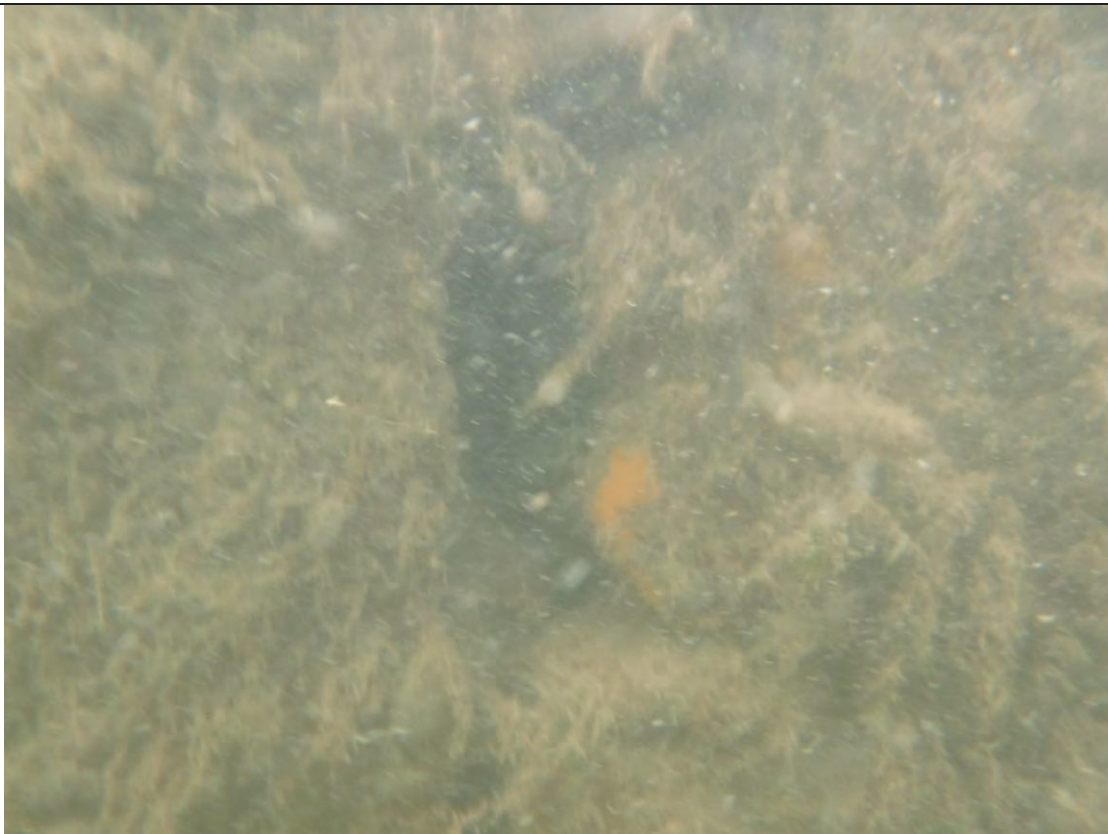
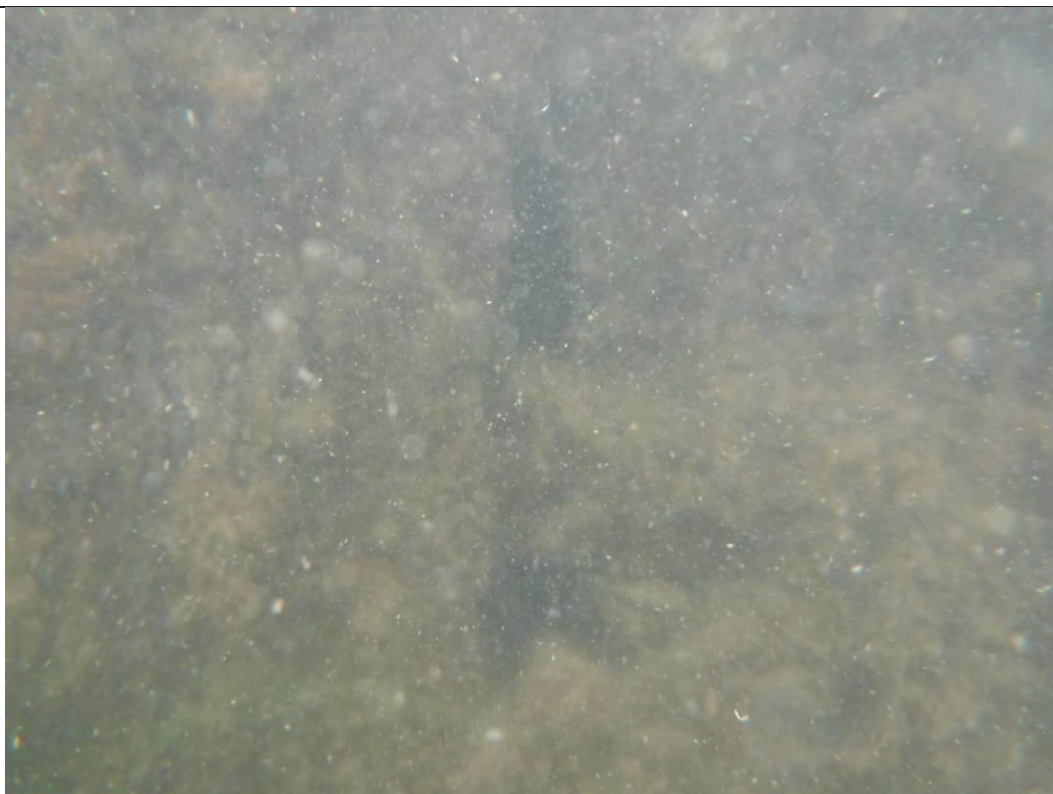
752m	-90° directional change onto a more recently build structure formed with steel Larsen pile work	-	-	-	-
755m	-Culvert located 2m off the dock bottom 1m H x0.6m W	1	A	N	-
747m-769m	-Lock gate.	-	-	-	-
773m	-Vertical crack located 0.5m below the waterline and continues to the silts built up on the dock bottom. The crack is staggered down through a number of course. Average width of 40mm with a maximum of 100mm where jointing has all so opened and a penetration of 200mm. (14-16)	3	B	R	iii.
773m	-Approximate start of a 90° direction change in the wall	-	-	-	-
781m	-Approximate end of the corner	-	-	-	-
787m	-Approximate start of a 90° direction change in the wall	-	-	-	-
792m	-Approximate end of the corner	-	-	-	-
824m	-Void located 3.5m below the waterline 0.2m x0.1m x0.15m penetration.	2	B	R	ii.
961m	-Void located 3.5m below the waterline 0.5m x0.1m x0.15m penetration.	2	B	R	ii.
915m	-Approximate start of a 90° direction change in the wall	-	-	-	-

Overall, the structure remains in good condition with no bulging or failures found. Open jointing with varying widths, were found throughout the structure below water. This is mainly concentrated within 5m of the waterline. The South wall had a much larger concentration of open joint and was where the largest could be found. The most significant defect identified was a crack at 773m.

**Photograph 14.** 773m Vertical crack

**Photograph 15. 773m Vertical crack**

**Photograph 16. 773m Vertical crack**

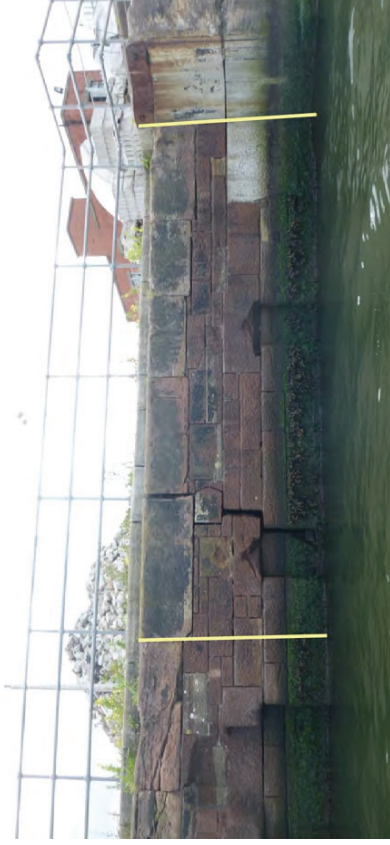
**Figure A2 - Bramley Moore: Chainage -19 to -13m**

Chainage (m)	Feature	Level (m from top)	Dimensions (m)	Description
-19 to -13	Coping	0 to 0.5	-	Good - Minor cracks created by minor movement. Surface defects in coping or limited mortar loss from joints
-19 to -13	Brickwork / Masonry	0.5 to 2.3	-	Good - Minor cracks created by minor movement. Surface defects in bricks or limited mortar loss from joints
-19 to -13	Marine Growth	1.6 to 2.3	-	Minor growth. Features partially obscured
-18.5 to -18	Recess	1.1 to 2.3	-	Fair - Slight brick/block displacement. Mortar loss from joints and joint/brick/block cracking. Rounding of recess edges
-16 to -15.5	Recess	1.2 to 2.3	-	Good - Surface defects in blocks/bricks, minor cracks and/or limited mortar loss from joints
-19 to -13	Vegetation	0 (coping)	-	Minor growth. Features partially obscured. Onset of structural degradation by root growth
-19 to -13	Hand railing / Fence	0 (coping)	H = 1.1m	Very Good - No visible defects. Well maintained with no signs of corrosion

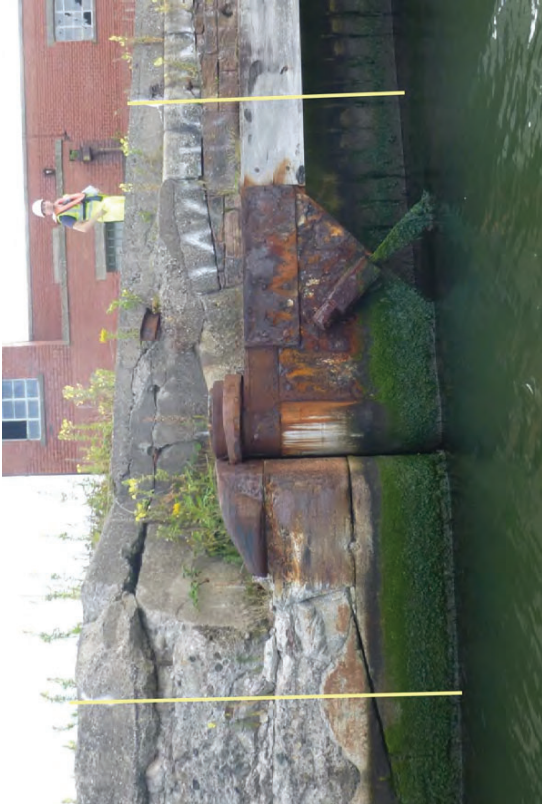
Figure A6 - Bramley Moore: Chainage 5 to 10m

Chainage (m)	Feature	Level (m from top)	Dimensions (m)	Description
5 to 10	Concrete	0 to 1	-	Poor - Extensive spalling and severe cracking, exposed rebar, extensive movement or damage likely to affect structural integrity
5 to 10	Brickwork / Masonry	0.7 to 2.2	-	Good - Minor cracks created by minor movement. Surface defects in coping or limited mortar loss from joints
5 to 10	Marine Growth	1.9 to 2.2	-	Minimal growth. Features remain visible
7 to 10	Lock Gate	1 to 2.2	-	Gate within recess. Fair condition, split timbers and established decay, corrosion to fixings and gaps at timber joints. Some movement in gates
7 to 10	Obstruction	1 to 2.2	-	Significant obstruction. Features obscured. Condition cannot be assessed
7	Vegetation	0.5 to 1	-	Significant growth. Features partially obscured. Significant structural degradation by root growth
8	Metalwork	0.2	L = 0.5m	I-beam. Fair condition, extensive corrosion with minor thickness loss and/or partially bent and deformed

8 to 10	Coping	0.5 to 0.7	-	Fair - Slight brick displacement created by movement. Mortar loss from joints and joint/brick cracking
5 to 10	Concrete	0 (coping)	-	Good - Structurally sound but with minor cracks and localised honeycombing/flaking with no significant defects
5 to 10	Vegetation	0 (coping)	-	Minor growth. Features partially obscured. Onset of structural degradation by root growth

Chainage (m)	Feature	Defect	Level (m from top)	Description
5 to 5.5	Concrete	Impact Damage	0 to 1	Localised impact damage resulting in chipping/fragmentation of wall materials
5 to 8	Concrete	Cracking	0 to 1	Significant horizontal cracking of mortar joints and/or bricks/blocks. Indicates wall movement/settlement
5 to 10	Brickwork / Masonry	Loss of Mortar	0.7 to 2.2	Mortar loss to bricks/blocks extends below surface and has the potential to weaken/loosen surrounding bricks/blocks
7 to 10	Lock Gate	Decay	1 to 2.2	Decay is throughout intertidal zone leading to weakening of timber elements and localised section loss
7 to 10	Lock Gate	Corrosion	1 to 2.2	Progressive corrosion has lead to deep pitting and loss of thickness weakening the metal

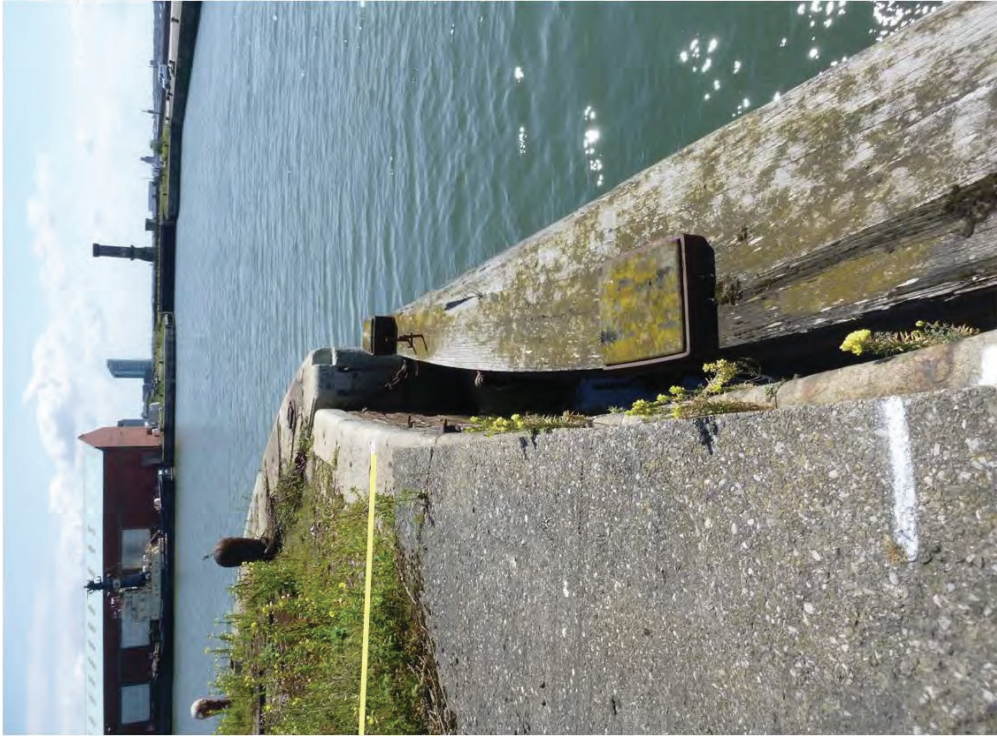
Figure A7a - Bramley Moore: Coping Chainage 10 to 15m

Overall Condition Rating		
Overall Assessment	3	Fair

Chainage (m)	Feature	Level (m from top)	Dimensions (m)	Description
10 to 15	Coping	0.3 to 0.5	-	Good - Minor cracks created by minor movement. Surface defects in coping or limited mortar loss from joints
10 to 15	Brickwork / Masonry	0.5 to 0.7	-	Good - Minor cracks created by minor movement. Surface defects in bricks or limited mortar loss from joints
10 to 15	Lock Gate	0.7 to 1.8	-	Gate within recess. Fair condition, split timbers and established decay, corrosion to fixings and gaps at timber joints. Some movement in gates
10 to 15	Obstruction	0.7 to 1.8	-	Significant obstruction. Features obscured. Condition cannot be assessed
10 to 15	Marine Growth	1.5 to 1.8	-	Minimal growth. Features remain visible
10 to 15	Concrete	0 to 0.3		Good - Structurally sound but with minor cracks and localised honeycombing/flaking with no significant defects

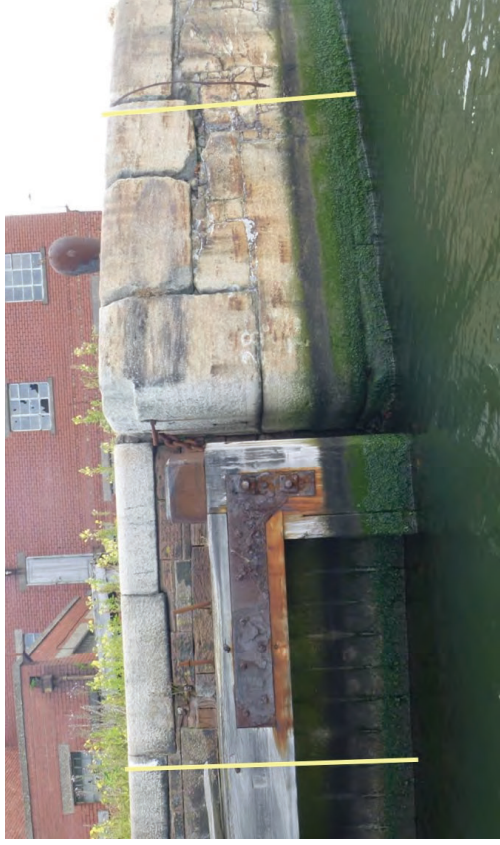
**Figure A8 - Bramley Moore: Chainage 15 to 20m**

Chainage (m)	Feature	Level (m from top)	Dimensions (m)	Description
15 to 20	Coping	0 to 1	-	Good - Minor cracks created by minor movement. Surface defects in coping or limited mortar loss from joints
15 to 20	Brickwork / Masonry	0.2 to 1.8	-	Good - Minor cracks created by minor movement. Surface defects in bricks or limited mortar loss from joints
15 to 20	Marine Growth	1.5 to 1.8	-	Minimal growth. Features remain visible
15 to 17.5	Lock Gate	0.4 to 1.8	-	Gate within recess. Fair condition, split timbers and established decay, corrosion to fixings and gaps at timber joints. Some movement in gates
15 to 17.5	Obstruction	0.4 to 1.8	-	Significant obstruction. Features obscured. Condition cannot be assessed
15 to 20	Vegetation	0 (coping)	-	Minor growth. Features partially obscured. Onset of structural degradation by root growth
16 to 20	Cobbles	0 (coping)	-	Good - Minor cracks created by settlement/heave. Surface defects in cobbles or limited mortar loss from joints

19 to 20	Miscellaneous	0 (coping)	-	Steel cable to secure the gates in the open position. Minor corrosion.
19.5	Metalwork	0 (coping)	D = 0.2m	Metal fixing. Good condition, localised surface corrosion
