**A24 Chainage 95 to 100m**

**Figure A24 - Bramley Moore: Chainage 95 to 100m**

<b>Inspection Date &amp; Time</b>	12th - 13th July 2017
<b>Weather Conditions</b>	Warm & Sunny
<b>Water Conditions</b>	Impounded Water
<b>Wall Height (m)</b>	1.8m (+6.6mOD / +4.8mOD)

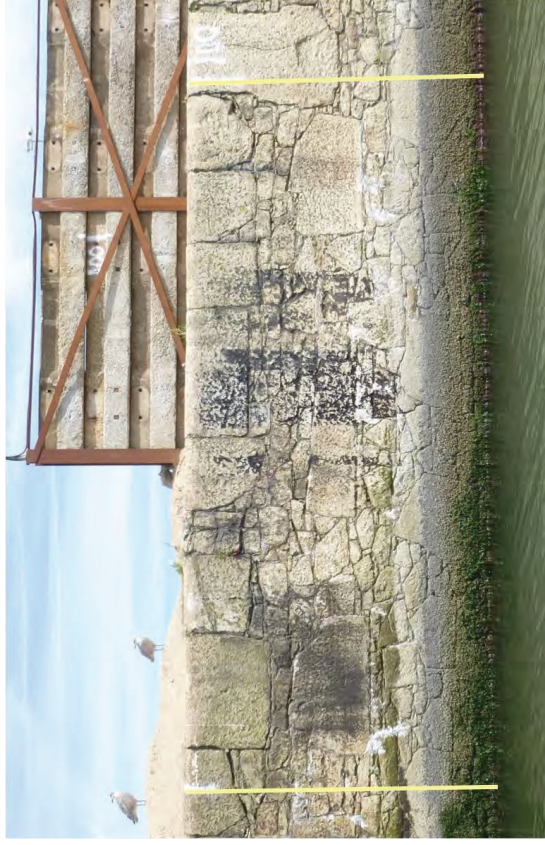
Overall Assessment	1	Very Good
--------------------	---	-----------

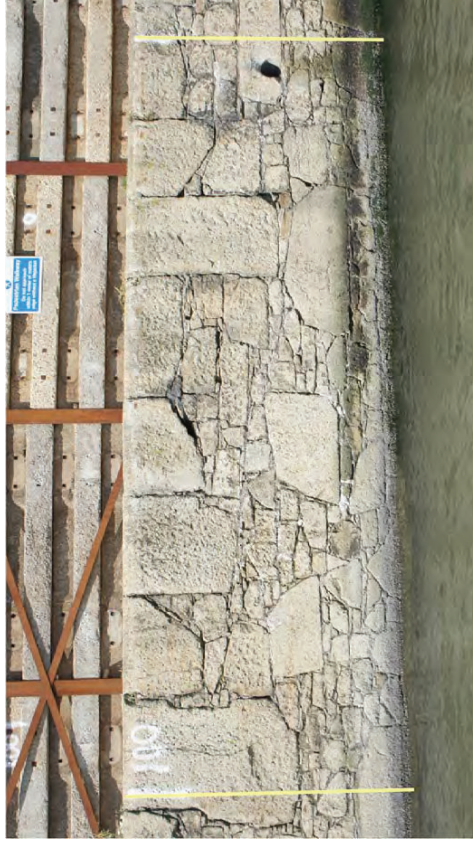
**Figure A25 - Bramley Moore: Chainage 100 to 105m**

Overall Assessment	2	Good
--------------------	---	------

Chainage (m)	Feature	Level (m from top)	Dimensions (m)	Description
100 to 105	Coping	0 to 1.1	-	Good - Minor cracks created by minor movement. Surface defects in coping or limited mortar loss from joints
100 to 105	Brickwork / Masonry	0 to 1.8	-	Good - Minor cracks created by minor movement. Surface defects in blocks or limited mortar loss from joints
100 to 105	Marine Growth	1.6 to 1.8	-	Minimal growth. Features remain visible
104.5	Weephole / Outfall	1	-	Circular weephole/outfall. Good condition, some degradation but fully operable
100 to 101	Coping	0 (coping)	-	Obscured due to large amounts of sand
101 to 105	Cobbles	0 (coping)	-	Good - Minor cracks created by settlement/heave. Surface defects in cobbles or limited mortar loss from joints

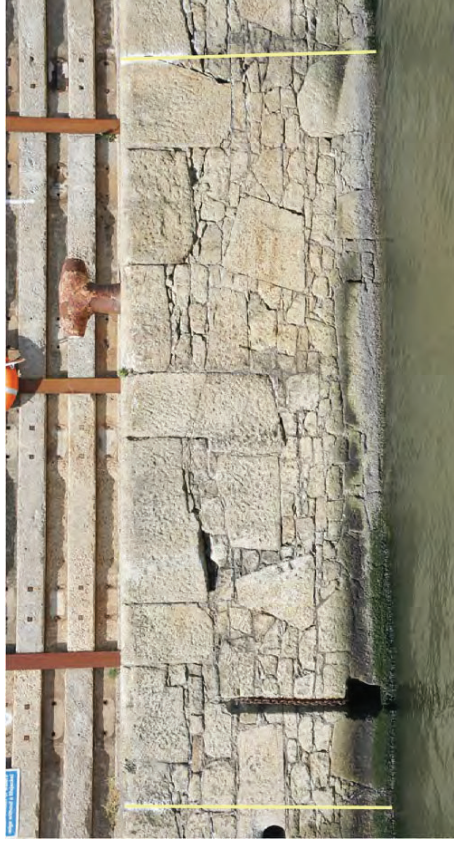
**Figure A26 - Bramley Moore: Chainage 105 to 110m**

Overall Assessment	2	Good
--------------------	---	------

Chainage (m)	Feature	Level (m from top)	Dimensions (m)	Description
105 to 110	Coping	0 to 0.4	-	Good - Minor cracks created by minor movement. Surface defects in coping or limited mortar loss from joints
105 to 110	Brickwork / Masonry	0 to 1.8	-	Good - Minor cracks created by minor movement. Surface defects in bricks or limited mortar loss from joints
105 to 110	Marine Growth	1.6 to 1.8	-	Minimal growth. Features remain visible
106	Mooring Chain	0.7 to 1.5	-	Fixed within recess. Fair condition, extensive corrosion with minor thickness loss and/or minor damage to links
106	Weephole / Outfall	1.5	D = 0.2m	Rectangular weephole/outfall. Good condition, some degradation but fully operable
105 to 110	Coping	0 (coping)	-	Obscured due to large amounts of sand
108	Mooring Bollard	0 (coping)	H = 0.8m	T-Shaped bollard embedded into coping. Good condition, localised surface corrosion

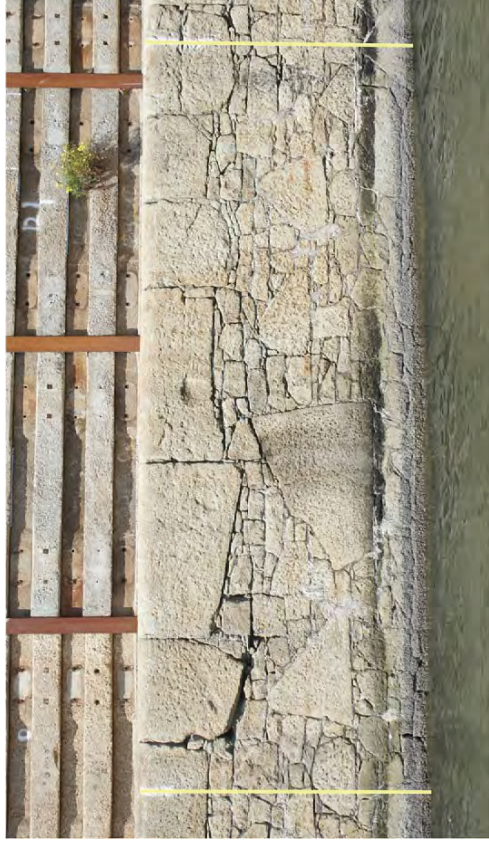
**Figure A28 - Bramley Moore: Chainage 115 to 120m**

Overall Assessment	2	Good
--------------------	---	------

Chainage (m)	Feature	Level (m from top)	Dimensions (m)	Description
115 to 120	Coping	0 to 0.7	-	Good - Minor cracks created by minor movement. Surface defects in coping or limited mortar loss from joints
115 to 120	Brickwork / Masonry	0.5 to 1.8	-	Good - Minor cracks created by minor movement. Surface defects in bricks or limited mortar loss from joints
115 to 120	Marine Growth	1.6 to 1.8	-	Minimal growth. Features remain visible
115 to 120	Coping	0 (coping)	-	Obscured due to large amounts of sand
115	Manhole	0 (coping)	-	Fair - Extensive corrosion and minor damage but manhole housing remains sound. Some deterioration to material surrounding manhole

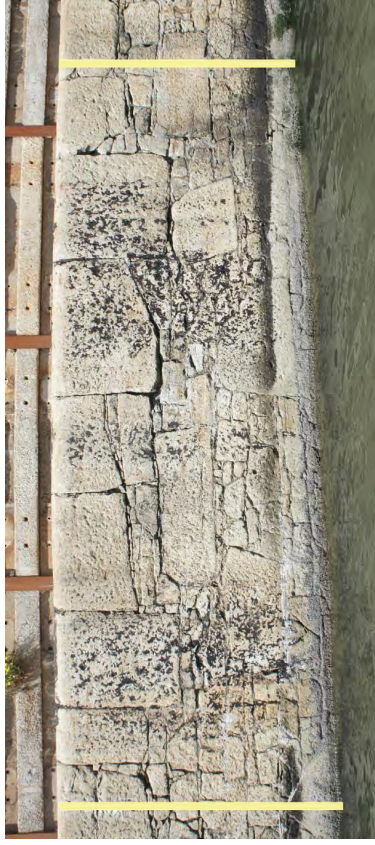
**Figure A29 - Bramley Moore: Chainage 120 to 125m**

Overall Assessment	2	Good
--------------------	---	------

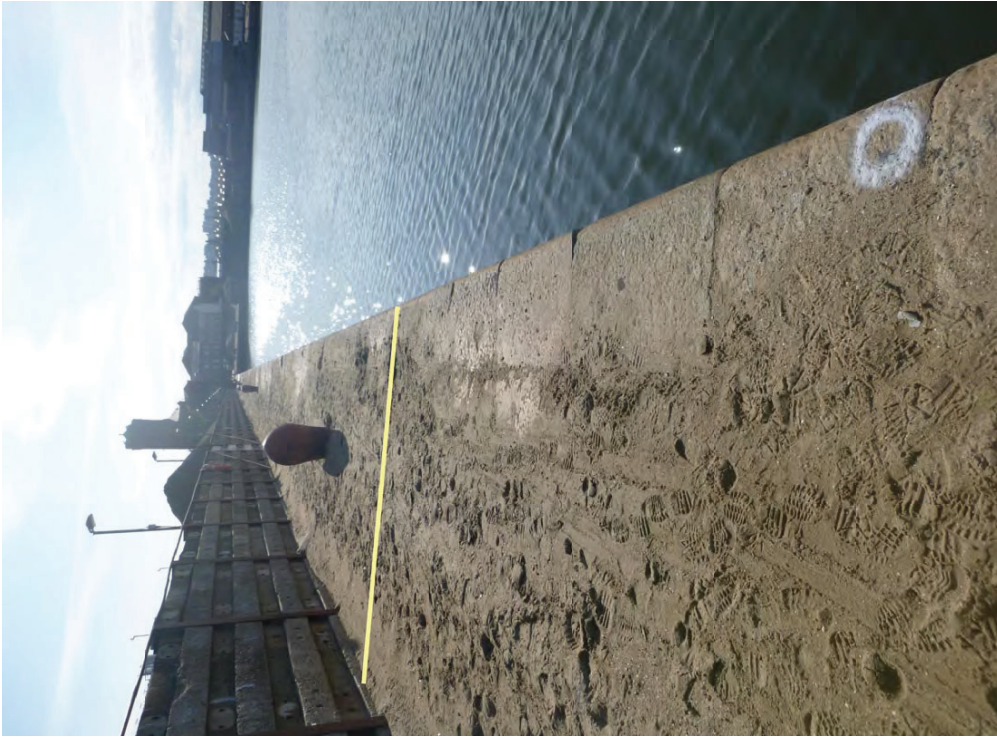
Figure A30a - Bramley Moore: Coping Chainage 125 to 130m

<b>Overall Condition Rating</b>		
Overall Assessment	2	Good

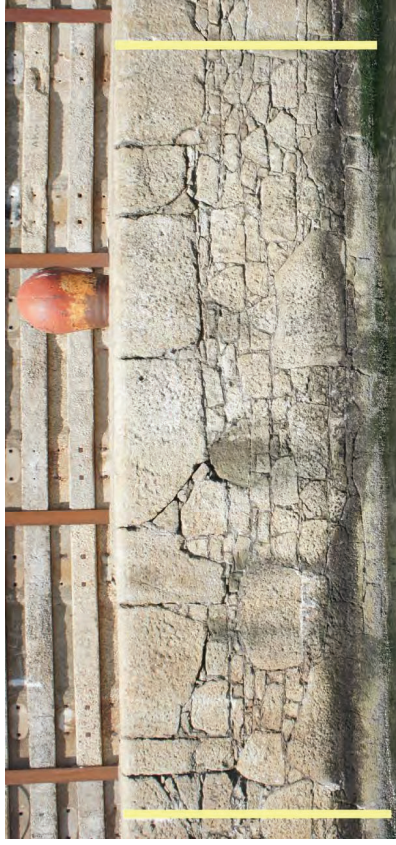
**Figure A31 - Bramley Moore: Chainage 130 to 135m**

Overall Assessment	2	Good
--------------------	---	------

Chainage (m)	Feature	Level (m from top)	Dimensions (m)	Description
130 to 135	Coping	0 to 0.7	-	Good - Minor cracks created by minor movement. Surface defects in coping or limited mortar loss from joints
130 to 135	Brickwork / Masonry	0.4 to 1.8	-	Good - Minor cracks created by minor movement. Surface defects in bricks or limited mortar loss from joints
130 to 135	Marine Growth	1.6 to 1.8	-	Minimal growth. Features remain visible
130 to 135	Coping	0 (coping)	-	Obscured due to large amounts of sand
134	Mooring Bollard	0 (coping)	H = 0.8m	Single bitt bollard. Good condition, localised surface corrosion

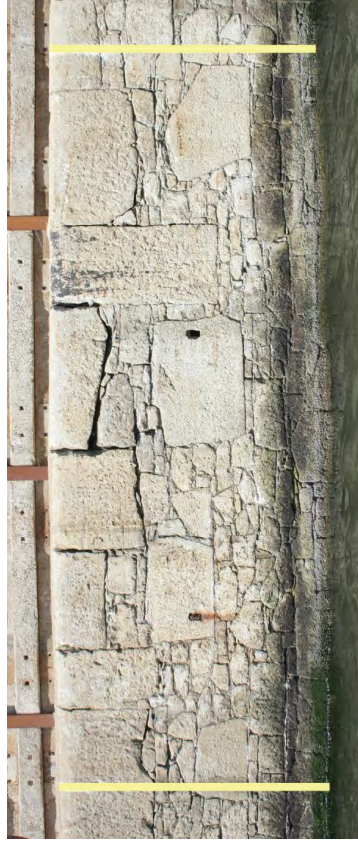
**Figure A32 - Bramley Moore: Chainage 135 to 140m**

Overall Assessment	2	Good
--------------------	---	------

Chainage (m)	Feature	Level (m from top)	Dimensions (m)	Description
135 to 140	Coping	0 to 1.1	-	Good - Minor cracks created by minor movement. Surface defects in coping or limited mortar loss from joints
135 to 140	Brickwork / Masonry	0.4 to 1.8	-	Good - Minor cracks created by minor movement. Surface defects in bricks or limited mortar loss from joints
135 to 140	Marine Growth	1.6 to 1.8	-	Minimal growth. Features remain visible
136 and 137.5	Metalwork	0.9	-	Metal fixing. Poor condition, extensive corrosion with major thickness loss and/or significantly bent and deformed
135 to 140	Coping	0 (coping)	-	Obscured due to large amounts of sand

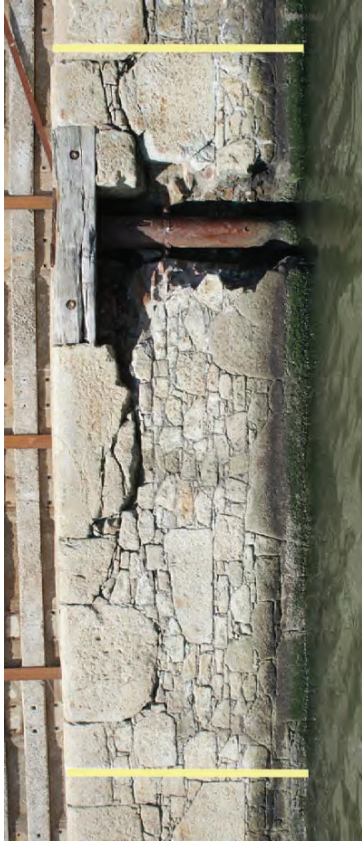
Figure A33 - Bramley Moore: Chainage 140 to 145m

Chainage (m)	Feature	Level (m from top)	Dimensions (m)	Description
140 to 145	Coping	0 to 0.7	-	Fair - Slight coping displacement created by movement. Mortar loss from joints and joints/coping cracking. Rounding/chipping of coping edges
140 to 142	Brickwork / Masonry	0.4 to 1.8	-	Good - Minor cracks created by minor movement. Surface defects in bricks or limited mortar loss from joints
142 to 145	Brickwork / Masonry	0.4 to 1.8	-	Fair - Slight brick displacement created by movement. Mortar loss from joints and joint/brick cracking
140 to 145	Marine Growth	1.7 to 1.8	-	Minor growth. Features partially obscured
143 to 144.5	Timber	0 to 0.2	-	Good - Localised minor damage. Onset of insect or fungal decay with slight loss of timber. Slight gaps at joints and mild misalignment
144	Weephole / Outfall	0.2 to 1.8	-	Piped outfall. Poor condition, loss of material surrounding outfall. Significant corrosion and associated loss of outfall elements

140 to 145	Coping	0 (coping)	-	Obscured due to large amounts of sand

Overall Assessment	3	Fair
--------------------	---	------

Chainage (m)	Feature	Defect	Level (m from top)	Description
142 to 143	Coping	Cracking	0.3 to 0.5	Significant horizontal cracking of mortar joints and/or bricks/blocks. Indicates wall movement/settlement
143 to 144	Brickwork / Masonry	Loss of Bricks/Blocks	0.2 to 0.5	Loss of large group of bricks/blocks. Defects are linked to wall movements and/or overloading of the wall
143 to 144.5	Timber	Splitting	0 to 0.2	Minor splitting and cracks caused by historic shrinkage of timber. Defects are cosmetic only
144	Weephole / Outfall	Corrosion	0.2 to 1.8	Progressive corrosion has lead to deep pitting and loss of thickness weakening the metal
144 to 145	Coping	Cracking	0.3 to 0.5	Significant horizontal cracking of mortar joints and/or bricks/blocks. Indicates wall movement/settlement

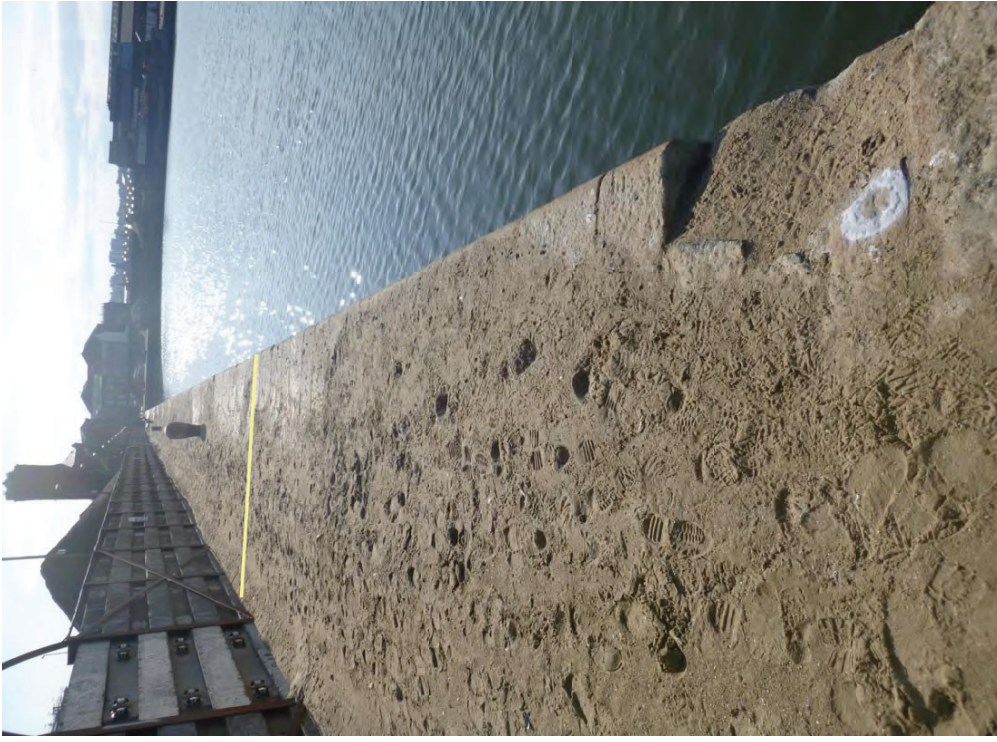
Figure A34a - Bramley Moore: Coping Chainage 145 to 150m

Overall Condition Rating		
Overall Assessment	3	Fair

Chainage (m)	Feature	Level (m from top)	Dimensions (m)	Description
145 to 150	Coping	0 to 0.7	-	Fair - Slight coping displacement created by movement. Mortar loss from joints and joints/coping cracking. Rounding/chipping of coping edges
145 to 150	Brickwork / Masonry	0.3 to 0.9	-	Fair - Slight brick displacement created by movement. Mortar loss from joints and joint/brick cracking
145 to 150	Brickwork / Masonry	0.9 to 1.8	-	Good - Minor cracks created by minor movement. Surface defects in bricks or limited mortar loss from joints
145 to 150	Marine Growth	1.6 to 1.8	-	Minor growth. Features partially obscured
145 to 150	Coping	0 (coping)	-	Obscured due to large amounts of sand

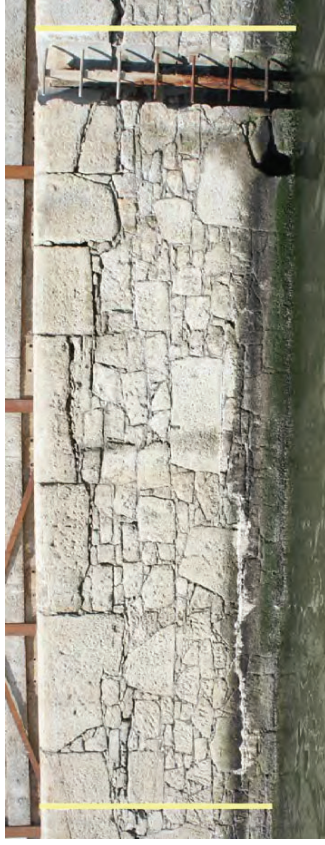
**Figure A36 - Bramley Moore: Chainage 155 to 160m**

Overall Assessment	2	Good
--------------------	---	------

Chainage (m)	Feature	Level (m from top)	Dimensions (m)	Description
155 to 160	Coping	0 to 0.5	-	Good - Minor cracks created by minor movement. Surface defects in coping or limited mortar loss from joints
155 to 160	Brickwork / Masonry	0.3 to 1.8	-	Good - Minor cracks created by minor movement. Surface defects in bricks or limited mortar loss from joints
156 to 160	Marine Growth	1.6 to 1.8	-	Minimal growth. Features remain visible
159	Weephole / Outfall	1.6	D = 0.2m	Circular weephole/outfall. Good condition, some degradation but fully operable
159.5	Ladder	0 to 1.8	-	Ladder within recess. Good condition, some corrosion in intertidal zone
155 to 156	Coping	0 (coping)	-	Obscured due to large amounts of sand
156 to 160	Cobbles	0 (coping)	-	Good - Minor cracks created by settlement/heave. Surface defects in cobbles or limited mortar loss from joints

Chainage (m)	Feature	Defect	Level (m from top)	Description
155 to 157	Brickwork / Masonry	Staining / Calcification	1.5	White staining concentrated around mortar joints indicative of early sulphate attack. May lead to future spalling and deterioration of mortar
157 to 160	Coping	Loss of Mortar	0.3 to 0.5	Mortar loss to coping stone is limited to the surface. Defects are cosmetic only
159	Brickwork / Masonry	Brick/Block Displacement	1.6	Displacement of small groups of bricks/blocks. Defects are cosmetic but have the potential to affect the walls integrity
159	Coping	Cracking	0.3 to 0.4	Significant horizontal cracking of mortar joints and/or bricks/blocks. Indicates wall movement/settlement

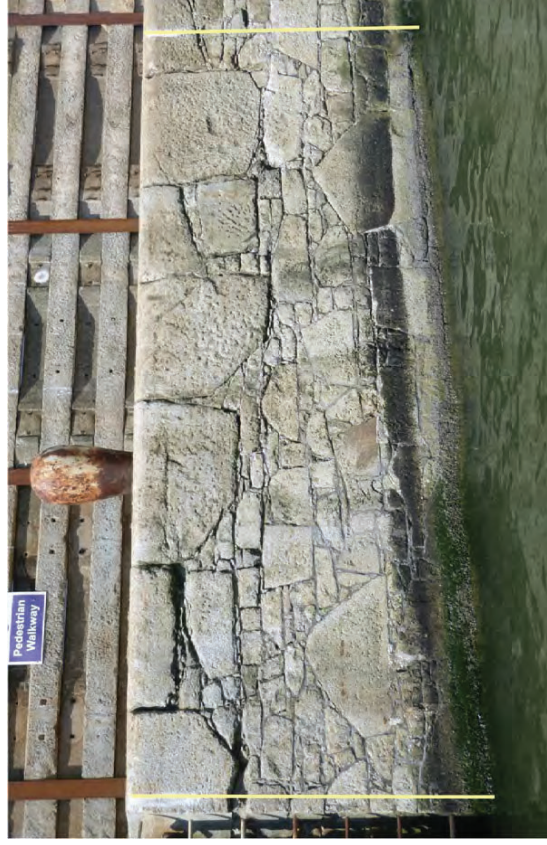
**Figure A37 - Bramley Moore: Chainage 160 to 165m**

Overall Assessment	2	Good
--------------------	---	------

Chainage (m)	Feature	Level (m from top)	Dimensions (m)	Description
160 to 165	Coping	0 to 0.5	-	Good - Minor cracks created by minor movement. Surface defects in coping or limited mortar loss from joints
160 to 165	Brickwork / Masonry	0.2 to 0.5	-	Good - Minor cracks created by minor movement. Surface defects in bricks or limited mortar loss from joints
160 to 162	Marine Growth	1.6 to 1.8	-	Minor growth. Features partially obscured
160 to 163	Coping	0 (coping)	-	Obscured due to large amounts of sand
162	Mooring Bollard	0 (coping)	H = 0.8m	Single bitt bollard. Good condition, localised surface corrosion
163 to 165	Cobbles	0 (coping)	-	Good - Minor cracks created by settlement/heave. Surface defects in cobbles or limited mortar loss from joints

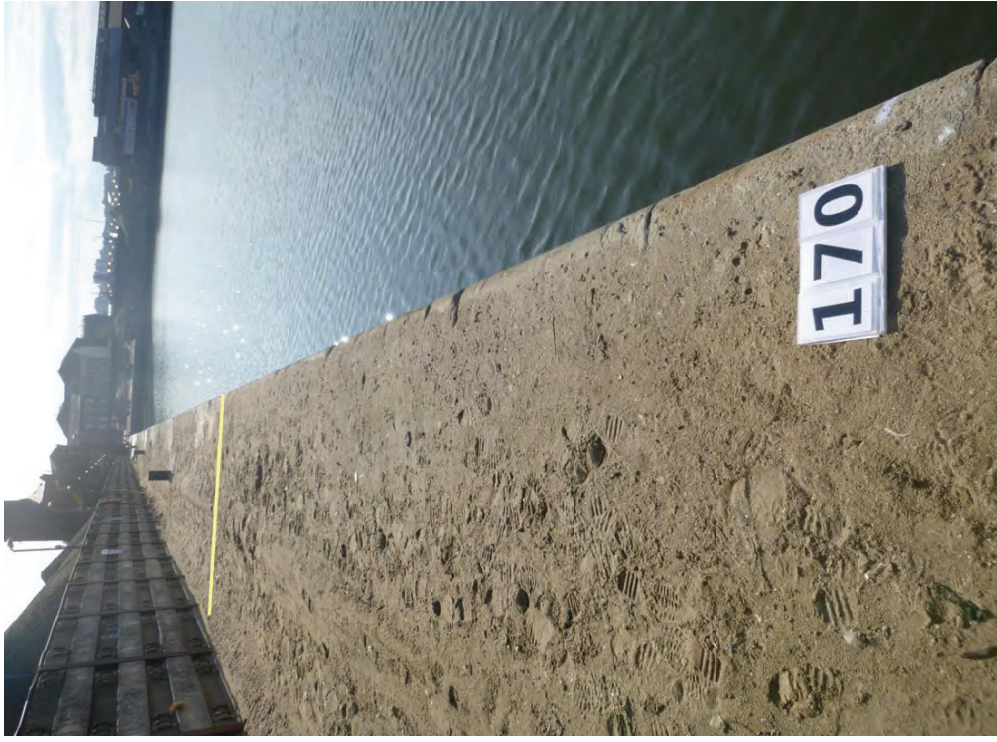
Figure A39a - Bramley Moore: Coping Chainage 170 to 175m

Overall Condition Rating		
Overall Assessment	2	Good
