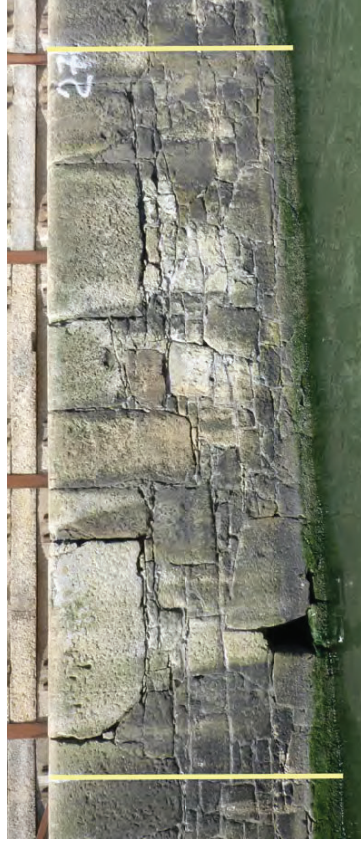
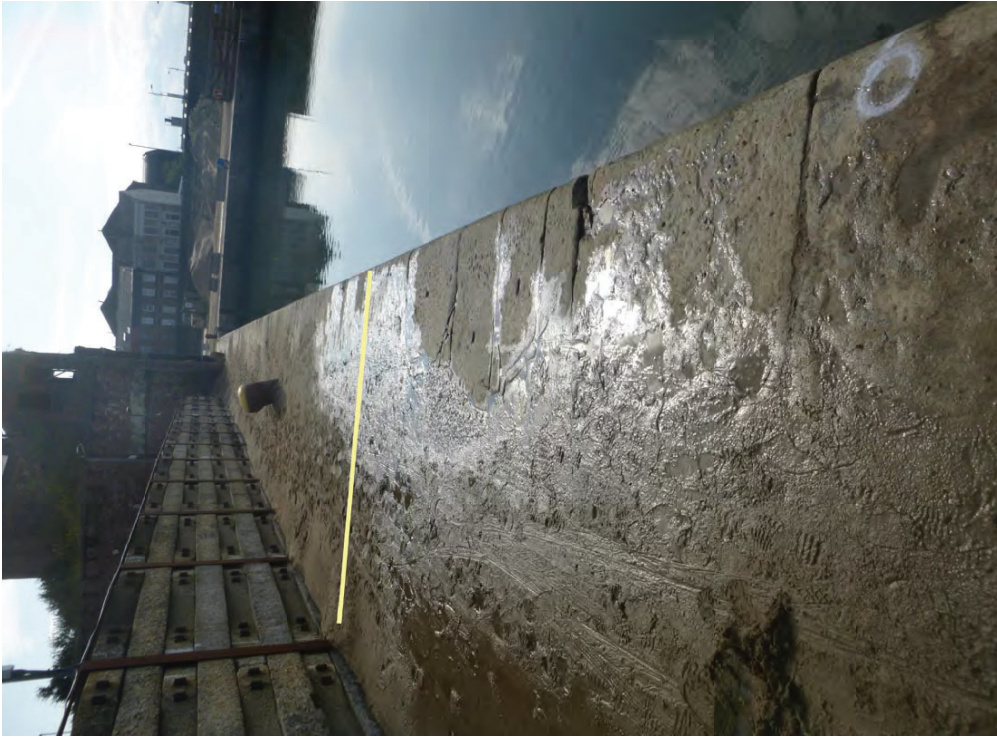
**Figure A58 - Bramley Moore: Chainage 265 to 270m**

| Chainage (m) | Feature | Level (m from top) | Dimensions (m) | Description |
|---|---|---|---|---|
| 265 to 270 | Coping | 0 to 0.6 | - | Good - Minor cracks created by minor movement. Surface defects in coping or limited mortar loss from joints |
| 265 to 270 | Brickwork / Masonry | 0.4 to 1.8 | - | Good - Minor cracks created by minor movement. Surface defects in bricks or limited mortar loss from joints |
| 265 to 270 | Marine Growth | 1.6 to 1.8 | - | Minimal growth. Features remain visible |
| 266 | Weephole / Outfall | 1.5 | D = 0.2m | Rectangular weephole/outfall. Good condition, some degradation but fully operable |
| 265 to 270 | Coping | 0 (coping) | - | Obscured due to large amounts of sand |

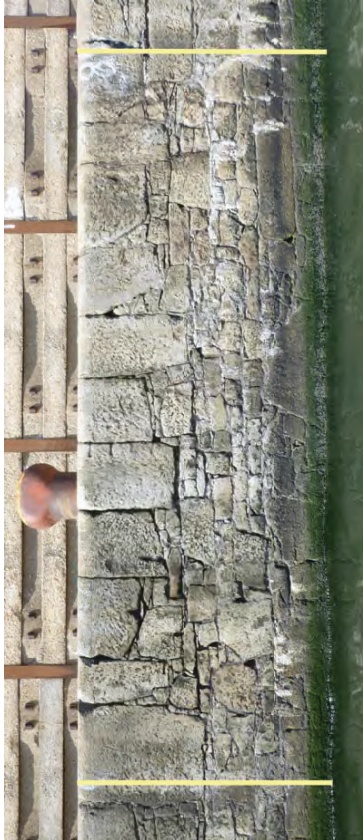
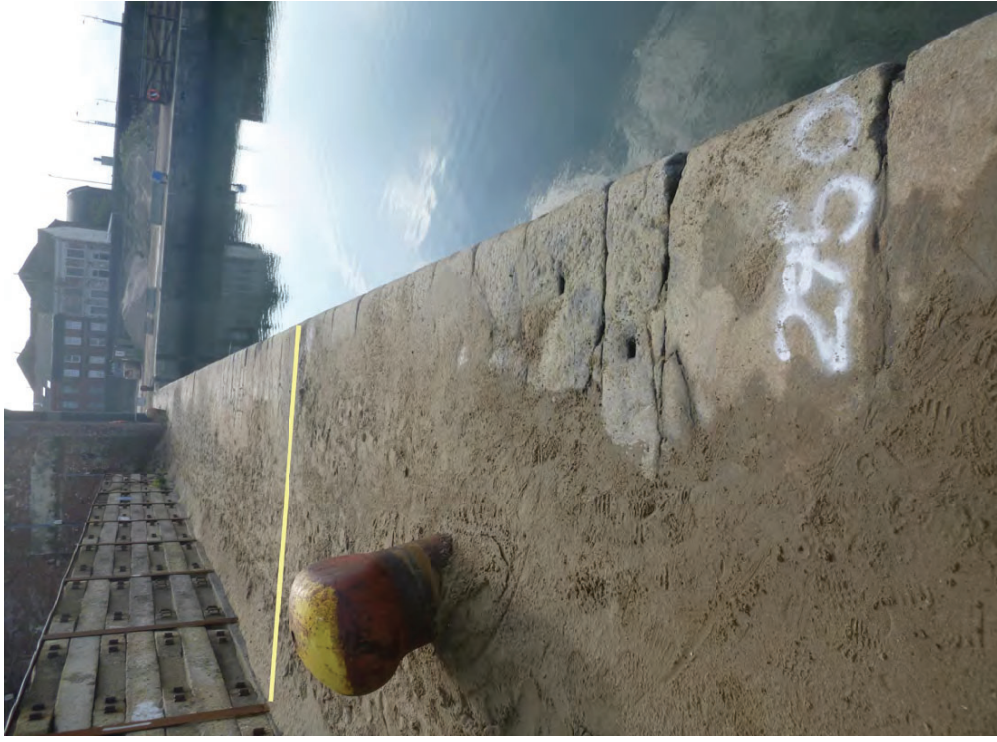
Figure A60 - Bramley Moore: Chainage 275 to 280m

| Chainage (m) | Feature | Level (m from top) | Dimensions (m) | Description |
|---|---|---|---|---|
| 275 to 280 | Coping | 0 to 0.5 | - | Good - Minor cracks created by minor movement. Surface defects in coping or limited mortar loss from joints |
| 275 to 280 | Brickwork / Masonry | 0.5 to 1.8 | - | Good - Minor cracks created by minor movement. Surface defects in bricks or limited mortar loss from joints |
| 275 to 280 | Marine Growth | 1.6 to 1.8 | - | Minor growth. Features partially obscured |
| 275 to 280 | Coping | 0 (coping) | - | Obscured due to large amounts of sand |
| 277 | Mooring Bollard | 0 (coping) | H = 0.8m | Single bitt bollard. Fair condition, extensive corrosion with minor thickness loss and/or minor movement to bollard |

| Chainage (m) | Feature | Defect | Level (m from top) | Description |
|---|---|---|---|---|
| 275 to 280 | Coping | Loss of Mortar | 0 to 0.5 | Mortar loss to bricks/blocks extends below surface and has the potential to weaken/loosen surrounding bricks/blocks |
| 275 to 277 and 279 | Brickwork / Masonry | Loss of Bricks/Blocks | 0.5 to 1.5 | Partial loss of brickwork such as rounding/ chipping of edges |
| 275 to 280 | Brickwork / Masonry | Staining / Calcification | 0.5 to 1.5 | White staining concentrated around mortar joints indicative of early sulphate attack. May lead to future spalling and deterioration of mortar |
| 277 | Mooring Bollard | Movement | 0 (coping) | Rotation of mooring bollard. Indicative of impact damage and/or overloading of bollard |

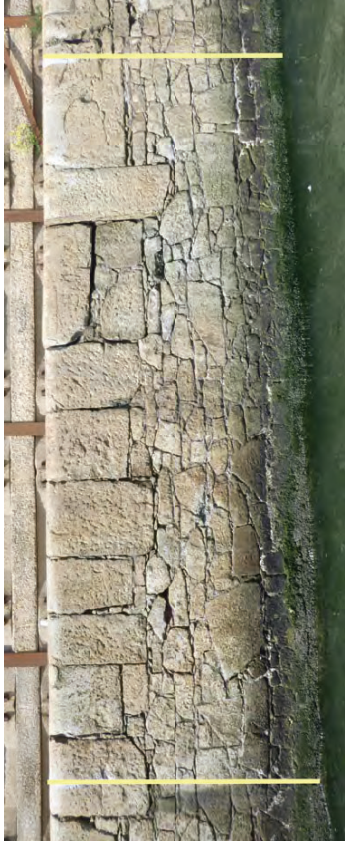
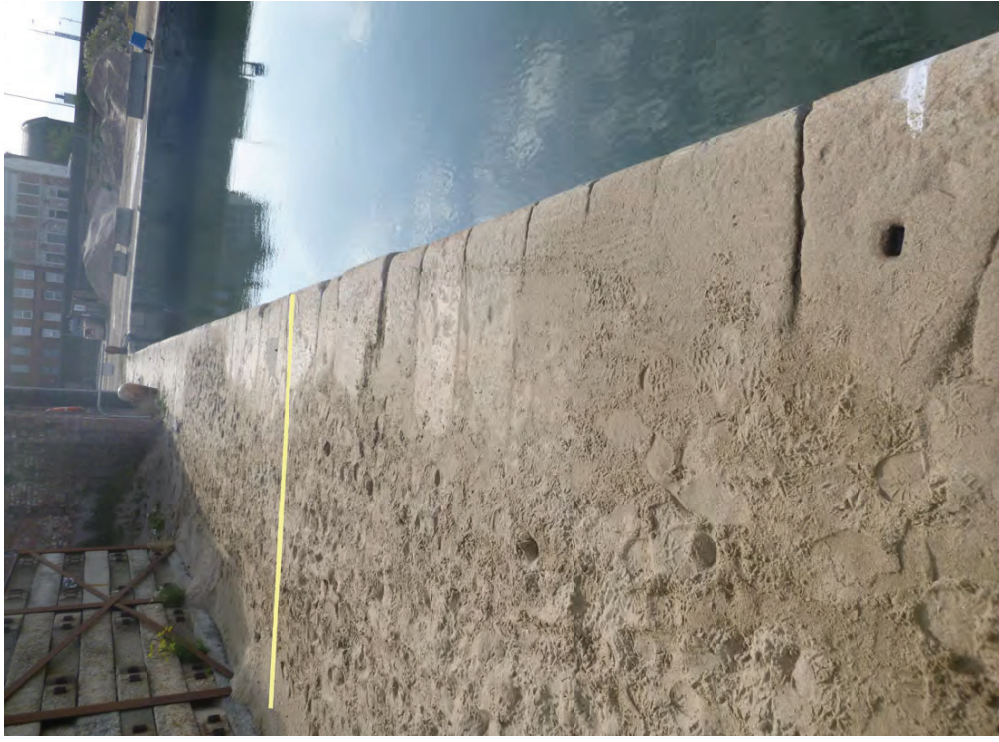
Figure A63a - Bramley Moore: Coping Chainage 290 to 295m

| Chainage (m) | Feature | Level (m from top) | Dimensions (m) | Description |
|---|---|---|---|---|
| 290 to 295 | Coping | 0 to 1.0 | - | Good - Minor cracks created by minor movement. Surface defects in coping or limited mortar loss from joints |
| 290 to 295 | Brickwork / Masonry | 0.5 to 1.8 | - | Good - Minor cracks created by minor movement. Surface defects in bricks or limited mortar loss from joints |

| Chainage (m) | Feature | Defect | Level (m from top) | Description |
|---|---|---|---|---|
| 290 to 295 | Coping | Loss of Mortar | 0 to 1.0 | Mortar loss to coping stone is limited to the surface. Defects are cosmetic only |
| 294 | Coping | Loss of Mortar | 0 to 1.0 | Mortar loss to coping stones extends below surface and has the potential to weaken/loosen surrounding bricks/blocks |
| 294 | Coping | Coping Displacement | 0 | Displacement of singular coping stones. Defects are cosmetic only |
| 290 and 294 | Brickwork / Masonry | Loss of Mortar | 0.8 | Mortar loss to bricks/blocks extends below surface and has the potential to weaken/loosen surrounding bricks/blocks |
| 290 to 295 | Brickwork / Masonry | Staining / Calcification | 0.5 to 1.5 | White staining concentrated around mortar joints indicative of early sulphate attack. May lead to future spalling and deterioration of mortar |

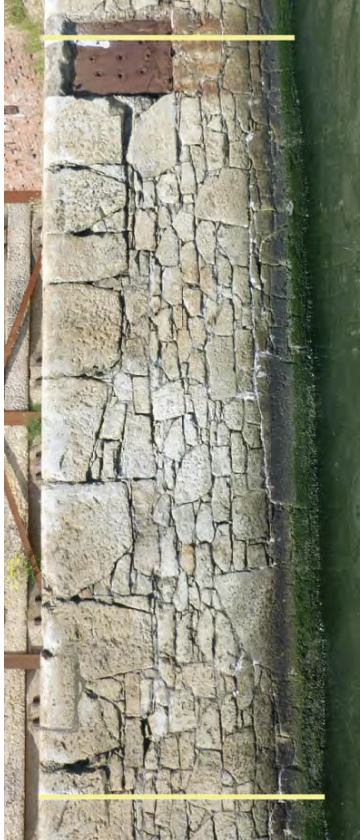
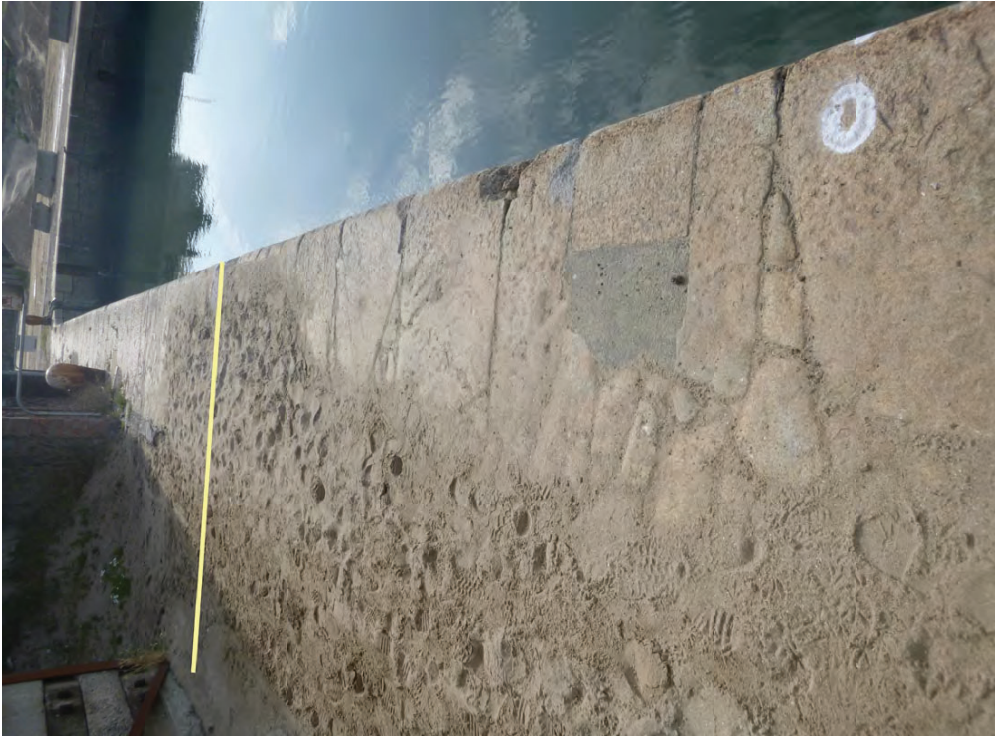
Figure A64 - Bramley Moore: Chainage 295 to 300m

| Chainage (m) | Feature | Level (m from top) | Dimensions (m) | Description |
|---|---|---|---|---|
| 295 to 300 | Coping | 0 to 0.6 | - | Good - Minor cracks created by minor movement. Surface defects in coping or limited mortar loss from joints |
| 295 to 300 | Brickwork / Masonry | 0.5 to 1.8 | - | Good - Minor cracks created by minor movement. Surface defects in bricks or limited mortar loss from joints |
| 295.5 to 300 | Metalwork | 0.2 to 0.9 | 0.6 x 0.7m | Plate. Fair condition, extensive corrosion with minor thickness loss and/or minor movement and damage visible |
| 295 to 296 | Cobbles | 0 (coping) | - | Good - Minor cracks created by settlement/heave. Surface defects in cobbles or limited mortar loss from joints |

| Chainage (m) | Feature | Defect | Level (m from top) | Description |
|---|---|---|---|---|
| 295 to 300 | Coping | Loss of Coping | 0 to 0.3 | Loss/fracturing to edge of coping stone but block remains sound. Likely linked to impact damage |
| 295 to 300 | Coping | Loss of Mortar | 0 to 0.6 | Mortar loss to coping stone is limited to the surface. Defects are cosmetic only |
| 296 to 297.5 | Brickwork / Masonry | Staining / Calcification | 1.5 to 1.8 | White staining concentrated around mortar joints indicative of early sulphate attack. May lead to future spalling and deterioration of mortar |
| 295 | Brickwork / Masonry | Loss of Mortar | 0.2 to 0.7 | Mortar loss to bricks/blocks is limited to the surface. Defects are cosmetic only |
| 295.5 to 300 | Metalwork | Corrosion | 0.2 to 0.9 | Progressive corrosion has lead to deep pitting and loss of thickness weakening the metal |

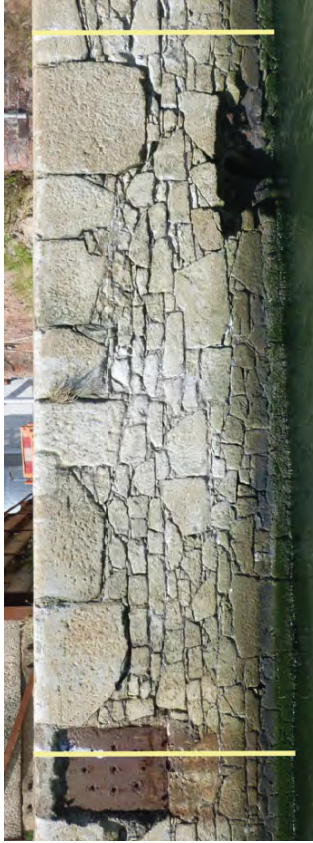
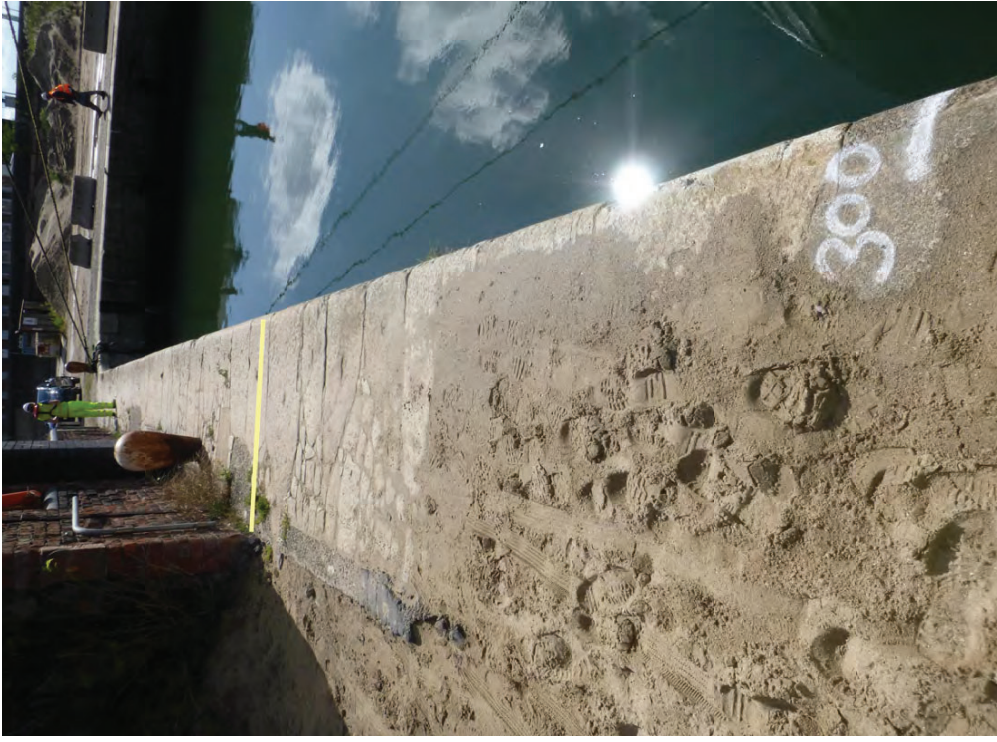
Figure A65a - Bramley Moore: Coping Chainage 300 to 305m

| Chainage (m) | Feature | Level (m from top) | Dimensions (m) | Description |
|---|---|---|---|---|
| 300 to 305 | Coping | 0 to 0.7 | - | Good - Minor cracks created by minor movement. Surface defects in coping or limited mortar loss from joints |
| 300 to 305 | Brickwork / Masonry | 0.3 to 1.8 | - | Good - Minor cracks created by minor movement. Surface defects in bricks or limited mortar loss from joints |
| 300 | Metalwork | 0.2 to 0.9 | 0.6 x 0.7m | Plate. Fair condition, extensive corrosion with minor thickness loss and/or minor movement and damage visible |
| 304 | Weephole / Outfall | 1.7 | D = 0.2m | Circular weephole/outfall. Poor condition, loss of material surrounding weephole/outfall. Any fixings are lost or significantly damaged |
| 303 to 305 | Cobbles | 0 (coping) | - | Good - Minor cracks created by settlement/heave. Surface defects in cobbles or limited mortar loss from joints |

| Chainage (m) | Feature | Defect | Level (m from top) | Description |
|---|---|---|---|---|
| 300 to 301 | Coping | Loss of Coping | 0 | Loss/fracturing to edge of coping stone but block remains sound. Likely linked to impact damage |
| 300 to 305 | Coping | Loss of Mortar | 0 to 0.8 | Mortar loss to coping stone is limited to the surface. Defects are cosmetic only |
| 302 to 303 | Brickwork / Masonry | Staining / Calcification | 0.5 to 1.5 | White staining concentrated around mortar joints indicative of early sulphate attack. May lead to future spalling and deterioration of mortar |
| 300 | Metalwork | Corrosion | 0.2 to 0.9 | Progressive corrosion has lead to deep pitting and loss of thickness weakening the metal |
| 304 to 305 | Brickwork / Masonry | Loss of Bricks/Blocks | 1.6 to 1.8 | Loss of large group of bricks/blocks. Defects are linked to wall movements and/or overloading of the wall |

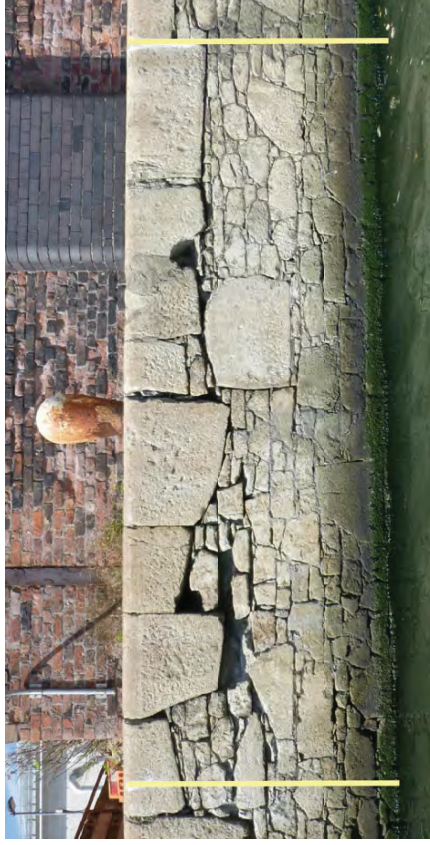
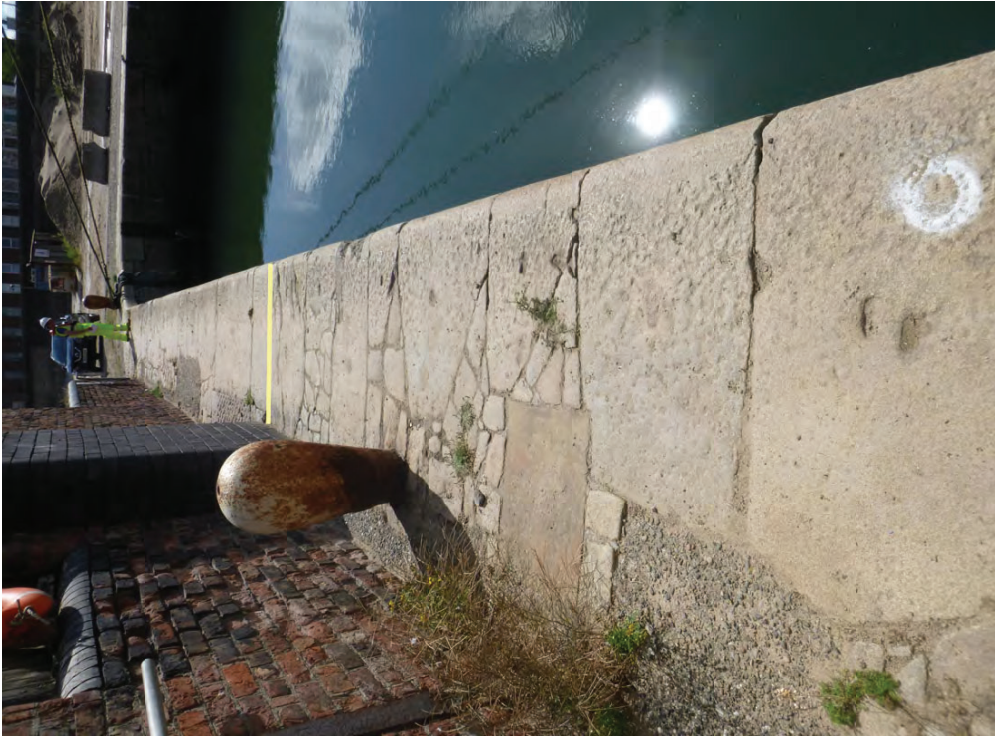
**Figure A66 - Bramley Moore: Chainage 305 to 310m**

| Chainage (m) | Feature | Level (m from top) | Dimensions (m) | Description |
|---|---|---|---|---|
| 305 to 310 | Coping | 0 to 0.7 | - | Good - Minor cracks created by minor movement. Surface defects in coping or limited mortar loss from joints |
| 305 to 310 | Brickwork / Masonry | 0.4 to 1.8 | - | Fair - Missing bricks. Mortar loss from joints and joint/brick cracking |
| 305 to 306 | Concrete | 0 (coping) | - | Good - Structurally sound but with minor cracks and localised honeycombing/flaking with no significant defects |
| 306 to 310 | Cobbles | 0 (coping) | - | Good - Minor cracks created by settlement/heave. Surface defects in cobbles or limited mortar loss from joints |
| 308 | Mooring Bollard | 0 (coping) | H = 0.8m | Short pillar bollard. Good condition, localised surface corrosion |

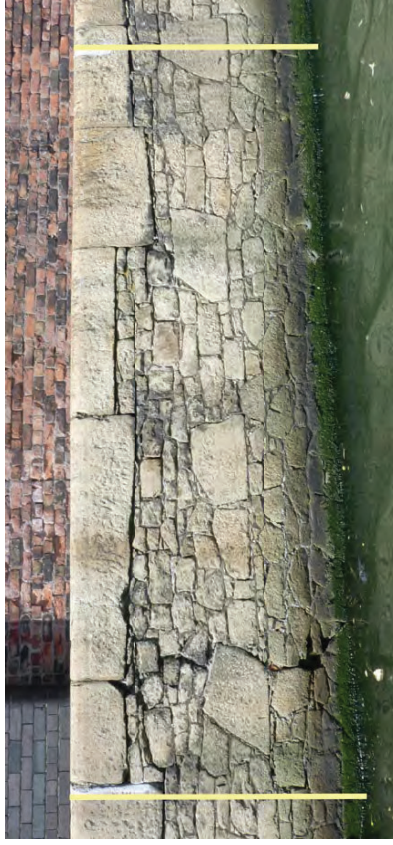
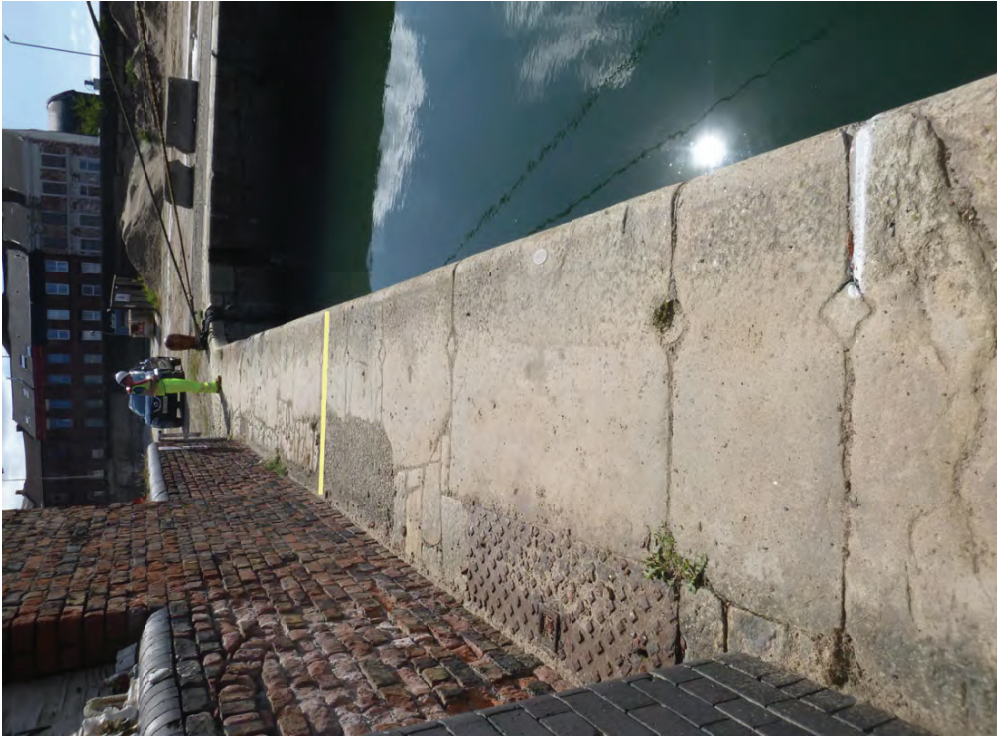
**Figure A67 - Bramley Moore: Chainage 310 to 315m**

| Chainage (m) | Feature | Level (m from top) | Dimensions (m) | Description |
|---|---|---|---|---|
| 310 to 315 | Coping | 0 to 0.5 | - | Good - Minor cracks created by minor movement. Surface defects in coping or limited mortar loss from joints |
| 310 to 315 | Brickwork / Masonry | 0.5 to 1.8 | - | Good - Minor cracks created by minor movement. Surface defects in bricks or limited mortar loss from joints |
| 311 to 312 | Manhole | 0 (coping) | 1 x 0.3m | Good - Localised surface corrosion with slight loss of thickness. Manhole housing remains sound |
| 312 to 315 | Cobbles | 0 (coping) | - | Good - Minor cracks created by settlement/heave. Surface defects in cobbles or limited mortar loss from joints |

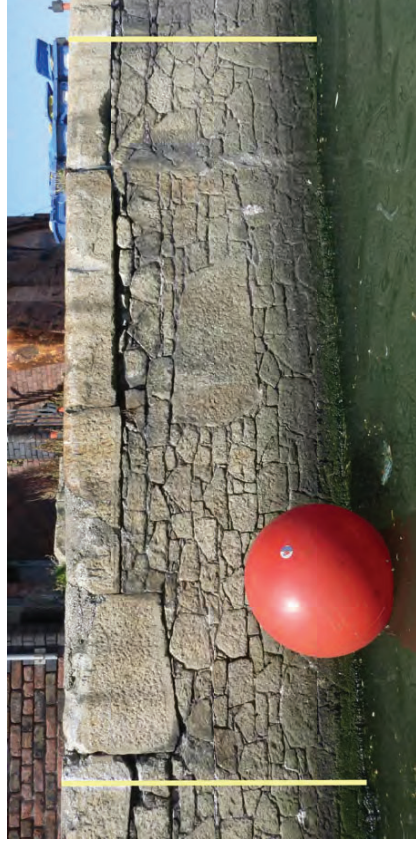
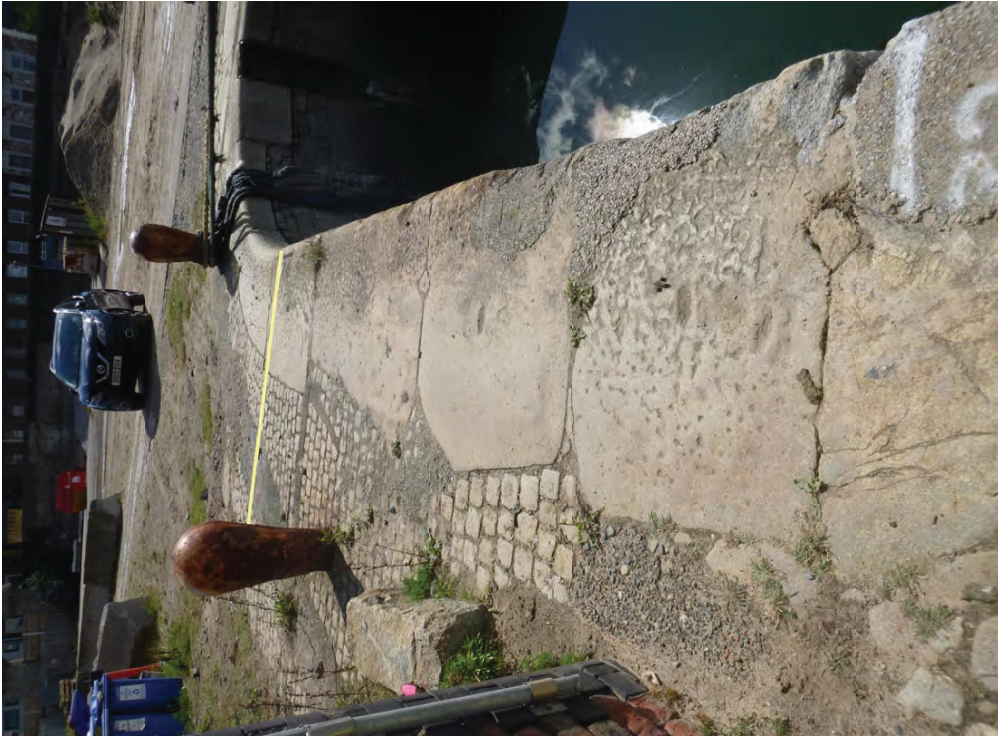
**Figure A69 - Bramley Moore: Chainage 320 to 325m**

| Chainage (m) | Feature | Level (m from top) | Dimensions (m) | Description |
|---|---|---|---|---|
| 320 to 325 | Coping | 0 to 0.6 | - | Fair - Slight coping displacement created by movement. Mortar loss from joints and joints/coping cracking. Rounding/chipping of coping edges |
| 320 to 325 | Brickwork / Masonry | 0.6 to 1.8 | - | Good - Minor cracks created by minor movement. Surface defects in bricks or limited mortar loss from joints |
| 320 to 321 | Concrete | 0 (coping) | - | Good - Structurally sound but with minor cracks and localised honeycombing/flaking with no significant defects |
| 321 to 325 | Cobbles | 0 (coping) | - | Good - Minor cracks created by settlement/heave. Surface defects in cobbles or limited mortar loss from joints |
| 324 | Mooring Bollard | 0 (coping) | H = 1m | Single bitt bollard. Good condition, localised surface corrosion |
| 320-322 | Repair | 0 (coping) | | Concrete repair to coping |

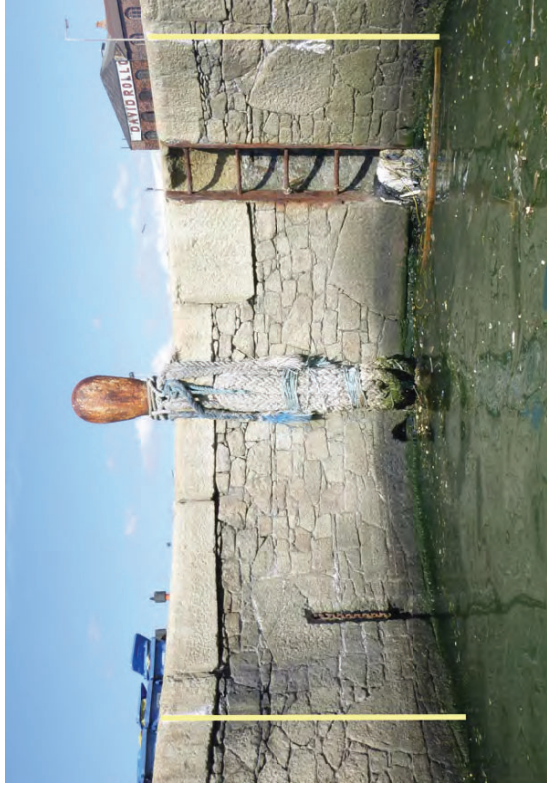
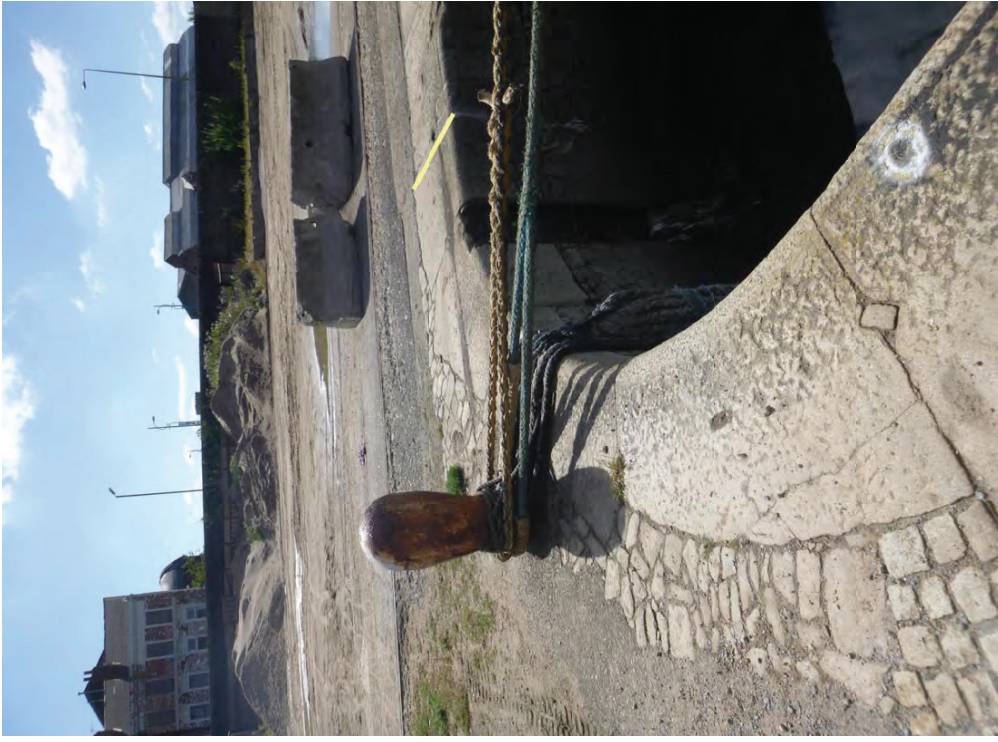
**Figure A70 - Bramley Moore: Chainage 325 to 330m**

| Chainage (m) | Feature | Level (m from top) | Dimensions (m) | Description |
|---|---|---|---|---|
| 325 to 330 | Coping | 0 to 0.5 | - | Good - Minor cracks created by minor movement. Surface defects in coping or limited mortar loss from joints |
| 325 to 330 | Brickwork / Masonry | 0.5 to 1.8 | - | Good - Minor cracks created by minor movement. Surface defects in bricks or limited mortar loss from joints |
| 321 | Mooring Chain | 0.9 to 1.8 | - | Fixed within recess. Fair condition, extensive corrosion with minor thickness loss and/or minor damage to links |
| 323 | Fender | 0 to 1.8 | - | Rope Fender. Fair condition, rope is frayed but has not unravelled. Rope is attached to mooring bollard above |
| 323 | Weephole / Outfall | 1.7 | - | Circular weephole/outfall. Fair condition, some deterioration of material surrounding weephole/outfall. Any fixings have minor damage |
| 324 | Ladder | 0 to 1.8 | - | Ladder within recess. Fair condition, extensive corrosion and/or some damaged/bent rungs |
| 325 to 330 | Cobbles | 0 (coping) | - | Good - Minor cracks created by settlement/heave. Surface defects in cobbles or limited mortar loss from joints |
| 323 | Mooring Bollard | 0 (coping) | - | Single bitt bollard. Good condition, localised surface corrosion |

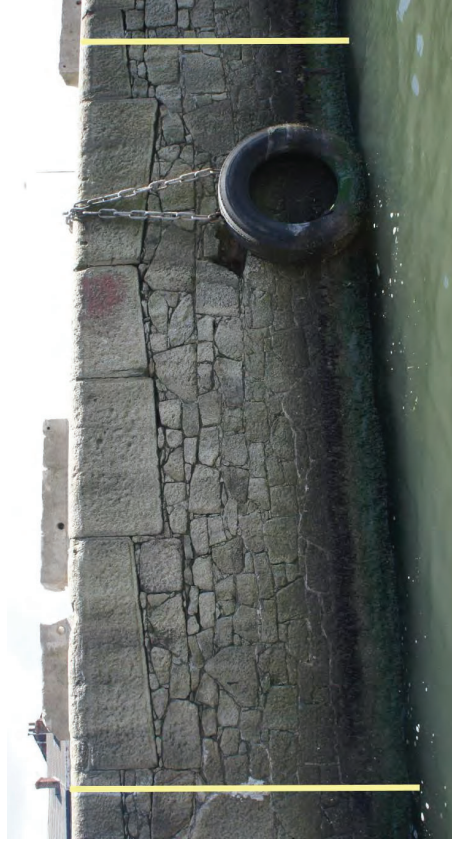
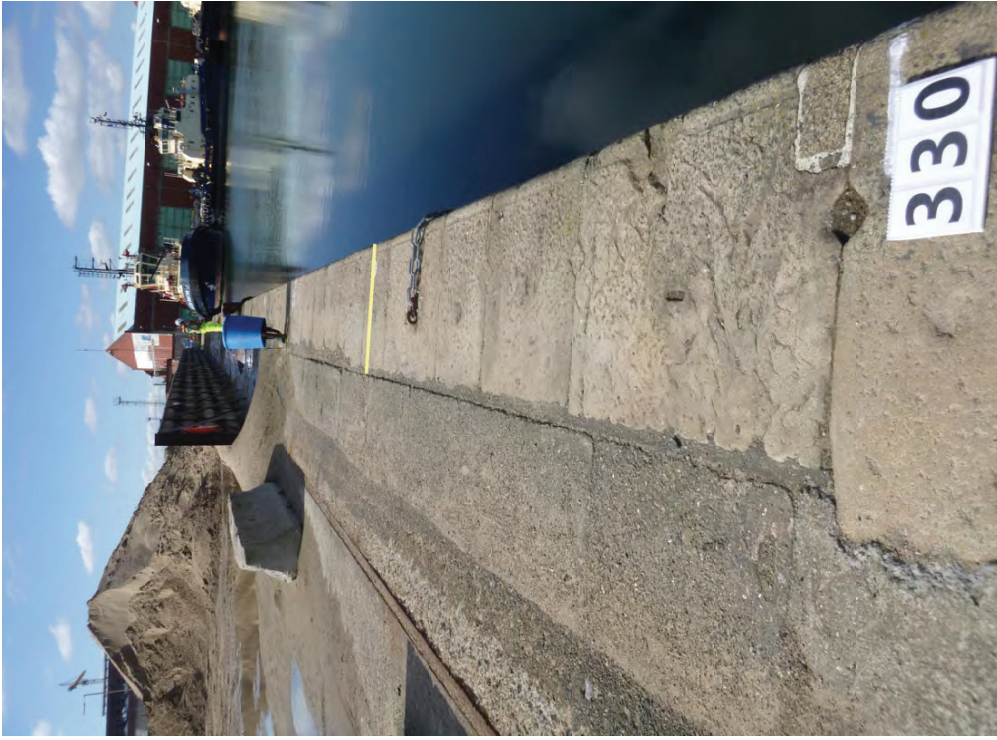
**Figure A71 - Bramley Moore: Chainage 330 to 335m**

| Chainage (m) | Feature | Level (m from top) | Dimensions (m) | Description |
|---|---|---|---|---|
| 330 to 335 | Coping | 0 to 0.6 | - | Good - Minor cracks created by minor movement. Surface defects in coping or limited mortar loss from joints |
| 330 to 335 | Brickwork / Masonry | 0.6 to 1.8 | - | Good - Minor cracks created by minor movement. Surface defects in bricks or limited mortar loss from joints |
| 334 | Fender | 0 to 1.7 | - | Tyre Fender. Good condition, fixed to bollard/coping with chain/rope |
| 330 to 335 | Concrete | 0 (coping) | - | Good - Structurally sound but with minor cracks and localised honeycombing/flaking with no significant defects |

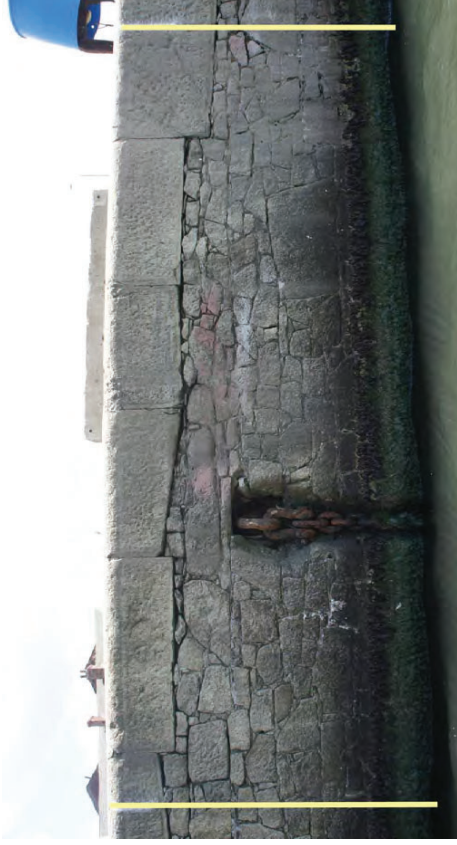
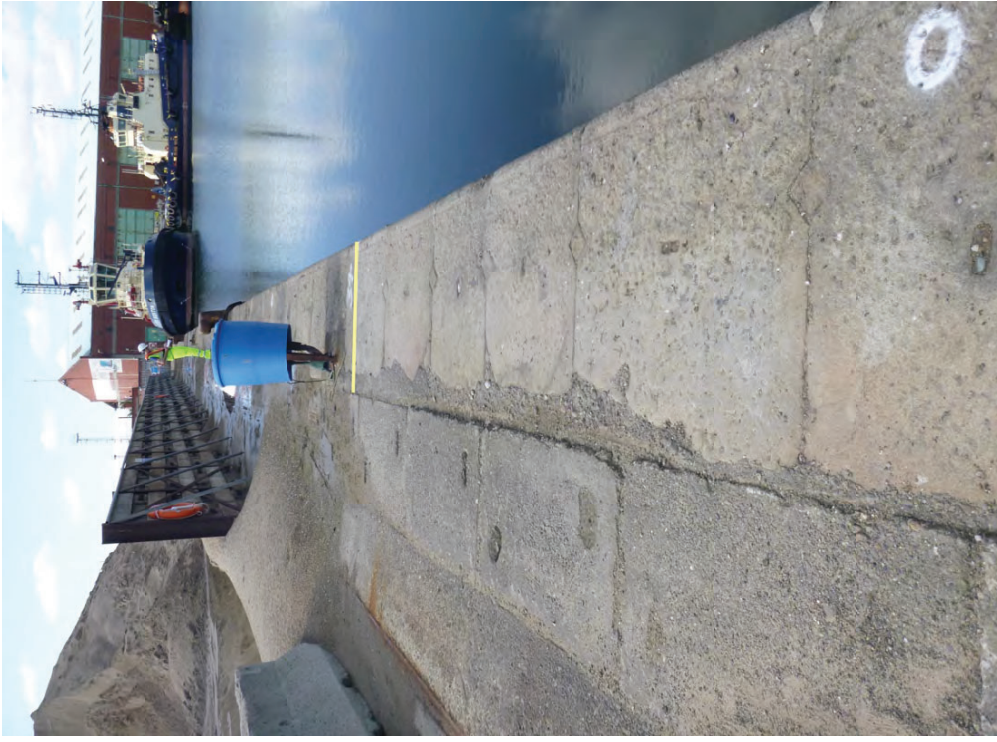
**Figure A72 - Bramley Moore: Chainage 335 to 340m**

| Chainage (m) | Feature | Level (m from top) | Dimensions (m) | Description |
|---|---|---|---|---|
| 335 to 340 | Coping | 0 to 0.6 | - | Good - Minor cracks created by minor movement. Surface defects in coping or limited mortar loss from joints |
| 335 to 340 | Brickwork / Masonry | 0.6 to 1.8 | - | Good - Minor cracks created by minor movement. Surface defects in bricks or limited mortar loss from joints |
| 336.5 | Mooring Chain | 0.8 to 1.8 | - | Fixed within recess. Good condition, localised surface corrosion |
| 335 to 340 | Concrete | 0 (coping) | - | Good - Structurally sound but with minor cracks and localised honeycombing/flaking with no significant defects |

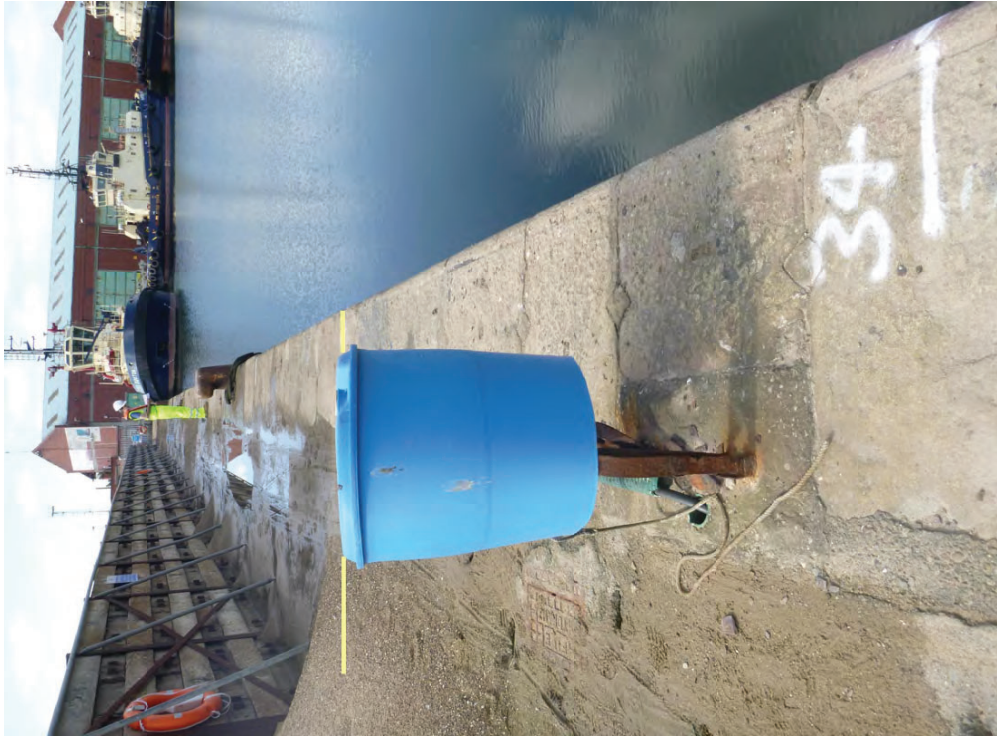
Figure A73a - Bramley Moore: Coping Chainage 340 to 345m

| Chainage (m) | Feature | Level (m from top) | Dimensions (m) | Description |
|---|---|---|---|---|
| 340 to 345 | Coping | 0 to 0.7 | - | Fair - Slight coping displacement created by movement. Mortar loss from joints and joints/coping cracking. Rounding/chipping of coping edges |
| 340 to 345 | Brickwork / Masonry | 0.7 to 1.8 | - | Good - Minor cracks created by minor movement. Surface defects in bricks or limited mortar loss from joints |
| 341 | Weephole / Outfall | 1 | D = 0.2m | Rectangular weephole/outfall. Good condition, some degradation but fully operable |
| 342.5 | Weephole / Outfall | 0.6 | D = 0.15m | Rectangular weephole/outfall. Fair condition, some deterioration of material surrounding weephole/outfall. Any fixings have minor damage |
| 340 to 345 | Concrete | 0 (coping) | - | Good - Structurally sound but with minor cracks and localised honeycombing/flaking with no significant defects |
| 341 | Miscellaneous | 0 (coping) | H = 1m | Possible electrical equipment attached the steel posts and covered in plastic barrel |

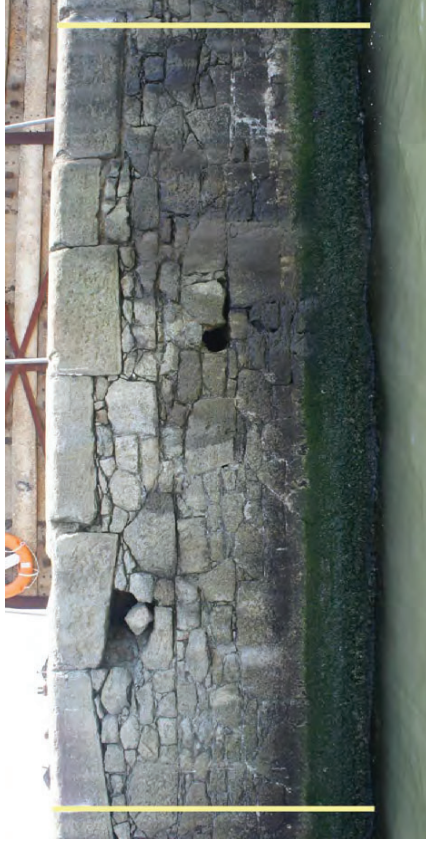
**Figure A74 - Bramley Moore: Chainage 345 to 350m**

| Chainage (m) | Feature | Level (m from top) | Dimensions (m) | Description |
|---|---|---|---|---|
| 345 to 350 | Coping | 0 to 0.4 | - | Good - Minor cracks created by minor movement. Surface defects in coping or limited mortar loss from joints |
| 345 to 350 | Brickwork / Masonry | 0.4 to 1.8 | - | Good - Minor cracks created by minor movement. Surface defects in bricks or limited mortar loss from joints |
| 347.5 | Weephole / Outfall | 1 | D = 0.15m | Circular weephole/outfall. Good condition, nsome degradation but fully operable |
| 345 to 350 | Concrete | 0 (coping) | - | Good - Structurally sound but with minor cracks and localised honeycombing/flaking with no significant defects |
