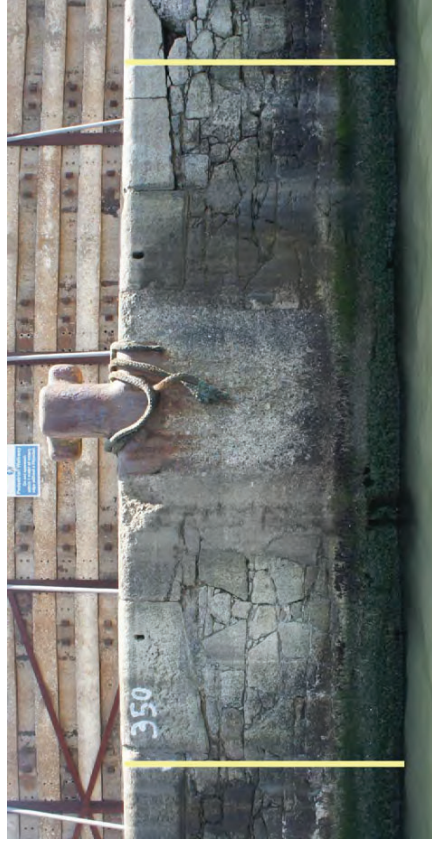
**Figure A75 - Bramley Moore: Chainage 350 to 355m**

| Overall Assessment | 2 | Good |

| Chainage (m) | Feature | Level (m from top) | Dimensions (m) | Description |
|---|---|---|---|---|
| 350 to 352, 353 to 355 | Coping | 0 to 0.5 | - | Good - Minor cracks created by minor movement. Surface defects in coping or limited mortar loss from joints |
| 352 to 353 | Repair | 0 to 1.5 | - | Concrete repair to brickwork/blockwork |
| 350 to 355 | Brickwork / Masonry | 0.5 to 1.8 | - | Good - Minor cracks created by minor movement. Surface defects in bricks or limited mortar loss from joints |
| 350 to 355 | Marine Growth | 1.5 to 1.8 | - | Minimal growth. Features remain visible |
| 350 to 355 | Coping | 0 (coping) | - | Obscured due to large amounts of sand |
| 352.5 | Mooring Bollard | 0 (coping) | H = 0.8m | T-Shaped bollard embedded into coping. Good condition, localised surface corrosion |

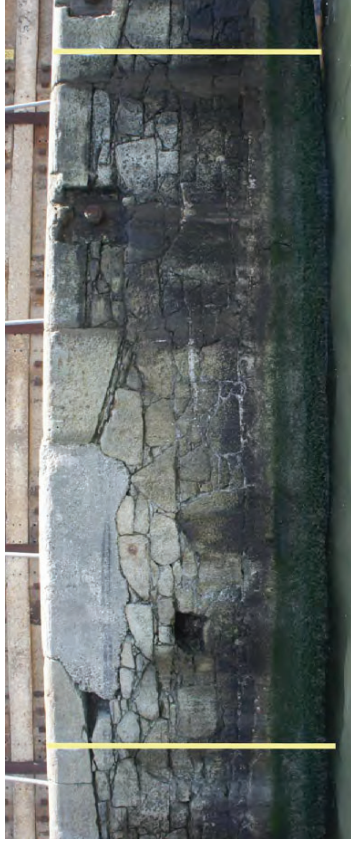
**Figure A76 - Bramley Moore: Chainage 355 to 360m**

| Chainage (m) | Feature | Level (m from top) | Dimensions (m) | Description |
|---|---|---|---|---|
| 355 to 351, 353 to 355 | Coping | 0 to 0.5 | - | Good - Minor cracks created by minor movement. Surface defects in coping or limited mortar loss from joints |
| 351 to 353 | Repair | 0 to 0.5 | - | Concrete repair to coping |
| 355 to 360 | Brickwork / Masonry | 0.3 to 1.8 | - | Good - Minor cracks created by minor movement. Surface defects in bricks or limited mortar loss from joints |
| 351 | Weephole / Outfall | 1 | D = 0.2m | Rectangular weephole/outfall. Fair condition, some deterioration of material surrounding weephole/outfall. Any fixings have minor damage |
| 358.5 | Anchor | 0.1 to 0.4 | 0.3 x 0.3m | Good - Localised surface corrosion with slight loss of thickness. No physical deformation or movement of anchor ties/plates |

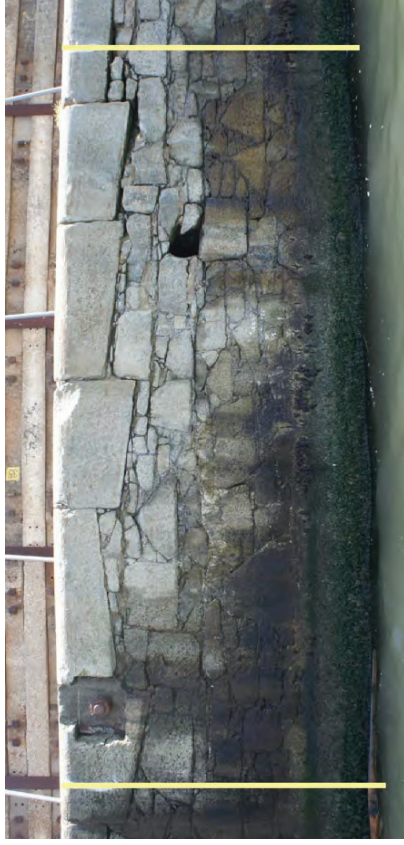
**Figure A77 - Bramley Moore: Chainage 360 to 365m**

| Chainage (m) | Feature | Level (m from top) | Dimensions (m) | Description |
|---|---|---|---|---|
| 360 to 365 | Coping | 0 to 0.5 | - | Good - Minor cracks created by minor movement. Surface defects in coping or limited mortar loss from joints |
| 360 to 365 | Brickwork / Masonry | 0.5 to 1.8 | - | Good - Minor cracks created by minor movement. Surface defects in bricks or limited mortar loss from joints |
| 360.5 | Anchor | 0.1 to 0.4 | 0.3 x 0.3m | Good - Localised surface corrosion with slight loss of thickness. No physical deformation or movement of anchor ties/plates |
| 364 | Weephole / Outfall | 0.9 | D = 0.2m | Rectangular weephole/outfall. Fair condition, some deterioration of material surrounding weephole/outfall. Any fixings have minor damage |
| 360 to 361 | Metalwork | 0 (coping) | - | Rail track. Poor condition, extensive corrosion with major thickness loss |

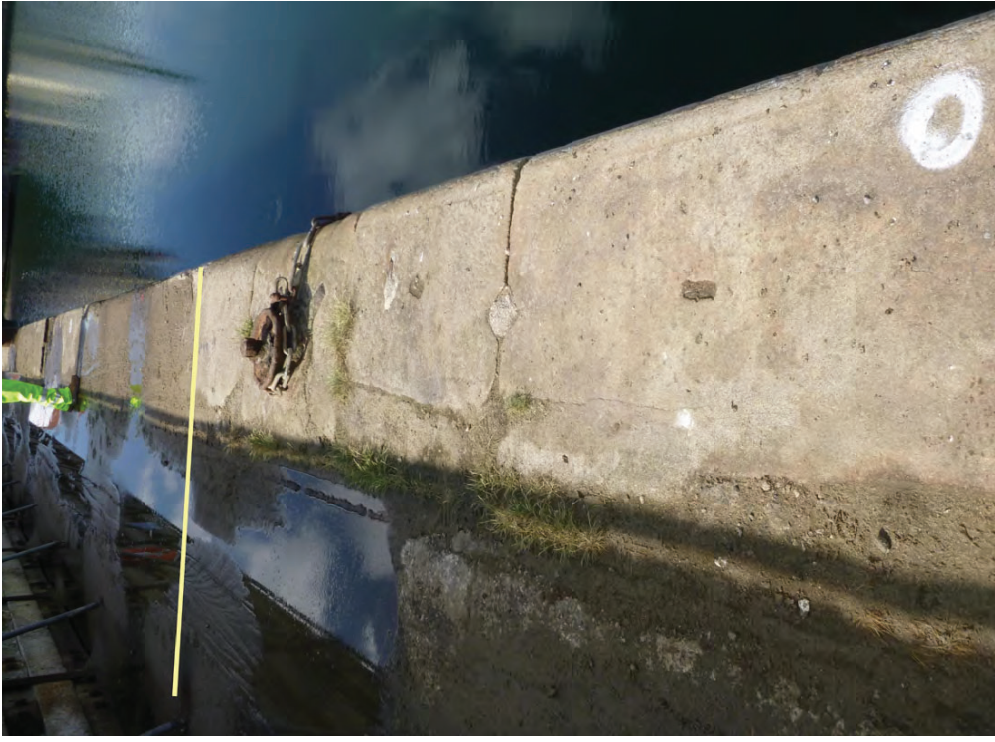
Figure A78a - Bramley Moore: Coping Chainage 365 to 370m

| Overall Condition Rating | 4 | Poor |

| Chainage (m) | Feature | Level (m from top) | Dimensions (m) | Description |
|---|---|---|---|---|
| 365 to 369 | Coping | 0 to 0.4 | - | Fair - Slight coping displacement created by movement. Mortar loss from joints and joints/coping cracking. Rounding/chipping of coping edges |
| 369 to 370 | Repair | 0 to 0.5 | - | Concrete repair to coping |
| 365 to 370 | Brickwork / Masonry | 0.5 to 1.8 | - | Poor - Substantial cracking and damage created by movement. Missing bricks, extensive spalling and/or misalignment of bricks. |
| 367.5 | Mooring Chain | 0.9 to 1.8 | - | Fixed within recess. Fair condition, extensive corrosion with minor thickness loss and/or minor damage to links |
| 365 to 370 | Concrete | 0 (coping) | - | Good - Structurally sound but with minor cracks and localised honeycombing/flaking with no significant defects |
| 365 to 370 | Metalwork | 0 (coping) | - | Rail track. Fair condition, extensive corrosion with minor thickness loss |
| 367.5 | Mooring Bollard | 0 (coping) | H = 0.2m | Short pillar bollard. Good condition, localised surface corrosion |

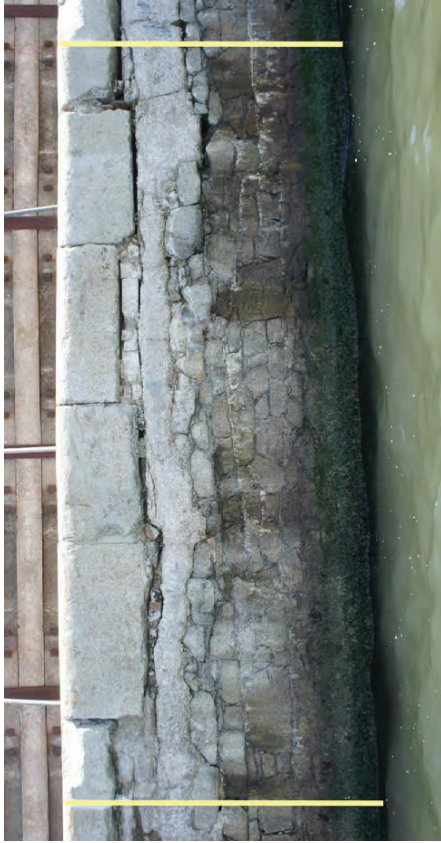
A83 Chainage 390 to 395m

| Chainage (m) | Feature | Level (m from top) | Dimensions (m) | Description |
|---|---|---|---|---|
| 390 to 395 | Coping | 0 to 0.5 | - | Fair - Slight coping displacement created by movement. Mortar loss from joints and joints/coping cracking. Rounding/chipping of coping edges |
| 390 to 395 | Repair | 0.5 to 0.8 | - | Concrete repair to brickwork/blockwork |
| 390 to 395 | Brickwork / Masonry | 0.8 to 1.8 | - | Good - Minor cracks created by minor movement. Surface defects in bricks or limited mortar loss from joints |
| 390 to 395 | Concrete | 0 (coping) | - | Good - Structurally sound but with minor cracks and localised honeycombing/flaking with no significant defects |
| 390 to 395 | Metalwork | 0 (coping) | - | Rail track. Fair condition, extensive corrosion with minor thickness loss |

| Defects | | | | |
|---|---|---|---|---|
| 390 to 391 | Coping | Loss of Coping | 0 to 0.2 | Loss/fracturing to edge of coping stone but block remains sound. Likely linked to impact damage |
| 391 to 395 | Coping | Loss of Mortar | 0.4 to 0.5 | Mortar loss to coping stones extends below surface and has the potential to weaken/loosen surrounding bricks/blocks |
| 390 to 395 | Repair | Flaking / Spalling | 0.5 to 0.8 | Minor spalling or surface concrete most likely due to impact damage or early onset of reinforcement corrosion |
| 390 to 395 | Brickwork / Masonry | Loss of Mortar | 0.8 to 1 | Mortar loss to bricks/blocks extends below surface and has the potential to weaken/loosen surrounding bricks/blocks |

| Overall Assessment | 2 | Good |

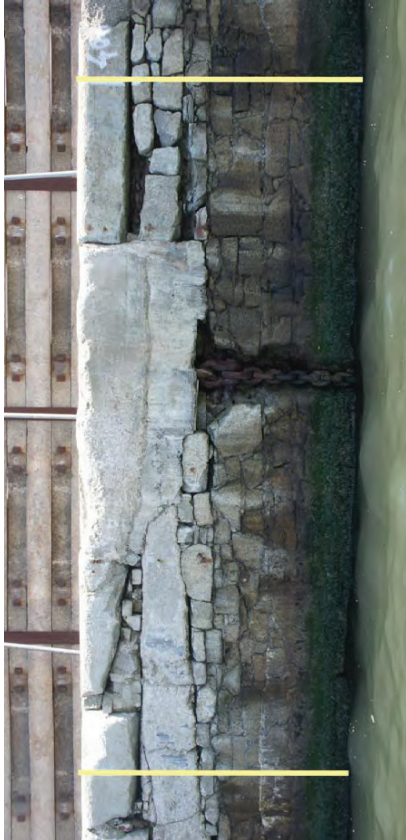
Figure A84 - Bramley Moore: Chainage 395 to 400m

| Chainage (m) | Feature | Level (m from top) | Dimensions (m) | Description |
|---|---|---|---|---|
| 395 to 397, 399 to 400 | Coping | 0 to 0.5 | - | Fair - Slight coping displacement created by movement. Mortar loss from joints and joints/coping cracking. Rounding/chipping of coping edges |
| 397 to 399 | Repair | 0 to 1 | - | Concrete repair to coping |
| 395 to 400 | Brickwork / Masonry | 0.5 to 1.8 | - | Fair - Slight brick displacement created by movement. Mortar loss from joints and joint/brick cracking |
| 398 | Mooring Chain | 1 to 1.8 | - | Fixed within recess. Good condition. Localised surface corrosion |
| 395 to 400 | Concrete | 0 (coping) | - | Fair - Rust staining, localised spalling, lengthy cracking and some movement or extensive honeycombing |
| 395 to 400 | Metalwork | 0 (coping) | - | Rail track. Fair condition, extensive corrosion with minor thickness loss |

| Chainage (m) | Feature | Defect | Level (m from top) | Description |
|---|---|---|---|---|
| 395 to 397, 399 to 400 | Coping | Loss of Coping | 0 to 0.5 | Loss/fracturing to edge of coping stone but block remains sound. Likely linked to impact damage |
| 395 to 397, 399 to 400 | Coping | Loss of Mortar | 0.2 to 0.5 | Mortar loss to coping stones extends below surface and has the potential to weaken/loosen surrounding bricks/blocks |
| 397 to 399 | Repair | Flaking / Spalling | 0 to 1 | Minor spalling or surface concrete most likely due to impact damage or early onset of reinforcement corrosion |
| 395 to 400 | Brickwork / Masonry | Loss of Mortar | 0.2 to 1 | Mortar loss to bricks/blocks is significant resulting in loosening of bricks/blocks |
| 399 to 400 | Brickwork / Masonry | Loss of Bricks/Blocks | 0.3 to 1 | Loss of small group of bricks/blocks. Defects are cosmetic but have the potential to affect the walls integrity |

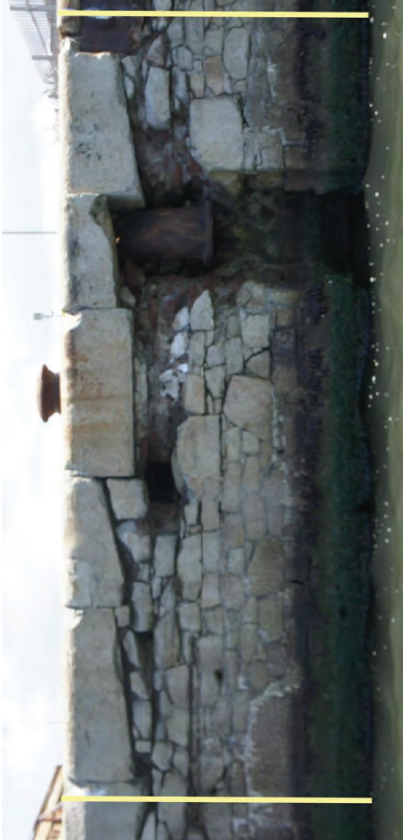
A88 Chainage 415 to 420m

| Chainage (m) | Feature | Level (m from top) | Dimensions (m) | Description |
|---|---|---|---|---|
| 415 to 420 | Coping | 0 to 0.5 | - | Poor - Substantial cracking and damage created by movement. Extensive coping damage and/or misalignment/missing of blocks. |
| 415 to 420 | Brickwork / Masonry | 0.5 to 1.8 | - | Poor - Substantial cracking and damage created by movement. Missing bricks, extensive spalling and/or misalignment of bricks. |
| 417 | Weephole / Outfall | 0.5 to 0.7 | D = 0.2m | Rectangular weephole/outfall. Fair condition, some deterioration of material surrounding weephole/outfall. Any fixings have minor damage |
| 418.5 | Weephole / Outfall | 0.4 to 1.8 | D = 0.35m | Piped outfall. Poor condition, loss of material surrounding outfall. Significant corrosion and associated loss of outfall elements |
| 415 to 420 | Metalwork | 0 (coping) | - | Rail track. Fair condition, extensive corrosion with minor thickness loss |
| 415 to 420 | Concrete | 0 (coping) | - | Fair - Rust staining, localised spalling, lengthy cracking and some movement or extensive honeycombing |
| 417.5 | Mooring Bollard | 0 (coping) | H = 0.2m | Short pillar bollard. Good condition, localised surface corrosion |

| Chainage (m) | Feature | Defect | Level (m from top) | Description |
|---|---|---|---|---|
| 415 to 420 | Coping | Loss of Mortar | 0.3 to 0.5 | Mortar loss to coping stones is significant resulting in loosening of bricks/blocks |
| 415 to 420 | Coping | Loss of Coping | 0 to 0.5 | Loss/fracturing to edge of coping stone but block remains sound. Likely linked to impact damage |
| 415 to 420 | Brickwork / Masonry | Loss of Mortar | 0.5 to 1.2 | Mortar loss to bricks/blocks is significant resulting in loosening of bricks/blocks |
| 417 to 420 | Brickwork / Masonry | Loss of Bricks/Blocks | 0.5 to 0.9 | Full brick/block loss leading to exposure of material behind the wall. Progressive failure of wall through material washout likely |
| 415 to 417 | Concrete | Cracking | 0 (coping) | Significant cracking of concrete. Indicates wall movement/settlement |
| 416 to 418 | Concrete | Flaking / Spalling | 0 (coping) | Minor spalling or surface concrete most likely due to impact damage or early onset of reinforcement corrosion |

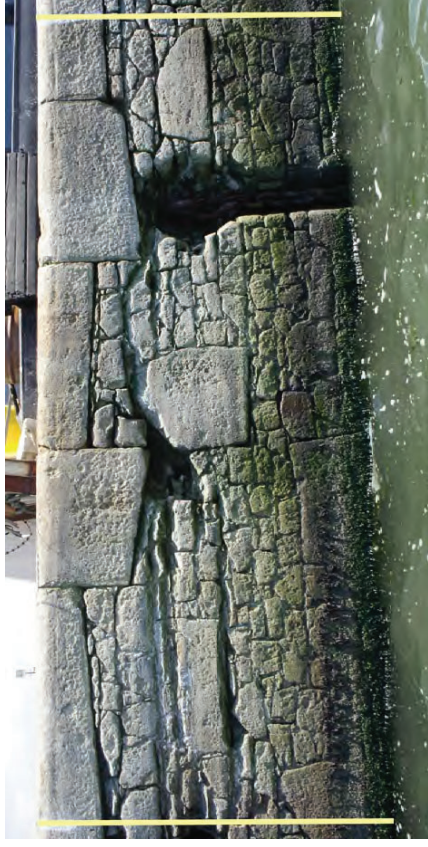
**Figure A90 - Bramley Moore: Chainage 425 to 430m**

| Chainage (m) | Feature | Level (m from top) | Dimensions (m) | Description |
|---|---|---|---|---|
| 425 to 430 | Coping | 0 to 0.5 | - | Good - Minor cracks created by minor movement. Surface defects in coping or limited mortar loss from joints |
| 425 to 430 | Brickwork / Masonry | 0.5 to 1.8 | - | Fair - Slight brick displacement created by movement. Mortar loss from joints and joint/brick cracking |
| 428.5 | Mooring Chain | 0.5 to 1.8 | - | Fixed within recess. Fair condition, extensive corrosion with minor thickness loss and/or minor damage to links |
| 425 to 426.5 | Concrete | 0 (coping) | - | Good - Structurally sound but with minor cracks and localised honeycombing/flaking with no significant defects |
| 425 to 426.5 | Metalwork | 0 (coping) | - | Rail track. Fair condition, extensive corrosion with minor thickness loss |
| 426.5 | Hand railing / Fence | 0 (coping) | H = 2.2m | Fair - Extensive corrosion with minor loss of thickness. Some damage, deformation or movement to posts or rails |
| 426.5 to 430 | Obstruction | 0 (coping) | - | Significant obstruction. Features obscured. Condition cannot be assessed |

| <b>Chainage<br/>(m)</b> | <b>Feature</b> | <b>Defect</b> | <b>Level (m<br/>from top)</b> | <b>Description</b> |
|---|---|---|---|---|
| 425 to 430 | Coping | Loss of Mortar | 0.3 to 0.5 | Mortar loss to coping stone is limited to the surface. Defects are cosmetic only |
| 425 to 430 | Brickwork /<br>Masonry | Loss of Mortar | 0.3 to 1 | Mortar loss to bricks/blocks extends below surface and has the potential to weaken/loosen surrounding bricks/blocks |
| 427.5 | Brickwork /<br>Masonry | Loss of Bricks/BLOCKS | 0.5 to 1 | Loss of small group of bricks/blocks. Defects are cosmetic but have the potential to affect the walls integrity |
| 428.5 | Brickwork /<br>Masonry | Impact Damage | 0.5 to 1 | Localised impact damage resulting in chipping/fragmentation of wall materials |

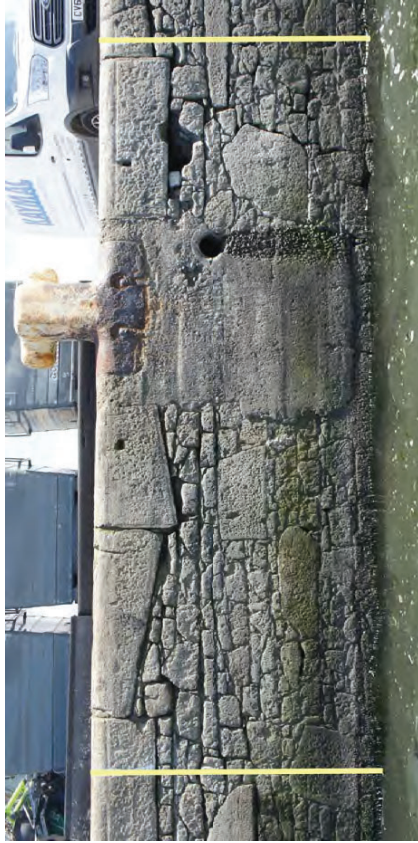
A91 Chainage 430 to 435m

| Chainage (m) | Feature | Level (m from top) | Dimensions (m) | Description |
|---|---|---|---|---|
| 430 to 443, 444 to 445 | Coping | 0 to 0.5 | - | Good - Minor cracks created by minor movement. Surface defects in coping or limited mortar loss from joints |
| 430 to 443, 444 to 445 | Brickwork / Masonry | 0.5 to 1.8 | - | Good - Minor cracks created by minor movement. Surface defects in bricks or limited mortar loss from joints |
| 443 to 444 | Repair | 0 to 1.6 | - | Concrete repair to brickwork/blockwork |
| 433.5 | Weephole / Outfall | 0.8 | D = 0.15m | Circular weephole/outfall. Good condition, some degradation but fully operable |
| 430 to 434 | Obstruction | 0 (coping) | - | Significant obstruction. Features obscured. Condition cannot be assessed |
| 433 | Mooring Bollard | 0 (coping) | H = 0.8m | T-Shaped bollard embedded into coping. Good condition, localised surface corrosion |
| 434 to 435 | Concrete | 0 (coping) | - | Very Good - Hair-line cracks and small surface cavities may be apparent |

| Chainage (m) | Feature | Defect | Level (m from top) | Description |
|---|---|---|---|---|
| 430 to 443, 444 to 445 | Coping | Loss of Mortar | 0.3 to 0.3 | Mortar loss to coping stone is limited to the surface. Defects are cosmetic only |
| 430 to 443, 444 to 445 | Brickwork / Masonry | Loss of Mortar | 0.3 to 1 | Mortar loss to bricks/blocks extends below surface and has the potential to weaken/loosen surrounding bricks/blocks |

| Overall Assessment | 2 | Good |
