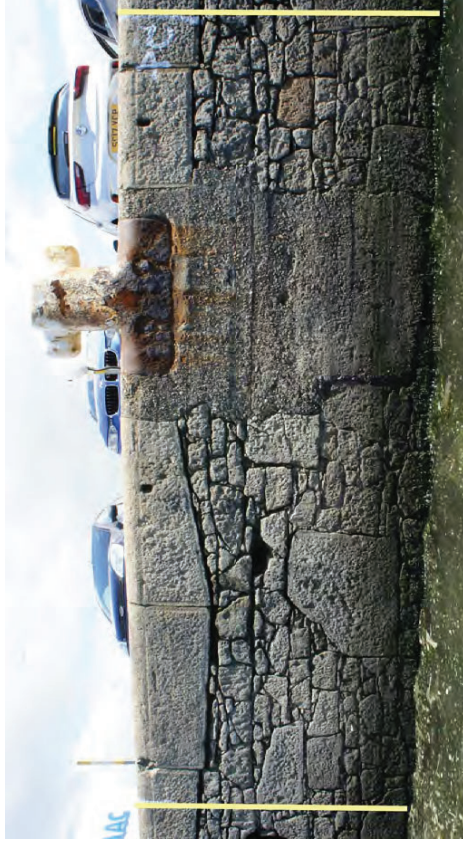
Figure A94 - Bramley Moore: Chainage 445 to 450m

Chainage (m)	Feature	Level (m from top)	Dimensions (m)	Description
445 to 448, 449 to 450	Coping	0 to 0.5	-	Good - Minor cracks created by minor movement. Surface defects in coping or limited mortar loss from joints
445 to 448, 449 to 450	Brickwork / Masonry	0.5 to 1.8	-	Good - Minor cracks created by minor movement. Surface defects in bricks or limited mortar loss from joints
448 to 449	Repair	0 to 1.8	-	Concrete repair to brickwork/blockwork
445 to 450	Concrete	0 (coping)	-	Very Good - Hair-line cracks and small surface cavities may be apparent
448	Mooring Bollard	0 (coping)	H = 0.8m	T-Shaped bollard embedded into coping. Good condition, localised surface corrosion

Chamage (m)	Feature	Defect	Level (m from top)	Description
445 to 448, 449 to 450	Coping	Loss of Mortar	0.3 to 0.5	Mortar loss to coping stone is limited to the surface. Defects are cosmetic only
445 to 448, 449 to 450	Brickwork / Masonry	Loss of Mortar	0.3 to 1.2	Mortar loss to bricks/blocks extends below surface and has the potential to weaken/loosen surrounding bricks/blocks
447 and 449	Coping	Loss of Bricks/Blocks	0.2	Holes in blockwork, likely left by historic fixings. Defects are cosmetic but have the potential to affect the walls integrity.
447	Brickwork / Masonry	Loss of Bricks/Blocks	0.9	Loss of small group of bricks/blocks. Defects are cosmetic but have the potential to affect the walls integrity

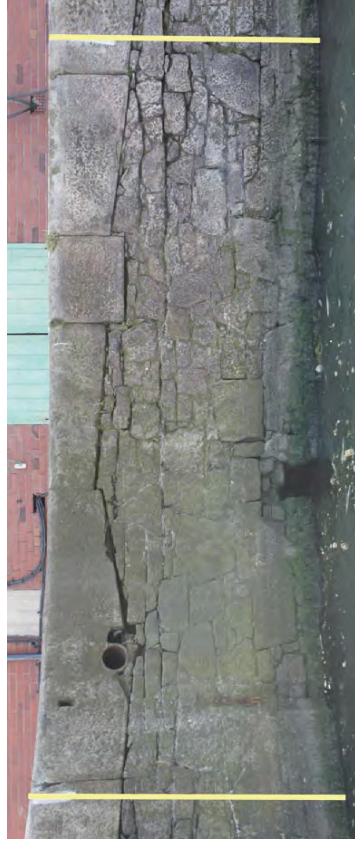
Figure A96 - Bramley Moore: Chainage 455 to 460m

Chainage (m)	Feature	Level (m from top)	Dimensions (m)	Description
455 to 460	Coping	0 to 0.5	-	Good - Minor cracks created by minor movement. Surface defects in coping or limited mortar loss from joints
455 to 460	Brickwork / Masonry	0.5 to 1.8	-	Good - Minor cracks created by minor movement. Surface defects in bricks or limited mortar loss from joints
455 to 460	Marine Growth	1.5 to 1.8	-	Significant growth. Features obscured. Condition cannot be assessed

455.5	Mooring Chain	1 to 1.3	-	Fixed to wall. Fair condition, extensive corrosion with minor thickness loss and/or minor damage to links
456	Weephole / Outfall	0.5	D = 0.15m	Circular weephole/outfall. Fair condition, some deterioration of material surrounding weephole/outfall. Any fixings have minor damage
457	Weephole / Outfall	1.8	D = 0.25m	Rectangular weephole/outfall. Good condition, some degradation but fully operable
455 to 460	Concrete	0 (coping)	-	Good - Structurally sound but with minor cracks and localised honeycombing/flaking with no significant defects

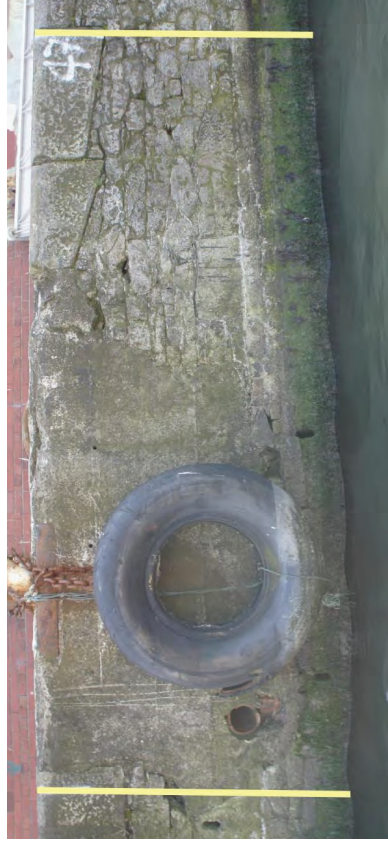
Figure A98 - Bramley Moore: Chainage 465 to 470m

Chainage (m)	Feature	Level (m from top)	Dimensions (m)	Description
465 to 468	Repair	0 to 1.5	-	Concrete repair to brickwork/blockwork
467 to 470	Coping	0 to 0.5	-	Good - Minor cracks created by minor movement. Surface defects in coping or limited mortar loss from joints
467 to 470	Brickwork / Masonry	0.5 to 1.8	-	Good - Minor cracks created by minor movement. Surface defects in bricks or limited mortar loss from joints
465 to 470	Marine Growth	1.5 to 1.8	-	Minor growth. Features partially obscured
465	Weephole / Outfall	1.5	D = 0.15m	Circular weephole/outfall. Good condition, some degradation but fully operable

466.5	Fender	0 to 1.6	-	Tyre Fender. Good condition, fixed to bollard/coping with chain/rope
465 to 470	Concrete	0 (coping)	-	Good - Structurally sound but with minor cracks and localised honeycombing/flaking with no significant defects

466.5	Mooring Bollard	0 (coping)	H = 0.8m	T-Shaped bollard embedded into coping. Good condition, localised surface corrosion

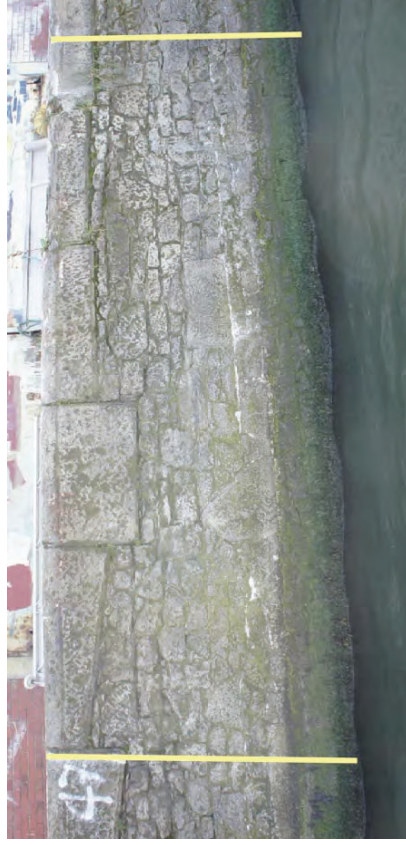
Figure A99 - Bramley Moore: Chainage 470 to 475m

Chainage (m)	Feature	Level (m from top)	Dimensions (m)	Description
470 to 475	Coping	0 to 0.5	-	Good - Minor cracks created by minor movement. Surface defects in coping or limited mortar loss from joints
470 to 475	Brickwork / Masonry	0.5 to 1.8	-	Good - Minor cracks created by minor movement. Surface defects in bricks or limited mortar loss from joints
470 to 475	Marine Growth	1.5 to 1.8	-	Minor growth. Features partially obscured
470 to 475	Concrete	0 (coping)	-	Good - Structurally sound but with minor cracks and localised honeycombing/flaking with no significant defects
470 to 475	Vegetation	0 (coping)	-	Minor growth. Features partially obscured. Vegetation does not affect structural integrity
473.5	Metalwork	0 (coping)	0.1 x 0.1m	Metal fixing. Good condition, localised surface corrosion

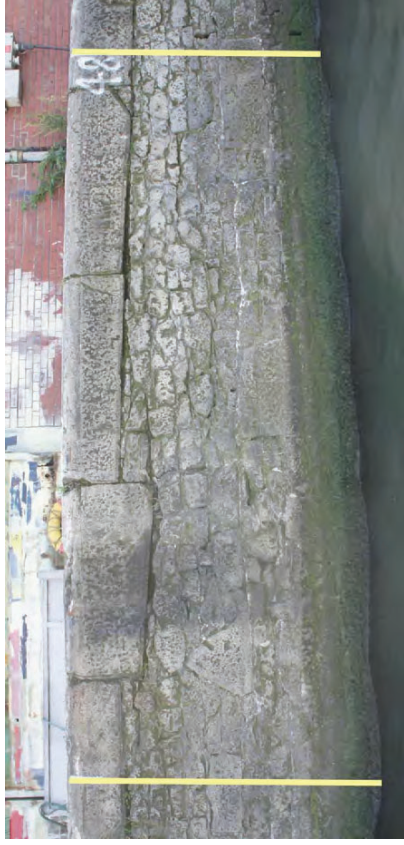
Figure A100 - Bramley Moore: Chainage 475 to 480m

Features / Condition				
Chainage (m)	Feature	Level (m from top)	Dimensions (m)	Description
475 to 480	Coping	0 to 0.5	-	Good - Minor cracks created by minor movement. Surface defects in coping or limited mortar loss from joints
475 to 480	Brickwork / Masonry	0.5 to 1.8	-	Good - Minor cracks created by minor movement. Surface defects in blocks or limited mortar loss from joints
475 to 480	Marine Growth	1.5 to 1.8	-	Minimal growth. Features remain visible
475 to 480	Concrete	0 (coping)	-	Minimal growth. Features remain visible. Vegetation does not affect structural integrity
475 to 480	Vegetation	0 (coping)	-	Minimal growth. Features remain visible. Vegetation does not affect structural integrity
477.5	Metalwork	0 (coping)	0.1 x 0.1m	Metal fixing. Good condition, localised surface corrosion

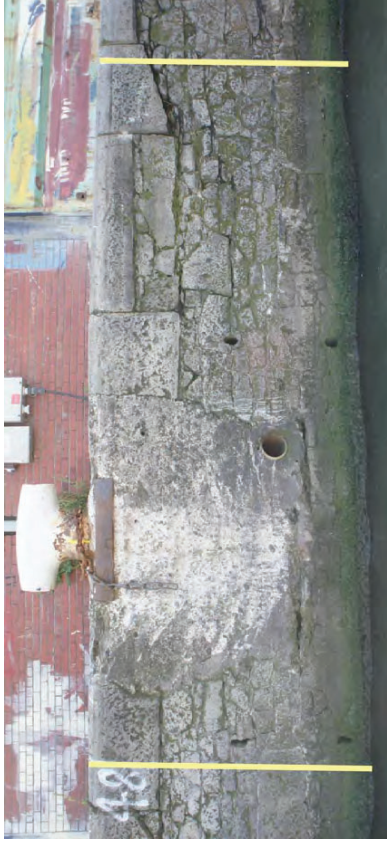
Figure A101. - Bramley Moore: Chainage 480 to 485m

Chainage (m)	Feature	Level (m from top)	Dimensions (m)	Description
480 to 481, 483 to 485	Coping	0 to 0.5	-	Good - Minor cracks created by minor movement. Surface defects in coping or limited mortar loss from joints
480 to 485	Brickwork / Masonry	0.5 to 1.8	-	Good - Minor cracks created by minor movement. Surface defects in bricks or limited mortar loss from joints
481 to 483	Repair	0 to 1.5	-	Concrete repair to brickwork/blockwork
480 to 485	Marine Growth	1.5 to 1.8	-	Minimal growth. Features remain visible

482.5	Weephole / Outfall	1.2	D = 0.2m	Circular weephole/outfall. Good condition, some degradation but fully operable
480 to 485	Concrete	0 (coping)	-	Good - Structurally sound but with minor cracks and localised honeycombing/flaking with no significant defects
480 to 485	Vegetation	0 (coping)	-	Minimal growth. Features remain visible. Vegetation does not affect structural integrity
481 and 484.5	Metalwork	0 (coping)	0.1 x 0.1m	Metal fixing. Good condition, localised surface corrosion
482	Mooring Bollard	0 (coping)	H = 0.8m	T-Shaped bollard embedded into coping. Good condition, localised surface corrosion

Chainage (m)	Feature	Defect	Level (m from top)	Description
483 to 485	Coping	Loss of Mortar	0.3 to 0.5	Mortar loss to coping stone is limited to the surface. Defects are cosmetic only
483 to 485	Brickwork / Masonry	Loss of Mortar	0.3 to 1	Mortar loss to bricks/blocks is limited to the surface. Defects are cosmetic only
480 to 483	Brickwork / Masonry	Loss of Bricks/Blocks	1 to 1.8	Holes in blockwork, likely left by historic fixings. Defects are cosmetic but have the potential to affect the walls integrity.

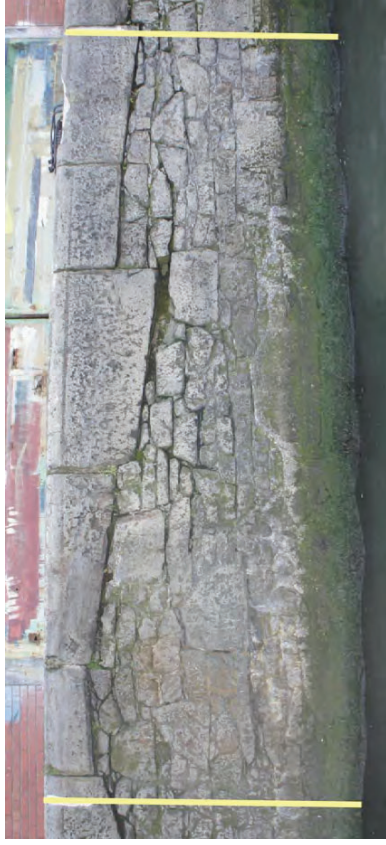
Figure A102 - Bramley Moore: Chainage 485 to 490m

Chainage (m)	Feature	Level (m from top)	Dimensions (m)	Description
485 to 490	Coping	0 to 0.6	-	Good - Minor cracks created by minor movement. Surface defects in coping or limited mortar loss from joints
485 to 490	Brickwork / Masonry	0.5 to 1.8	-	Good - Minor cracks created by minor movement. Surface defects in blocks or limited mortar loss from joints
485 to 490	Marine Growth	1.5 to 1.8	-	Minimal growth. Features remain visible
485 to 490	Concrete	0 (coping)	-	Good - Structurally sound but with minor cracks and localised honeycombing/flaking with no significant defects
485 to 490	Vegetation	0 (coping)	-	Minimal growth. Features remain visible. Vegetation does not affect structural integrity
489	Metalwork	0 (coping)	0.1 x 0.1m	Metal fixing. Good condition, localised surface corrosion

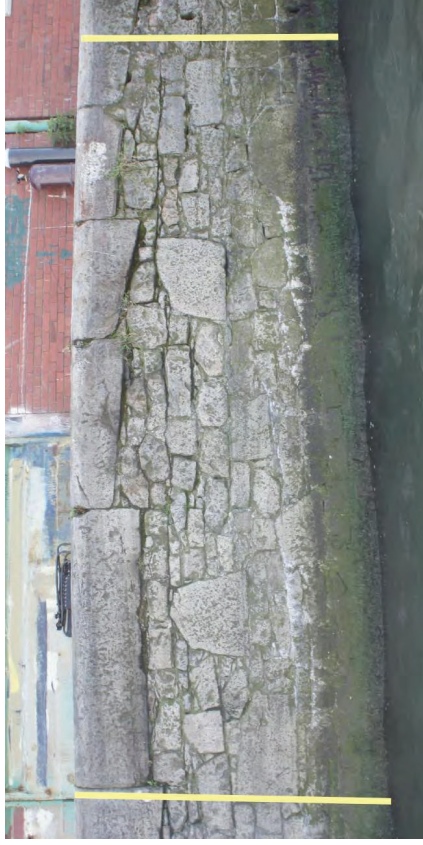
Figure A103 - Bramley Moore: Chainage 490 to 495m

Chainage (m)	Feature	Level (m from top)	Dimensions (m)	Description
490 to 495	Coping	0 to 0.5	-	Good - Minor cracks created by minor movement. Surface defects in coping or limited mortar loss from joints
490 to 495	Brickwork / Masonry	0.5 to 1.8	-	Good - Minor cracks created by minor movement. Surface defects in blocks or limited mortar loss from joints
490 to 495	Marine Growth	1.5 to 1.8	-	Minimal growth. Features remain visible
490 to 495	Concrete	0 (coping)	-	Good - Structurally sound but with minor cracks and localised honeycombing/flaking with no significant defects
490 to 495	Vegetation	0 (coping)	-	Minimal growth. Features remain visible. Vegetation does not affect structural integrity
492.5	Metalwork	0 (coping)	0.1 x 0.1m	Metal fixing. Good condition, localised surface corrosion

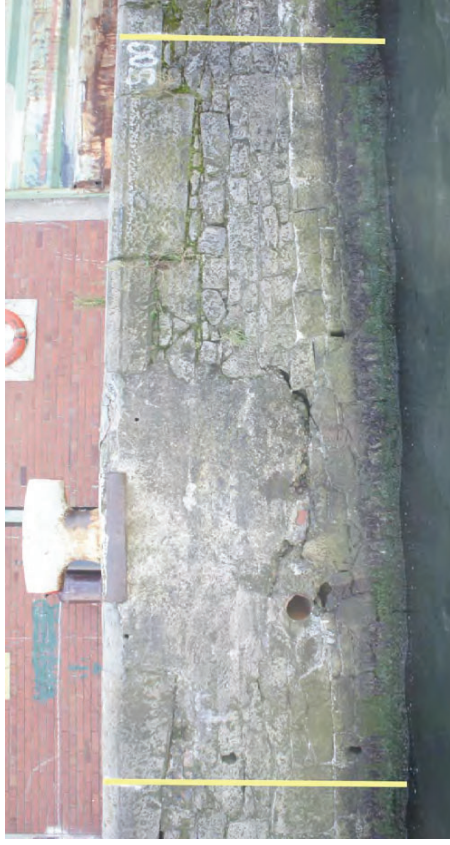
Figure A104 - Bramley Moore: Chainage 495 to 500m

Chainage (m)	Feature	Level (m from top)	Dimensions (m)	Description
495 to 496, 498 to 500	Coping	0 to 0.5	-	Good - Minor cracks created by minor movement. Surface defects in coping or limited mortar loss from joints
495 to 500	Brickwork / Masonry	0.5 to 1.8	-	Good - Minor cracks created by minor movement. Surface defects in blocks or limited mortar loss from joints
496 to 498	Repair	0 to 1.5	-	Concrete repair to brickwork/blockwork
495 to 500	Marine Growth	1.5 to 1.8	-	Minimal growth. Features remain visible

496.5	Weephole / Outfall	1.5	D = 0.15m	Circular weephole/outfall. Good condition, some degradation but fully operable
495 to 500	Concrete	0 (coping)	-	Good - Structurally sound but with minor cracks and localised honeycombing/flaking with no significant defects
495 to 500	Vegetation	0 (coping)	-	Minimal growth. Features remain visible. Vegetation does not affect structural integrity
497	Mooring Bollard	0 (coping)	H = 0.8m	Good - Localised surface corrosion with slight loss of thickness. No physical deformation or movement

Chainage (m)	Feature	Defect	Level (m from top)	Description
498 to 500	Coping	Loss of Mortar	0.2 to 0.5	Mortar loss to coping stone is limited to the surface. Defects are cosmetic only
498 to 500	Brickwork / Masonry	Loss of Mortar	0.2 to 0.7	Mortar loss to bricks/blocks is limited to the surface. Defects are cosmetic only
495	Brickwork / Masonry	Loss of Bricks/Blocks	1 to 2	Holes in blockwork, likely left by historic fixings. Defects are cosmetic but have the potential to affect the walls integrity.
497 to 498	Repair	Loss of Mortar	1.4 to 1.5	Mortar loss to bricks/blocks extends below surface and has the potential to weaken/loosen surrounding bricks/blocks
495 to 497	Concrete	Cracking	0 (coping)	Minor cracking of concrete typical of shrinkage or thermal expansion. Cracks are non structural

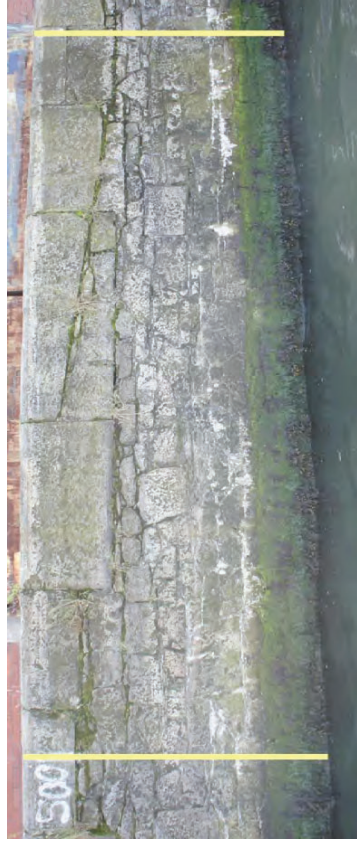
Figure A105 - Bramley Moore: Chainage 500 to 505m

Chainage (m)	Feature	Level (m from top)	Dimensions (m)	Description
500 to 505	Coping	0 to 0.5	-	Good - Minor cracks created by minor movement. Surface defects in coping or limited mortar loss from joints
500 to 505	Brickwork / Masonry	0.5 to 1.8	-	Good - Minor cracks created by minor movement. Surface defects in blocks or limited mortar loss from joints
500 to 505	Marine Growth	1.5 to 1.8	-	Minimal growth. Features remain visible
500 to 505	Concrete	0 (coping)	-	Good - Structurally sound but with minor cracks and localised honeycombing/flaking with no significant defects
500 to 505	Vegetation	0 (coping)	-	Minimal growth. Features remain visible. Vegetation does not affect structural integrity
504	Metalwork	0 (coping)	0.1 x 0.1m	Metal fixing. Good condition, localised surface corrosion

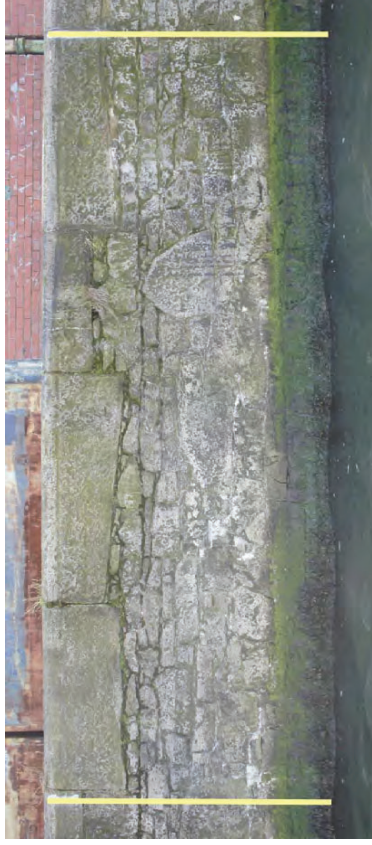
Figure A106 - Bramley Moore: Chainage 505 to 510m

Chainage (m)	Feature	Level (m from top)	Dimensions (m)	Description
505 to 510	Coping	0 to 0.5	-	Good - Minor cracks created by minor movement. Surface defects in coping or limited mortar loss from joints
505 to 510	Brickwork / Masonry	0.5 to 1.8	-	Good - Minor cracks created by minor movement. Surface defects in blocks or limited mortar loss from joints
505 to 510	Marine Growth	1.5 to 1.8	-	Minimal growth. Features remain visible
505 to 510	Concrete	0 (coping)	-	Good - Structurally sound but with minor cracks and localised honeycombing/flaking with no significant defects
505 to 510	Vegetation	0 (coping)	-	Minimal growth. Features remain visible. Vegetation does not affect structural integrity
507.5	Metalwork	0 (coping)	0.1 x 0.1m	Metal fixing. Good condition, localised surface corrosion

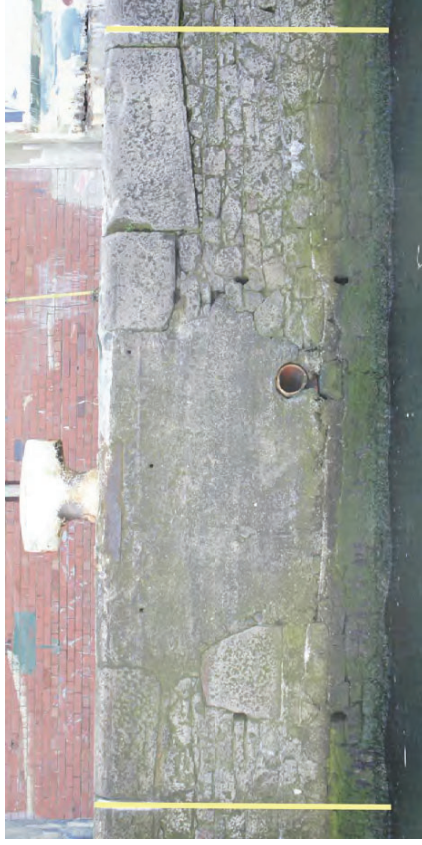
Figure A107 - Bramley Moore: Chainage 510 to 515m

Chainage (m)	Feature	Level (m from top)	Dimensions (m)	Description
510 to 511, 513 to 515	Coping	0 to 0.5	-	Good - Minor cracks created by minor movement. Surface defects in coping or limited mortar loss from joints
510 to 515	Brickwork / Masonry	0.5 to 1.8	-	Good - Minor cracks created by minor movement. Surface defects in blocks or limited mortar loss from joints
510 to 515	Marine Growth	1.5 to 1.8	-	Minimal growth. Features remain visible
511 to 513	Repair	0 to 1.5	-	Concrete repair to brickwork/blockwork
513	Weephole / Outfall	1.8	D = 0.15m	Circular weephole/outfall. Good condition, some degradation but fully operable
510 to 515	Concrete	0 (coping)	-	Good - Structurally sound but with minor cracks and localised honeycombing/flaking with no significant defects
510 to 515	Vegetation	0 (coping)	-	Minimal growth. Features remain visible. Vegetation does not affect structural integrity
512	Mooring Bollard	0 (coping)	H = 0.8m	Good - Localised surface corrosion with slight loss of thickness. No physical deformation or movement

511 and 515	Metalwork	0 (coping)	0.1 x 0.1m	Metal fixing. Good condition, localised surface corrosion

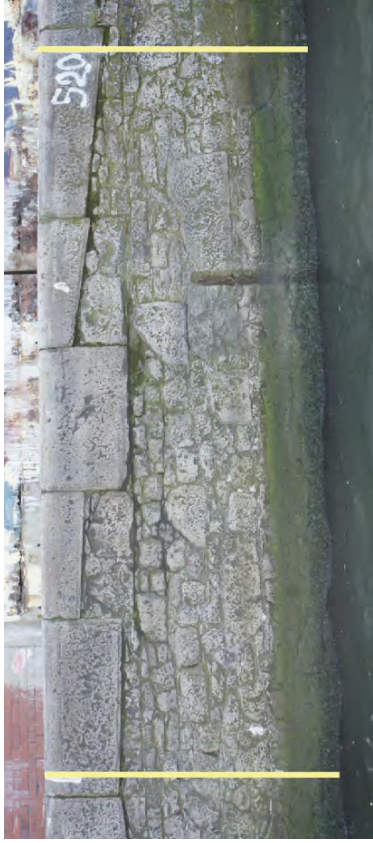
Figure A108 - Bramley Moore: Chainage 515 to 520m

Chainage (m)	Feature	Level (m from top)	Dimensions (m)	Description
515 to 520	Coping	0 to 0.5	-	Good - Minor cracks created by minor movement. Surface defects in coping or limited mortar loss from joints
515 to 520	Brickwork / Masonry	0.5 to 1.8	-	Good - Minor cracks created by minor movement. Surface defects in blocks or limited mortar loss from joints
515 to 520	Marine Growth	1.5 to 1.8	-	Minimal growth. Features remain visible
518	Mooring Chain	0.9 to 1.8	-	Fixed within recess. Fair condition, extensive corrosion with minor thickness loss and/or minor damage to links
515 to 520	Vegetation	0 (coping)	-	Minimal growth. Features remain visible. Vegetation does not affect structural integrity
515 to 520	Concrete	0 (coping)	-	Good - Structurally sound but with minor cracks and localised honeycombing/flaking with no significant defects
519	Metalwork	0 (coping)	0.1 x 0.1m	Metal fixing. Good condition, localised surface corrosion

Chainage (m)	Feature	Defect	Level (m from top)	Description
515 to 520	Coping	Loss of Mortar	0 to 0.5	Mortar loss to coping stone is limited to the surface. Defects are cosmetic only
515 to 520	Brickwork / Masonry	Loss of Mortar	0.5 to 1	Mortar loss to bricks/blocks is limited to the surface. Defects are cosmetic only
3.5	Brickwork / Masonry	Loss of Bricks/Blocks	1 to 1.8	Holes in Brickwork / Masonry, likely left by historic fixings. Defects are cosmetic but have the potential to affect the walls integrity.

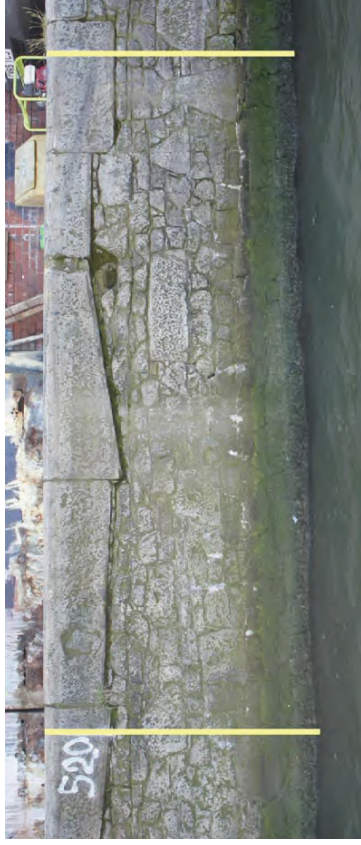
Figure A109 - Bramley Moore: Chainage 520 to 525m

Chainage (m)	Feature	Level (m from top)	Dimensions (m)	Description
520 to 525	Coping	0 to 0.5	-	Good - Minor cracks created by minor movement. Surface defects in coping or limited mortar loss from joints
520 to 525	Brickwork / Masonry	0.5 to 1.8	-	Good - Minor cracks created by minor movement. Surface defects in blocks or limited mortar loss from joints
520 to 525	Marine Growth	1.5 to 1.8	-	Minimal growth. Features remain visible
520 to 525	Vegetation	0 (coping)	-	Minimal growth. Features remain visible. Vegetation does not affect structural integrity
520 to 525	Concrete	0 (coping)	-	Good - Structurally sound but with minor cracks and localised honeycombing/flaking with no significant defects
523	Metalwork	0 (coping)	0.1 x 0.1m	Metal fixing. Good condition, localised surface corrosion

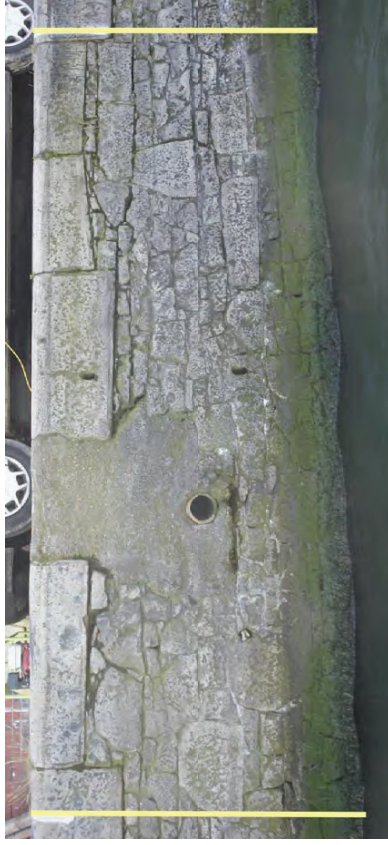
Figure A110 - Bramley Moore: Chainage 525 to 530m

Chainage (m)	Feature	Level (m from top)	Dimensions (m)	Description
525 to 527, 528 to 530	Coping	0 to 0.5	-	Good - Minor cracks created by minor movement. Surface defects in coping or limited mortar loss from joints
525 to 530	Brickwork / Masonry	0.5 to 1.8	-	Good - Minor cracks created by minor movement. Surface defects in blocks or limited mortar loss from joints
525 to 530	Marine Growth	1.5 to 1.8	-	Minimal growth. Features remain visible
527 to 528	Repair	0 to 1	-	Concrete repair to brickwork/blockwork

527.5	Weephole / Outfall	0.9	D = 0.15m	Circular weephole/outfall. Good condition, some degradation but fully operable
525 to 530	Concrete	0 (coping)	-	Good - Structurally sound but with minor cracks and localised honeycombing/flaking with no significant defects
525 to 530	Vegetation	0 (coping)	-	Minimal growth. Features remain visible. Vegetation does not affect structural integrity
526 and 529.5	Metalwork	0 (coping)	0.1 x 0.1m	Metal fixing. Good condition, localised surface corrosion
