A112 Chainage 535 to 540m

Figure A112 - Bramley Moore: Chainage 535 to 540m

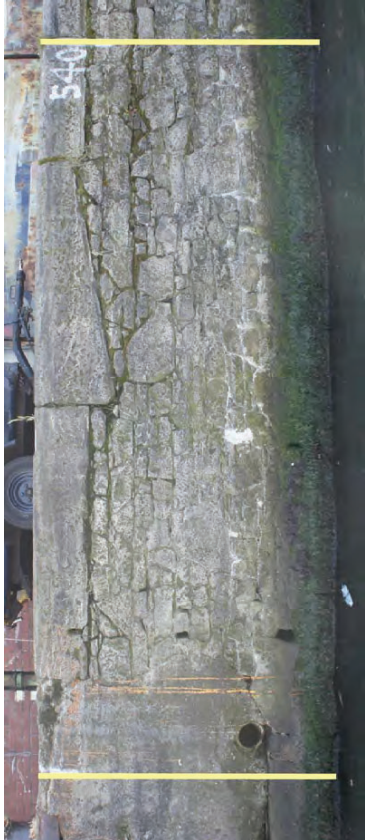
| Chainage (m) | Feature | Level (m from top) | Dimensions (m) | Description |
|---|---|---|---|---|
| 535 to 535.5 | Repair | 0 to 1.5 | - | Concrete repair to brickwork/blockwork |
| 535.5 to 540 | Coping | 0 to 0.5 | - | Good - Minor cracks created by minor movement. Surface defects in coping or limited mortar loss from joints |
| 535.5 to 540 | Brickwork / Masonry | 0.5 to 1.8 | - | Good - Minor cracks created by minor movement. Surface defects in blocks or limited mortar loss from joints |
| 535 to 540 | Marine Growth | 1.5 to 1.8 | - | Minimal growth. Features remain visible |
| 535 | Weephole / Outfall | 1.5 | D = 0.15m | Circular weephole/outfall. Good condition, some degradation but fully operable |
| 535 to 540 | Concrete | 0 (coping) | - | Good - Structurally sound but with minor cracks and localised honeycombing/flaking with no significant defects |
| 537 | Metalwork | 0 (coping) | 0.1 x 0.1m | Metal fixing. Good condition, localised surface corrosion |

| Chainage (m) | Feature | Defect | Level (m from top) | Description |
|---|---|---|---|---|
| 535 to 535.5 | Repair | Impact Damage | 0 to 0.3 | Localised impact damage resulting in chipping/fragmentation of wall materials |
| 535 to 540 | Coping | Loss of Mortar | 0.4 to 0.5 | Mortar loss to coping stone is limited to the surface. Defects are cosmetic only |
| 535 to 540 | Brickwork / Masonry | Loss of Mortar | 0.5 to 0.8 | Mortar loss to bricks/blocks is limited to the surface. Defects are cosmetic only |
| 536 | Brickwork / Masonry | Loss of Bricks/Blocks | 0.2 to 1.8 | Holes in Brickwork / Masonry, likely left by historic fixings. Defects are cosmetic but have the potential to affect the walls integrity. |
| 535 to 537 | Concrete | Cracking | 0 (coping) | Minor cracking of concrete typical of shrinkage or thermal expansion. Cracks are non-structural |

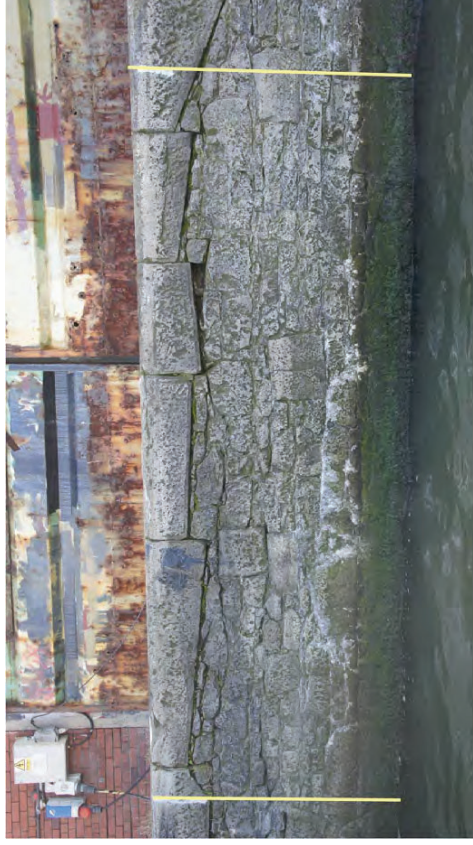
**Figure A119 - Bramley Moore: Chainage 570 to 575m**

| Chainage (m) | Feature | Level (m from top) | Dimensions (m) | Description |
|---|---|---|---|---|
| 570 to 575 | Coping | 0 to 0.4 | - | Good - Minor cracks created by minor movement. Surface defects in coping or limited mortar loss from joints |
| 570 to 575 | Brickwork / Masonry | 0.4 to 1.8 | - | Good - Minor cracks created by minor movement. Surface defects in bricks or limited mortar loss from joints |
| 570 to 575 | Marine Growth | 1.5 to 1.8 | - | Minor growth. Features partially obscured |
| 570 to 575 | Concrete | 0 (coping) | - | Good - Structurally sound but with minor cracks and localised honeycombing/flaking with no significant defects |
| 570 to 573 | Vegetation | 0 (coping) | - | Minor growth. Features partially obscured. Vegetation does not affect structural integrity |
| 571 | Metalwork | 0 (coping) | 0.1 x 0.1m | Metal fixing. Good condition, localised surface corrosion |

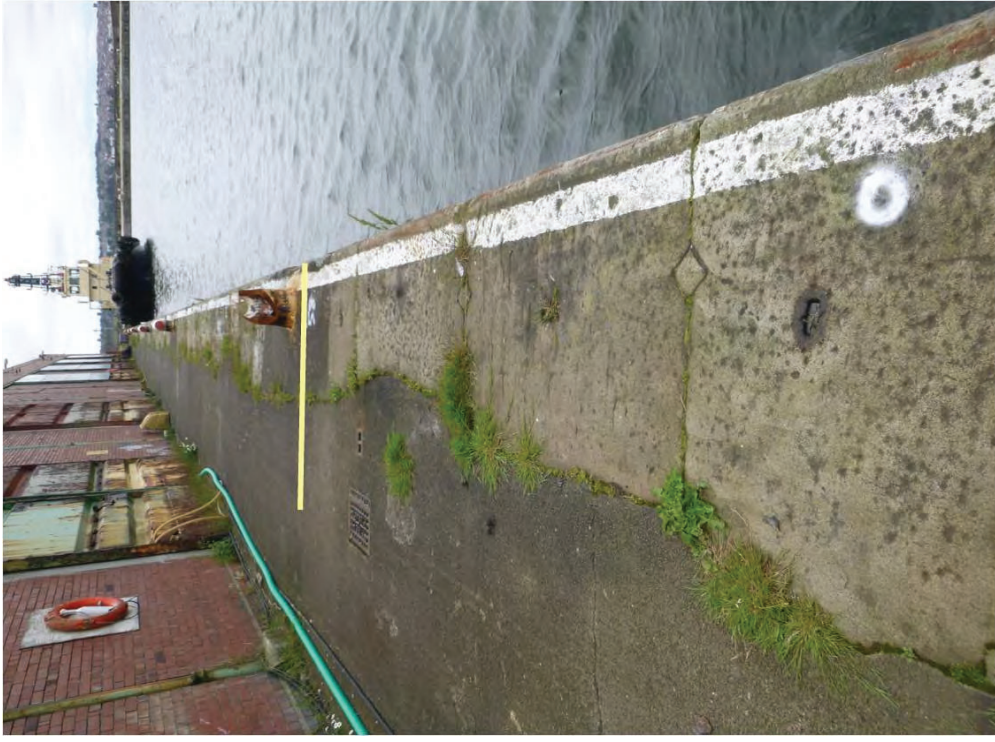
Figure A120a - Bramley Moore: Coping Chainage 575 to 580m

| Chainage (m) | Feature | Level (m from top) | Dimensions (m) | Description |
|---|---|---|---|---|
| 575 to 579 | Coping | 0 to 0.5 | - | Good - Minor cracks created by minor movement. Surface defects in coping or limited mortar loss from joints |
| 575 to 579 | Blockwork | 0.5 to 1.8 | - | Good - Minor cracks created by minor movement. Surface defects in blocks or limited mortar loss from joints |
| 579 to 580 | Repair | 0 to 1.5 | - | Concrete repair to brickwork/blockwork |
| 575 to 580 | Marine Growth | 1.5 to 1.8 | - | Minimal growth. Features remain visible |
| 577.5 | Mooring Chain | 1.2 to 1.8 | - | Fixed within recess. Fair condition, extensive corrosion with minor thickness loss and/or minor damage to links |
| 575 to 580 | Vegetation | 0 (coping) | - | Minimal growth. Features remain visible. Vegetation does not affect structural integrity |
| 575 to 580 | Concrete | 0 (coping) | - | Good - Structurally sound but with minor cracks and localised honeycombing/flaking with no significant defects |
| 579 | Metalwork | 0 (coping) | 0.1 x 0.1m | Metal fixing. Good condition, localised surface corrosion |

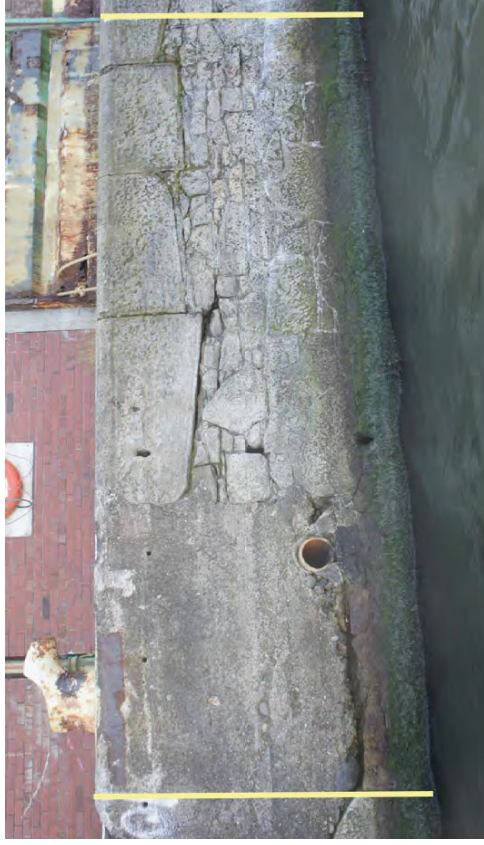
**Figure A121 - Bramley Moore: Chainage 580 to 585m**

| Chainage (m) | Feature | Level (m from top) | Dimensions (m) | Description |
|---|---|---|---|---|
| 580 to 582 | Repair | 0 to 1.5 | - | Concrete repair to brickwork/blockwork |
| 582 to 585 | Coping | 0 to 0.5 | - | Good - Minor cracks created by minor movement. Surface defects in coping or limited mortar loss from joints |
| 582 to 585 | Brickwork / Masonry | 0.5 to 1.8 | - | Good - Minor cracks created by minor movement. Surface defects in blocks or limited mortar loss from joints |
| 580 to 585 | Marine Growth | 1.5 to 1.8 | - | Minimal growth. Features remain visible |
| 582 | Weephole / Outfall | 1.5 | D = 0.15m | Circular weephole/outfall. Good condition, some degradation but fully operable |
| 580 to 585 | Vegetation | 0 (coping) | - | Minimal growth. Features remain visible. Vegetation does not affect structural integrity |
| 580 to 585 | Concrete | 0 (coping) | - | Good - Structurally sound but with minor cracks and localised honeycombing/flaking with no significant defects |
| 581 | Mooring Bollard | 0 (coping) | H = 0.4m | Mooring bollard broken, derelict and beyond repair |

| Chainage (m) | Feature | Defect | Level (m from top) | Description |
|---|---|---|---|---|
| 582 to 583 | Coping | Loss of Mortar | 0.3 to 0.5 | Mortar loss to coping stone is limited to the surface. Defects are cosmetic only |
| 582 to 583 | Brickwork / Masonry | Loss of Mortar | 0.5 to 0.8 | Mortar loss to bricks/blocks extends below surface and has the potential to weaken/loosen surrounding bricks/blocks |
| 582 | Brickwork / Masonry | Loss of Bricks/Blocks | 0.2 to 2 | Holes in Brickwork / Masonry, likely left by historic fixings. Defects are cosmetic but have the potential to affect the walls integrity. |
| 581 | Mooring Bollard | Collapse / Failure | 0 (coping) | Mooring bollard has broken in two following impact or overloading. Remains are corroded |

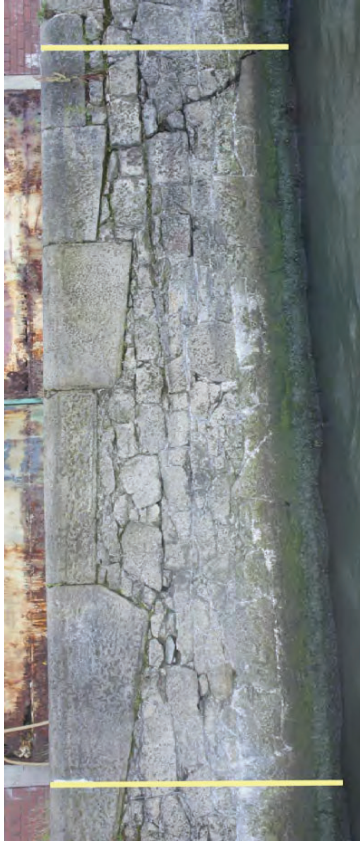
Figure A122 - Bramley Moore: Chainage 585 to 590m

| Chainage (m) | Feature | Level (m from top) | Dimensions (m) | Description |
|---|---|---|---|---|
| 585 to 590 | Coping | 0 to 0.5 | - | Good - Minor cracks created by minor movement. Surface defects in coping or limited mortar loss from joints |
| 585 to 590 | Brickwork / Masonry | 0.5 to 1.8 | - | Good - Minor cracks created by minor movement. Surface defects in bricks or limited mortar loss from joints |
| 585 to 590 | Marine Growth | 1.5 to 1.8 | - | Minimal growth. Features remain visible |
| 585 to 590 | Vegetation | 0 (coping) | - | Minimal growth. Features remain visible. Vegetation does not affect structural integrity |
| 585 to 590 | Concrete | 0 (coping) | - | Good - Structurally sound but with minor cracks and localised honeycombing/flaking with no significant defects |

| Chainage (m) | Feature | Defect | Level (m from top) | Description |
|---|---|---|---|---|
| 585 to 590 | Coping | Loss of Mortar | 0.3 to 0.5 | Mortar loss to coping stone is limited to the surface. Defects are cosmetic only |
| 589 to 590 | Brickwork / Masonry | Loss of Mortar | 0.5 to 0.8 | Mortar loss to bricks/blocks extends below surface and has the potential to weaken/loosen surrounding bricks/blocks |
| 589 to 590 | Brickwork / Masonry | Cracking | 0.5 to 1.5 | Minor vertical cracking limited to mortar joints indicating potential onset of wall movement/settlement |

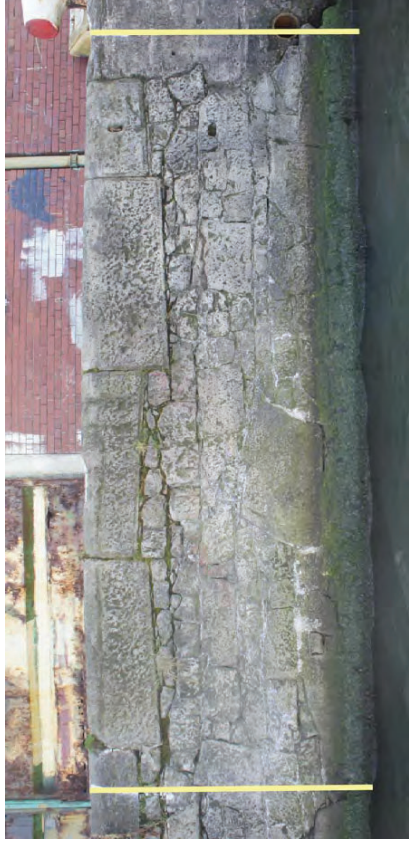
**Figure A123 - Bramley Moore: Chainage 590 to 595m**

| Chainage (m) | Feature | Level (m from top) | Dimensions (m) | Description |
|---|---|---|---|---|
| 590 to 595 | Coping | 0 to 0.5 | - | Good - Minor cracks created by minor movement. Surface defects in coping or limited mortar loss from joints |
| 590 to 595 | Brickwork / Masonry | 0.5 to 1.8 | - | Good - Minor cracks created by minor movement. Surface defects in bricks or limited mortar loss from joints |
| 590 to 595 | Marine Growth | 1.5 to 1.8 | - | Minimal growth. Features remain visible |
| 590 to 595 | Vegetation | 0 (coping) | - | Minimal growth. Features remain visible. Vegetation does not affect structural integrity |
| 590 to 595 | Concrete | 0 (coping) | - | Good - Structurally sound but with minor cracks and localised honeycombing/flaking with no significant defects |
| 590 | Metalwork | 0 (coping) | 0.1 x 0.1m | Metal fixing. Good condition, localised surface corrosion |
| 594.5 | Manhole | 0 (coping) | 0.5 x 0.5m | Good - Localised surface corrosion with slight loss of thickness. Manhole housing remains sound |

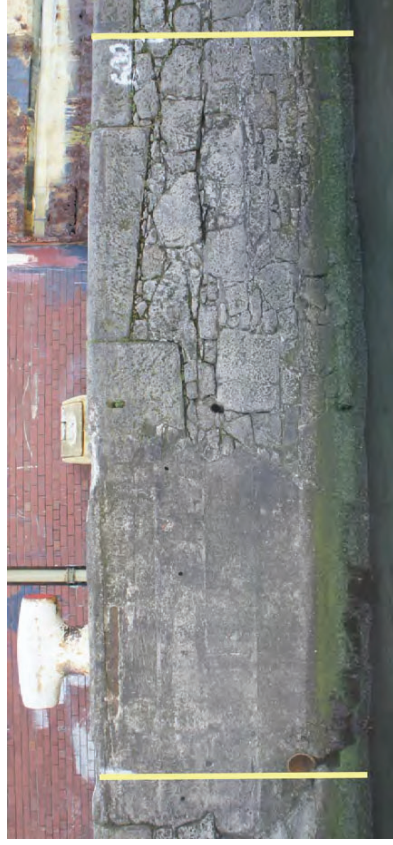
**Figure A124 - Bramley Moore: Chainage 595 to 600m**

| Chainage (m) | Feature | Level (m from top) | Dimensions (m) | Description |
|---|---|---|---|---|
| 595 to 597.5 | Repair | 0 to 1.5 | - | Concrete repair to coping |
| 597.5 to 600 | Coping | 0 to 0.5 | - | Good - Minor cracks created by minor movement. Surface defects in coping or limited mortar loss from joints |
| 597.5 to 600 | Brickwork / Masonry | 0.5 to 1.8 | - | Good - Minor cracks created by minor movement. Surface defects in blocks or limited mortar loss from joints |
| 595 to 600 | Marine Growth | 1.5 to 1.8 | - | Minimal growth. Features remain visible |
| 595 | Weephole / Outfall | 1.5 | D = 0.15m | Circular weephole/outfall. Good condition, some degradation but fully operable |
| 595 to 600 | Vegetation | 0 (coping) | - | Minimal growth. Features remain visible. Vegetation does not affect structural integrity |
| 595 to 600 | Concrete | 0 (coping) | - | Good - Structurally sound but with minor cracks and localised honeycombing/flaking with no significant defects |
| 596 | Mooring Bollard | 0 (coping) | H = 0.8m | T-Shaped bollard embedded into coping. Good condition, localised surface corrosion |

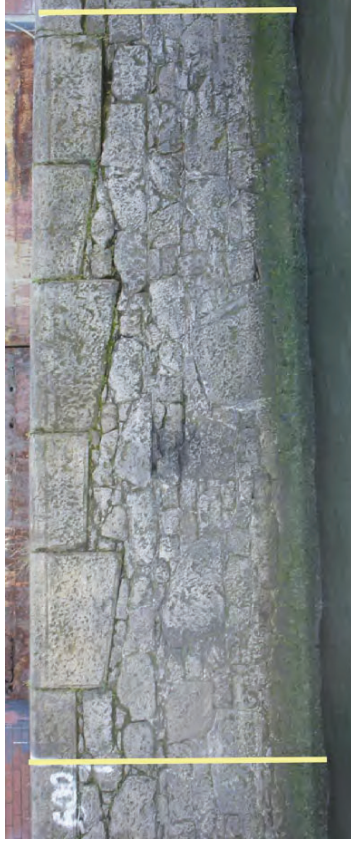
**Figure A125 - Bramley Moore: Chainage 600 to 605m**

| Chainage (m) | Feature | Level (m from top) | Dimensions (m) | Description |
|---|---|---|---|---|
| 600 to 605 | Coping | 0 to 0.5 | - | Good - Minor cracks created by minor movement. Surface defects in coping or limited mortar loss from joints |
| 600 to 605 | Brickwork / Masonry | 0.5 to 1.8 | - | Good - Minor cracks created by minor movement. Surface defects in blocks or limited mortar loss from joints |
| 600 to 605 | Marine Growth | 1.5 to 1.8 | - | Minimal growth. Features remain visible |
| 600 to 605 | Vegetation | 0 (coping) | - | Minimal growth. Features remain visible. Vegetation does not affect structural integrity |
| 600 to 605 | Concrete | 0 (coping) | - | Good - Structurally sound but with minor cracks and localised honeycombing/flaking with no significant defects |
| 602.5 | Metalwork | 0 (coping) | 0.1 x 0.1m | Metal fixing. Good condition, localised surface corrosion |

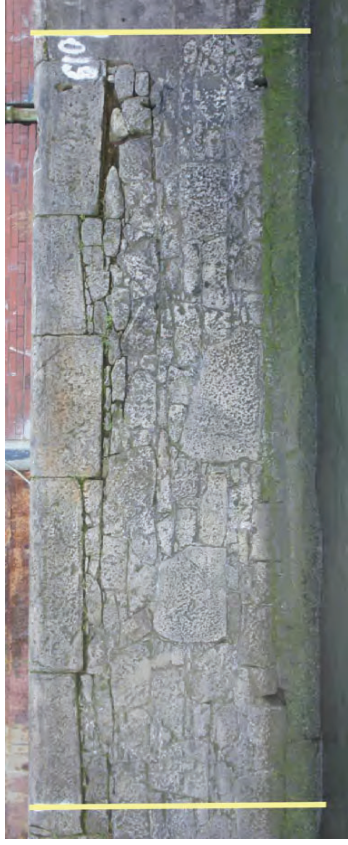
**Figure A126 - Bramley Moore: Chainage 605 to 610m**

| Chainage (m) | Feature | Level (m from top) | Dimensions (m) | Description |
|---|---|---|---|---|
| 605 to 610 | Coping | 0 to 0.5 | - | Good - Minor cracks created by minor movement. Surface defects in coping or limited mortar loss from joints |
| 605 to 610 | Brickwork / Masonry | 0.5 to 1.8 | - | Good - Minor cracks created by minor movement. Surface defects in blocks or limited mortar loss from joints |
| 605 to 610 | Marine Growth | 1.5 to 1.8 | - | Minimal growth. Features remain visible |
| 605 to 610 | Concrete | 0 (coping) | - | Good - Structurally sound but with minor cracks and localised honeycombing/flaking with no significant defects |
| 606 to 610 | Vegetation | 0 (coping) | - | Minimal growth. Features remain visible. Vegetation does not affect structural integrity |
| 606 | Metalwork | 0 (coping) | 0.1 x 0.1m | Metal fixing. Good condition, localised surface corrosion |

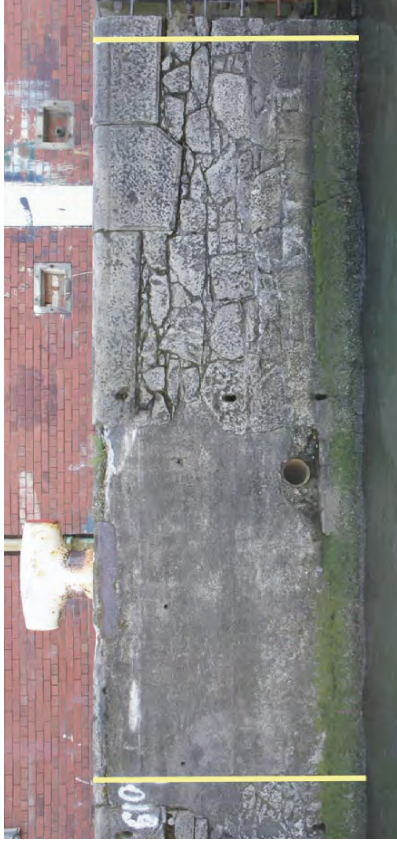
Figure A127 - Bramley Moore: Chainage 610 to 615m

| Chainage (m) | Feature | Level (m from top) | Dimensions (m) | Description |
|---|---|---|---|---|
| 610 to 612.5 | Repair | 0 to 1.5 | - | Concrete repair to brickwork/blockwork |
| 612.5 to 615 | Coping | 0 to 0.5 | - | Good - Minor cracks created by minor movement. Surface defects in coping or limited mortar loss from joints |
| 612.5 to 615 | Brickwork / Masonry | 0.5 to 1.8 | - | Good - Minor cracks created by minor movement. Surface defects in bricks or limited mortar loss from joints |
| 610 to 615 | Marine Growth | 1.5 to 1.8 | - | Minimal growth. Features remain visible |
| 612.5 | Weephole / Outfall | 1.5 | D = 0.15m | Circular weephole/outfall. Good condition, some degradation but fully operable |
| 610 to 615 | Vegetation | 0 (coping) | - | Minimal growth. Features remain visible. Vegetation does not affect structural integrity |
| 610 to 615 | Concrete | 0 (coping) | - | Good - Structurally sound but with minor cracks and localised honeycombing/flaking with no significant defects |
| 611.5 | Mooring Bollard | 0 (coping) | H = 0.8m | T-Shaped bollard embedded into coping. Good condition, localised surface corrosion |

| Chainage (m) | Feature | Defect | Level (m from top) | Description |
|---|---|---|---|---|
| 612.5 | Brickwork / Masonry | Loss of Bricks/Blocks | 0 to 1.8 | Holes in blockwork, likely left by historic fixings. Defects are cosmetic but have the potential to affect the walls integrity. |
| 612.5 to 615 | Coping | Loss of Mortar | 0.3 to 0.5 | Mortar loss to coping stone is limited to the surface. Defects are cosmetic only |
| 612.5 to 615 | Brickwork / Masonry | Loss of Mortar | 0.5 to 1 | Mortar loss to bricks/blocks is significant resulting in loosening of bricks/blocks |
