**A128 Chainage 615 to 620m**

**Figure A128 - Bramley Moore: Chainage 615 to 620m**

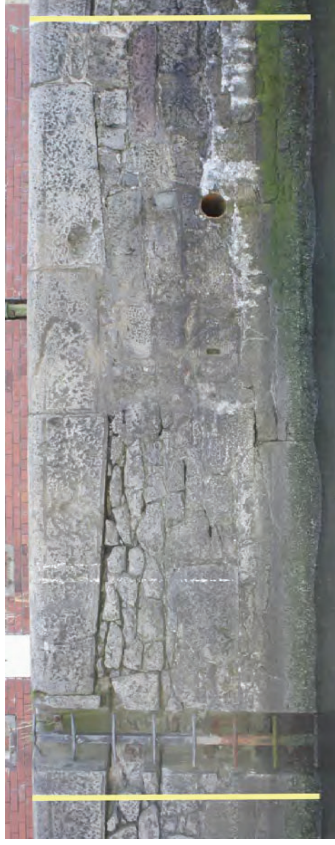
| Features / Condition | | | | |
|---|---|---|---|---|
| 615 to 620 | Coping | 0 to 0.5 | - | Good - Minor cracks created by minor movement. Surface defects in coping or limited mortar loss from joints |
| 615 to 620 | Brickwork / Masonry | 0.5 to 1.8 | - | Good - Minor cracks created by minor movement. Surface defects in blocks or limited mortar loss from joints |
| 615 to 620 | Marine Growth | 1.5 to 1.8 | - | Minimal growth. Features remain visible |
| 615.5 | Ladder | 0 to 1.8 | - | Ladder within recess. Good condition, some corrosion in intertidal zone |
| 618.5 | Weephole / Outfall | 1.3 | D = 0.15m | Circular weephole/outfall. Good condition, some degradation but fully operable |
| 615 to 620 | Concrete | 0 (coping) | - | Fair - Rust staining, localised spalling, lengthy cracking and some movement or extensive honeycombing |
| 615 to 618 | Vegetation | 0 (coping) | - | Minimal growth. Features remain visible. Vegetation does not affect structural integrity |
| 618 | Metalwork | 0 (coping) | 0.1 x 0.1m | Metal fixing. Good condition, localised surface corrosion |

| Overall Condition Rating | | |
|---|---|---|
| Overall Assessment | 2 | Good |

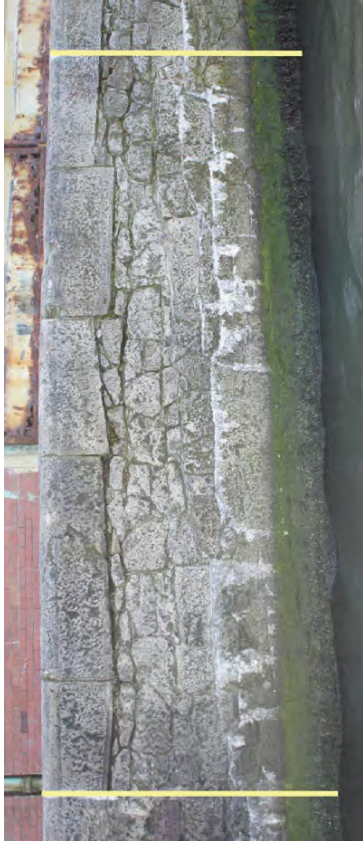
Figure A129 - Bramley Moore: Chainage 620 to 625m

| Chainage (m) | Feature | Level (m from top) | Dimensions (m) | Description |
|---|---|---|---|---|
| 620 to 625 | Coping | 0 to 0.5 | - | Good - Minor cracks created by minor movement. Surface defects in coping or limited mortar loss from joints |
| 620 to 625 | Brickwork / Masonry | 0.5 to 1.8 | - | Good - Minor cracks created by minor movement. Surface defects in blocks or limited mortar loss from joints |
| 620 to 625 | Marine Growth | 1.5 to 1.8 | - | Minimal growth. Features remain visible |
| 620 to 625 | Vegetation | 0 (coping) | - | Minimal growth. Features remain visible. Vegetation does not affect structural integrity |
| 620 to 625 | Concrete | 0 (coping) | - | Good - Structurally sound but with minor cracks and localised honeycombing/flaking with no significant defects |

| Chainage (m) | Feature | Defect | Level (m from top) | Description |
|---|---|---|---|---|
| 620 to 625 | Coping | Loss of Mortar | 0.4 to 0.5 | Mortar loss to coping stone is limited to the surface. Defects are cosmetic only |
| 620 to 625 | Brickwork / Masonry | Loss of Mortar | 0.5 to 0.8 | Mortar loss to bricks/blocks is limited to the surface. Defects are cosmetic only |
| 620 to 625 | Brickwork / Masonry | Staining / Calcification | 1.2 to 1.5 | White staining concentrated around mortar joints indicative of early sulphate attack. May lead to future spalling and deterioration of mortar |
| 620 to 625 | Coping | Vegetation Damage | 0 (coping) | Small and shallow rooted vegetation resulting in surface cracks and the early onset of mortar degradation |

| Overall Assessment | 2 | Good |

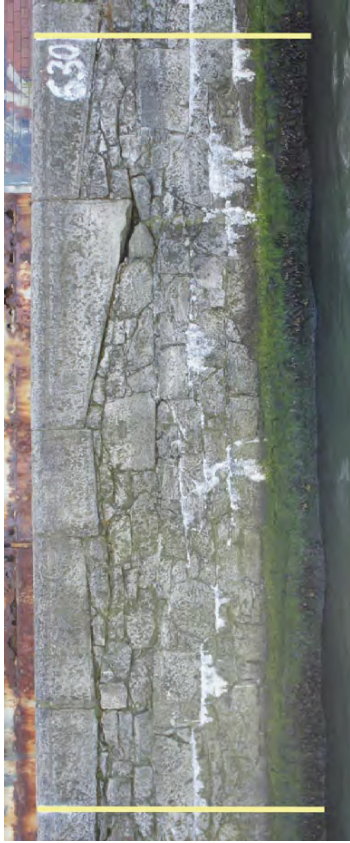
Figure A130 - Bramley Moore: Chainage 625 to 630m

| Chainage (m) | Feature | Level (m from top) | Dimensions (m) | Description |
|---|---|---|---|---|
| 625 to 630 | Coping | 0 to 0.5 | - | Good - Minor cracks created by minor movement. Surface defects in coping or limited mortar loss from joints |
| 625 to 630 | Brickwork / Masonry | 0.5 to 1.8 | - | Good - Minor cracks created by minor movement. Surface defects in blocks or limited mortar loss from joints |
| 625 to 630 | Marine Growth | 1.5 to 1.8 | - | Minimal growth. Features remain visible |
| 625 to 630 | Vegetation | 0 (coping) | - | Minimal growth. Features remain visible. Vegetation does not affect structural integrity |
| 625 to 630 | Concrete | 0 (coping) | - | Good - Structurally sound but with minor cracks and localised honeycombing/flaking with no significant defects |

| Chainage (m) | Feature | Defect | Level (m from top) | Description |
|---|---|---|---|---|
| 628 to 629 | Coping | Loss of Mortar | 0.3 to 0.5 | Mortar loss to coping stone is limited to the surface. Defects are cosmetic only |
| 628 | Brickwork / Masonry | Loss of Mortar | 0.5 to 0.7 | Mortar loss to bricks/blocks extends below surface and has the potential to weaken/loosen surrounding bricks/blocks |
| 625 to 630 | Brickwork / Masonry | Staining / Calcification | 1 to 1.5 | White staining concentrated around mortar joints indicative of early sulphate attack. May lead to future spalling and deterioration of mortar |
| 625 to 630 | Coping | Vegetation Damage | 0 (coping) | Small and shallow rooted vegetation resulting in surface cracks and the early onset of mortar degradation |
| 625 to 630 | Concrete | Cracking | 0 (coping) | Minor cracking of concrete typical of shrinkage or thermal expansion. Cracks are non-structural |

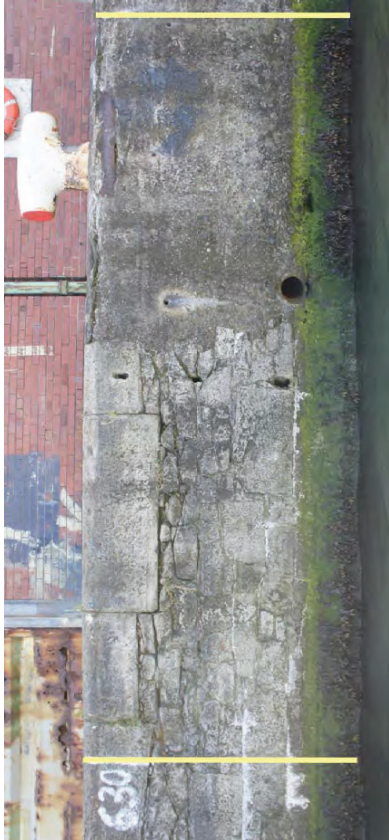
**A131 Chainage 630 to 635m**

| Chainage (m) | Feature | Level (m from top) | Dimensions (m) | Description |
|---|---|---|---|---|
| 630 to 633 | Coping | 0 to 0.5 | - | Good - Minor cracks created by minor movement. Surface defects in coping or limited mortar loss from joints |
| 630 to 633 | Brickwork / Masonry | 0.5 to 1.8 | - | Good - Minor cracks created by minor movement. Surface defects in blocks or limited mortar loss from joints |
| 633 to 635 | Repair | 0 to 1.5 | - | Concrete repair to brickwork/blockwork |
| 633 | Weephole / Outfall | 1.5 | D = 0.15m | Circular weephole/outfall. Good condition, some degradation but fully operable |
| 630 to 635 | Concrete | 0 (coping) | - | Good - Structurally sound but with minor cracks and localised honeycombing/flaking with no significant defects |
| 634 | Mooring Bollard | 0 (coping) | H = 0.8m | T-Shaped bollard embedded into coping. Good condition, localised surface corrosion |

| Chainage (m) | Feature | Defect | Level (m from top) | Description |
|---|---|---|---|---|
| 630 to 633 | Coping | Loss of Mortar | 0.3 to 0.5 | Mortar loss to coping stone is limited to the surface. Defects are cosmetic only |
| 630 to 633 | Brickwork / Masonry | Loss of Mortar | 0.5 to 0.6 | Mortar loss to bricks/blocks extends below surface and has the potential to weaken/loosen surrounding bricks/blocks |
| 633 | Brickwork / Masonry | Loss of Bricks/Blocks | 1 to 1.8 | Holes in blockwork, likely left by historic fixings. Defects are cosmetic but have the potential to affect the walls integrity. |
| 630 to 633 | Coping | Vegetation Damage | 0 (coping) | Small and shallow rooted vegetation resulting in surface cracks and the early onset of mortar degradation |
| 630 to 635 | Concrete | Cracking | 0 (coping) | Minor cracking of concrete typical of shrinkage or thermal expansion. Cracks are non-structural |

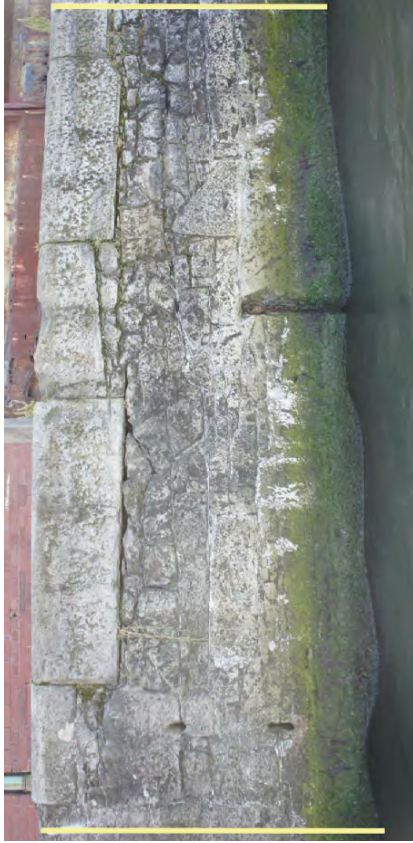
A132 Chainage 635 to 640m

| Chainage (m) | Feature | Level (m from top) | Dimensions (m) | Description |
|---|---|---|---|---|
| 635 to 640 | Coping | 0 to 0.5 | - | Good - Minor cracks created by minor movement. Surface defects in coping or limited mortar loss from joints |
| 635 to 640 | Brickwork / Masonry | 0.5 to 1.8 | - | Good - Minor cracks created by minor movement. Surface defects in blocks or limited mortar loss from joints |
| 637.5 | Mooring Chain | 1.4 to 1.8 | - | Fixed to wall. Poor condition, extensive corrosion with major thickness loss and/or significant damage to links |
| 635 to 640 | Concrete | 0 (coping) | - | Good - Structurally sound but with minor cracks and localised honeycombing/flaking with no significant defects |

| Chainage (m) | Feature | Defect | Level (m from top) | Description |
|---|---|---|---|---|
| 636 to 638 | Coping | Loss of Mortar | 0.5 to 1 | Mortar loss to coping stone is limited to the surface. Defects are cosmetic only |
| 636 to 638 | Brickwork / Masonry | Loss of Mortar | 0.5 to 0.7 | Mortar loss to bricks/blocks extends below surface and has the potential to weaken/loosen surrounding bricks/blocks |
| 636 | Brickwork / Masonry | Loss of Bricks/Blocks | 0.5 to 1.5 | Holes in blockwork, likely left by historic fixings. Defects are cosmetic but have the potential to affect the walls integrity. |
| 635 to 640 | Coping | Vegetation Damage | 0 (coping) | Small and shallow rooted vegetation resulting in surface cracks and the early onset of mortar degradation |

| Overall Assessment | 2 | Good |

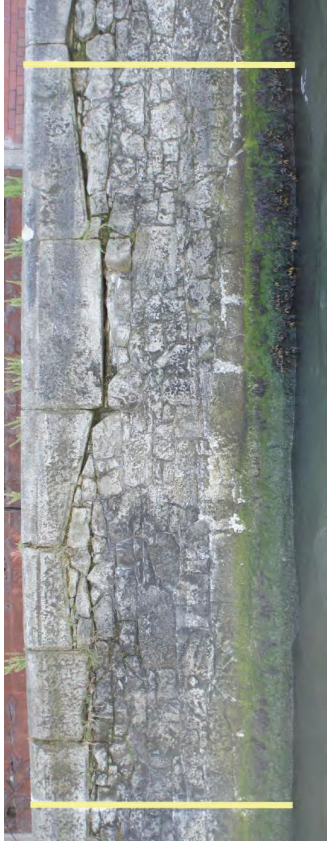
Figure A133 - Bramley Moore: Chainage 640 to 645m

| Chainage (m) | Feature | Level (m from top) | Dimensions (m) | Description |
|---|---|---|---|---|
| 640 to 645 | Coping | 0 to 0.5 | - | Good - Minor cracks created by minor movement. Surface defects in coping or limited mortar loss from joints |
| 640 to 645 | Brickwork / Masonry | 0.5 to 1.8 | - | Good - Minor cracks created by minor movement. Surface defects in blocks or limited mortar loss from joints |
| 640 to 645 | Concrete | 0 (coping) | - | Good - Structurally sound but with minor cracks and localised honeycombing/flaking with no significant defects |

| Chainage (m) | Feature | Defect | Level (m from top) | Description |
|---|---|---|---|---|
| 642 to 645 | Coping | Loss of Mortar | 0.3 to 0.5 | Mortar loss to coping stones extends below surface and has the potential to weaken/loosen surrounding bricks/blocks |
| 642 to 645 | Brickwork / Masonry | Loss of Mortar | 0.5 to 0.7 | Mortar loss to bricks/blocks extends below surface and has the potential to weaken/loosen surrounding bricks/blocks |
| 642 to 645 | Brickwork / Masonry | Staining / Calcification | 1.3 to 1.5 | White staining concentrated around mortar joints indicative of early sulphate attack. May lead to future spalling and deterioration of mortar |
| 640 to 645 | Concrete | Cracking | 0 (coping) | Minor cracking of concrete typical of shrinkage or thermal expansion. Cracks are non-structural |
| 640 to 645 | Coping | Vegetation Damage | 0 (coping) | Small and shallow rooted vegetation resulting in surface cracks and the early onset of mortar degradation |

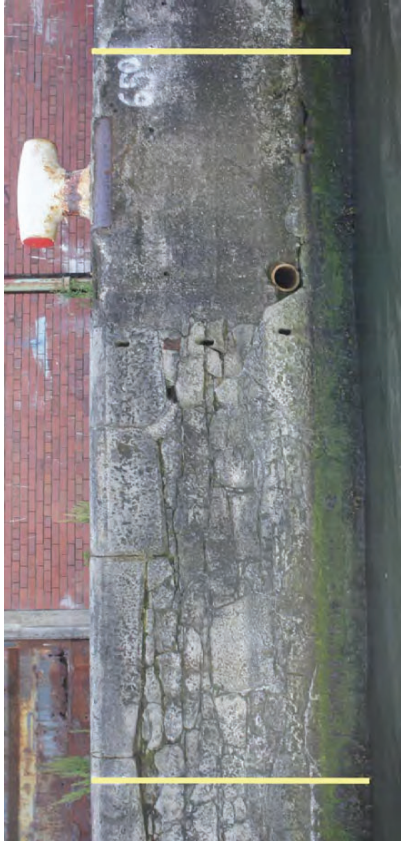
A134 Chainage 645 to 650m

| Chainage (m) | Feature | Level (m from top) | Dimensions (m) | Description |
|---|---|---|---|---|
| 645 to 648 | Coping | 0 to 0.5 | - | Good - Minor cracks created by minor movement. Surface defects in coping or limited mortar loss from joints |
| 645 to 648 | Brickwork / Masonry | 0.5 to 1.8 | - | Good - Minor cracks created by minor movement. Surface defects in blocks or limited mortar loss from joints |
| 648 to 650 | Repair | 0 to 1.5 | - | Concrete repair to brickwork/blockwork |
| 648 | Weephole / Outfall | 1.5 | D = 0.15m | Circular weephole/outfall. Good condition, some degradation but fully operable |
| 645 to 650 | Concrete | 0 (coping) | - | Good - Structurally sound but with minor cracks and localised honeycombing/flaking with no significant defects |
| 649 | Mooring Bollard | 0 (coping) | H = 0.8m | T-Shaped bollard embedded into coping. Good condition, localised surface corrosion |

| Defects | | | | |
|---|---|---|---|---|
| 640 to 642 | Brickwork / Masonry | Loss of Mortar | 0.5 to 1 | Mortar loss to coping stones extends below surface and has the potential to weaken/loosen surrounding bricks/blocks |
| 643 | Brickwork / Masonry | Loss of Bricks/Blocks | 0 to 1.5 | Holes in blockwork, likely left by historic fixings. Defects are cosmetic but have the potential to affect the walls integrity. |
| 645 to 650 | Coping | Vegetation Damage | 0 (coping) | Small and shallow rooted vegetation resulting in surface cracks and the early onset of mortar degradation |
| 645 to 650 | Concrete | Vegetation Damage | 0 (coping) | Small and shallow rooted vegetation resulting in surface cracks and the early onset of mortar degradation |

| Overall Assessment | 2 | Good |

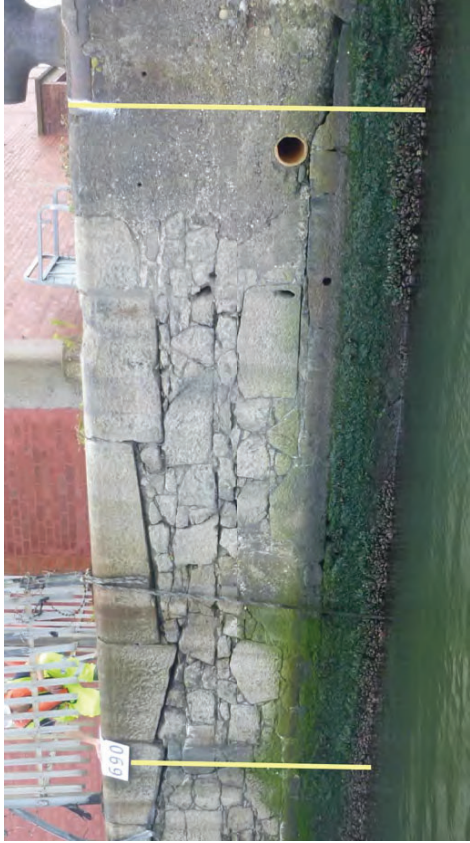
A143 Chainage 690 to 695m

| Chainage (m) | Feature | Level (m from top) | Dimensions (m) | Description |
|---|---|---|---|---|
| 690 to 694 | Coping | 0 to 0.5 | - | Good - Minor cracks created by minor movement. Surface defects in coping or limited mortar loss from joints |
| 690 to 694 | Brickwork / Masonry | 0.5 to 1.8 | - | Good - Minor cracks created by minor movement. Surface defects in blocks or limited mortar loss from joints |
| 694 to 695 | Repair | 0 to 1.5 | - | Concrete repair to brickwork/blockwork |
| 695 | Weephole / Outfall | 1.5 | D = 0.15m | Circular weephole/outfall. Good condition, some degradation but fully operable |
| 690 to 691.5 | Hand railing / Fence | 0 (coping) | H = 2.2m | Good - Localised corrosion with slight loss of thickness. No physical damage, deformation or movement to posts or rails |
| 690 to 695 | Concrete | 0 (coping) | - | Good - Structurally sound but with minor cracks and localised honeycombing/flaking with no significant defects |

| Defects | | | | |
|---|---|---|---|---|
| 690 to 695 | Coping | Loss of Mortar | 0 to 0.5 | Mortar loss to coping stones extends below surface and has the potential to weaken/loosen surrounding bricks/blocks |
| 690 to 695 | Brickwork / Masonry | Loss of Mortar | 0.5 to 1 | Mortar loss to bricks/blocks extends below surface and has the potential to weaken/loosen surrounding bricks/blocks |
| 693 to 694 | Coping | Loss of Coping | 0 to 0.2 | Loss/fracturing to edge of coping stone but block remains sound. Likely linked to impact damage |

| Overall Assessment | 2 | Good |

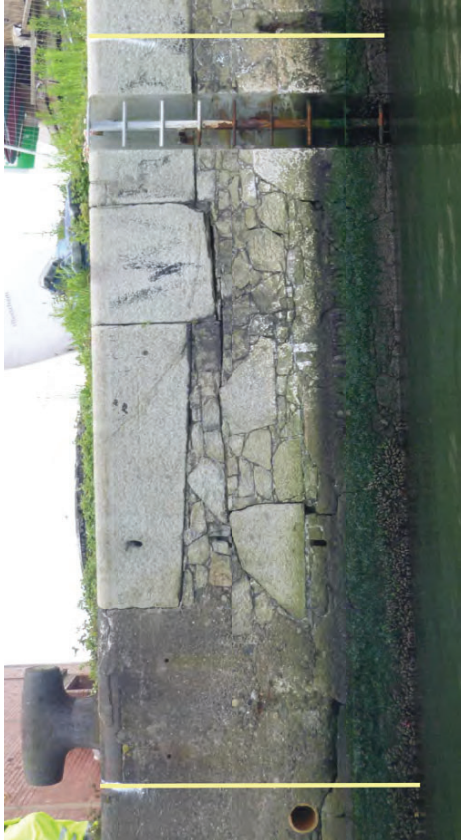
Figure A144 - Bramley Moore: Chainage 695 to 700m

| Chainage (m) | Feature | Level (m from top) | Dimensions (m) | Description |
|---|---|---|---|---|
| 695 to 696 | Repair | 0 to 1.5 | - | Concrete repair to brickwork/blockwork |
| 696 to 700 | Coping | 0 to 0.6 | - | Good - Minor cracks created by minor movement. Surface defects in coping or limited mortar loss from joints |
| 696 to 700 | Brickwork / Masonry | 0.4 to 1.8 | - | Good - Minor cracks created by minor movement. Surface defects in blocks or limited mortar loss from joints |
| 699.5 | Ladder | 0 to 2 | - | Ladder within recess. Fair condition, extensive corrosion and/or some damaged/bent rungs |
| 695 | Mooring Bollard | 0 (coping) | H = 0.5m | T-Shaped bollard embedded into coping. Good condition, localised surface corrosion |

| Chainage (m) | Feature | Defect | Level (m from top) | Description |
|---|---|---|---|---|
| 695 to 696 | Repair | Loss of Mortar | 1.5 | Mortar loss to bricks/blocks extends below surface and has the potential to weaken/loosen surrounding bricks/blocks |
| 696 to 700 | Coping | Loss of Mortar | 0 to 0.5 | Mortar loss to coping stones extends below surface and has the potential to weaken/loosen surrounding bricks/blocks |
| 696 to 700 | Brickwork / Masonry | Loss of Mortar | 0.5 to 1 | Mortar loss to bricks/blocks is limited to the surface. Defects are cosmetic only |
| 692 | Brickwork / Masonry | Loss of Bricks/Blocks | 0.5 to 1.5 | Holes in blockwork, likely left by historic fixings. Defects are cosmetic but have the potential to affect the walls integrity. |
| 699.5 | Ladder | Corrosion | 0 to 1.8 | Onset of corrosion to surface layers which may include pitting and/or flaking of the surface metal. Defects are cosmetic only |

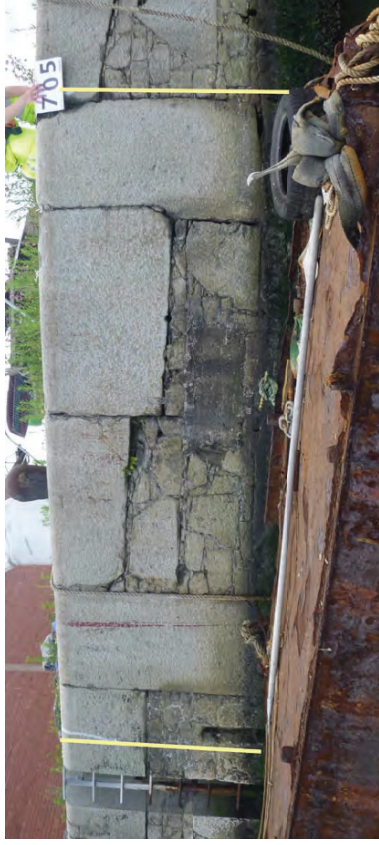
**Figure A145 - Bramley Moore: Chainage 700 to 705m**

| Chainage (m) | Feature | Level (m from top) | Dimensions (m) | Description |
|---|---|---|---|---|
| 700 to 705 | Coping | 0 to 0.5 | - | Good - Minor cracks created by minor movement. Surface defects in coping or limited mortar loss from joints |
| 700 to 705 | Brickwork / Masonry | 0.5 to 1.8 | - | Good - Minor cracks created by minor movement. Surface defects in bricks or limited mortar loss from joints |
| 700 to 705 | Cobbles | 0 (coping) | - | Good - Minor cracks created by settlement/heave. Surface defects in cobbles or limited mortar loss from joints |
| 700 | Mooring Chain | 1.5 | - | Fixed within recess. Fair condition, extensive corrosion with minor thickness loss and/or minor damage to links |
| 702.5 | Mooring Bollard | 0 (coping) | H = 0.8m | Single bitt bollard. Good condition, localised surface corrosion |

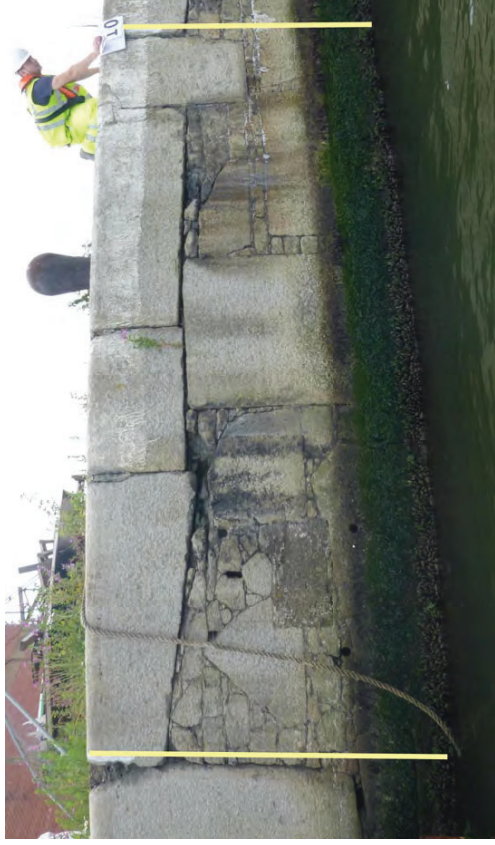
**Figure A146 - Bramley Moore: Chainage 705 to 710m**

| Chainage (m) | Feature | Level (m from top) | Dimensions (m) | Description |
|---|---|---|---|---|
| 705 to 710 | Coping | 0 to 0.5 | - | Good - Minor cracks created by minor movement. Surface defects in coping or limited mortar loss from joints |
| 705 to 710 | Brickwork / Masonry | 0.5 to 1.8 | - | Good - Minor cracks created by minor movement. Surface defects in bricks or limited mortar loss from joints |
| 709 | Mooring Bollard | 0 (coping) | H = 0.8m | Single bitt bollard. Good condition, localised surface corrosion |

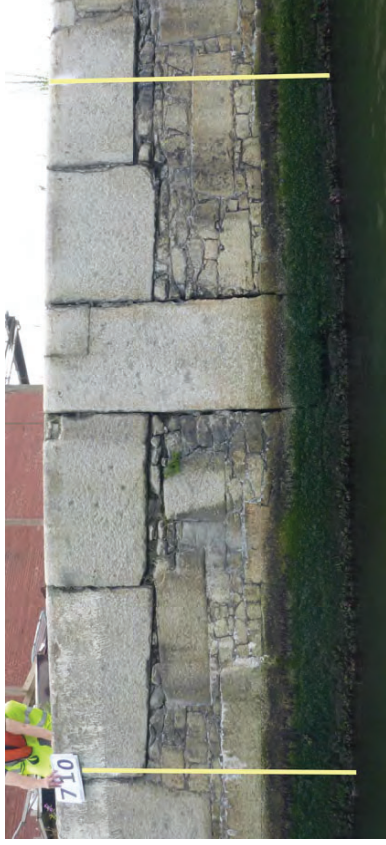
**Figure A147 - Bramley Moore: Chainage 710 to 715m**

| Chainage (m) | Feature | Defect | Level (m from top) | Description |
|---|---|---|---|---|
| 710 to 712, 714 to 715 | Coping | Loss of Mortar | 0.6 | Mortar loss to coping stone is limited to the surface. Defects are cosmetic only |
| 710 to 712, 714 to 715 | Brickwork / Masonry | Loss of Mortar | 0.6 to 0.8 | Mortar loss to bricks/blocks extends below surface and has the potential to weaken/loosen surrounding bricks/blocks |
| 712.5 and 713 | Brickwork / Masonry | Cracking | 0 to 1.6 | Minor vertical cracking limited to mortar joints indicating potential onset of wall movement/settlement |
| 710 to 715 | Coping | Vegetation Damage | 0 (coping) | Small and shallow rooted vegetation resulting in surface cracks and the early onset of mortar degradation |
