Bramley Moore Dock - Regent Road Wall

Wall Condition Survey

June 2020

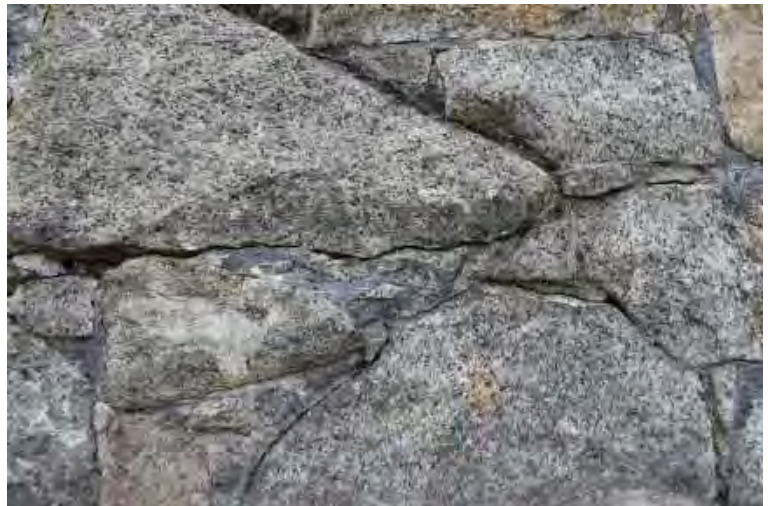
There are a considerable number of cracks which are visible on the face of the wall – these typically are at the interface of the stone to the mortar.

Cracking is more prevalent to the upper parts of the wall which are more exposed to weathering.

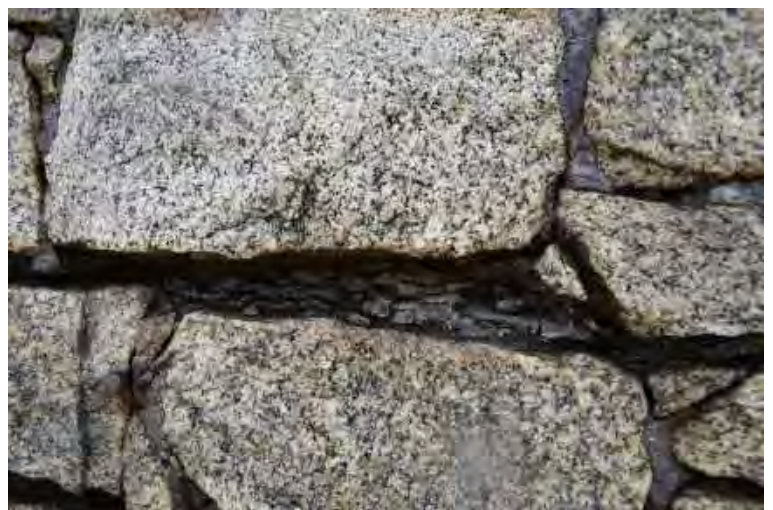
Some of the wider joints at high level show multiple cracking of the mortar beads where the overall mortar integrity has been compromised.

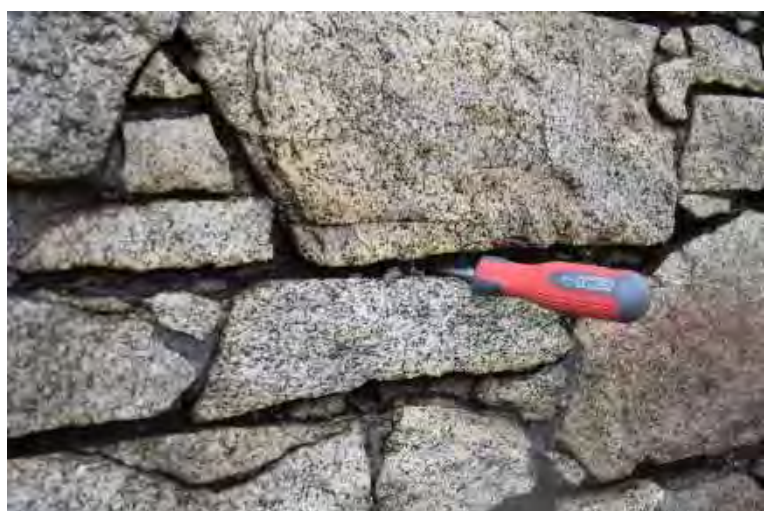
Cracking appears to be intrusive into the core of the wall with mortar separated from the face of the stones through the width of the stone.

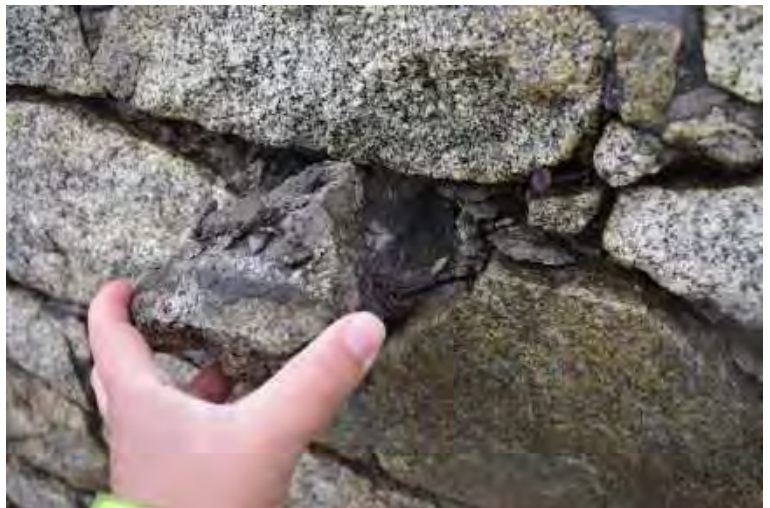
Where cracking is evident some of the smaller stones on the face are loose and pose a potential H&S issue especially in high wind conditions.

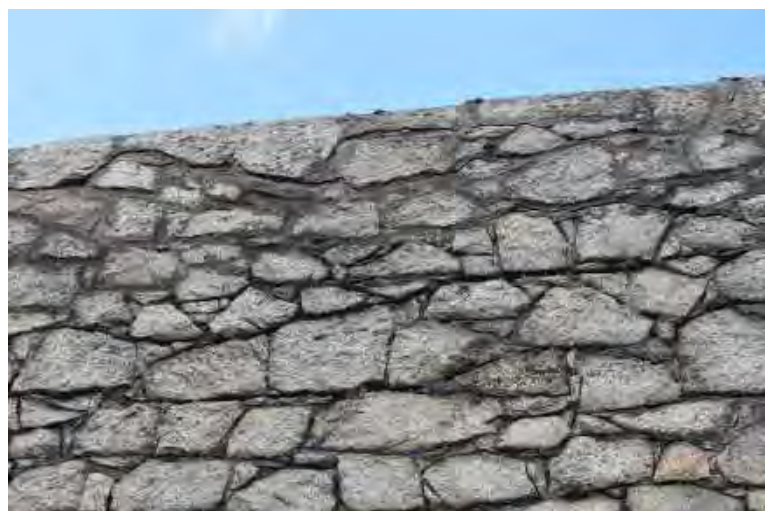
The coping stones have been re-pointed at some time however cracking is still evident in these areas showing continuing displacement.

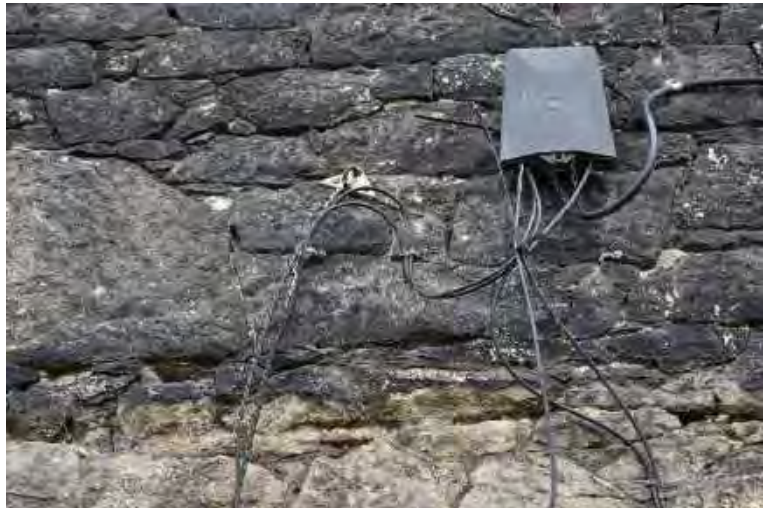
Electrical and utility services are present on the dockside elevation of the wall. These are fitted with ferrous fixings into the mortar beds. All fixings should be removed to prevent these corroding and further damaging the wall.

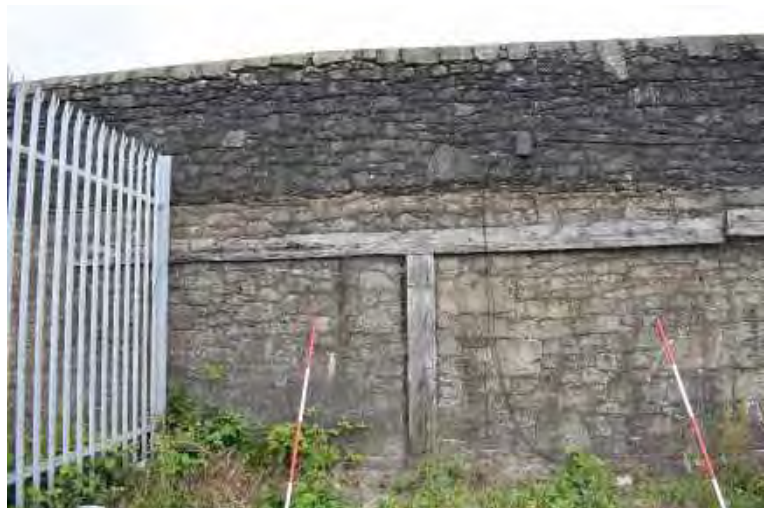
At positions along the wall various sheds have been constructed against the wall. Some of the timberwork and fixings remain which should be removed to prevent further damage to the wall.

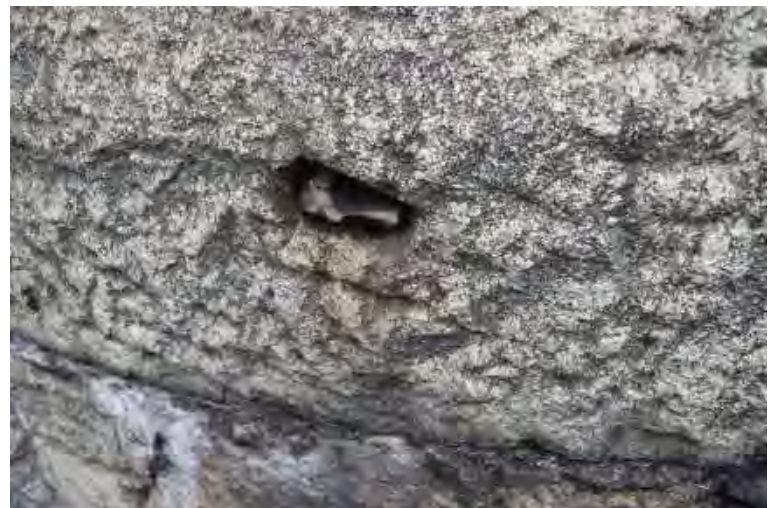
Evidence of previous ironwork ie handrails fitted at the gate piers within the stonework. Where ironwork is stable it can be retained however in most areas there is evidence of corrosion jacking and damage to mortar beds.

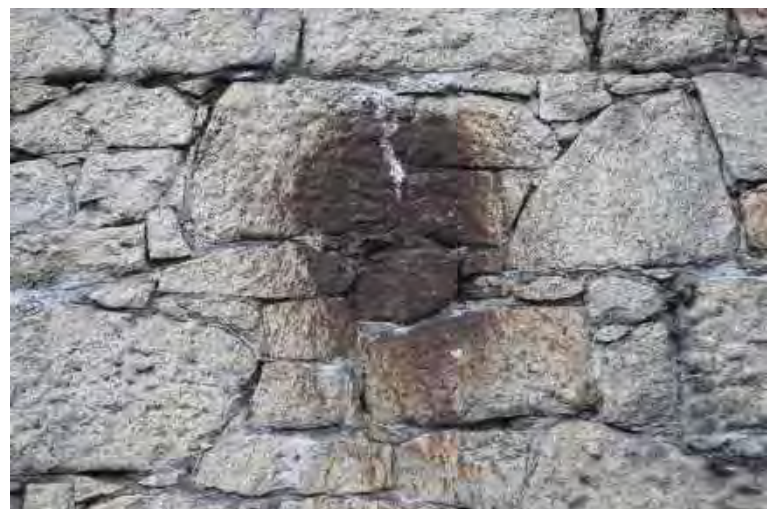
Rust staining is present in areas where embedded ironwork has been retained or cut close to the face of the wall.

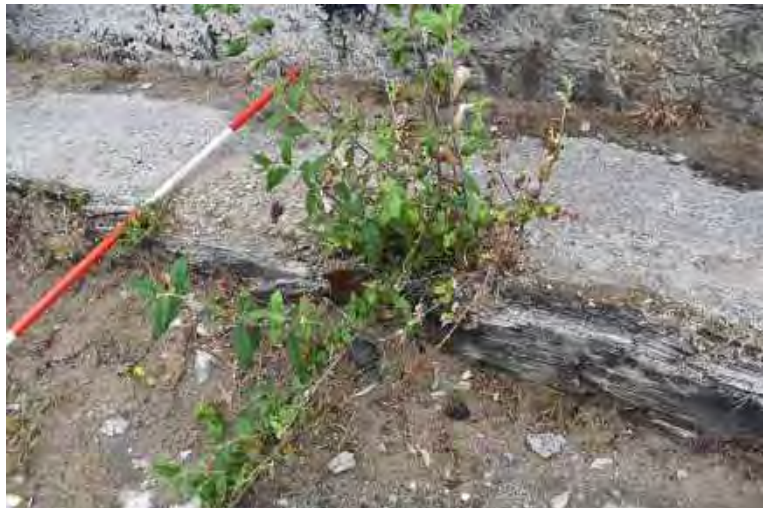
Any plant growth on the walls is undesirable as roots can penetrate the surface mortars and destabilise stonework. Buddleia is particularly invasive and its extensive root network can damage lime mortars forcing apart stones leading to movement and stone loss within the wall.

Any existing growth on the walls should be removed together with any soil build-up and the resultant damage made good to prevent further degradation of the wall and prevent water entering the wall core.

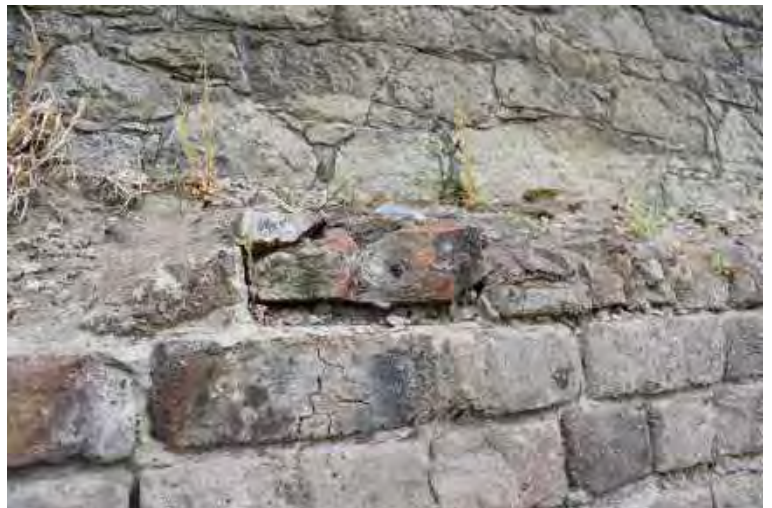
Upper courses of the brickwork wall have become dislodged and damaged by frost, impact and plant growth.

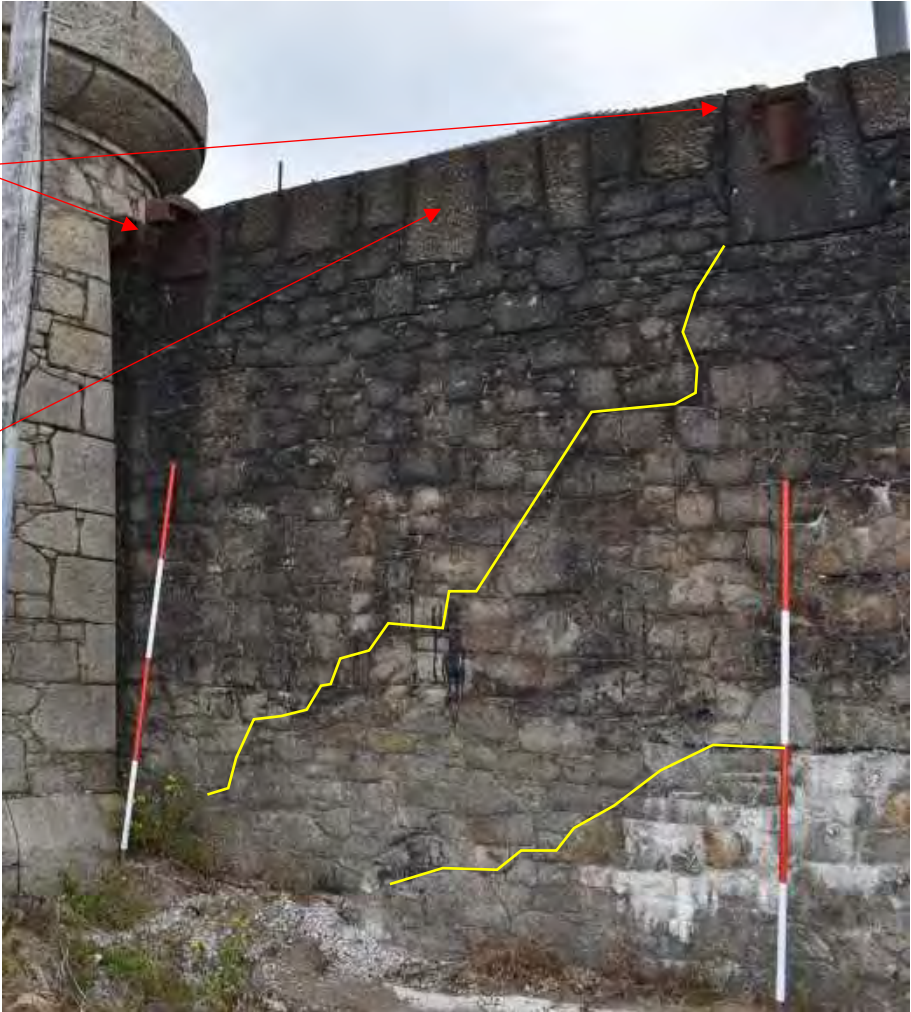
<p>Condition:</p>	<p>Generally stable with some cracking to face of the wall possibly due to movement / settlement of the gate pier. Paint and calcium staining to the rear of the wall and later fitted concrete plinth to base of wall.</p> <p>Proposed treatment: Remove later concrete plinth to base of wall. Re-point areas of cracked mortar Remove / treat staining to rear of wall.</p> <p>Repair damaged guide rails (where gates are required to be operational) otherwise clean back and apply protective coatings.</p>

Diagonal cracking –
repoint (possibly
inject) to reinstate
wall integrity.

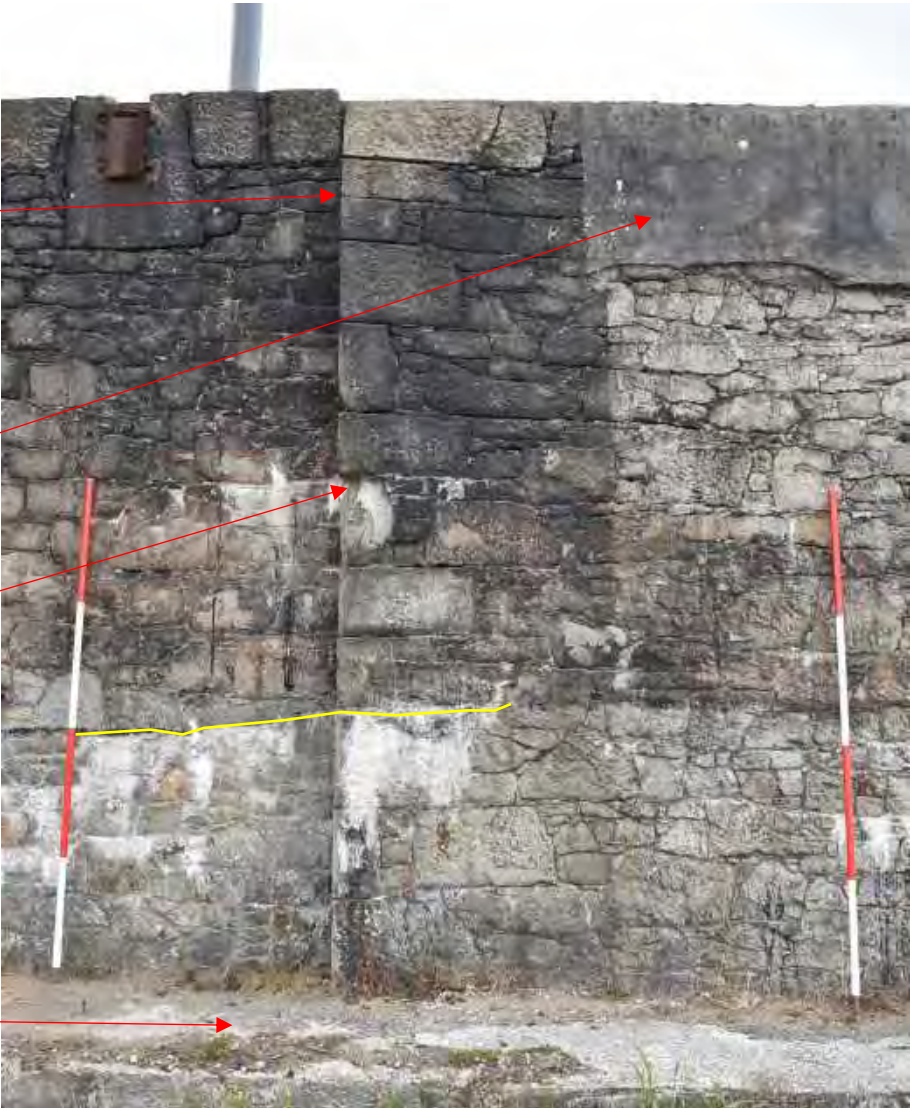
<p>Condition:</p>	<p>Generally stable with some cracking around stonework especially at the higher levels. Calcium deposits at low level and later fitted concrete plinth to base of wall. Coping stones partly covered with render (BMD side only).</p> <p>Pollution staining to face of the wall.</p> <p>Proposed treatment:</p> <p>Remove later concrete plinth to base of wall.</p> <p>Re-point areas of cracked mortar</p> <p>Remove render to upper section of wall and make good stonework.</p> <p>Remove / treat staining to rear of wall.</p>
