| Location Ref: | BMD Elevation – Section 44 |

| Location Ref: | RR Elevation – Section 01 |

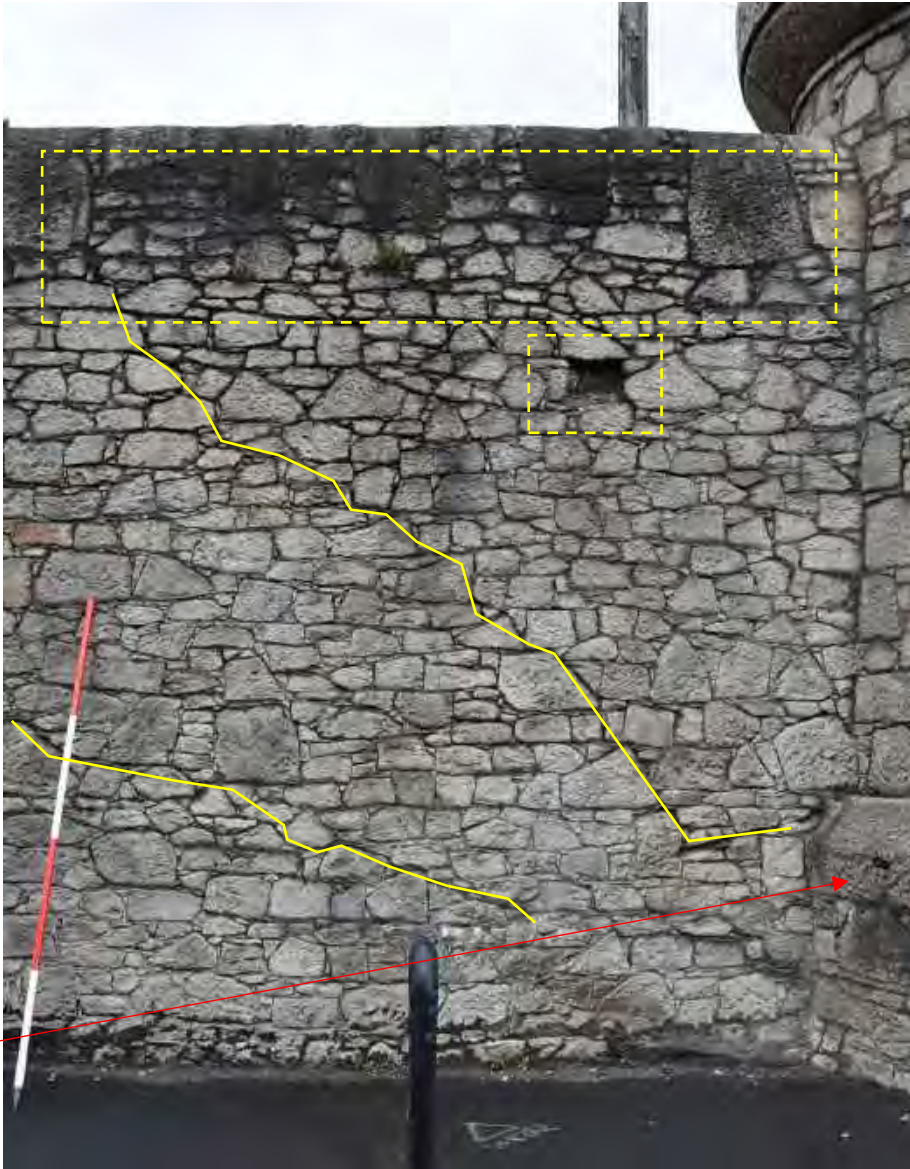
| Location Ref: | RR Elevation – Section 01 |
|--|---|
| <p>Wall section width approx. 3.0m</p> <p>Mortar loss and cracking to upper wall areas.</p> <p>Void area in wall.</p> <p>Cracking in wall.</p> <p>Ironwork in wall (possible handrail)</p> | |
| <p>Condition:</p> | <p>Coping stones to top of wall have been repointed (RR side only). Diagonal cracking within wall possibly due to settlement of gate pier. Wall is generally stable but with some cracking and mortar loss around stones especially at higher levels which requires repair.</p> <p>Proposed treatment: Re-point areas of cracked and missing mortar - additional grouting of the upper core areas may be required.</p> |

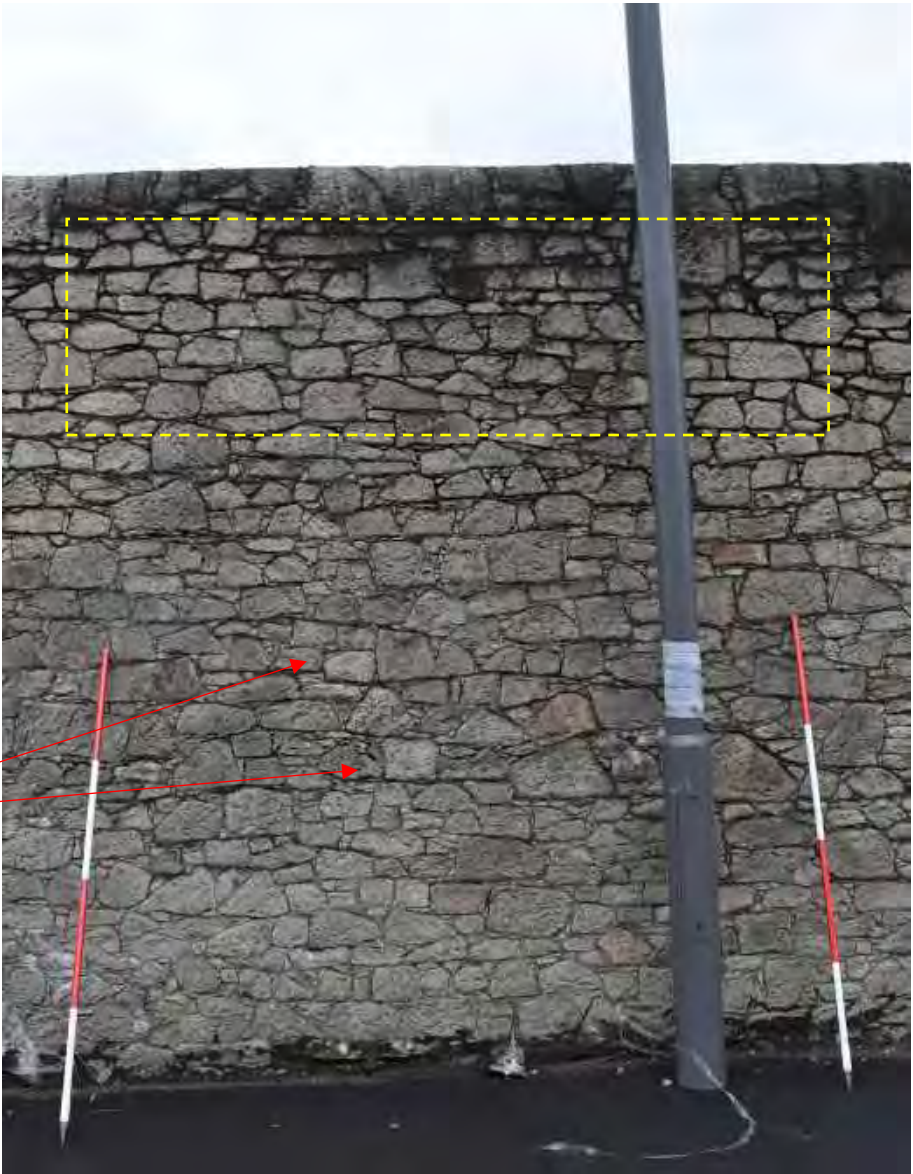
| Location Ref: | RR Elevation – Section 02 |

| Location Ref: | RR Elevation – Section 02 |
|--|---|
| <p>Wall section width approx. 3.0m</p> <p>Coping stones have been re-pointed.</p> <p>Mortar loss and cracking to upper wall areas.</p> <p>Minor cracking to mortar at lower levels</p> <p>Cracking</p> | <p>The photograph shows a close-up of a stone wall. A yellow dashed rectangular box is drawn on the upper portion of the wall, indicating an area of interest. Two red arrows originate from the word 'Cracking' in the text to the left and point to specific areas of mortar cracking in the lower-middle section of the wall. A vertical utility pole is visible on the right side of the wall, and two red-and-white striped survey poles are positioned at the base of the wall for scale.</p> |
| <p>Condition:</p> | <p>Coping stones to top of wall have been repointed (RR side only). Wall is generally stable but with some cracking and mortar loss around stones especially at higher levels which requires repair.</p> <p>Proposed treatment:</p> <p>Re-point areas of cracked and missing mortar - additional grouting of the upper core areas may be required.</p> |

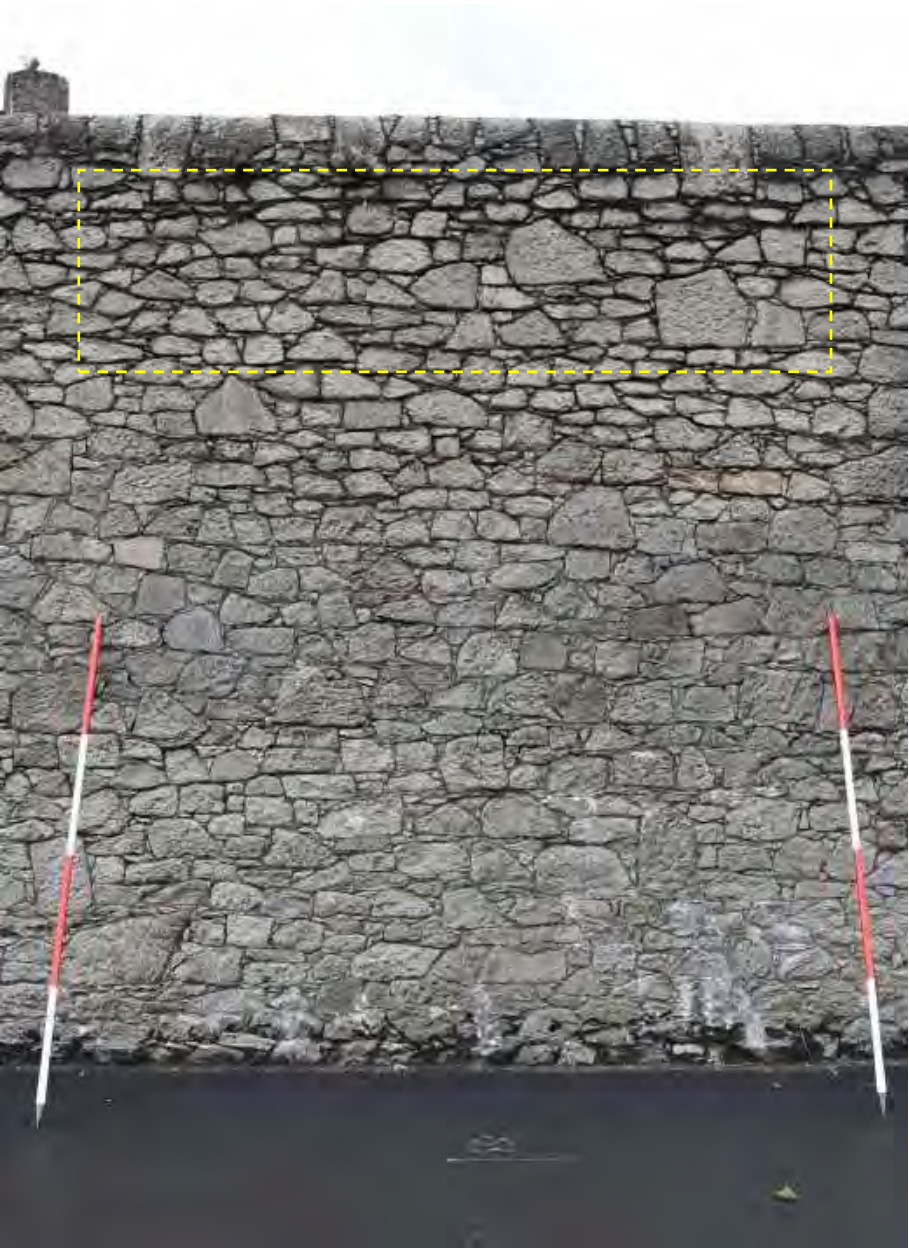
| Location Ref: | RR Elevation – Section 03 |
|---|--|
| <p>Wall section width approx. 3.0m</p> <p>Coping stones have been re-pointed (RR side only).</p> <p>Mortar loss and cracking to upper wall areas.</p> | |
| <p>Condition:</p> | <p>Coping stones to top of wall have been repointed (RR side only). Wall is generally stable but with some cracking and mortar loss around stones especially at higher levels which requires repair.</p> <p>Proposed treatment: Re-point areas of cracked and missing mortar - additional grouting of the upper core areas may be required.</p> |

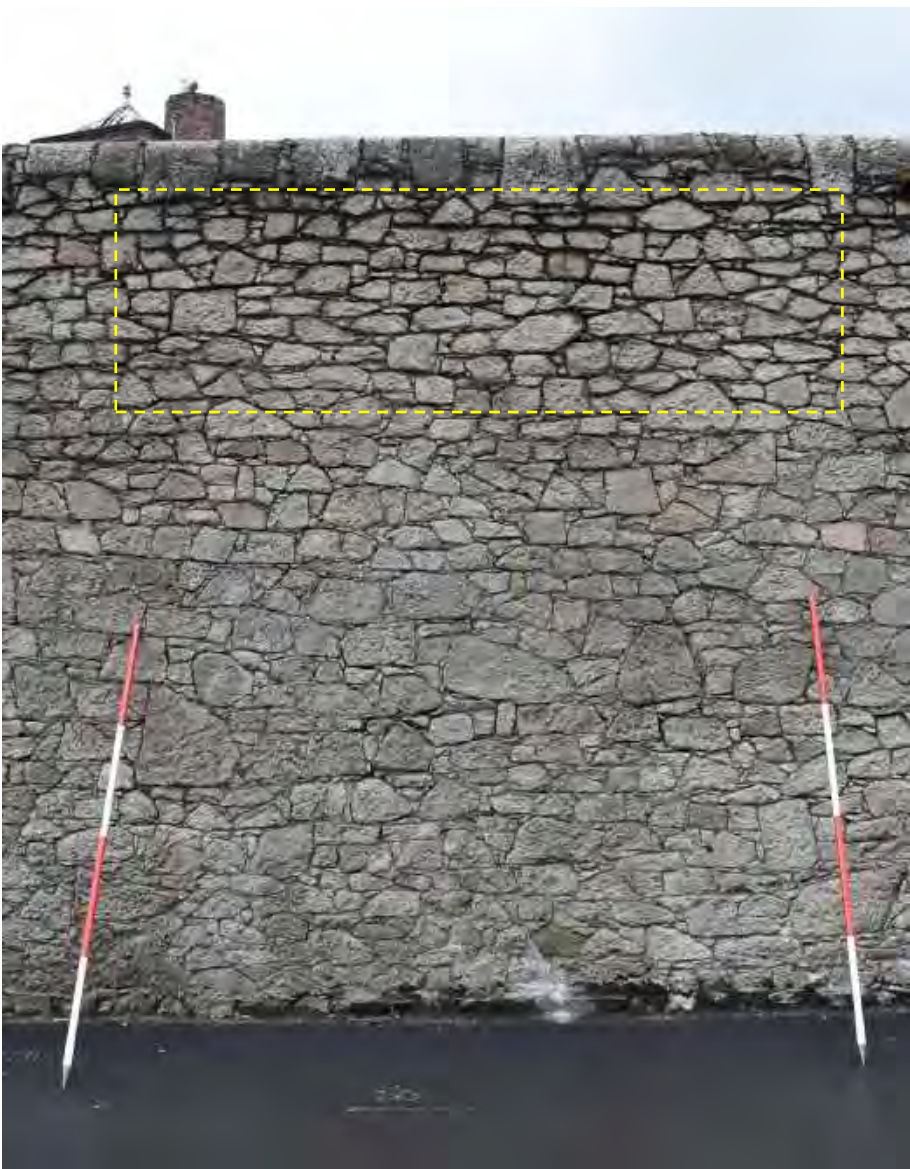
| Location Ref: | RR Elevation – Section 04 |
|---|--|
| <p>Wall section width approx. 3.0m</p> <p>Coping stones have been re-pointed (RR side only).</p> <p>Mortar loss and cracking to upper wall areas.</p> | |
| <p>Condition:</p> | <p>Coping stones to top of wall have been repointed (RR side only). Wall is generally stable but with some cracking and mortar loss around stones especially at higher levels which requires repair.</p> <p>Proposed treatment: Re-point areas of cracked and missing mortar - additional grouting of the upper core areas may be required.</p> |

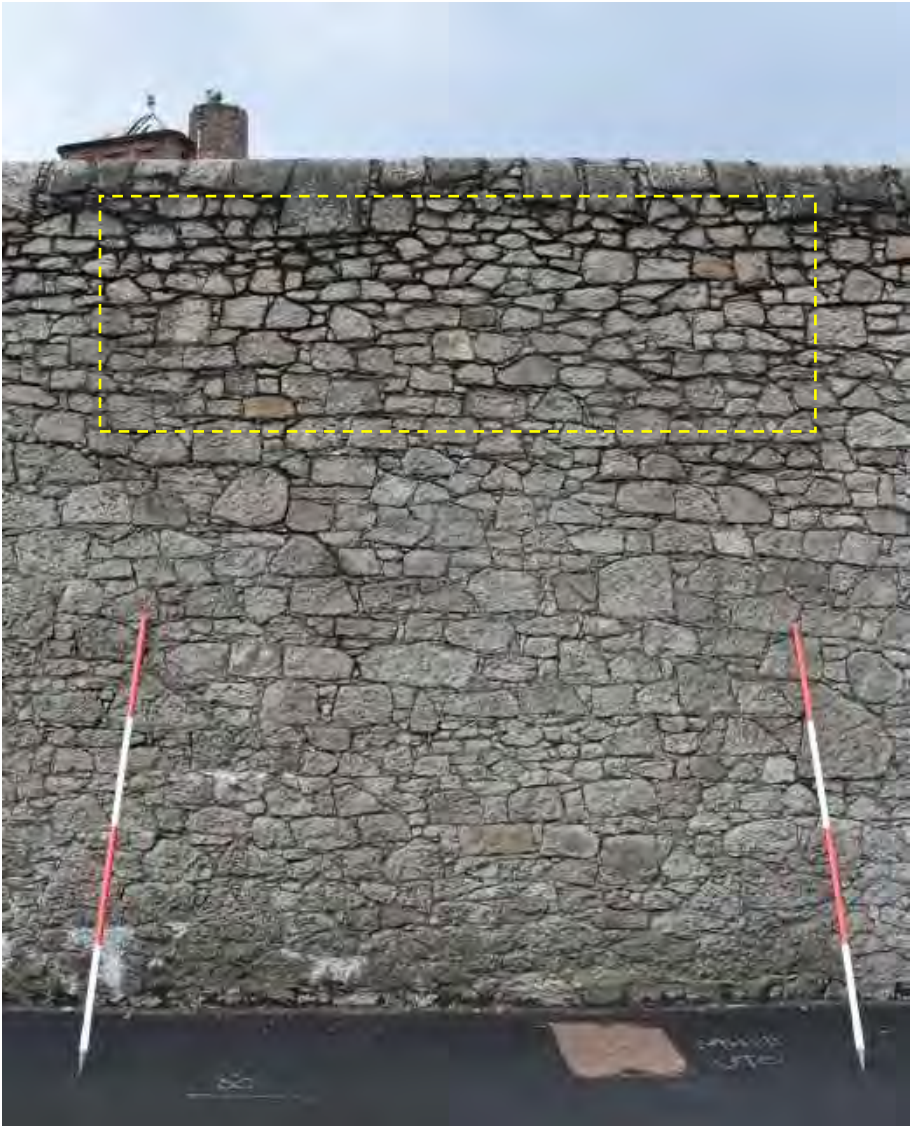
| Location Ref: | RR Elevation – Section 05 |
|---|--|
| <p>Wall section width approx. 3.0m</p> <p>Coping stones have been re-pointed (RR side only).</p> <p>Mortar loss and cracking to upper wall areas.</p> <p>Minor cracking to mortar at lower levels</p> | |
| <p>Condition:</p> | <p>Coping stones to top of wall have been repointed (RR side only). Wall is generally stable but with some cracking and mortar loss around stones especially at higher levels which requires repair.</p> <p>Proposed treatment: Re-point areas of cracked and missing mortar - additional grouting of the upper core areas may be required.</p> |

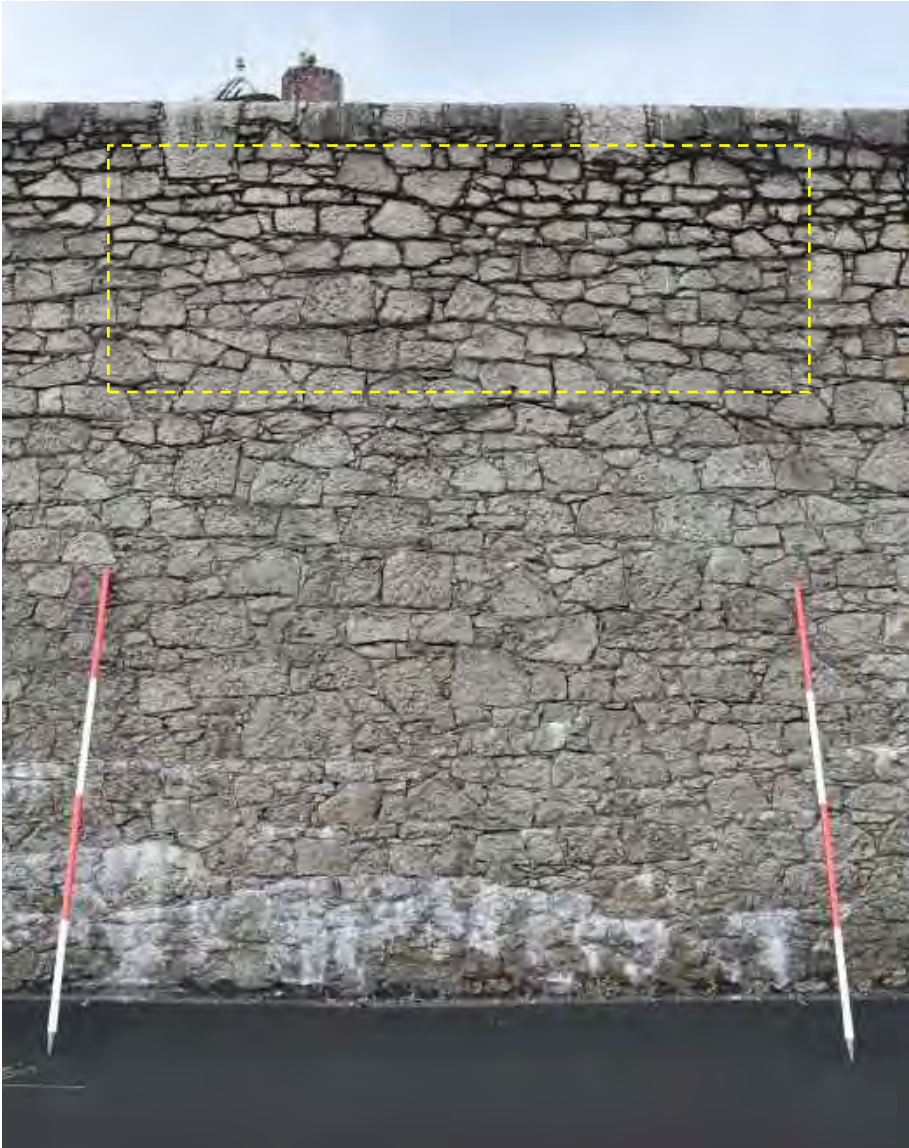
| Location Ref: | RR Elevation – Section 06 |
|---|--|
| <p>Wall section width approx. 3.0m</p> <p>Coping stones have been re-pointed (RR side only).</p> <p>Mortar loss and cracking to upper wall areas.</p> <p>Minor cracking to mortar at lower levels</p> | <p>The photograph shows a close-up of a stone wall. A yellow dashed rectangle is drawn over the upper portion of the wall, indicating the area of re-pointing. Two vertical poles with red and white segments are positioned at the base of the wall to provide a sense of scale. The wall itself is constructed from irregular stones with visible mortar joints.</p> |
| <p>Condition:</p> | <p>Coping stones to top of wall have been repointed (RR side only). Wall is generally stable but with some cracking and mortar loss around stones especially at higher levels which requires repair.</p> <p>Proposed treatment: Re-point areas of cracked and missing mortar - additional grouting of the upper core areas may be required.</p> |

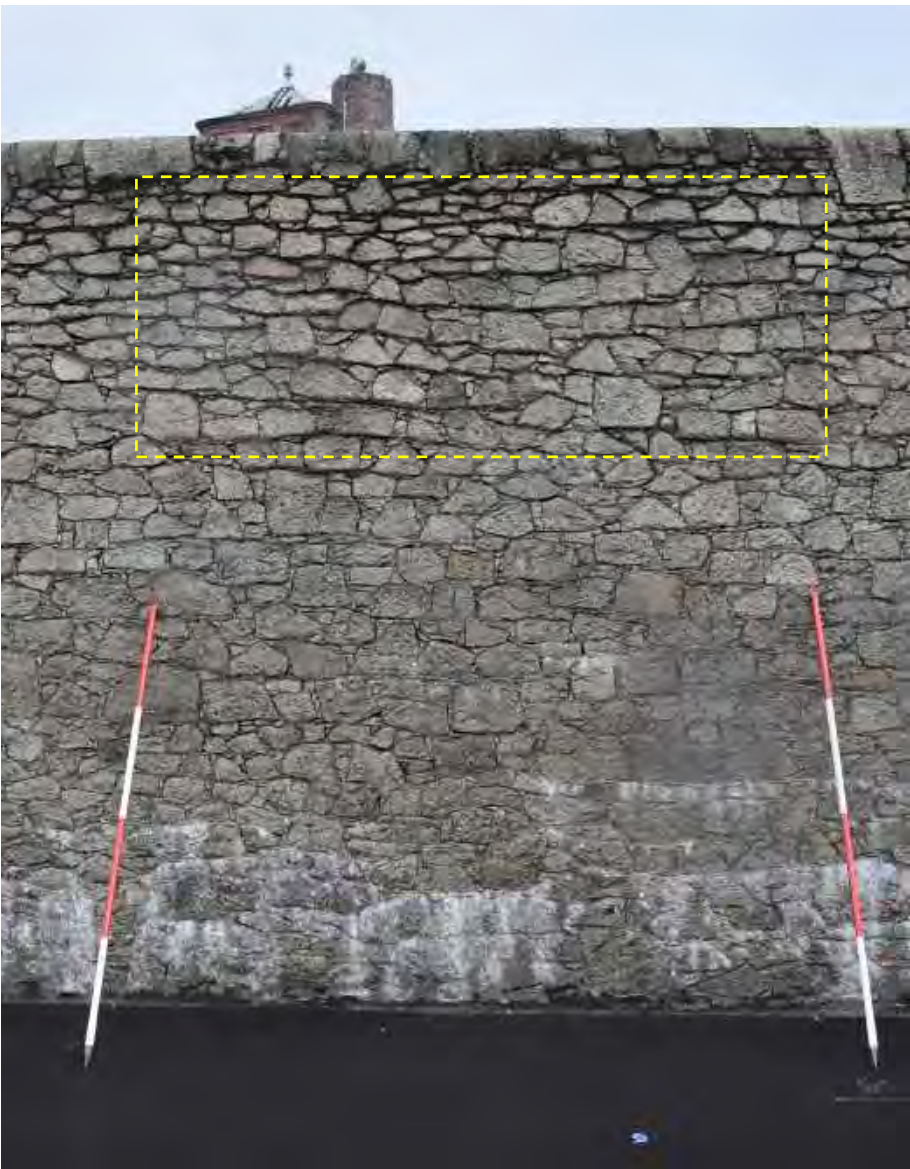
| Location Ref: | RR Elevation – Section 07 |
|---|---|
| <p>Wall section width approx. 3.0m</p> <p>Coping stones have been re-pointed (RR side only).</p> <p>Mortar loss and cracking to upper wall areas.</p> | |
| <p>Condition:</p> | <p>Coping stones to top of wall have been repointed (RR side only). Wall is generally stable but with some cracking and mortar loss around stones especially at higher levels which requires repair.</p> <p>Proposed treatment:</p> <p>Re-point areas of cracked and missing mortar - additional grouting of the upper core areas may be required.</p> |

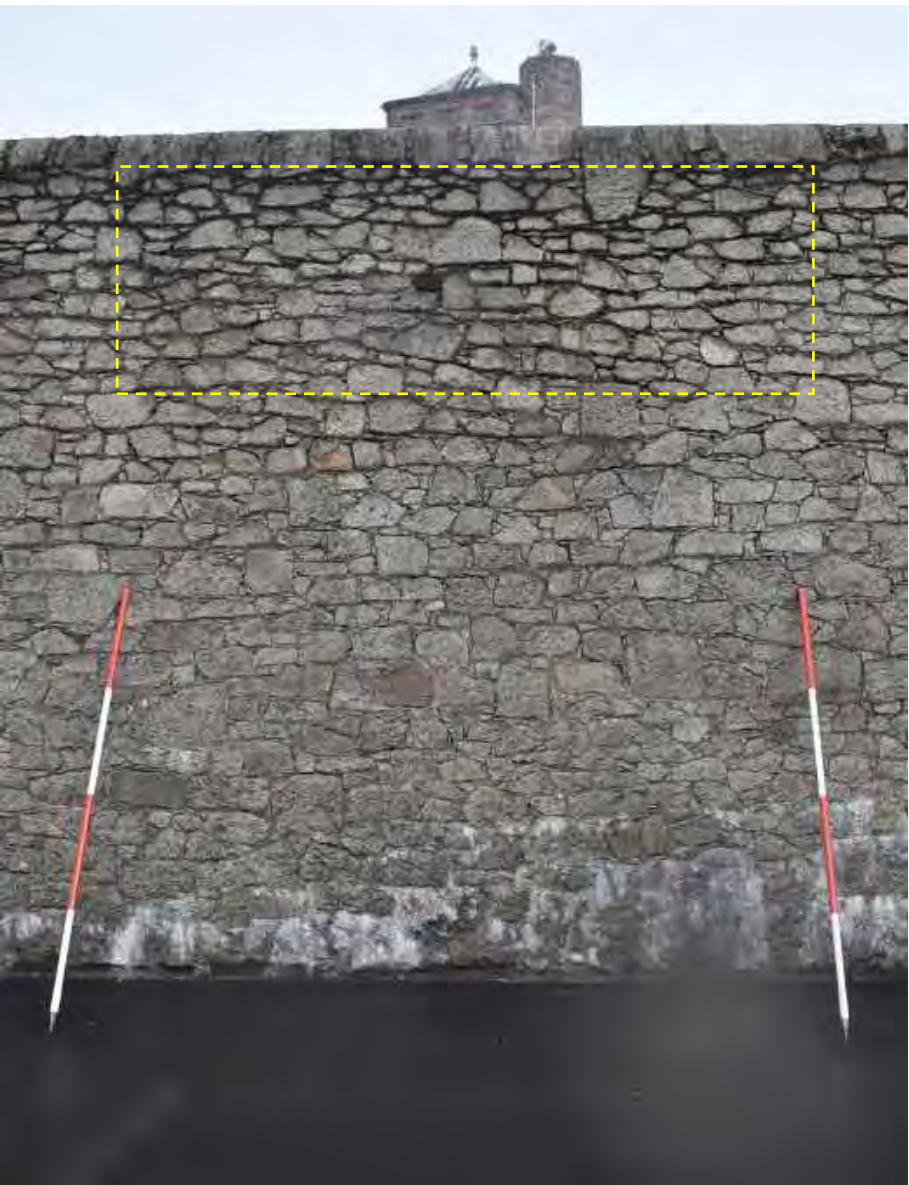
| Location Ref: | RR Elevation – Section 08 |
|---|--|
| <p>Wall section width approx. 3.0m</p> <p>Coping stones have been re-pointed (RR side only).</p> <p>Mortar loss and cracking to upper wall areas.</p> <p>Minor cracking to mortar at lower levels</p> | |
| <p>Condition:</p> | <p>Coping stones to top of wall have been repointed (RR side only). Wall is generally stable but with some cracking and mortar loss around stones especially at higher levels which requires repair.</p> <p>Proposed treatment: Re-point areas of cracked and missing mortar - additional grouting of the upper core areas may be required.</p> |

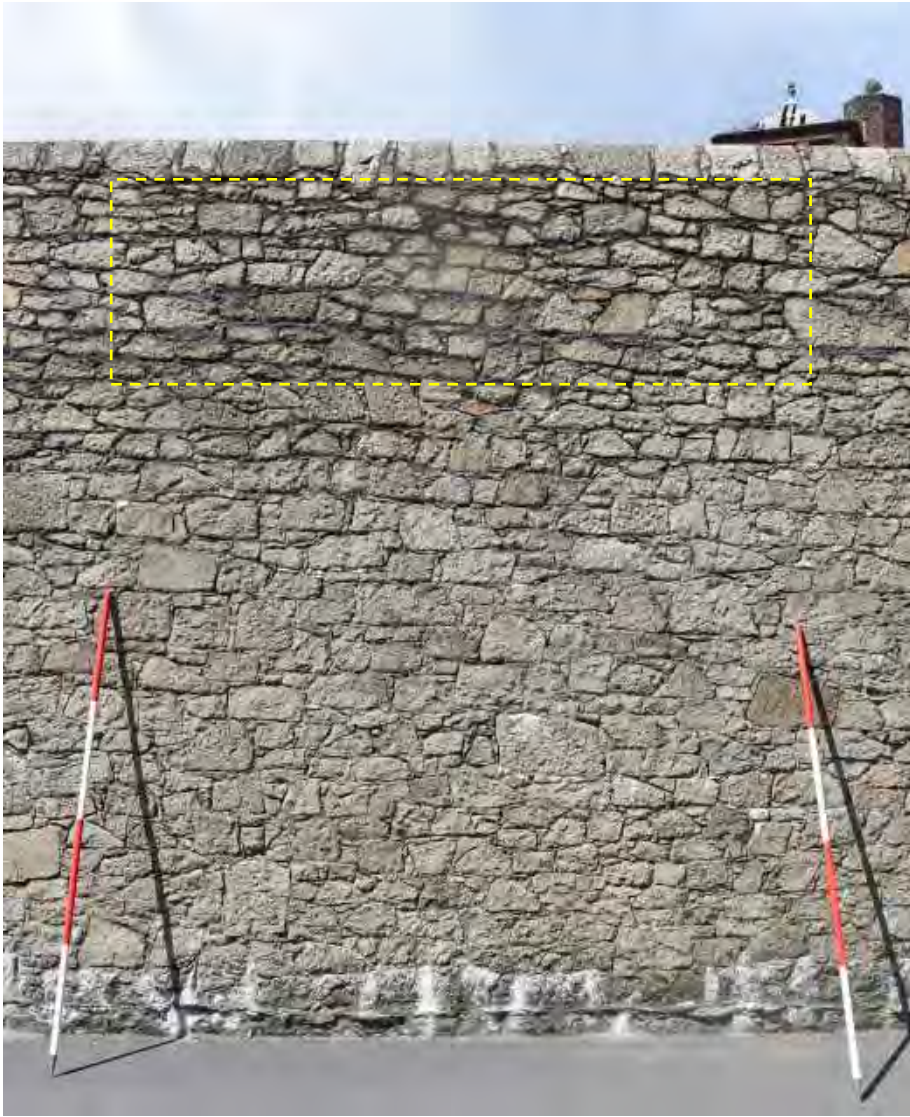
| Location Ref: | RR Elevation – Section 13 |
|---|---|
| <p>Wall section width approx. 3.0m</p> <p>Coping stones have been re-pointed (RR side only).</p> <p>Mortar loss and cracking to upper wall areas.</p> <p>Minor cracking to mortar at lower levels</p> | <p>The photograph shows a close-up of a stone wall. A yellow dashed rectangle is drawn on the upper portion of the wall, indicating the area of re-pointing. Two surveying poles with red and white markings are positioned at the base of the wall for scale. The wall shows signs of wear, including mortar loss and cracking, particularly in the upper section.</p> |
| <p>Condition:</p> | <p>Coping stones to top of wall have been repointed (RR side only). Wall is generally stable but with some cracking and mortar loss around stones especially at higher levels which requires repair.</p> <p>Proposed treatment: Re-point areas of cracked and missing mortar - additional grouting of the upper core areas may be required.</p> |

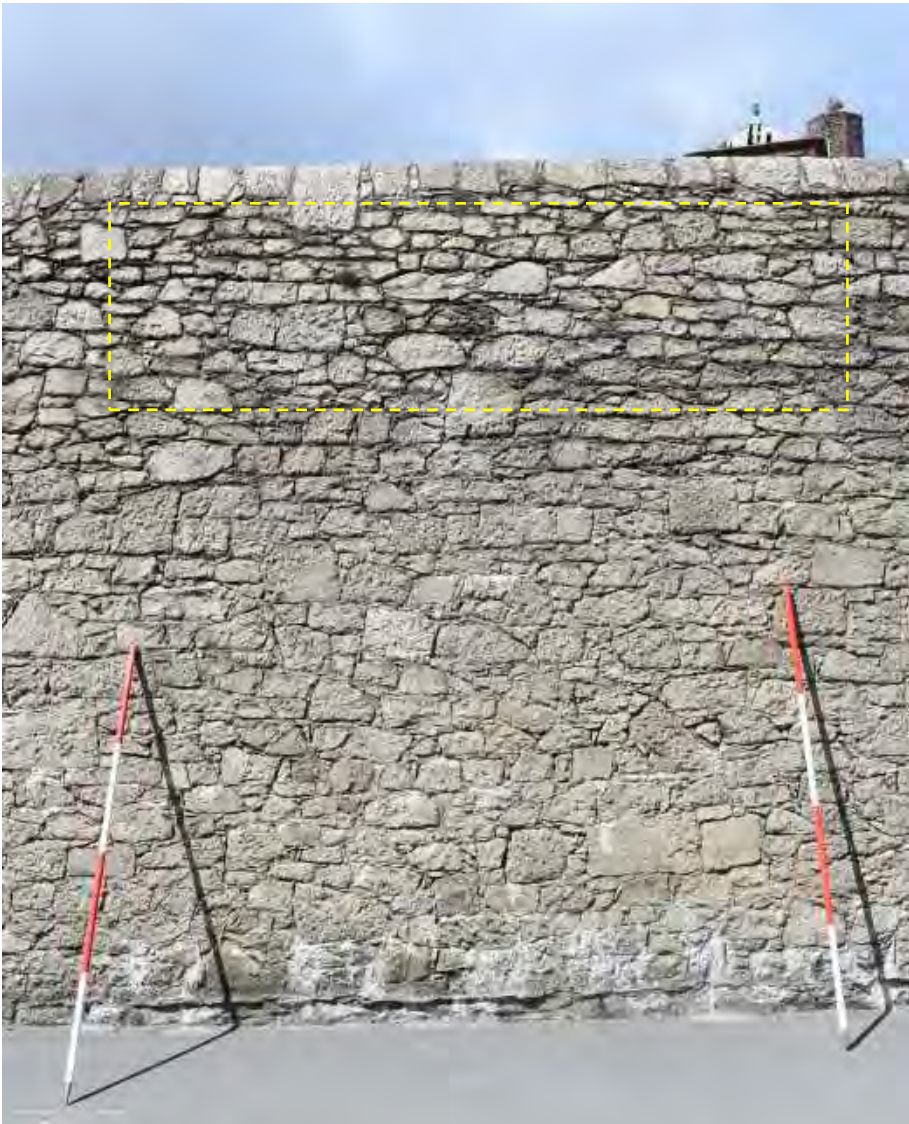
| Location Ref: | RR Elevation – Section 14 |
|---|--|
| <p>Wall section width approx. 3.0m</p> <p>Coping stones have been re-pointed (RR side only).</p> <p>Mortar loss and cracking to upper wall areas.</p> <p>Minor cracking to mortar at lower levels</p> | |
| <p>Condition:</p> | <p>Coping stones to top of wall have been repointed (RR side only). Wall is generally stable but with some cracking and mortar loss around stones especially at higher levels which requires repair.</p> <p>Proposed treatment: Re-point areas of cracked and missing mortar - additional grouting of the upper core areas may be required.</p> |

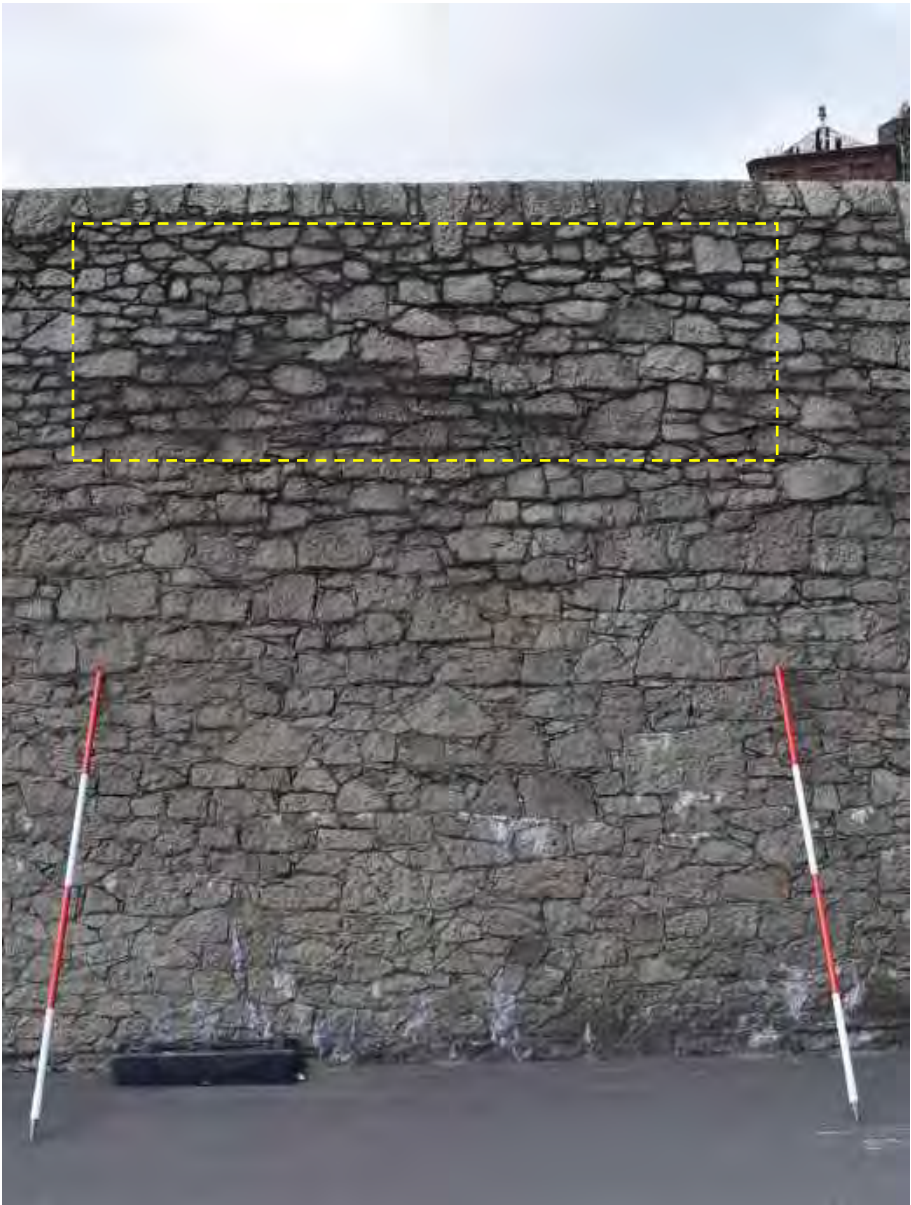
| Location Ref: | RR Elevation – Section 15 |
|---|--|
| <p>Wall section width approx. 3.0m</p> <p>Coping stones have been re-pointed (RR side only).</p> <p>Mortar loss and cracking to upper wall areas.</p> <p>Minor cracking to mortar at lower levels</p> | |
| <p>Condition:</p> | <p>Coping stones to top of wall have been repointed (RR side only). Wall is generally stable but with some cracking and mortar loss around stones especially at higher levels which requires repair.</p> <p>Proposed treatment: Re-point areas of cracked and missing mortar - additional grouting of the upper core areas may be required.</p> |

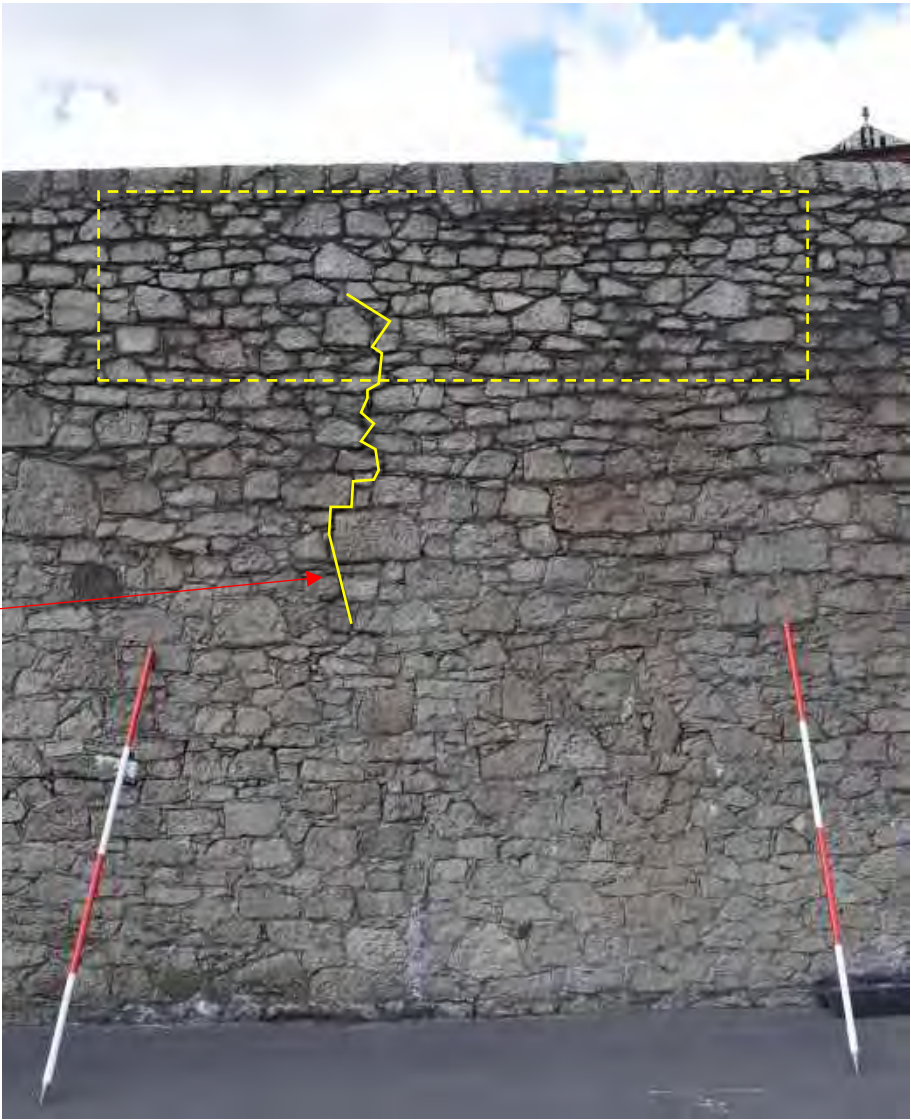
| Location Ref: | RR Elevation – Section 16 |
|--|--|
| <p>Wall section width approx. 3.0m</p> <p>Coping stones have been re-pointed (RR side only).</p> <p>Mortar loss and cracking to upper wall areas.</p> <p>Crack</p> | |
| <p>Condition:</p> | <p>Coping stones to top of wall have been repointed (RR side only). Wall is generally stable but with some cracking and mortar loss around stones especially at higher levels which requires repair.</p> <p>Proposed treatment: Re-point areas of cracked and missing mortar - additional grouting of the upper core areas may be required.</p> |

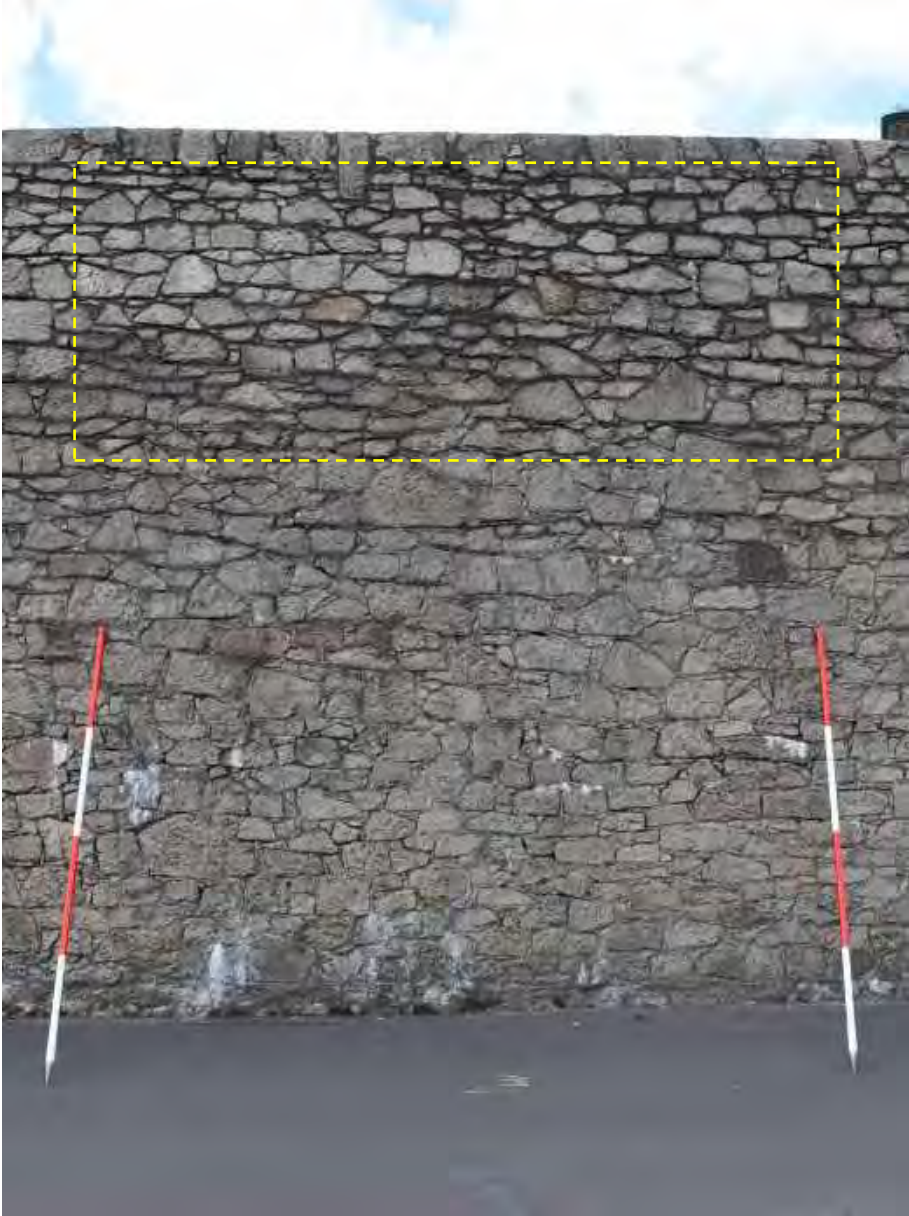
| Location Ref: | RR Elevation – Section 17 |
|---|---|
| <p>Wall section width approx. 3.0m</p> <p>Coping stones have been re-pointed (RR side only).</p> <p>Mortar loss and cracking to upper wall areas.</p> | A photograph of a stone wall, likely made of rough-hewn stones. A yellow dashed rectangle is drawn on the upper portion of the wall, indicating a specific area of interest or repair. Two surveying poles, which are white with red bands, are positioned vertically on either side of the wall at the bottom, providing a scale for the wall's height. The wall appears to be part of a larger structure, possibly a railway embankment or a bridge abutment, given the 'RR Elevation' label. |
| <p>Condition:</p> | <p>Coping stones to top of wall have been repointed (RR side only). Wall is generally stable but with some cracking and mortar loss around stones especially at higher levels which requires repair.</p> <p>Proposed treatment: Re-point areas of cracked and missing mortar - additional grouting of the upper core areas may be required.</p> |

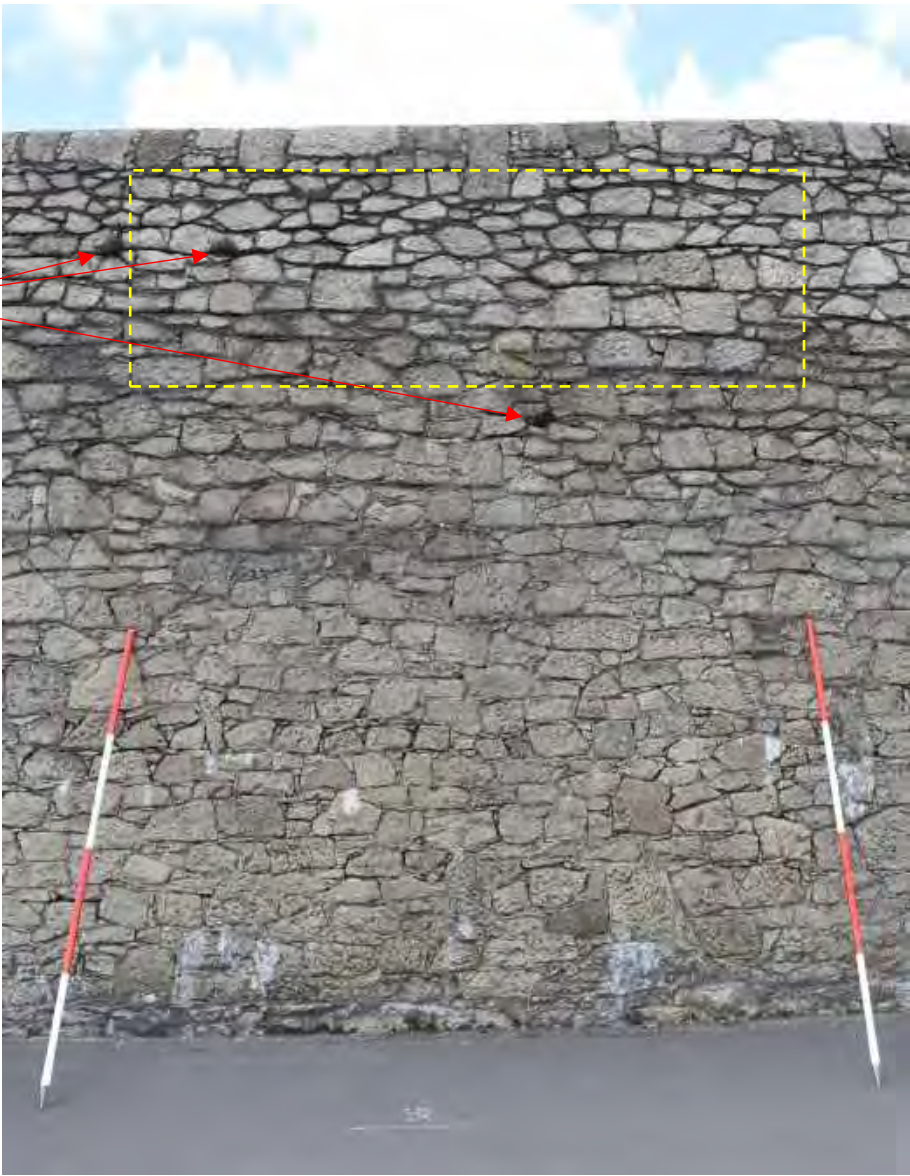
| Location Ref: | RR Elevation – Section 18 |
|---|--|
| <p>Wall section width approx. 3.0m</p> <p>Coping stones have been re-pointed (RR side only).</p> <p>Plant growth.</p> <p>Mortar loss and cracking to upper wall areas.</p> <p>Calcium deposits to lower wall.</p> | |
| <p>Condition:</p> | <p>Coping stones to top of wall have been repointed (RR side only). Wall is generally stable but with some cracking and mortar loss around stones especially at higher levels which requires repair.</p> <p>Proposed treatment: Re-point areas of cracked and missing mortar - additional grouting of the upper core areas may be required. Remove plant growth, treat and mortar repair.</p> |

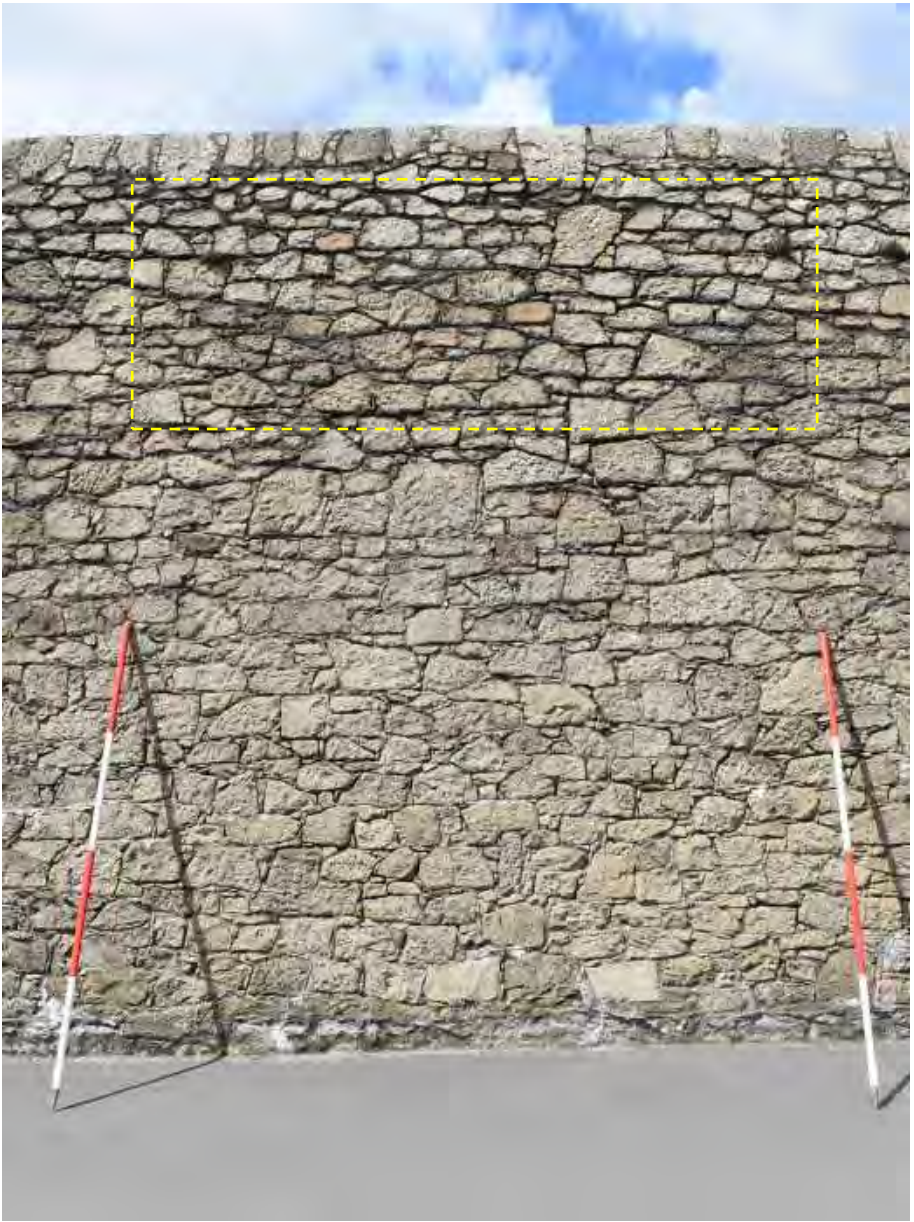
| Location Ref: | RR Elevation – Section 19 |
|---|---|
| <p>Wall section width approx. 3.0m</p> <p>Coping stones have been re-pointed (RR side only).</p> <p>Mortar loss and cracking to upper wall areas.</p> | A photograph of a stone wall, likely made of rough-hewn stones, showing some mortar loss and cracking. A yellow dashed rectangle highlights the upper section of the wall, indicating the area of re-pointing. Two surveying poles are visible at the base of the wall, used for measurement. |
| <p>Condition:</p> | <p>Coping stones to top of wall have been repointed (RR side only). Wall is generally stable but with some cracking and mortar loss around stones especially at higher levels which requires repair.</p> <p>Proposed treatment:</p> <p>Re-point areas of cracked and missing mortar - additional grouting of the upper core areas may be required.</p> |

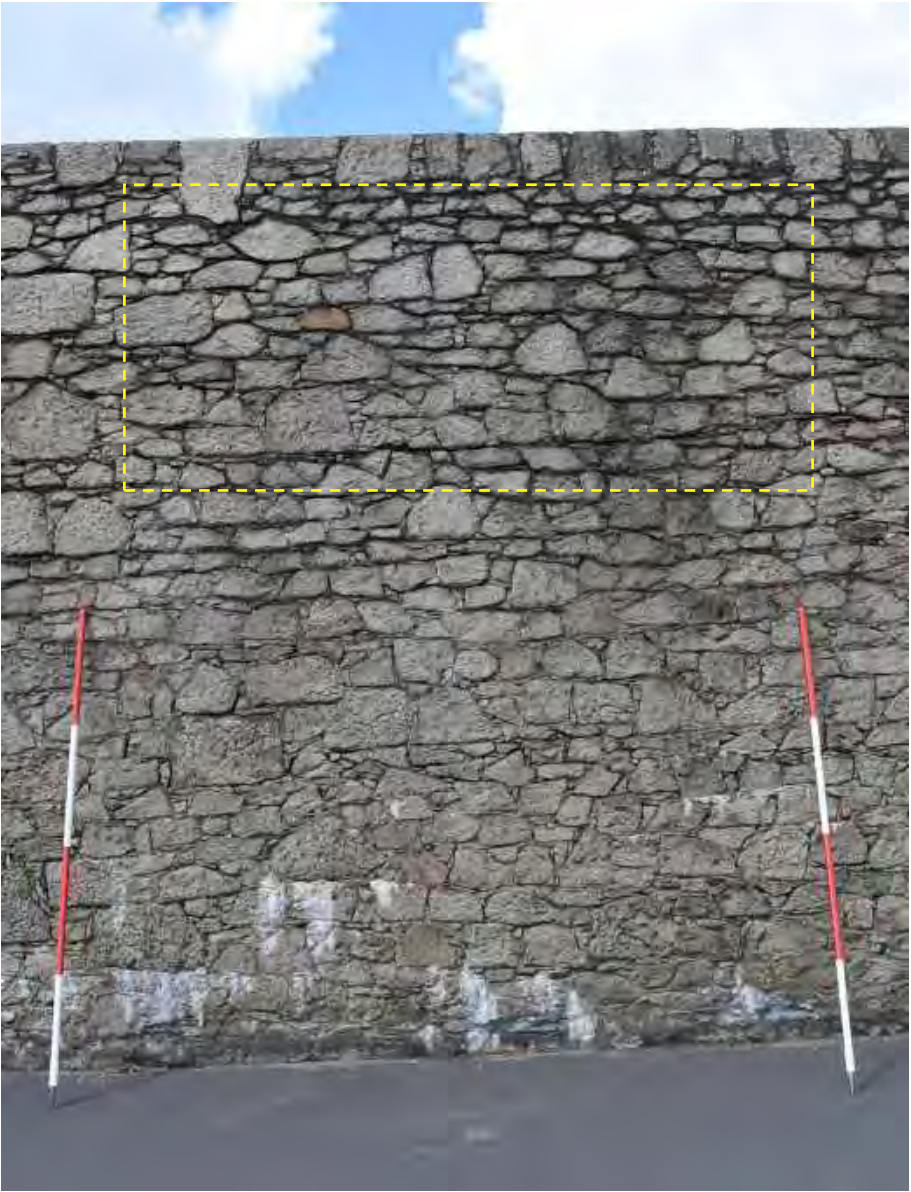
| Location Ref: | RR Elevation – Section 20 |
|---|--|
| <p>Wall section width approx. 3.0m</p> <p>Coping stones have been re-pointed (RR side only).</p> <p>Mortar loss and cracking to upper wall areas.</p> <p>Minor cracking to mortar at lower levels</p> <p>Calcium deposits at low level.</p> | |
| <p>Condition:</p> | <p>Coping stones to top of wall have been repointed (RR side only). Wall is generally stable but with some cracking and mortar loss around stones especially at higher levels which requires repair.</p> <p>Proposed treatment: Re-point areas of cracked and missing mortar - additional grouting of the upper core areas may be required.</p> |

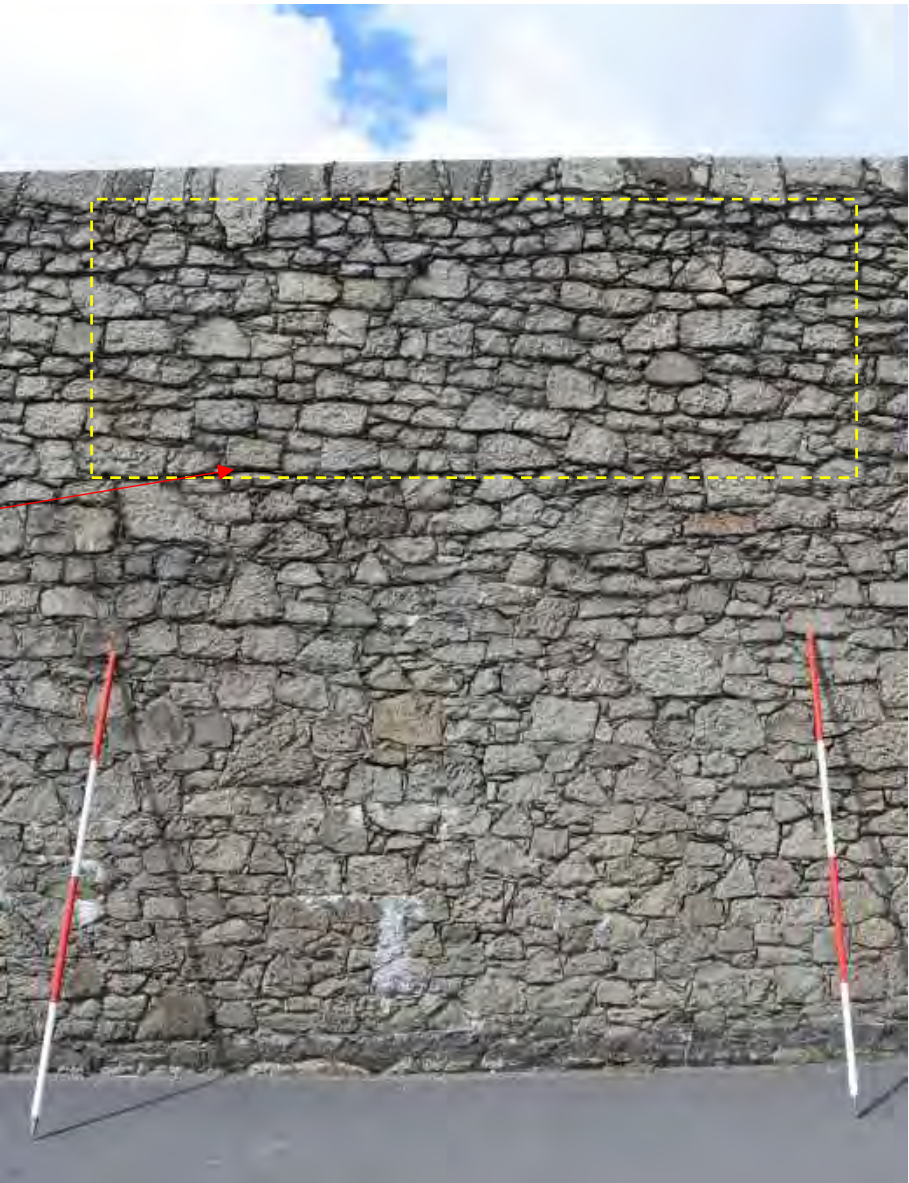
| Location Ref: | RR Elevation – Section 22 |
|--|--|
| <p>Wall section width approx. 3.0m</p> <p>Coping stones have been re-pointed (RR side only).</p> <p>Mortar loss and cracking to upper wall areas.</p> <p>Crack</p> <p>Minor cracking to mortar at lower levels</p> | |
| <p>Condition:</p> | <p>Coping stones to top of wall have been repointed (RR side only). Wall is generally stable but with some cracking and mortar loss around stones especially at higher levels which requires repair.</p> <p>Proposed treatment: Re-point areas of cracked and missing mortar - additional grouting of the upper core areas may be required.</p> |

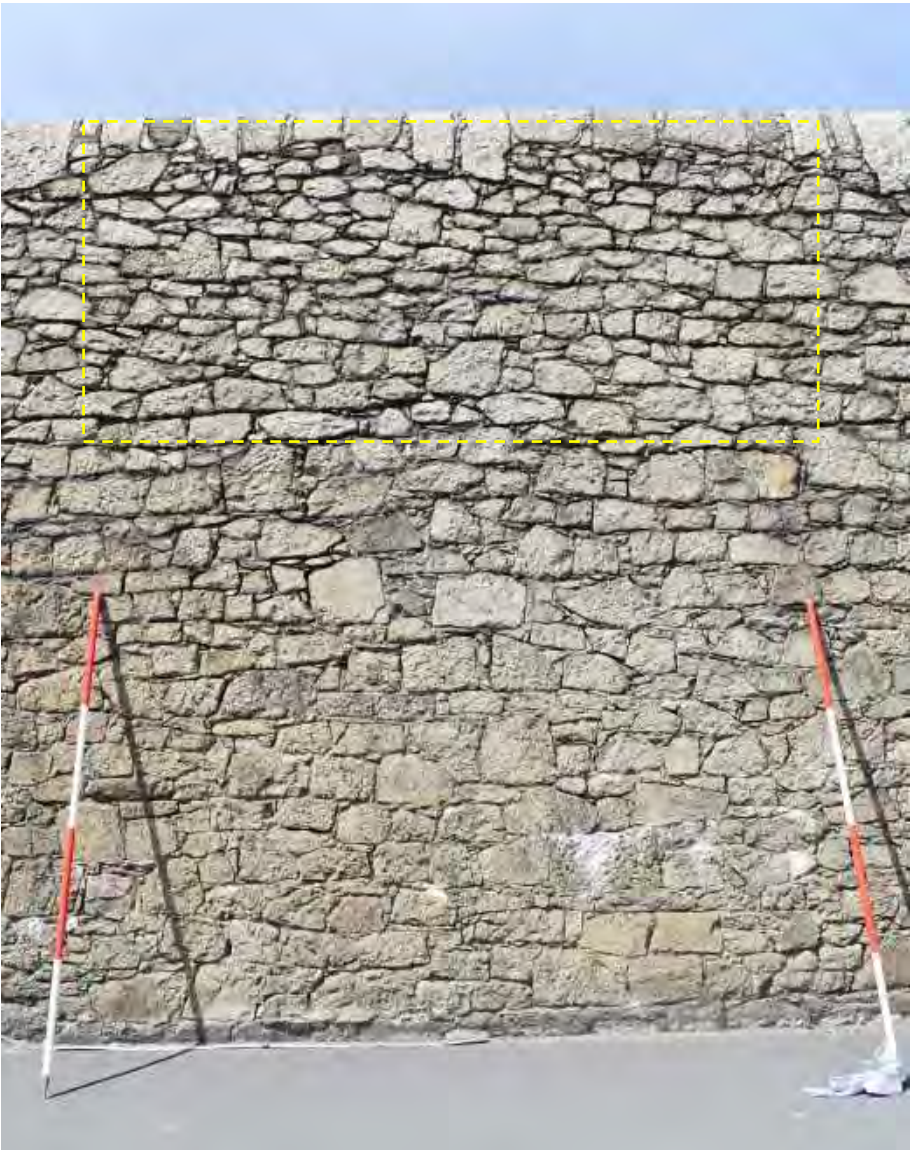
| Location Ref: | RR Elevation – Section 23 |
|---|--|
| <p>Wall section width approx. 3.0m</p> <p>Coping stones have been re-pointed (RR side only).</p> <p>Significant mortar loss and cracking to upper wall areas.</p> <p>Minor cracking to mortar at lower levels</p> | |
