| Location Ref: | BMD Elevation – Section 44 |

| Location Ref: | RR Elevation – Section 01 |

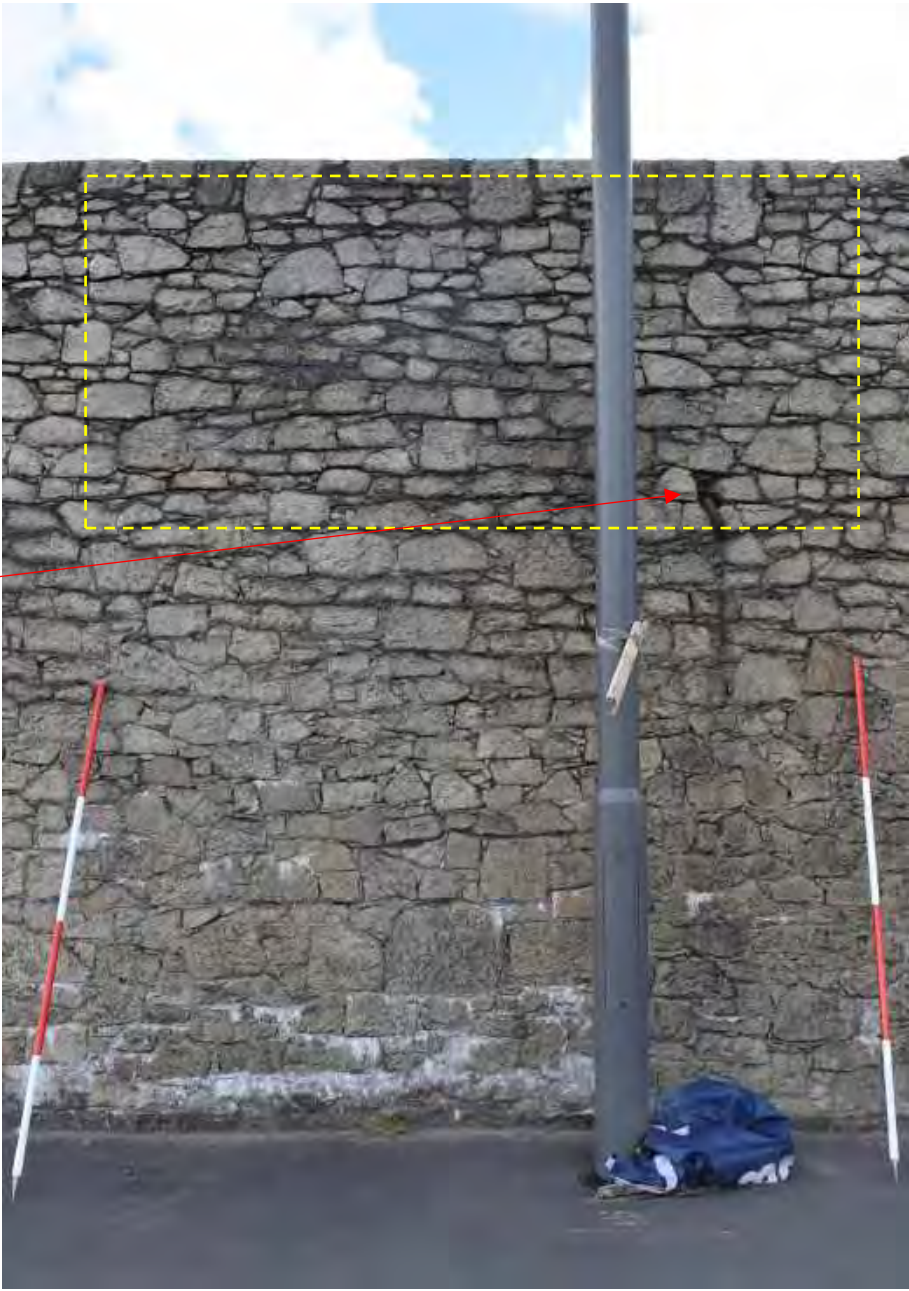
| Location Ref: | RR Elevation – Section 26 |
|--|--|
| <p>Wall section width approx. 3.0m</p> <p>Coping stones have been re-pointed (RR side only).</p> <p>Mortar loss and cracking to upper wall areas.</p> <p>Conduit in wall.</p> <p>Minor cracking to mortar at lower levels.</p> <p>Calcium deposits at low level.</p> | |

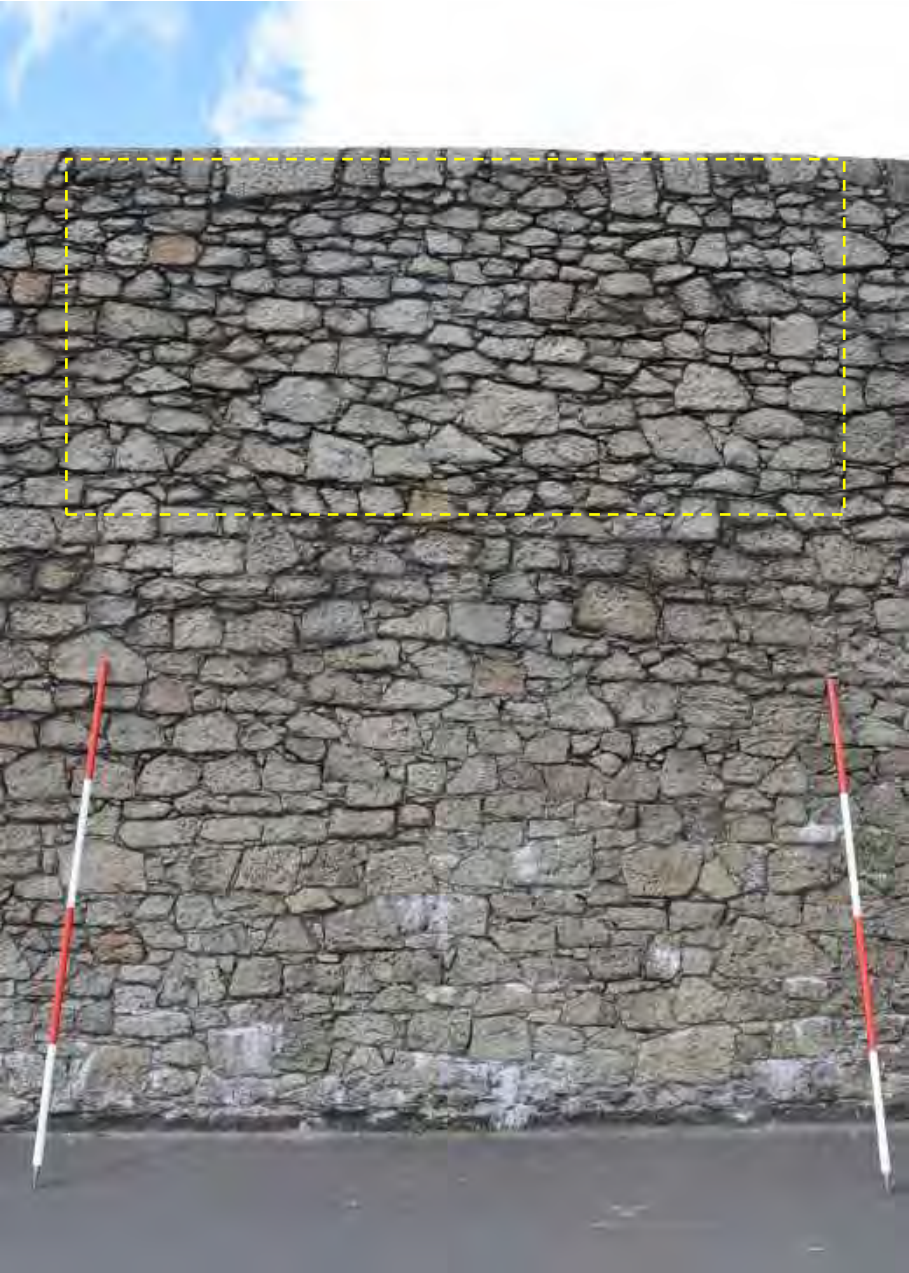
| Location Ref: | RR Elevation – Section 27 |
|--|--|
| <p>Wall section width approx. 3.0m</p> <p>Coping stones have been re-pointed (RR side only).</p> <p>Mortar loss and cracking to upper wall areas.</p> <p>Minor cracking to mortar at lower levels.</p> | |

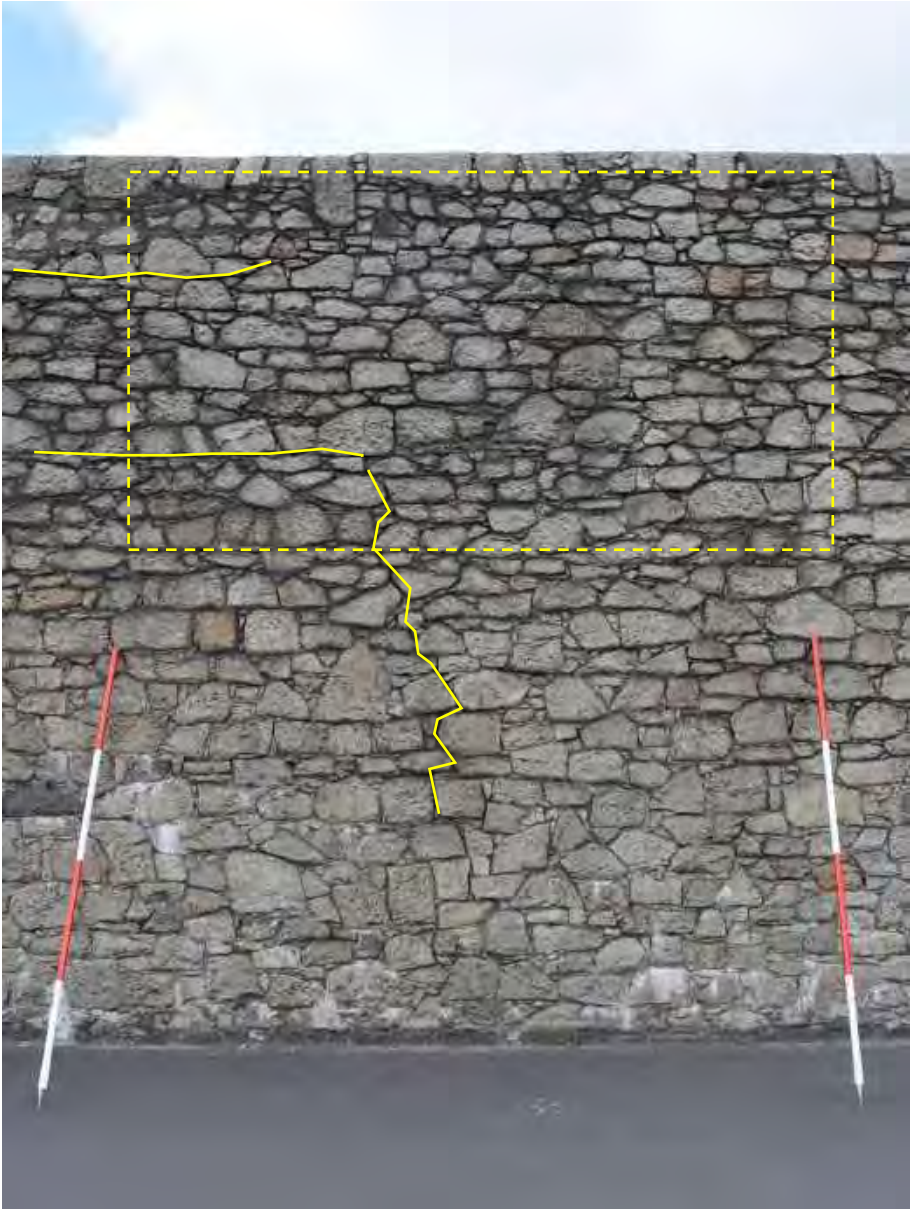
| Location Ref: | RR Elevation – Section 28 |
|--|--|
| <p>Wall section width approx. 3.0m</p> <p>Coping stones have been re-pointed (RR side only).</p> <p>Mortar loss and cracking to upper wall areas.</p> <p>Minor cracking to mortar at lower levels.</p> | |

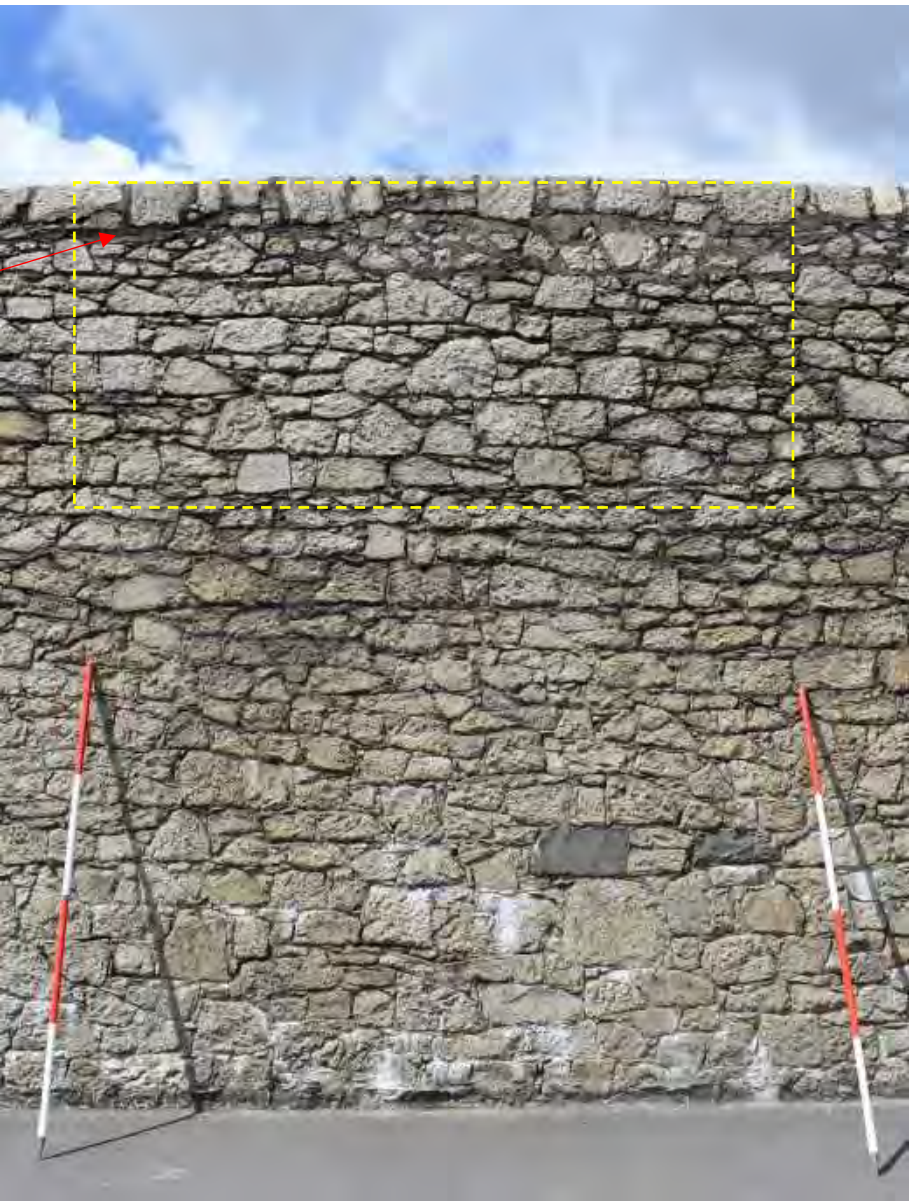
| Location Ref: | RR Elevation – Section 29 |
|--|---|
| <p>Wall section width approx. 3.0m</p> <p>Coping stones have been re-pointed (RR side only).</p> <p>Large crack to underside of the coping stones.</p> <p>Mortar loss and cracking to upper wall areas.</p> <p>Minor cracking to mortar at lower levels.</p> | |

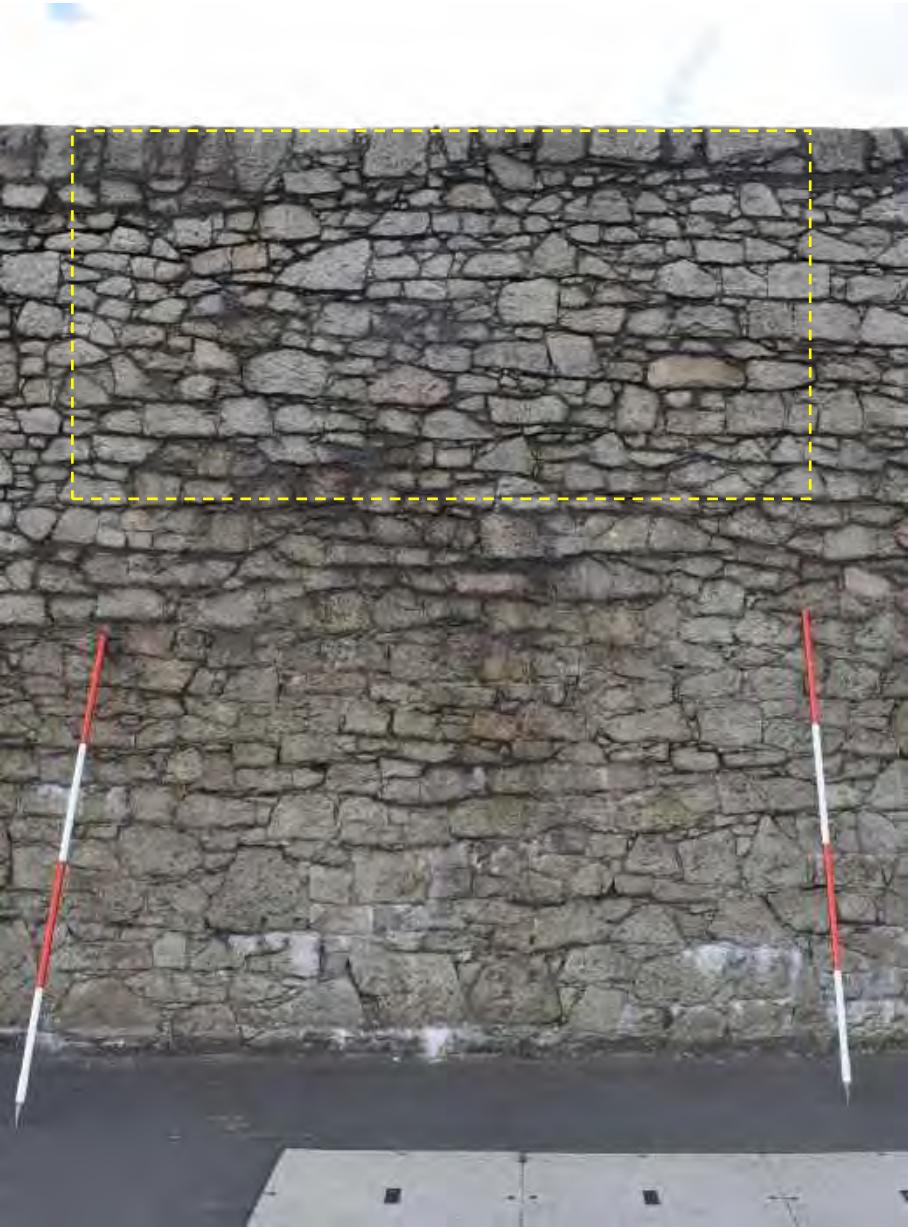
| Location Ref: | RR Elevation – Section 30 |
|---|--|
| <p>Wall section width approx. 3.0m</p> <p>Coping stones have been re-pointed (RR side only).</p> <p>Significant cracking to underside of the coping stones.</p> <p>Mortar loss and cracking to upper wall areas.</p> <p>Minor cracking to mortar at lower levels.</p> | |

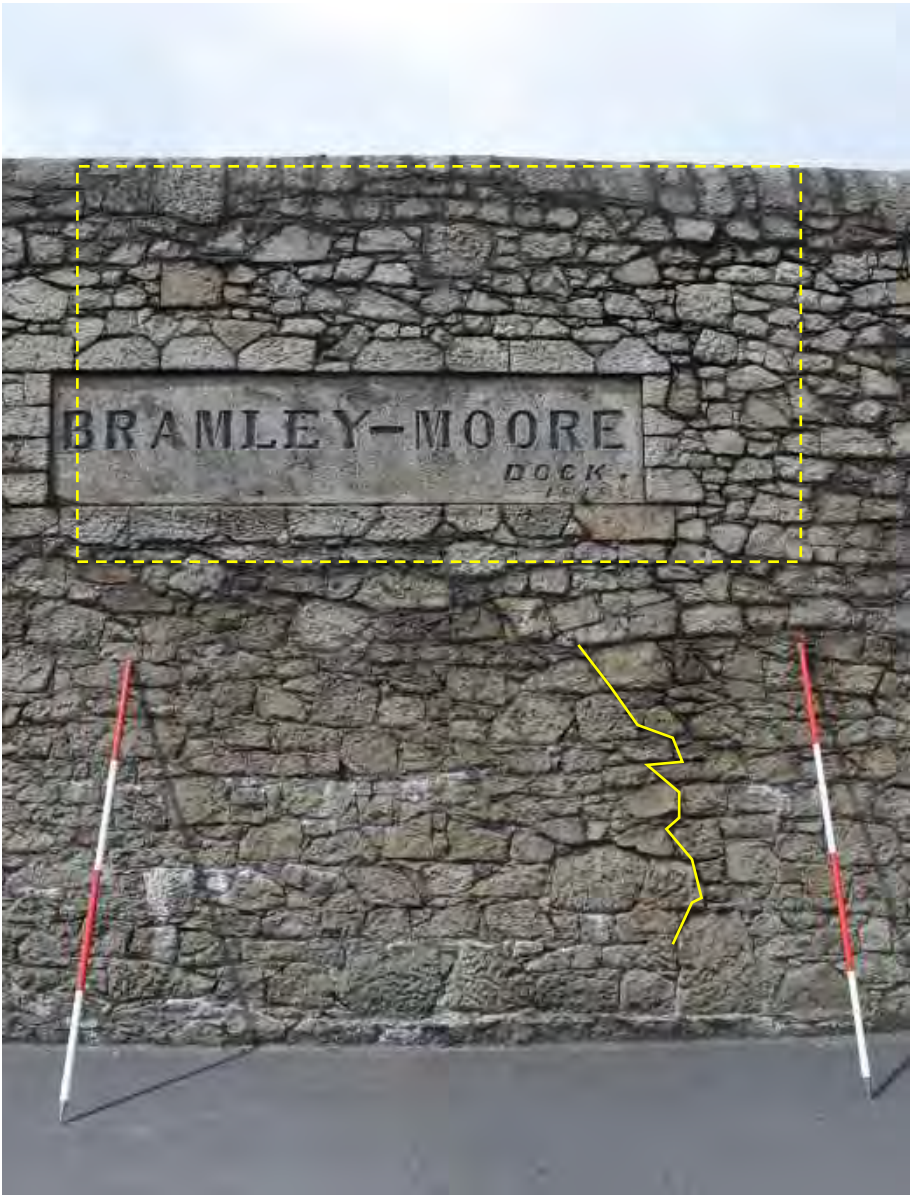
| Location Ref: | RR Elevation – Section 31 |
|--|--|
| <p>Wall section width approx. 3.0m</p> <p>Coping stones have been re-pointed (RR side only).</p> <p>Mortar loss and cracking to upper wall areas.</p> <p>Minor cracking to mortar at lower levels.</p> | |

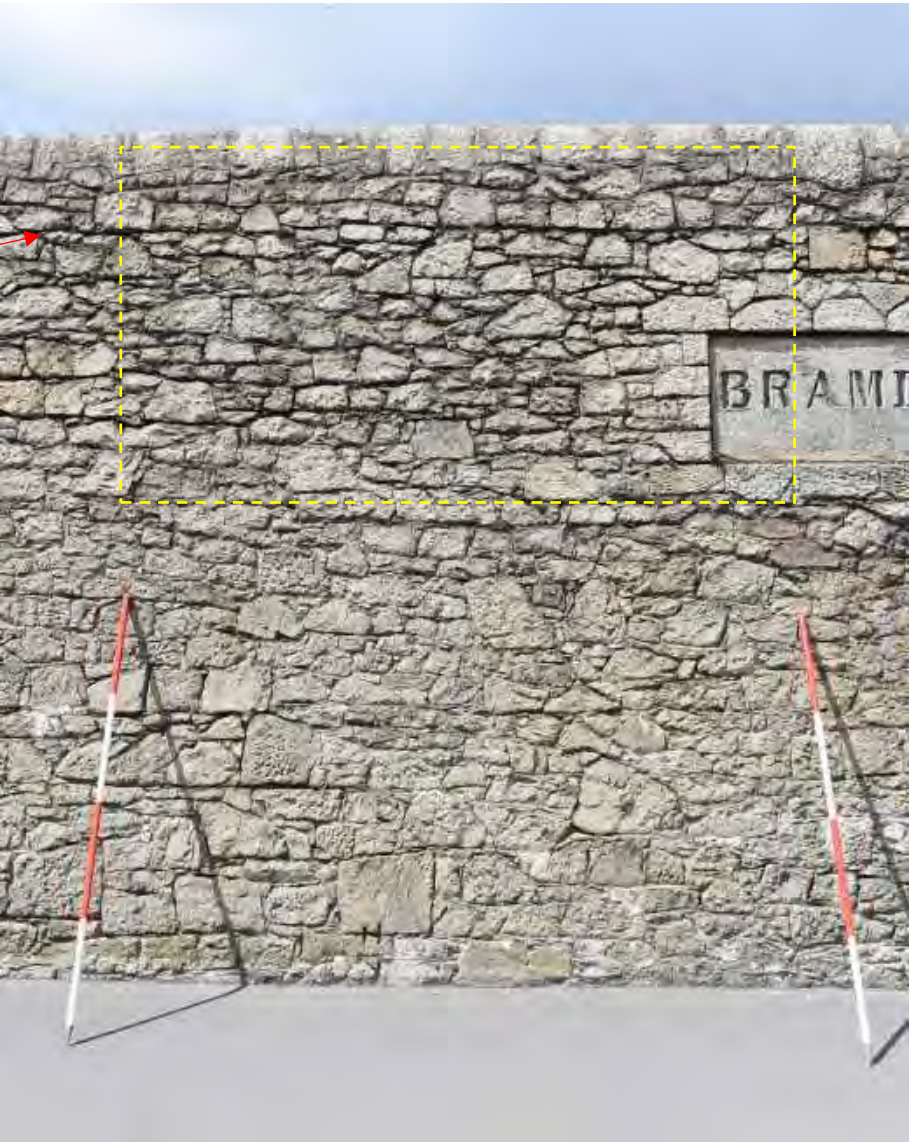
| Location Ref: | RR Elevation – Section 32 |
|---|---|
| <p>Wall section width approx. 3.0m</p> <p>Coping stones have been re-pointed (RR side only).</p> <p>Crack</p> <p>Mortar loss and cracking to upper wall areas.</p> <p>Minor cracking to mortar at lower levels.</p> | <p>The photograph shows a close-up of a stone wall. A yellow dashed rectangular box is drawn around the upper portion of the wall, from the top coping stones down to about two-thirds of the way up. A red arrow points from the text 'Crack' to a vertical crack in the mortar between stones in the upper part of the wall. The wall is made of irregular, greyish-brown stones. To the right, a stone plaque with the letters 'BRAMI' is visible. Two surveying poles with red and white stripes are positioned at the base of the wall for scale. The ground in front of the wall is a light grey concrete or asphalt surface.</p> |

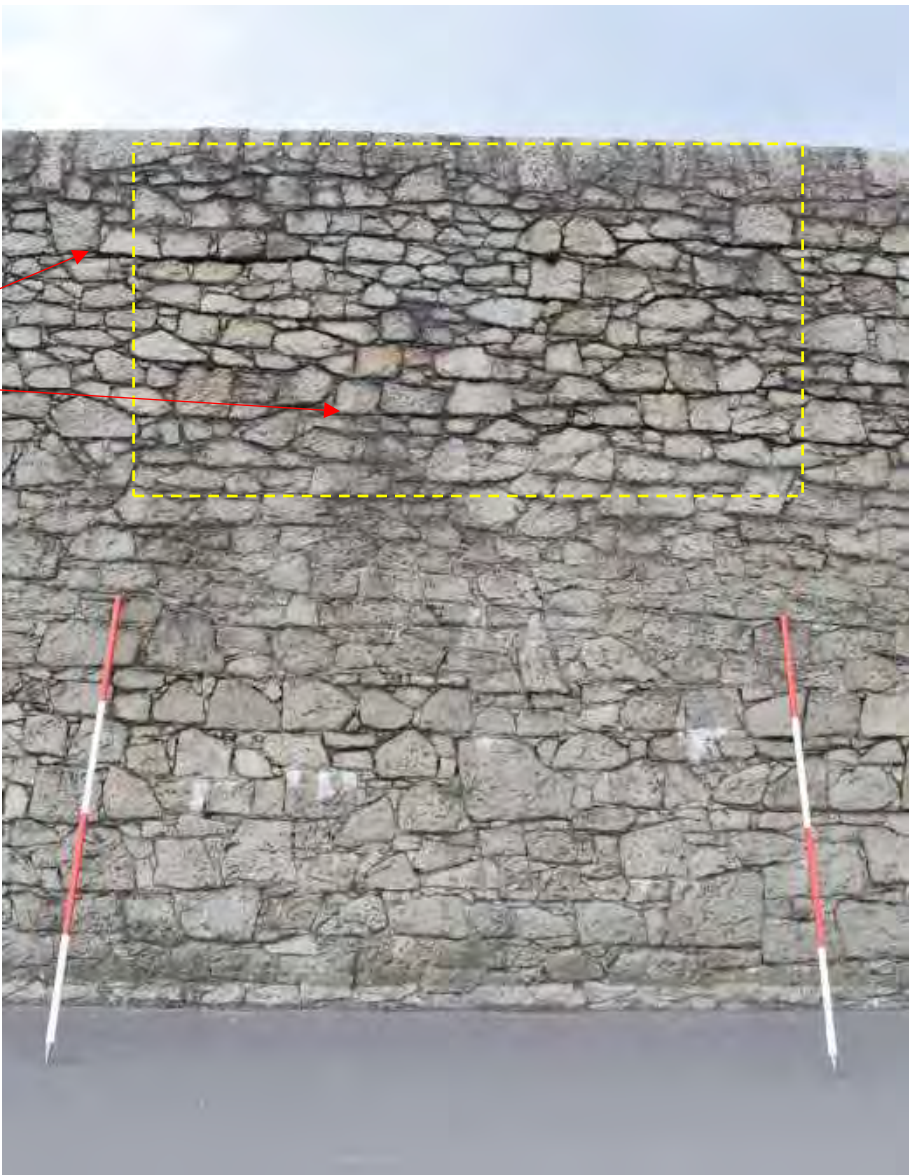
| Location Ref: | RR Elevation – Section 33 |
|--|---|
| <p>Wall section width approx. 3.0m</p> <p>Coping stones have been re-pointed (RR side only).</p> <p>Cracks</p> <p>Mortar loss and cracking to upper wall areas.</p> <p>Minor cracking to mortar at lower levels.</p> | |

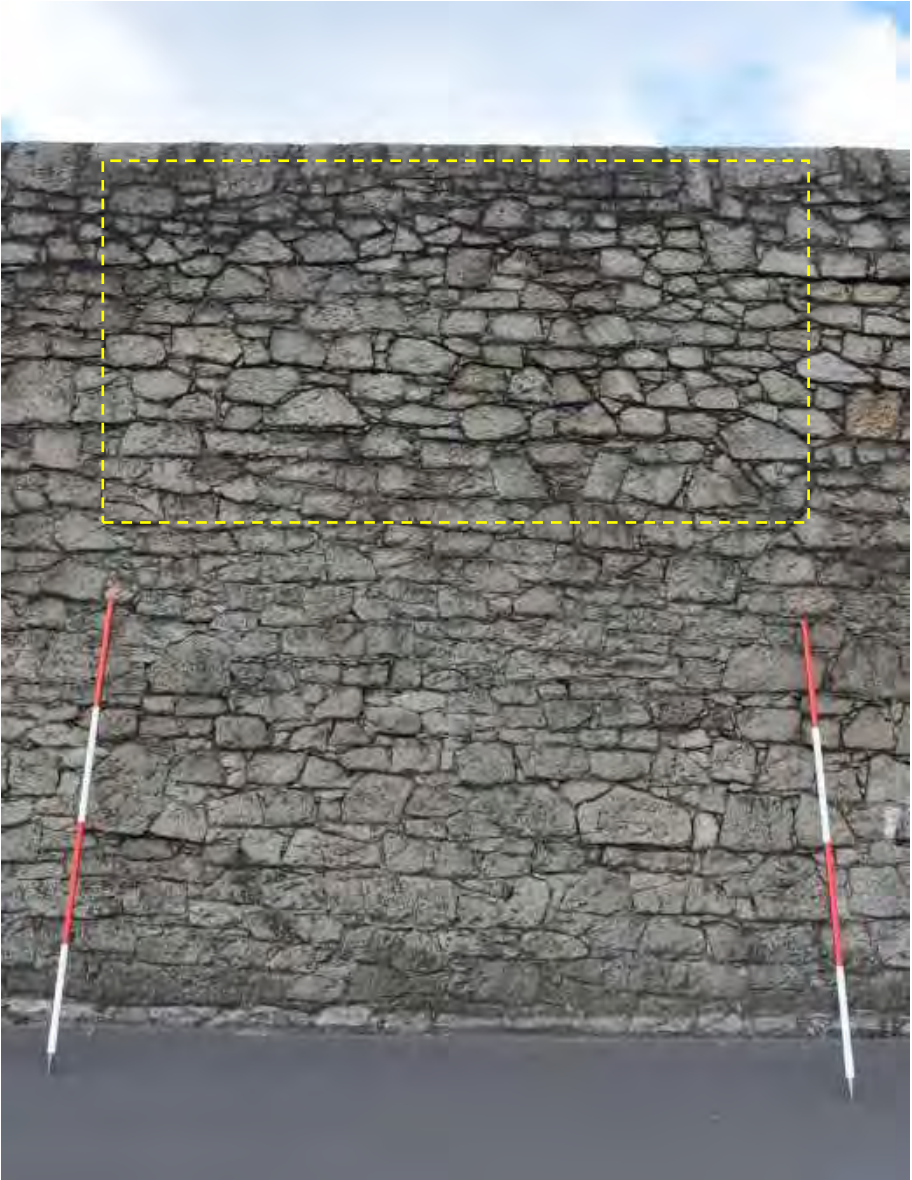
| Location Ref: | RR Elevation – Section 34 |
|--|--|
| <p>Wall section width approx. 3.0m</p> <p>Coping stones have been re-pointed (RR side only).</p> <p>Mortar loss and cracking to upper wall areas.</p> <p>Minor cracking to mortar at lower levels.</p> | |

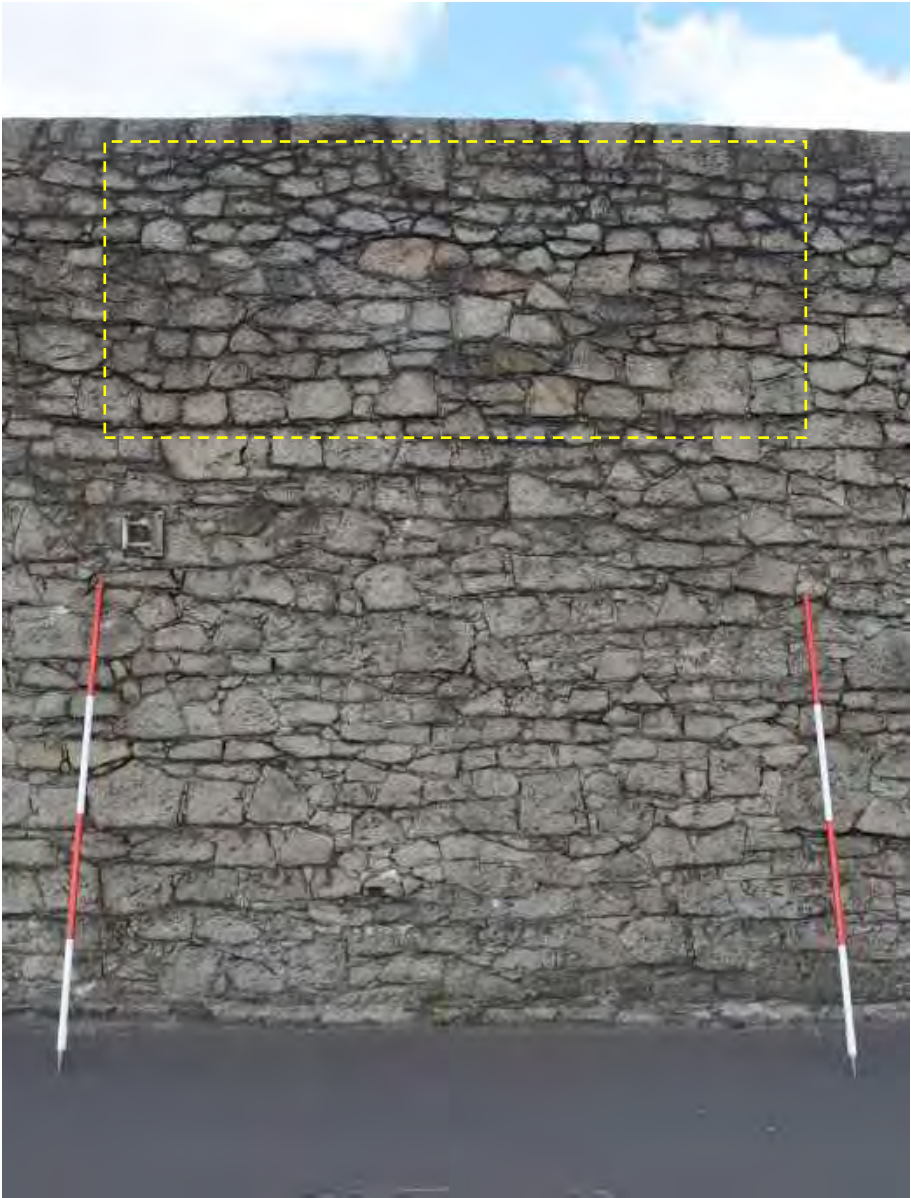
| Location Ref: | RR Elevation – Section 35 |
|---|---|
| <p>Wall section width approx. 3.0m</p> <p>Coping stones have been re-pointed (RR side only).</p> <p>Mortar loss and cracking to upper wall areas.</p> <p>Sign fixed to wall.</p> <p>Minor cracking to mortar at lower levels.</p> | |

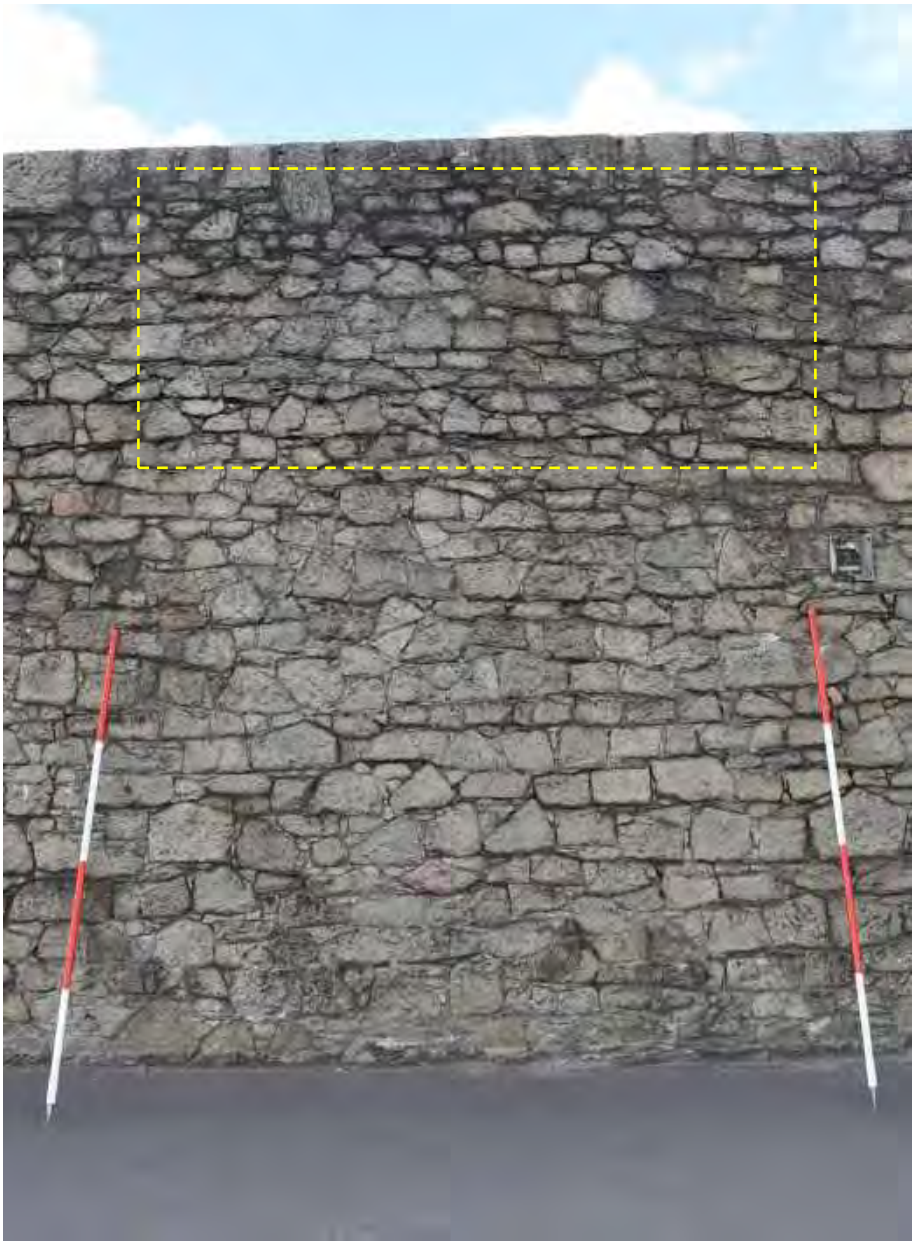
| Location Ref: | RR Elevation – Section 36 |
|---|--|
| <p>Wall section width approx. 3.0m</p> <p>Coping stones have been re-pointed (RR side only).</p> <p>Mortar loss and cracking to upper wall areas.</p> <p>More minor mortar loss and cracking to lower levels.</p> | |

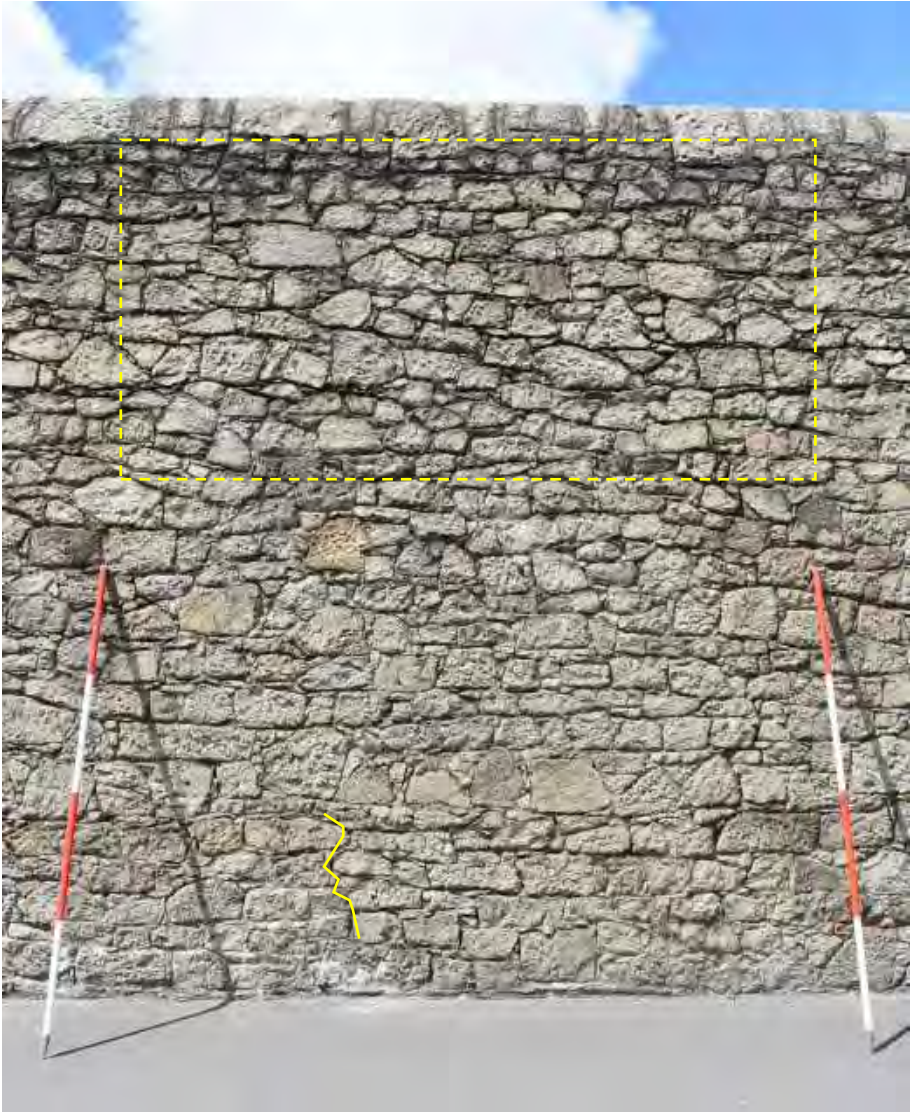
| Location Ref: | RR Elevation – Section 37 |
|---|--|
| <p>Wall section width approx. 3.0m</p> <p>Coping stones have been re-pointed (RR side only).</p> <p>Mortar loss and cracking to upper wall areas.</p> <p>More minor mortar loss and cracking to lower levels.</p> | |

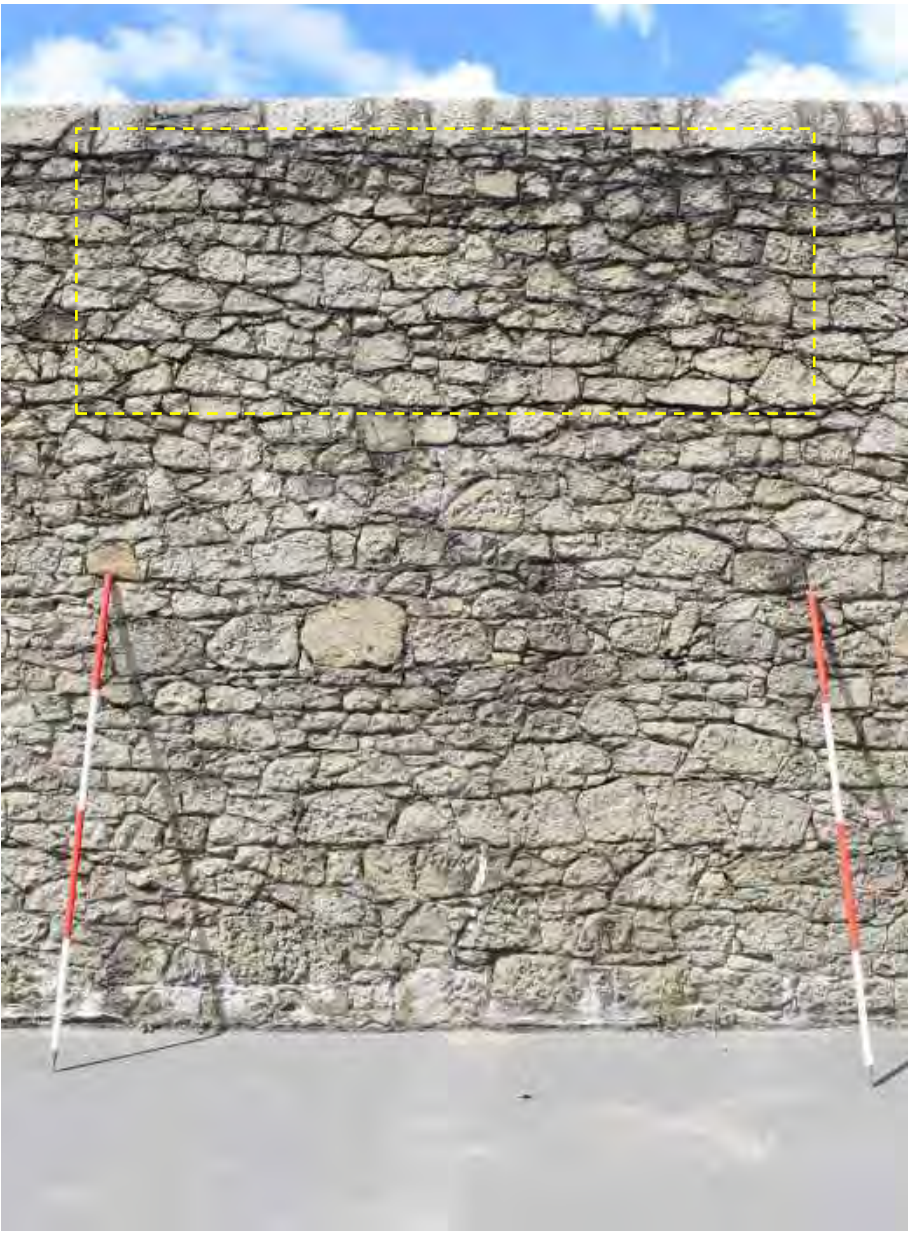
| Location Ref: | RR Elevation – Section 38 |
|---|--|
| <p>Wall section width approx. 3.0m</p> <p>Coping stones have been re-pointed (RR side only).</p> <p>Mortar loss and cracking to upper wall areas.</p> <p>More minor mortar loss and cracking to lower levels.</p> | <p>The photograph shows a close-up of a stone wall. A yellow dashed rectangular box is drawn over the upper portion of the wall, indicating the area where coping stones have been re-pointed. Two surveying poles, one on the left and one on the right, are positioned vertically against the wall to provide a sense of scale. The wall is constructed from irregular, greyish-brown stones with visible mortar joints. The sky is visible at the top of the frame.</p> |

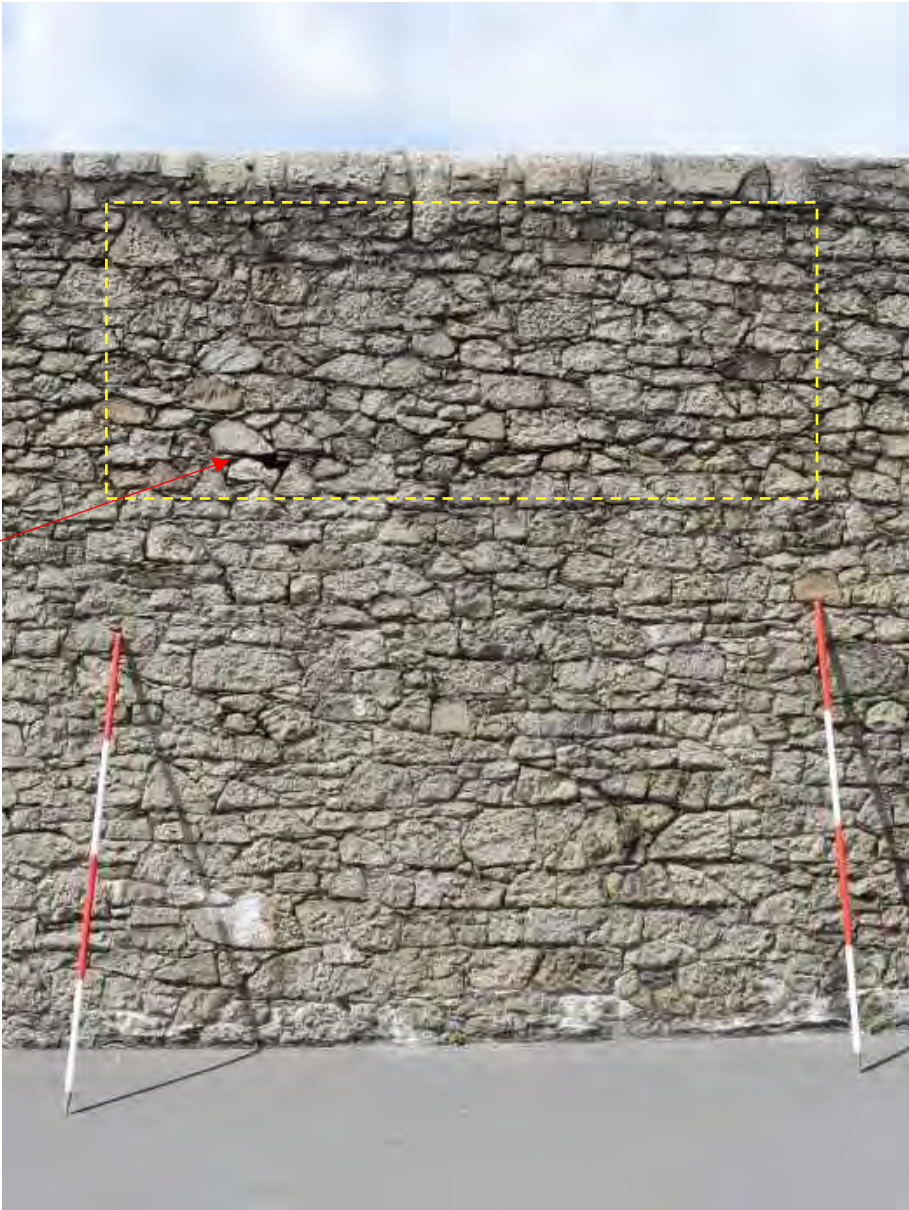
| Location Ref: | RR Elevation – Section 39 |
|---|--|
| <p>Wall section width approx. 3.0m</p> <p>Coping stones have been re-pointed (RR side only).</p> <p>Mortar loss and cracking to upper wall areas.</p> <p>Missing stone. </p> <p>More minor mortar loss and cracking to lower levels.</p> | |

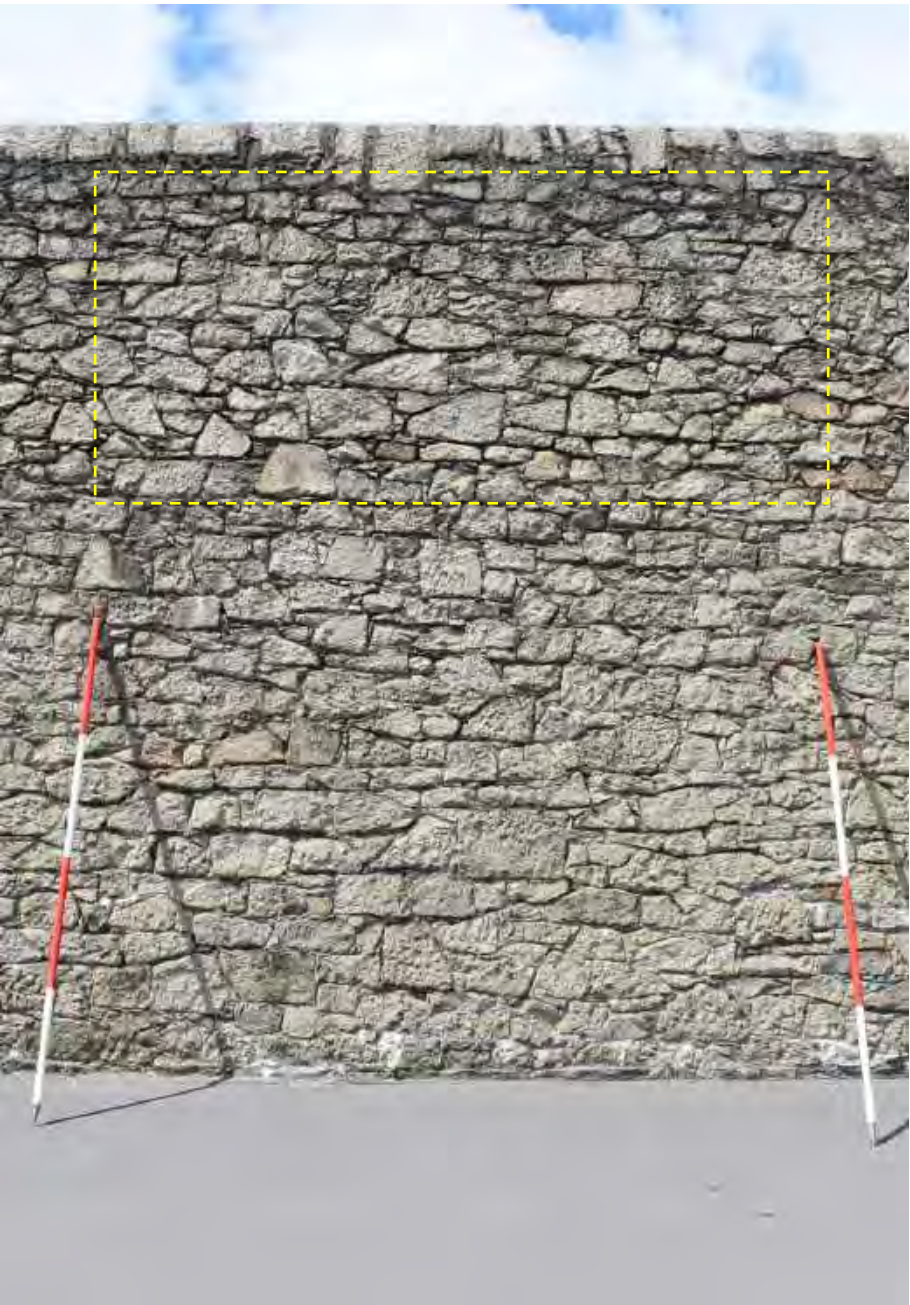
| Location Ref: | RR Elevation – Section 40 |
|---|--|
| <p>Wall section width approx. 3.0m</p> <p>Coping stones have been re-pointed (RR side only).</p> <p>Mortar loss and cracking to upper wall areas.</p> <p>More minor mortar loss and cracking to lower levels.</p> | |

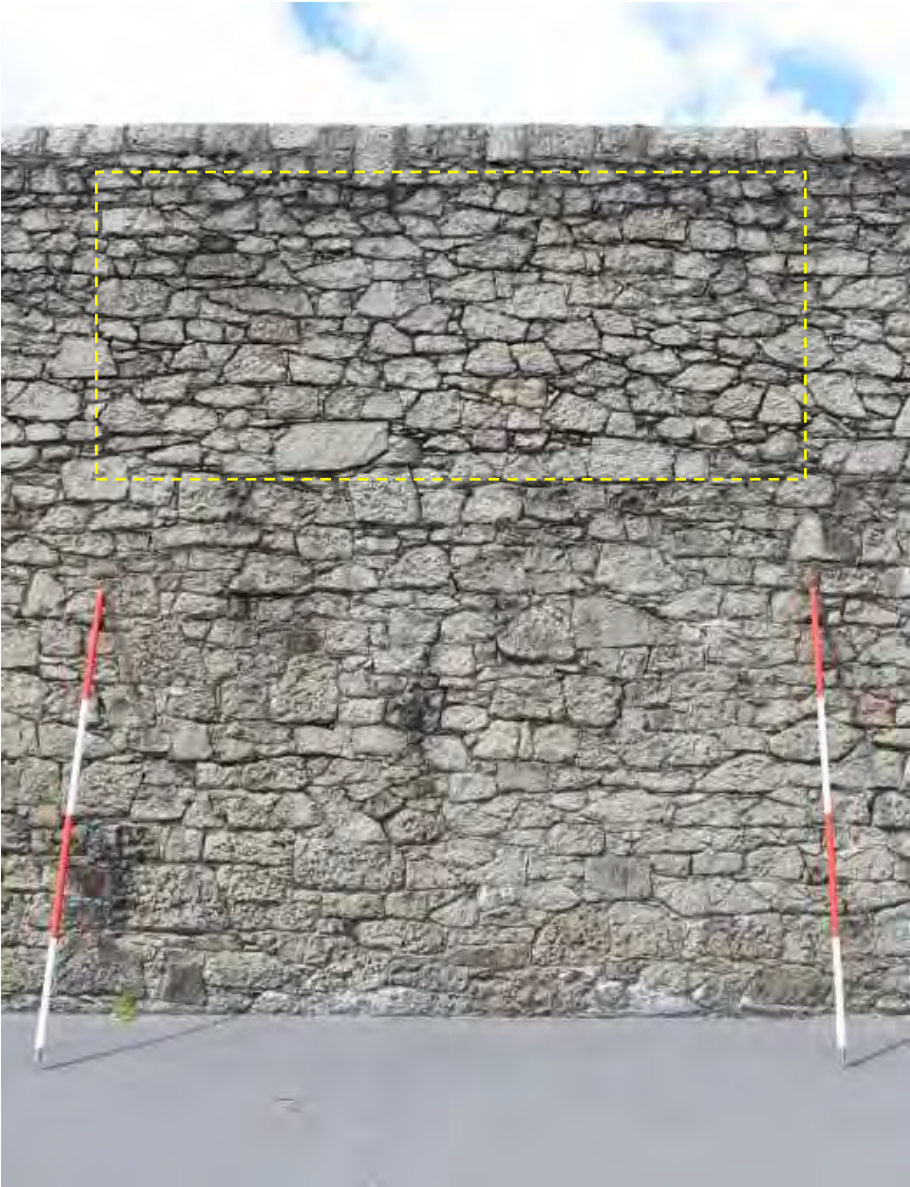
| Location Ref: | RR Elevation – Section 41 |
|---|--|
| <p>Wall section width approx. 3.0m</p> <p>Coping stones have been re-pointed (RR side only).</p> <p>Mortar loss and cracking to upper wall areas.</p> <p>More minor mortar loss and cracking to lower levels.</p> | |

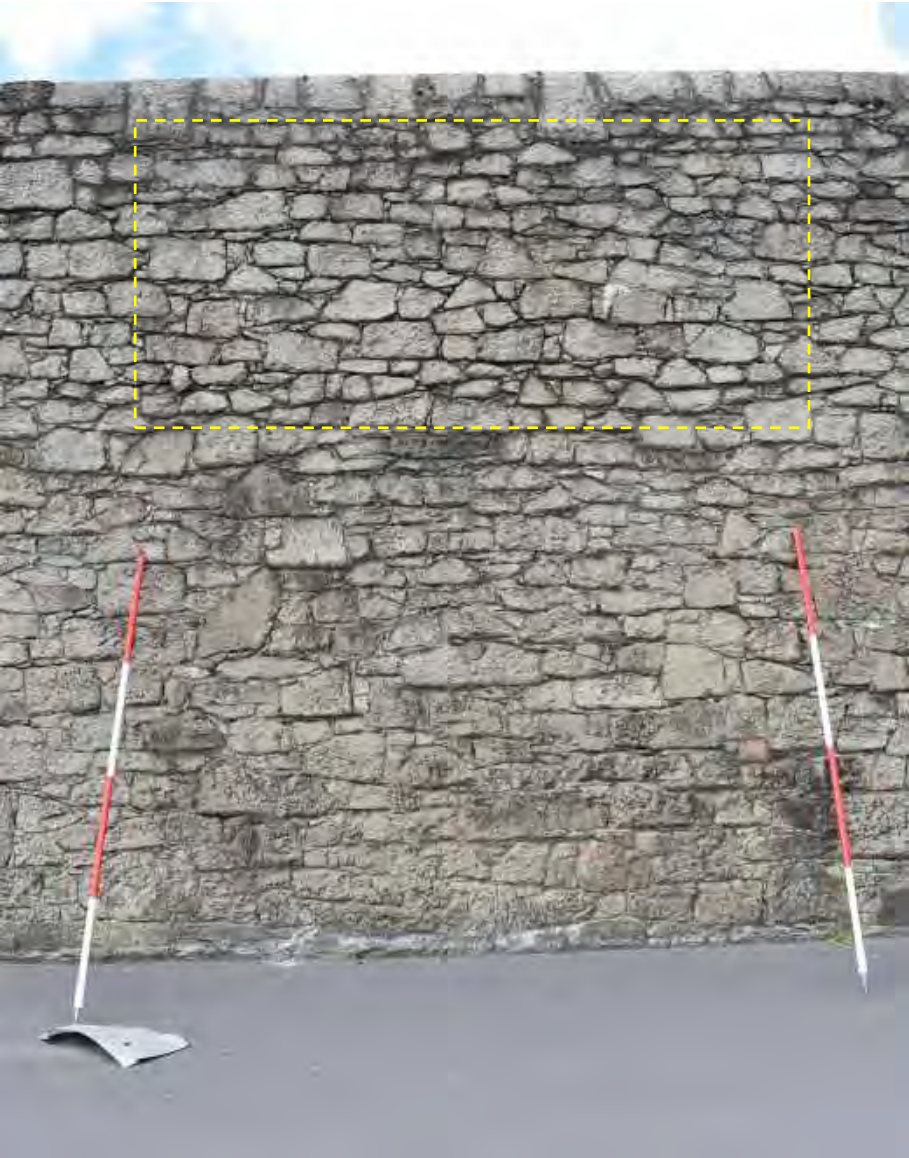
| Location Ref: | RR Elevation – Section 42 |
|---|--|
| <p>Wall section width approx. 3.0m</p> <p>Coping stones have been re-pointed (RR side only).</p> <p>Mortar loss and cracking to upper wall areas.</p> <p>More minor mortar loss and cracking to lower levels.</p> | A photograph of a stone wall, likely made of rough-hewn stones. A yellow dashed rectangular box is drawn on the upper portion of the wall, indicating a specific area of interest or repair. At the base of the wall, two surveying poles with red and white segments are positioned on either side of a small, flat, light-colored object on the ground. The wall appears to be part of a larger structure, possibly a railway embankment or a bridge abutment, given the 'RR Elevation' label. |

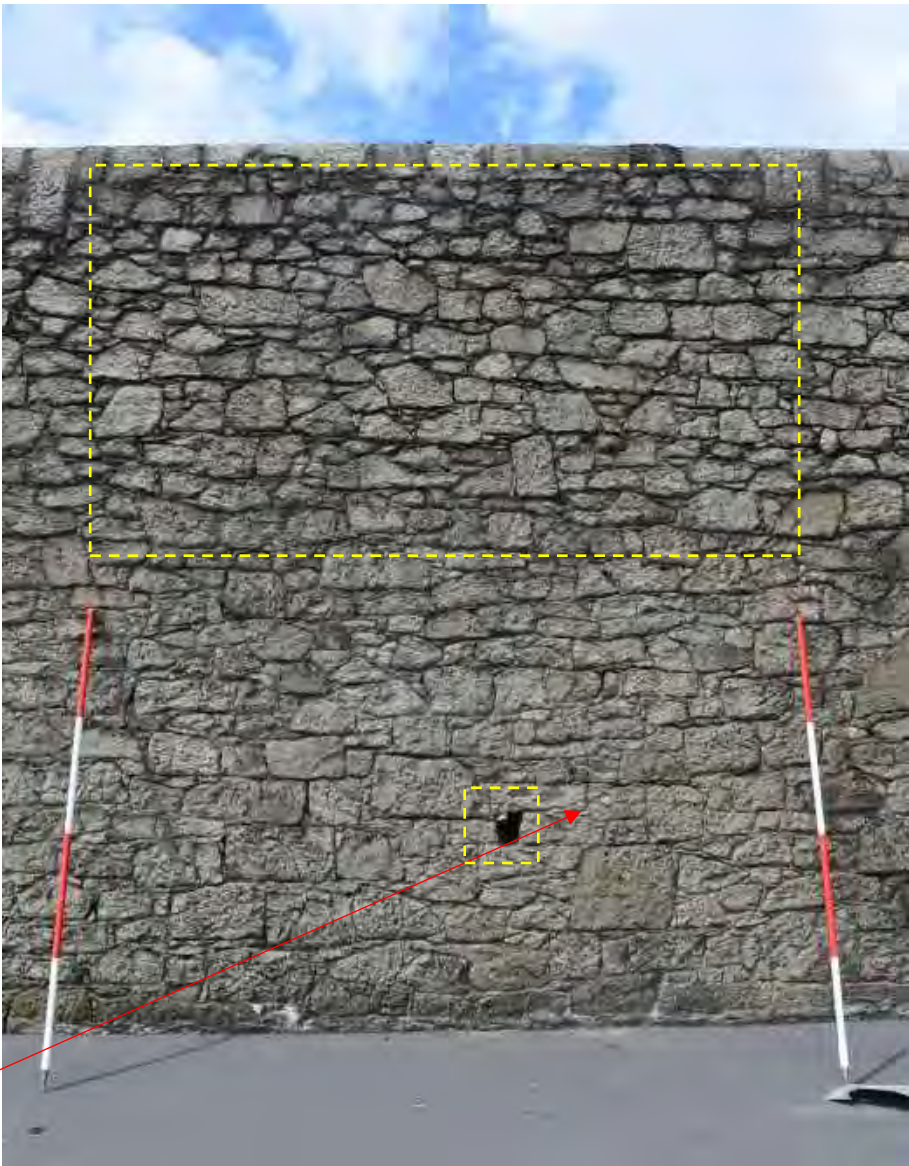
| Location Ref: | RR Elevation – Section 43 |
|---|--|
| <p>Wall section width approx. 3.0m</p> <p>Coping stones have been re-pointed (RR side only).</p> <p>Mortar loss and cracking to upper wall areas.</p> <p>More minor mortar loss and cracking to lower levels.</p> <p>Hole through wall.</p> <p>Core hole.</p> | |

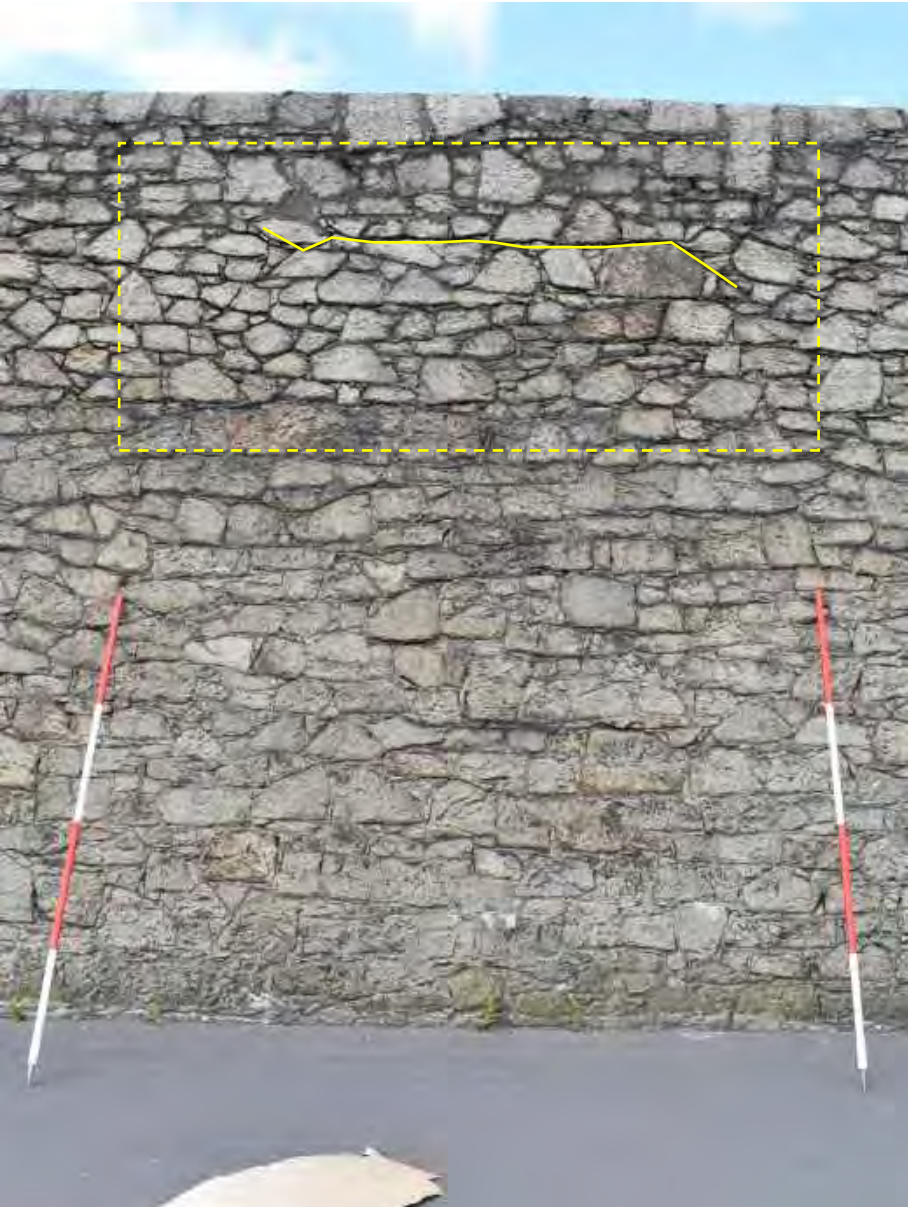
| Location Ref: | RR Elevation – Section 44 |
|---|---|
| <p>Wall section width approx. 3.0m</p> <p>Coping stones have been re-pointed (RR side only).</p> <p>Mortar loss and cracking to upper wall areas.</p> <p>More minor mortar loss and cracking to lower levels.</p> | |
