| Location Ref: | BMD Elevation – Section 44 |

| Location Ref: | RR Elevation – Section 01 |

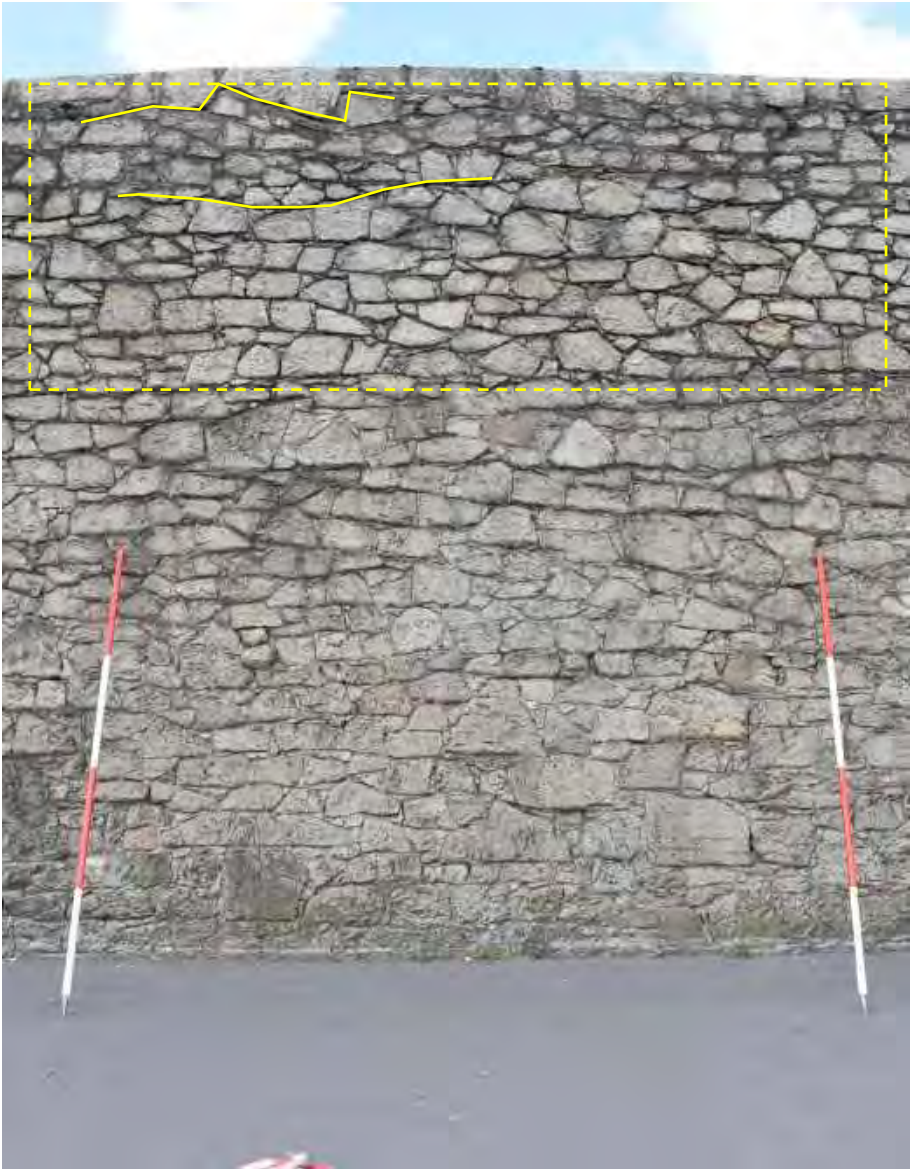
| Location Ref: | RR Elevation – Section 45 |
|---|--|
| <p>Wall section width approx. 3.0m</p> <p>Coping stones have been re-pointed (RR side only).</p> <p>Mortar loss and cracking to upper wall areas.</p> <p>More minor mortar loss and cracking to lower levels.</p> | |

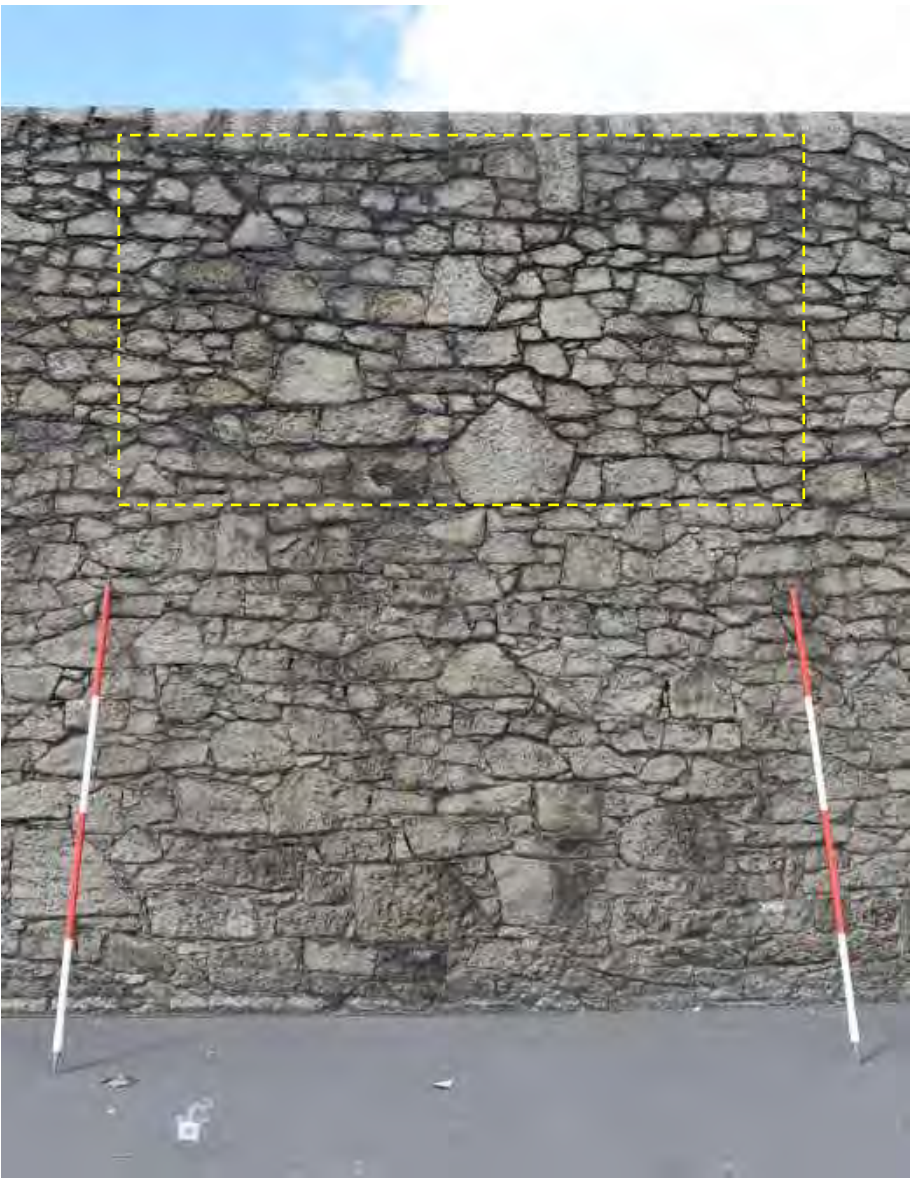
| Location Ref: | RR Elevation – Section 46 |
|---|--|
| <p>Wall section width approx. 3.0m</p> <p>Coping stones have been re-pointed (RR side only).</p> <p>Mortar loss and cracking to upper wall areas.</p> <p>More minor mortar loss and cracking to lower levels.</p> | |

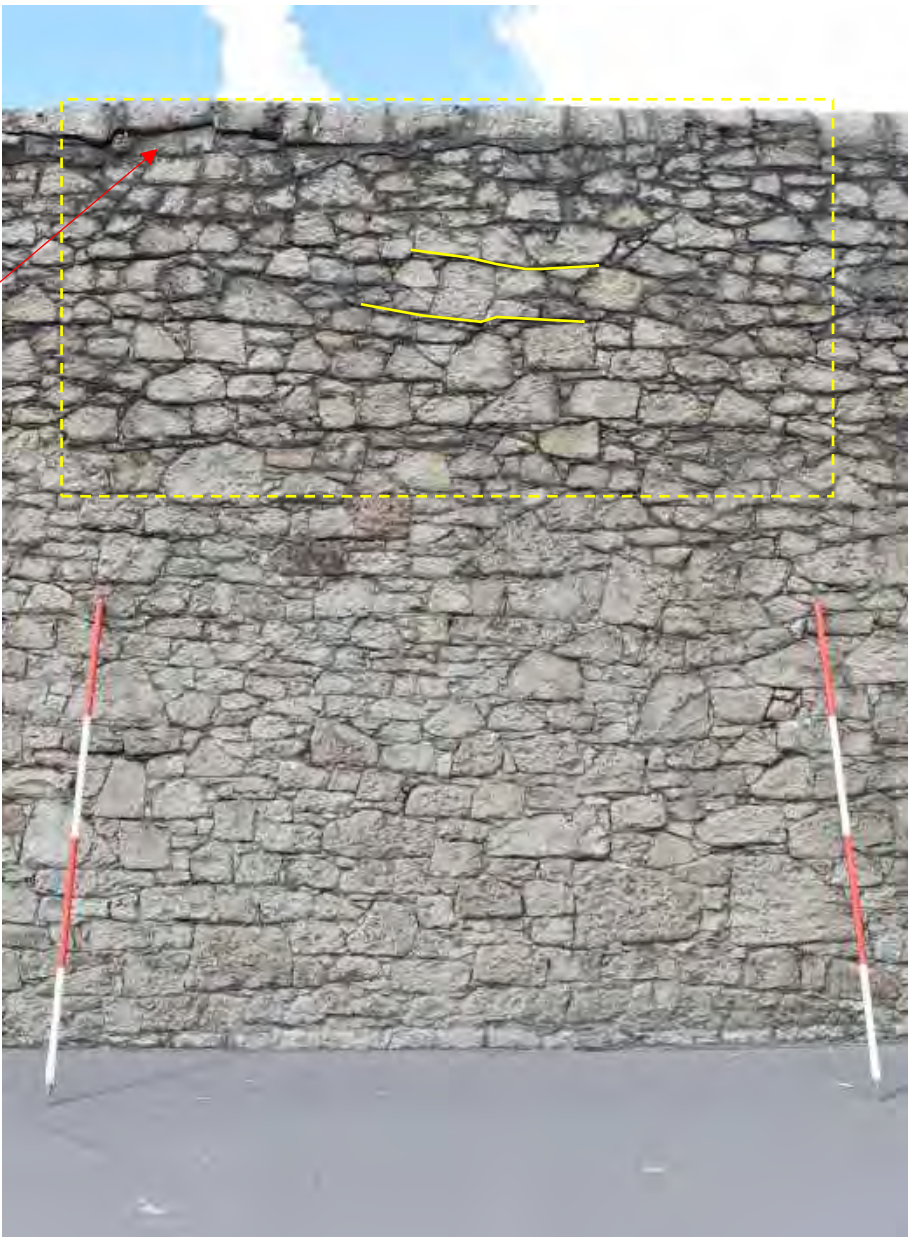
| Location Ref: | RR Elevation – Section 47 |
|---|--|
| <p>Wall section width approx. 3.0m</p> <p>Coping stones have been re-pointed (RR side only).</p> <p>Cracks and displacement under coping stones.</p> <p>Mortar loss and cracking to upper wall areas.</p> <p>More minor mortar loss and cracking to lower levels.</p> | |

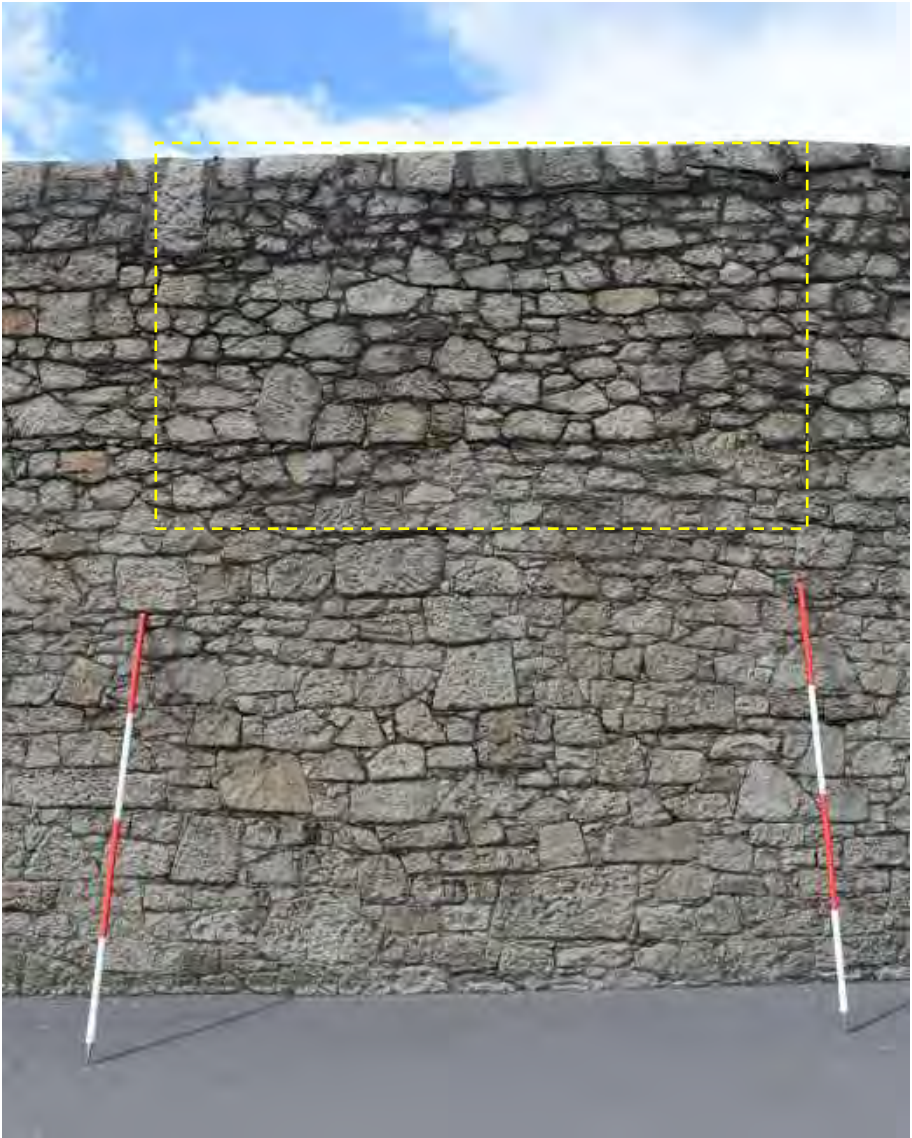
| Location Ref: | RR Elevation – Section 48 |
|---|--|
| <p>Wall section width approx. 3.0m</p> <p>Coping stones have been re-pointed (RR side only).</p> <p>Cracking and displacement under coping stones.</p> <p>Mortar loss and cracking to upper wall areas.</p> <p>More minor mortar loss and cracking to lower levels.</p> | |

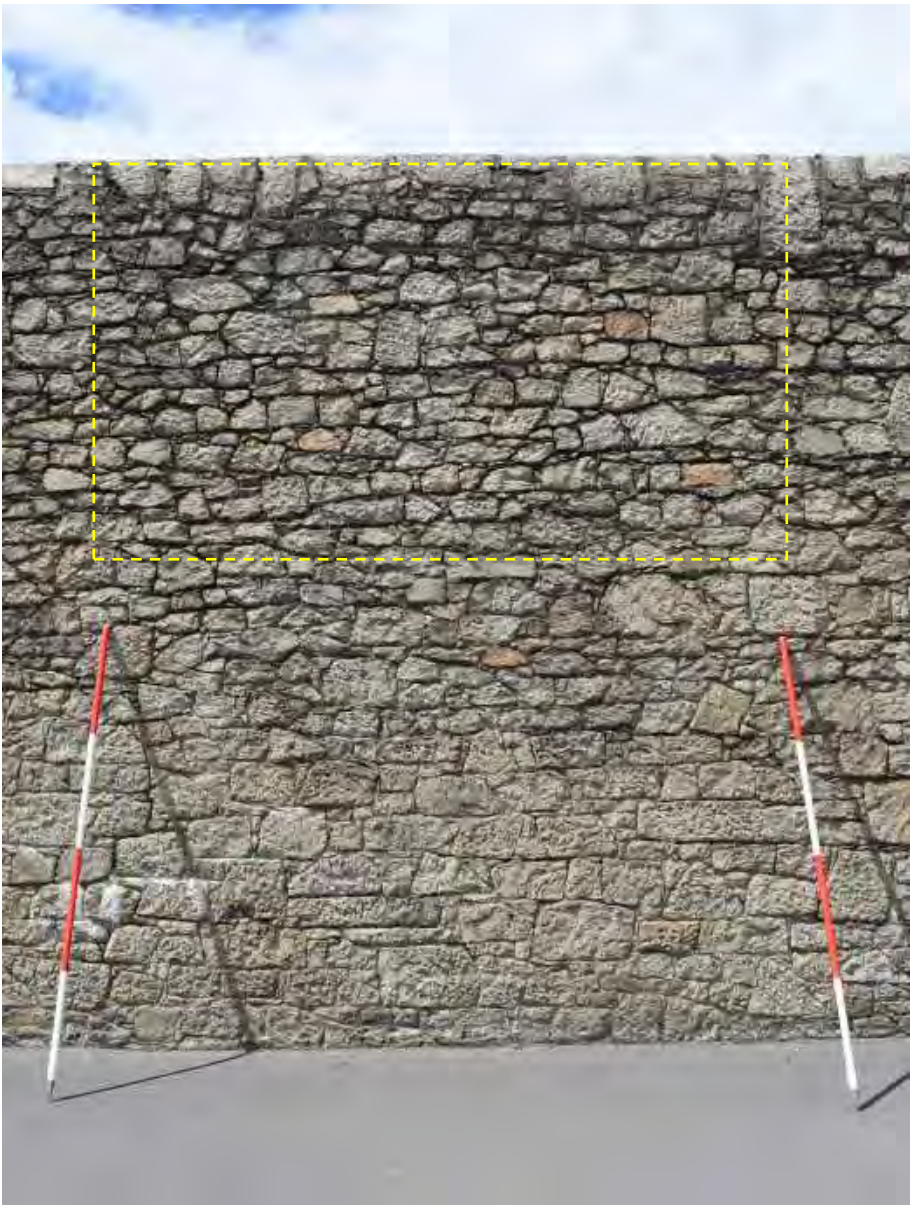
| Location Ref: | RR Elevation – Section 49 |
|---|--|
| <p>Wall section width approx. 3.0m</p> <p>Coping stones have been re-pointed (RR side only).</p> <p>Mortar loss and cracking to upper wall areas.</p> <p>More minor mortar loss and cracking to lower levels.</p> | |

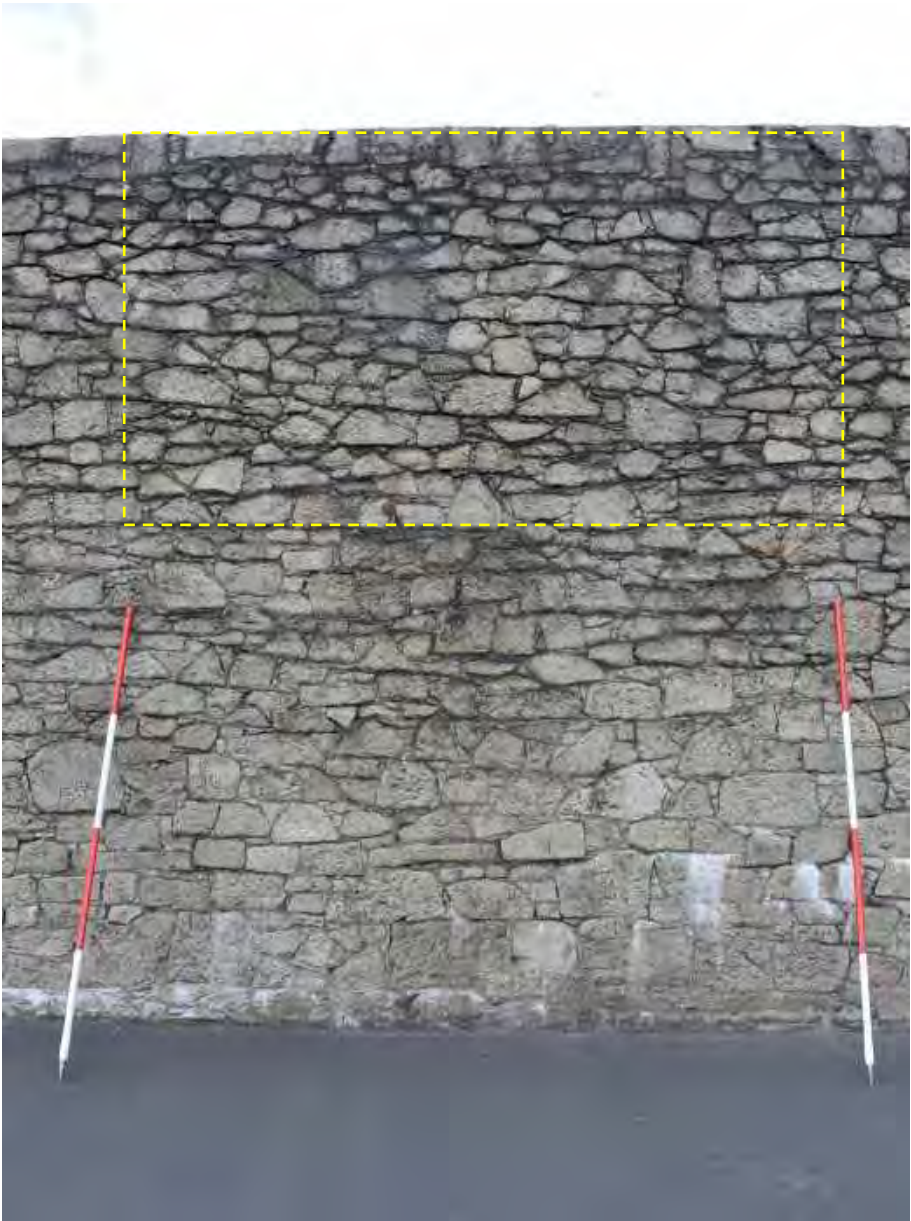
| Location Ref: | RR Elevation – Section 50 |
|---|--|
| <p>Wall section width approx. 3.0m</p> <p>Coping stones have been re-pointed (RR side only).</p> <p>Mortar loss and cracking to upper wall areas.</p> <p>More minor mortar loss and cracking to lower levels.</p> | |

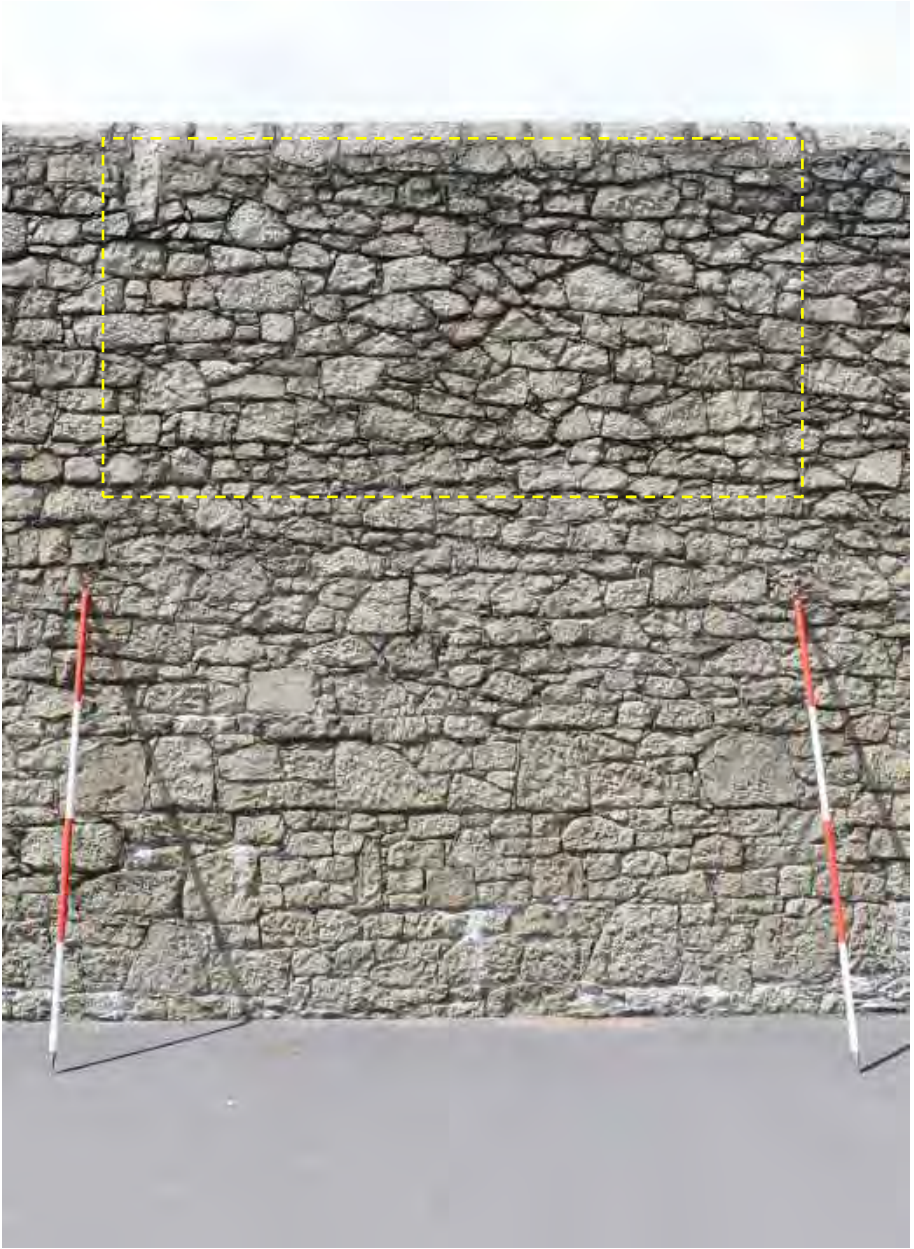
| Location Ref: | RR Elevation – Section 51 |
|---|--|
| <p>Wall section width approx. 3.0m</p> <p>Coping stones have been re-pointed (RR side only).</p> <p>Mortar loss and cracking to upper wall areas.</p> <p>More minor mortar loss and cracking to lower levels.</p> | A photograph of a stone wall, likely made of rough-hewn stones, showing mortar loss and cracking. A yellow dashed rectangle highlights the upper section of the wall. Two red-and-white surveying poles are positioned at the base of the wall for scale. |

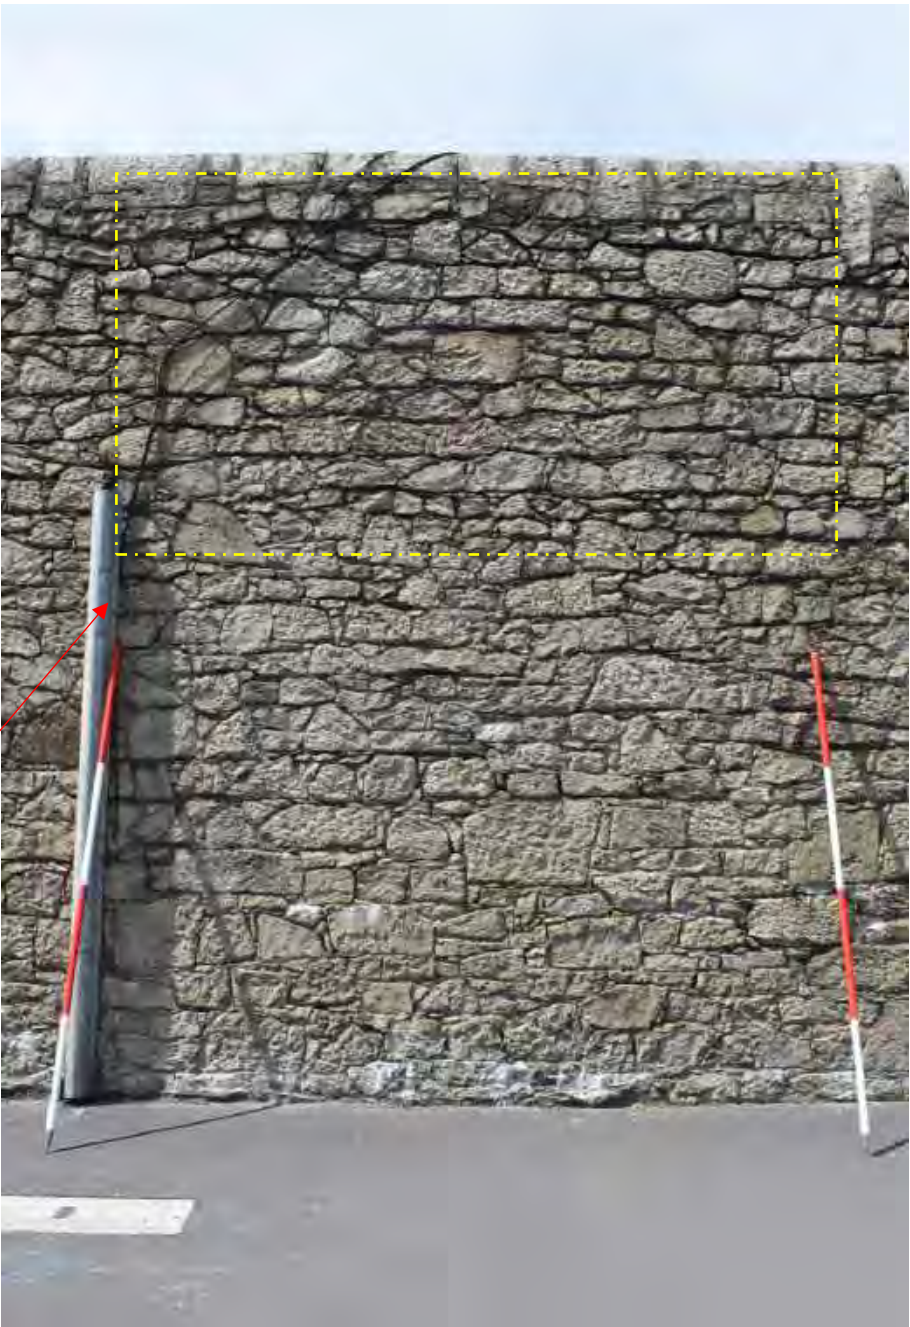
| Location Ref: | RR Elevation – Section 52 |
|--|---|
| <p>Wall section width approx. 3.0m</p> <p>Coping stones have been re-pointed (RR side only).</p> <p>Mortar loss and cracking to upper wall areas.</p> <p>More minor mortar loss and cracking to lower levels.</p> <p>Telephone lines run to steel protection shield.</p> | <p>The photograph shows a close-up of a stone wall. A yellow dashed rectangle is drawn around the upper portion of the wall, indicating the area where coping stones have been re-pointed. A red arrow points from the text 'Telephone lines run to steel protection shield.' to a vertical steel shield on the left side of the wall. The wall is made of irregular stones with visible mortar joints. The ground in front of the wall is paved.</p> |

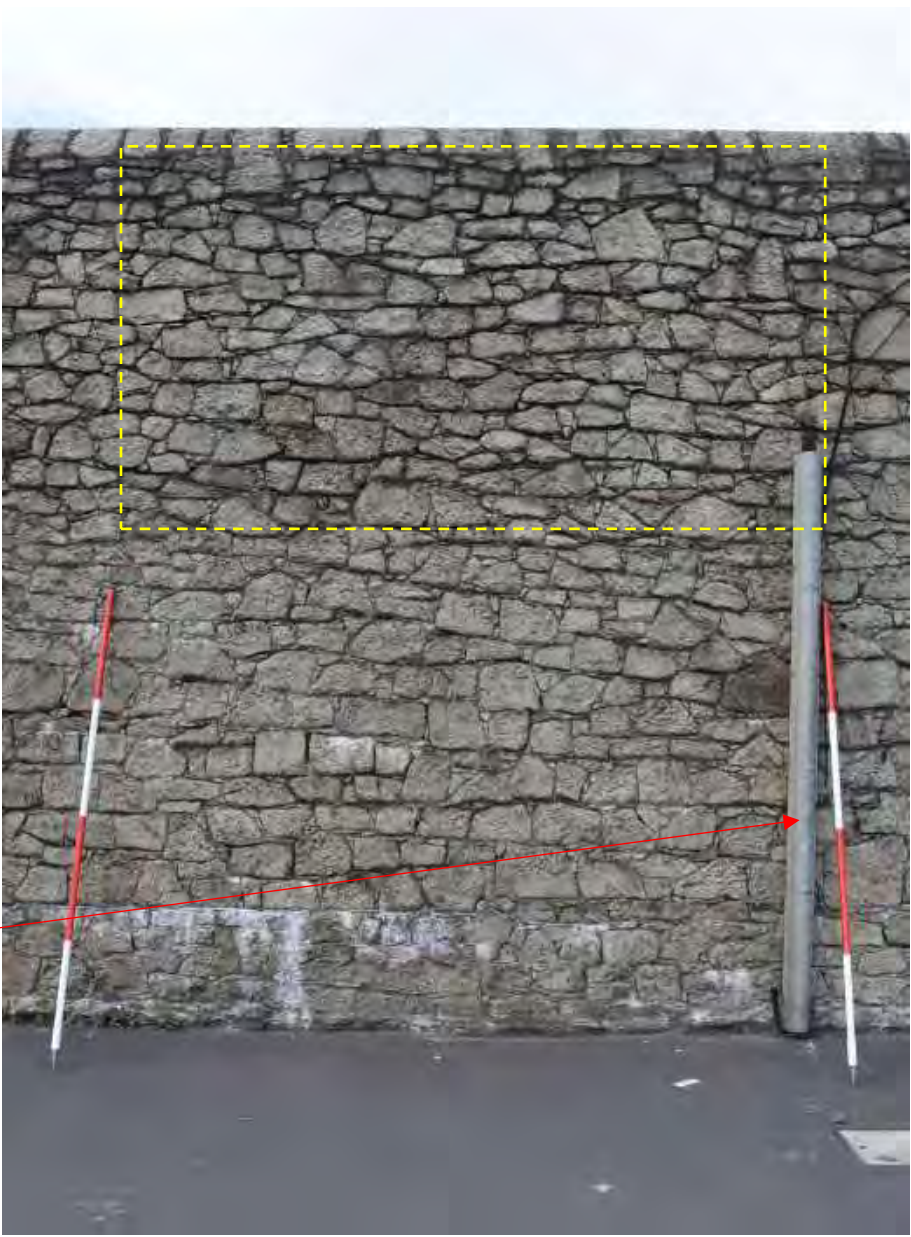
| Location Ref: | RR Elevation – Section 53 |
|---|--|
| <p>Wall section width approx. 3.0m</p> <p>Coping stones have been re-pointed (RR side only).</p> <p>Mortar loss and cracking to upper wall areas.</p> <p>More minor mortar loss and cracking to lower levels.</p> <p>Metal shield fitted to wall to protected telephone services.</p> | |

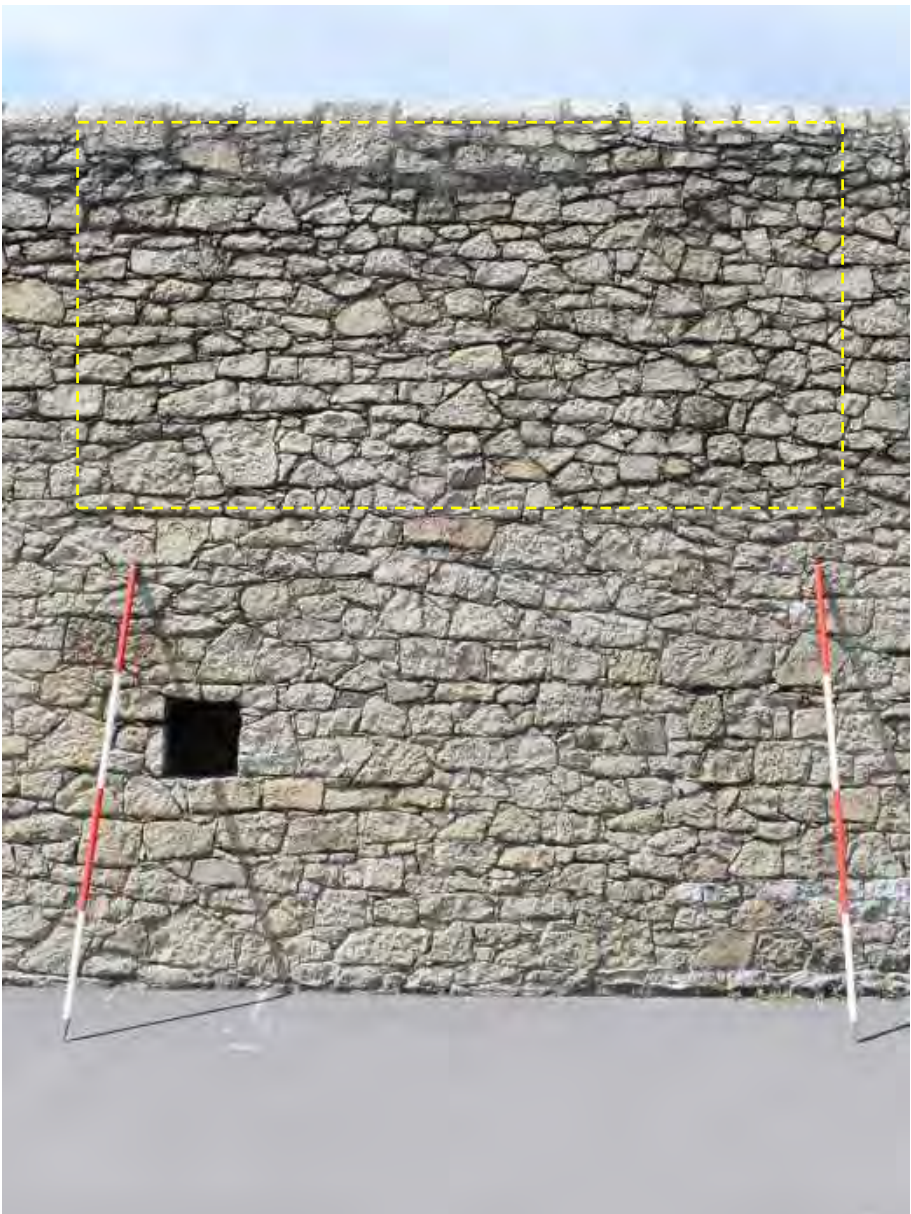
| Location Ref: | RR Elevation – Section 54 |
|---|---|
| <p>Wall section width approx. 3.0m</p> <p>Coping stones have been re-pointed (RR side only).</p> <p>Mortar loss and cracking to upper wall areas.</p> <p>More minor mortar loss and cracking to lower levels.</p> <p>Pocket formed within wall.</p> | |

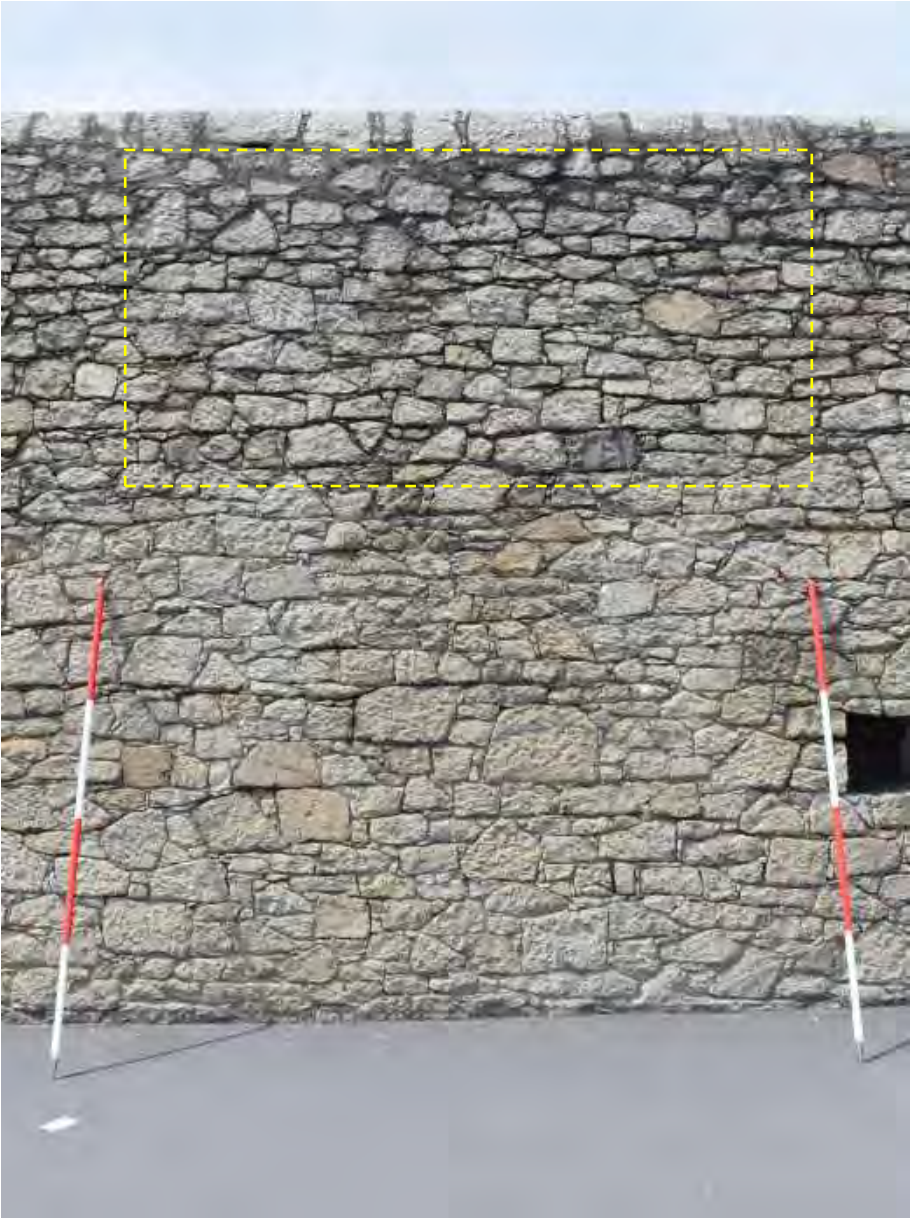
| Location Ref: | RR Elevation – Section 55 |
|---|--|
| <p>Wall section width approx. 3.0m</p> <p>Coping stones have been re-pointed (RR side only).</p> <p>Mortar loss and cracking to upper wall areas.</p> <p>More minor mortar loss and cracking to lower levels.</p> | |

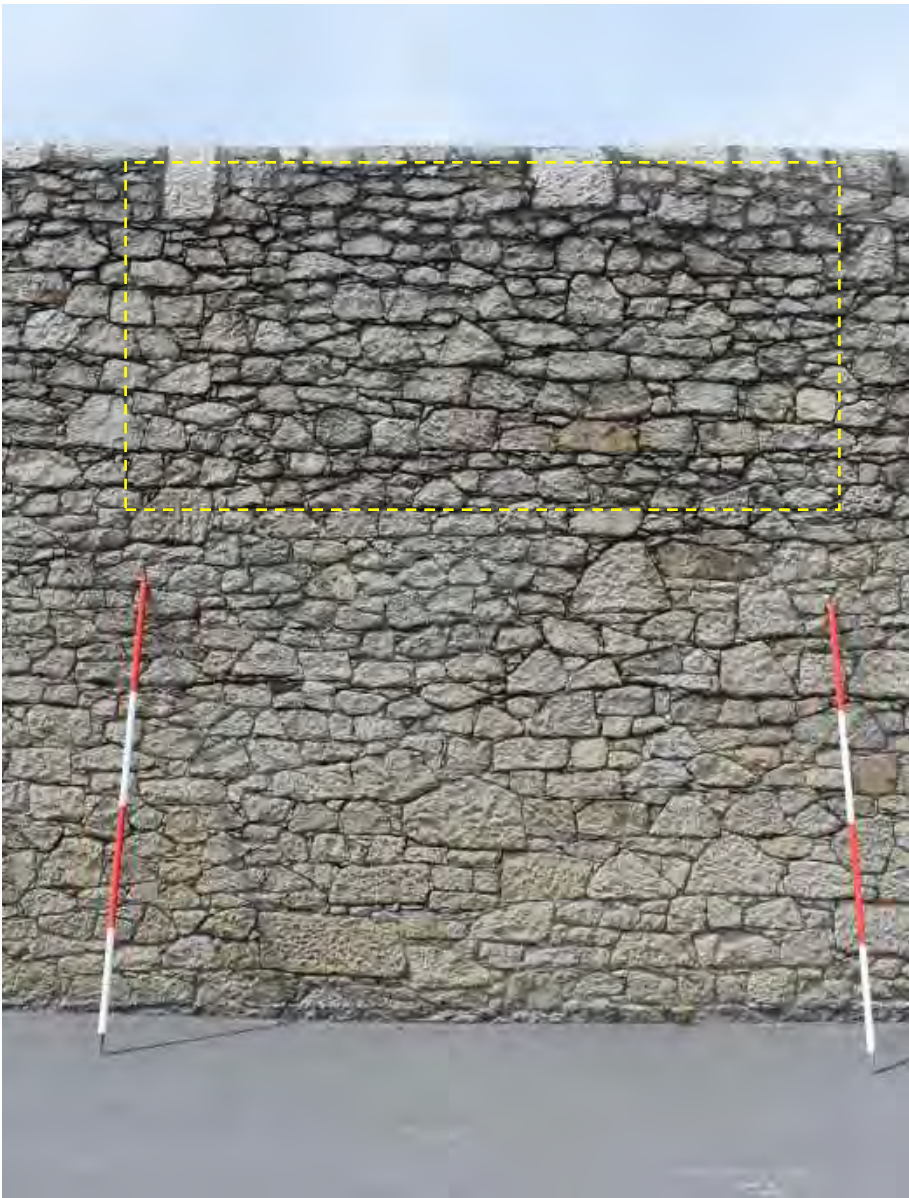
| Location Ref: | RR Elevation – Section 56 |
|---|--|
| <p>Wall section width approx. 3.0m</p> <p>Coping stones have been re-pointed (RR side only).</p> <p>Mortar loss and cracking to upper wall areas.</p> <p>More minor mortar loss and cracking to lower levels.</p> | |

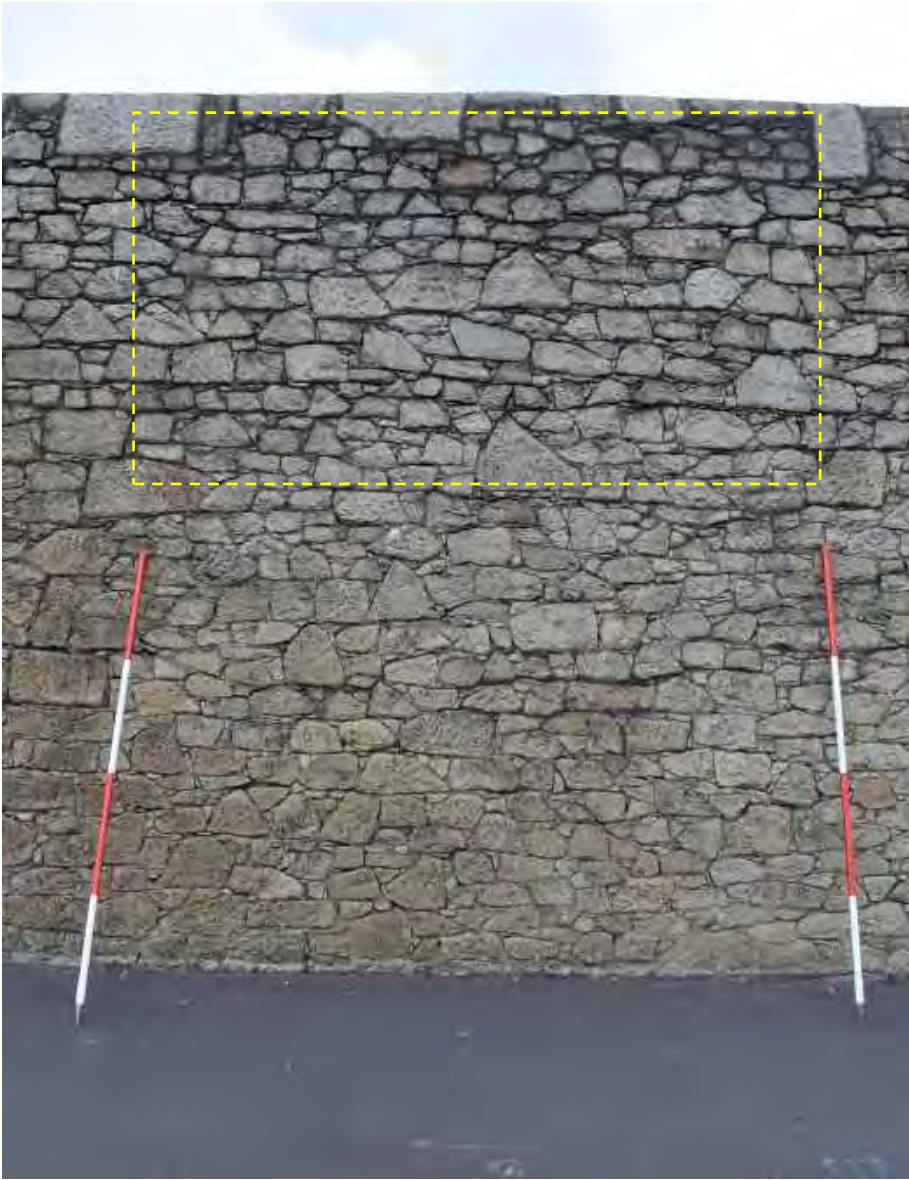
| Location Ref: | RR Elevation – Section 57 |
|---|--|
| <p>Wall section width approx. 3.0m</p> <p>Coping stones have been re-pointed (RR side only).</p> <p>Mortar loss and cracking to upper wall areas.</p> <p>More minor mortar loss and cracking to lower levels.</p> | |

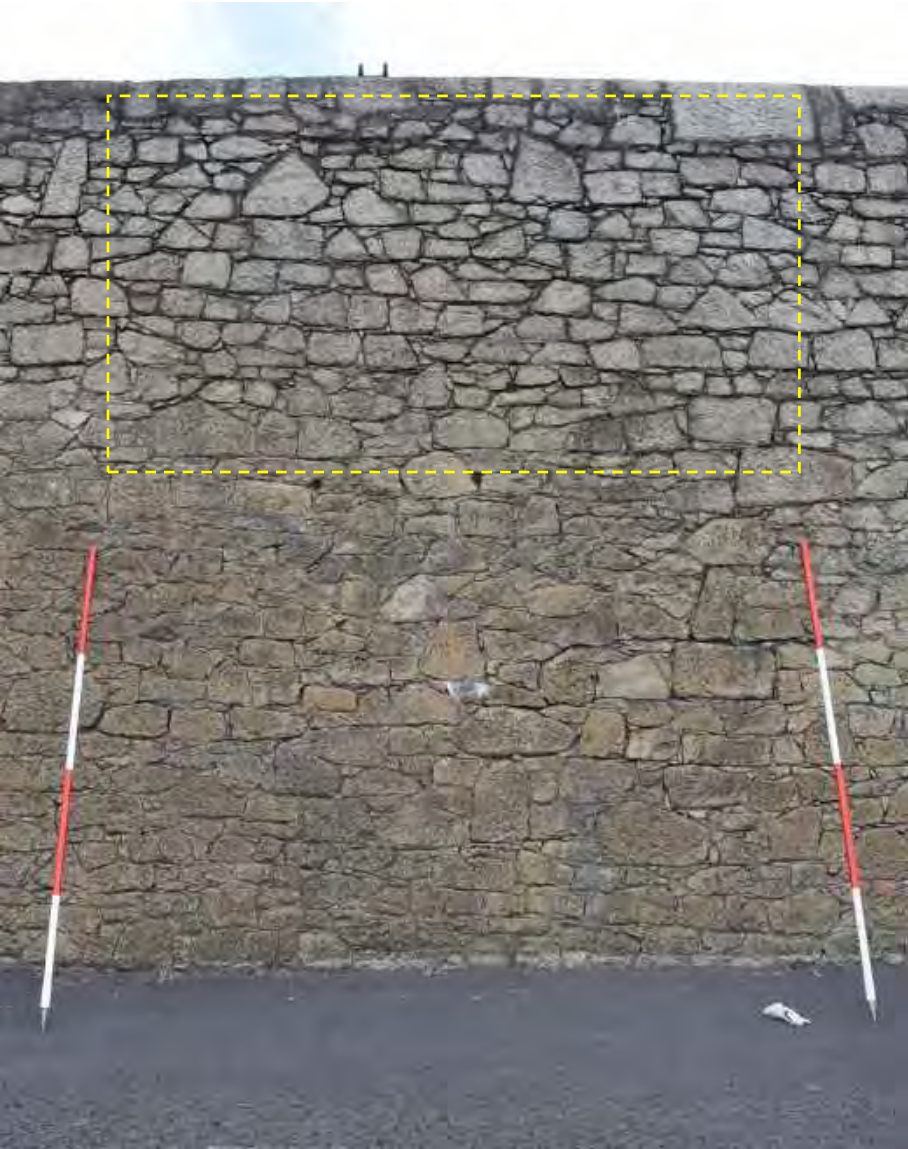
| Location Ref: | RR Elevation – Section 58 |
|---|--|
| <p>Wall section width approx. 3.0m</p> <p>Coping stones have been re-pointed (RR side only).</p> <p>Mortar loss and cracking to upper wall areas.</p> <p>More minor mortar loss and cracking to lower levels.</p> | |

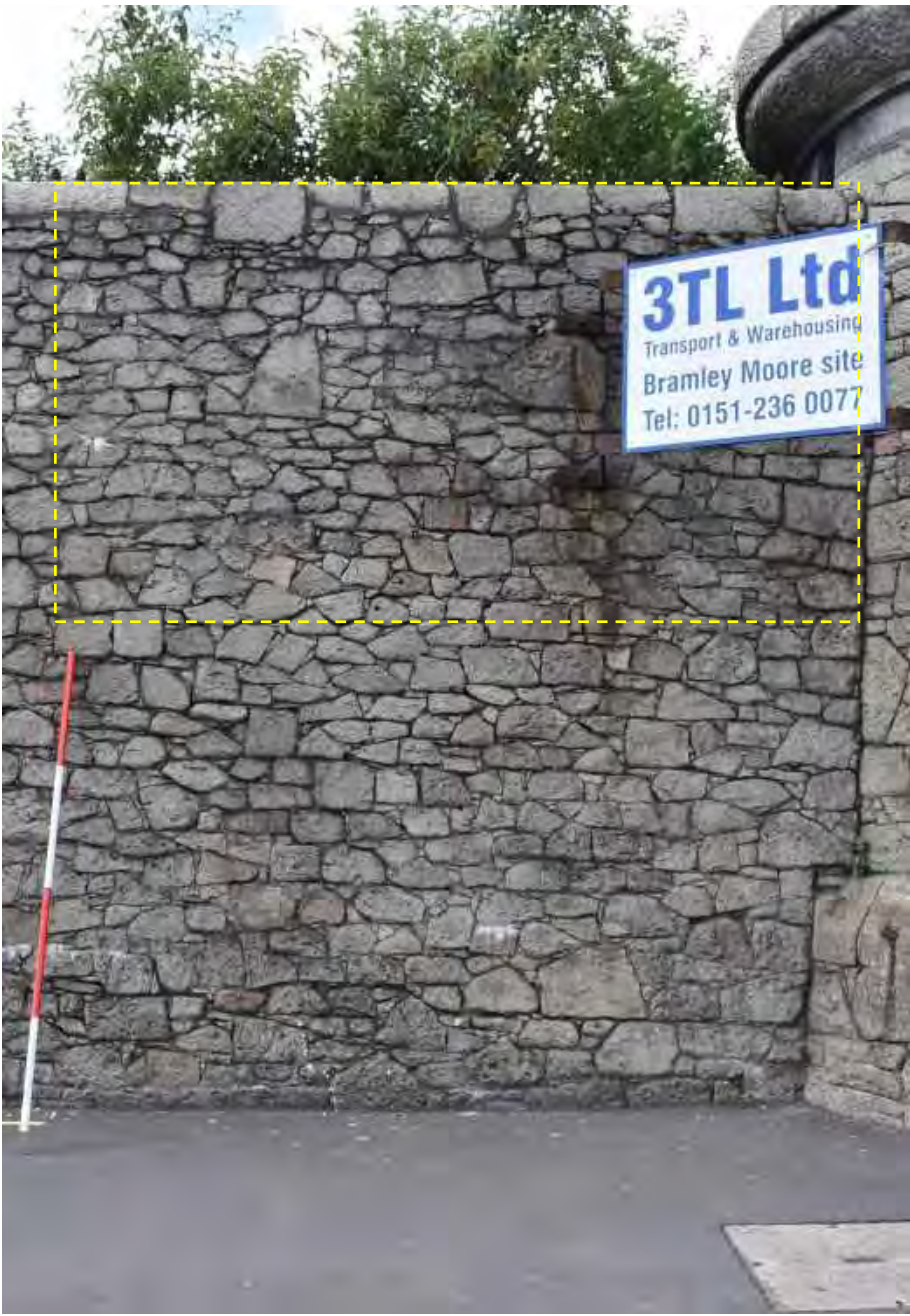
| Location Ref: | RR Elevation South – Section 01 |
|--|---|
| <p>Wall section width approx. 3.0m</p> <p>Coping stones have been re-pointed (RR side only).</p> <p>Mortar loss and cracking to upper wall areas.</p> <p>More minor mortar loss and cracking to lower levels.</p> <p>Sign fixed to wall with ferrous brackets.</p> | <p>The photograph shows a close-up of a stone wall made of irregular grey stones. A yellow dashed rectangular box is drawn over the upper portion of the wall. A blue and white sign is attached to the wall with metal brackets. The sign reads '3TL Ltd', 'Transport & Warehousing', 'Bramley Moore site', and 'Tel: 0151-236 0077'. A red and white measuring pole is leaning against the wall on the left side. The top of the wall shows coping stones. Green foliage is visible above the wall, and a concrete path is at the bottom.</p> |

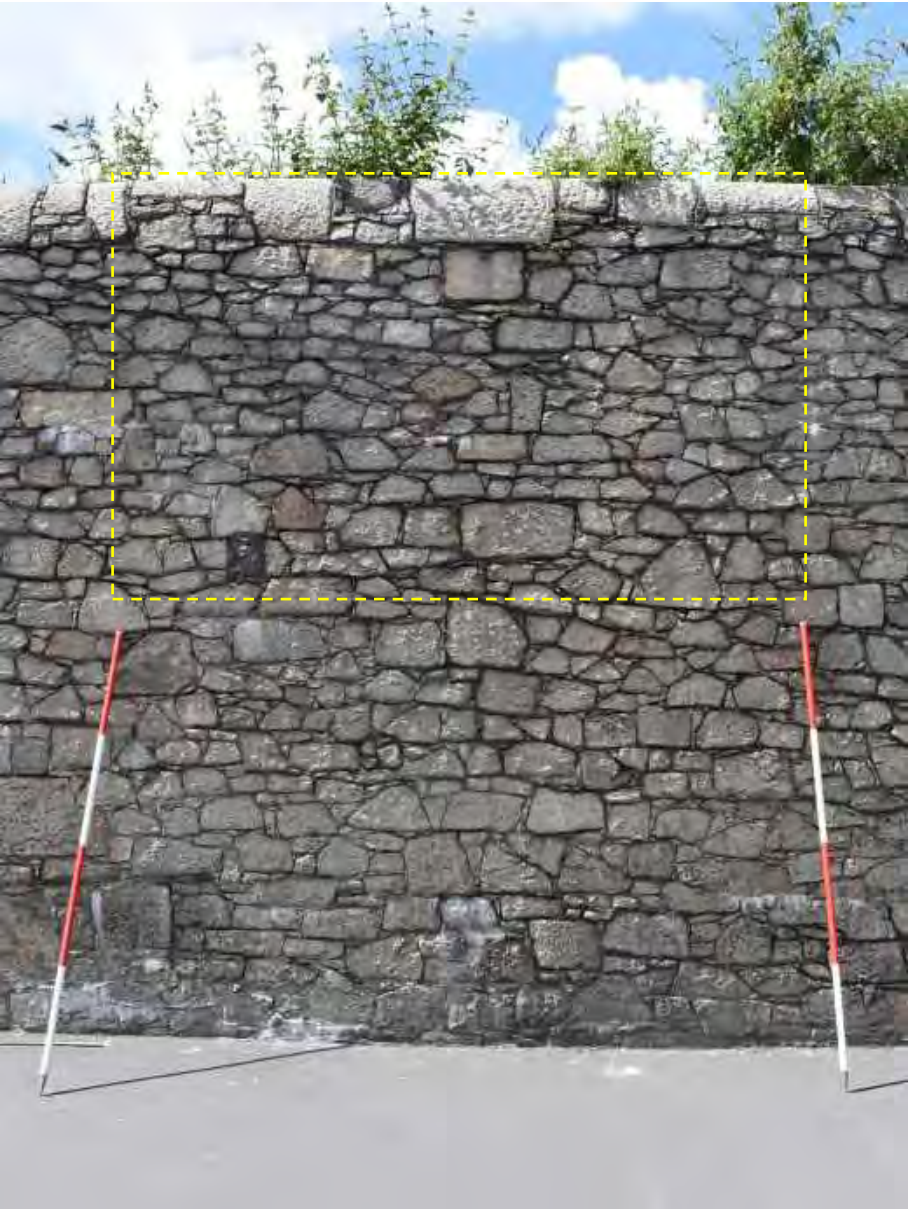
| Location Ref: | RR South Elevation – Section 02 |
|---|---|
| <p>Wall section width approx. 3.0m</p> <p>Coping stones have been re-pointed (RR side only).</p> <p>Mortar loss and cracking to upper wall areas.</p> <p>More minor mortar loss and cracking to lower levels.</p> | A photograph of a stone wall, likely made of rough-hewn stones, showing some mortar loss and cracking. A yellow dashed rectangle highlights the upper section of the wall, indicating the area of re-pointing. Two red-and-white poles are placed vertically at the base of the wall to provide a sense of scale. The wall is situated outdoors, with some vegetation visible at the top. |

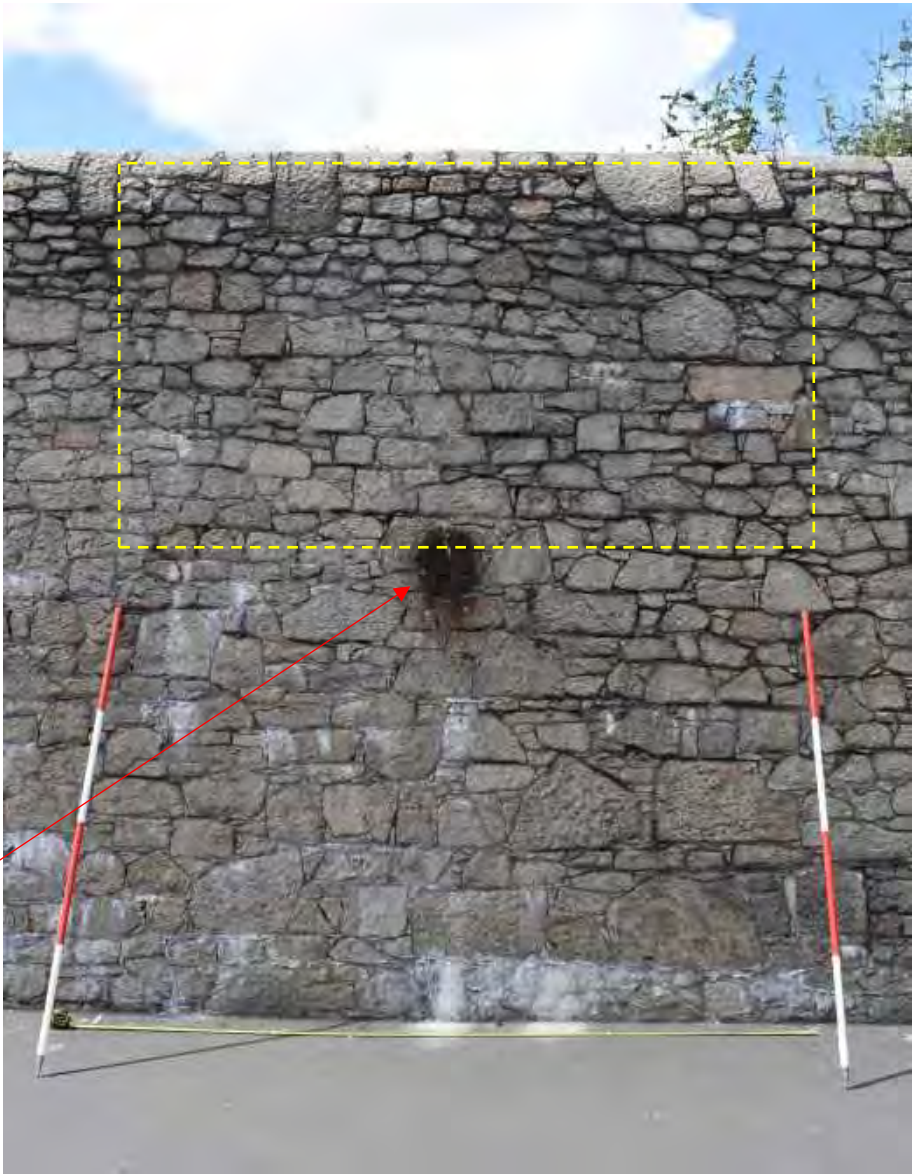
| Location Ref: | RR South Elevation – Section 03 |
|---|--|
| <p>Wall section width approx. 3.0m</p> <p>Coping stones have been re-pointed (RR side only).</p> <p>Mortar loss and cracking to upper wall areas.</p> <p>More minor mortar loss and cracking to lower levels.</p> <p>Rust staining to face of wall.</p> | |

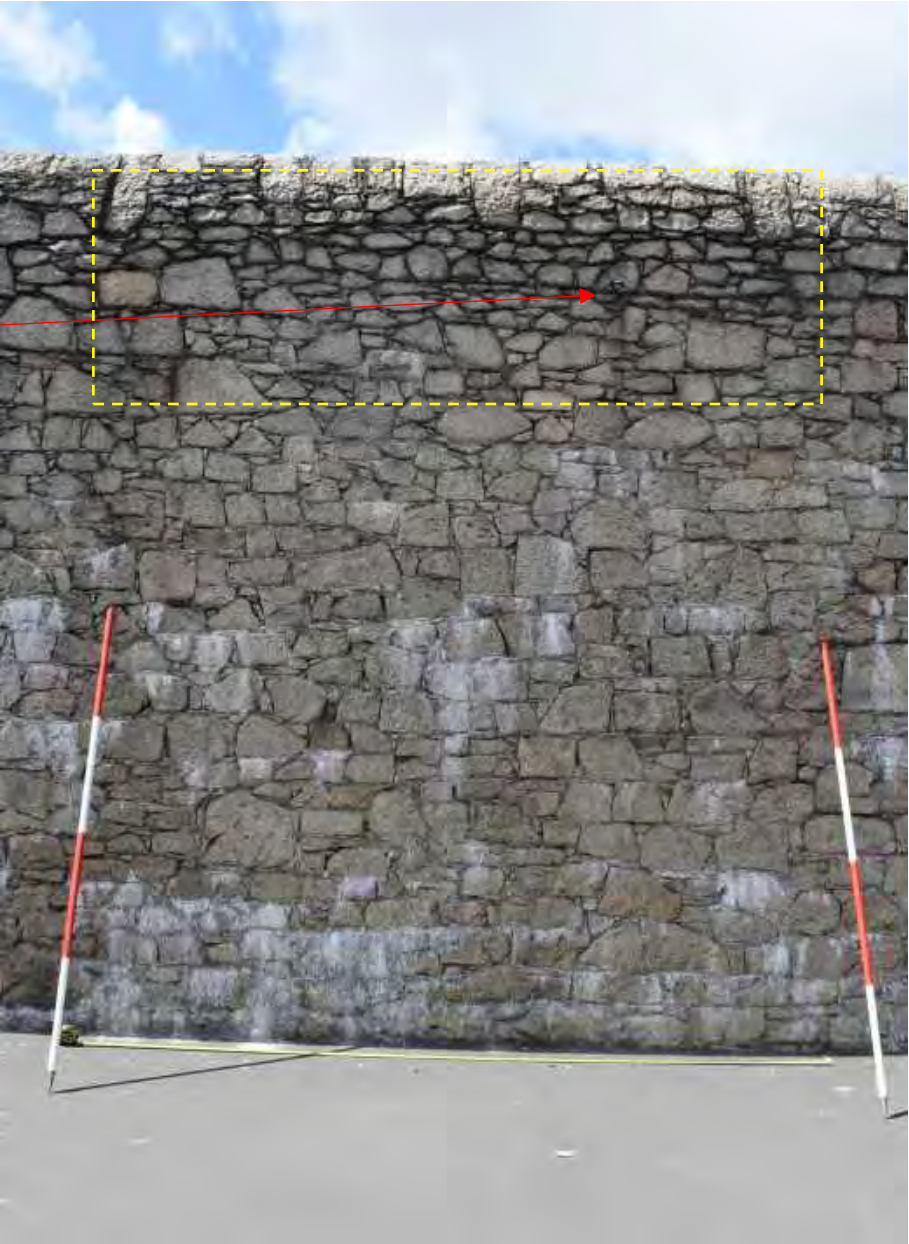
| Location Ref: | RR South Elevation – Section 04 |
|---|--|
| <p>Wall section width approx. 3.0m</p> <p>Coping stones have been re-pointed (RR side only).</p> <p>Iron pin. </p> <p>Mortar loss and cracking to upper wall areas.</p> <p>More minor mortar loss and cracking to lower levels.</p> | |

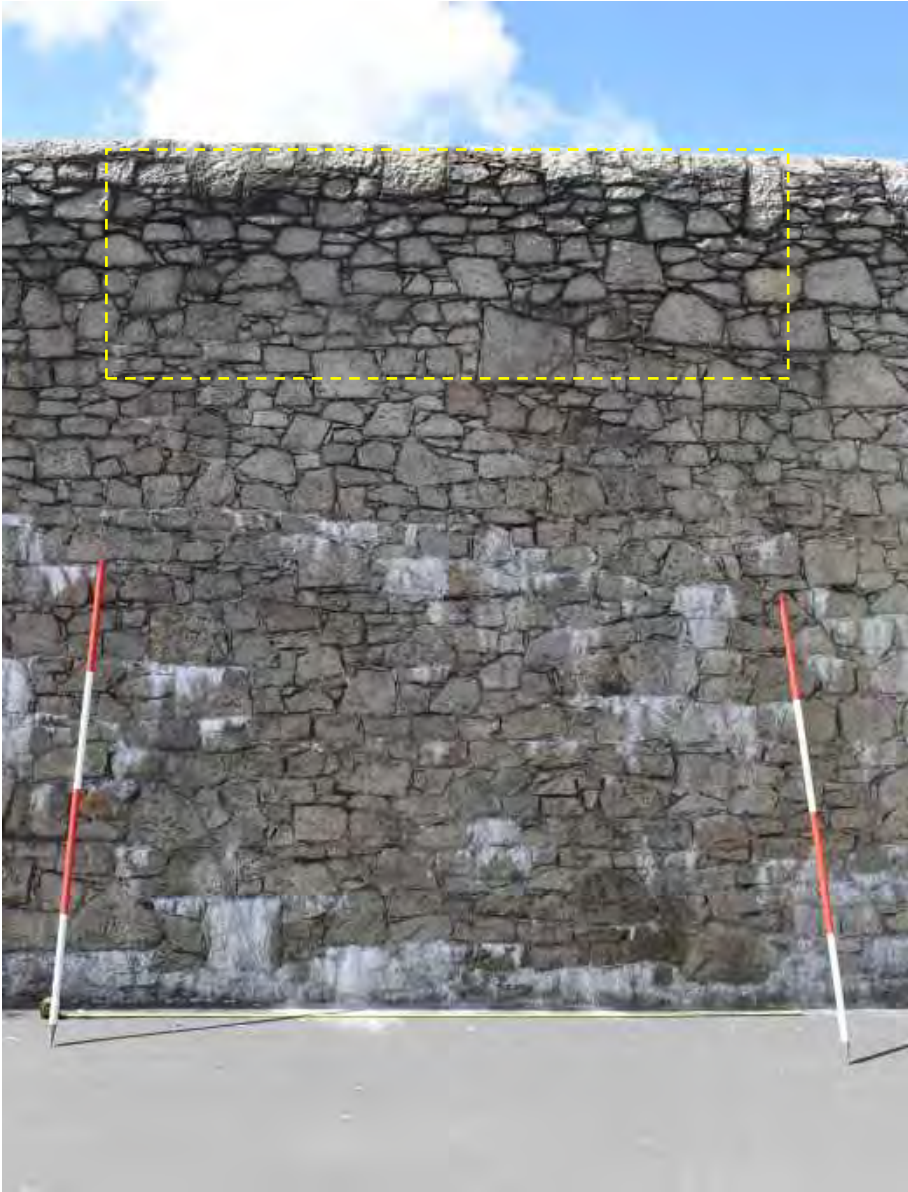
| Location Ref: | RR South Elevation – Section 05 |
|---|--|
| <p>Wall section width approx. 3.0m</p> <p>Coping stones have been re-pointed (RR side only).</p> <p>Mortar loss and cracking to upper wall areas.</p> <p>More minor mortar loss and cracking to lower levels.</p> | <p>The photograph shows a close-up of a stone wall. A yellow dashed rectangular box is drawn around the top portion of the wall, indicating the area where coping stones have been re-pointed. Two survey poles, which are white with red sections, are positioned vertically on either side of the wall at the bottom. The wall itself is constructed from irregular, dark grey stones with visible mortar joints. The sky above the wall is blue with some white clouds.</p> |
