| Location Ref: | BMD Elevation – Section 44 |

| Location Ref: | RR Elevation – Section 01 |

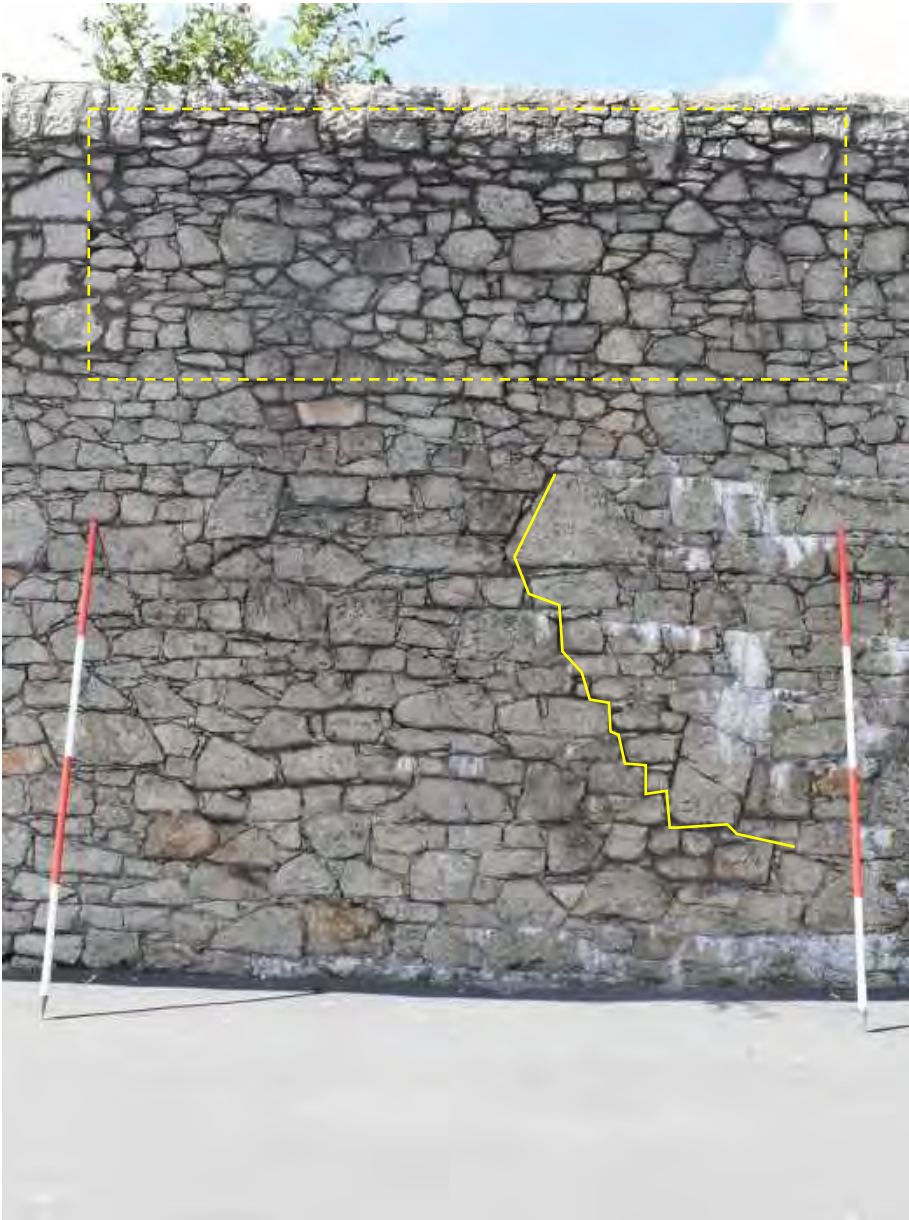
| Location Ref: | RR South Elevation – Section 06 |
|---|---|
| <p>Wall section width approx. 3.0m</p> <p>Coping stones have been re-pointed (RR side only).</p> <p>Mortar loss and cracking to upper wall areas.</p> <p>More minor mortar loss and cracking to lower levels.</p> | |

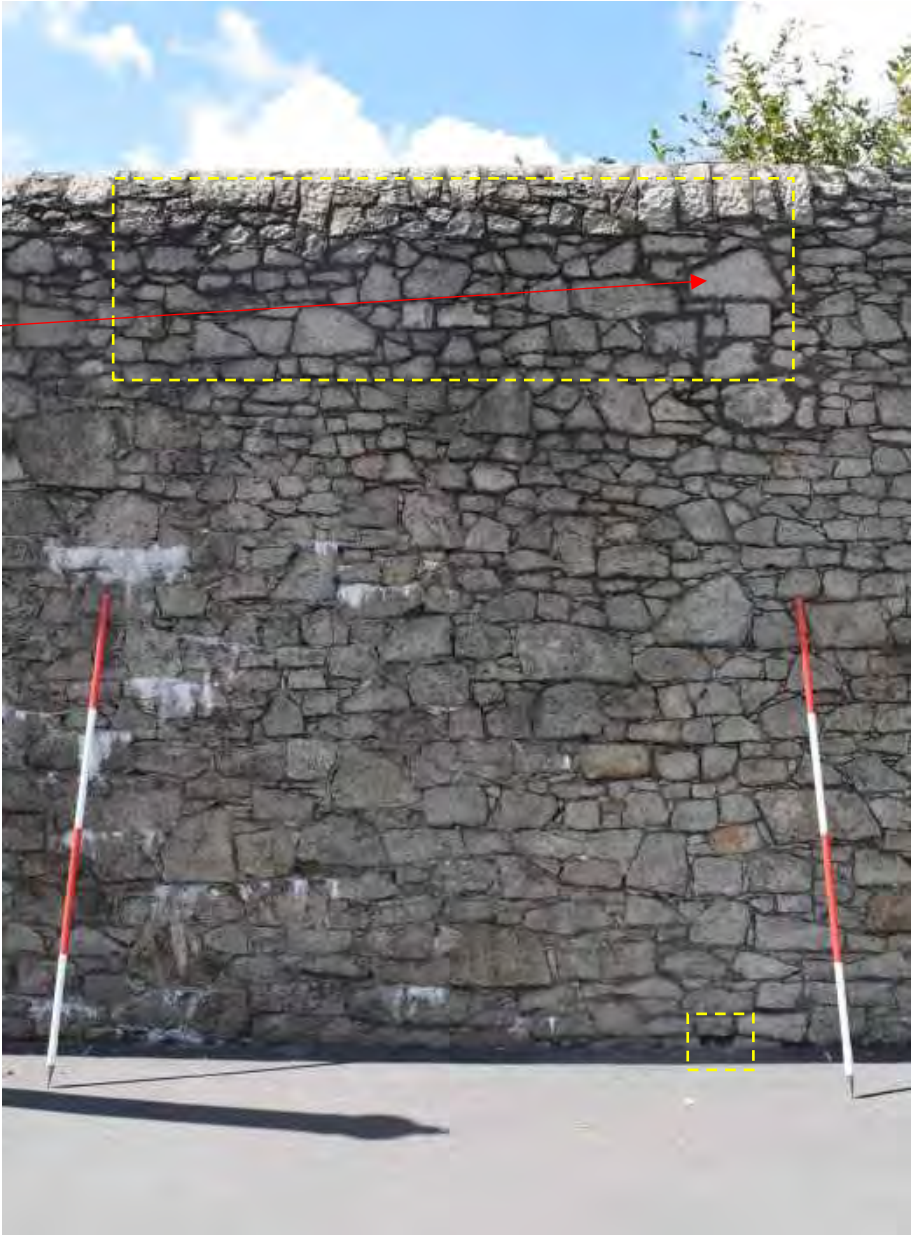
| Location Ref: | RR South Elevation – Section 07 |
|---|---|
| <p>Wall section width approx. 3.0m</p> <p>Coping stones have been re-pointed (RR side only).</p> <p>Area re-pointed.</p> <p>Mortar loss and cracking to upper wall areas.</p> <p>More minor mortar loss and cracking to lower levels.</p> <p>Small void</p> | |

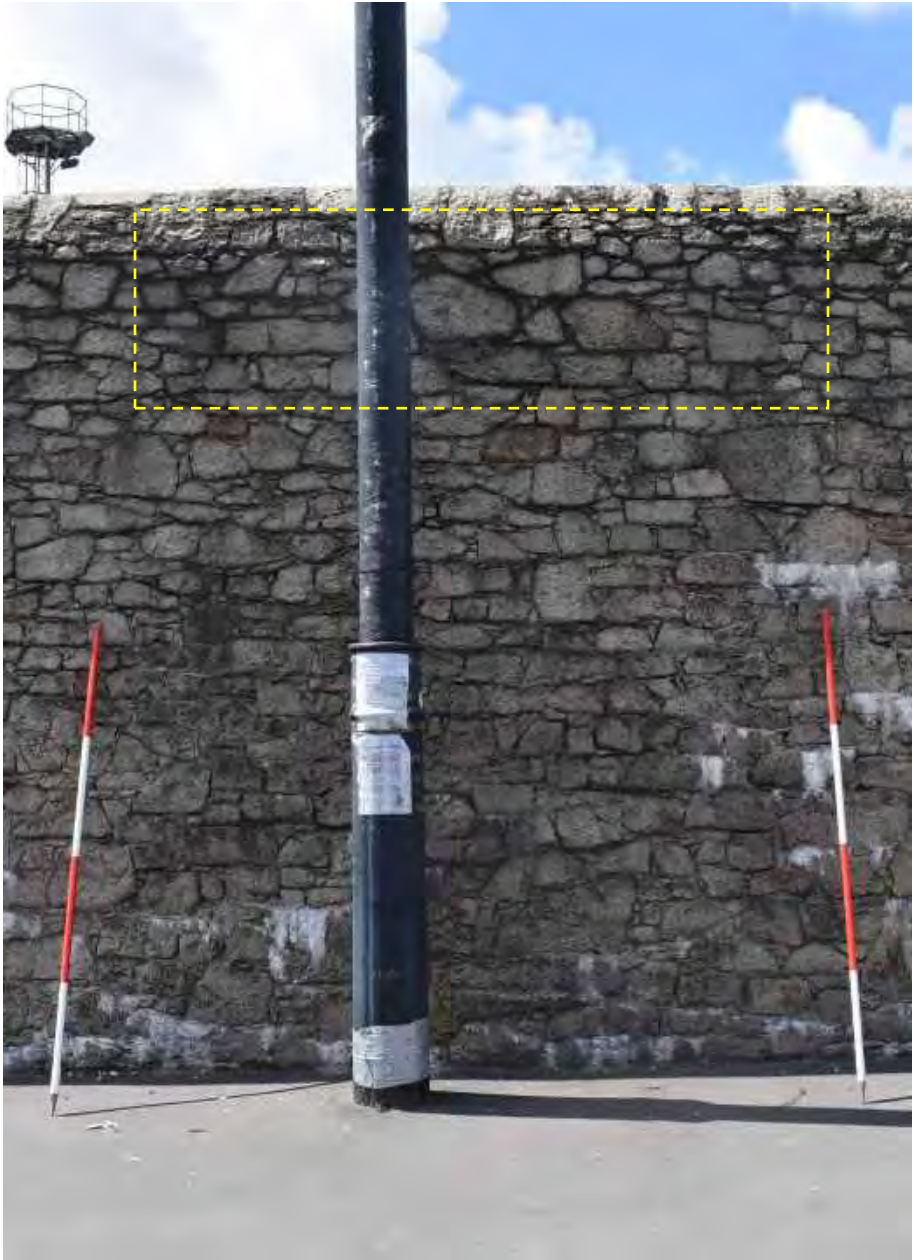
| Location Ref: | RR South Elevation – Section 08 |
|---|--|
| <p>Wall section width approx. 3.0m</p> <p>Coping stones have been re-pointed (RR side only).</p> <p>Mortar loss and cracking to upper wall areas.</p> <p>More minor mortar loss and cracking to lower levels.</p> | |

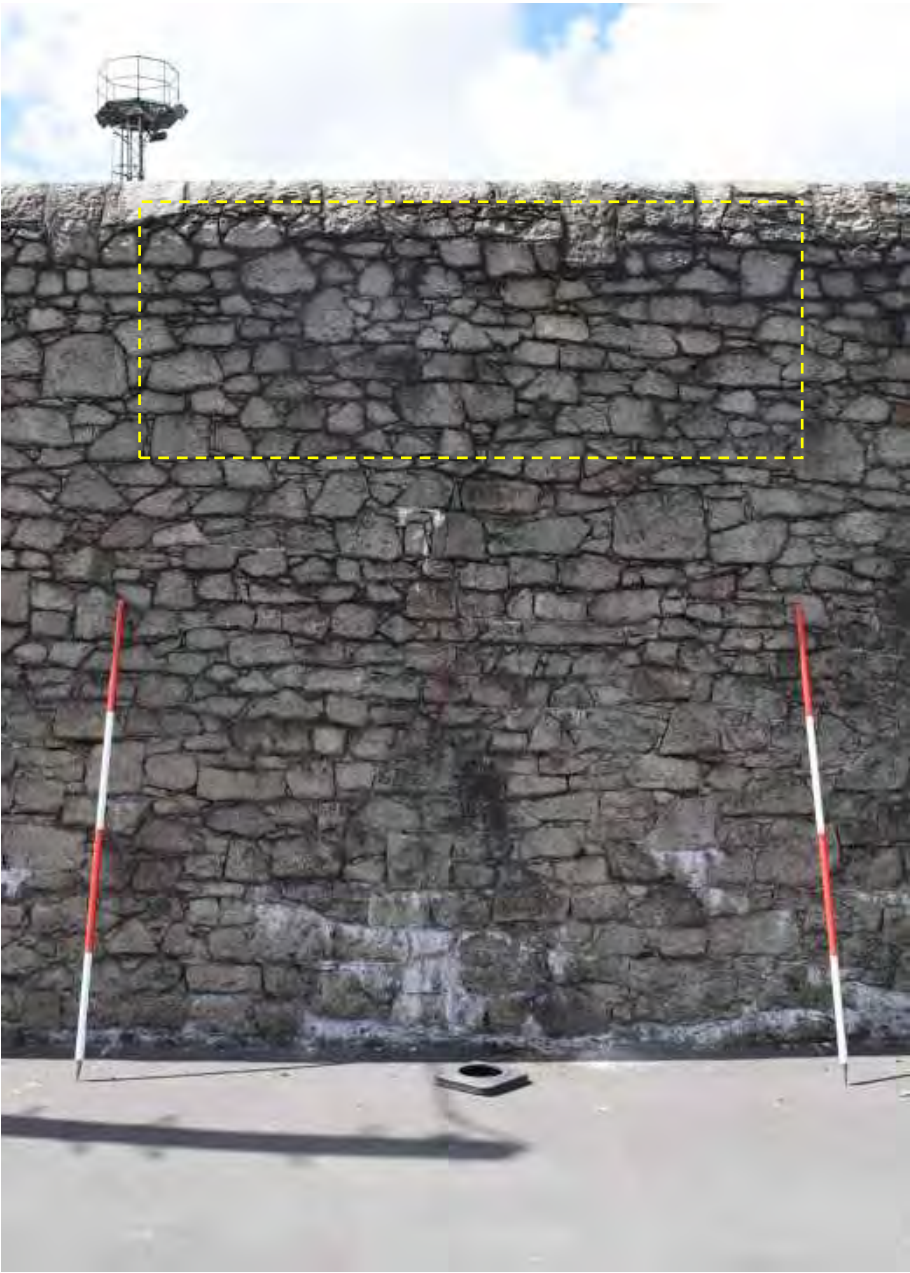
| Location Ref: | RR South Elevation – Section 09 |
|---|--|
| <p>Wall section width approx. 3.0m</p> <p>Coping stones have been re-pointed (RR side only).</p> <p>Mortar loss and cracking to upper wall areas.</p> <p>More minor mortar loss and cracking to lower levels.</p> <p>Staining and calcium deposits to lower wall areas.</p> | <p>The photograph shows a close-up of a stone wall. A yellow dashed rectangle is drawn on the upper portion of the wall, indicating an area of interest or repair. Two vertical poles with red and white segments are positioned on the ground in front of the wall to provide a sense of scale. The wall itself is constructed from irregular, dark grey stones with visible mortar joints. Some staining and calcium deposits are visible on the lower part of the wall.</p> |

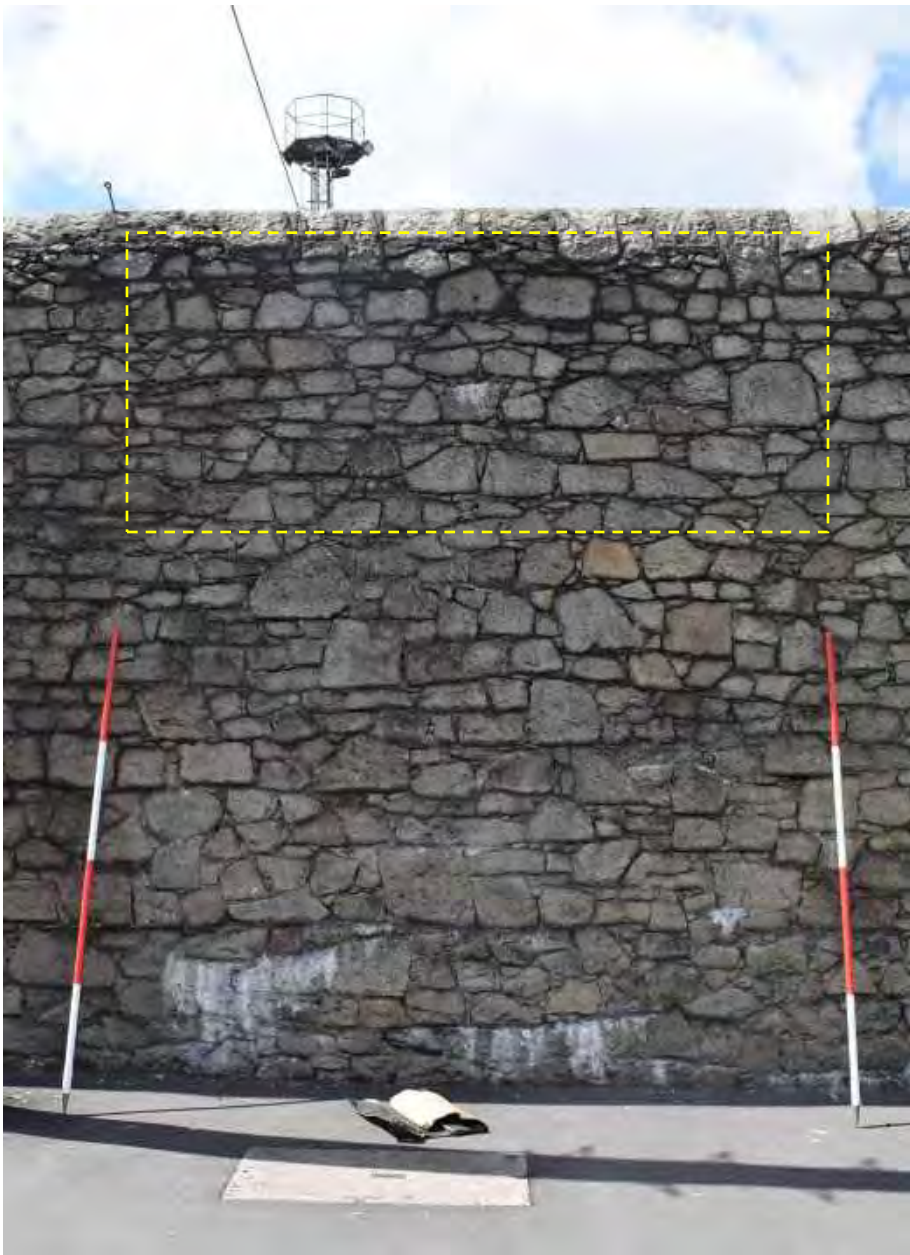
| Location Ref: | RR South Elevation – Section 10 |
|---|--|
| <p>Wall section width approx. 3.0m</p> <p>Coping stones have been re-pointed (RR side only).</p> <p>Mortar loss and cracking to upper wall areas.</p> <p>More minor mortar loss and cracking to lower levels.</p> | |

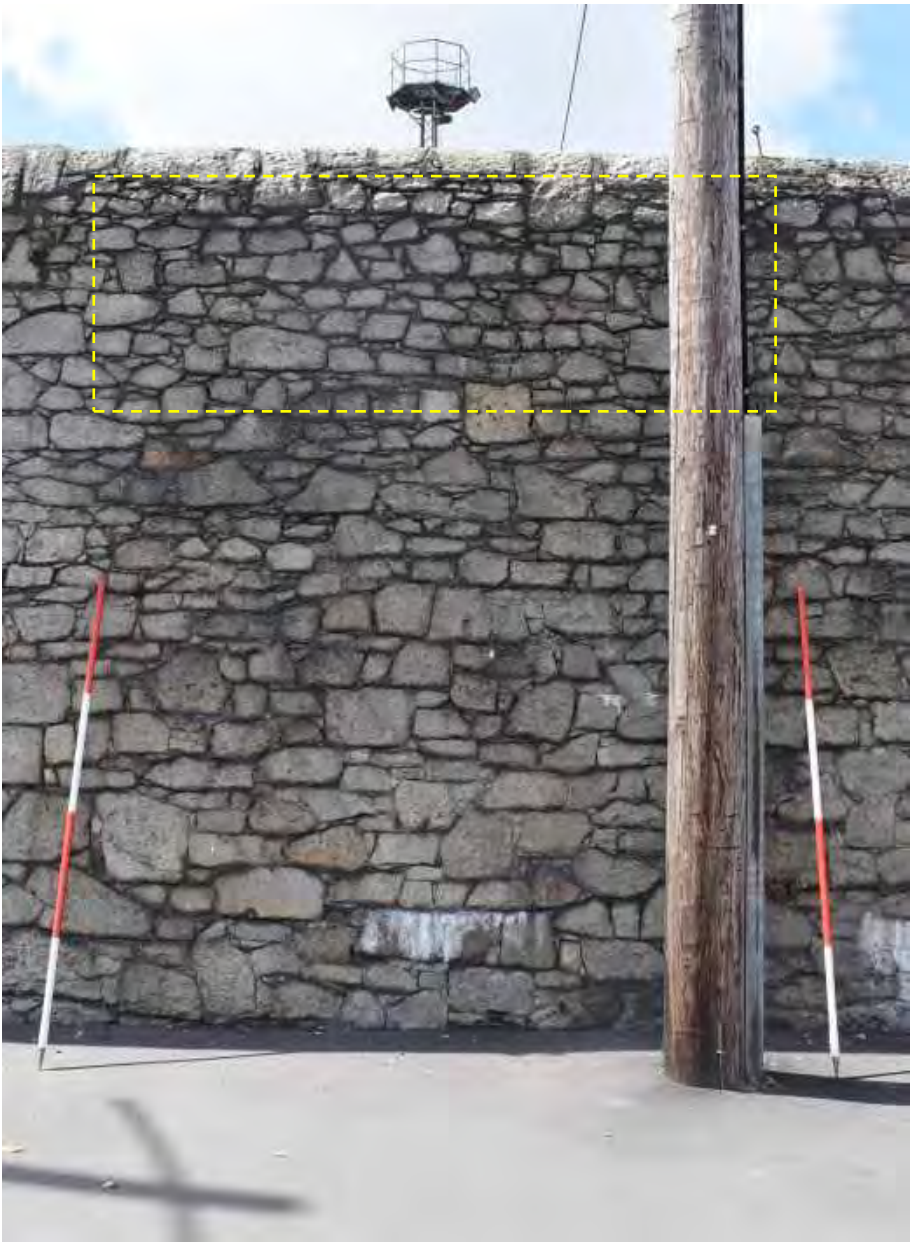
| Location Ref: | RR South Elevation – Section 11 |
|---|--|
| <p>Wall section width approx. 3.0m</p> <p>Coping stones have been re-pointed (RR side only).</p> <p>Mortar loss and cracking to upper wall areas.</p> <p>More minor mortar loss and cracking to lower levels.</p> | |

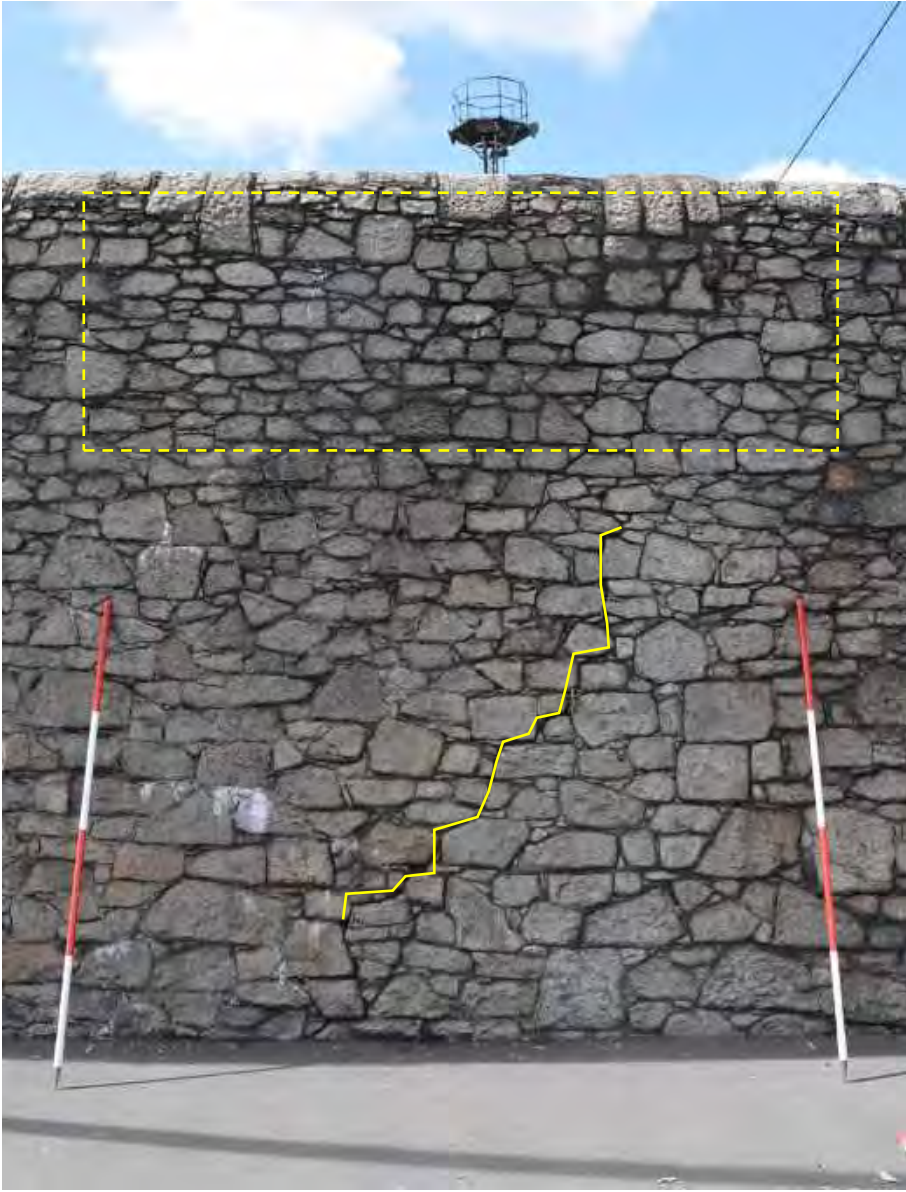
| Location Ref: | RR South Elevation – Section 12 |
|---|--|
| <p>Wall section width approx. 3.0m</p> <p>Coping stones have been re-pointed (RR side only).</p> <p>Mortar loss and cracking to upper wall areas.</p> <p>More minor mortar loss and cracking to lower levels.</p> | |

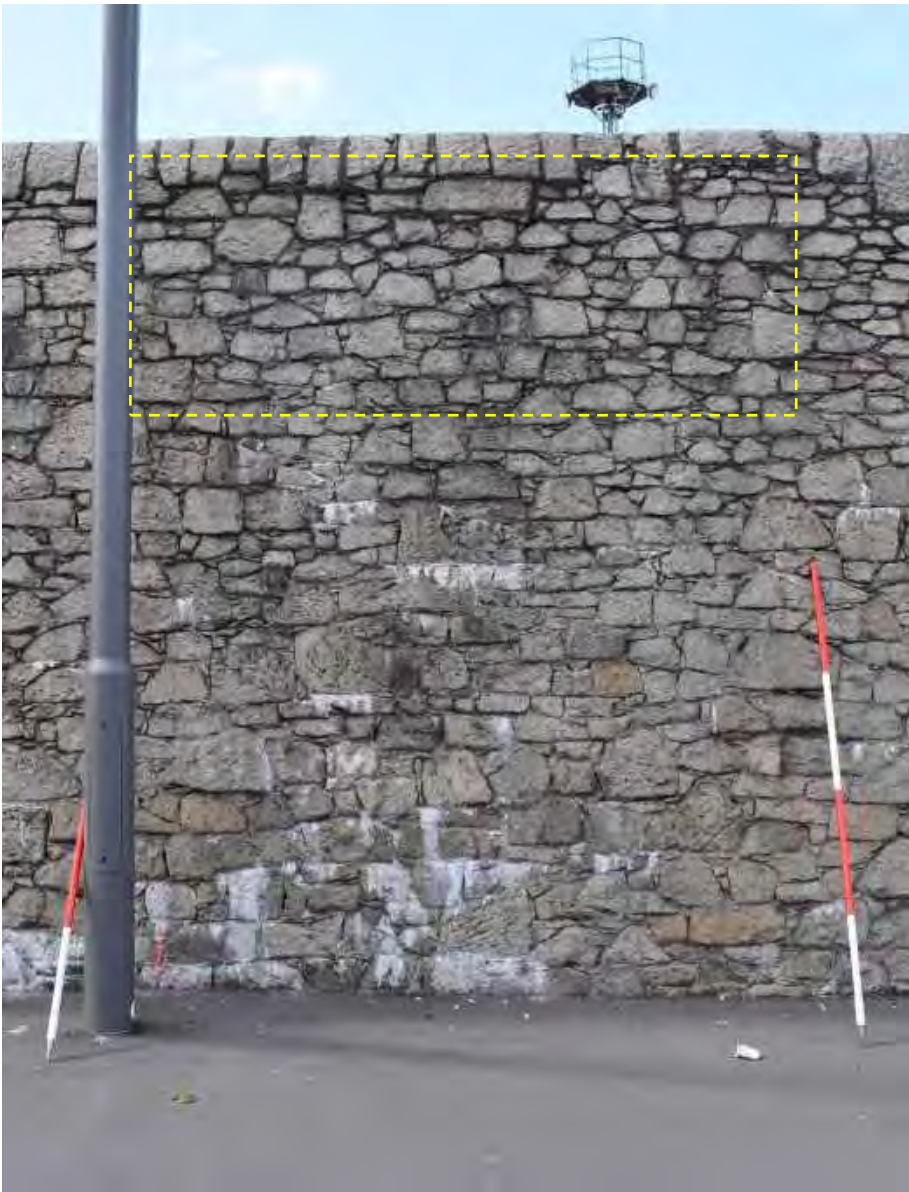
| Location Ref: | RR South Elevation – Section 13 |
|---|--|
| <p>Wall section width approx. 3.0m</p> <p>Coping stones have been re-pointed (RR side only).</p> <p>Mortar loss and cracking to upper wall areas.</p> <p>More minor mortar loss and cracking to lower levels.</p> | |

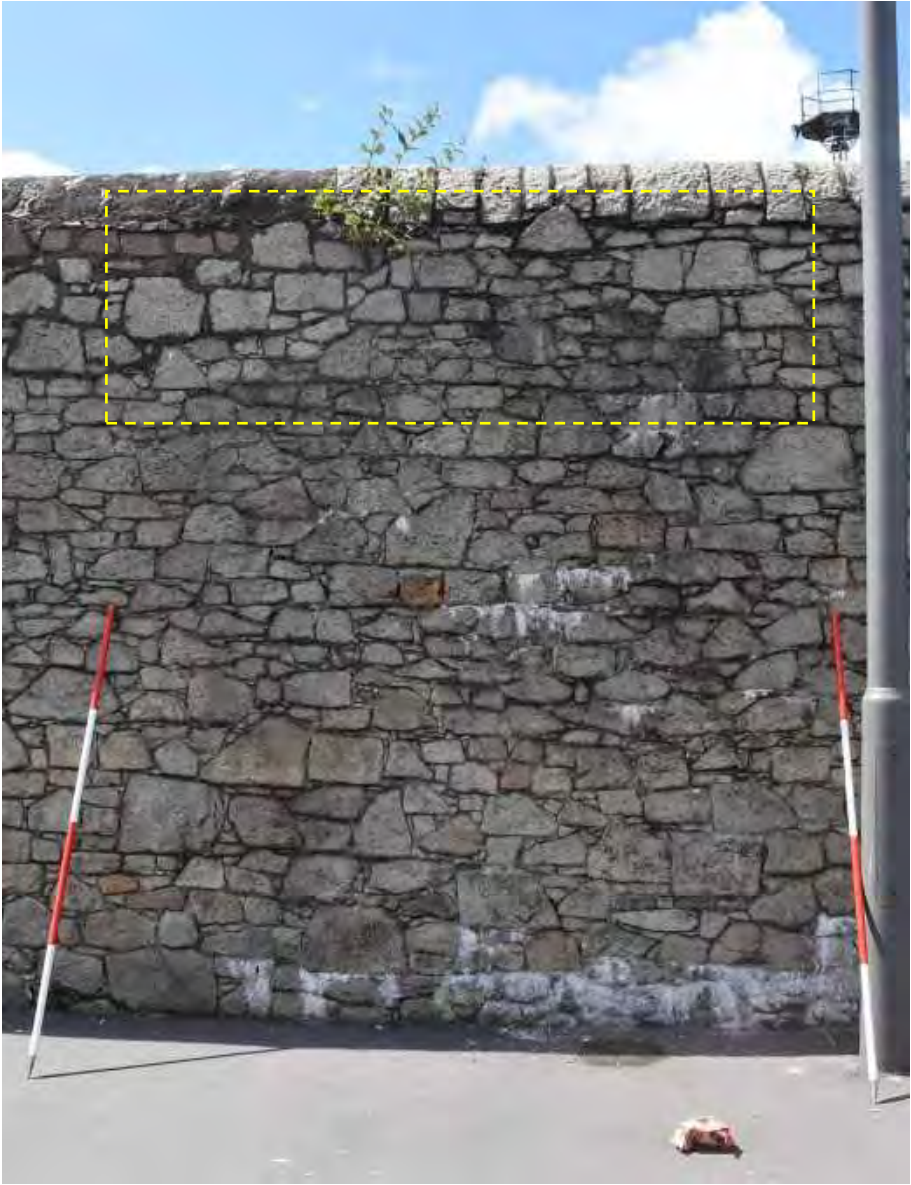
| Location Ref: | RR South Elevation – Section 14 |
|---|---|
| <p>Wall section width approx. 3.0m</p> <p>Coping stones have been re-pointed (RR side only).</p> <p>Mortar loss and cracking to upper wall areas.</p> <p>More minor mortar loss and cracking to lower levels.</p> | |

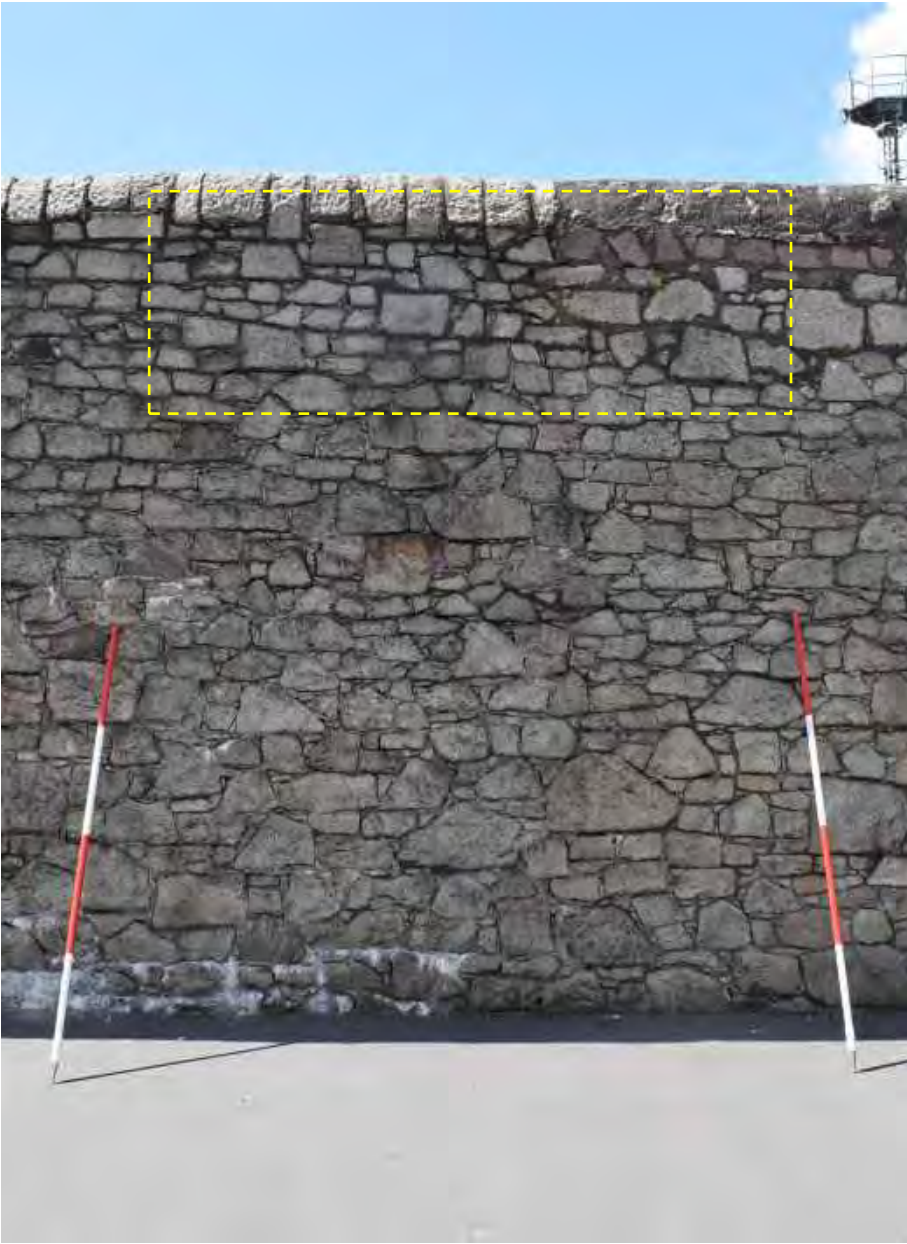
| Location Ref: | RR South Elevation – Section 15 |
|---|--|
| <p>Wall section width approx. 3.0m</p> <p>Coping stones have been re-pointed (RR side only).</p> <p>Mortar loss and cracking to upper wall areas.</p> <p>More minor mortar loss and cracking to lower levels.</p> | |

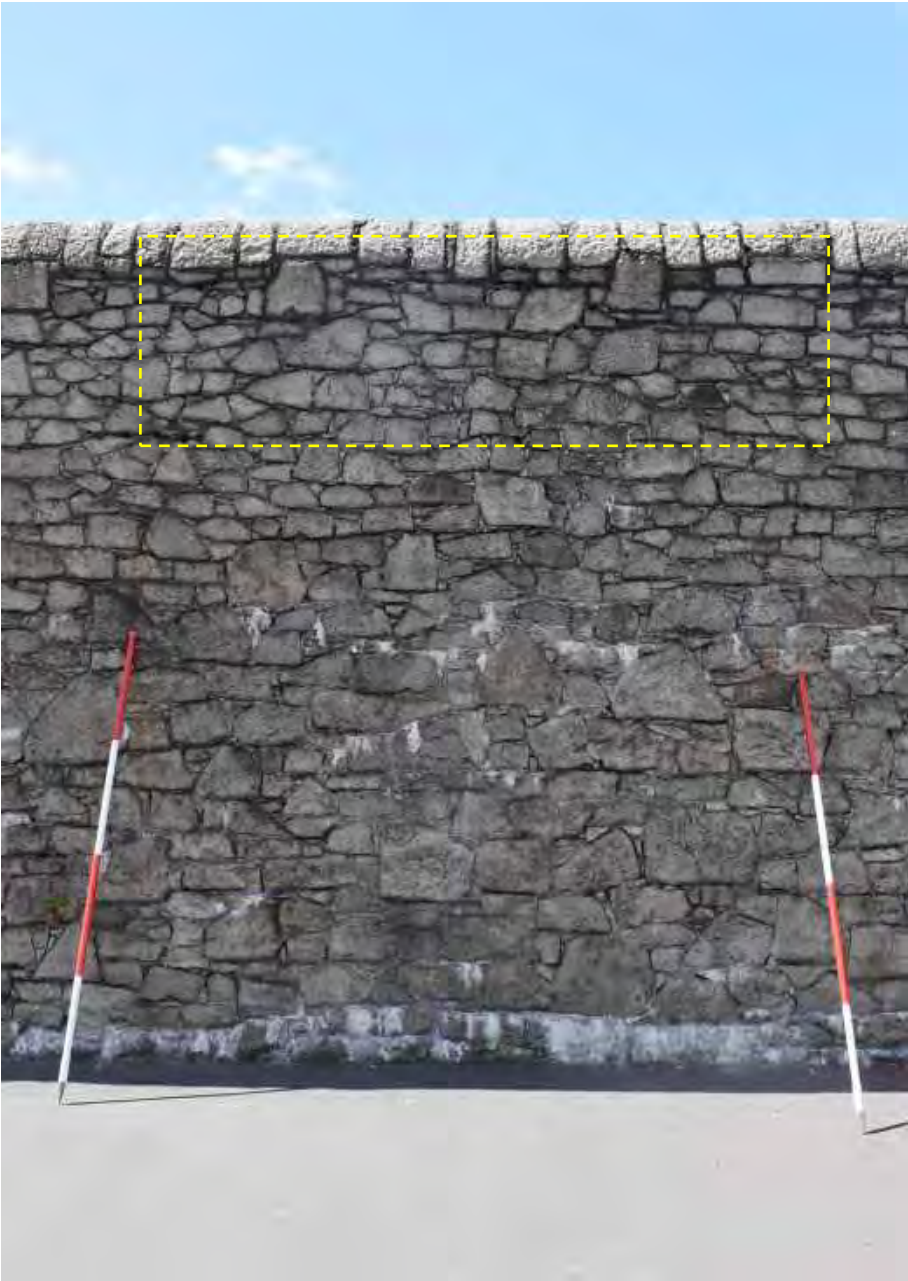
| Location Ref: | RR South Elevation – Section 16 |
|---|--|
| <p>Wall section width approx. 3.0m</p> <p>Coping stones have been re-pointed (RR side only).</p> <p>Mortar loss and cracking to upper wall areas.</p> <p>More minor mortar loss and cracking to lower levels.</p> | |

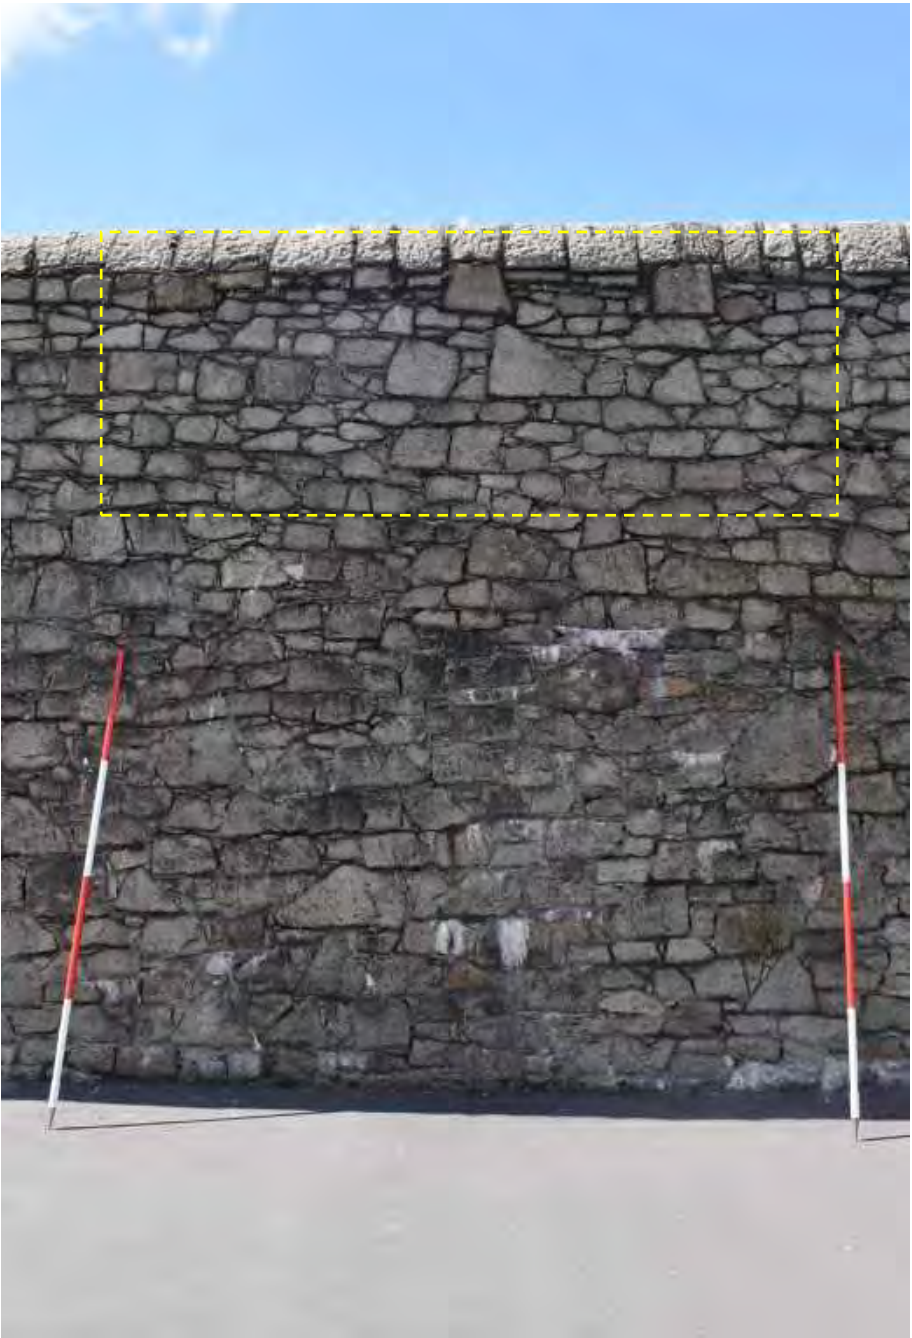
| Location Ref: | RR South Elevation – Section 17 |
|---|--|
| <p>Wall section width approx. 3.0m</p> <p>Coping stones have been re-pointed (RR side only).</p> <p>Mortar loss and cracking to upper wall areas.</p> <p>More minor mortar loss and cracking to lower levels.</p> | |

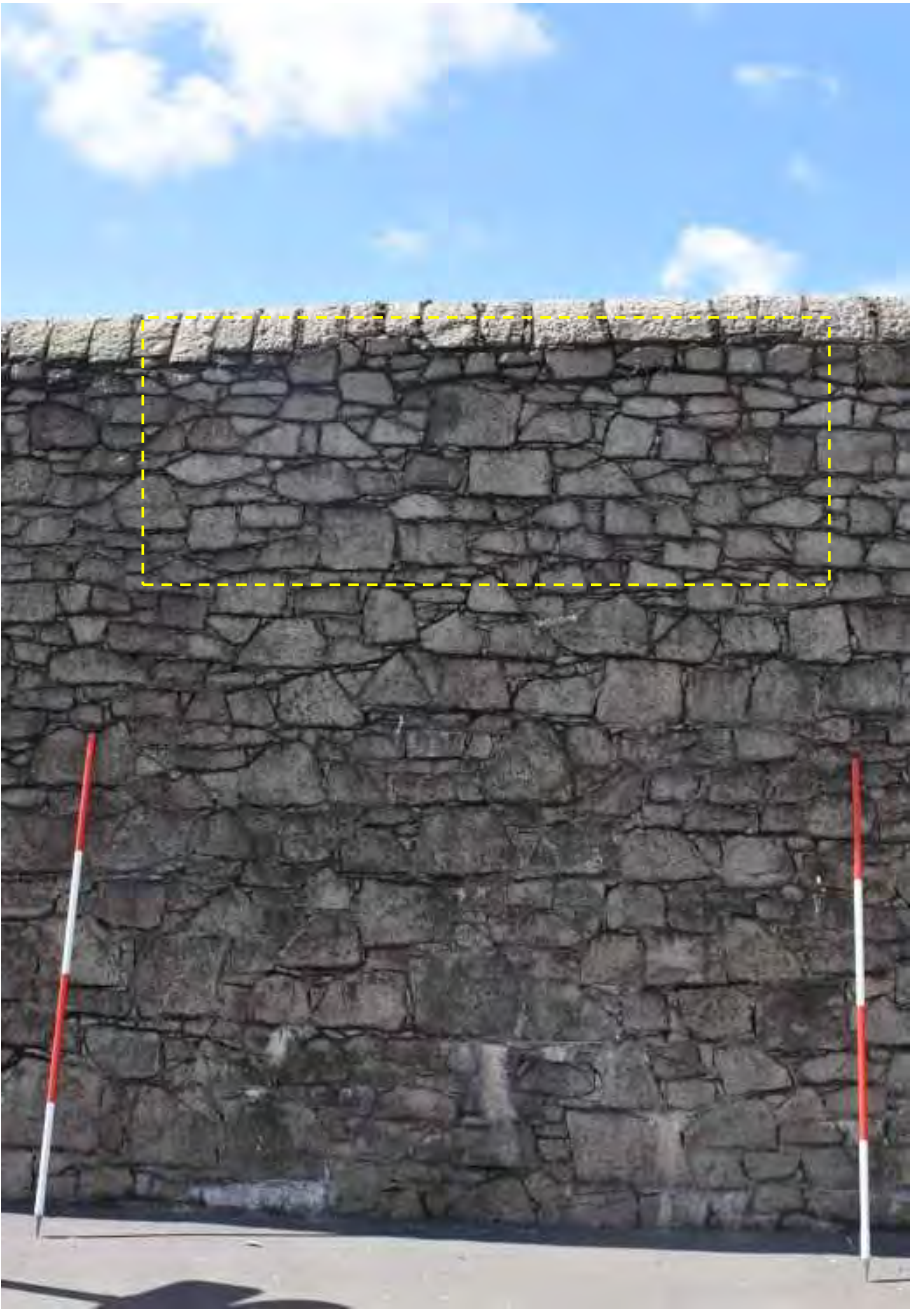
| Location Ref: | RR South Elevation – Section 18 |
|---|---|
| <p>Wall section width approx. 3.0m</p> <p>Coping stones have been re-pointed (RR side only).</p> <p>Mortar loss and cracking to upper wall areas.</p> <p>More minor mortar loss and cracking to lower levels.</p> | <p>The photograph shows a close-up of a stone wall. A yellow dashed rectangular box is drawn over the upper portion of the wall, indicating the area of re-pointing. Two vertical poles with red and white segments are positioned on either side of the wall at the bottom to provide a sense of scale. The sky is visible above the wall.</p> |

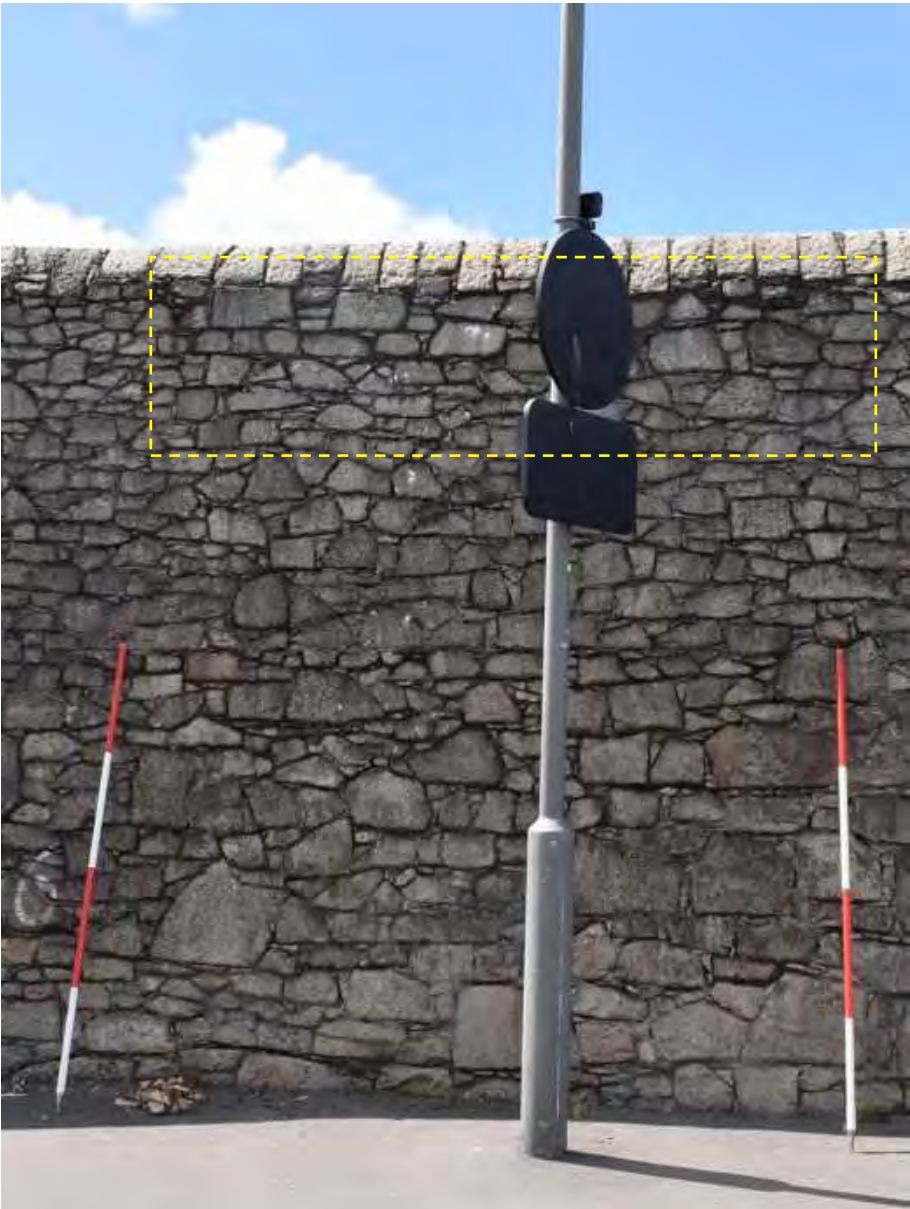
| Location Ref: | RR South Elevation – Section 19 |
|---|--|
| <p>Wall section width approx. 3.0m</p> <p>Coping stones have been re-pointed (RR side only).</p> <p>Mortar loss and cracking to upper wall areas.</p> <p>More minor mortar loss and cracking to lower levels.</p> | |
