## ASBESTOS REFURBISHMENT & DEMOLITION SURVEY

15-33 Hardman Street  
Liverpool  
L1 9AS

For  
Carpenter Investments Ltd

**Issue Date:** 25/05/2016  
**Copy No:** 1

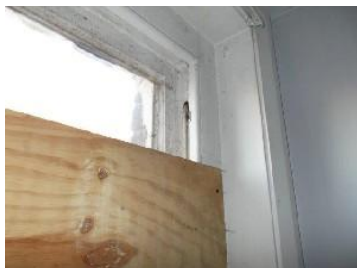
Ref. No. 797001/001

DESCRIPTION: Rope. Sash windows – Flat and throughout property.

<b>Type Detail:</b>	Rope	<b>Lab. Ref. No:</b>	J080776
<b>Access:</b>	Good	<b>Amount Present (approx):</b>	Unknown

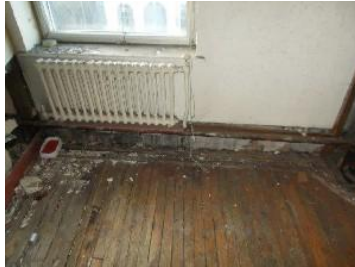
DESCRIPTION: Insulation debris to pipework. Throughout second floor - Sample taken R2.

<b>Type Detail:</b>	Insulation	<b>Lab. Ref. No:</b>	J080776
<b>Access:</b>	Poor	<b>Amount Present (approx):</b>	Unknown

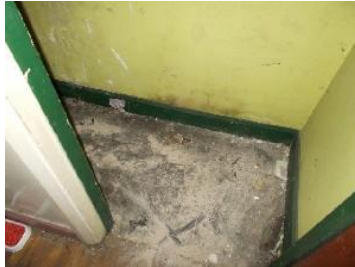
DESCRIPTION: Floor tiles & adhesive. Under flat stairs R4.

<b>Type Detail:</b>	Vinyl Material	<b>Lab. Ref. No:</b>	J080776
<b>Access:</b>	Good	<b>Amount Present (approx):</b>	3m2

<b>Product Type:</b>	Asbestos-Reinforced Composites	1
<b>Extent of Deterioration:</b>	Good Condition	0
<b>Surface Treatment:</b>	Composites containing asbestos	0
<b>Asbestos Type:</b>	Chrysotile	1
<b>Adjust:</b>		0
<b>Priority Level:</b>		2

**Chrysotile was found in both the tiles and the adhesive**

### RECOMMENDATION (Based on priority level above):

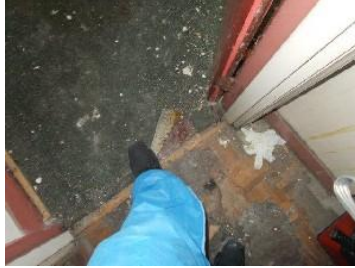
DESCRIPTION: Floor covering. Under carpet R5 - Second floor.

<b>Type Detail:</b>	Vinyl Material	<b>Lab. Ref. No:</b>	J080776
<b>Access:</b>	Poor	<b>Amount Present (approx):</b>	9m2

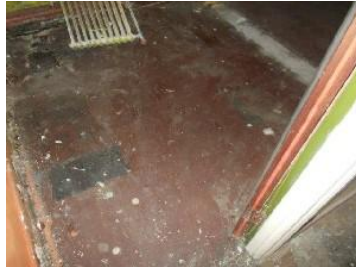
DESCRIPTION: Floor covering, R7 - Second Floor.

<b>Type Detail:</b>	Vinyl Material	<b>Lab. Ref. No:</b>	J080776
<b>Access:</b>	Good	<b>Amount Present (approx):</b>	Unknown

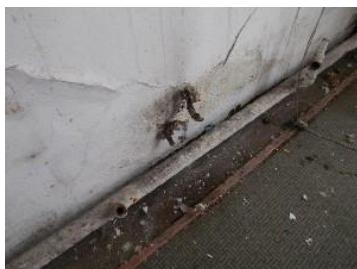
DESCRIPTION: Insulation debris on pipework. R13 - Second Floor.

<b>Type Detail:</b>	Insulation	<b>Lab. Ref. No:</b>	J080776
<b>Access:</b>	Good	<b>Amount Present (approx):</b>	Unknown
<b>Asbestos Present?</b>	None detected		
<b>Lab Detail:</b>

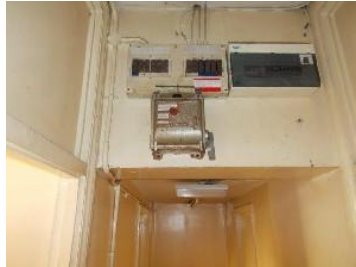
DESCRIPTION: Woven flashguards & rope seal. Electric panels throughout property.

<b>Type Detail:</b>	Woven Material and Rope	<b>Lab. Ref. No:</b>	J080776
<b>Access:</b>	Good	<b>Amount Present (approx):</b>	Throughout
<b>Asbestos Present?</b>	Yes		
<b>Lab Detail:</b>	Chrysotile - White

<b>Product Type:</b>	Asbestos-Reinforced Composites	1
<b>Extent of Deterioration:</b>	Good Condition	0
<b>Surface Treatment:</b>	Composites containing asbestos	0
<b>Asbestos Type:</b>	Chrysotile	1
<b>Adjust:</b>		0
<b>Priority Level:</b>		2

### RECOMMENDATION (Based on priority level above):

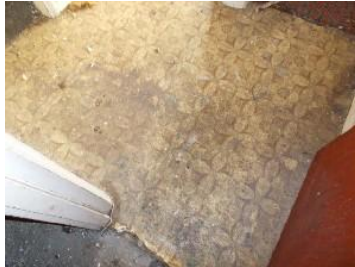
DESCRIPTION: Floor covering. Corridor - R25A, R48A, R49A, R50A & R51A.

<b>Type Detail:</b>	Vinyl Material	<b>Lab. Ref. No:</b>	J080776
<b>Access:</b>	Good	<b>Amount Present (approx):</b>	Unknown

<b>Product Type:</b>	Asbestos-Reinforced Composites	1
<b>Extent of Deterioration:</b>	Good Condition	0
<b>Surface Treatment:</b>	Composites containing asbestos	0
<b>Asbestos Type:</b>	Chrysotile	1
<b>Adjust:</b>		0
<b>Priority Level:</b>		2

### RECOMMENDATION (Based on priority level above):

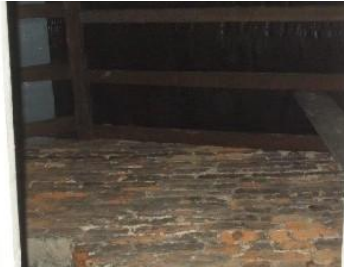
DESCRIPTION: Roofing felt. Loft space - Front of building.

<b>Type Detail:</b>	Bitumen	<b>Lab. Ref. No:</b>	J080776
<b>Access:</b>	Poor	<b>Amount Present (approx):</b>	Unknown

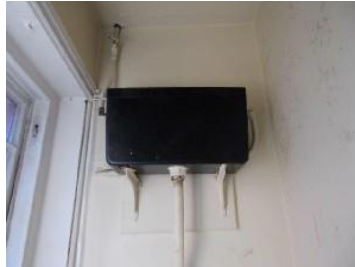
DESCRIPTION: WC cistern. Toilet R26.

<b>Type Detail:</b>	Resin	<b>Lab. Ref. No:</b>	J080776
<b>Access:</b>	Good	<b>Amount Present (approx):</b>	1

<b>Product Type:</b>	Asbestos-Reinforced Composites	1
<b>Extent of Deterioration:</b>	Good Condition	0
<b>Surface Treatment:</b>	Composites containing asbestos	0
<b>Asbestos Type:</b>	Amphibole excluding crocidolite	2
<b>Adjust:</b>		0
<b>Priority Level:</b>		<b>3</b>

### RECOMMENDATION (Based on priority level above):

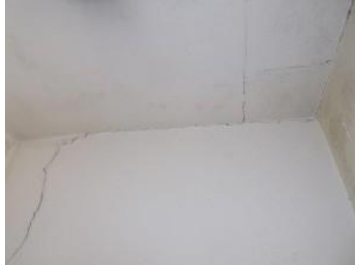
DESCRIPTION: Artex. Walls & Ceiling of R2.

<b>Type Detail:</b>	Textured Coating	<b>Lab. Ref. No:</b>	J080776
<b>Access:</b>	Good	<b>Amount Present (approx):</b>	12m2

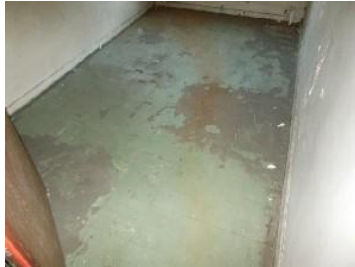
DESCRIPTION: Green floor tiles & adhesive. R30, R34 & R35.

Type Detail:	Vinyl Material	Lab. Ref. No:	J080776
Access:	Good	Amount Present (approx):	10m2

Product Type:	Asbestos-Reinforced Composites	1
Extent of Deterioration:	Good Condition	0
Surface Treatment:	Composites containing asbestos	0
Asbestos Type:	Chrysotile	1
Adjust:		0
Priority Level:		2

**Chrysotile was found in both the tiles and the adhesive**

### RECOMMENDATION (Based on priority level above):

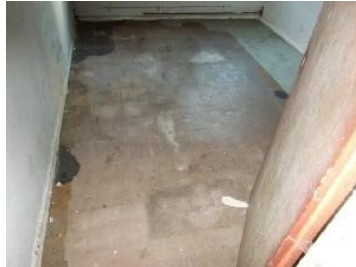
DESCRIPTION: Red floor tiles & adhesive. R31, R36 & R37.

<b>Type Detail:</b>	Vinyl Material	<b>Lab. Ref. No:</b>	J080776
<b>Access:</b>	Good	<b>Amount Present (approx):</b>	12m2

<b>Product Type:</b>	Asbestos-Reinforced Composites	1
<b>Extent of Deterioration:</b>	Good Condition	0
<b>Surface Treatment:</b>	Composites containing asbestos	0
<b>Asbestos Type:</b>	Chrysotile	1
<b>Adjust:</b>		0
<b>Priority Level:</b>		2

**Chrysotile was found in both the tiles and the adhesive**

### RECOMMENDATION (Based on priority level above):

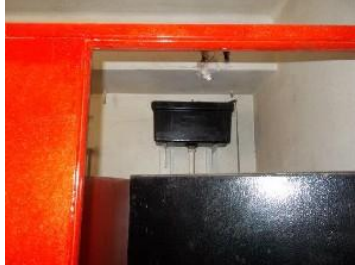
DESCRIPTION: WC cistern. R42.

<b>Type Detail:</b>	Resin	<b>Lab. Ref. No:</b>	J080776
<b>Access:</b>	Good	<b>Amount Present (approx):</b>	3

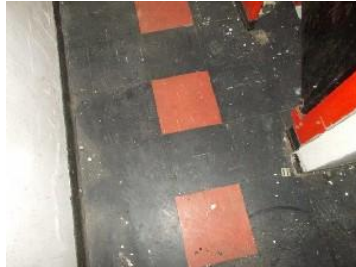
DESCRIPTION: Floor tiles. R42.

<b>Type Detail:</b>	Vinyl Material	<b>Lab. Ref. No:</b>	J080776
<b>Access:</b>	Good	<b>Amount Present (approx):</b>	10m2

<b>Product Type:</b>	Asbestos-Reinforced Composites	1
<b>Extent of Deterioration:</b>	Good Condition	0
<b>Surface Treatment:</b>	Composites containing asbestos	0
<b>Asbestos Type:</b>	Chrysotile	1
<b>Adjust:</b>		0
<b>Priority Level:</b>		2

### RECOMMENDATION (Based on priority level above):

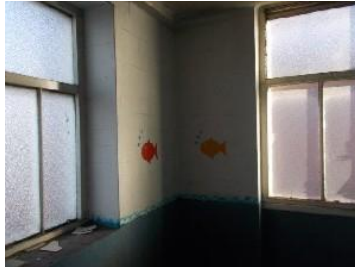
DESCRIPTION: Small wall tiles. R43, R48A & R122.

<b>Type Detail:</b>	Vinyl Material	<b>Lab. Ref. No:</b>	J080776
<b>Access:</b>	Good	<b>Amount Present (approx):</b>	Unknown

<b>Product Type:</b>	Asbestos-Reinforced Composites	1
<b>Extent of Deterioration:</b>	Good Condition	0
<b>Surface Treatment:</b>	Composites containing asbestos	0
<b>Asbestos Type:</b>	Chrysotile	1
<b>Adjust:</b>		0
<b>Priority Level:</b>		2

### RECOMMENDATION (Based on priority level above):

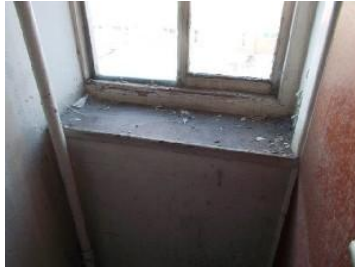
DESCRIPTION: Tiles & adhesive used on window sills. Corridor next to R43, R47 & R122.

<b>Type Detail:</b>	Vinyl Material	<b>Lab. Ref. No:</b>	J080776
<b>Access:</b>	Good	<b>Amount Present (approx):</b>	1m2

<b>Product Type:</b>	Asbestos-Reinforced Composites	1
<b>Extent of Deterioration:</b>	Good Condition	0
<b>Surface Treatment:</b>	Composites containing asbestos	0
<b>Asbestos Type:</b>	Chrysotile	1
<b>Adjust:</b>		0
<b>Priority Level:</b>		2

**Chrysotile was found in both the tiles and the adhesive**

### RECOMMENDATION (Based on priority level above):

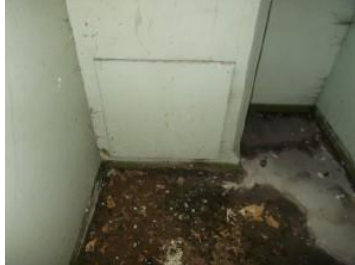
DESCRIPTION: Insulation board. Vent panel R38.

<b>Type Detail:</b>	Board	<b>Lab. Ref. No:</b>	J080776
<b>Access:</b>	Good	<b>Amount Present (approx):</b>	>1m2

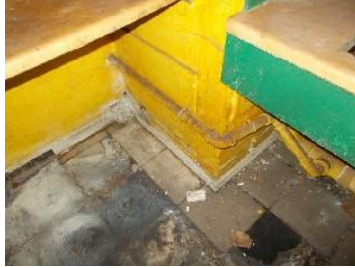
DESCRIPTION: Insulation board. Low level below worktop R40.

<b>Type Detail:</b>	Board	<b>Lab. Ref. No:</b>	J080776
<b>Access:</b>	Good	<b>Amount Present (approx):</b>	>1m2

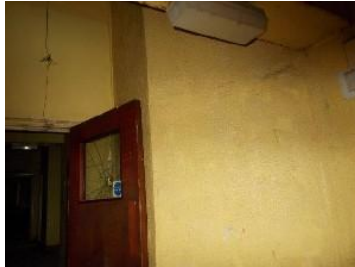
DESCRIPTION: Artex. Walls & ceilings R41.

<b>Type Detail:</b>	Textured Coating	<b>Lab. Ref. No:</b>	J080776
<b>Access:</b>	Good	<b>Amount Present (approx):</b>	100m2

<b>Product Type:</b>	Asbestos-Reinforced Composites	1
<b>Extent of Deterioration:</b>	High Damage	7
<b>Surface Treatment:</b>	Composites containing asbestos	0
<b>Asbestos Type:</b>	Chrysotile	1
<b>Adjust:</b>		0
	<b>Priority Level:</b>	<b>9</b>

### RECOMMENDATION (Based on priority level above):

This material should be repaired/encapsulated and then managed and maintained in the asbestos register but if at any time it falls into maintenance or refurbishment works, it should be properly risk assessed and can be removed by a competent contractor under the control of Asbestos Regulation 2012 and disposed of as special waste.

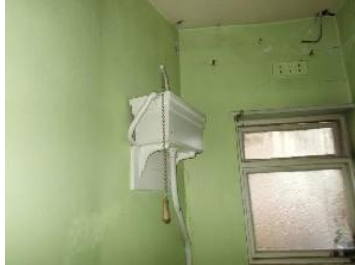
DESCRIPTION: WC cistern. R114 & R116.

<b>Type Detail:</b>	Resin	<b>Lab. Ref. No:</b>	J080776
<b>Access:</b>	Good	<b>Amount Present (approx):</b>	1

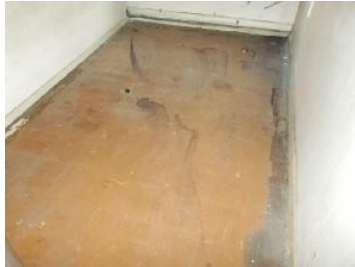
DESCRIPTION: Red floor tiles. R117 & R119.

<b>Type Detail:</b>	Vinyl Material	<b>Lab. Ref. No:</b>	J080776
<b>Access:</b>	Good	<b>Amount Present (approx):</b>	10m2

<b>Product Type:</b>	Asbestos-Reinforced Composites	1
<b>Extent of Deterioration:</b>	Good Condition	0
<b>Surface Treatment:</b>	Composites containing asbestos	0
<b>Asbestos Type:</b>	Chrysotile	1
<b>Adjust:</b>		0
<b>Priority Level:</b>		2

**Chrysotile was found in both the tiles and the adhesive**

### RECOMMENDATION (Based on priority level above):

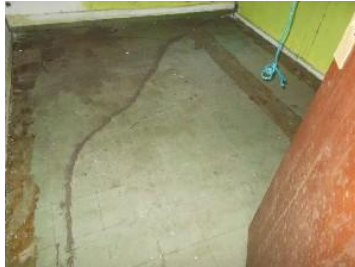
DESCRIPTION: Green floor tiles. R118 & R120.

<b>Type Detail:</b>	Vinyl Material	<b>Lab. Ref. No:</b>	J080776
<b>Access:</b>	Good	<b>Amount Present (approx):</b>	10m2

<b>Product Type:</b>	Asbestos-Reinforced Composites	1
<b>Extent of Deterioration:</b>	Good Condition	0
<b>Surface Treatment:</b>	Composites containing asbestos	0
<b>Asbestos Type:</b>	Chrysotile	1
<b>Adjust:</b>		0
<b>Priority Level:</b>		2

**Chrysotile was found in both the tiles and the adhesive**

### RECOMMENDATION (Based on priority level above):

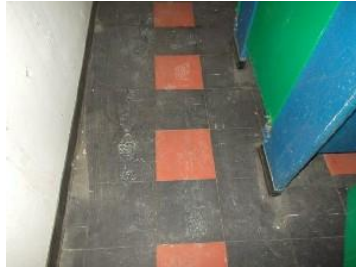
DESCRIPTION: Floor tiles. Toilet Block R121.

<b>Type Detail:</b>	Vinyl Material	<b>Lab. Ref. No:</b>	J080776
<b>Access:</b>	Good	<b>Amount Present (approx):</b>	Unknown

<b>Product Type:</b>	Asbestos-Reinforced Composites	1
<b>Extent of Deterioration:</b>	Good Condition	0
<b>Surface Treatment:</b>	Composites containing asbestos	0
<b>Asbestos Type:</b>	Chrysotile	1
<b>Adjust:</b>		0
<b>Priority Level:</b>		2

### RECOMMENDATION (Based on priority level above):

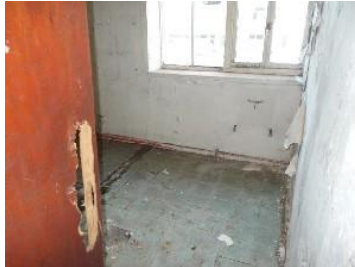
DESCRIPTION: Green floor tiles & tiles on window sill. R124.

Type Detail:	Vinyl Material	Lab. Ref. No:	J080776
Access:	Good	Amount Present (approx):	24m2

Product Type:	Asbestos-Reinforced Composites	1
Extent of Deterioration:	Good Condition	0
Surface Treatment:	Composites containing asbestos	0
Asbestos Type:	Chrysotile	1
Adjust:		0
Priority Level:		2

**Chrysotile was found in both the tiles and the adhesive**

### RECOMMENDATION (Based on priority level above):

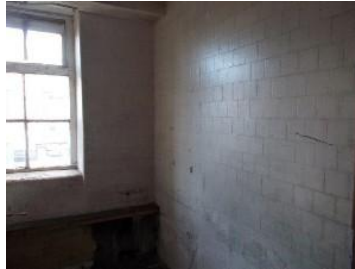
DESCRIPTION: Small wall tiles. R128.

<b>Type Detail:</b>	Vinyl Material	<b>Lab. Ref. No:</b>	J080776
<b>Access:</b>	Good	<b>Amount Present (approx):</b>	10m2

<b>Product Type:</b>	Asbestos-Reinforced Composites	1
<b>Extent of Deterioration:</b>	Good Condition	0
<b>Surface Treatment:</b>	Composites containing asbestos	0
<b>Asbestos Type:</b>	Chrysotile	1
<b>Adjust:</b>		0
<b>Priority Level:</b>		2

**Chrysotile was found in both the tiles and the adhesive**

### RECOMMENDATION (Based on priority level above):

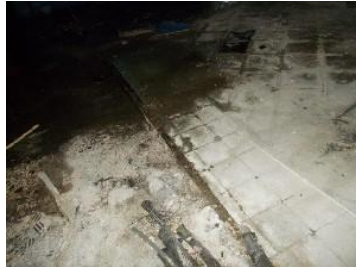
DESCRIPTION: Floor tiles. Club dance floor - First floor.

<b>Type Detail:</b>	Vinyl Material	<b>Lab. Ref. No:</b>	J080776
<b>Access:</b>	Good	<b>Amount Present (approx):</b>	Unknown

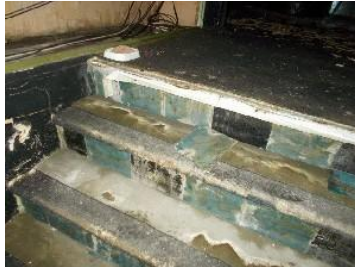
DESCRIPTION: Floor tiles. Fire exit in club.

<b>Type Detail:</b>	Vinyl Material	<b>Lab. Ref. No:</b>	J080776
<b>Access:</b>	Good	<b>Amount Present (approx):</b>	Unknown

<b>Product Type:</b>	Asbestos-Reinforced Composites	1
<b>Extent of Deterioration:</b>	Good Condition	0
<b>Surface Treatment:</b>	Composites containing asbestos	0
<b>Asbestos Type:</b>	Chrysotile	1
<b>Adjust:</b>		0
<b>Priority Level:</b>		2

### RECOMMENDATION (Based on priority level above):

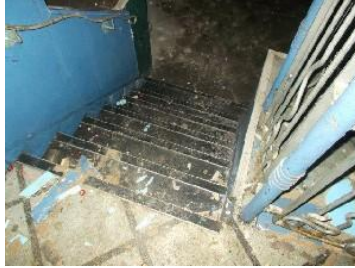
DESCRIPTION: Stair nosing. Club - First floor.

<b>Type Detail:</b>	Vinyl Material	<b>Lab. Ref. No:</b>	J080776
<b>Access:</b>	Good	<b>Amount Present (approx):</b>	Unknown
<b>Asbestos Present?</b>	None detected		
<b>Lab Detail:</b>

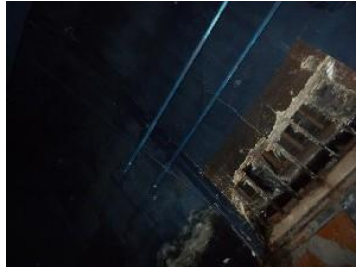
DESCRIPTION: Artex. Ceiling of Dance Hall.

<b>Type Detail:</b>	Textured Coating	<b>Lab. Ref. No:</b>	J080776
<b>Access:</b>	Scaffold Required	<b>Amount Present (approx):</b>	100m2

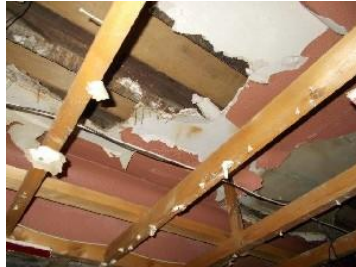
DESCRIPTION: Artex. Above damaged area of suspended ceiling - Ground Floor Club.

<b>Type Detail:</b>	Textured Coating	<b>Lab. Ref. No:</b>	J080776
<b>Access:</b>	Poor	<b>Amount Present (approx):</b>	200m2

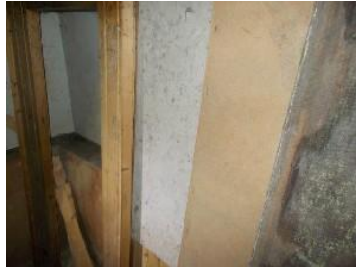
DESCRIPTION: Insulation board. Back of door understair corridor - Club Ground Floor.

<b>Type Detail:</b>	Board	<b>Lab. Ref. No:</b>	J080776
<b>Access:</b>	Good	<b>Amount Present (approx):</b>	1.5m2

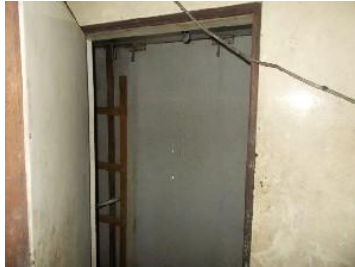
DESCRIPTION: Panels. Internal of fridge - Basement.

<b>Type Detail:</b>	Cement Product	<b>Lab. Ref. No:</b>	J080776
<b>Access:</b>	Good	<b>Amount Present (approx):</b>	24m2 x 2 fridges

<b>Product Type:</b>	Asbestos-Reinforced Composites	1
<b>Extent of Deterioration:</b>	Good Condition	0
<b>Surface Treatment:</b>	Composites containing asbestos	0
<b>Asbestos Type:</b>	Chrysotile	1
<b>Adjust:</b>		0
<b>Priority Level:</b>		2

### RECOMMENDATION (Based on priority level above):

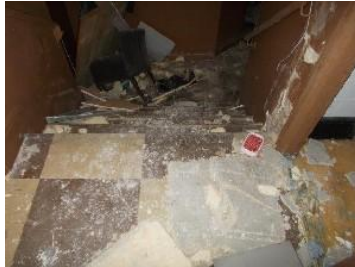
DESCRIPTION: Floor tiles. Staircase to Basement.

<b>Type Detail:</b>	Vinyl Material	<b>Lab. Ref. No:</b>	J080776
<b>Access:</b>	Good	<b>Amount Present (approx):</b>	6m2

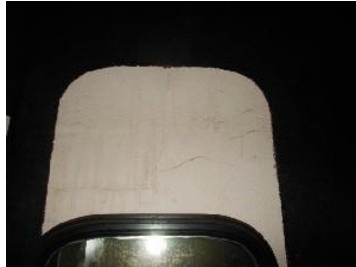
DESCRIPTION: Artex. Walls to basement staircase.

<b>Type Detail:</b>	Textured Coating	<b>Lab. Ref. No:</b>	J080776
<b>Access:</b>	Good	<b>Amount Present (approx):</b>	Unknown
<b>Asbestos Present?</b>	None detected		
<b>Lab Detail:</b>

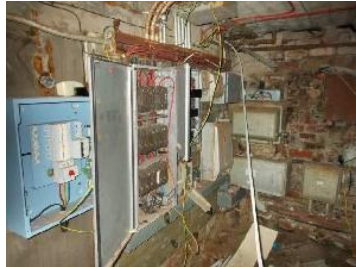
DESCRIPTION: Woven flashguards. Basement electric cupboard.

<b>Type Detail:</b>	Woven	<b>Lab. Ref. No:</b>	J080776
<b>Access:</b>	Good	<b>Amount Present (approx):</b>	Throughout Property

<b>Product Type:</b>	Asbestos-Reinforced Composites	1
<b>Extent of Deterioration:</b>	Good Condition	0
<b>Surface Treatment:</b>	Composites containing asbestos	0
<b>Asbestos Type:</b>	Chrysotile	1
<b>Adjust:</b>		0
<b>Priority Level:</b>		2

### RECOMMENDATION (Based on priority level above):

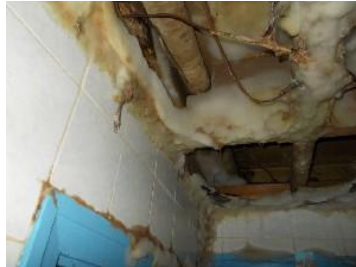
DESCRIPTION: Cloth insulation. Above ceiling toilet area - Basement of Club.

<b>Type Detail:</b>	Cloth	<b>Lab. Ref. No:</b>	J080776
<b>Access:</b>	Poor	<b>Amount Present (approx):</b>	Throughout Basement
<b>Asbestos Present?</b>	None detected		
<b>Lab Detail:</b>

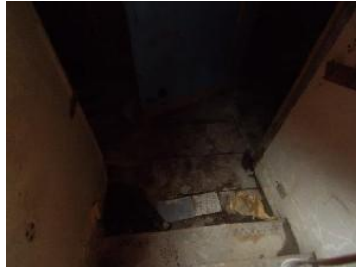
DESCRIPTION: Floor tiles. Steps in Basement.

<b>Type Detail:</b>	Vinyl Material	<b>Lab. Ref. No:</b>	J080776
<b>Access:</b>	Good	<b>Amount Present (approx):</b>	Unknown
<b>Asbestos Present?</b>	None detected		
<b>Lab Detail:</b>

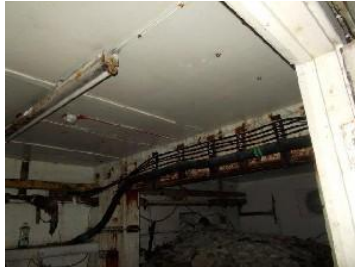
DESCRIPTION: Insulation board. Ceiling of old cellar ceiling - Basement.

Type Detail:	Board	Lab. Ref. No:	J080776
Access:	Poor	Amount Present (approx):	24m2

Product Type:	AIB, Textured Coating or Textile	2
Extent of Deterioration:	Medium Damage	6
Surface Treatment:	Enclosed sprays and lagging	1
Asbestos Type:	Amphibole excluding crocidolite	2
Adjust:		0
Priority Level:		11

RECOMMENDATION (Based on priority level above):

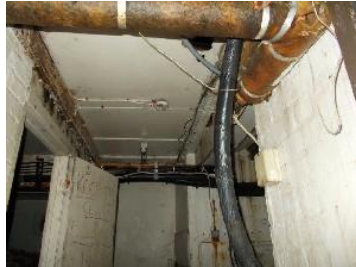
DESCRIPTION: Insulation board. Ceiling of corridor to Cellar.

<b>Type Detail:</b>	Board	<b>Lab. Ref. No:</b>	J080776
<b>Access:</b>	Good	<b>Amount Present (approx):</b>	6m2

<b>Product Type:</b>	AIB, Textured Coating or Textile	2
<b>Extent of Deterioration:</b>	Medium Damage	6
<b>Surface Treatment:</b>	Enclosed sprays and lagging	1
<b>Asbestos Type:</b>	Amphibole excluding crocidolite	2
<b>Adjust:</b>		0
<b>Priority Level:</b>		<b>11</b>

### RECOMMENDATION (Based on priority level above):

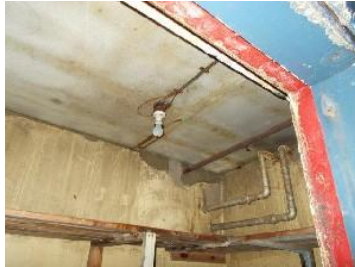
DESCRIPTION: Ceiling panels. Store room opposite Cellar.

<b>Type Detail:</b>	Cement Product	<b>Lab. Ref. No:</b>	J080776
<b>Access:</b>	Poor	<b>Amount Present (approx):</b>	3m2

<b>Product Type:</b>	Asbestos-Reinforced Composites	1
<b>Extent of Deterioration:</b>	Low Damage	1
<b>Surface Treatment:</b>	Enclosed sprays and lagging	1
<b>Asbestos Type:</b>	Chrysotile	1
<b>Adjust:</b>		0
<b>Priority Level:</b>		<b>4</b>

### RECOMMENDATION (Based on priority level above):

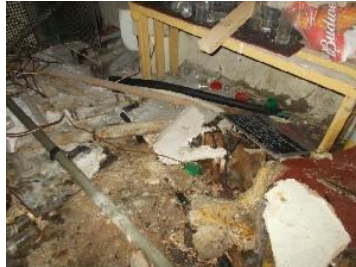
DESCRIPTION: Pipe lagging. Floor of basement area.

<b>Type Detail:</b>	Insulation	<b>Lab. Ref. No:</b>	J080776
<b>Access:</b>	Poor	<b>Amount Present (approx):</b>	Throughout Basement
<b>Asbestos Present?</b>	Yes		
<b>Lab Detail:</b>	Amosite - Brown

<b>Product Type:</b>	Thermal Insulation	3
<b>Extent of Deterioration:</b>	High Damage	7
<b>Surface Treatment:</b>	Unsealed lagging and sprays	3
<b>Asbestos Type:</b>	Amphibole excluding crocidolite	2
<b>Adjust:</b>		0
	<b>Priority Level:</b>	<b>15</b>

RECOMMENDATION (Based on priority level above):

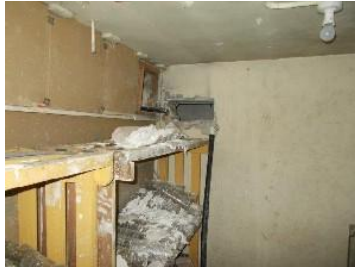
DESCRIPTION: Pipe lagging. Shelves in Basement.

<b>Type Detail:</b>	Insulation	<b>Lab. Ref. No:</b>	J080776
<b>Access:</b>	Poor	<b>Amount Present (approx):</b>	Throughout Store Room
<b>Asbestos Present?</b>	Yes		
<b>Lab Detail:</b>	Amosite - Brown

<b>Product Type:</b>	Thermal Insulation	3
<b>Extent of Deterioration:</b>	High Damage	7
<b>Surface Treatment:</b>	Unsealed lagging and sprays	3
<b>Asbestos Type:</b>	Amphibole excluding crocidolite	2
<b>Adjust:</b>		0
	<b>Priority Level:</b>	<b>15</b>

### RECOMMENDATION (Based on priority level above):

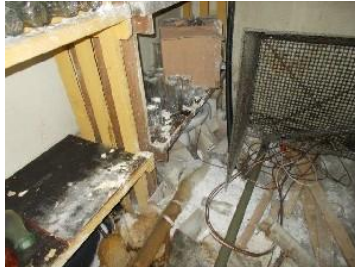
DESCRIPTION: Pipe insulation. On floor in Store Room.

<b>Type Detail:</b>	Insulation	<b>Lab. Ref. No:</b>	J080776
<b>Access:</b>	Poor	<b>Amount Present (approx):</b>	Throughout Store Room
<b>Asbestos Present?</b>	Yes		
<b>Lab Detail:</b>	Amosite - Brown

<b>Product Type:</b>	Thermal Insulation	3
<b>Extent of Deterioration:</b>	High Damage	7
<b>Surface Treatment:</b>	Unsealed lagging and sprays	3
<b>Asbestos Type:</b>	Amphibole excluding crocidolite	2
<b>Adjust:</b>		0
	<b>Priority Level:</b>	<b>15</b>

### RECOMMENDATION (Based on priority level above):

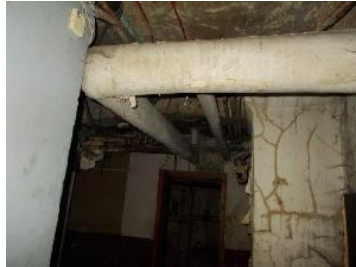
DESCRIPTION: Pipe insulation. Pipework throughout Basement.

<b>Type Detail:</b>	Insulation	<b>Lab. Ref. No:</b>	J080776
<b>Access:</b>	Good	<b>Amount Present (approx):</b>	Unknown

<b>Product Type:</b>	Thermal Insulation	3
<b>Extent of Deterioration:</b>	Medium Damage	6
<b>Surface Treatment:</b>	Unsealed lagging and sprays	3
<b>Asbestos Type:</b>	Amphibole excluding crocidolite	2
<b>Adjust:</b>		0
<b>Priority Level:</b>		<b>14</b>

### RECOMMENDATION (Based on priority level above):

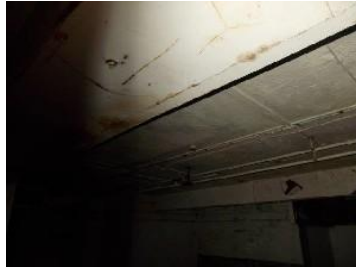
DESCRIPTION: Insulation board. Ceiling of Basement - Cellar area.

<b>Type Detail:</b>	Board	<b>Lab. Ref. No:</b>	J080776
<b>Access:</b>	Good	<b>Amount Present (approx):</b>	30m2

### RECOMMENDATION (Based on priority level above):

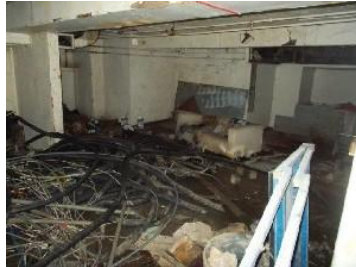
DESCRIPTION: General view of Cellar Board ceiling. .

<b>Type Detail:</b>	Board	<b>Lab. Ref. No:</b>	J080776
<b>Access:</b>	Poor	<b>Amount Present (approx):</b>	30m2

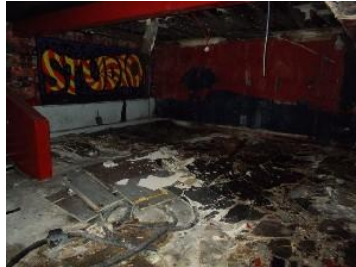
DESCRIPTION: General view of low level club. .

<b>Type Detail:</b>	Plasterboard	<b>Lab. Ref. No:</b>	J080776
<b>Access:</b>	Poor	<b>Amount Present (approx):</b>	Unknown

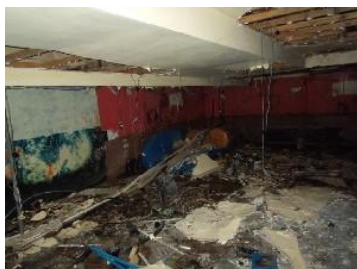
DESCRIPTION: General view of low level club. .

<b>Type Detail:</b>	plasterboard	<b>Lab. Ref. No:</b>	J080776
<b>Access:</b>	Poor	<b>Amount Present (approx):</b>	Unknown
<b>Asbestos Present?</b>	None detected		
<b>Lab Detail:</b>

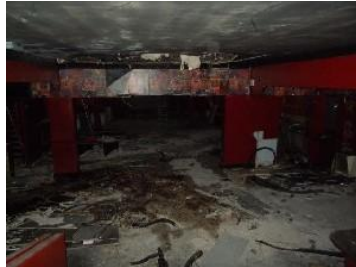
DESCRIPTION: General view of Club. .

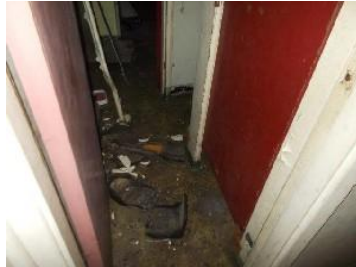
DESCRIPTION: WC cistern. Toilet area - Ground Floor Hostel Area.

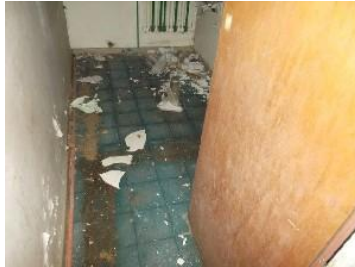
DESCRIPTION: Floor tiles. Hostel Bedrooms - Ground floor.

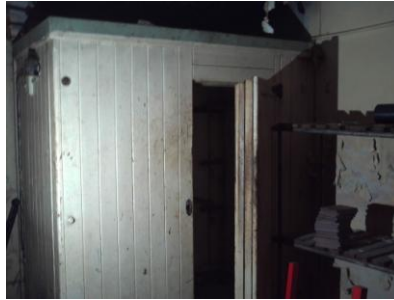
DESCRIPTION: Cement lining to fridge. Basement.

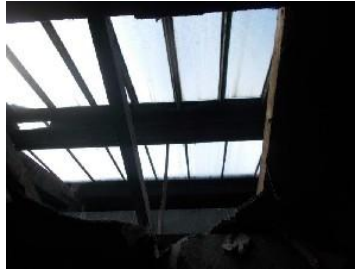
DESCRIPTION: Woven caulking. Skylights.

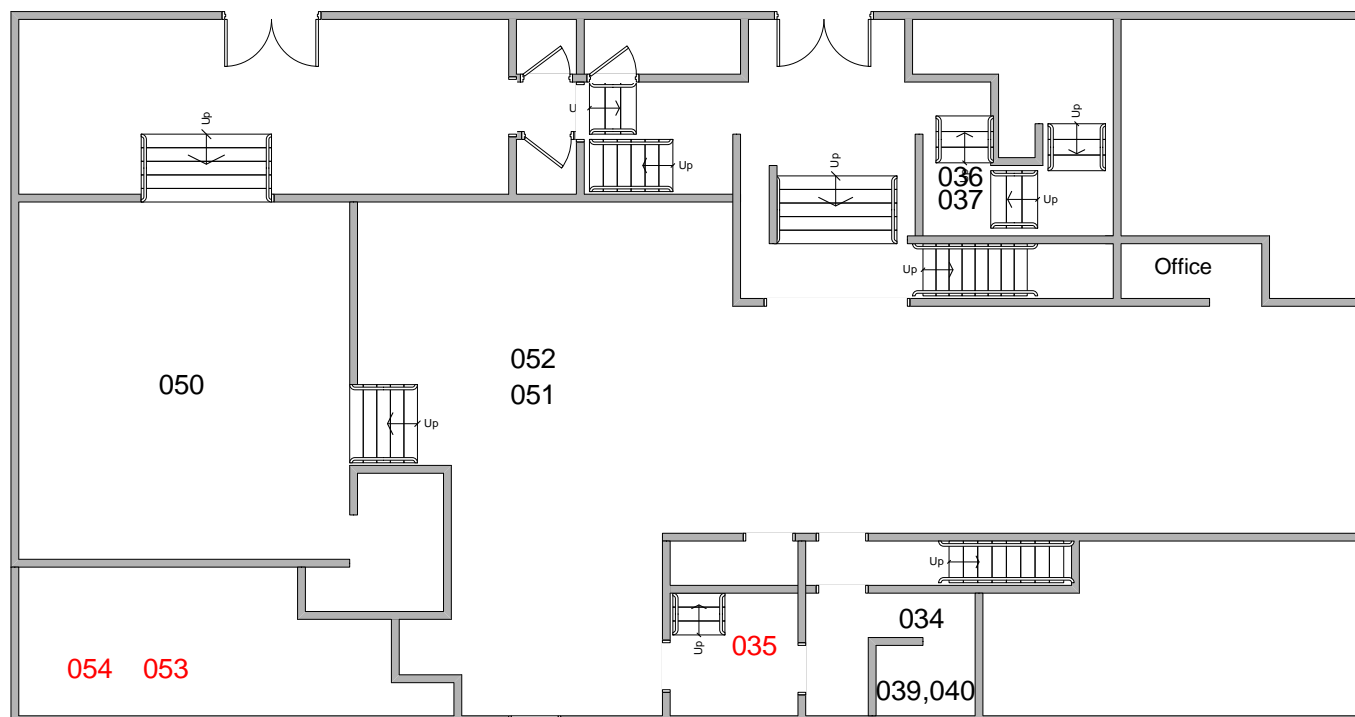
## 12.0 Site Plan

Samples  
038,041,042,043,044,045,046,047,048,049 are all  
in the basement. The basement should only be  
accessed by Licensed Asbestos Removal  
Contractors.
