# **STRUCTURAL SURVEY REPORT**

**BEECHLEY HOUSE, LIVERPOOL**

**REDROW HOMES LIMITED**

**CF 7834  
MARCH 2016**

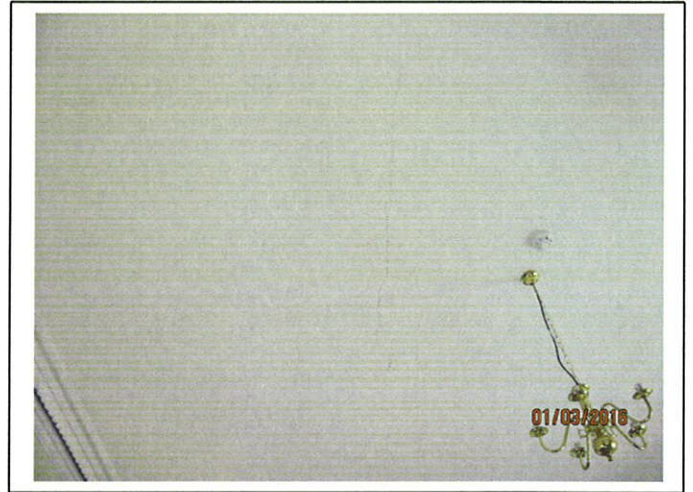
The plastered ceiling has several cracks in it which tend to run parallel with the front elevation. The crack in pattern is synonymous of de-bonding of plasterwork from what it is assumed to be the original laths. In the side elevation there is a fire exit door, the frame of which is showing signs of rot in the bottom right-hand corner.

Ground Floor  
Room 1 - Typical crack in the ceiling.

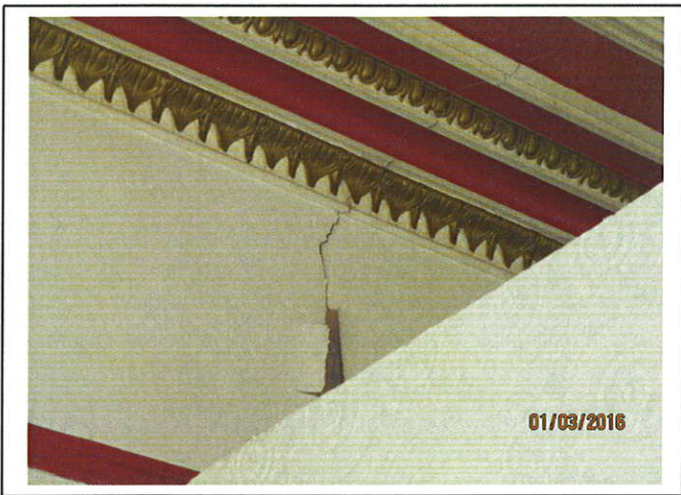
Ground Floor  
Room 3 - Cracking on section of wall adjacent to the staircase.

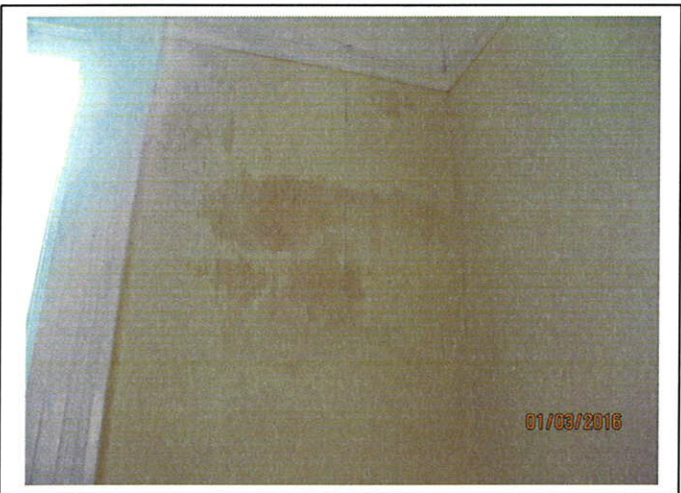
Ground Floor  
Room 9 - Typical damp penetration through from wall.

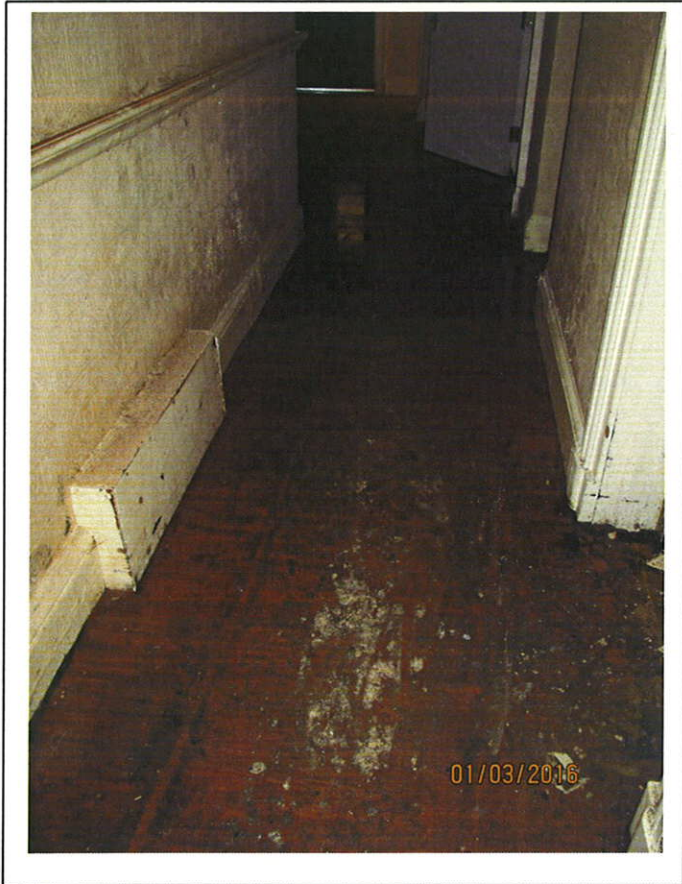
Ground Floor  
Flooding in front of 22

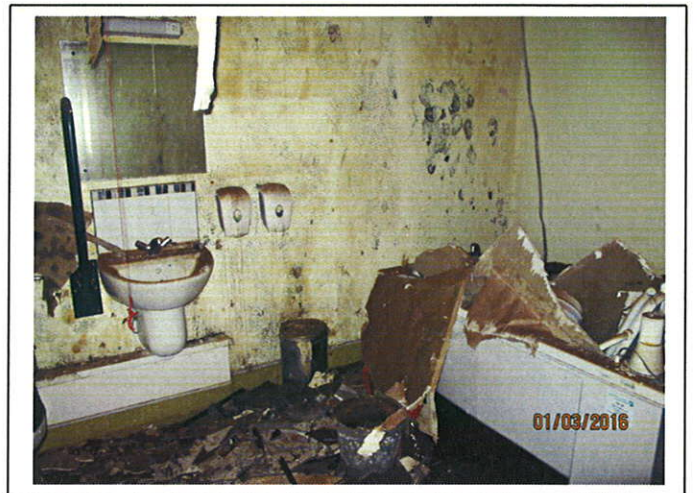
Room 22 is a bathroom area just beyond the corridor. This area has been significantly damaged by water ingress from above, that has caused the ceiling to collapse. There is extensive wet rot and possible dry rot (to be confirmed) in the room, and mould growth is present in the walls. However, the walls themselves appear to be in good order with no evidence of cracking beneath the fungal growth on the walls.

Ground Floor  
Room 22 - Water damage to bathroom

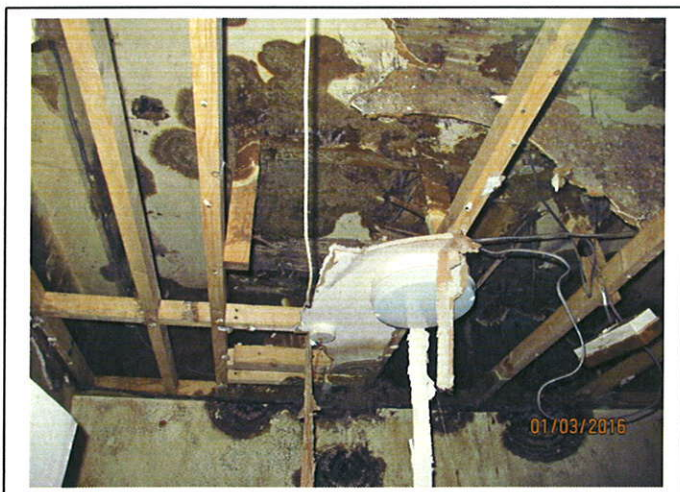
Ground Floor  
Room 22 - Water damage to bathroom.

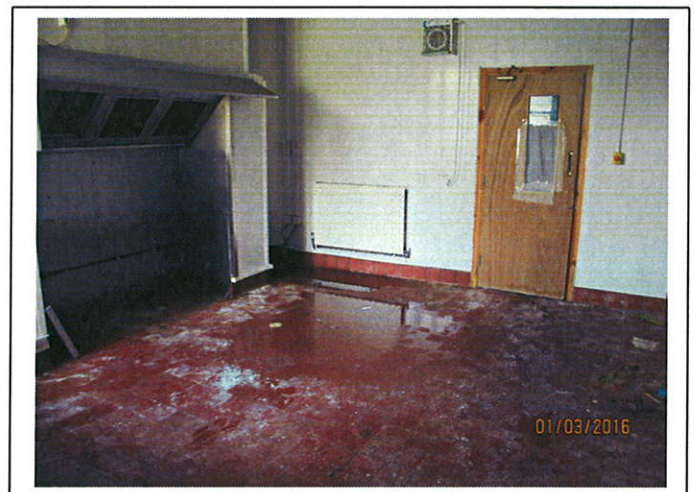
Ground Floor  
Room 19 - Water penetration and ponding on floor.

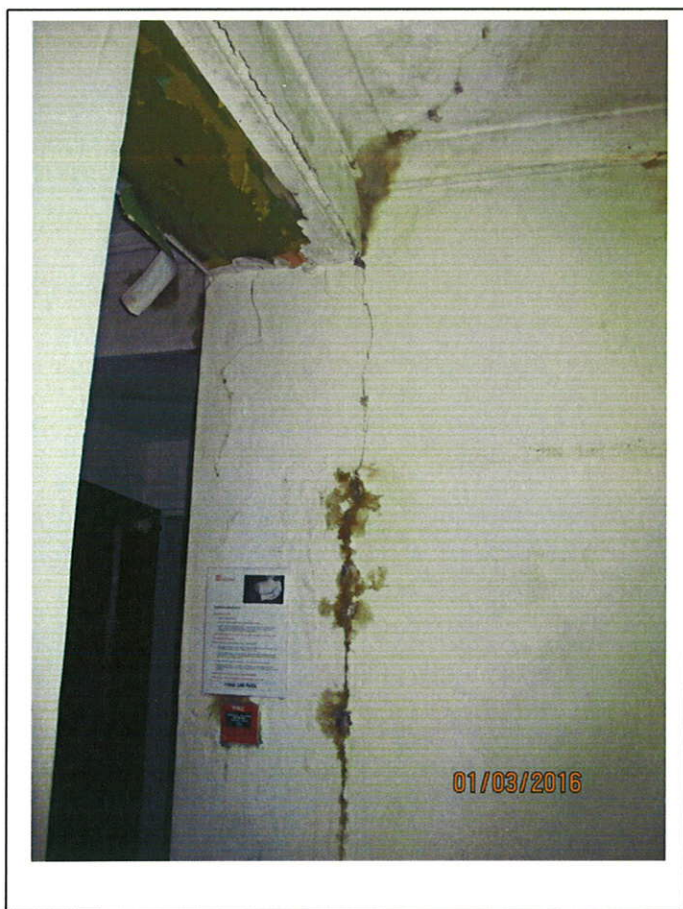
Room 9 is accessed via a small corridor which leads down several steps. The left-hand side of the corridor is showing signs of damp penetration through the walls, suggesting that there is possible leak in the roof. There is a loft hatch at the base of the stairs, which was lifted but only revealed a higher ceiling and no evidence of water penetration. In front of the door to Room 9 there is a timber drop beam around which there is evidence of water penetration through the roof structure, mould growth, staining of the finishes, and spalling of the plaster.

First Floor  
Corridor in front of Room 9 from roof - Damp penetration.

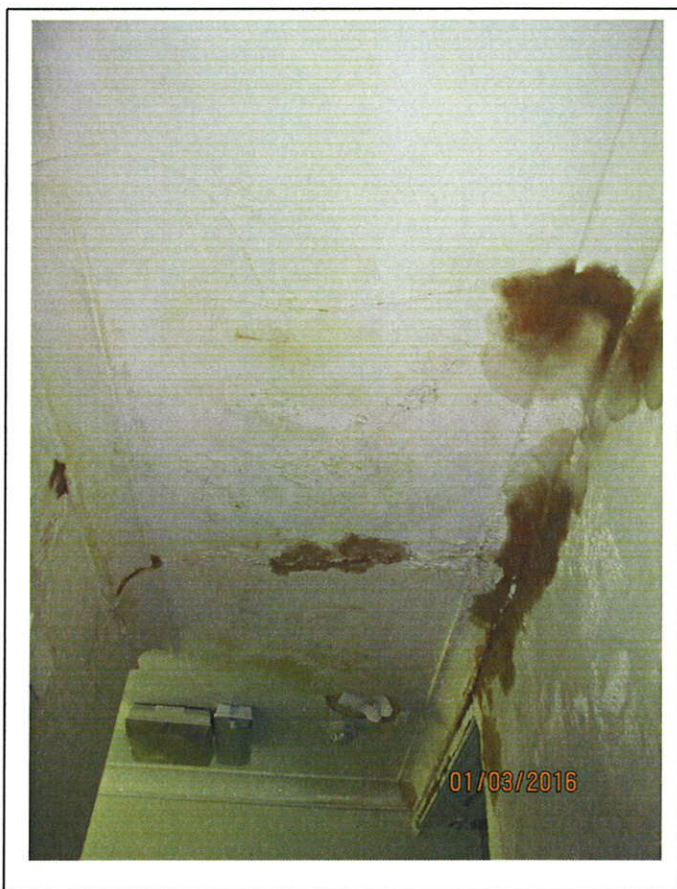
First Floor  
Corridor in front of Room 10 - Damp penetration and mould growth on the ceiling

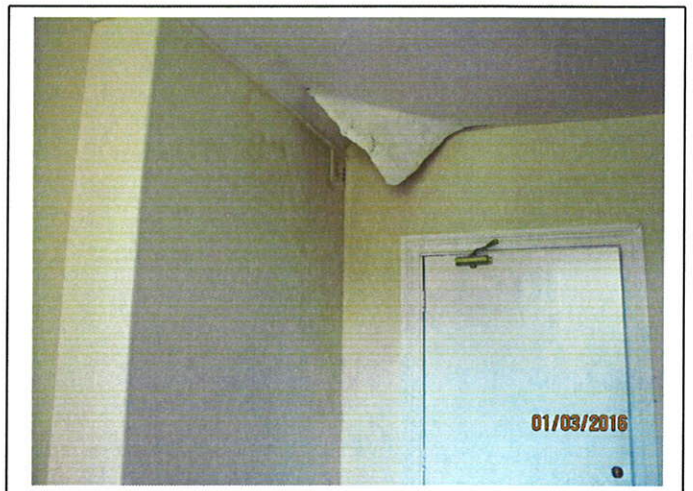
First Floor  
Room 15 - Leaking roof .

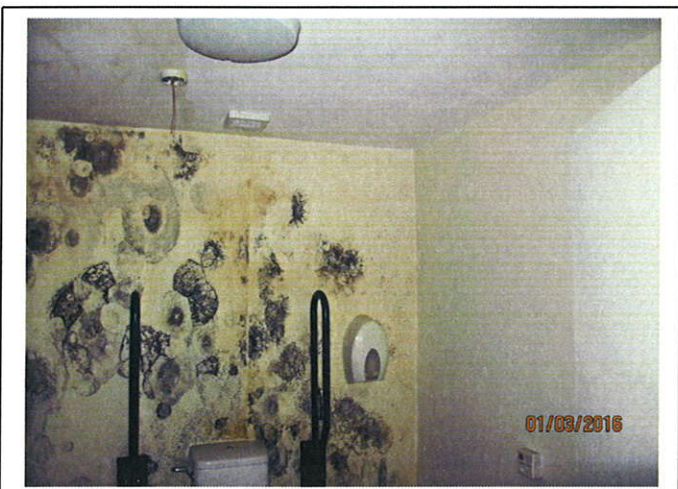
First Floor  
Room 20 - Mould growth on walls

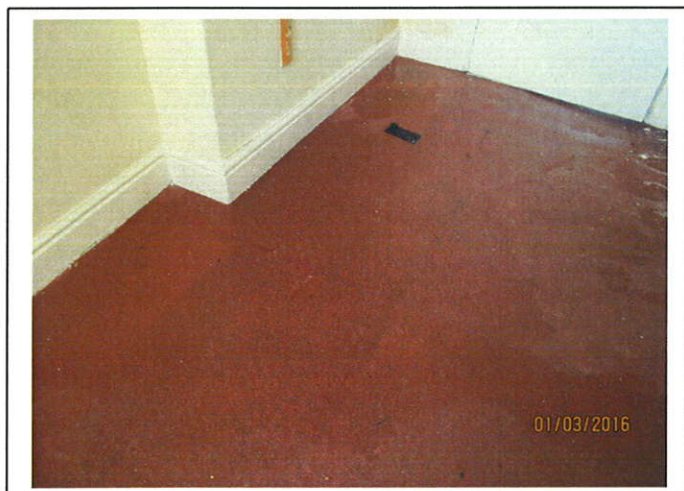
First Floor  
Room 15 - Ponding from leaking roof.

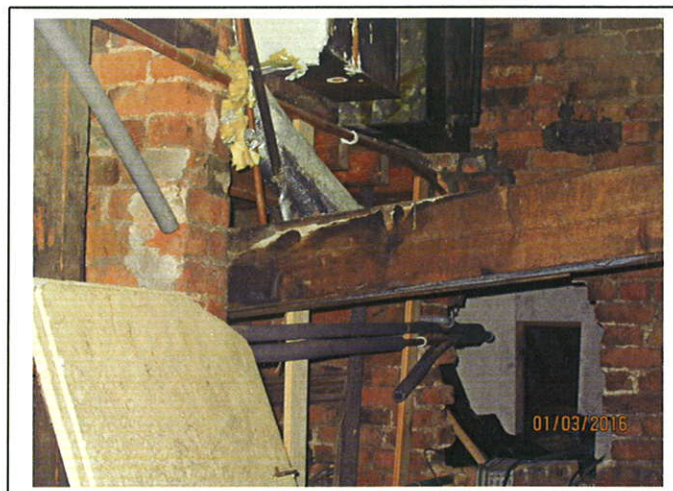
Roof void - Internal timber gutter.

- All flashings, valleys and lead-lined gutters should be assessed and replaced/repared as deemed necessary;
- If the existing roof structure is to remain, this will need to be checked structurally to assess whether or not it can carry the anticipated load from the proposed finishes;

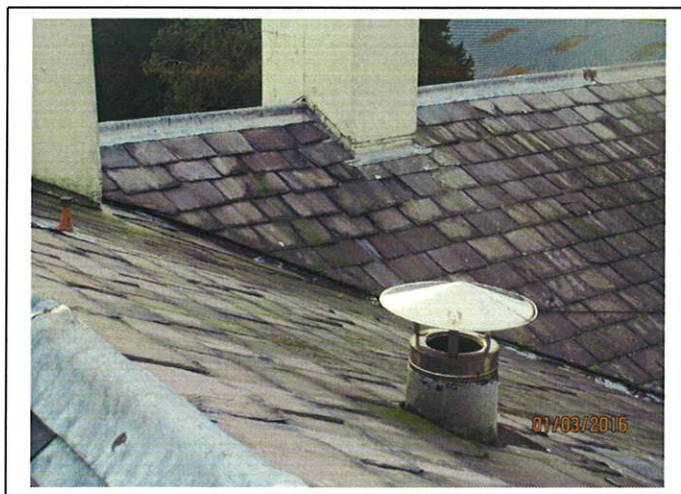
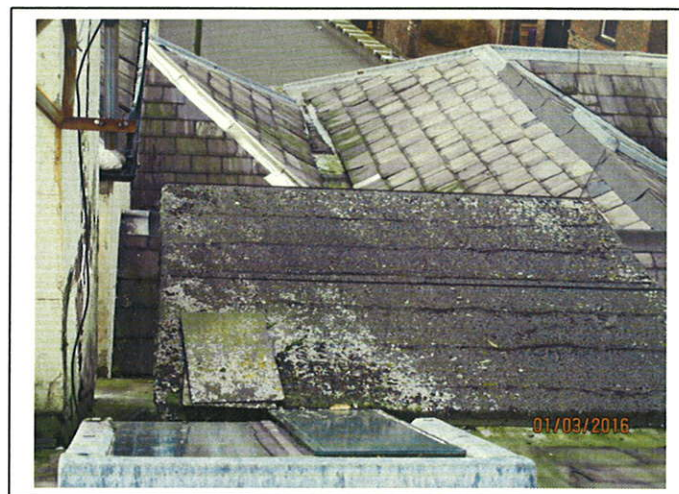
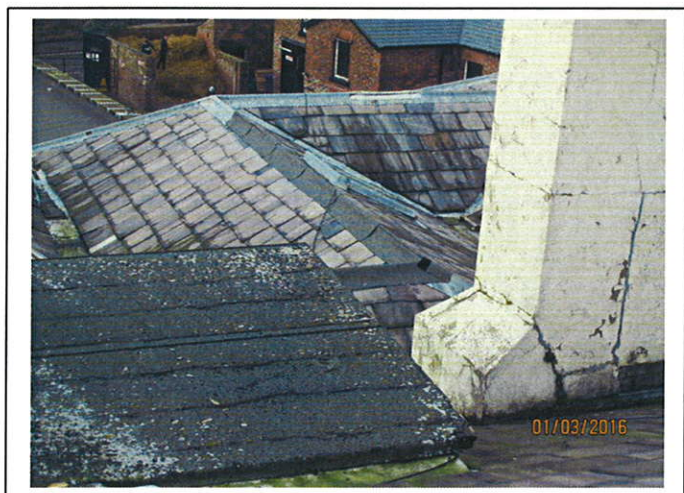
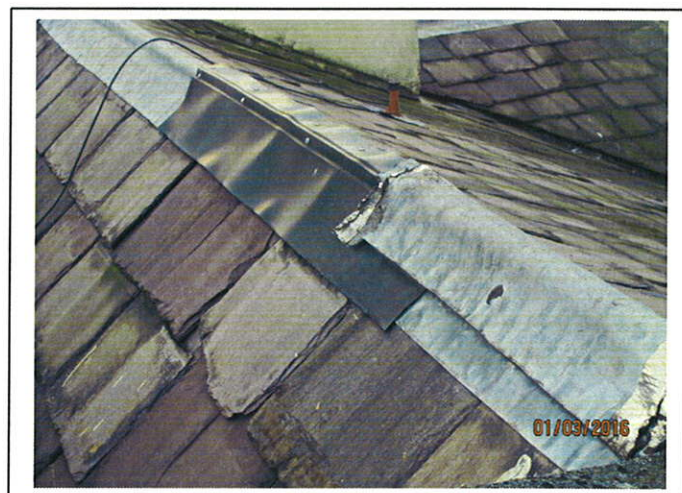
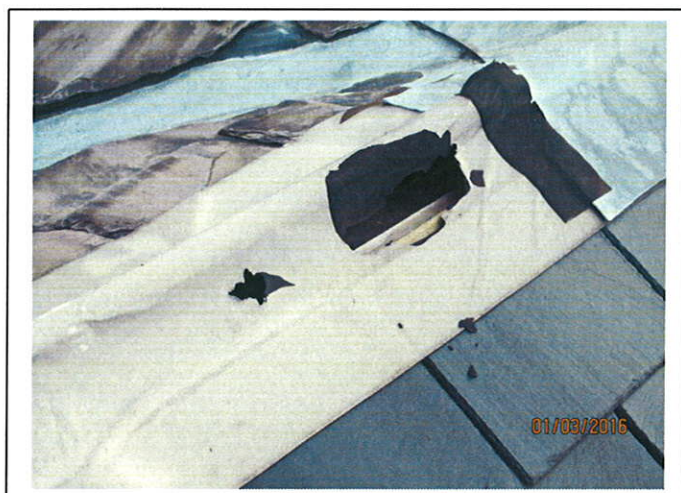
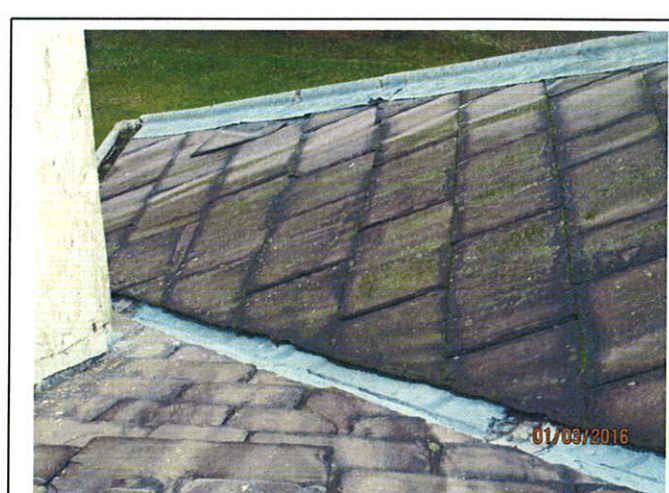
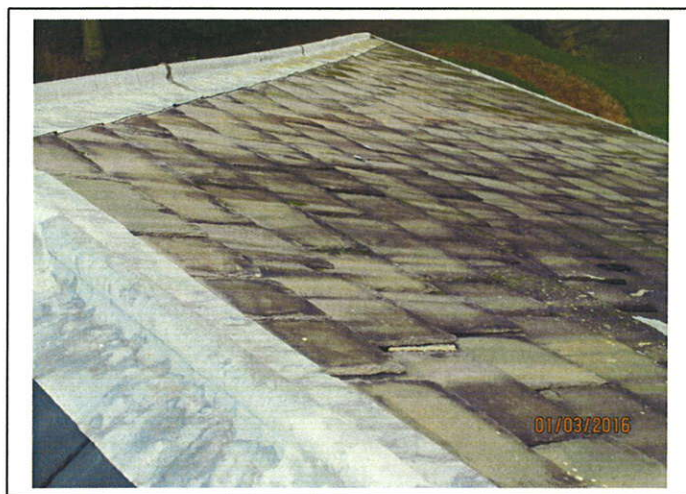
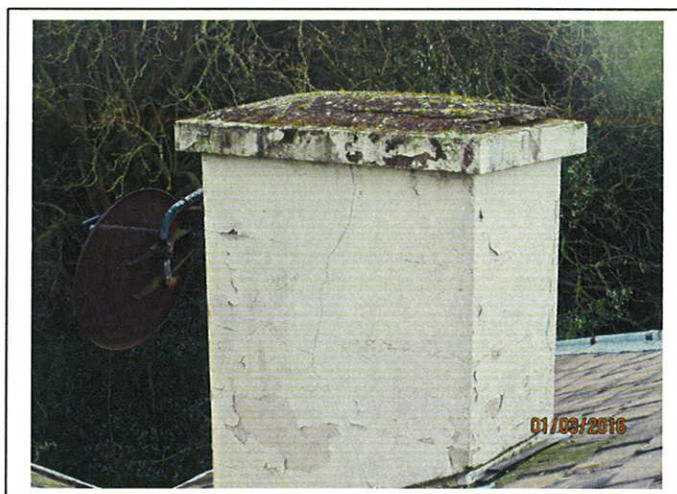
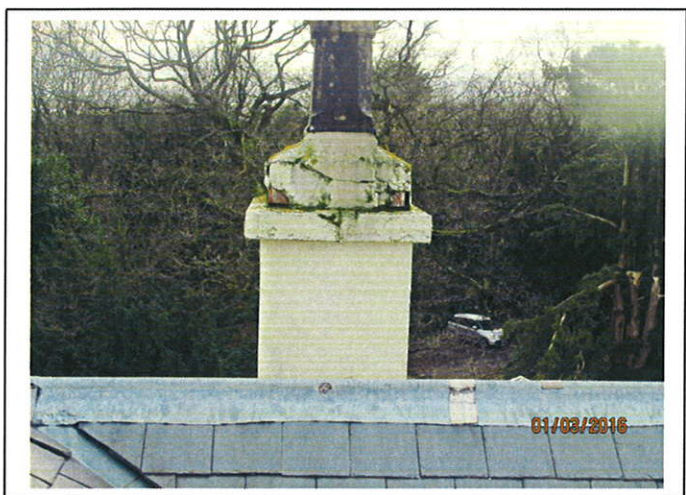
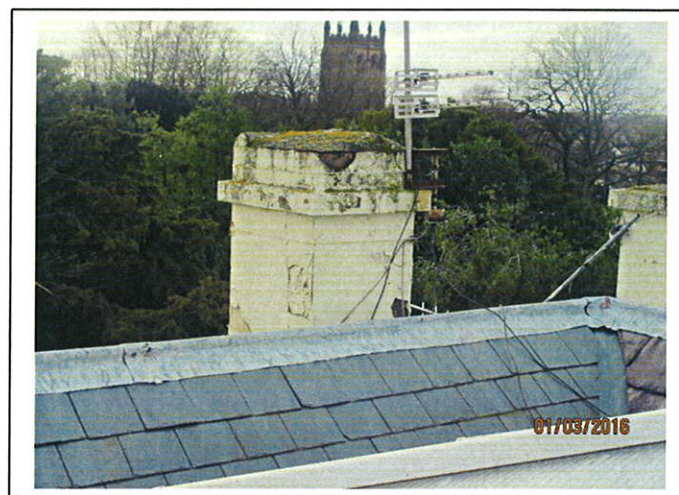
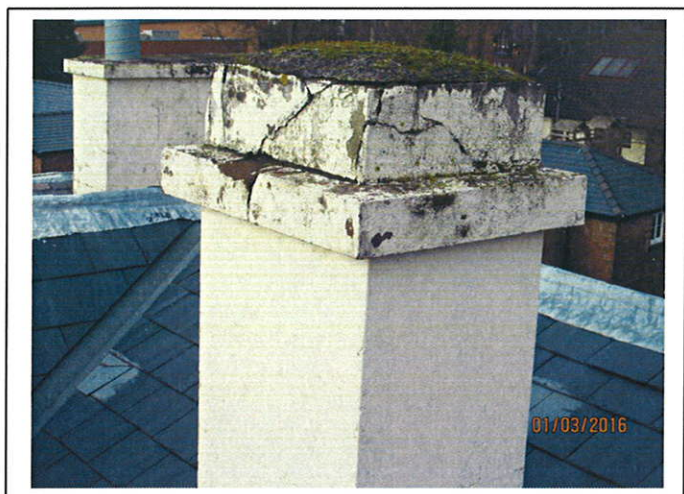
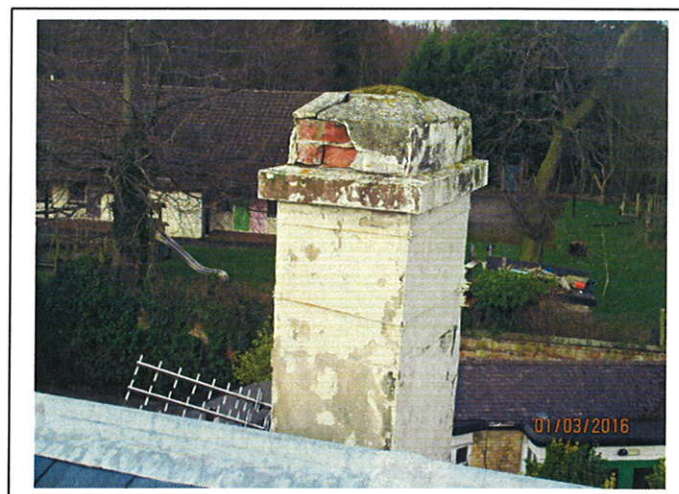
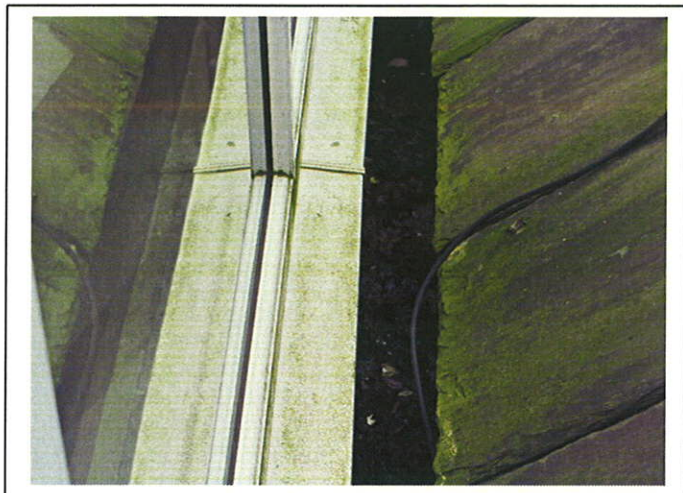
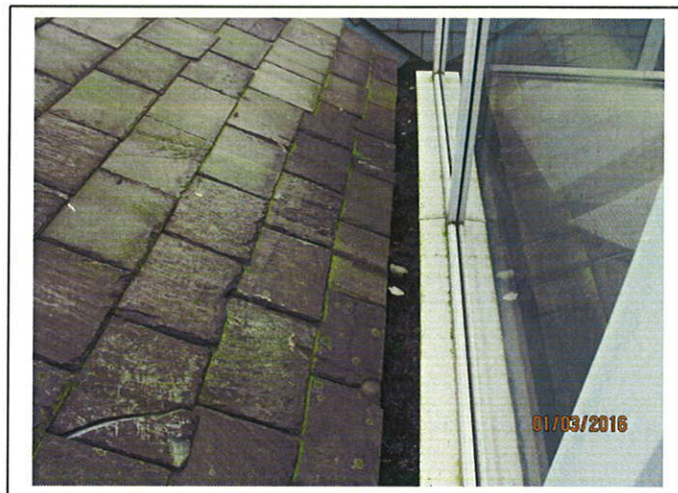
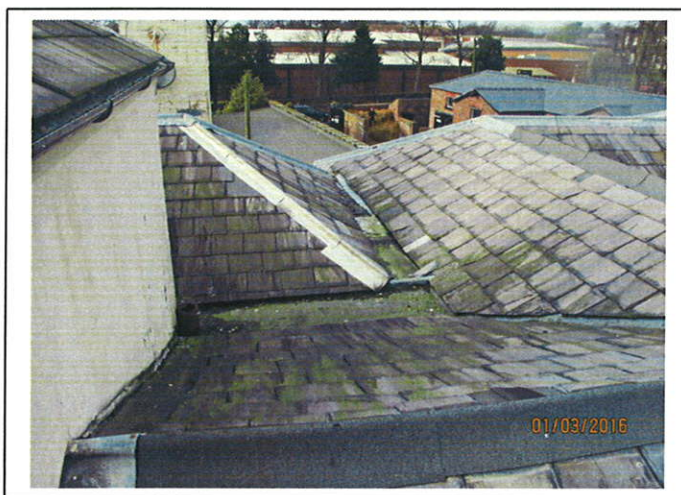
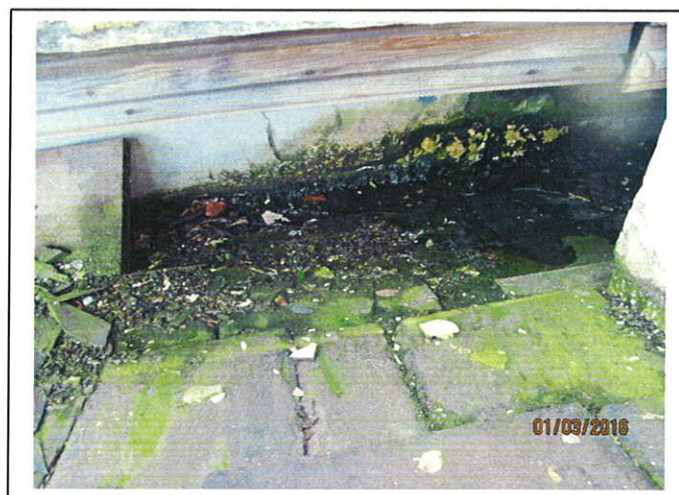
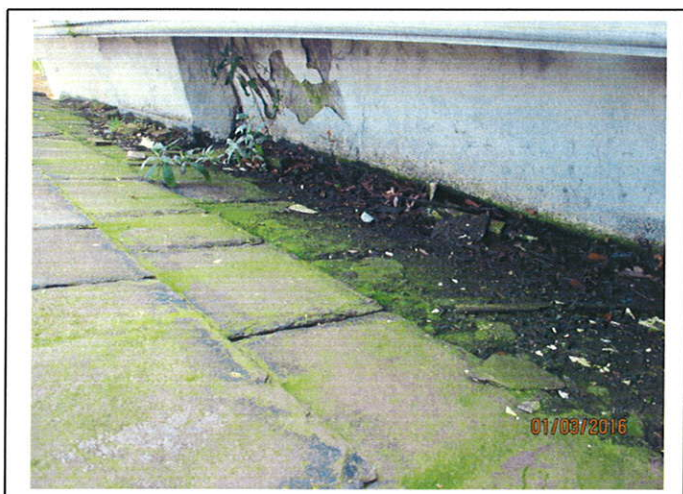
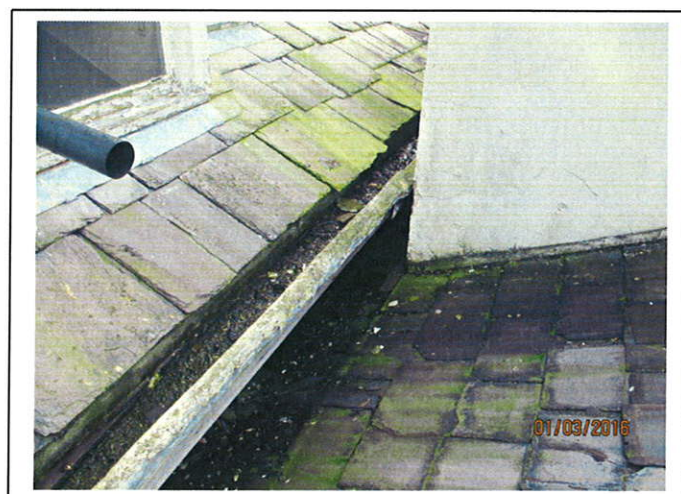
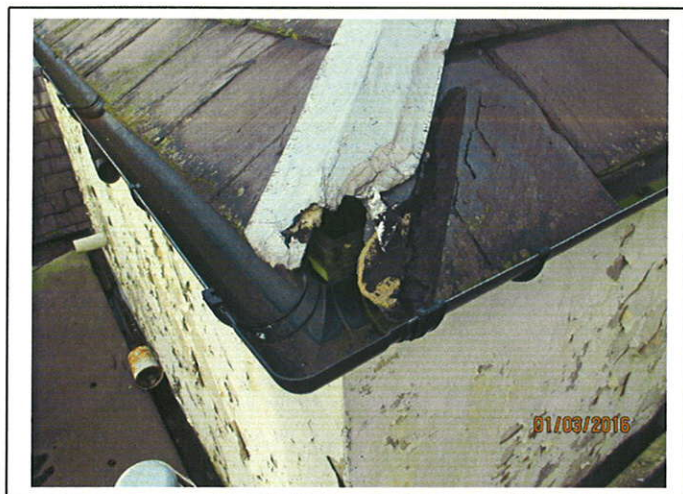
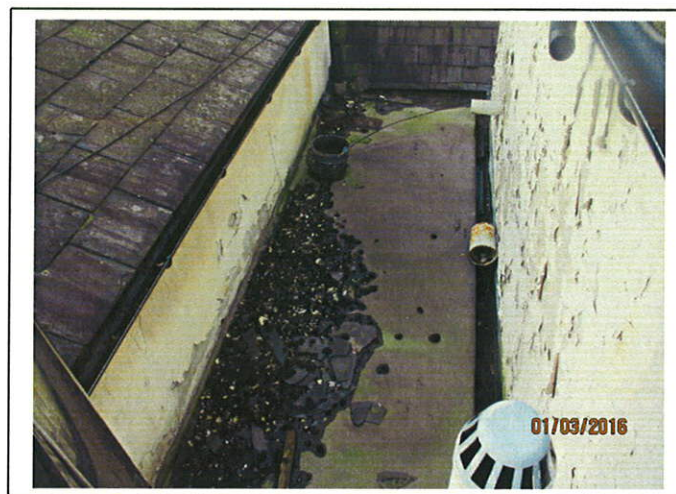
Main Roof - External Defects.

- The presence of a cavity wall, and the possibility of wall ties in the external wall is to be investigated;
- It is recommended that the roof coverings be fully removed and re-laid on new felt and battens;

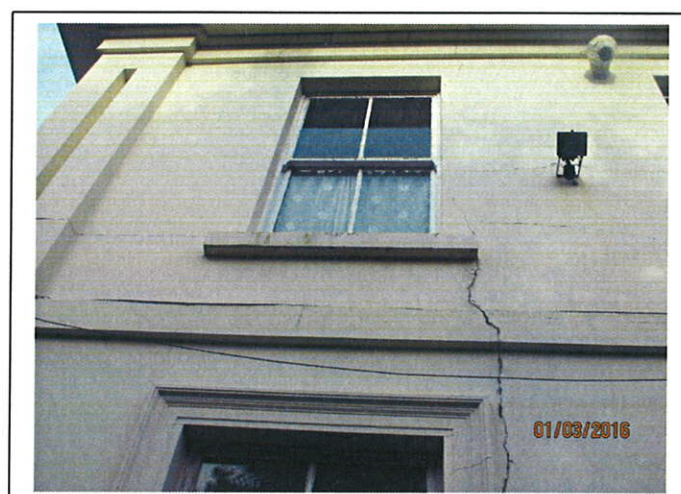
Front Elevation - Cracking in render.

- The rendered elevations have cracked to varying degrees, but the walls are structurally stable. Consideration should be given the benefits of full render removal and replacement, or breaking out of addled render and patch repair;

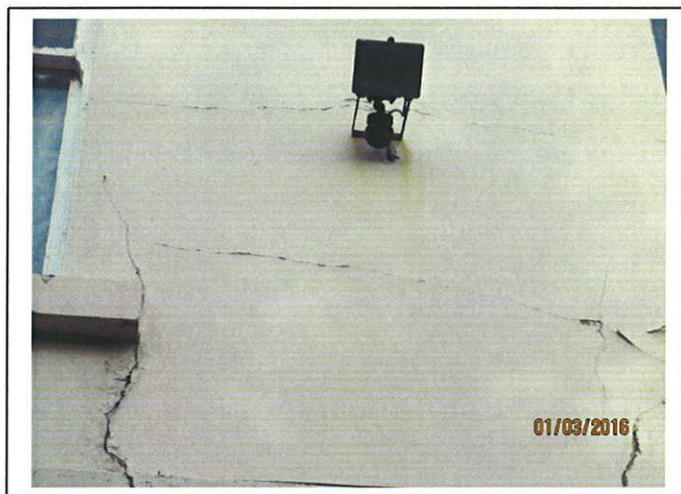
Front Elevation - Typical cracking in render.

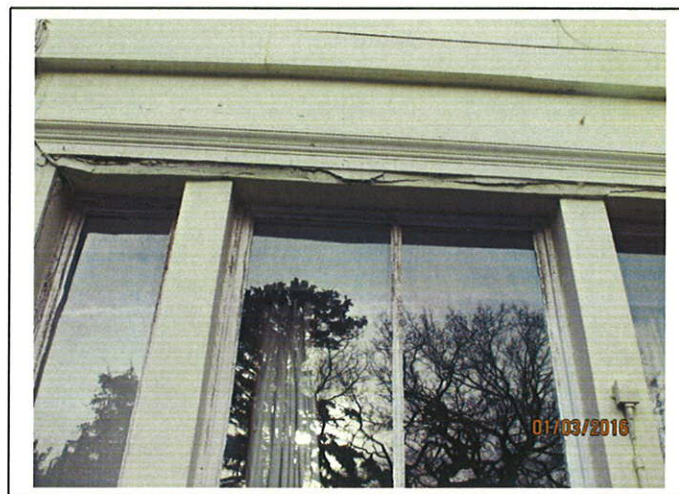
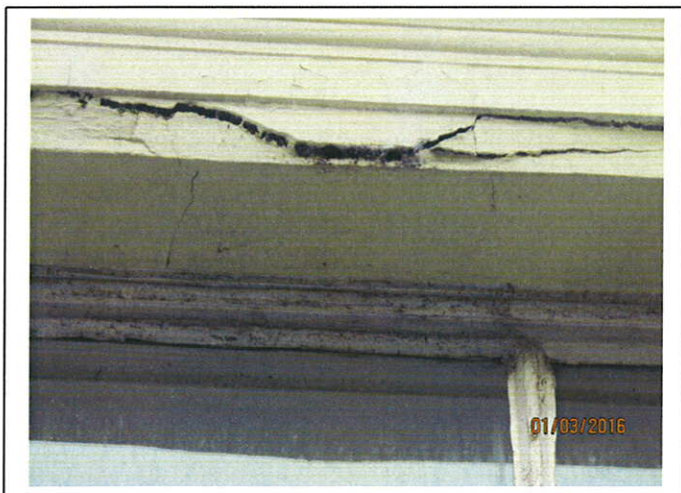
Front Elevation - Cracking over feature window.

- Localised replacement of several lintels is anticipated (most likely over feature window in the front elevation, to the left of the entrance portico and over the ground floor entrance into the building within the right-hand side elevation);

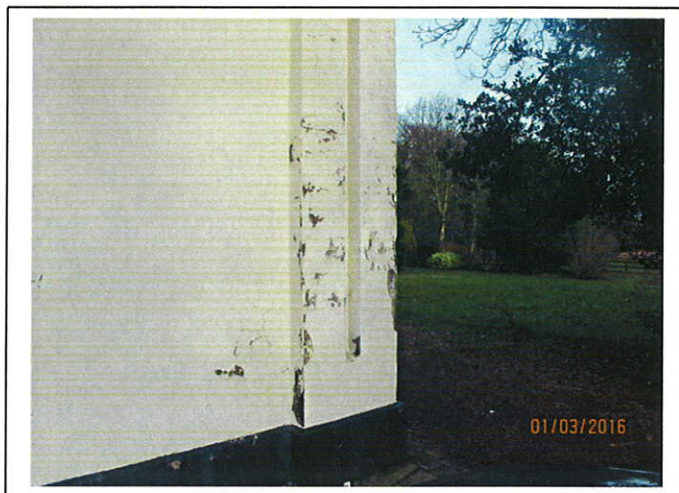
Efflorescing paintwork

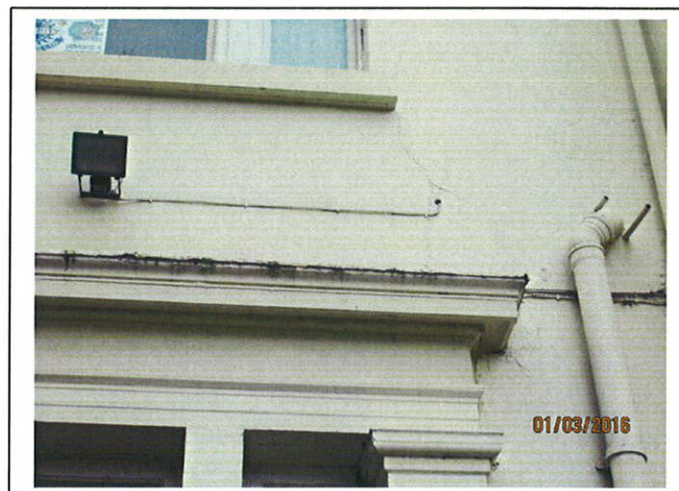
Typical cracking in render.

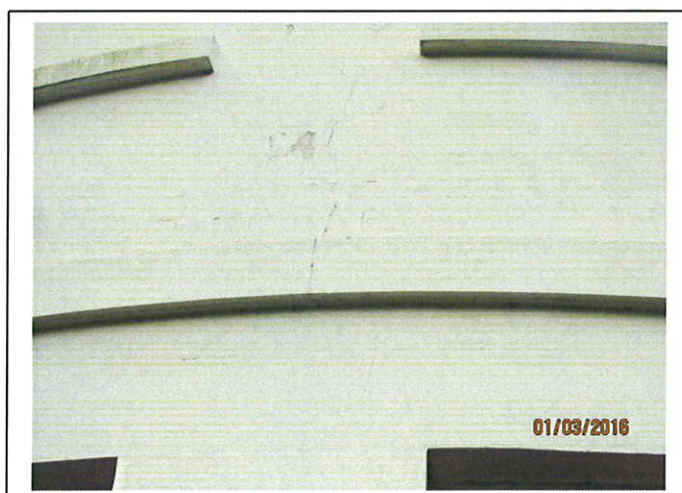
Typical cracking in render.

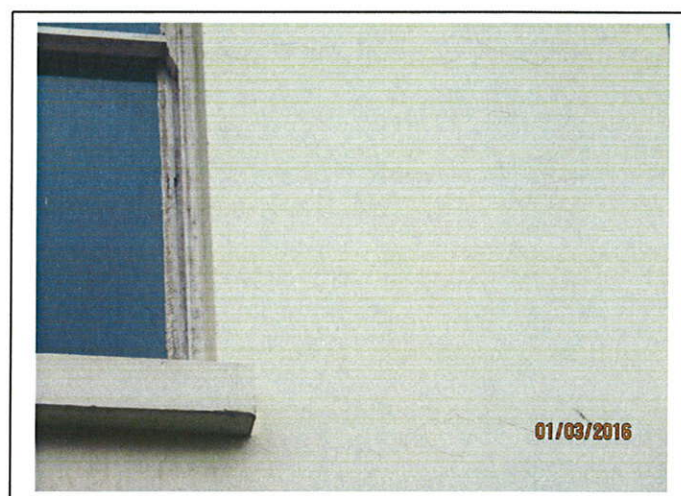
Typical cracking in render.

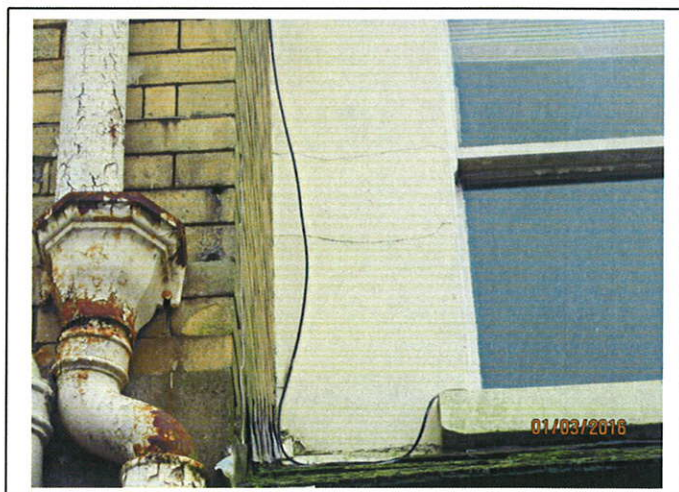
Left hand elevation - Cracking in render.

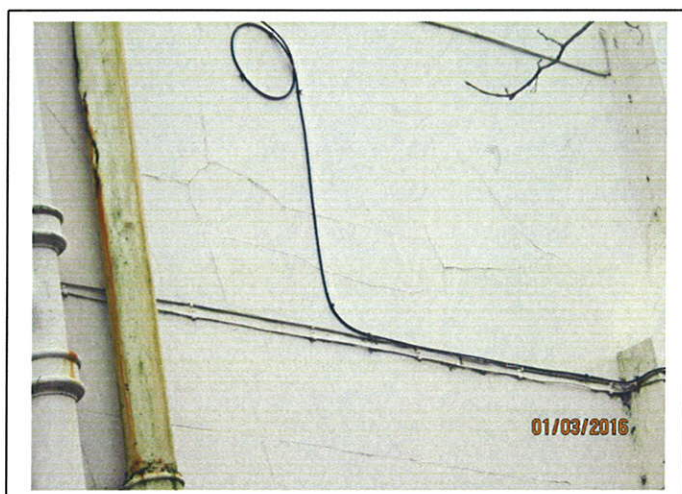
Left hand elevation - Cracking/crazing in render.

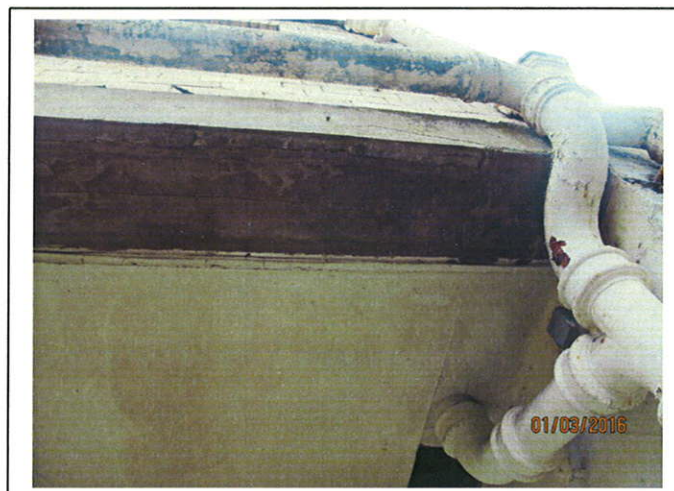
Spalled concrete lintel.

- It is anticipated that there may be timber lintels in the property, and these should be replaced with propriety concrete lintels or galvanised steel lintels when they are exposed;

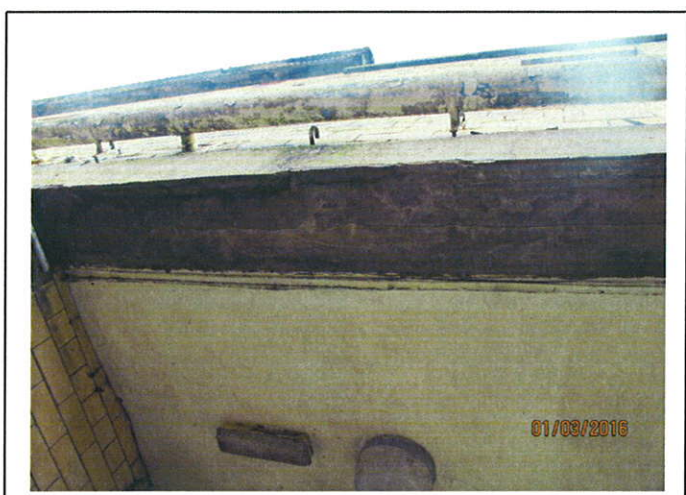
Spalled concrete lintel.

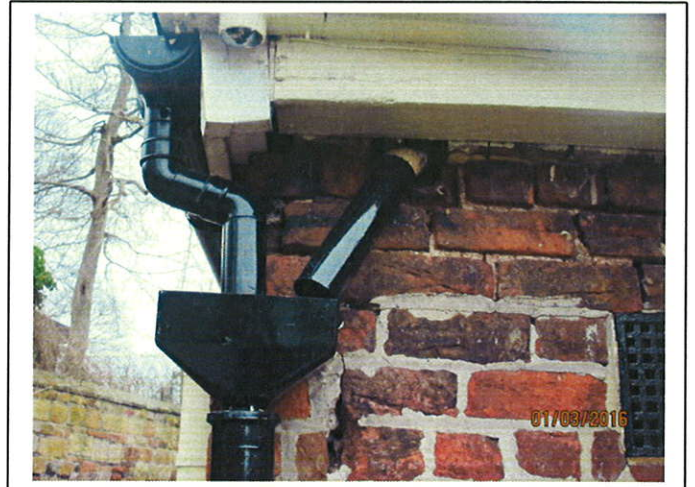
Damage to top left hand corner of left hand elevation.

- The property is in reasonable order and has been well maintained, with no evidence of significant structural movement;
- The loose masonry at eaves level on the corner formed with the left-hand gable and rear elevation should be repaired;
- Timber elements to the bay on the front elevation are starting to rot. The rotten members should be removed and replaced with treated timbers of similar size;
- The concrete lintels over windows in the rear elevation should be replaced with pre-cast concrete or proprietary galvanised lintels, specified to carry the anticipated design loads;
- The condition and insulation properties of the existing slab should be determined and, based on the findings, upgraded or broken out and re-laid to meet with Part L of the Building Regulations.

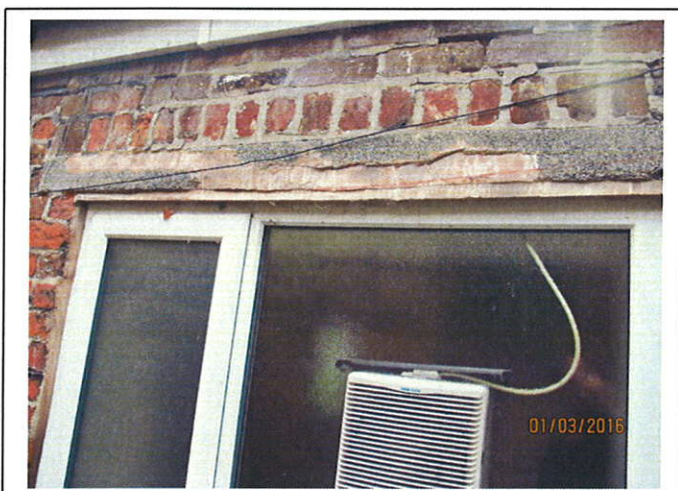
Spalling lintel on rear elevation.

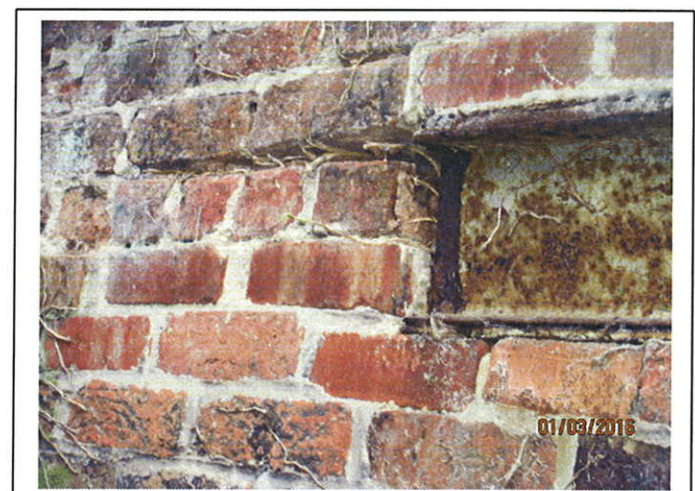
Corroded steel over window in rear elevation.

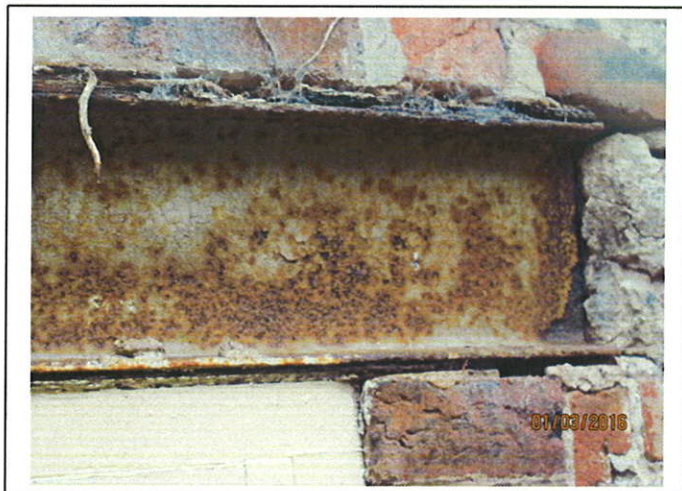
Corroded steel over window in rear elevation.

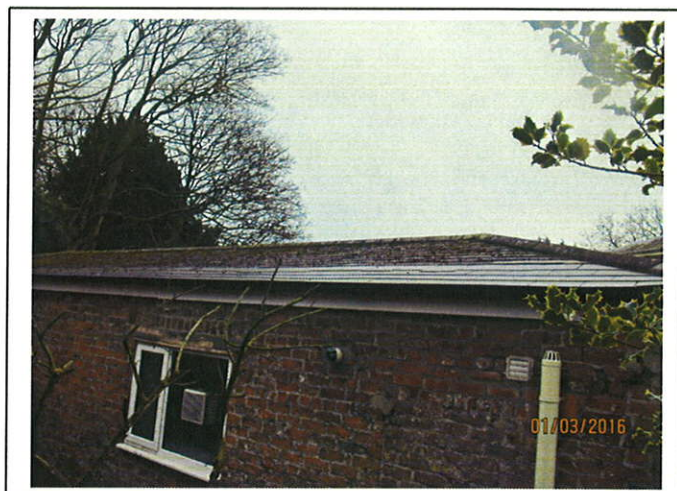
Localised repair to roof.

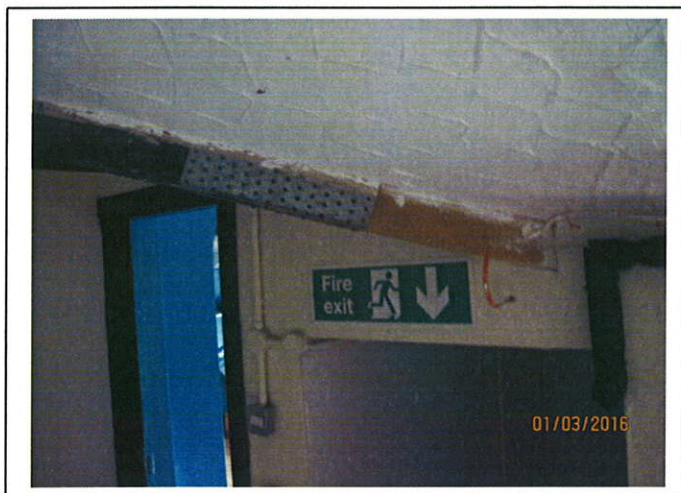
Splice repair to valley beam.

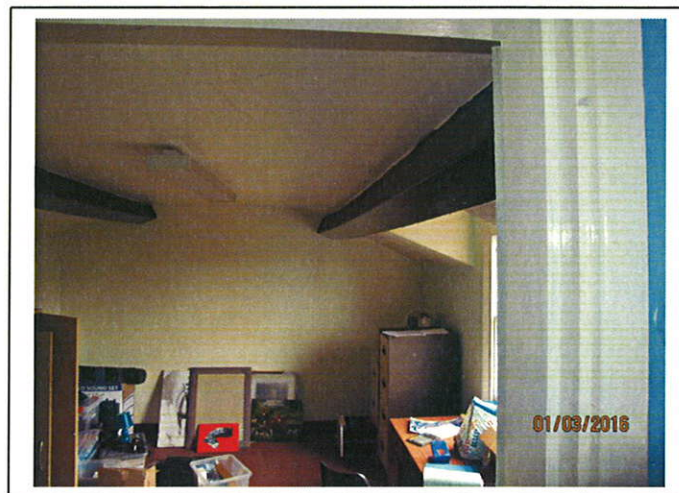
Deformation in purlin.

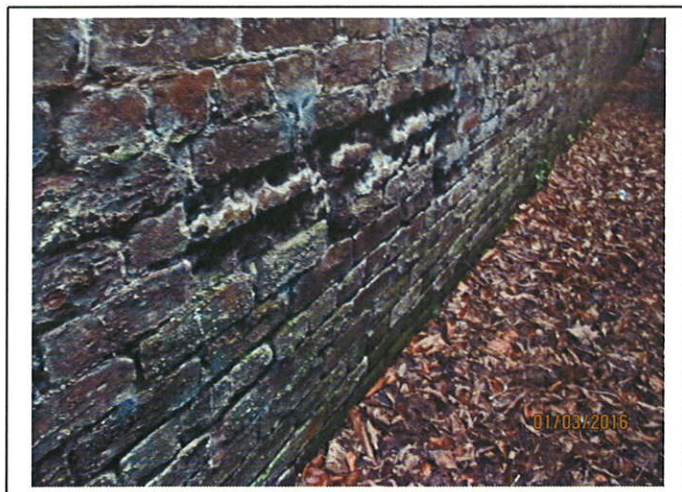
Rear Elevation - Spalled masonry.

- This building is well built, and is in reasonable order with no evidence of significant structural movement;
- Localised masonry repairs should be undertaken to areas of loose/de-bonded masonry noted at eaves level in the pikes on the front elevation;

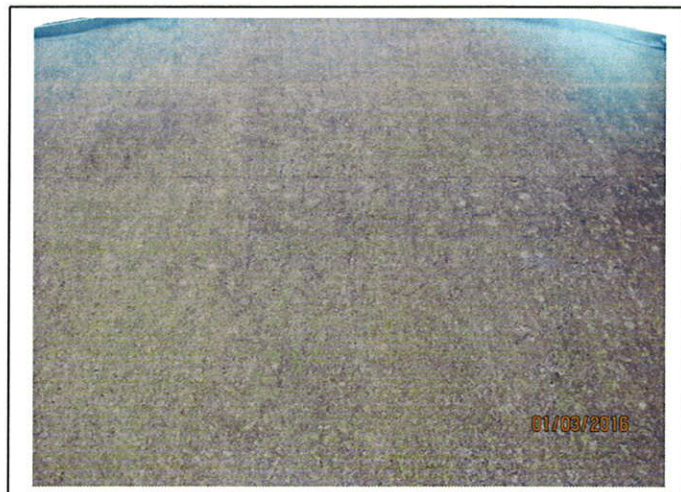
Right hand elevation Day joint in render.
