Appendix C.

Photographs of existing exterior.

Appendix D.

Photographs of existing interior.

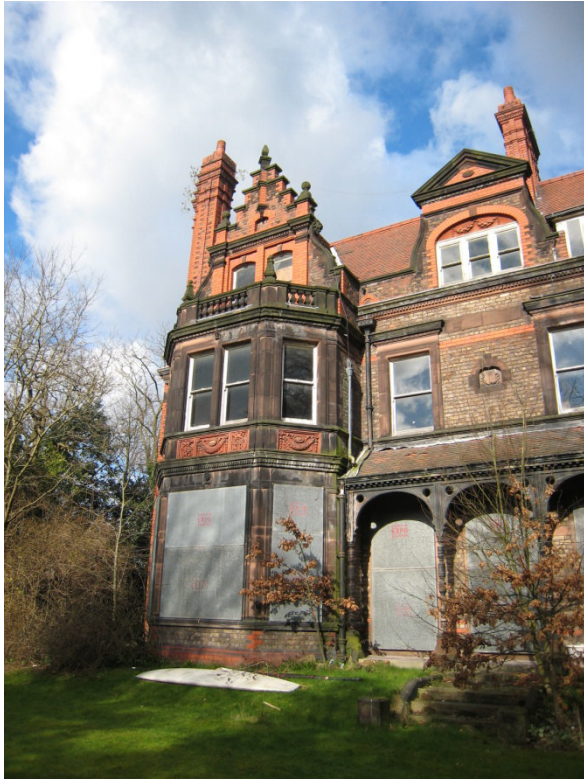
South elevation of Bridge House.

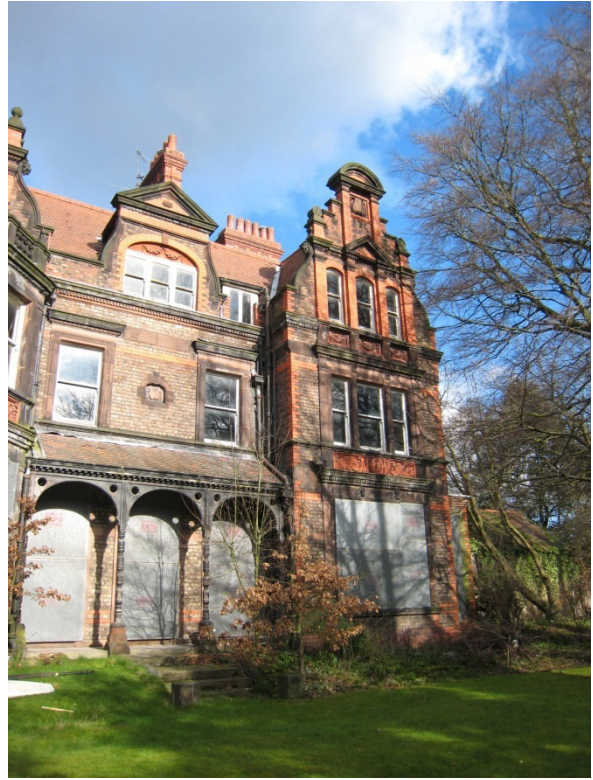
South elevation of Bridge House.

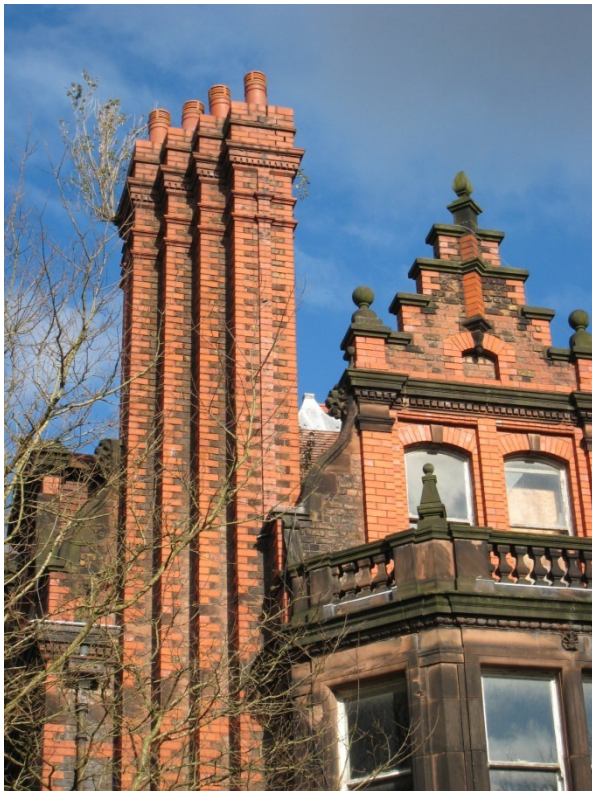
Main chimney stack S-W corner.

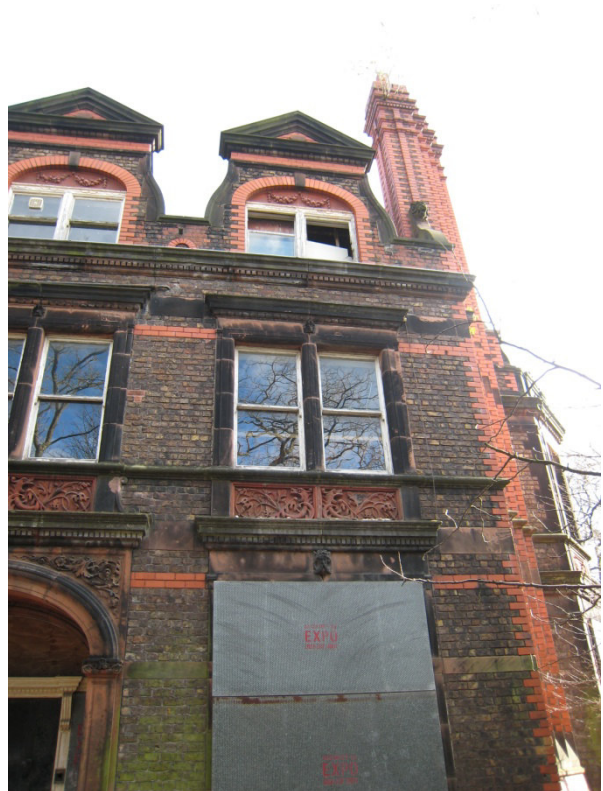
West elevation of Bridge House.

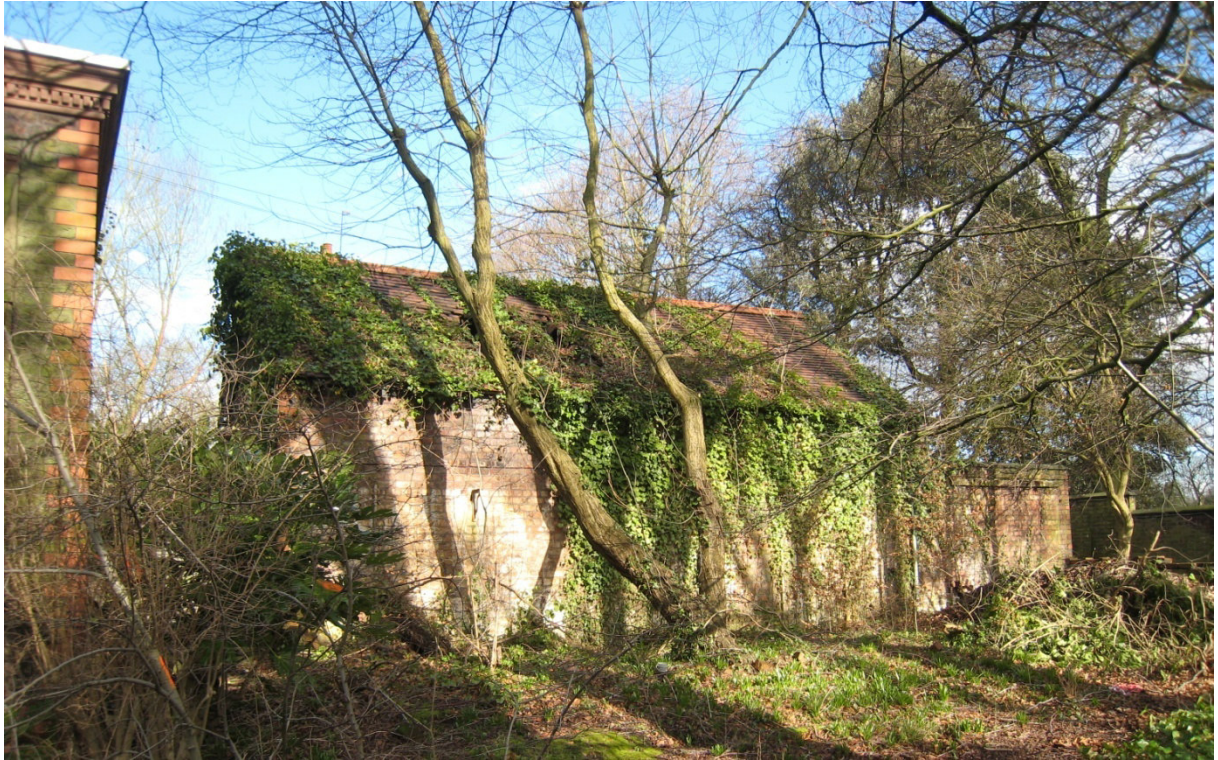
Garage building with hole in roof and threatened by unstable tree.

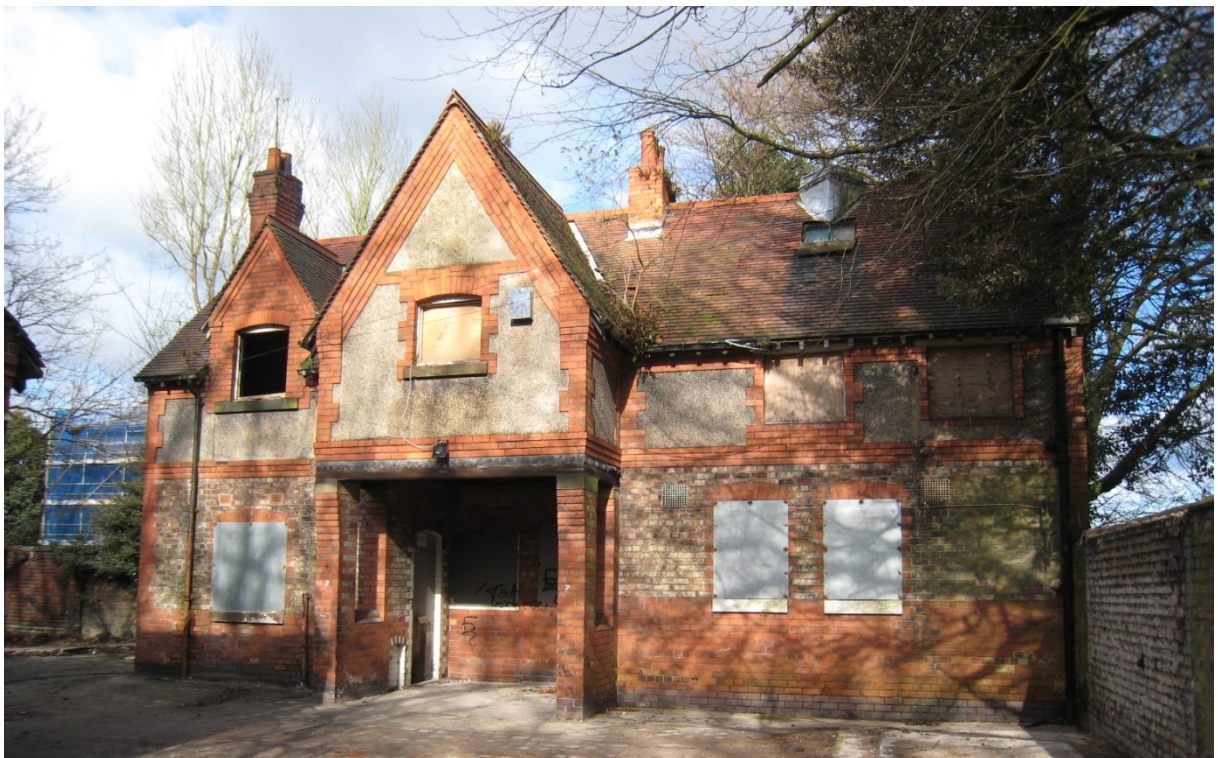
"The Cottage" building to the rear of Bridge House.

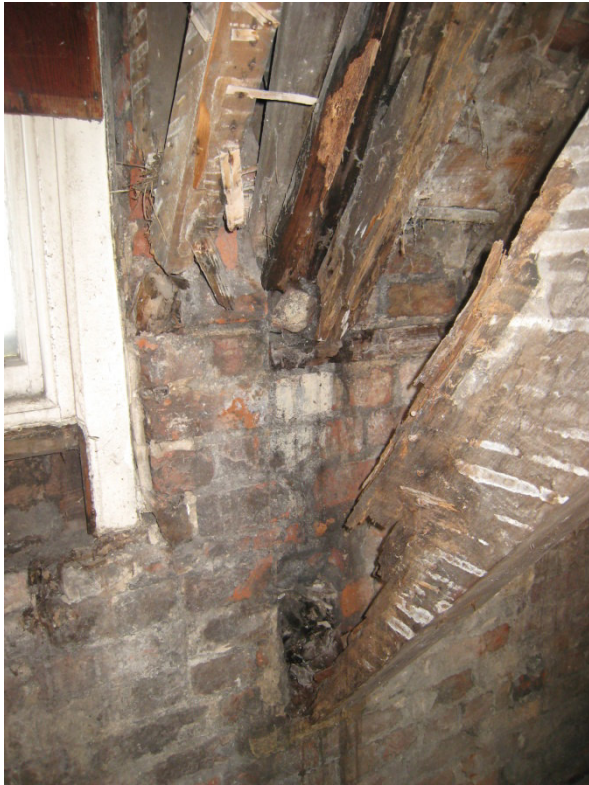
Truss foot destroyed by dry rot.

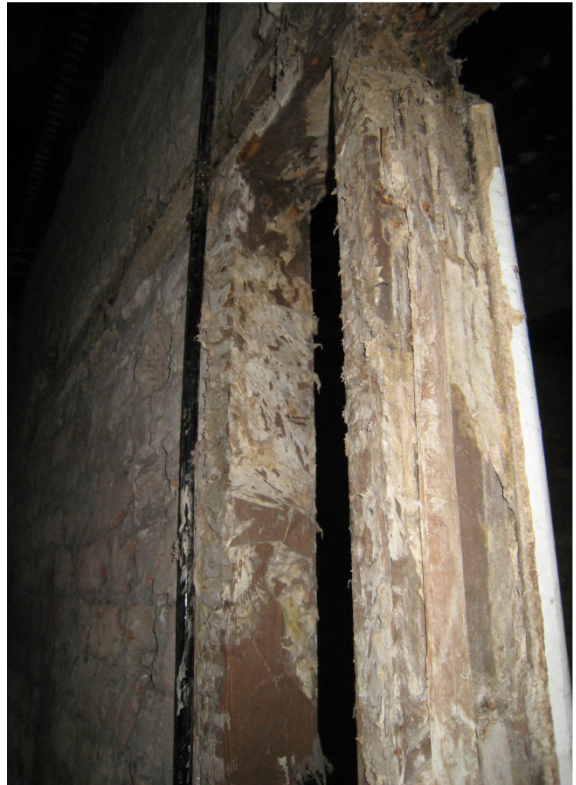
Mycelium from dry rot in stud wall.

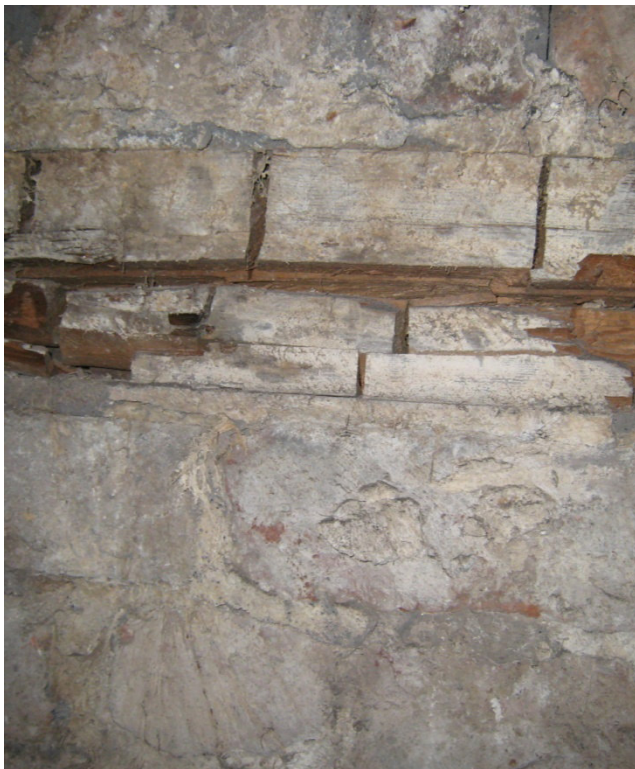
Cuboidal cracking in dry rot affected timber.

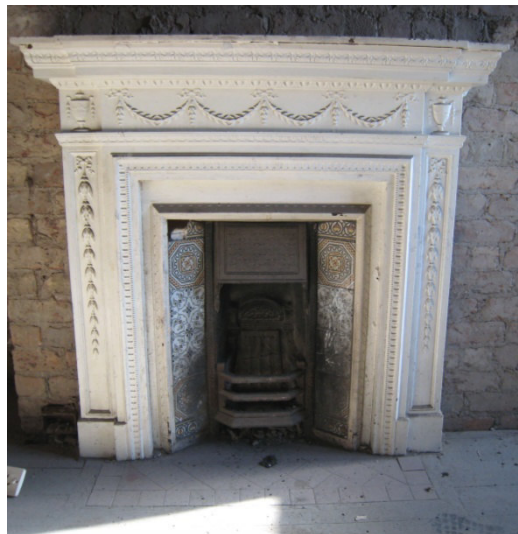
Existing fireplace on second floor.

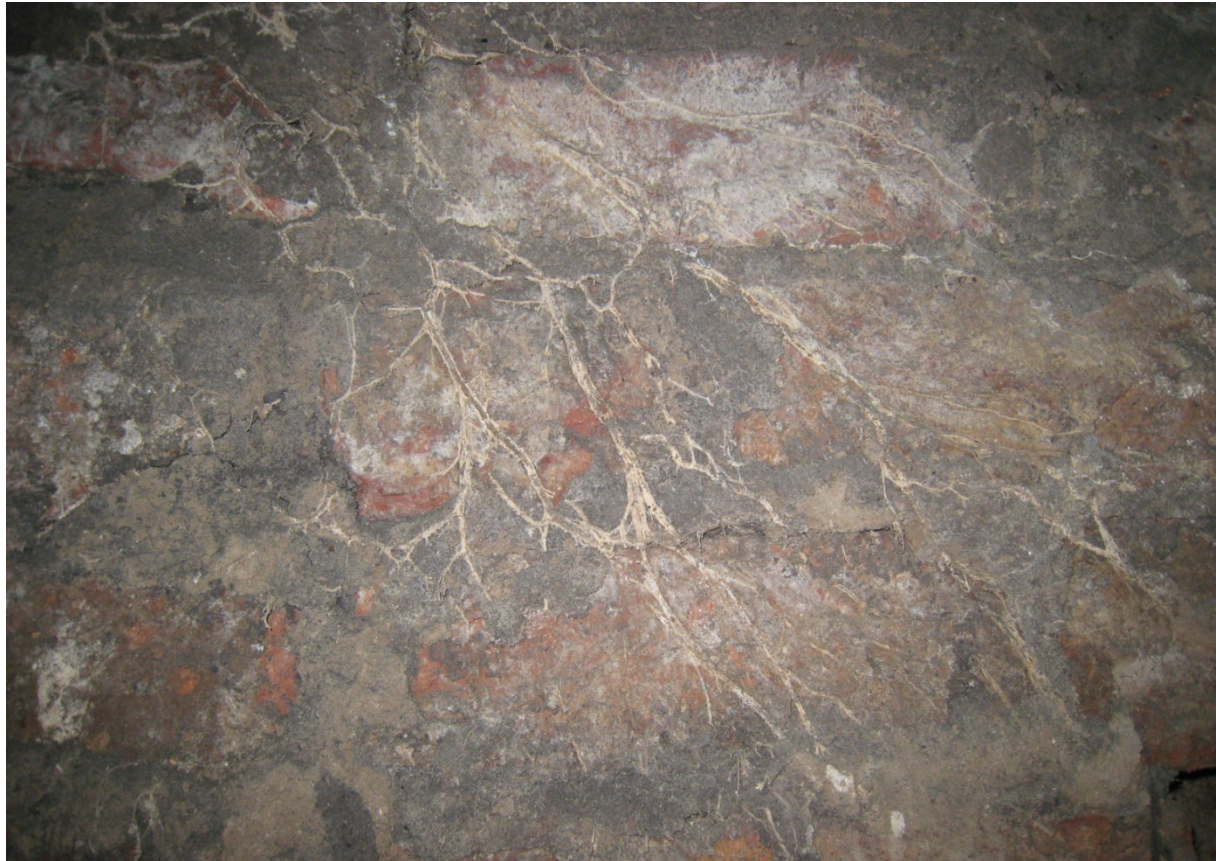
Dry rot strands which would have been behind plasterwork.

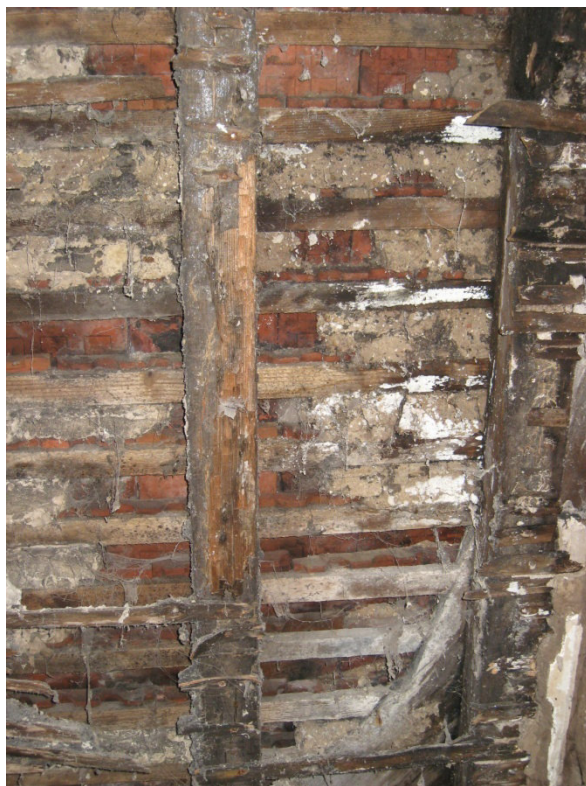
Rafters, roof battens and tiles.

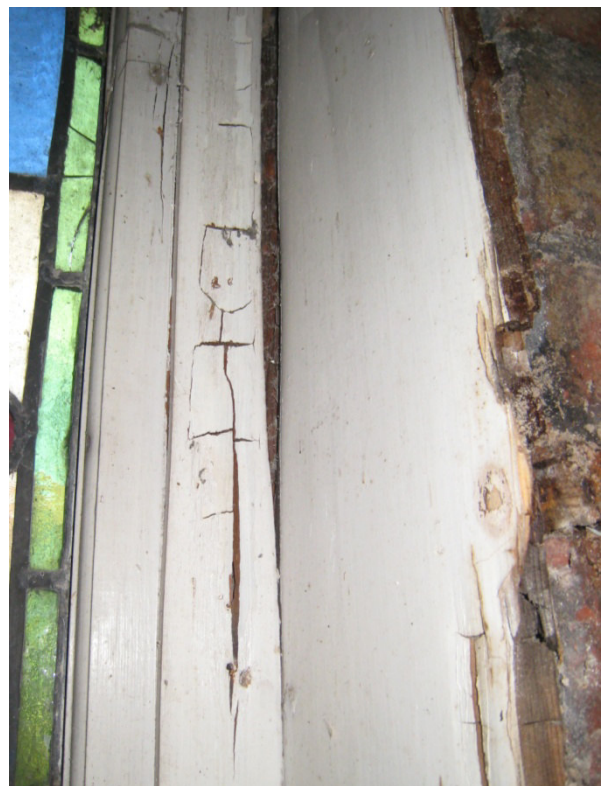
Cuboidal cracking in window frame.
