File Note: LEL_CRN_L156TF_PRA_001_REV A

Discipline: Preliminary Ecological Appraisal for Bats and Preliminary Roost Assessment

Site: Church Road North, Wavertree L15 6TF (Structure Grid Ref: SJ 3928 8936).

Site Visit Date: Thursday 18th June 2020

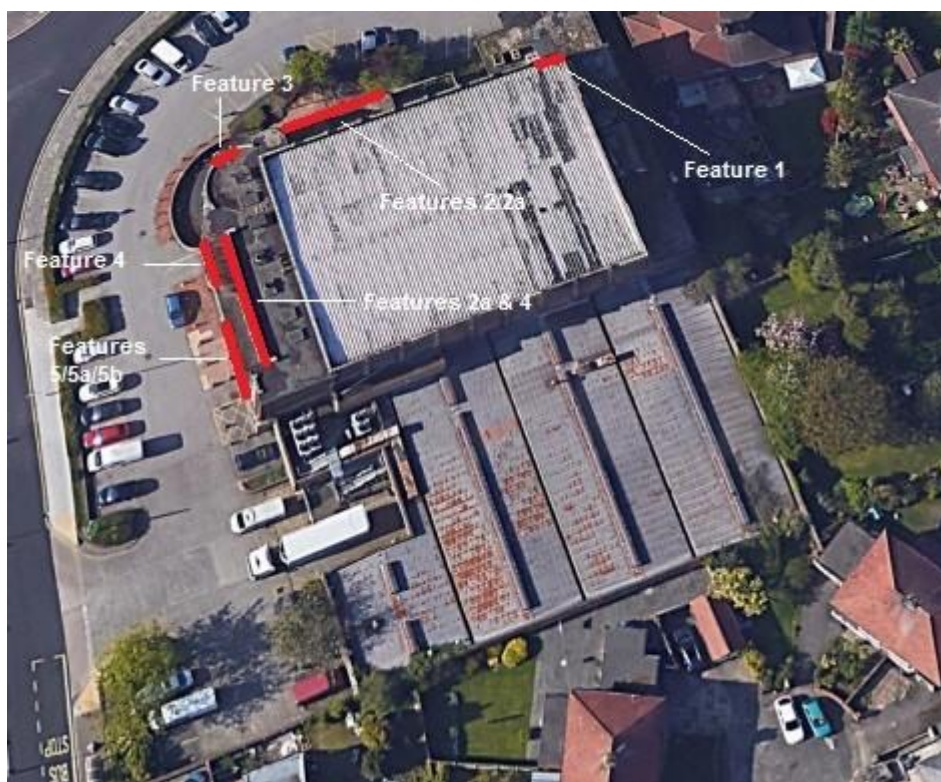
Figure 2: plan showing general layout of the structure with potential bat roosting features highlighted (red) and labelled. Figures 3a to 3h below provide some discussion in relation to the type of potential roost features observed.

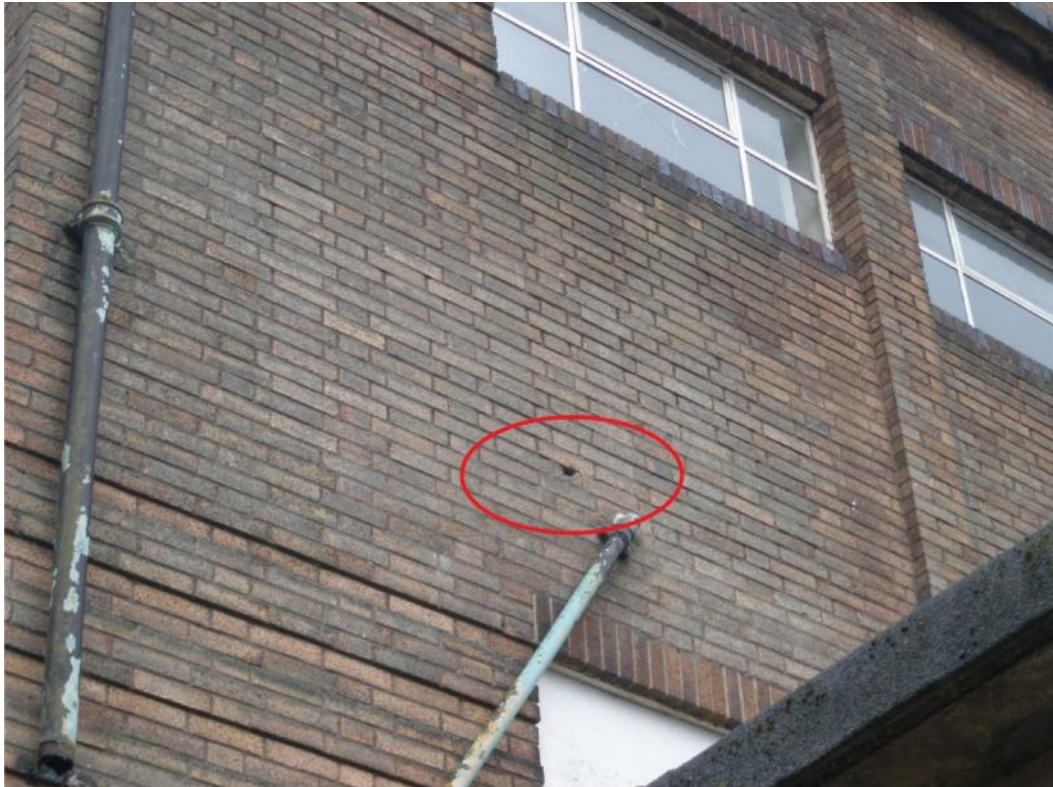
Figure 3a: Feature1 - located on the north-east aspect corner of the structure, small gap in brickwork.

It is recommended that to fully establish if bat species are using the structure, dusk emergence or dawn re-entry surveys are required to take place. In accordance with the BCT Guidelines Chapter 7 (Collins 2016), structures of **moderate** roost suitability require two survey visits. This should be carried out between May to September. Dependant on the level of activity encountered, an additional survey may be required to support any application for a European Protected Species mitigation licence, should one be required.

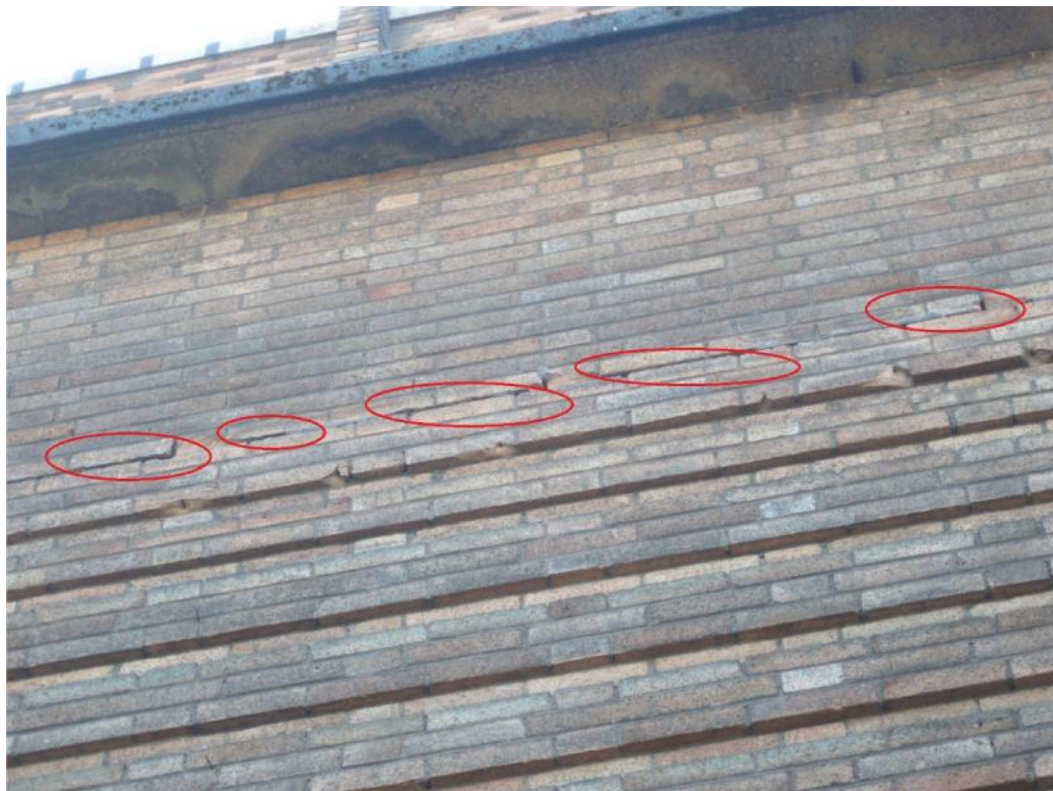
Figure 3b: Feature 2 – located on the north aspect of the structure, gaps in brickwork where pointing has eroded.

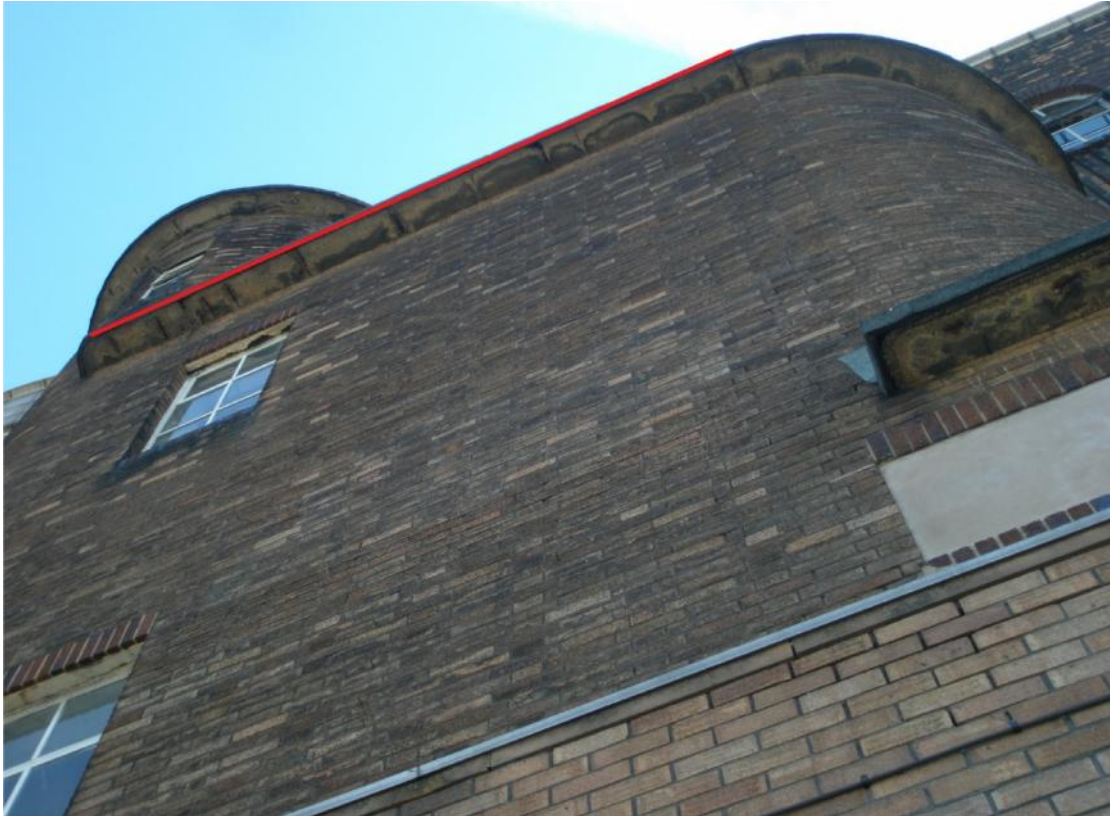
Figure 3c: Feature 2a – stonework overhangs on the north and west face of the structure show signs of weathering with potential gaps – see also Figure 3e.

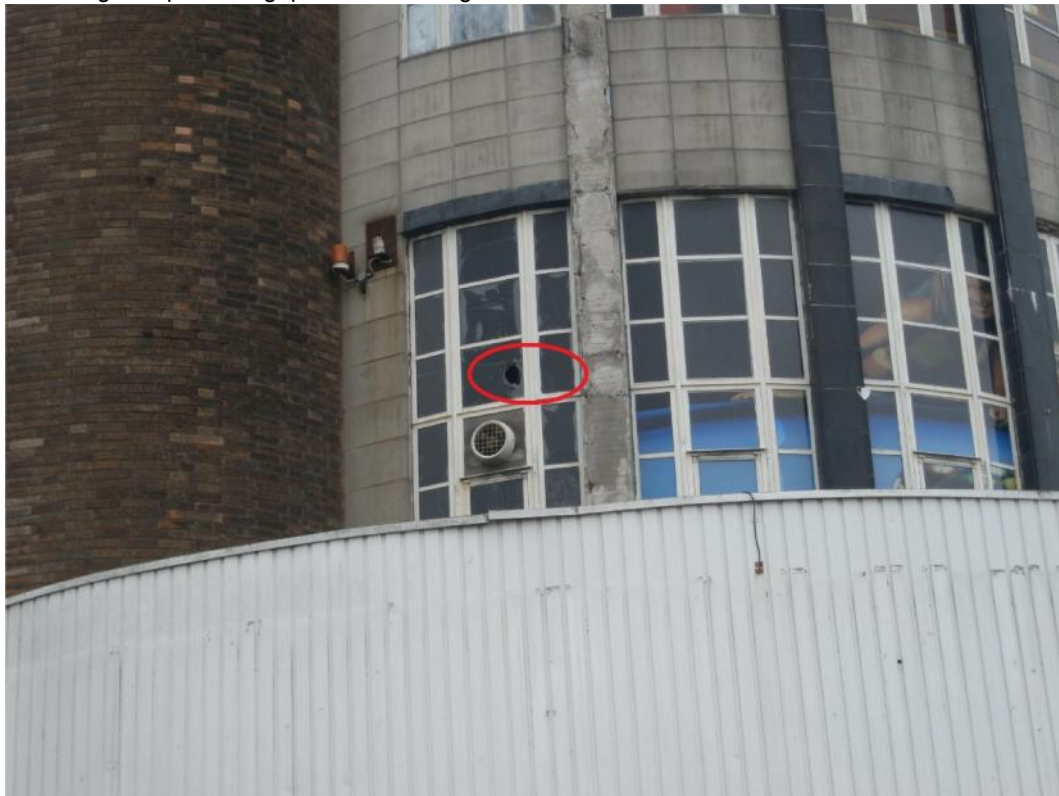
Figure 3d: Feature 3 – lower window above canopy at entrance to structure – broken pane may present opportunity for bat species to gain access to the structure.

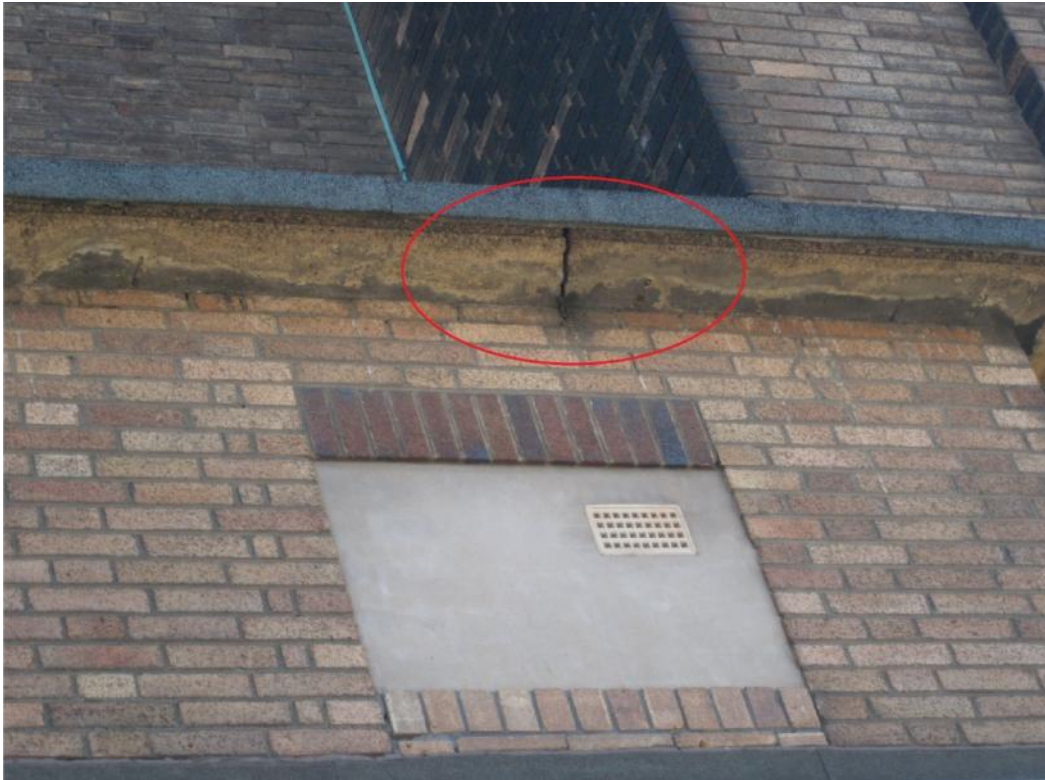
Figure 3e: Feature 4 – close up of crack in stonework overhang on the west face of the structure. There are similar overhangs on the north face of the structure which may also have potential roosting opportunities for bats.

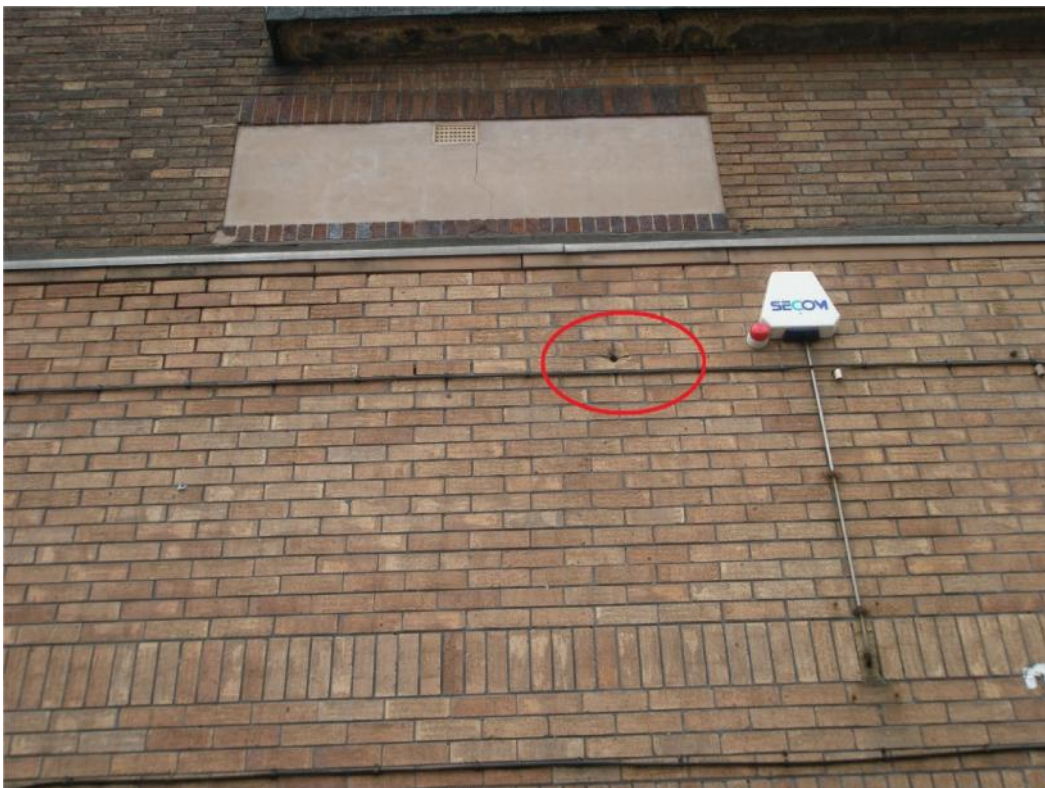
Figure 3f: Feature 5 – redundant modification fixing points on the front west face of the structure may also provide potential opportunities for roosting bats.

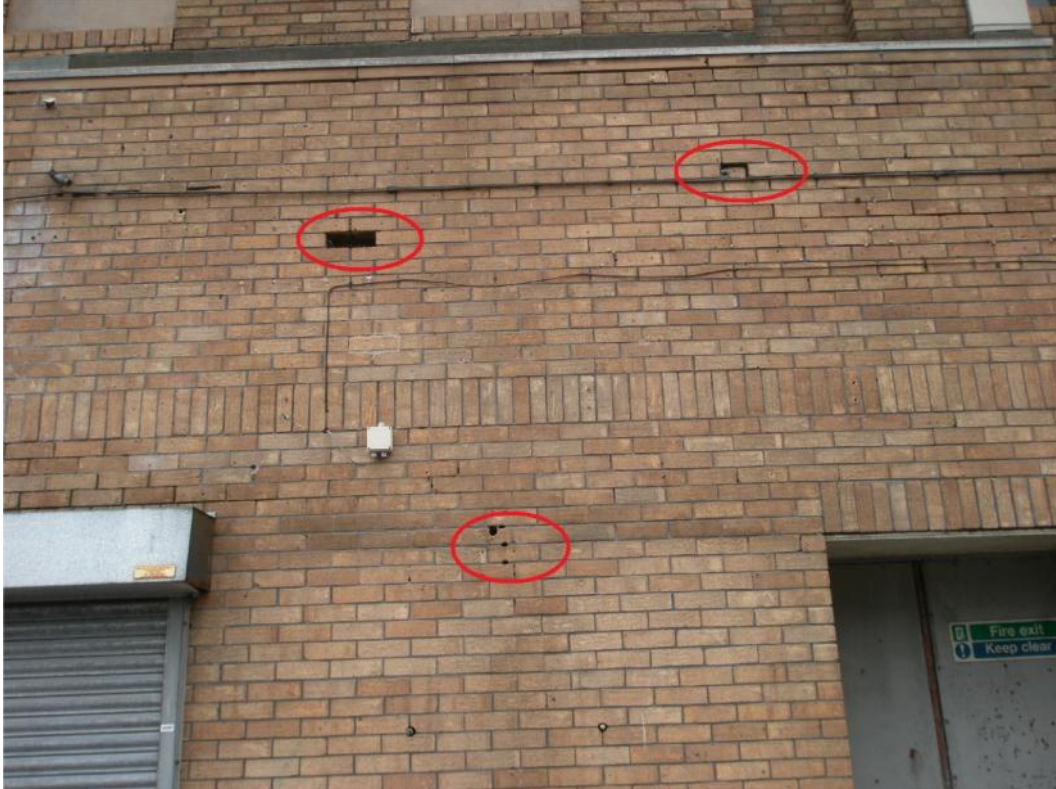
Figure 3g: Feature 5a – similarly to Figure 3f redundant modifications may provide potential opportunities for roosting bats.

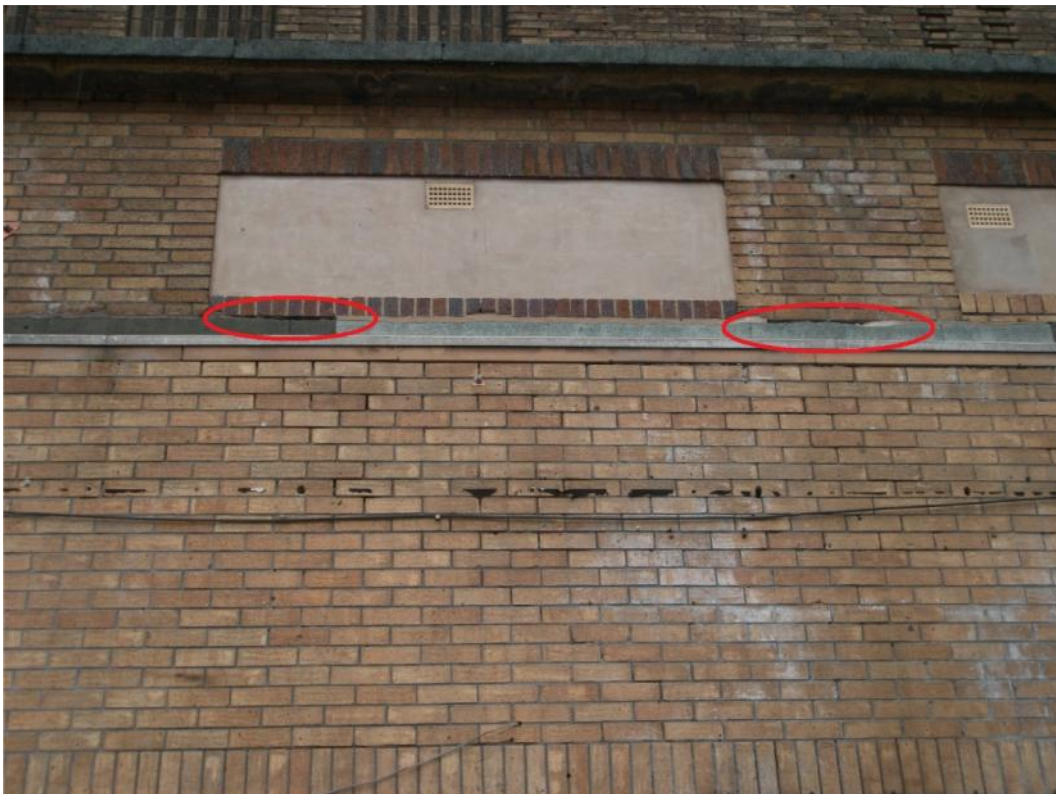
Figure 3h: Feature 5b – gaps in pointing on west face of structure.

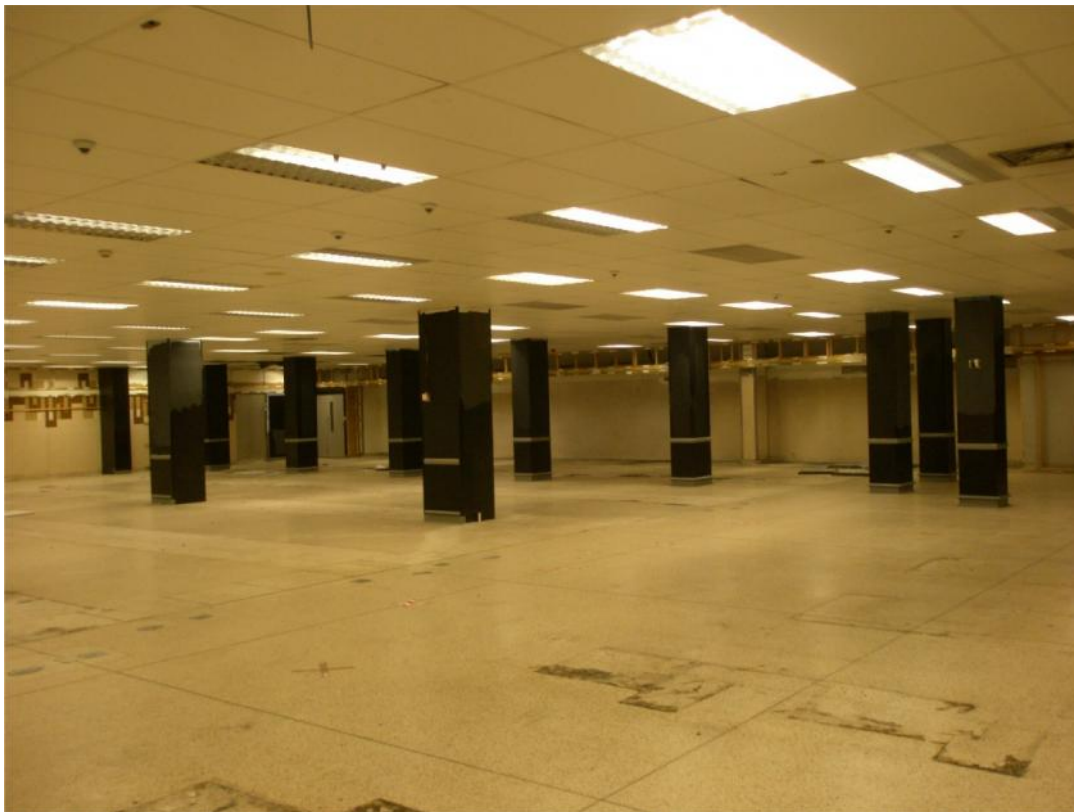
Figure 4a: Image 1 – shows the extensive shop former floor retail space brightly illuminated with strip lighting which was on when the structure was accessed.

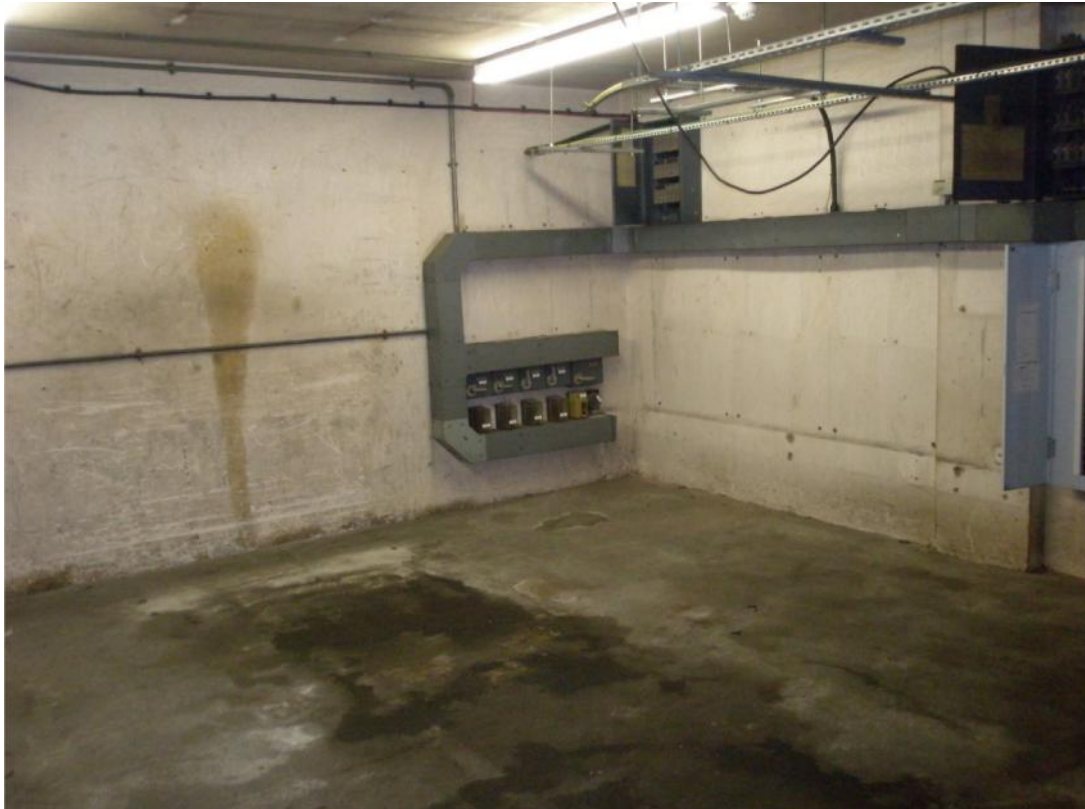
Figure 4b: Image 2 – one of a number of warehouse spaces which make up part of the single-storey brick-built structure to the south of 'the site'. Again, brightly illuminated with strip lighting and seemingly no possible access points for bats.

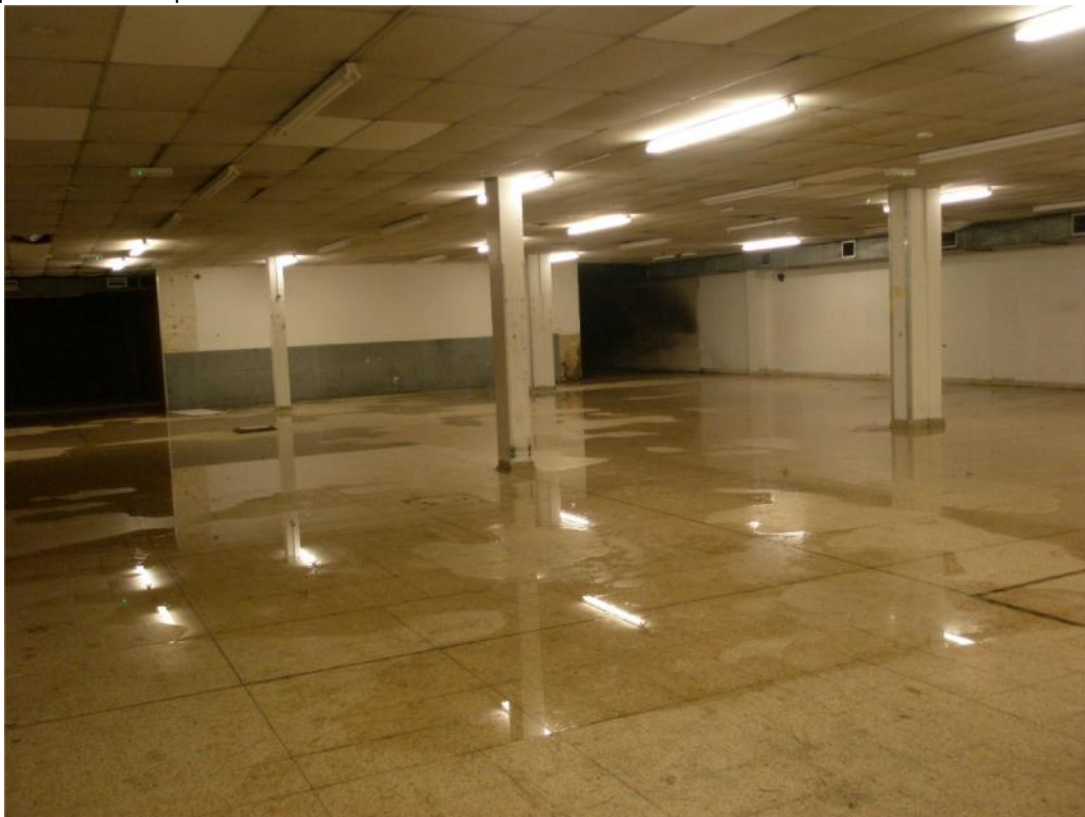
Figure 4c: Image 3 – another section of the warehousing area. Strip lighting and seemingly no access points for bats.

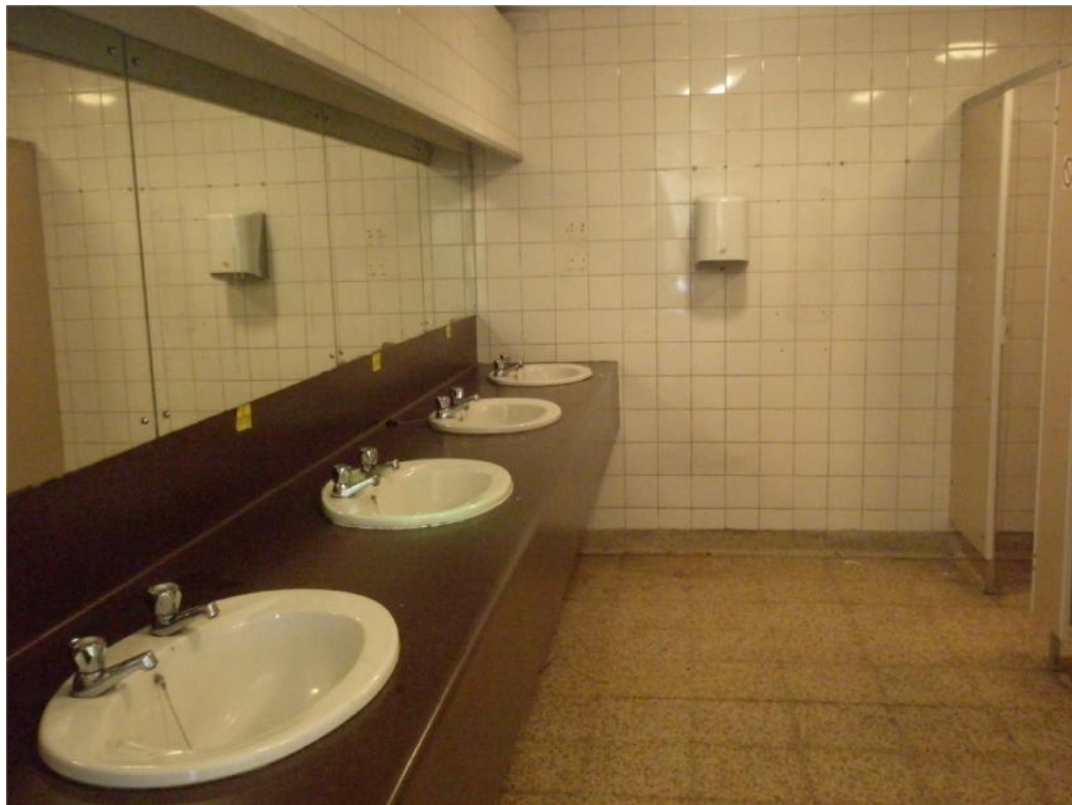
Figure 4e: Image 5 – toilets – windowless, clean, strip lit and with no possible access for bats.

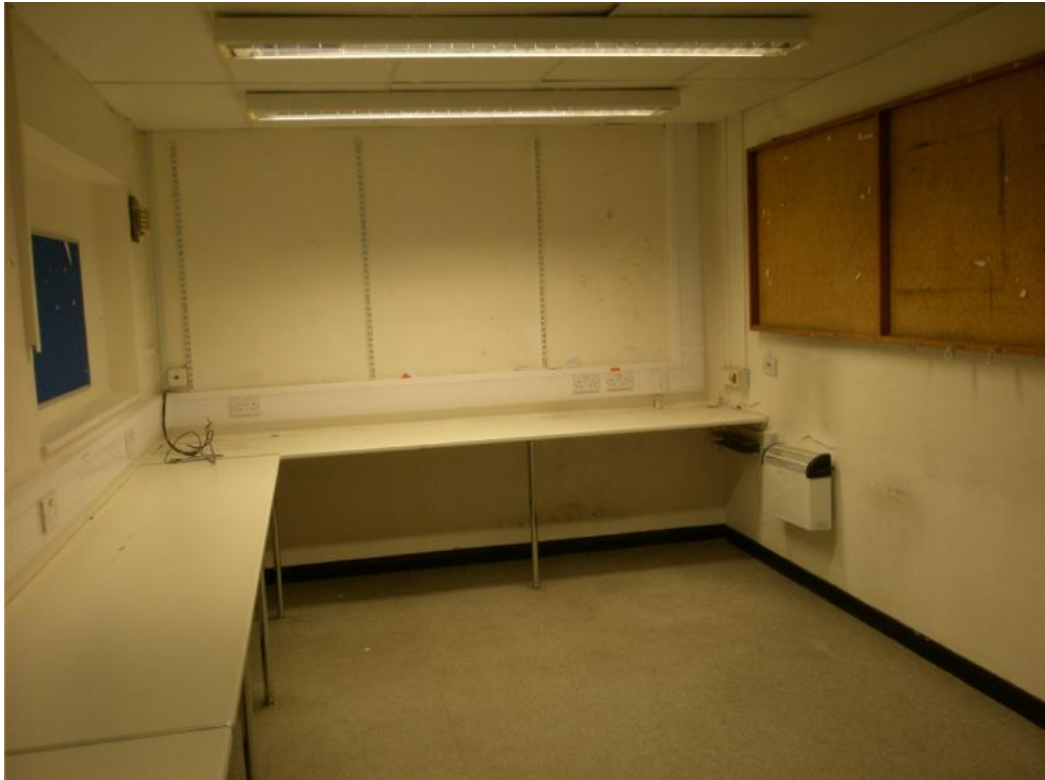
Figure 4f: Image 6 – rest room – similarly clean, strip lit and no possible access for bats.

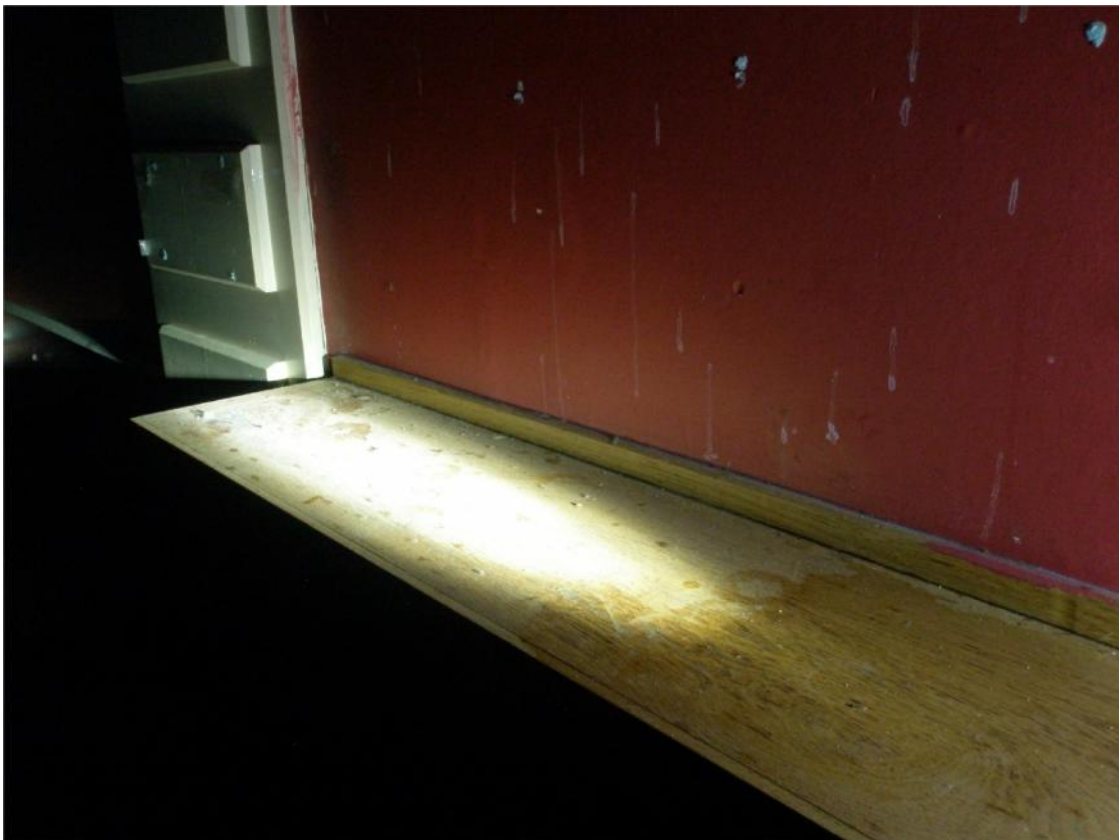
Figure 5b: Image 2 – shows a surface checked for evidence of bat droppings – none were found.

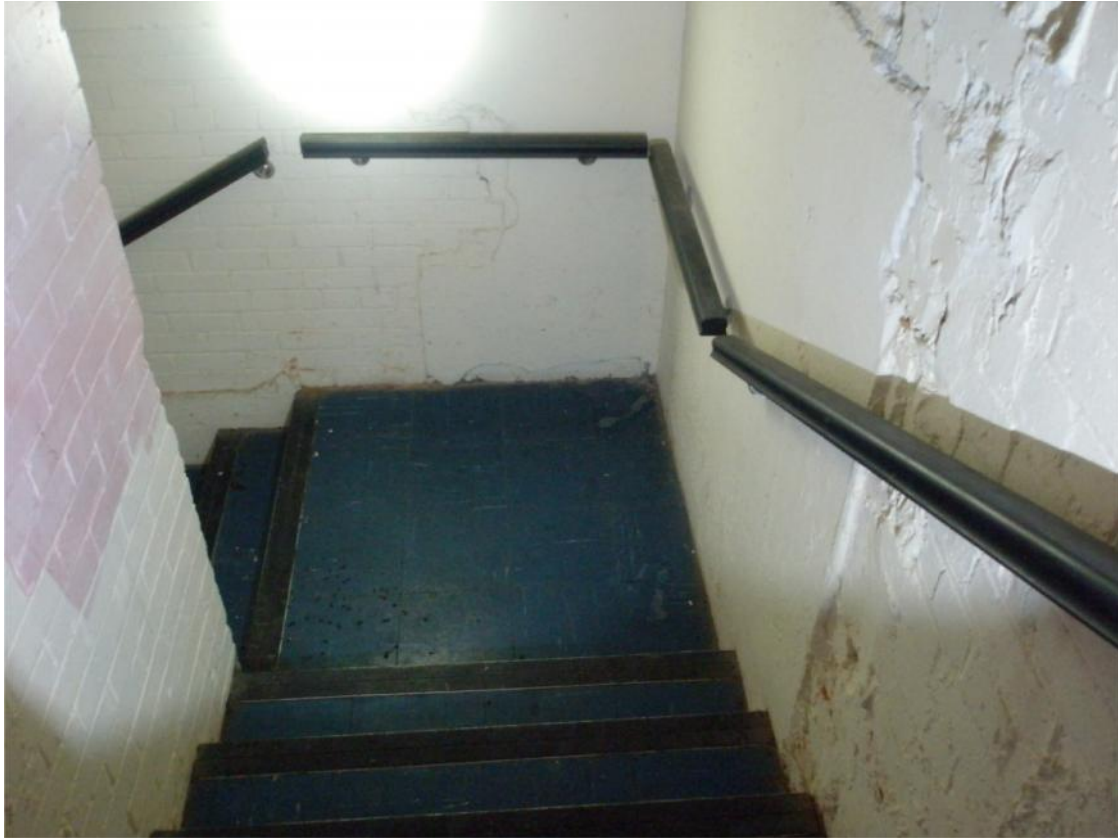
Figure 5c: Image 3 – shows another stairwell from the ground floor level to the former Riley's snooker club. Note the rat droppings at the bottom of the landing step.

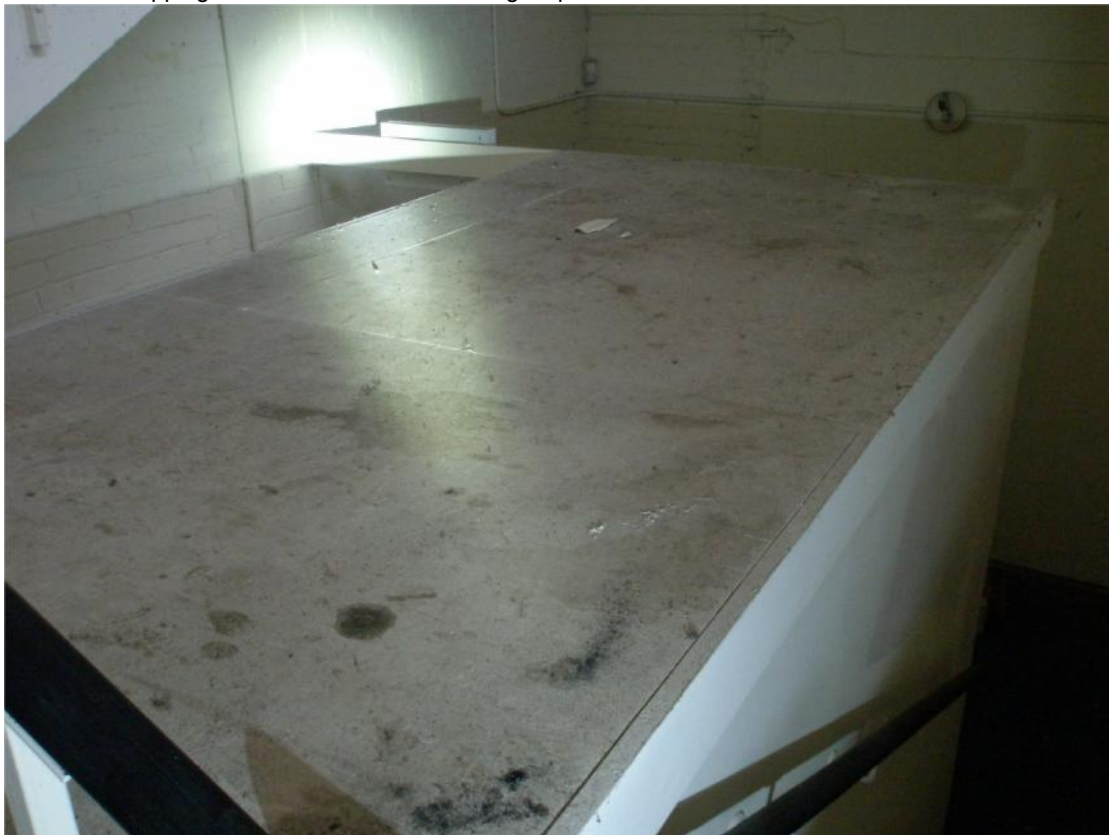
Figure 5d: Image 4 – shows surfaces in the stairwell in Figure 5 c above being checked for bat droppings – none were found.

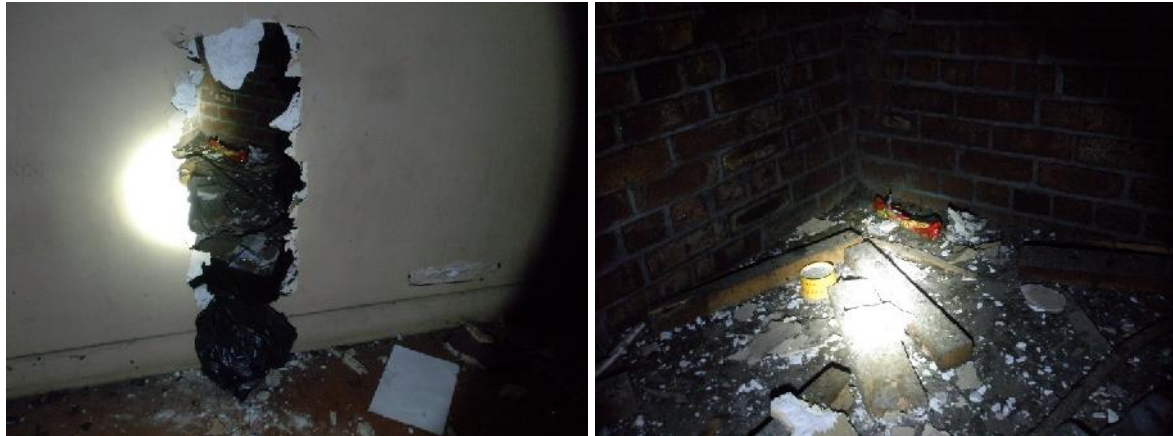
Figure 5e: Image 5 – false walls are numerous in nature in the mid-level spaces. Here we can see one has been ‘punched’ through – where possible these spaces were checked for evidence of use by bats – none were found.

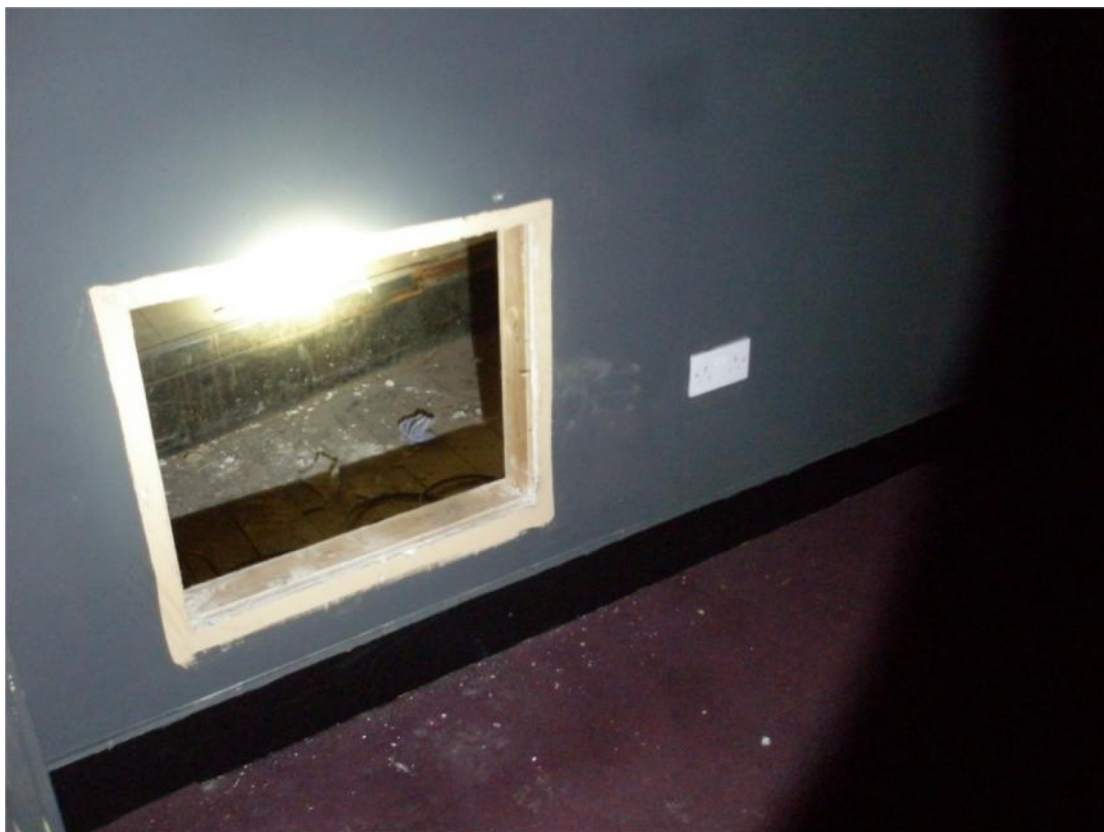
Figure 5f: Image 6 – shows another false wall where the only opportunity to view the space behind was with a torch from the snooker club side of the wall.

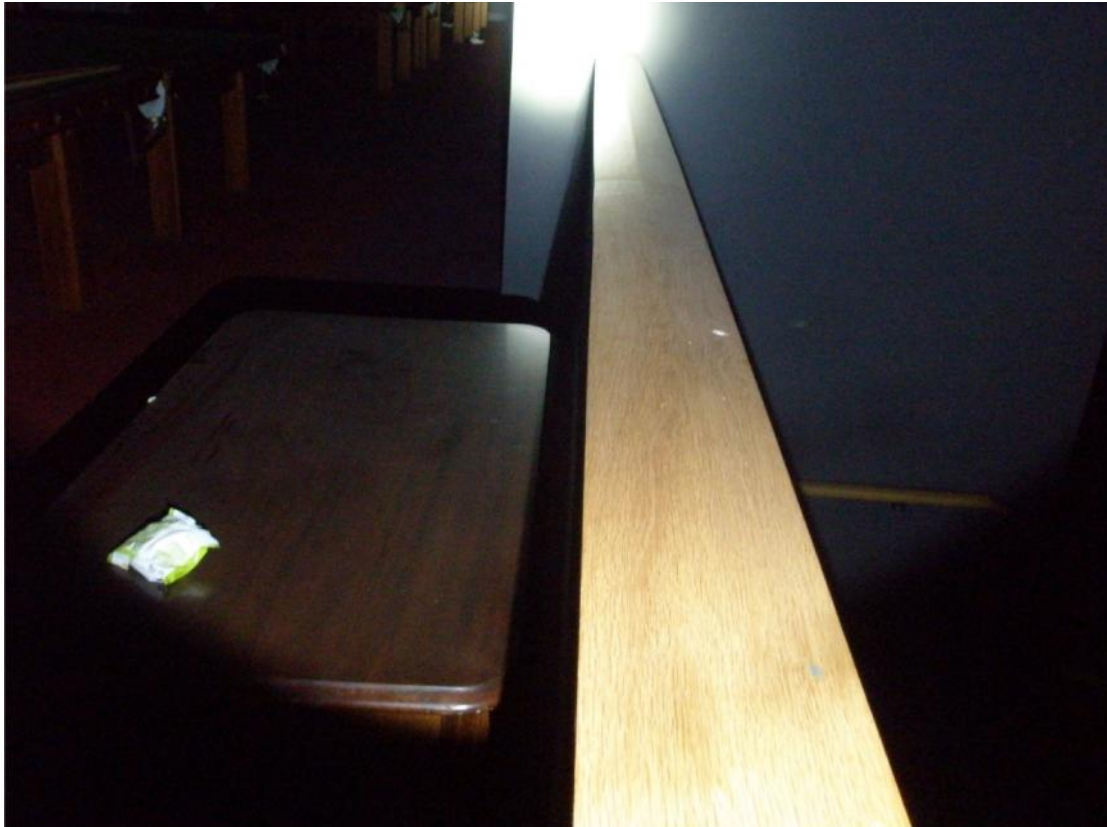
Figure 5g: Image 7 – shows further surfaces checked for evidence of bat droppings – none were found.

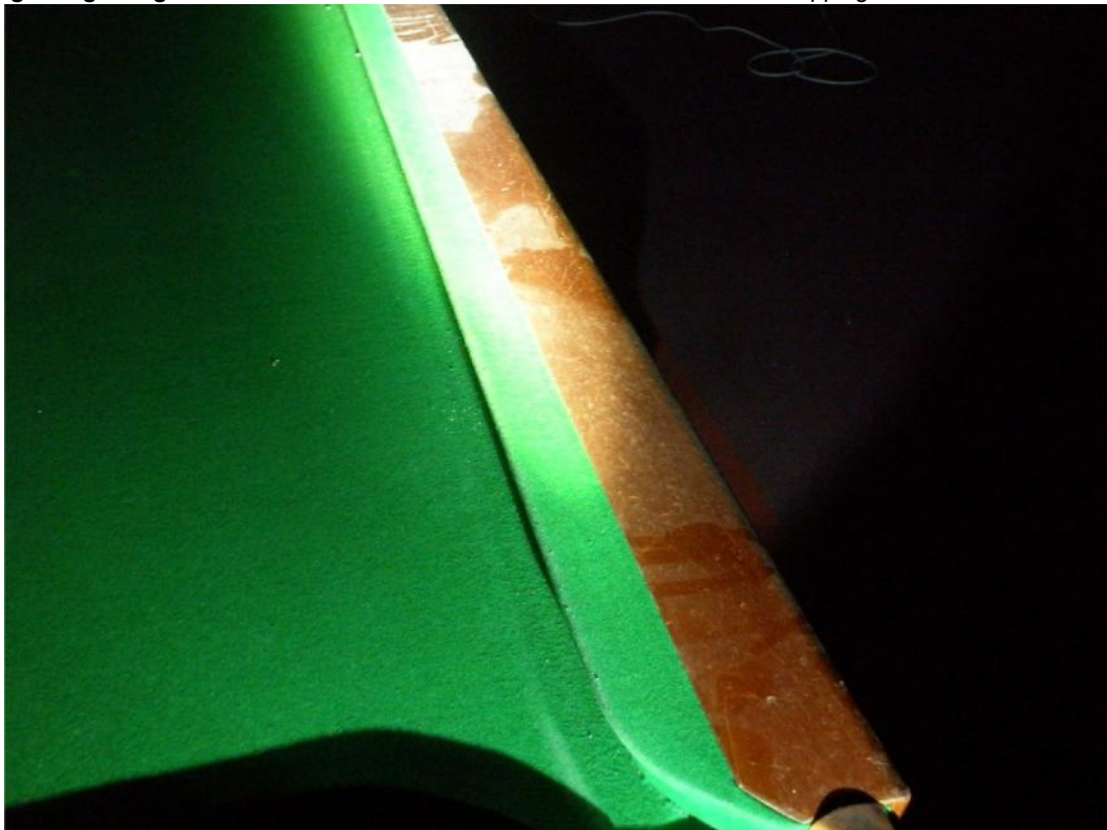
Figure 5h: Image 8 – a number of snooker tables remain – these exhibited no evidence of the space being used by bats.

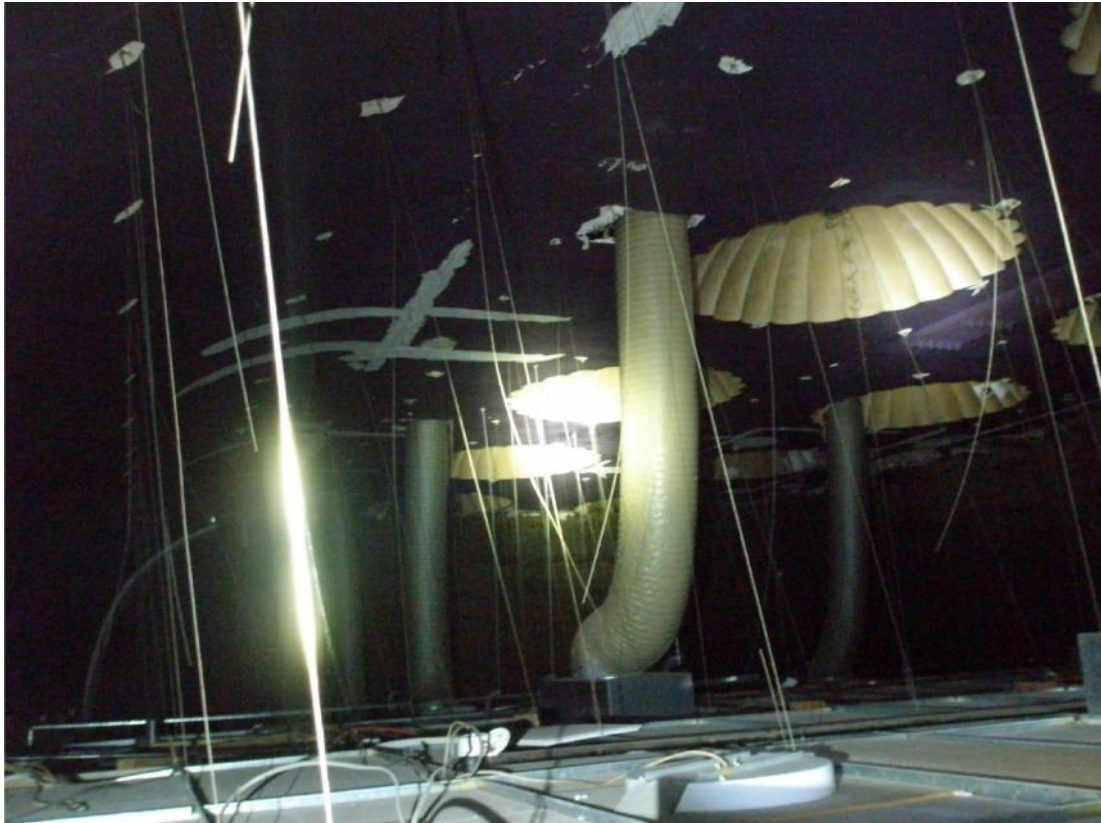
Figure 5i: Image 9 – shows the interior of the suspended ceiling. This was not accessible for health and safety reasons; however, it was possible to view the interior through a removed ceiling panel & check surrounding panels for evidence of use by bats – none were found. Here we can see the original roof of the cinema auditorium.

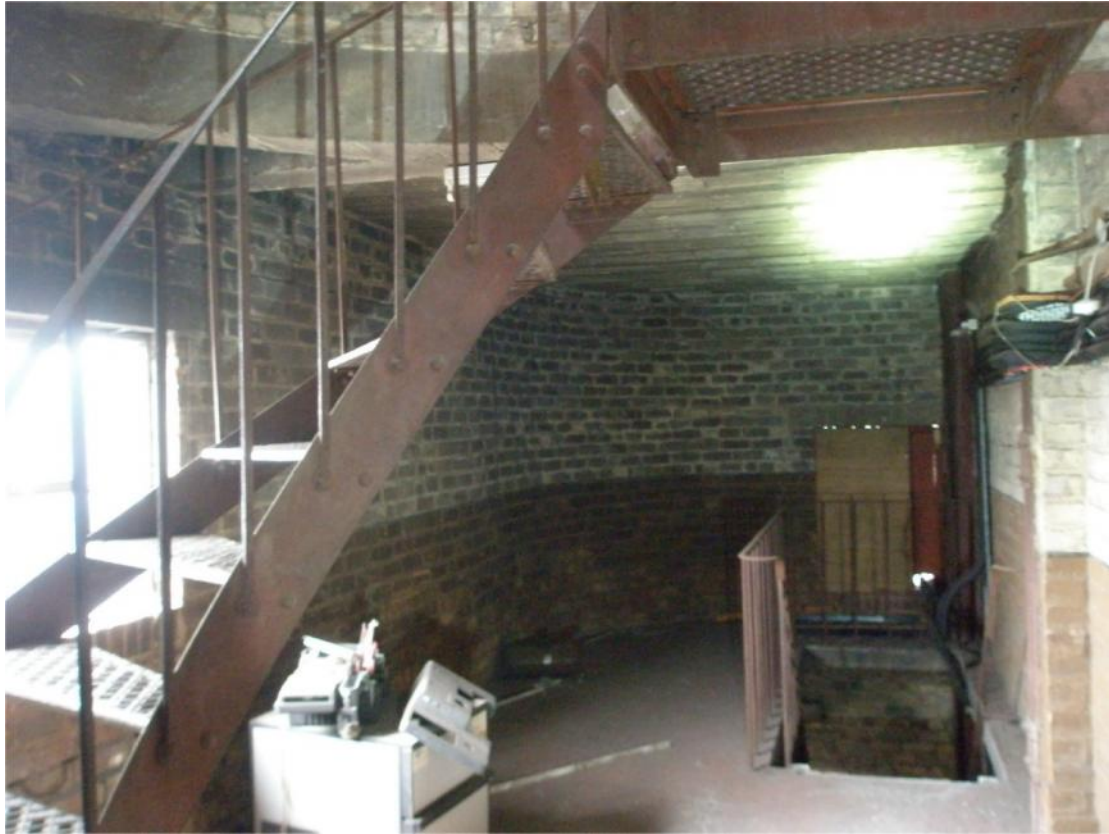
Figure 6a: Image 1 – stairwell up from former Riley's snooker club has a lobby area before another flight of stairs up to some corridors. It can be seen that daylight penetrates this area of the structure.

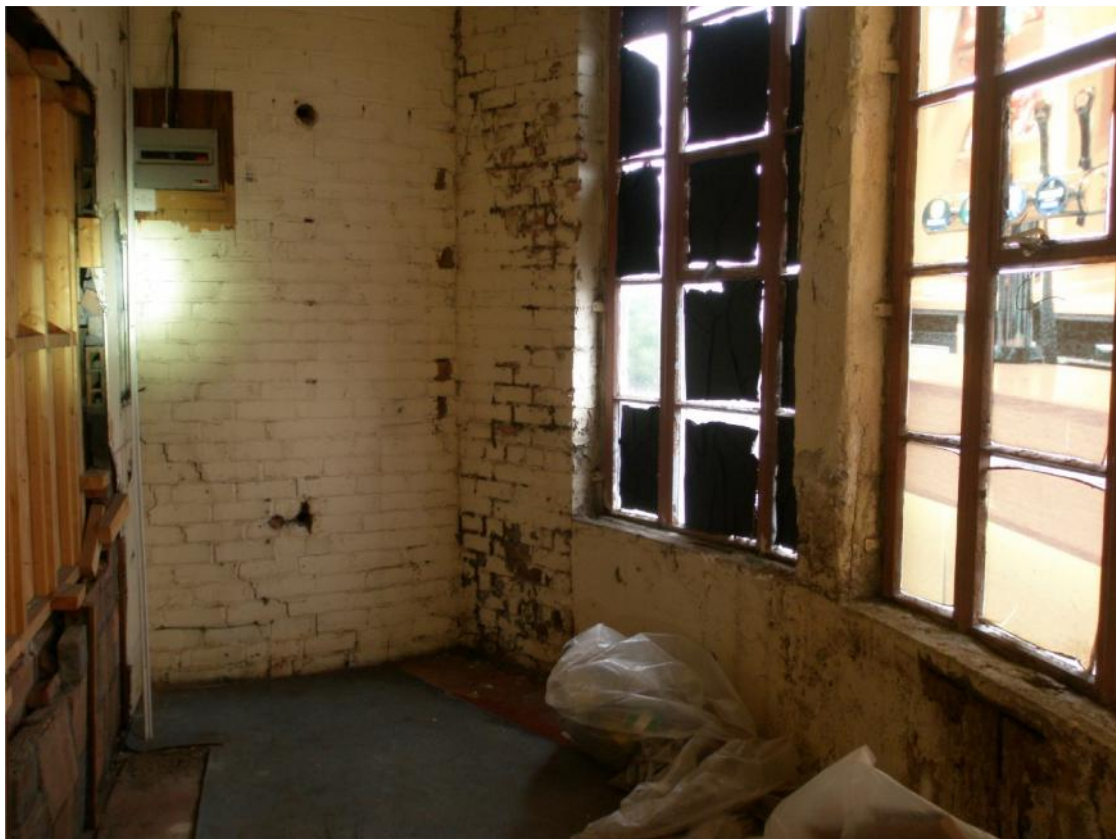
Figure 6b: Image 2 – another lobby area part-way up the stairwell also has daylight penetrating the structure.

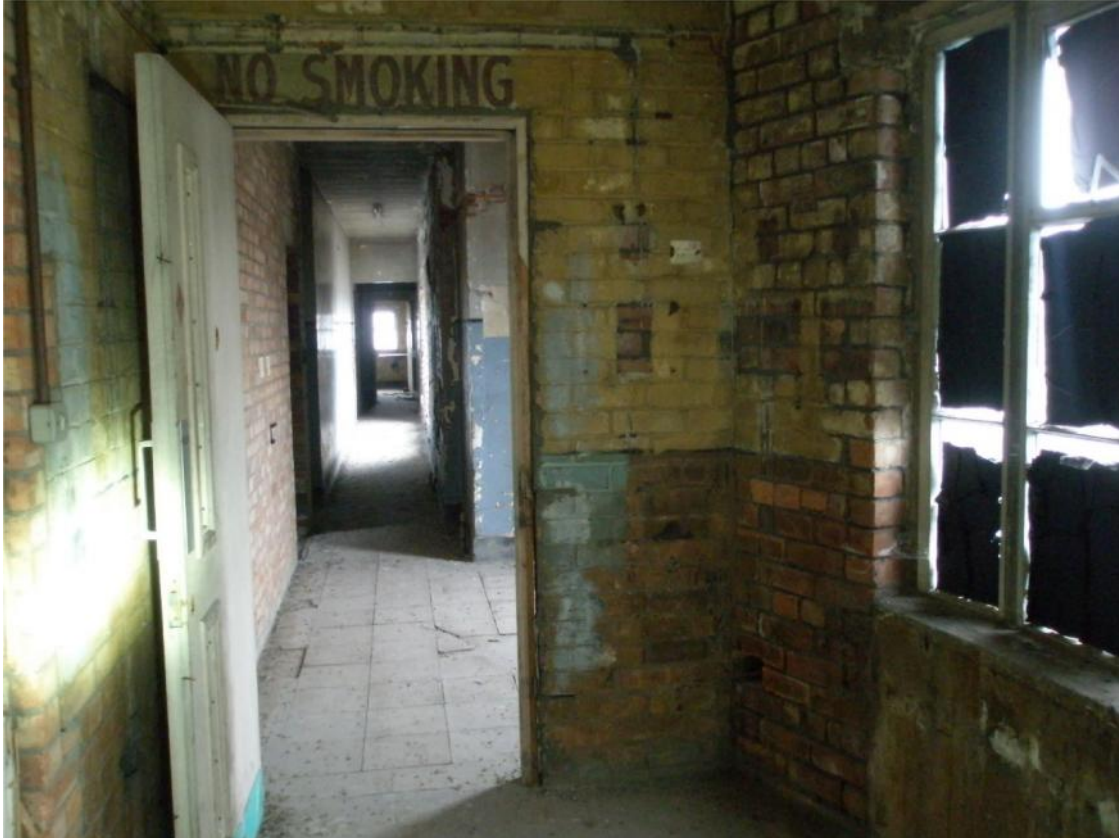
Figure 6d: Image 4 – this image shows the upper level of the structure. Here we have corridors exposed to daylight penetration.
