File Note: LEL_CRN_L156TF_PRA_001_REV A

Discipline: Preliminary Ecological Appraisal for Bats and Preliminary Roost Assessment

Site: Church Road North, Wavertree L15 6TF (Structure Grid Ref: SJ 3928 8936).

Site Visit Date: Thursday 18th June 2020

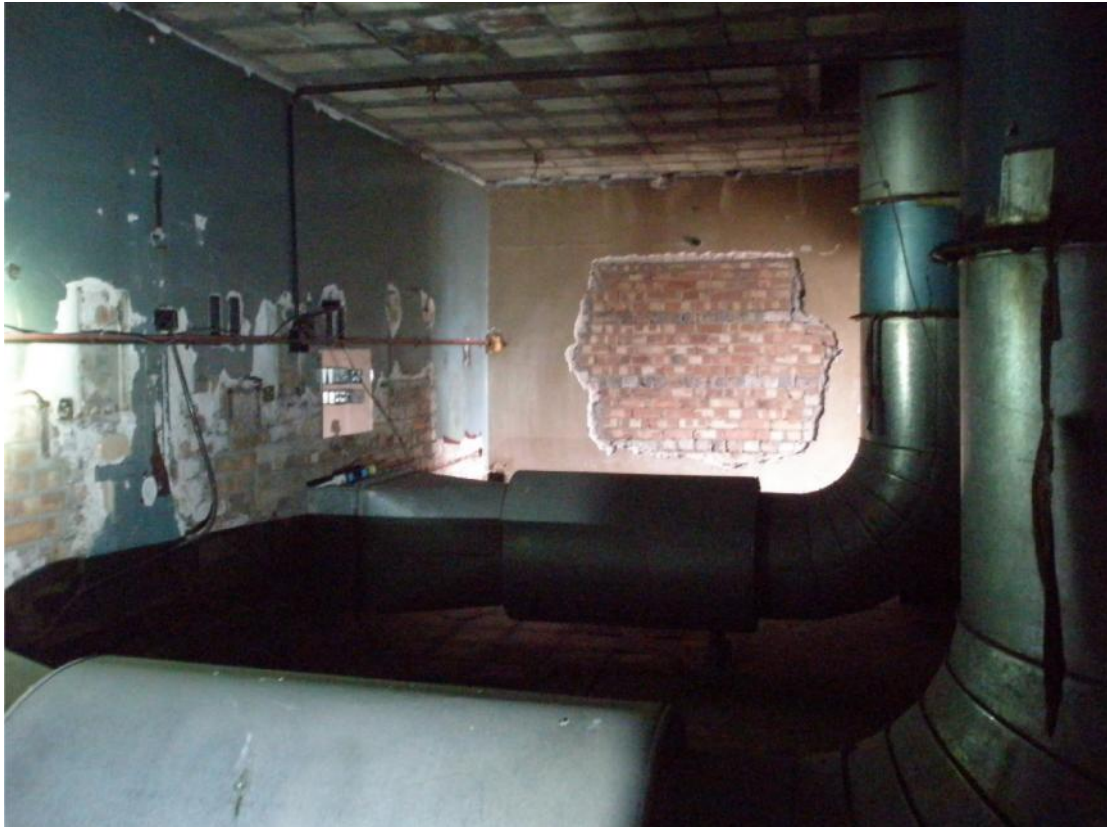
Figure 6e: Image 5 – one of the rooms off the corridor, though slightly darker, still has daylight penetrating from the corridor.

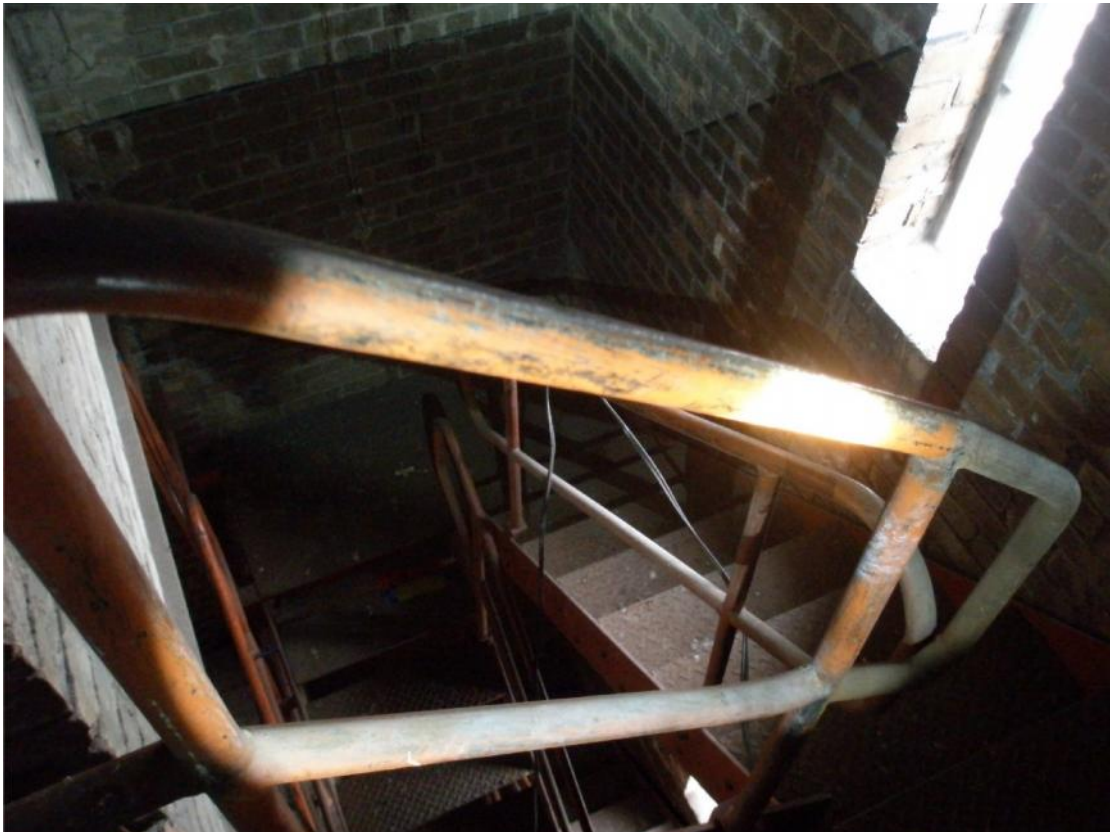
Figure 6f: Image 6 – this image shows another narrower stairwell down from the upper structure to ground level. Small windows allow daylight to penetrate

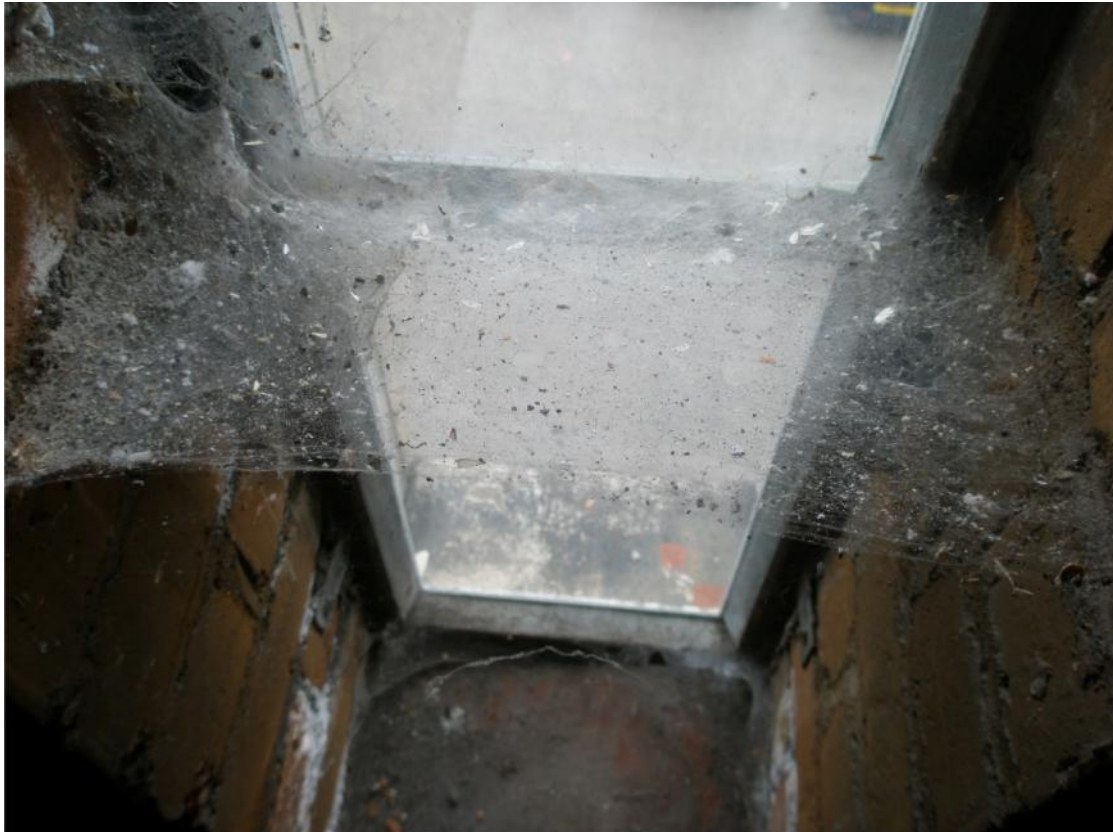
Figure 6g: Image 7 – cobwebs in the small windows of the stairwell discussed in Figure 6f were checked for bat droppings – none were present.

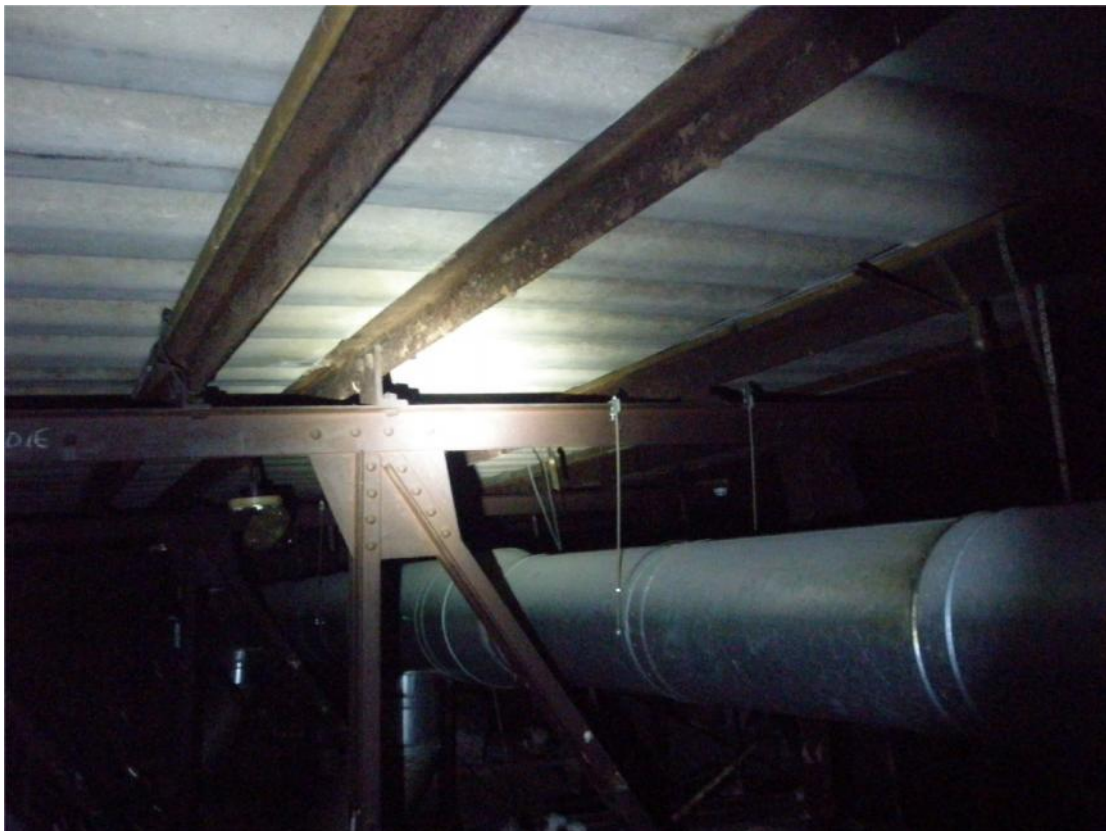
Figure 6j: Image 10 – this image shows the roofing material to the structure which appears to be corrugated asbestos and not metal as suggested in the Preliminary Ecological Appraisal.

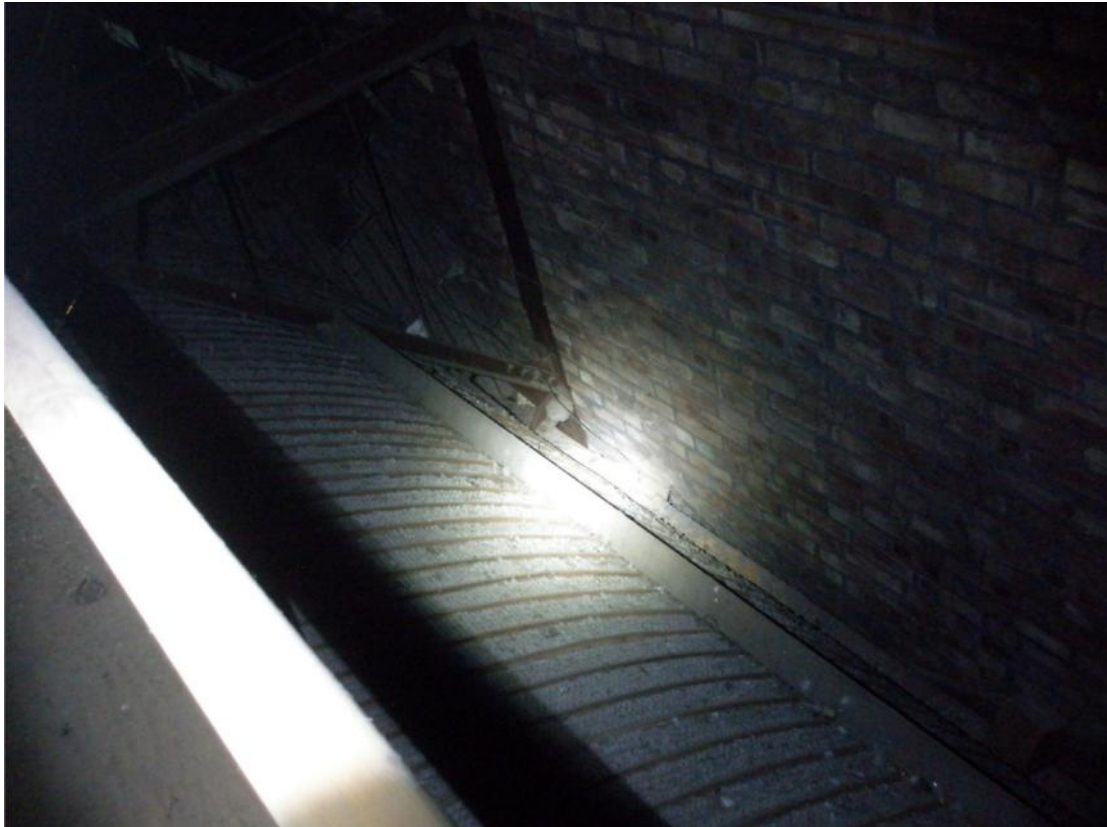
Figure 6k: Image 11 – a further image from the roof void showing the roof curvature of the auditorium where checks were made via torchlight for evidence of use by bats – none were found.

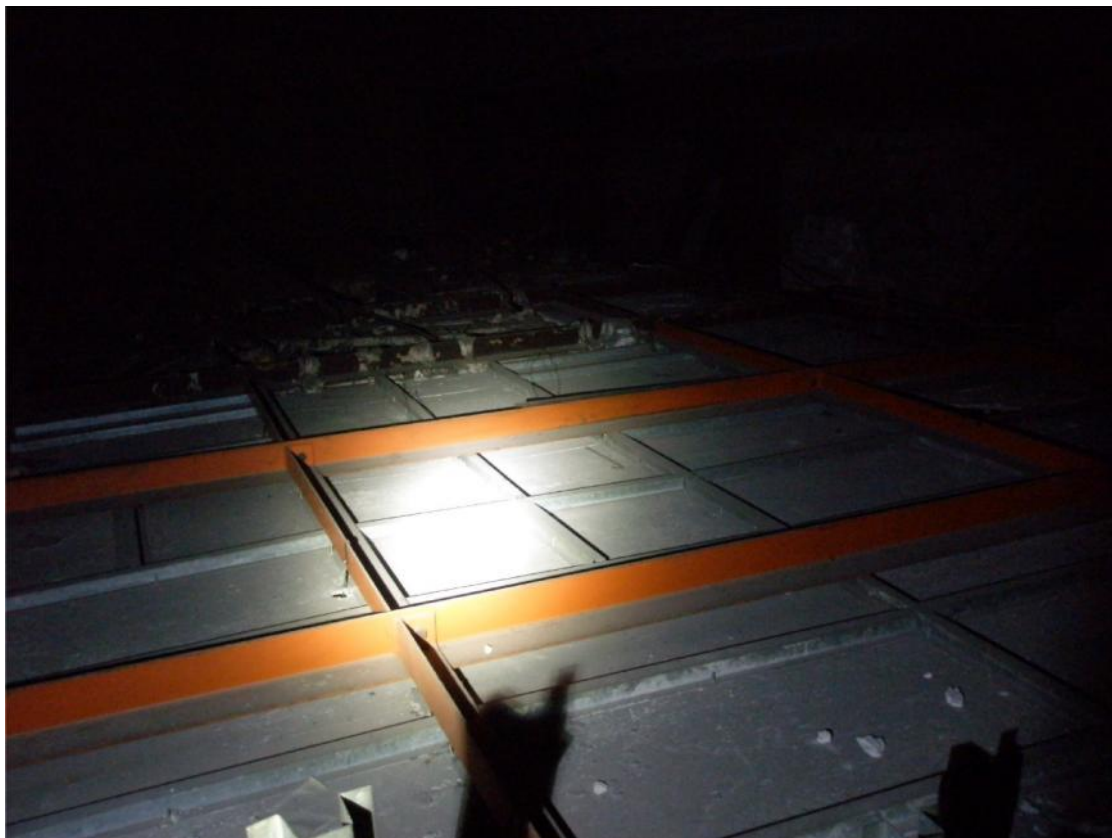
Figure 6i: Image 12 – another floor space in the roof void where checks for evidence of use by bats were made – none were found.
