Preliminary Roost Assessment

179-195 Oakfield Road

Anfield

URBED Ltd

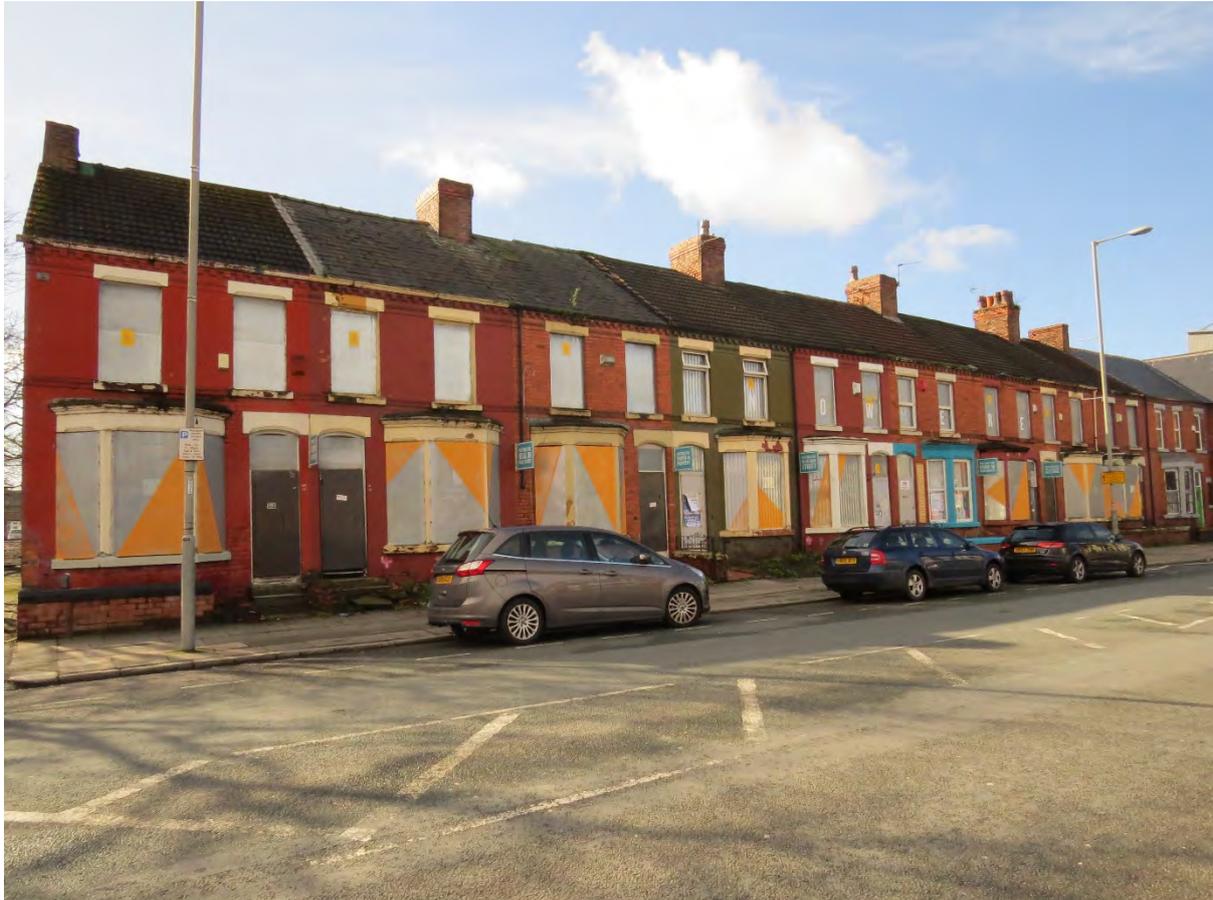
3.1a – The east side of the terrace with N° 179 to the left.

The terrace is in poor condition. Roof and ridge tiles have been broken or disturbed, possibly when leadwork was removed, these could give access to the inside of the building. Walls are in generally good condition, with few areas of missing mortar, and no suitable cracks in the brickwork or stonework.

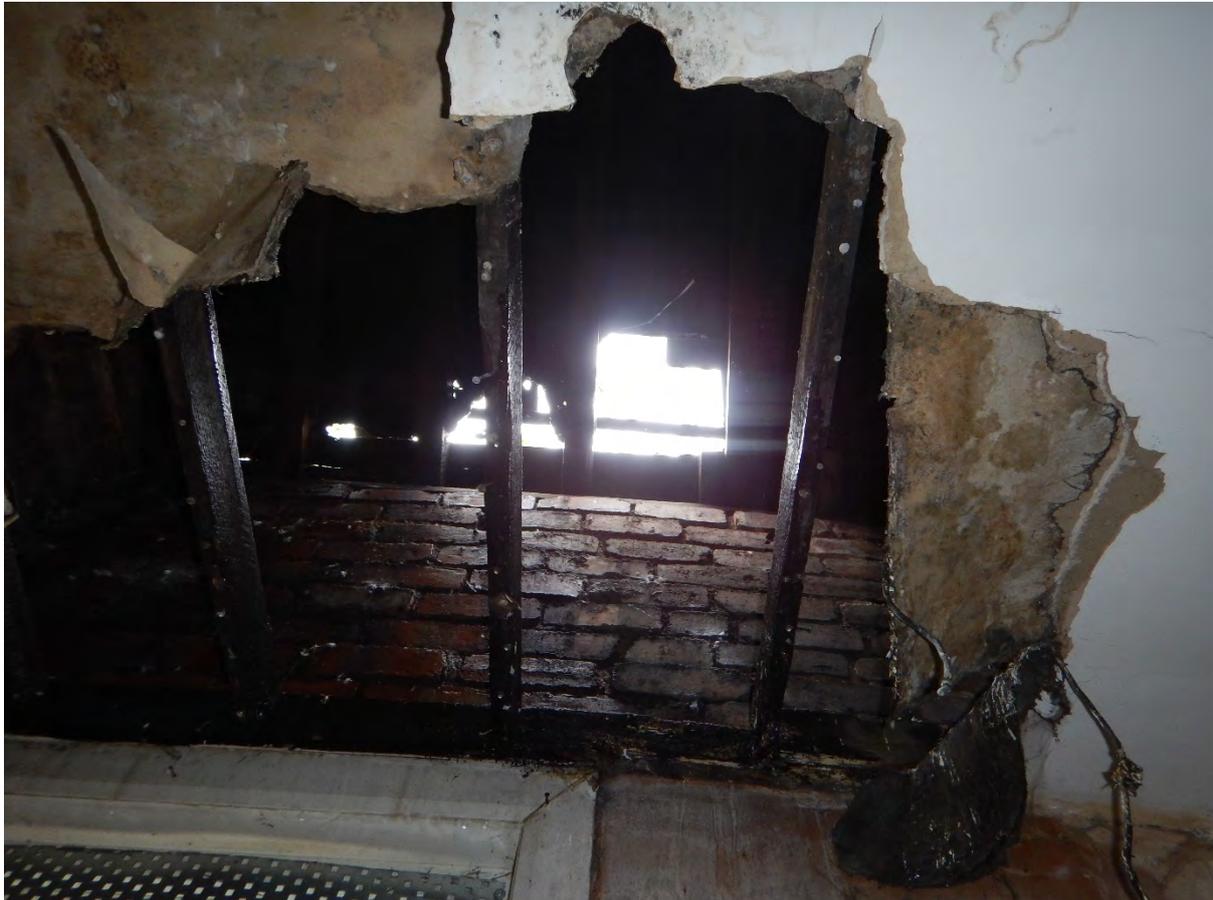
3.1a – A typical section of ceiling and roof void, now open to the elements, where ceilings have collapsed.

Roof voids are in general: draughty, wet, and open to the elements, with water running through, and areas of collapsed ceiling and rotting timbers offering little suitable shelter for roosting bats.

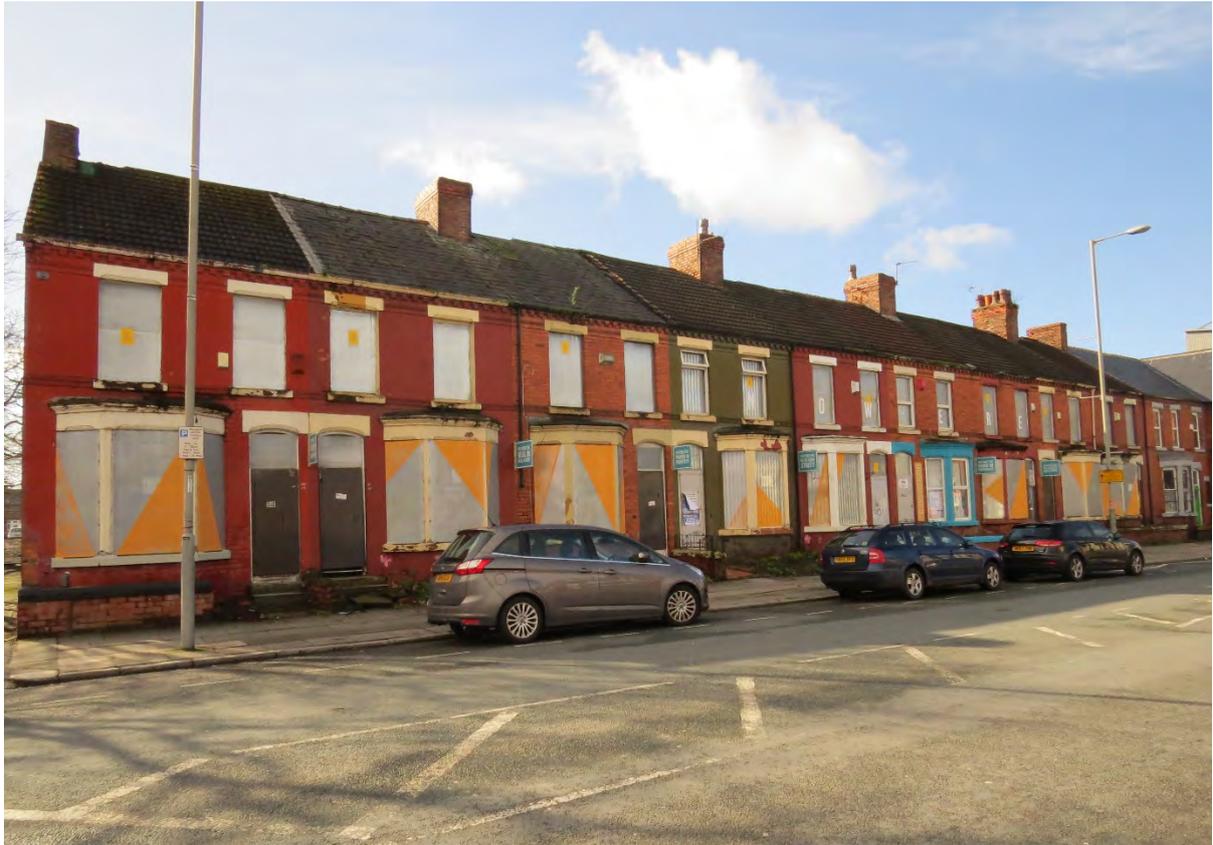
1 – The front of the terrace from Oakfield Road, and high level lighting.

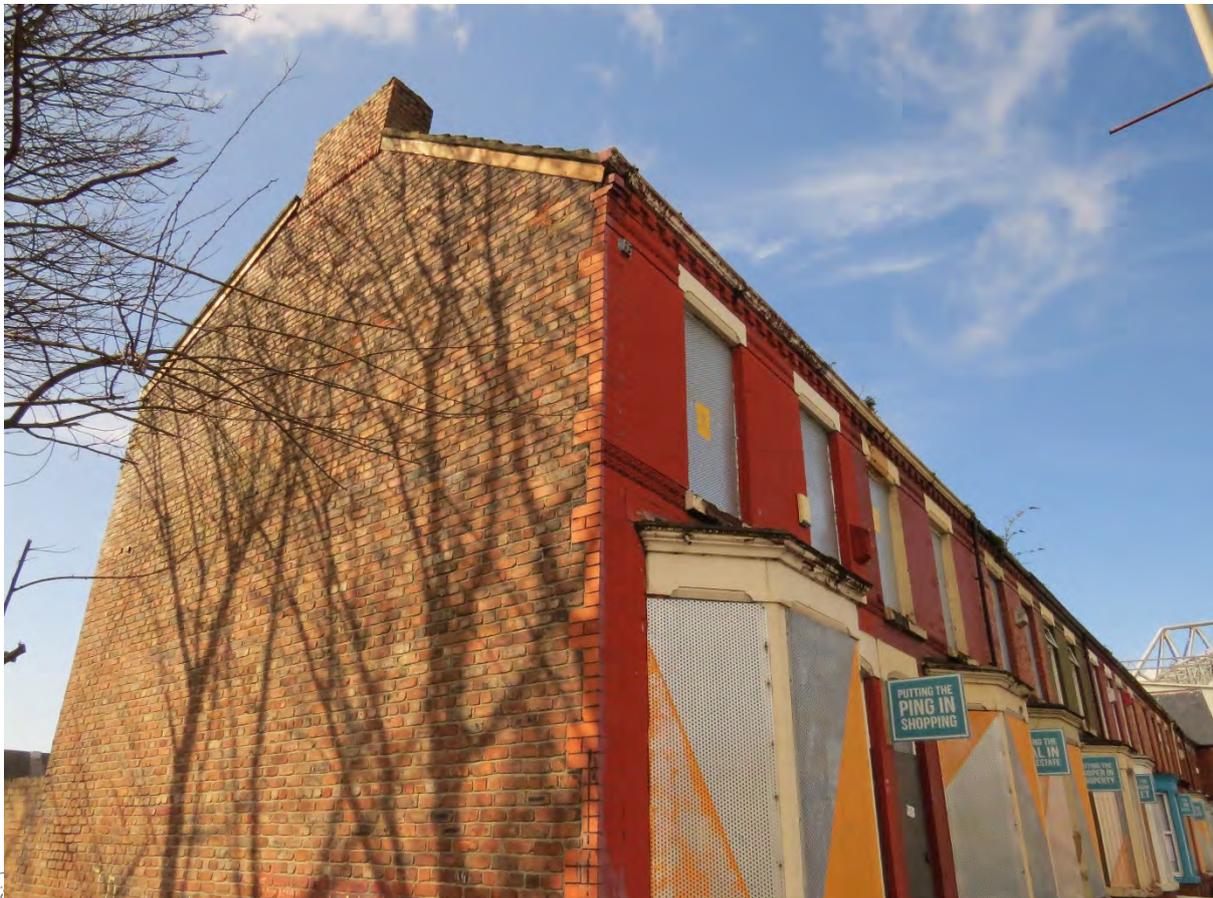
2 – The south gable end of the terrace.

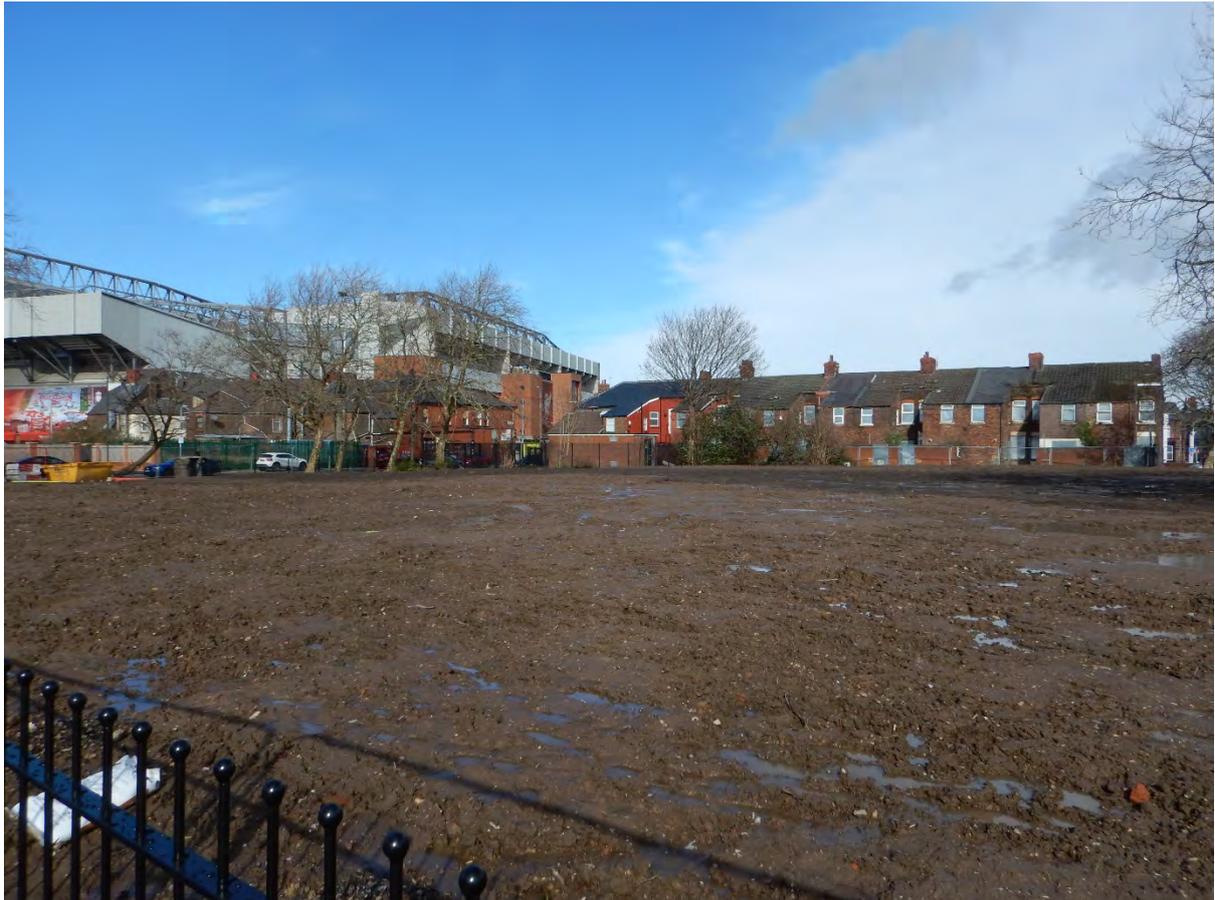
3 – Habitat to the rear of the terrace is an area of cleared ground.

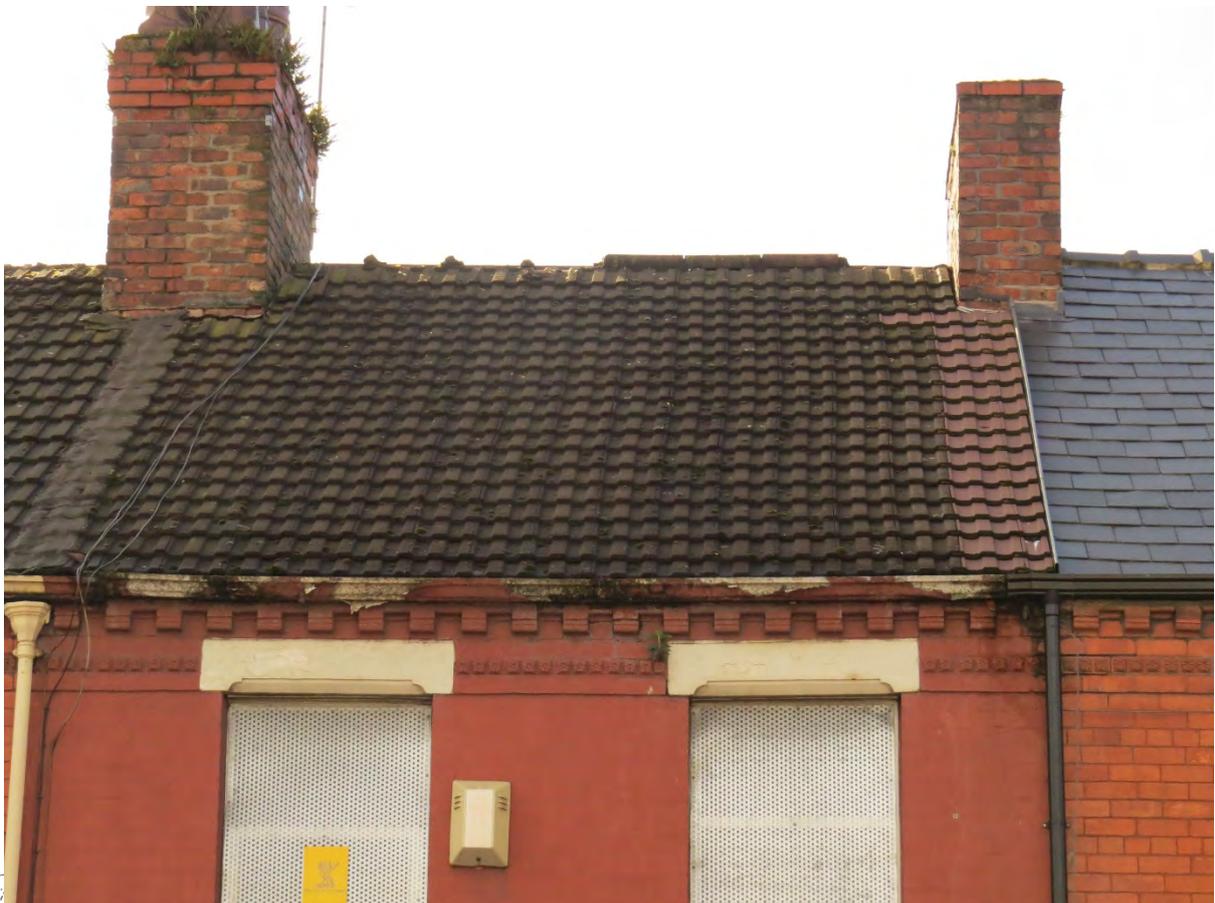
Leadwork was fitted at the base of chimneys, however, this has been removed from all of the houses, with the exception of N° 189, where it is tightly fitted. Ridge tiles have been removed from approximately 30% of the ridge line, those remaining are fixed in place with cement.

4 – Roofs are a mixture of slate and Marley tiles, many ridge tiles are missing.

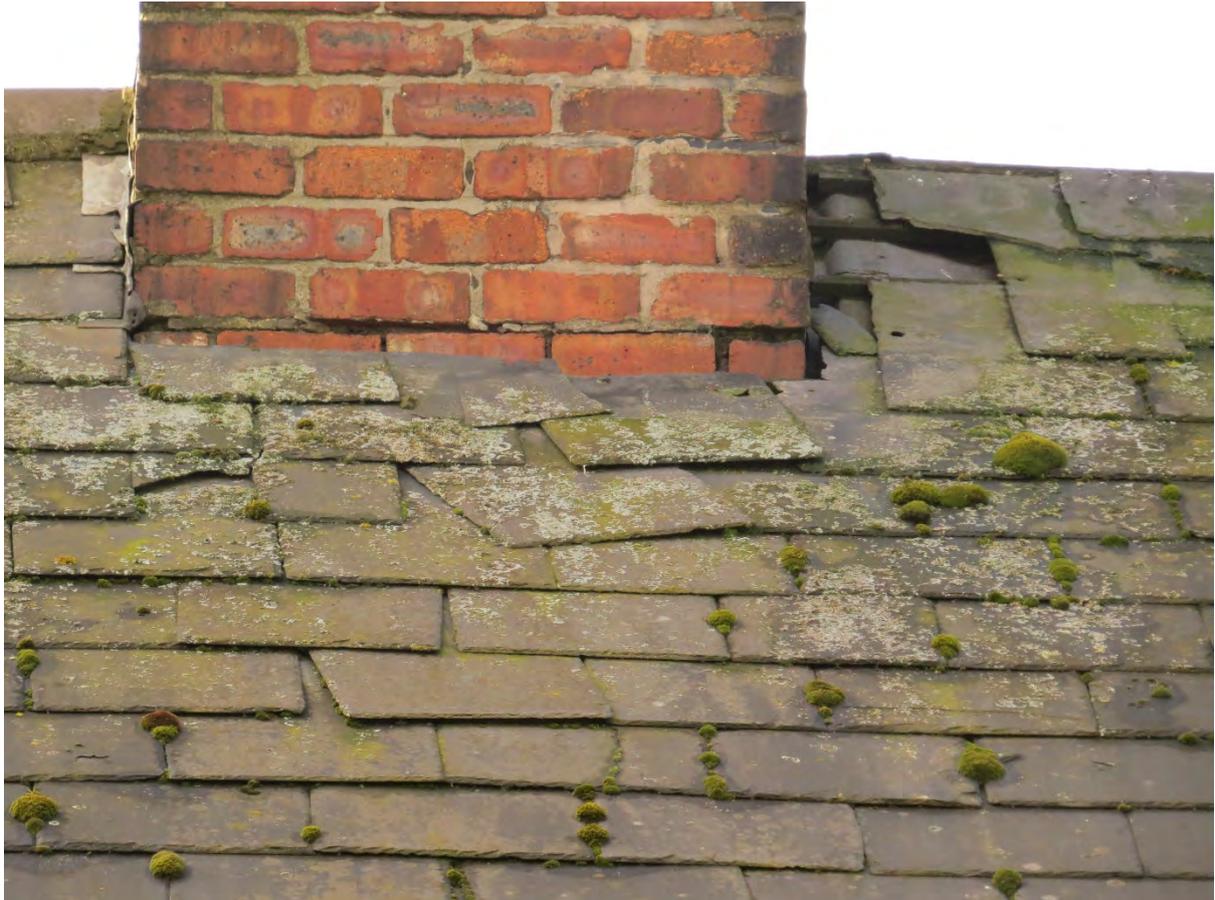
There are missing roof tiles at the rear of the properties, missing ridge tiles, and missing lead flashing around chimney bases. The missing tiles and leadwork have opened the roof voids to the elements, pigeons, and potentially to bats. Pigeons were present in every property (except for N° 189, whose roof is intact). There are large volumes of pigeon droppings, and rat droppings in each property.

5 – Roof and ridge tiles have been disturbed where leadwork has been removed.

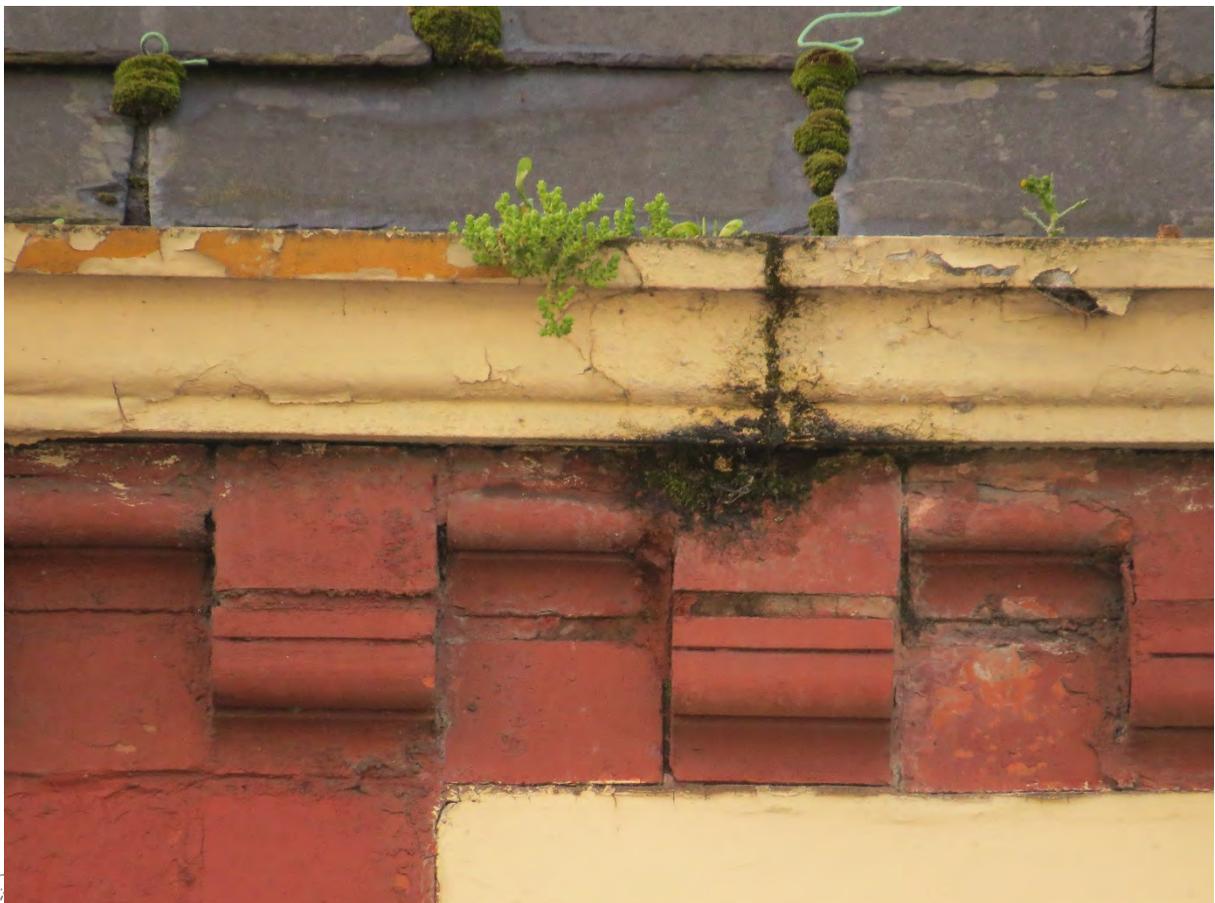
The walls are solid brick and are in good condition, with no cracks, or missing mortar which could be used by crevice dwelling bats. Window and door frames, lintels and window sills, are sealed into the brickwork with no suitable gaps.

6 – Brickwork and stonework are in good condition with no suitable gaps.

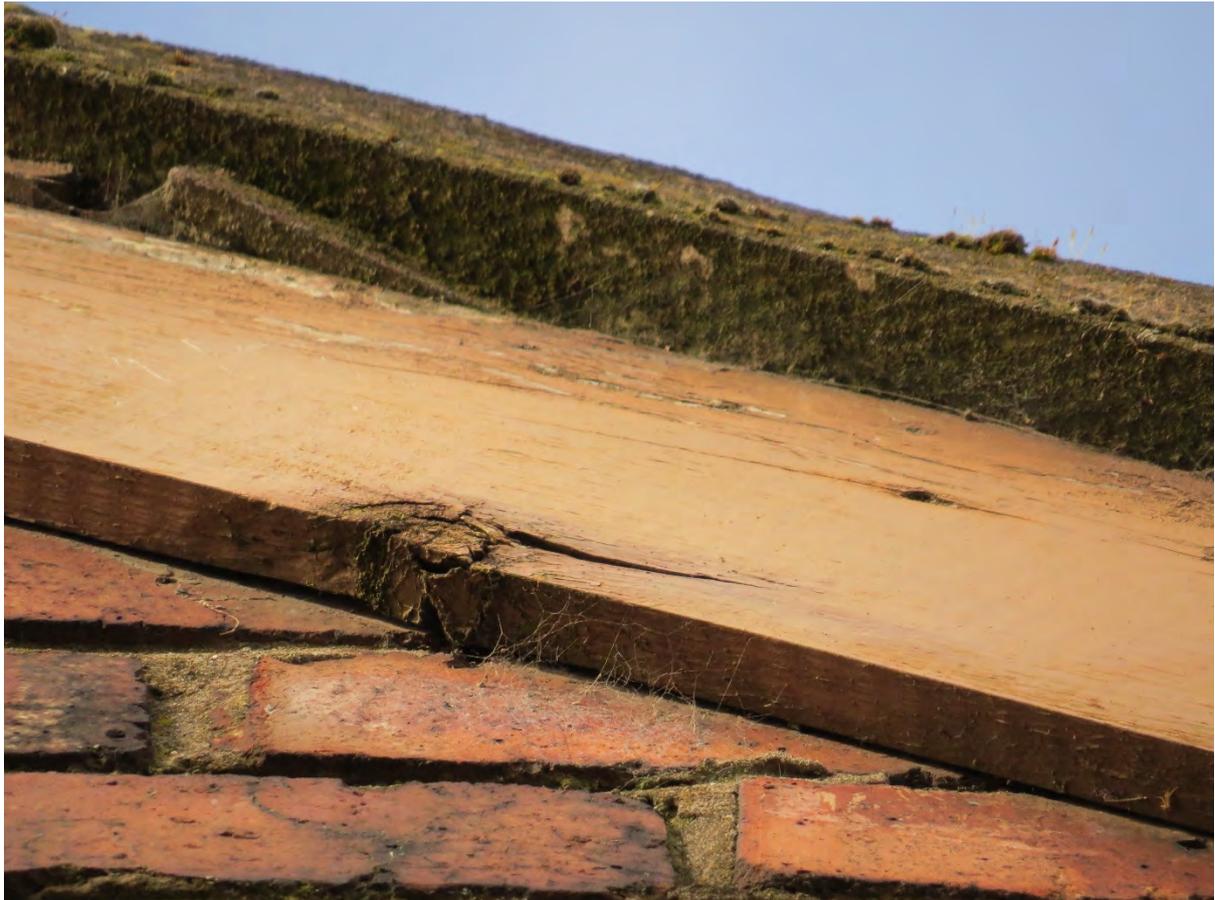
7 – Cement at the verge of the south gable end is intact, bargeboards are tightly fitted.

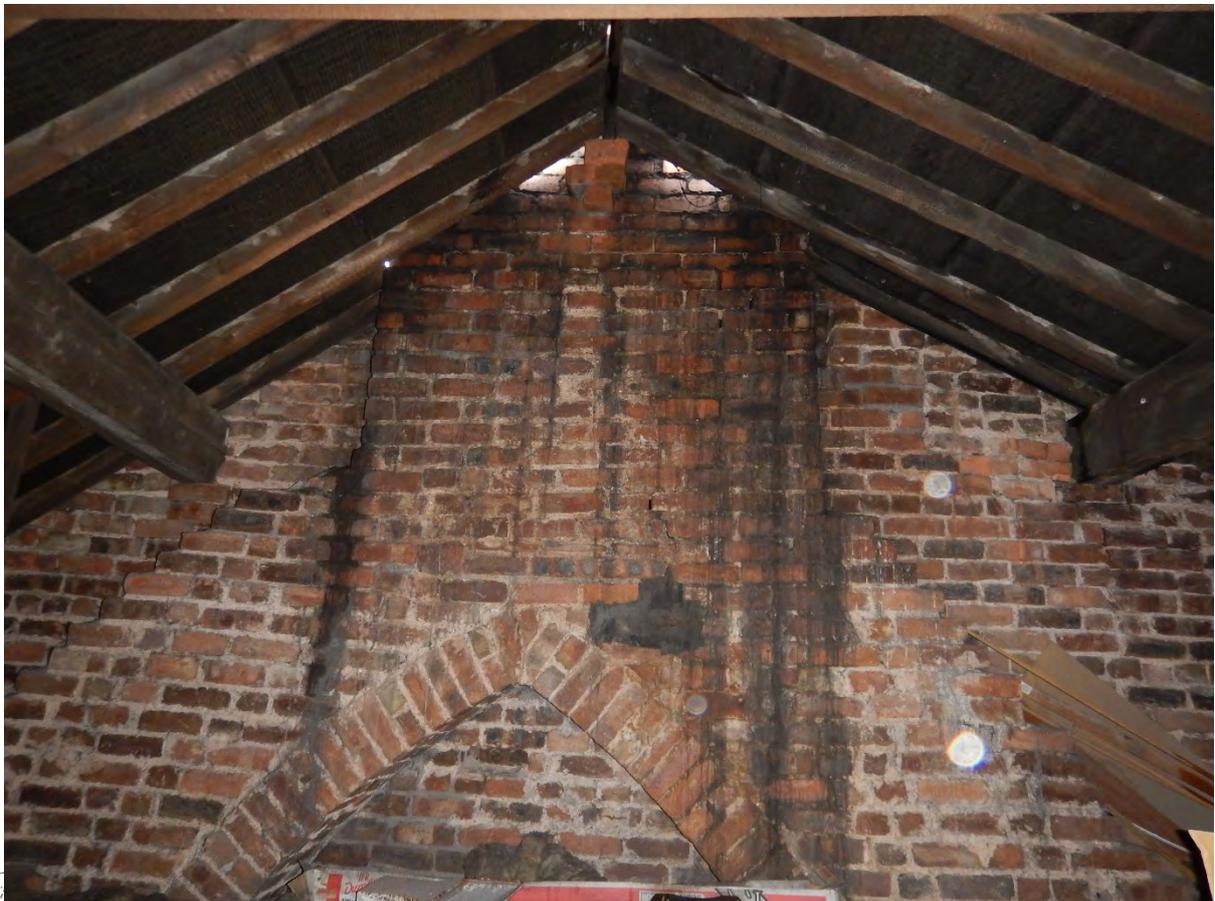
Roof voids have been opened by the theft of lead flashing, which has allowed water to rot timbers, and caused ceilings to collapse. The roof voids are open, wet, draughty, and unlikely to be used by roosting bats.

8 – Water is running down walls where leadwork and ridge tiles have been removed.

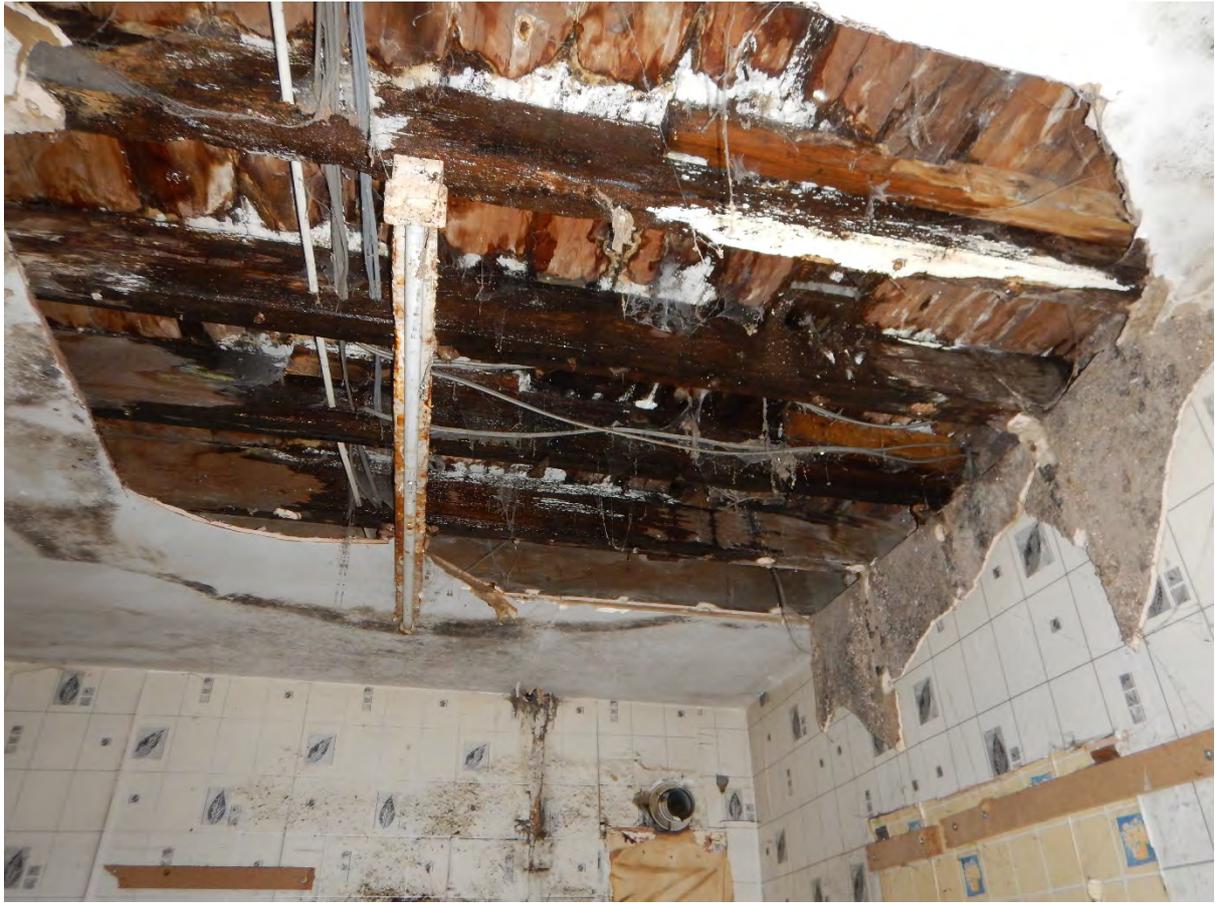
9 – The walls and floors are rotten as a result of water ingress.

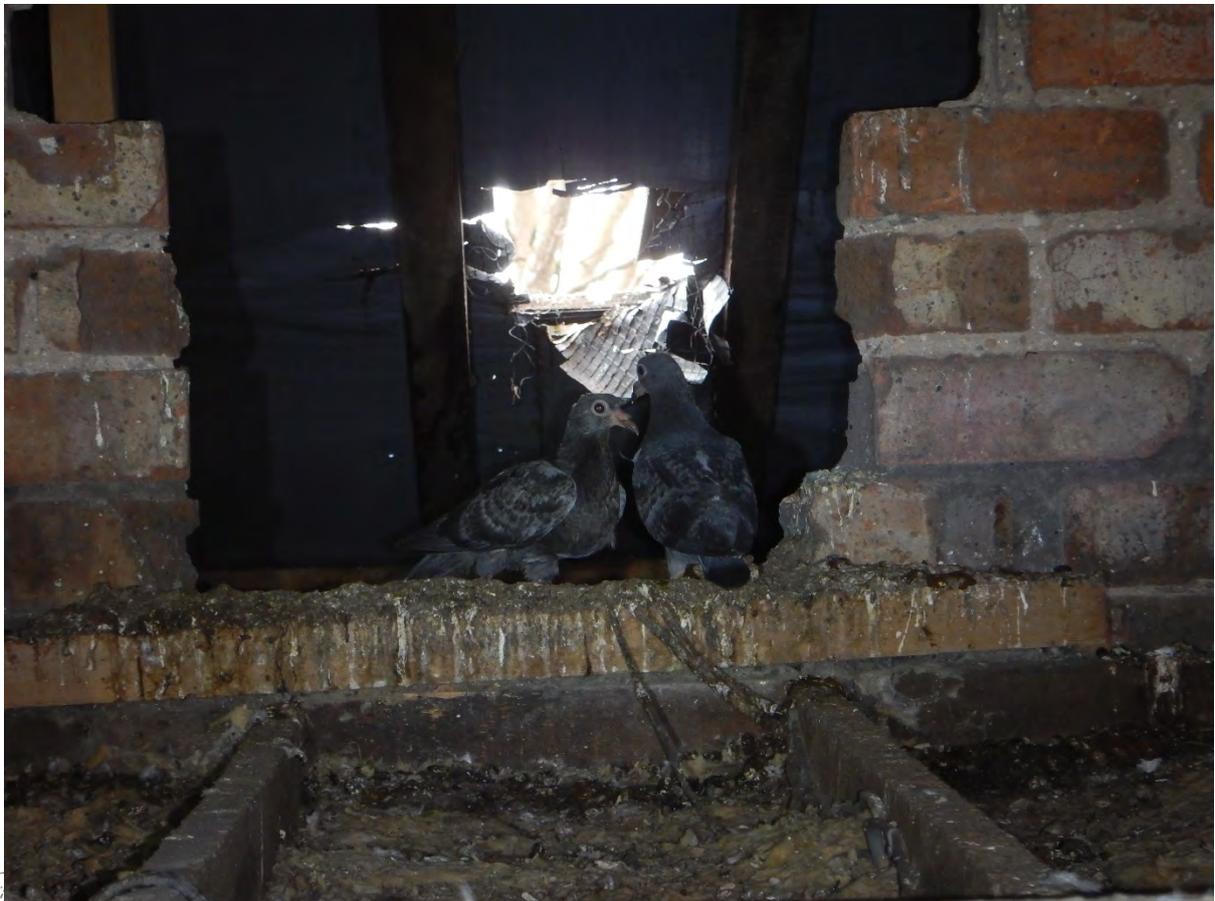
10 – Pigeons were present in all but one of the houses.

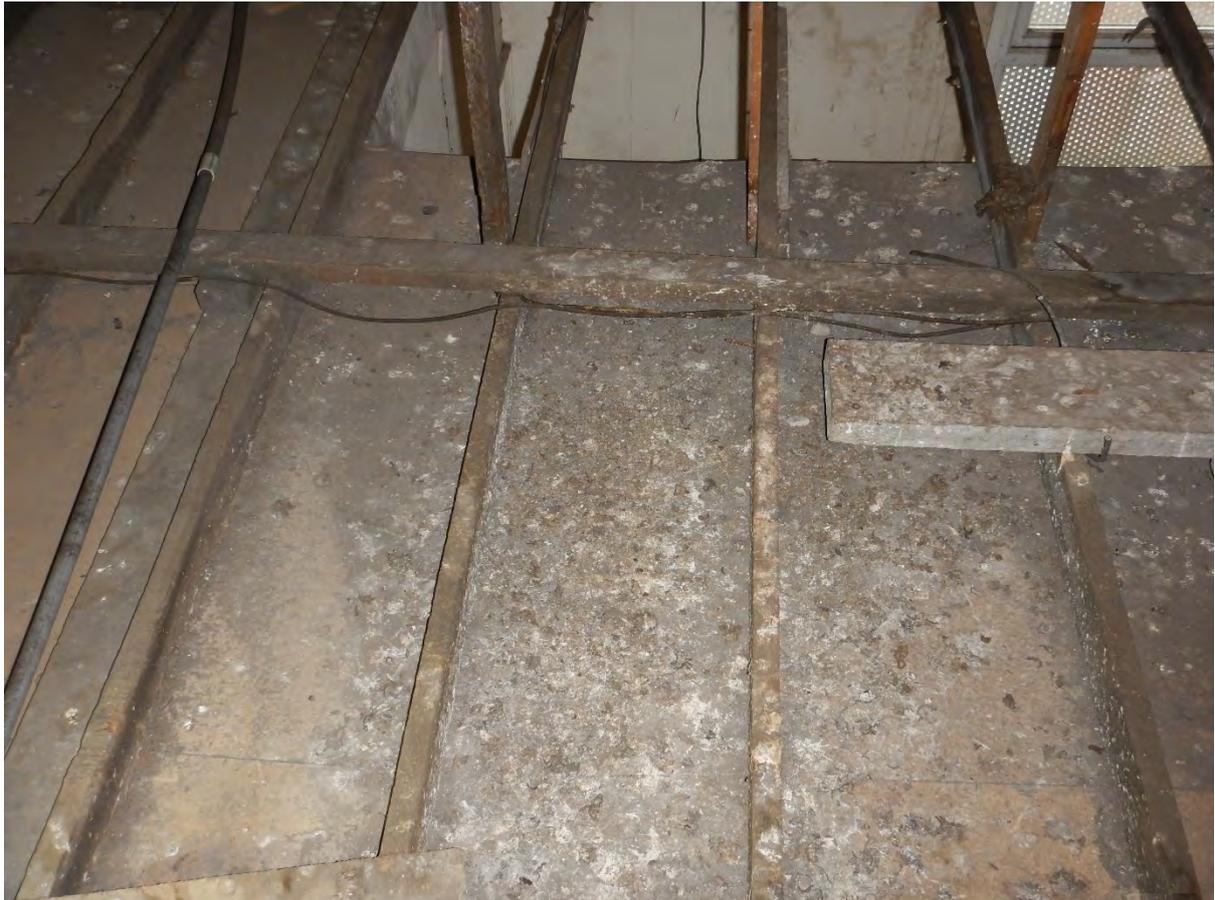
11 – Roof voids are matted with pigeon and rat droppings.

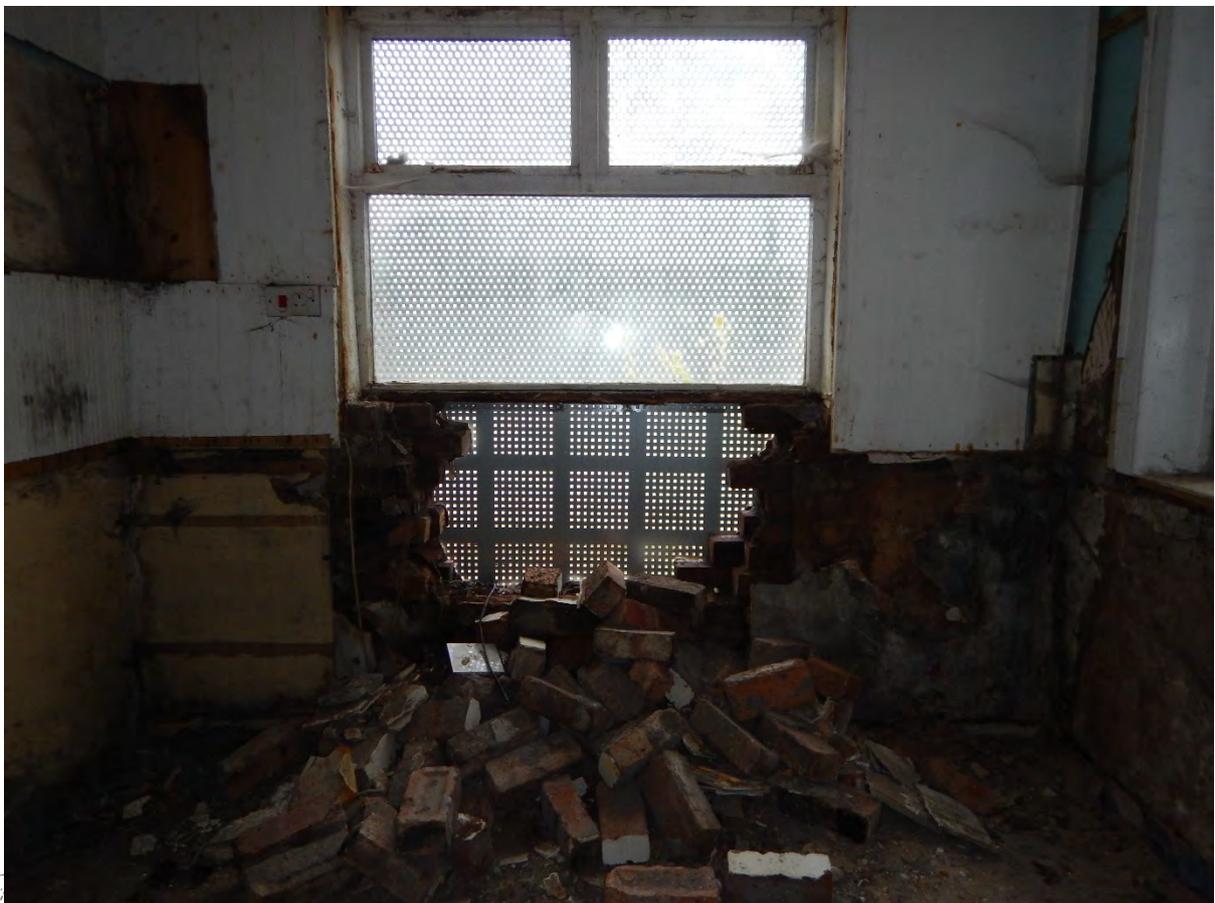
12 – The houses have been damaged and vandalised.

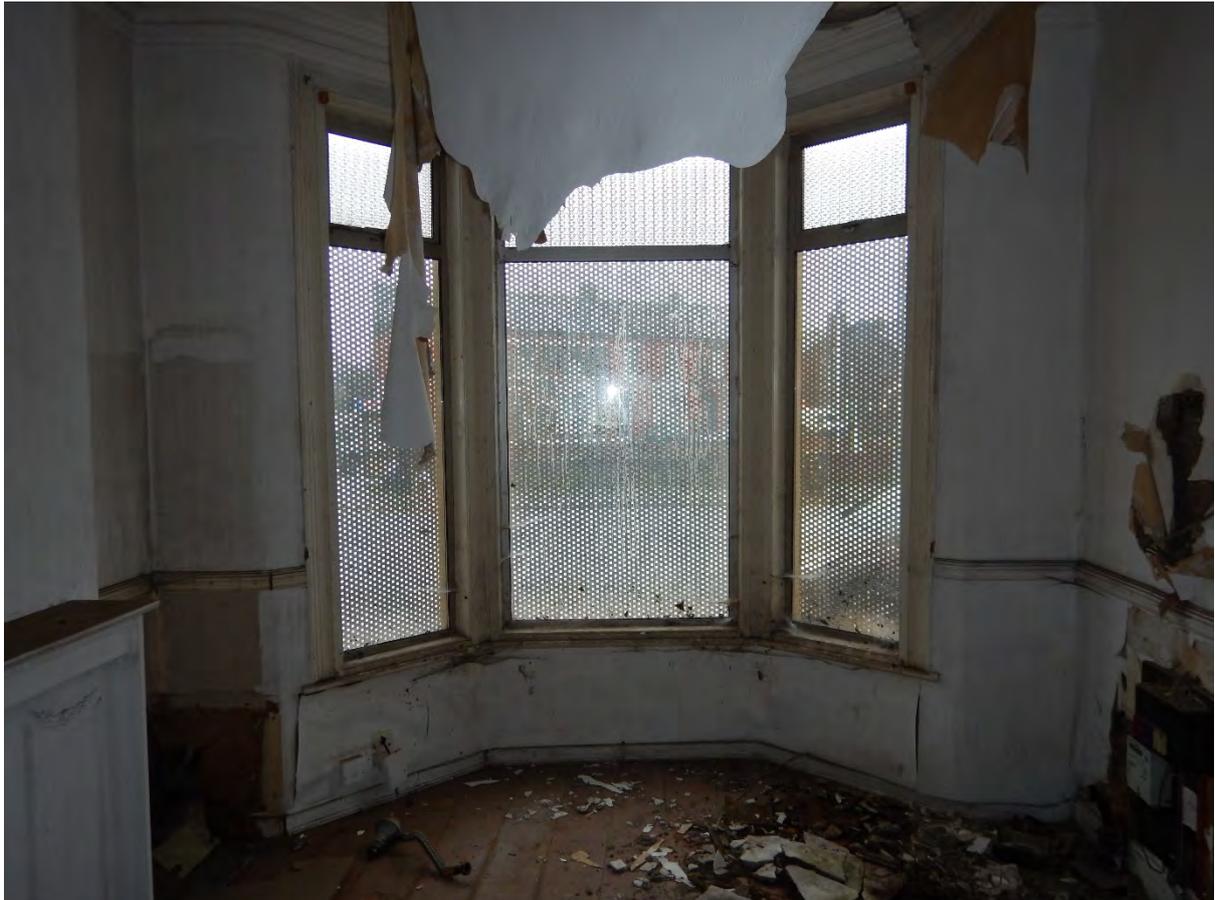
13 – Rooms are well lit by natural light through the windows.

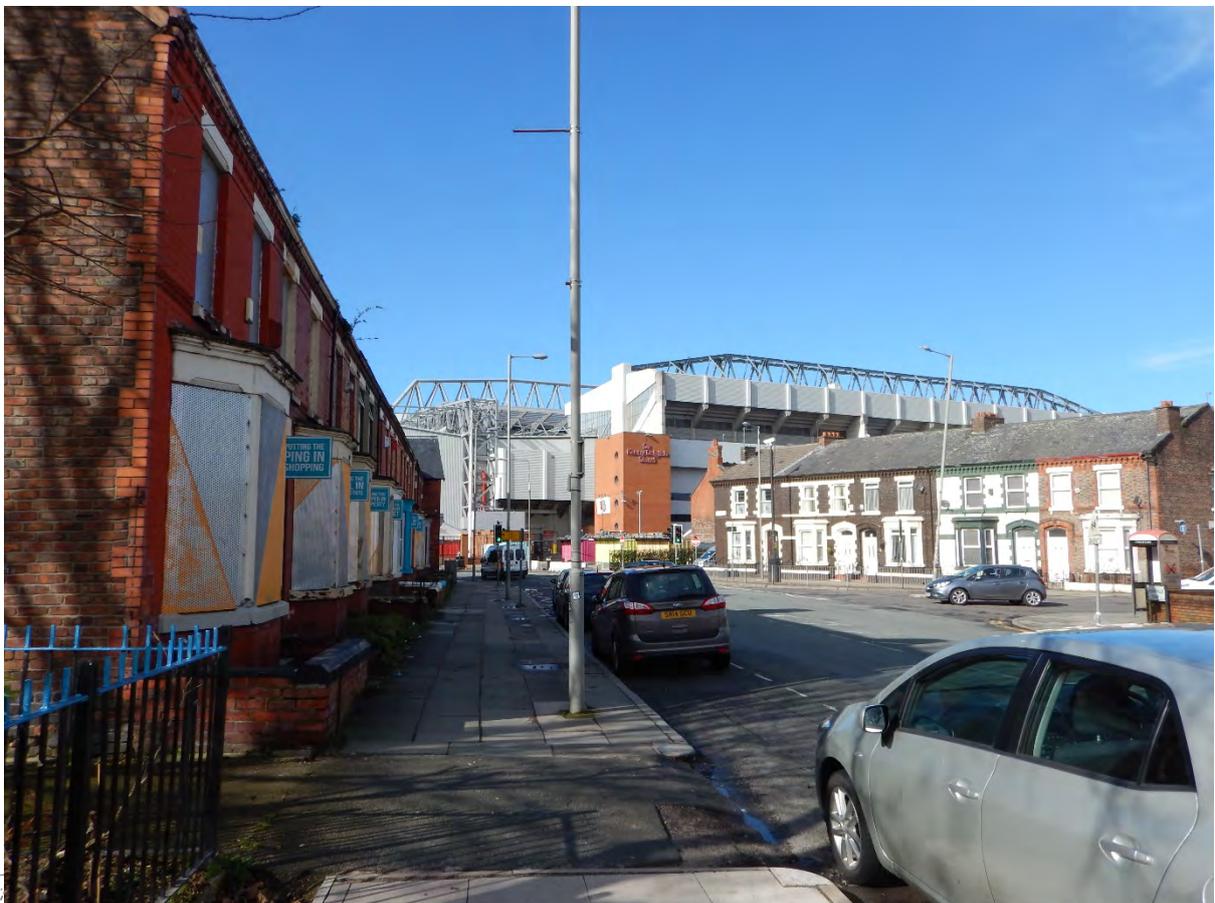
13 – The area surrounding the terrace is well lit and provides poor habitat for bats.
