# Rear of 92 Duke Street, Liverpool

Structural Stability Survey

285341-01 (00)

JANUARY 2013

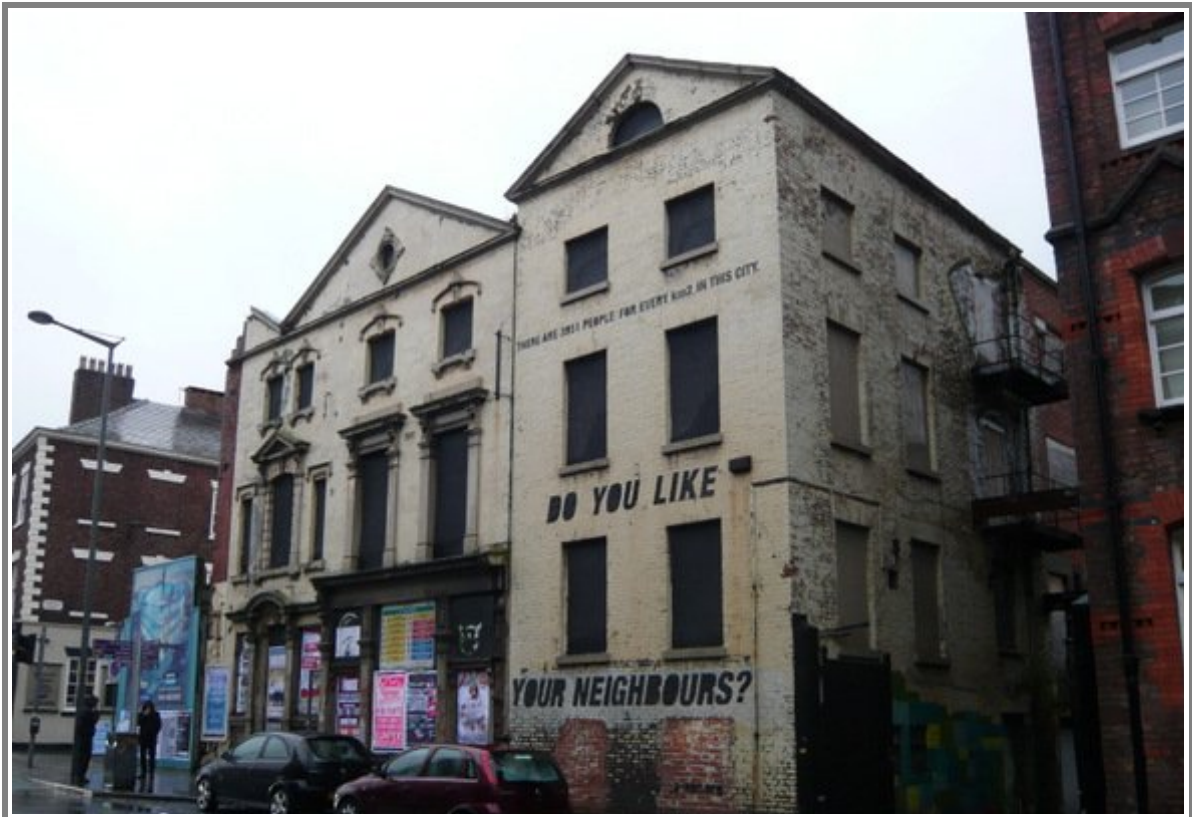
P1090053 **Photograph No: 1**

Front elevation No 90 Duke Street to the right No 92 Duke Street to the left

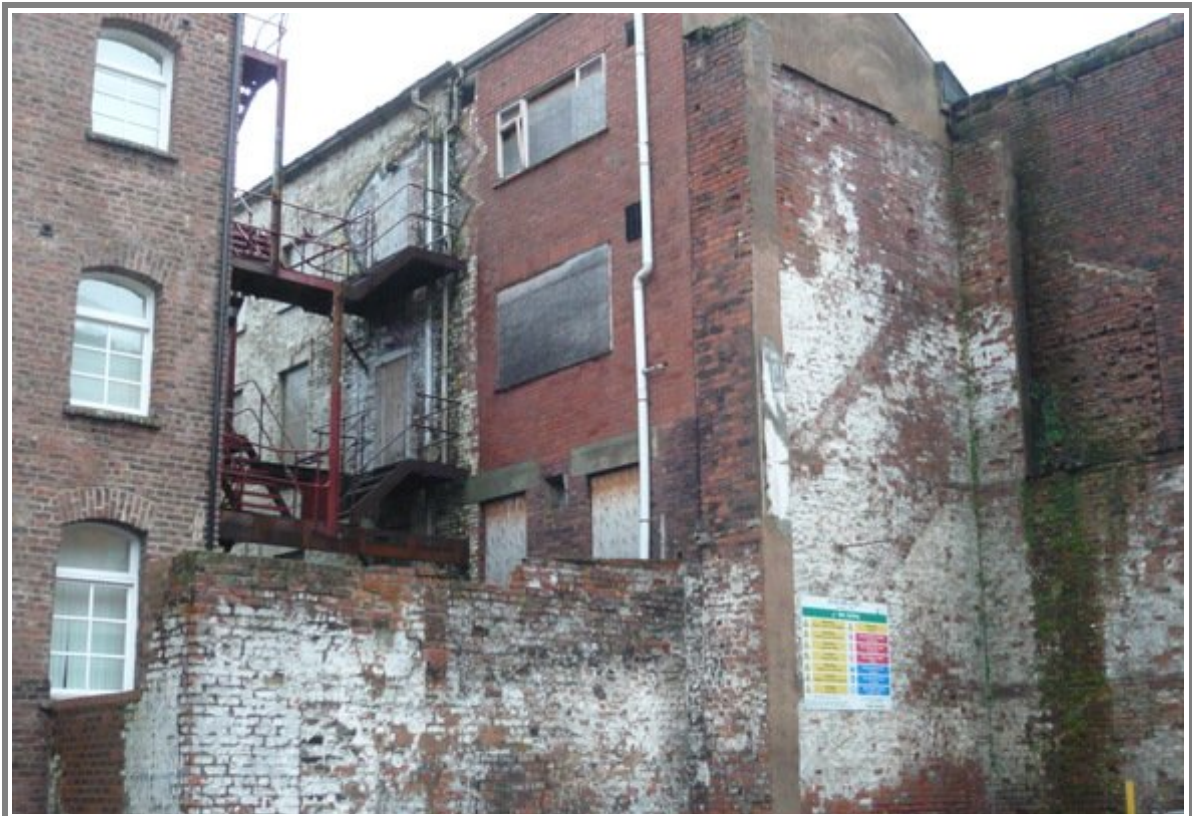
P1090013 **Photograph No: 2**

Rear of No 90 Duke Street

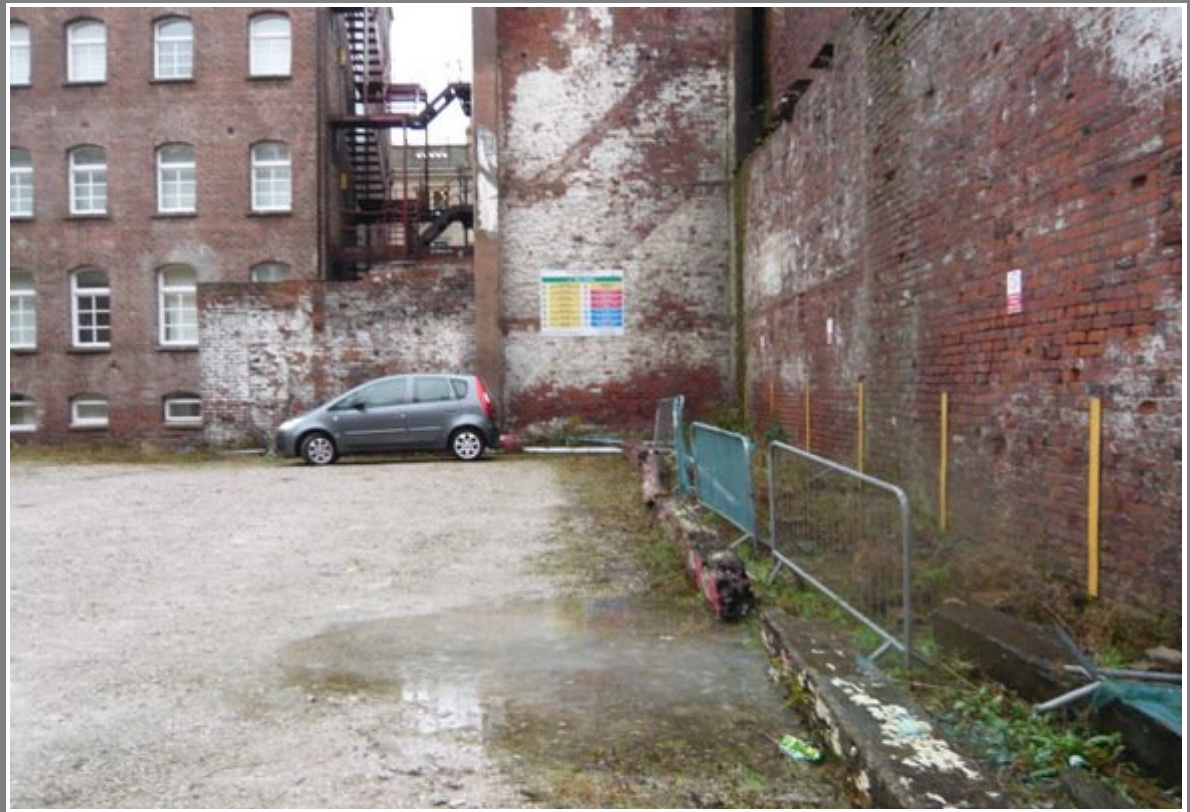
P1090069 **Photograph No: 3**

Rear car park area from where propping of the wall shown to the right is required (rear of No 90 Duke Street shown straight ahead)

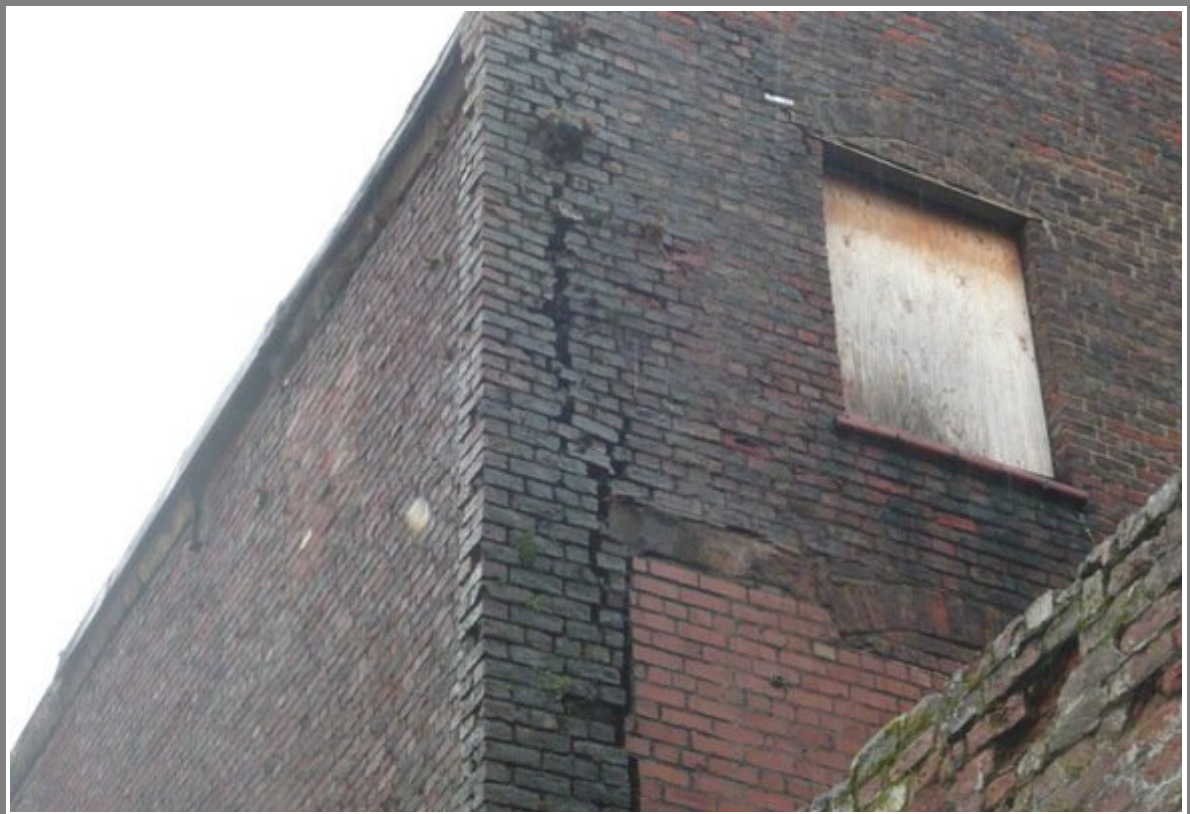
P1090026 **Photograph No: 4**

With regard to No. 92, the photographs in Appendix B show vertical separation and bowing at the corner of the rear wall and westernmost flank wall and to a lesser extent at the corner of the rear wall and easternmost flank wall.

Serious vertical crack to rear corner of No 92

It is recommended that a propping scheme using a fixed scaffold approach be adopted to restrain the westernmost flank wall and rear wall. It may be possible to 'novate' the scaffold structure across to the developer to assist with demolition at the appropriate time.

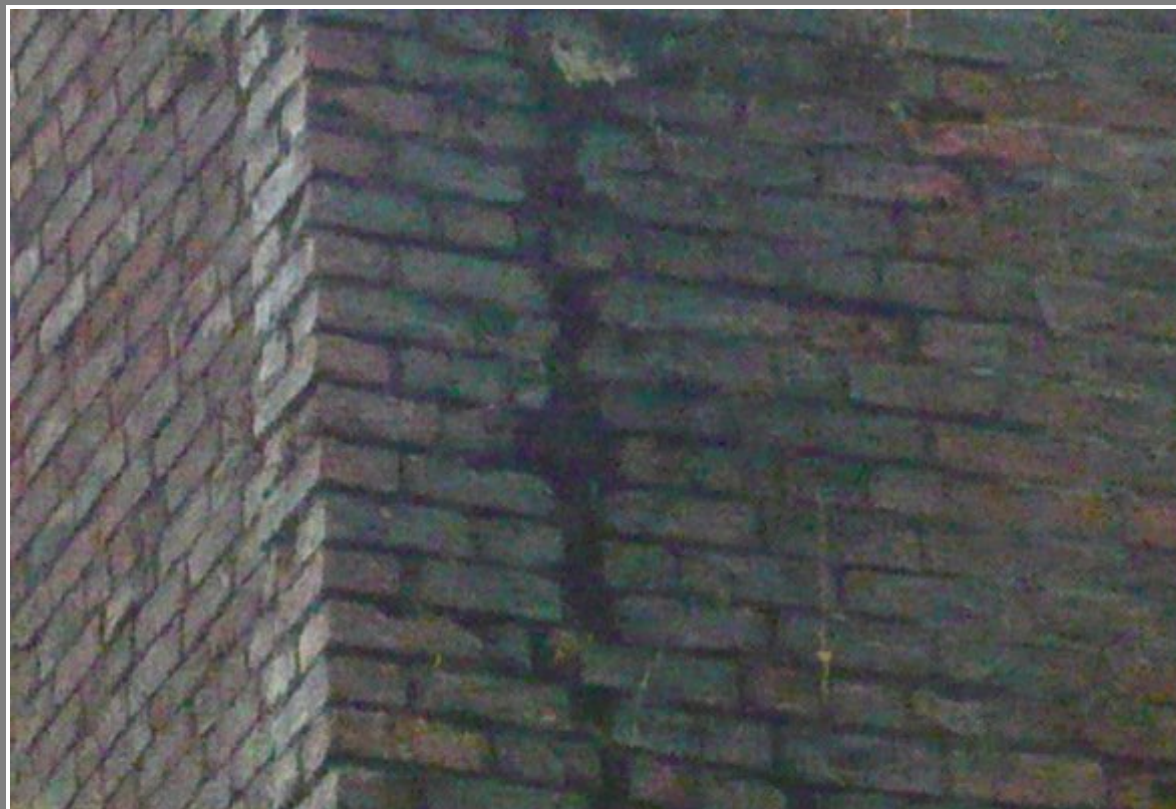
**Photograph No: 5**

Close up view of vertical crack to the rear of No 92 Duke Street

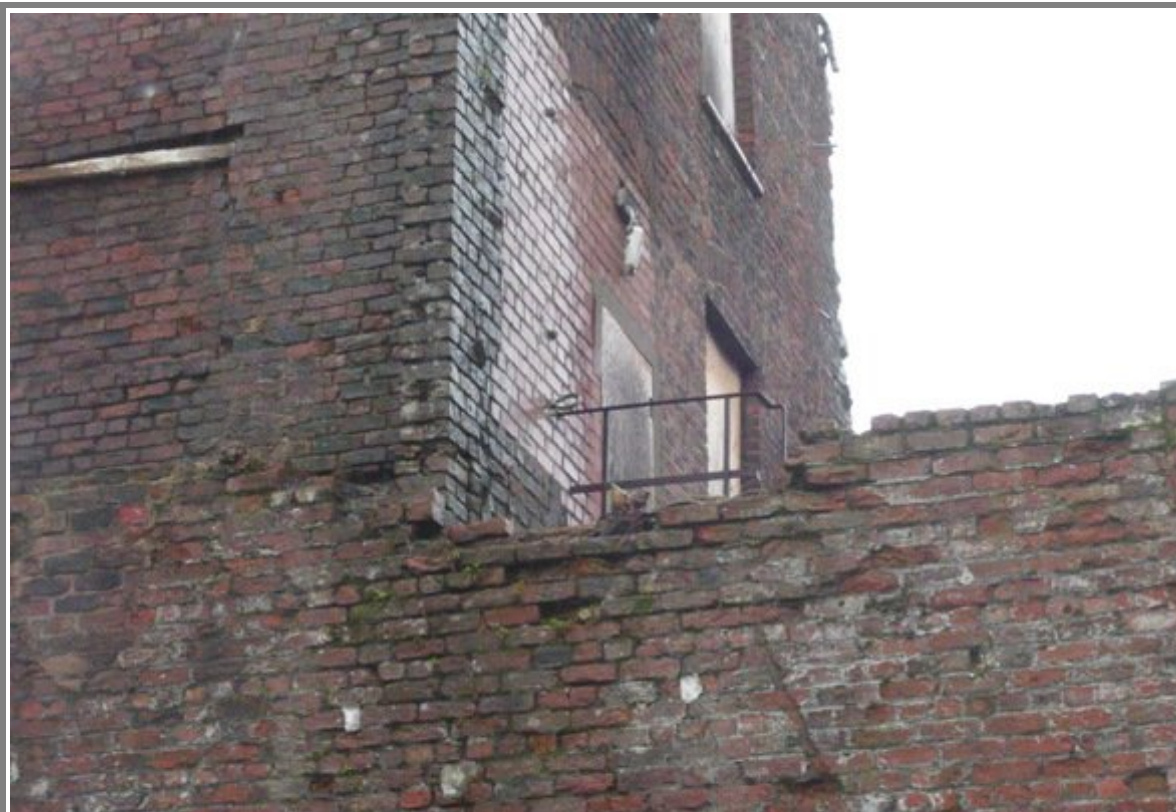
**Photograph No: 6**

Side view of crack to the rear of No 92 Duke Street

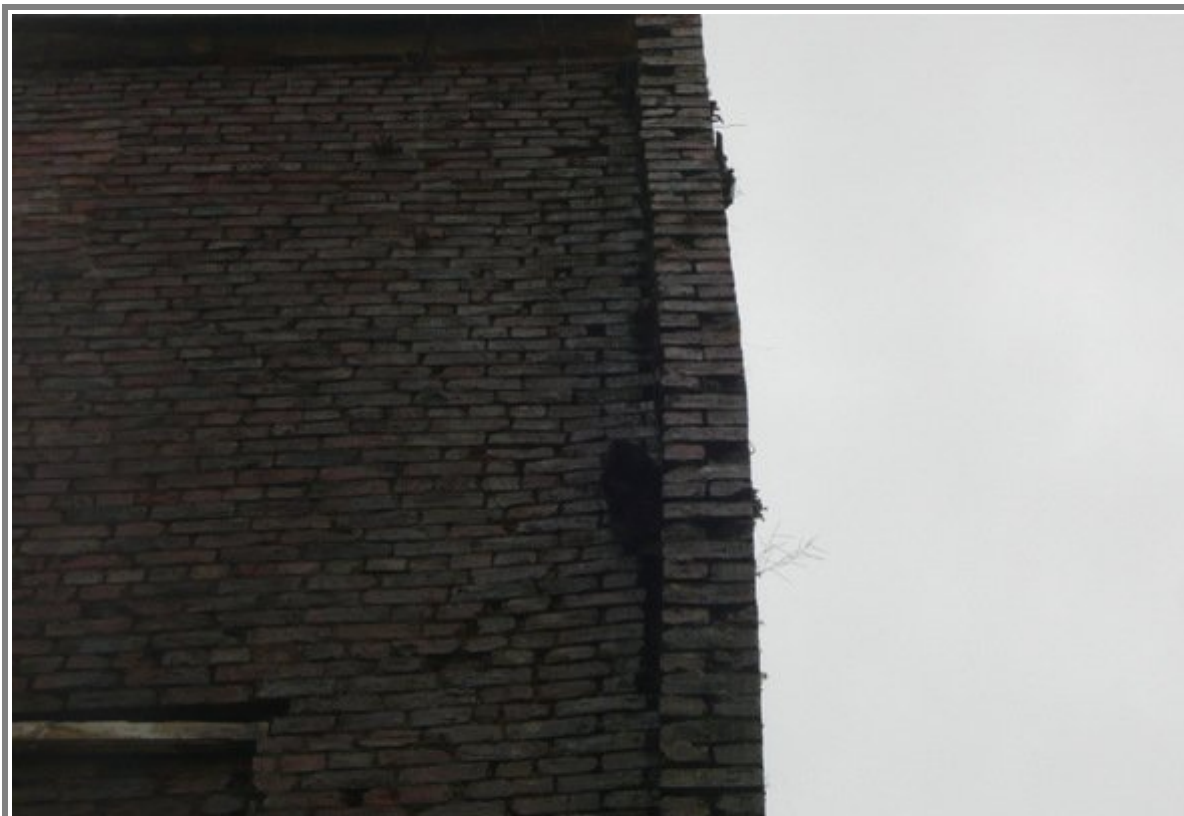
P1090025 **Photograph No: 7**

Rear wall bowing outwards at rear corner due to lack of bond

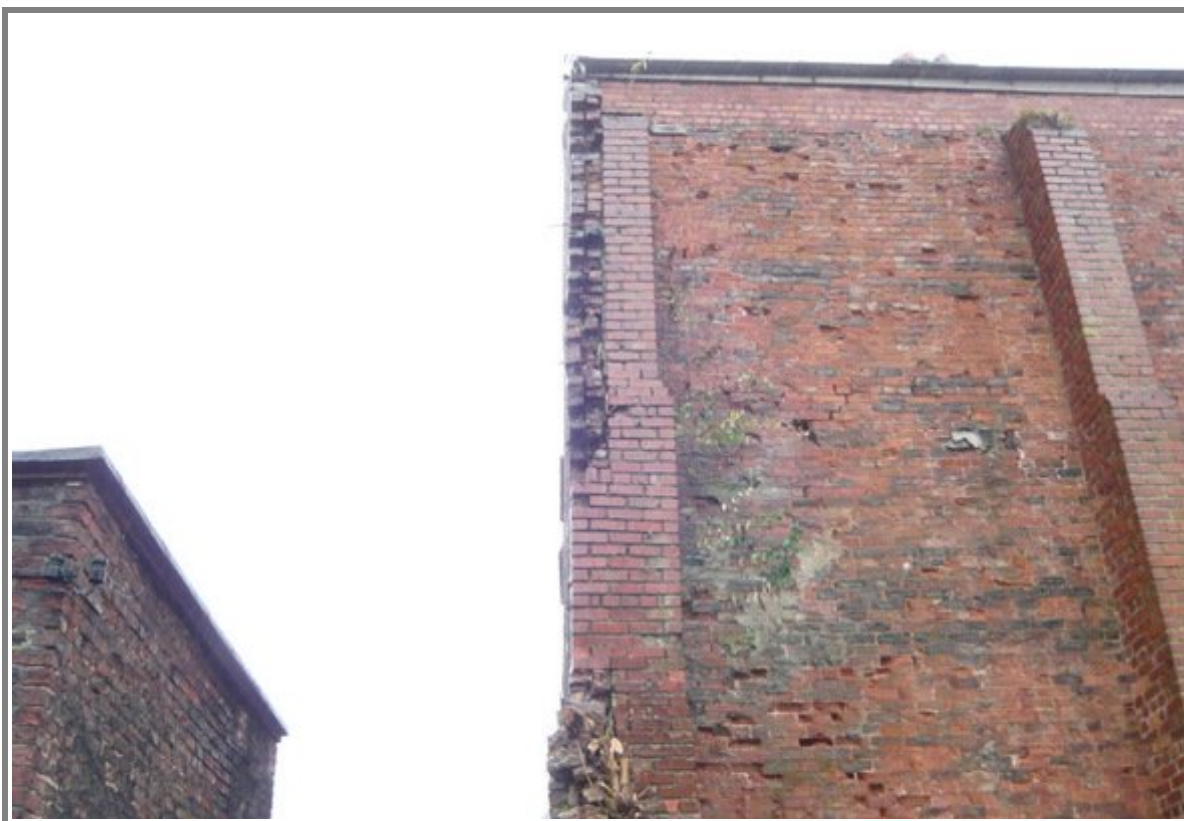
P1090035 **Photograph No: 8**

Crack to the other rear corner to No 92 Duke Street

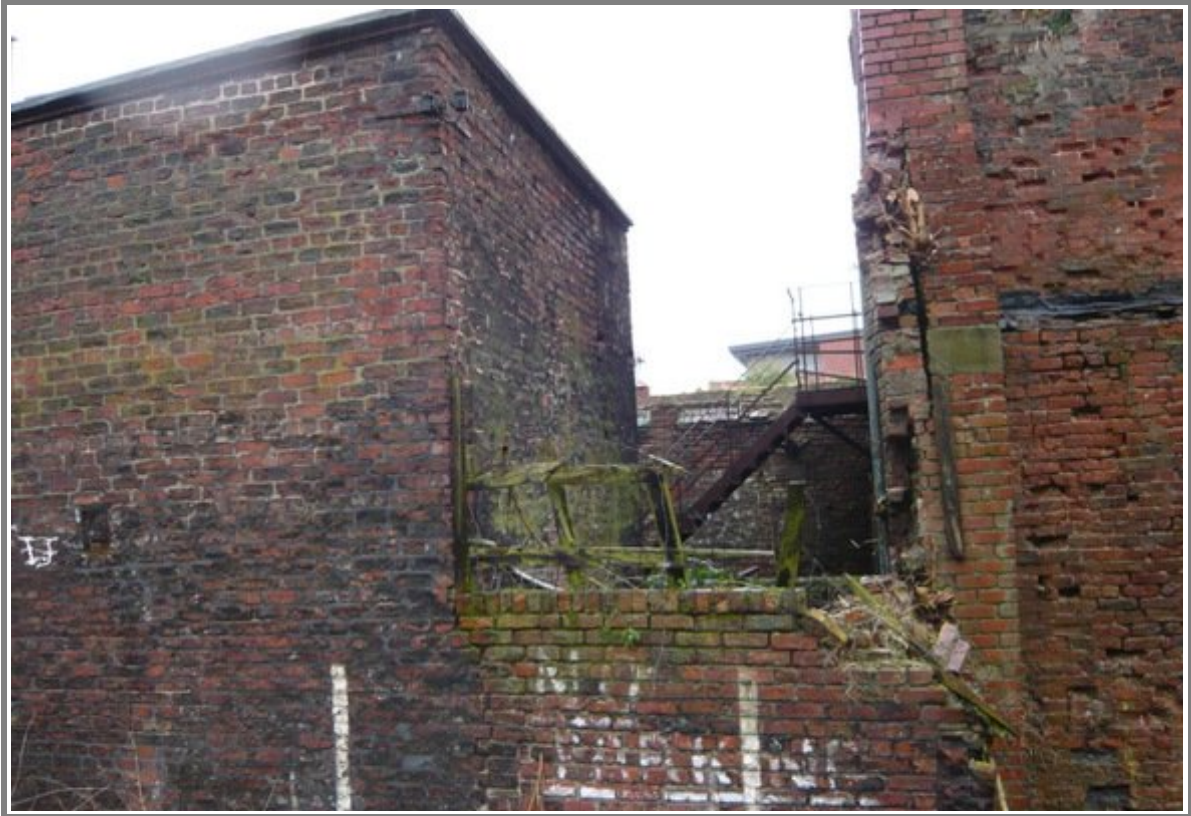
P1090037 **Photograph No: 9**

General view of rear of No 92 showing cracking at corner

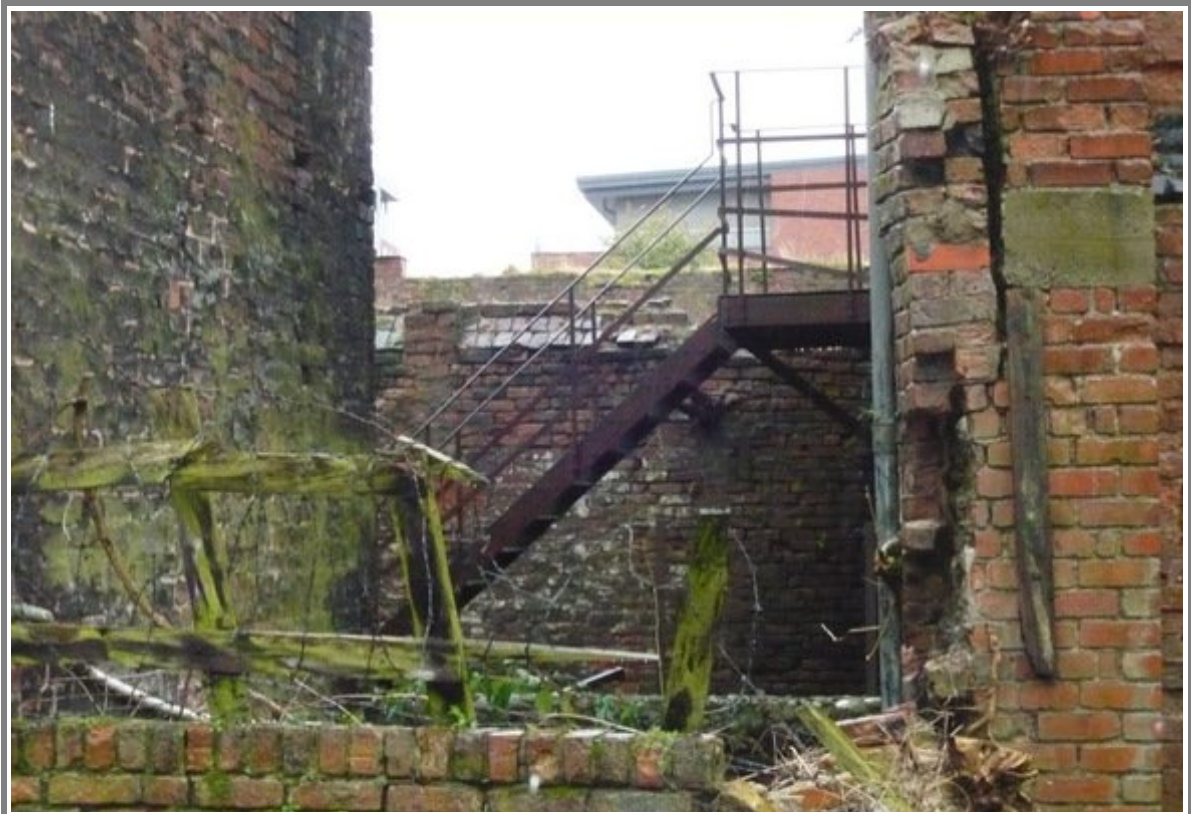
P1090036 **Photograph No: 10**

General view of rear of No 92 showing cracking at corner

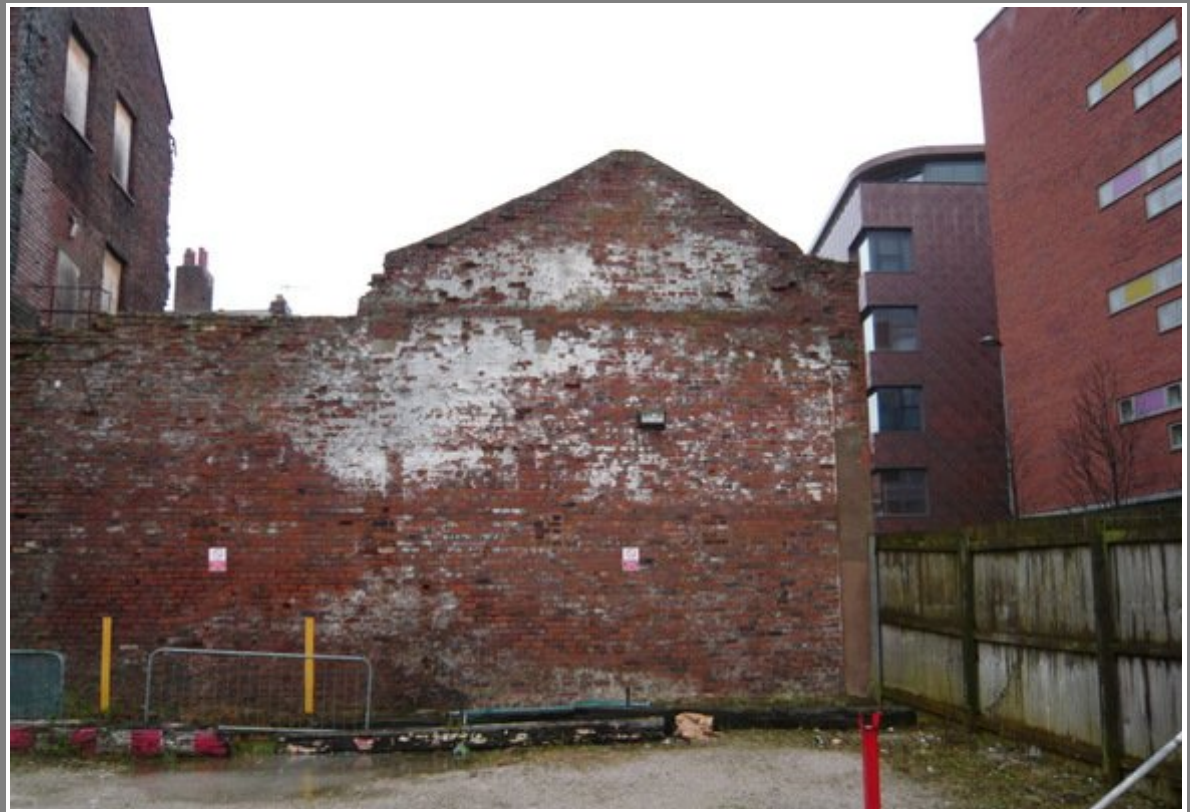
P1090030 **Photograph No: 11**

General view of 2 storey building (side elevation) at rear of No 92 Duke Street

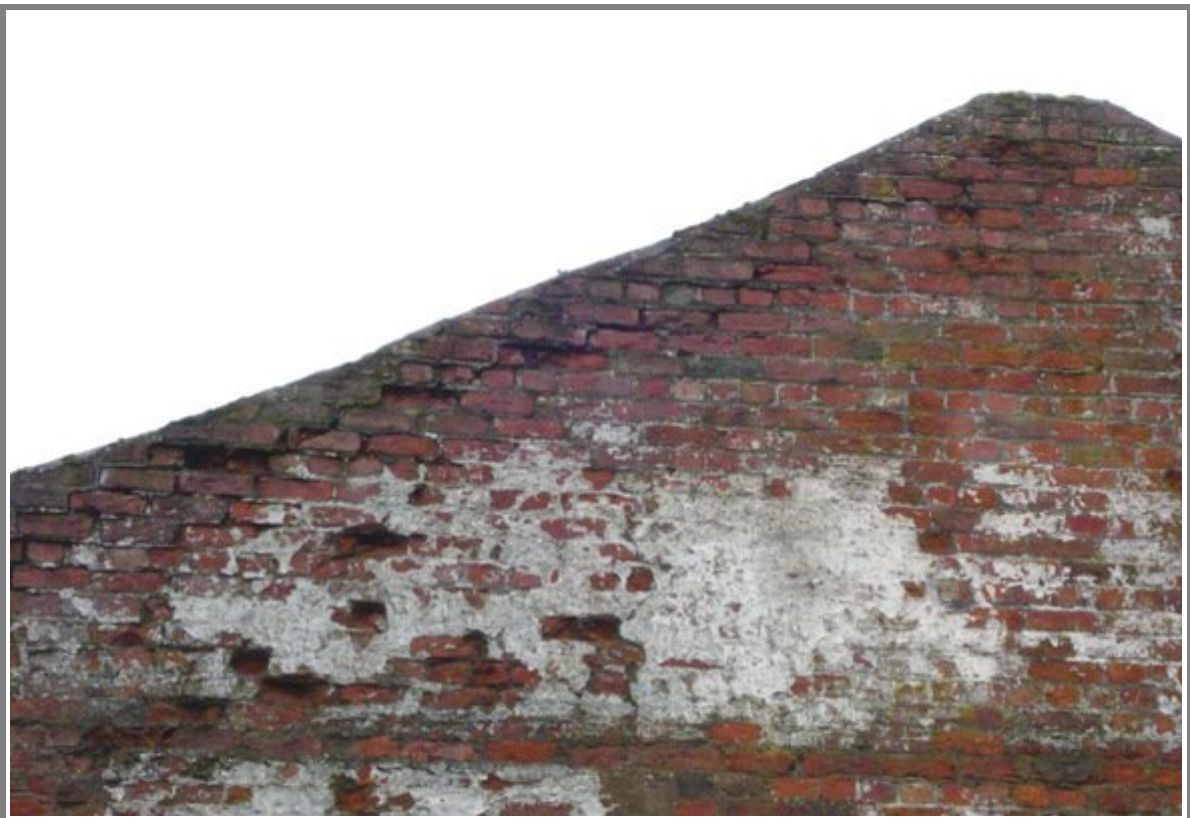
P1090032 **Photograph No: 12**

Loose brickwork at top of gable wall

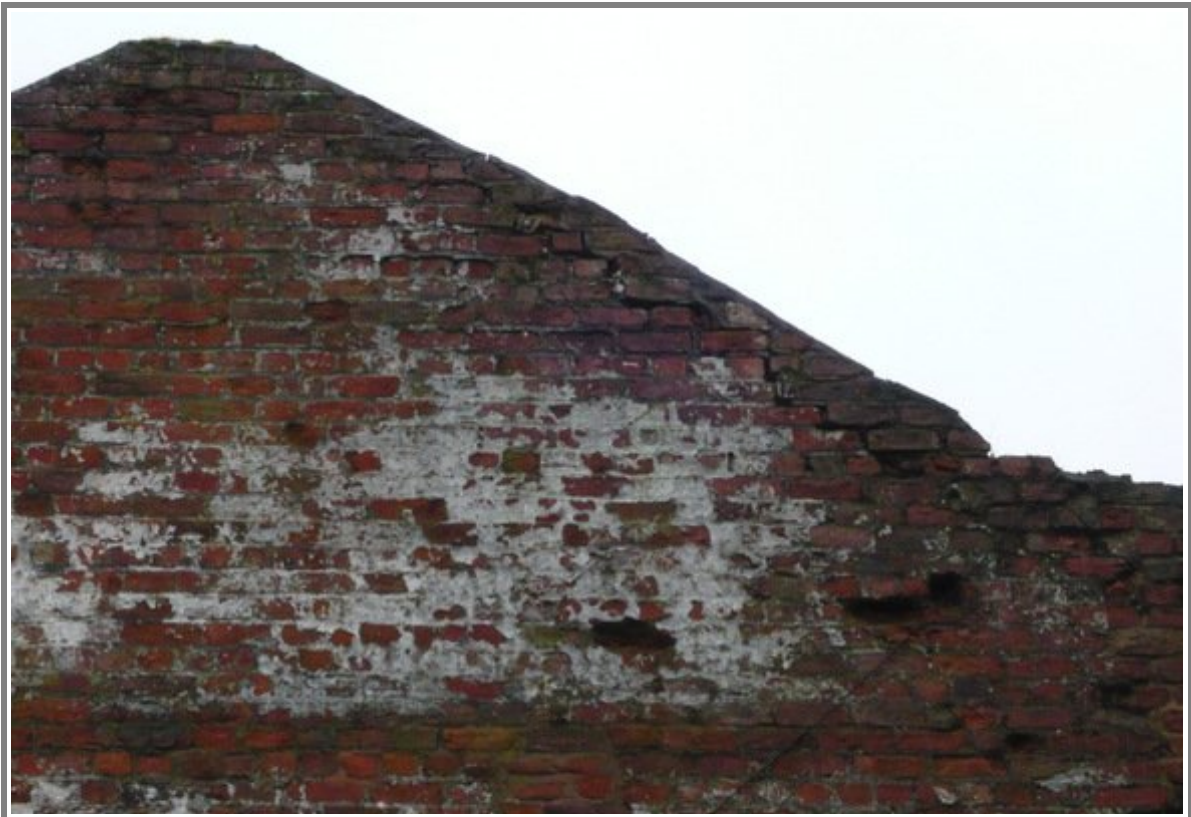
P1090033 **Photograph No: 13**

Loose brickwork at top of gable wall

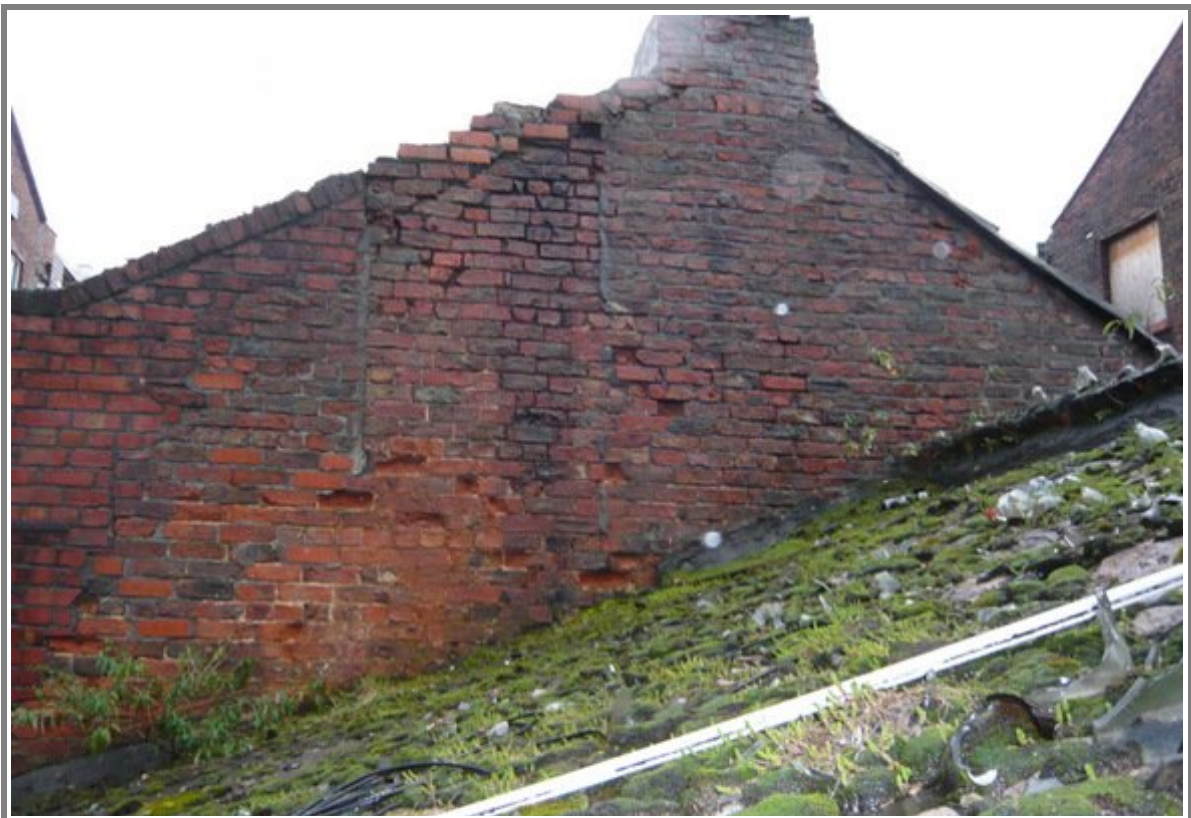
P1090044 **Photograph No: 14**

Damaged brickwork to gable wall to building at rear of No 92 Duke Street

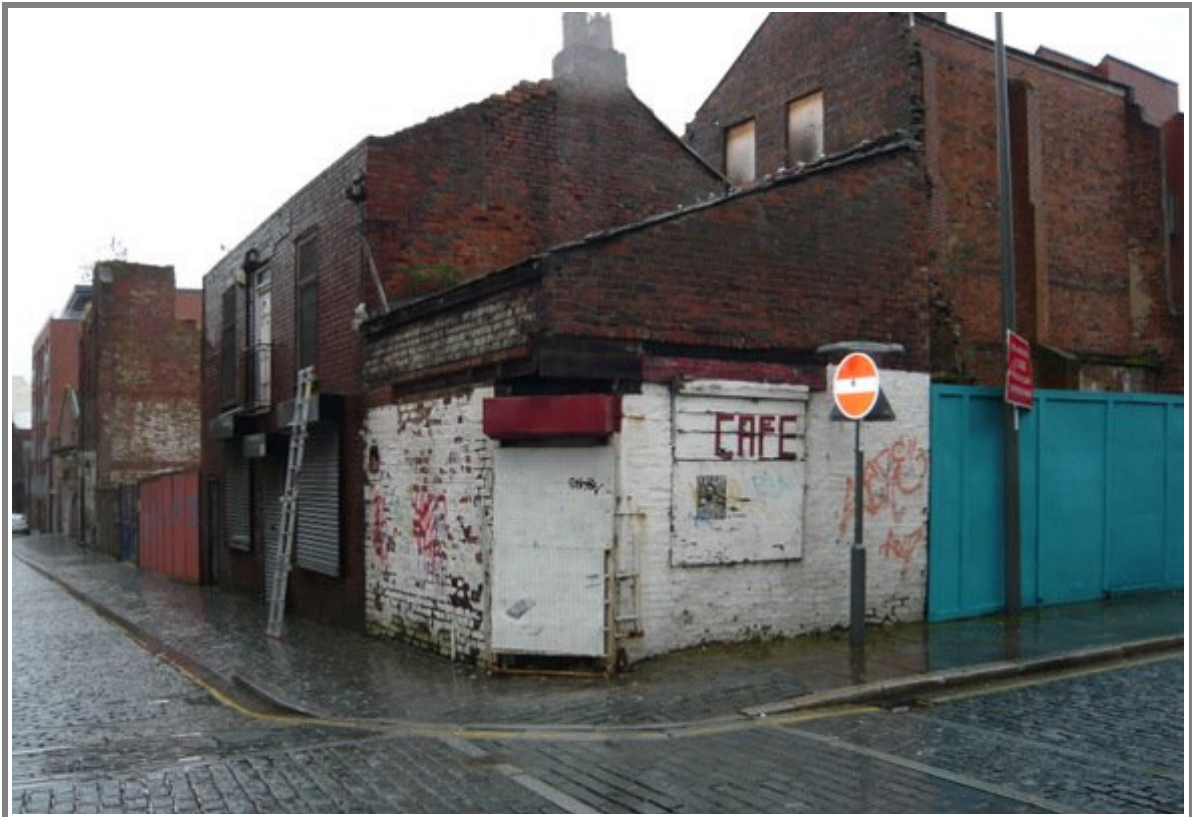
P1090045 **Photograph No: 15**

General view of single storey café building

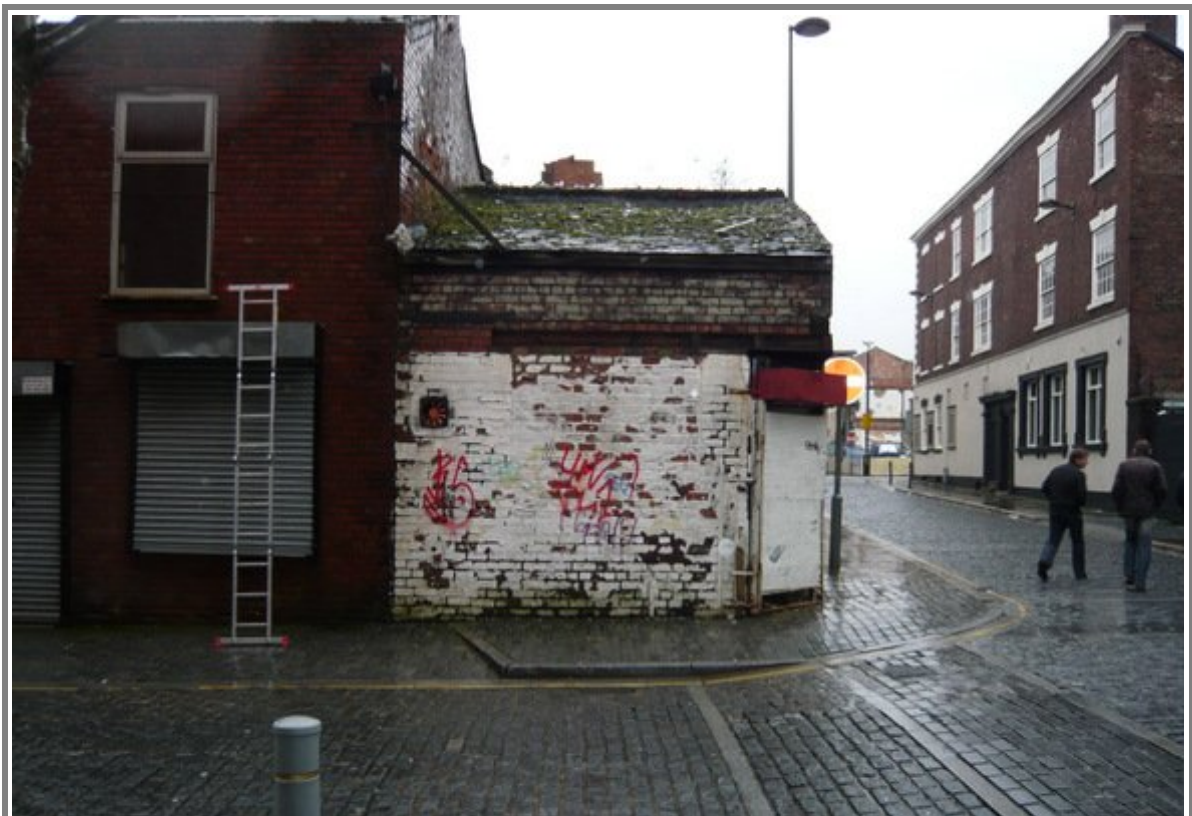
P1090046 **Photograph No: 16**

General view of single storey café building
