LIDL GREAT BRITAIN LTD

STRUCTURAL APPRAISAL REPORT

THE FORMER COOP SUPERMARKET
CHURCH ROAD NORTH
WAVERTREE
LIVERPOOL
L16 6TE

Ref: 09-143-DOC-002 Rev 2

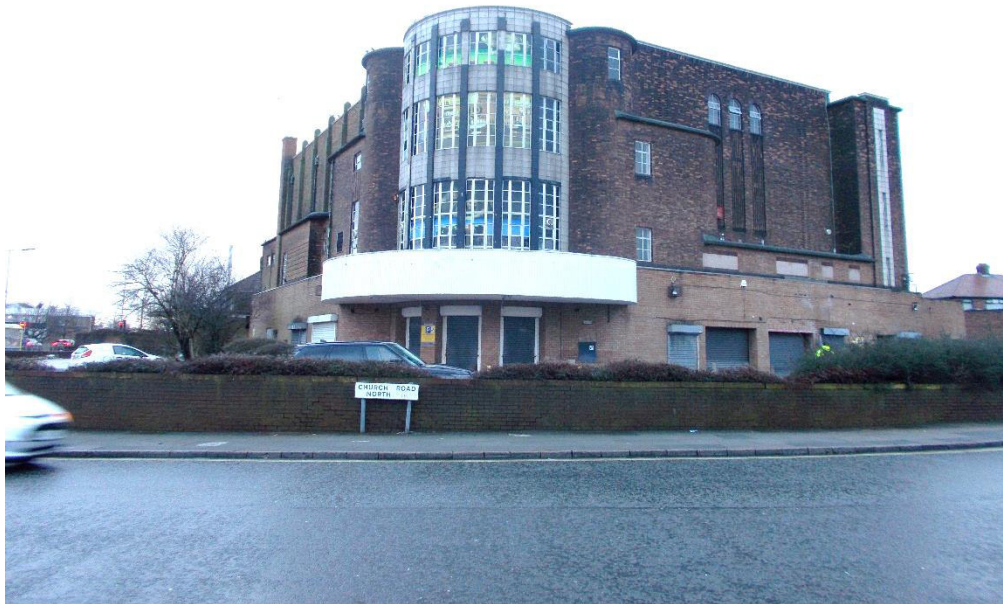
PHOTO NO: 1

The mortar pointing is in poor condition. There are significant vertical cracks in a number of the brick piers. It is almost certain that steel within the brick piers will be in contact with the inner face of the bricks and as the wall faces predominantly North will not fully dry out on a seasonal basis, thus the cracks are the result of corroding steel columns. The extent of steelwork corrosion is likely significant and will have been ongoing for most of the life of the building. Rainwater goods appear in poor condition. (See photograph nos 1, 2, 3 and 4)

The mortar pointing is in poor condition. (See photograph no 1)

The feature window is formed entirely in reinforced concrete. Concrete from the 1930s, especially where the concrete is of doubtful condition, is recognised as being generally of poor strength particularly in relation to the performance requirements of an institutional class building. The concrete is spalling comprehensively, and corroding reinforcement is visible. (see photograph nos 1 and 8)

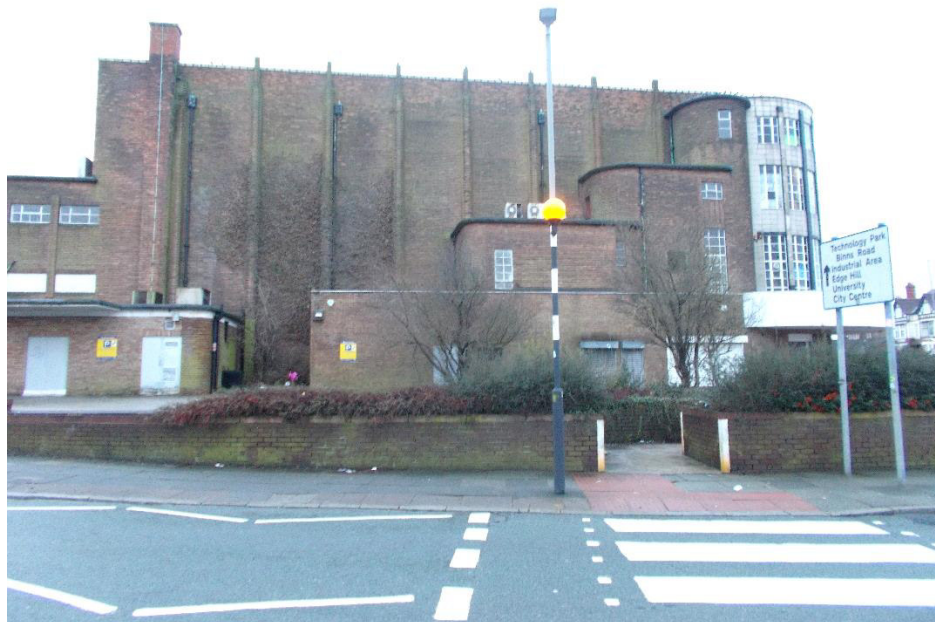
PHOTO NO: 2

North elevation – vegetation on wall noted

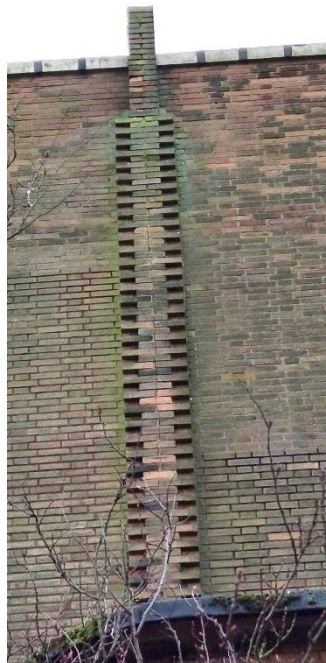
PHOTO NO: 4

)
)North elevation - cracking and poor downpipes
)

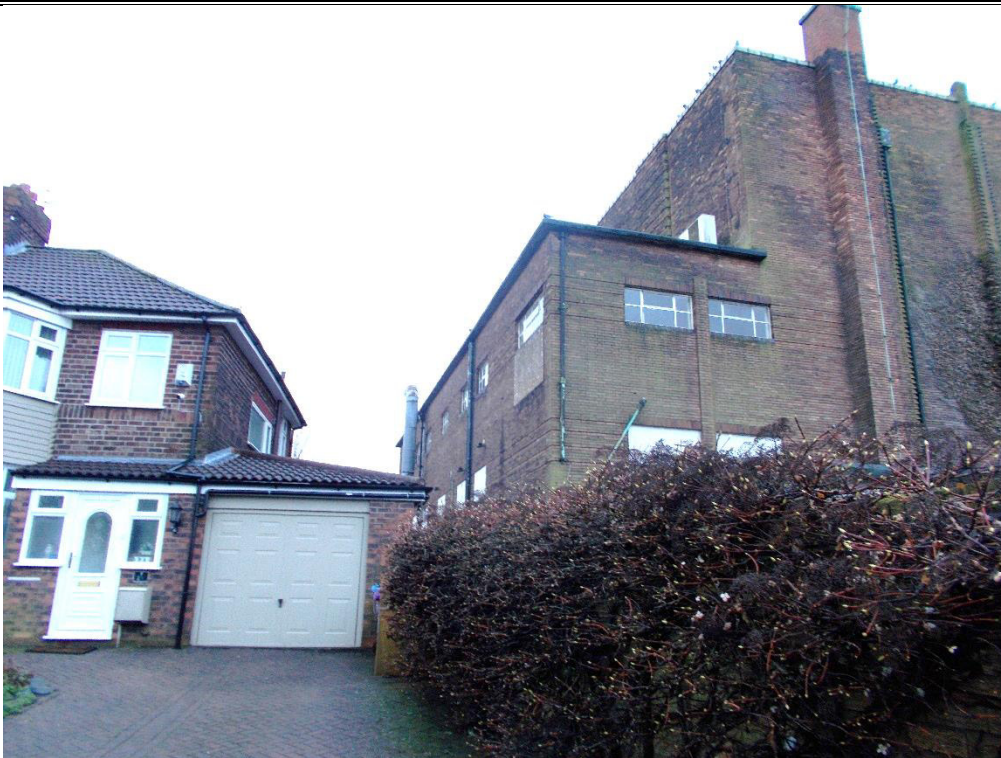
PHOTO NO: 5

The wall is in poor condition and seems to be within a poorly ventilated space being in close proximity to fencing and adjacent property. The wall also seems to be subject to restricted light and hence warm sunlight in better weather. The wall appears to be quite damp and the mortar pointing is in poor condition. (See photograph nos 5, 6 and 7)

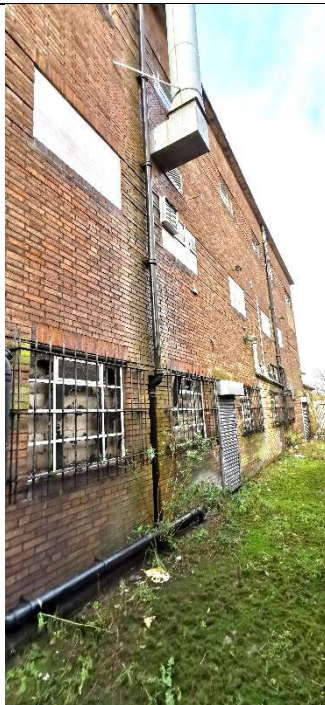
East elevation from passage – poor repair and moss growth

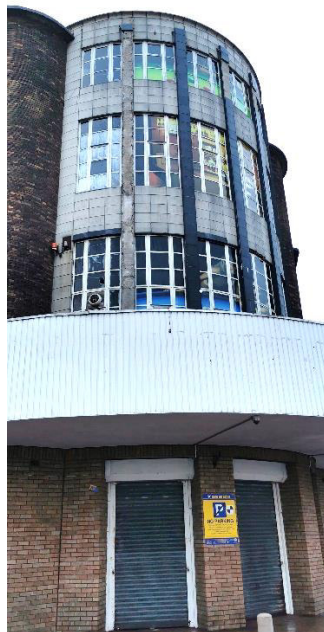
PHOTO NO: 8

Feature window – poor condition

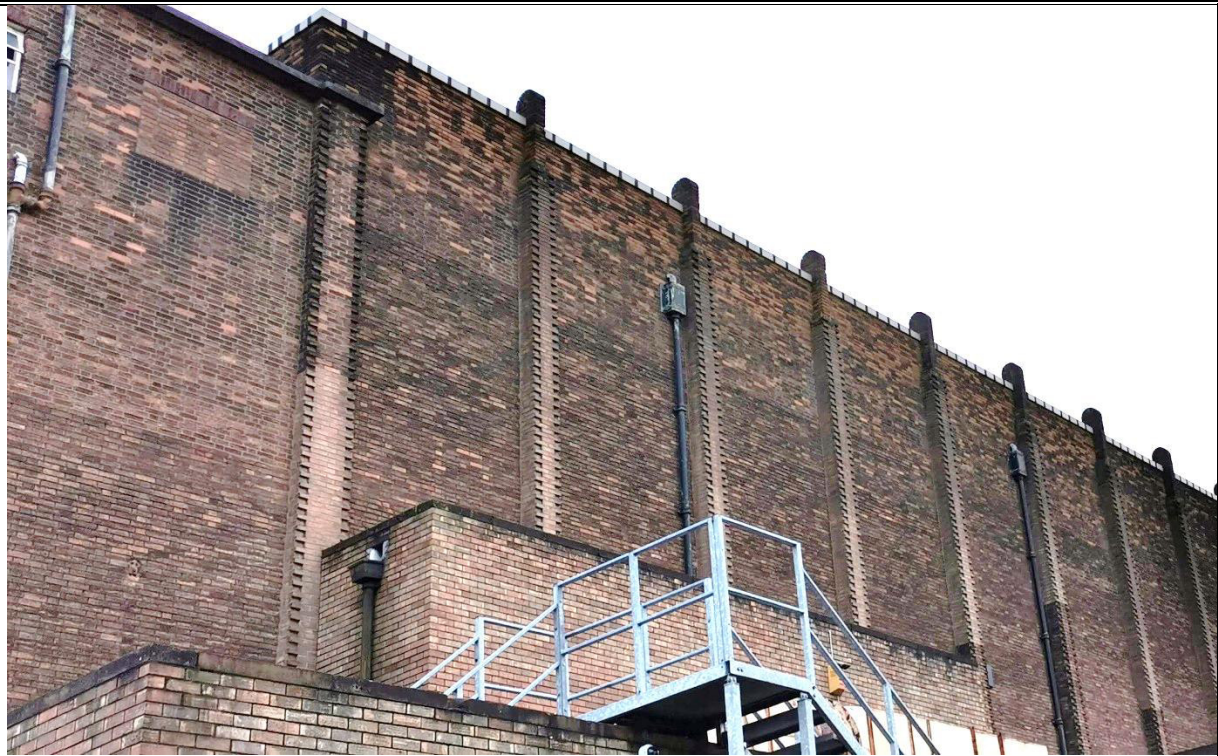
PHOTO NO: 9

The mortar pointing is in poor condition in many areas, and substantial areas of brickwork can be seen to have been replaced most notably at brick piers. Similar problems with corrosion of steelwork embedded with solid brickwork is anticipated. Rainwater goods appear in poor condition. (See photograph nos 9 and 10)

South elevation main building – showing patchwork
brickwork repairs and repointing

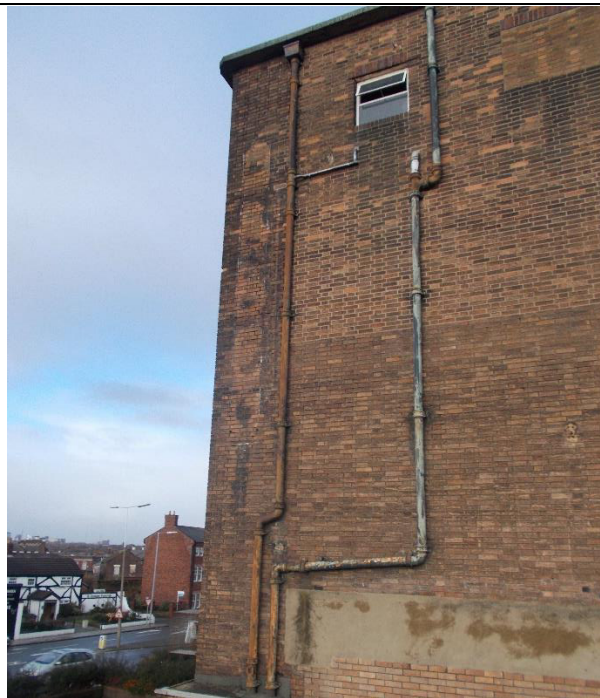
PHOTO NO: 10

South elevation poor repointing and rainwater
goods

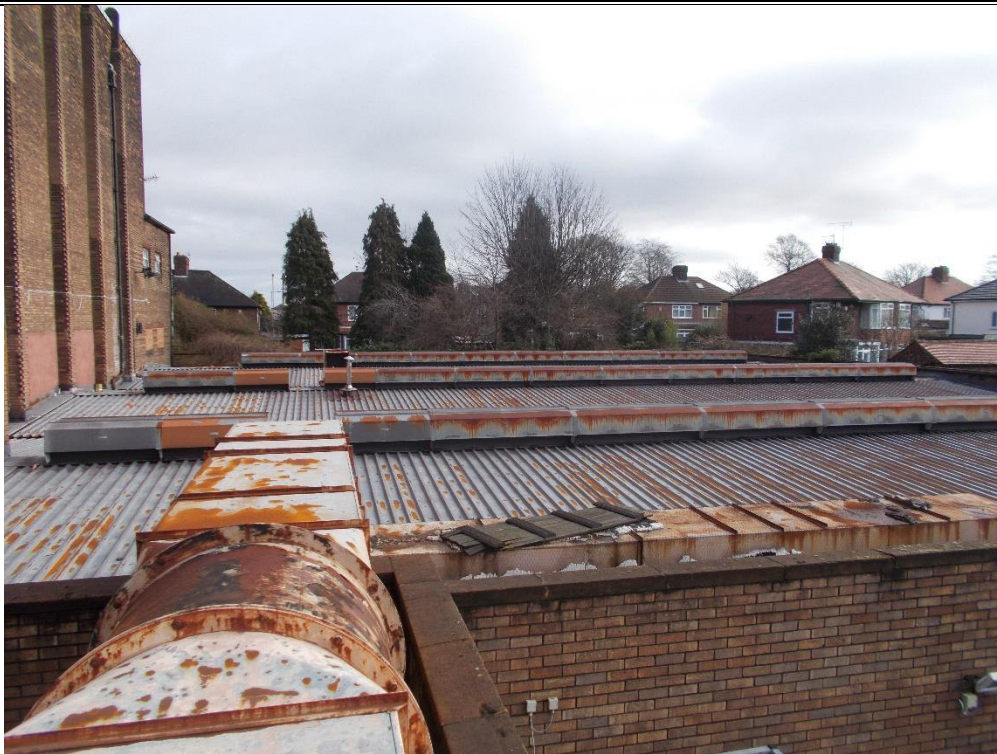
PHOTO NO: 11

Viewing of the pitched roof from the access gantry allowed mainly distant inspection. The metal roof cladding is in poor condition with most of the protective coating having disappeared and significant surface rusting of the metal cladding. The small area of flat roof at the roof gantry access point seemed intact where it was visible to see the asphalt surface through detritus. The flashing along the joint between the single storey roof and the main building South elevation was poor along its full length and appeared to have been badly installed. (See photograph no 11)

The metal cladding roof is in poor condition and is corroding extensively. Water penetration is evident on the internal ground slab suggesting that the roof leaks extensively. The support structure to the cladding seems to be performing adequately. (See photograph nos 11 and 14)

Single storey roof – poor condition

The roofs of both the original building and the single storey extension would need to be replaced in any renovation project.

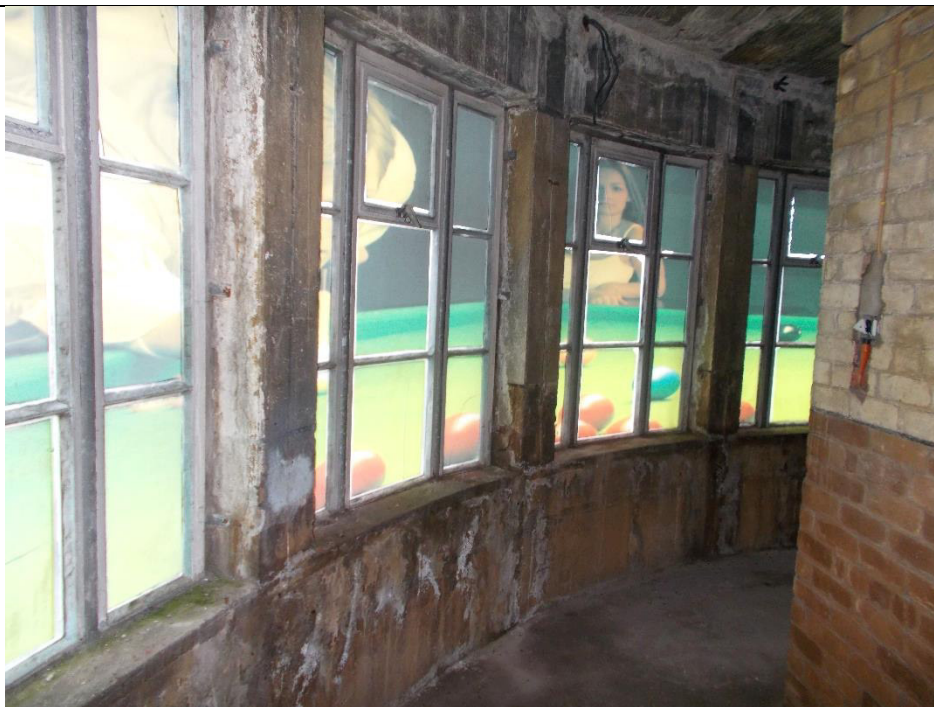
PHOTO NO: 12

This floor is limited to the ancillary areas immediately adjacent to the East and West elevations formed with brick walls, reinforced concrete floor beams and clay "pots" with the feature window in the NW corner as elsewhere. The reinforced concrete to the feature window in the NW corner is in the same poor condition as at first floor where substantial spalling of concrete and exposed corroding steel reinforcing bars are evident. (See photograph nos 12 and 13)

Feature window – crumbling reinforced concrete

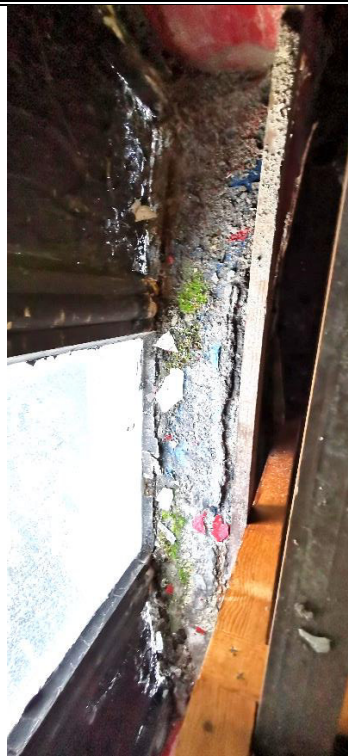
PHOTO NO: 13

Feature window - corroding reinforcement

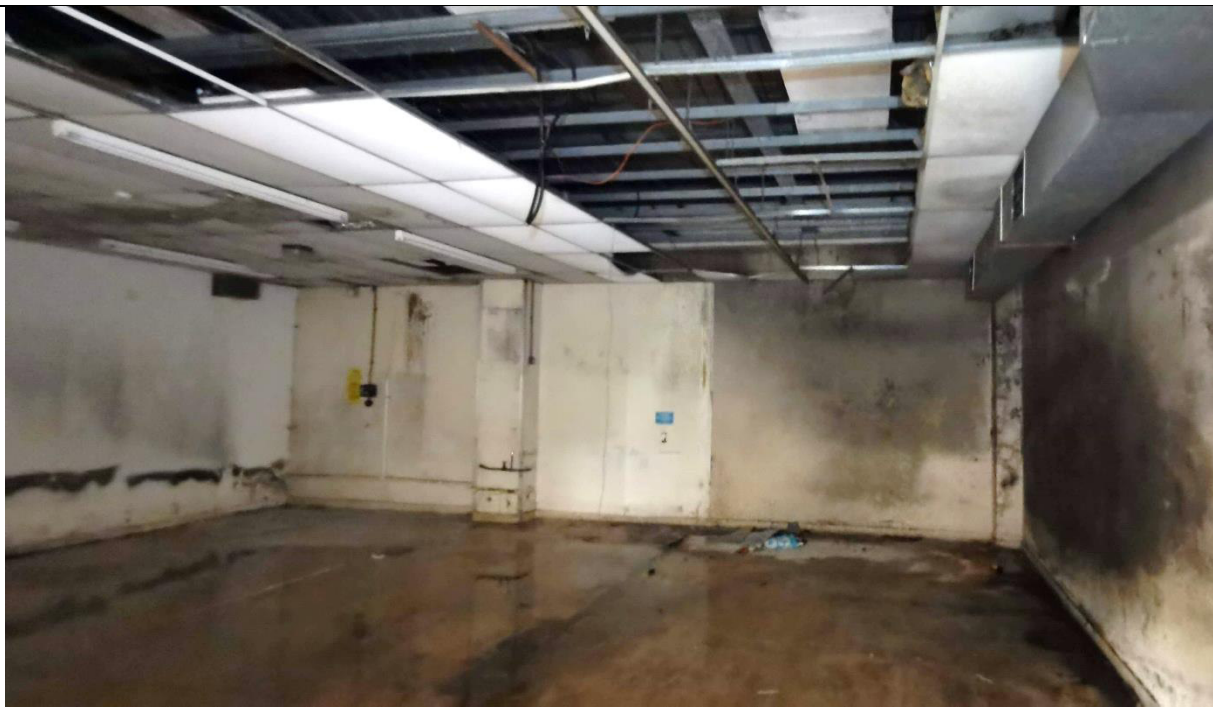
PHOTO NO: 14

The ground floor seems to be similar to the main building floor, however the surface is largely covered in water which seems to be rainwater leaking from the poor condition roof above. (see photograph no 14)

Single storey section - wet floor from leaking roof

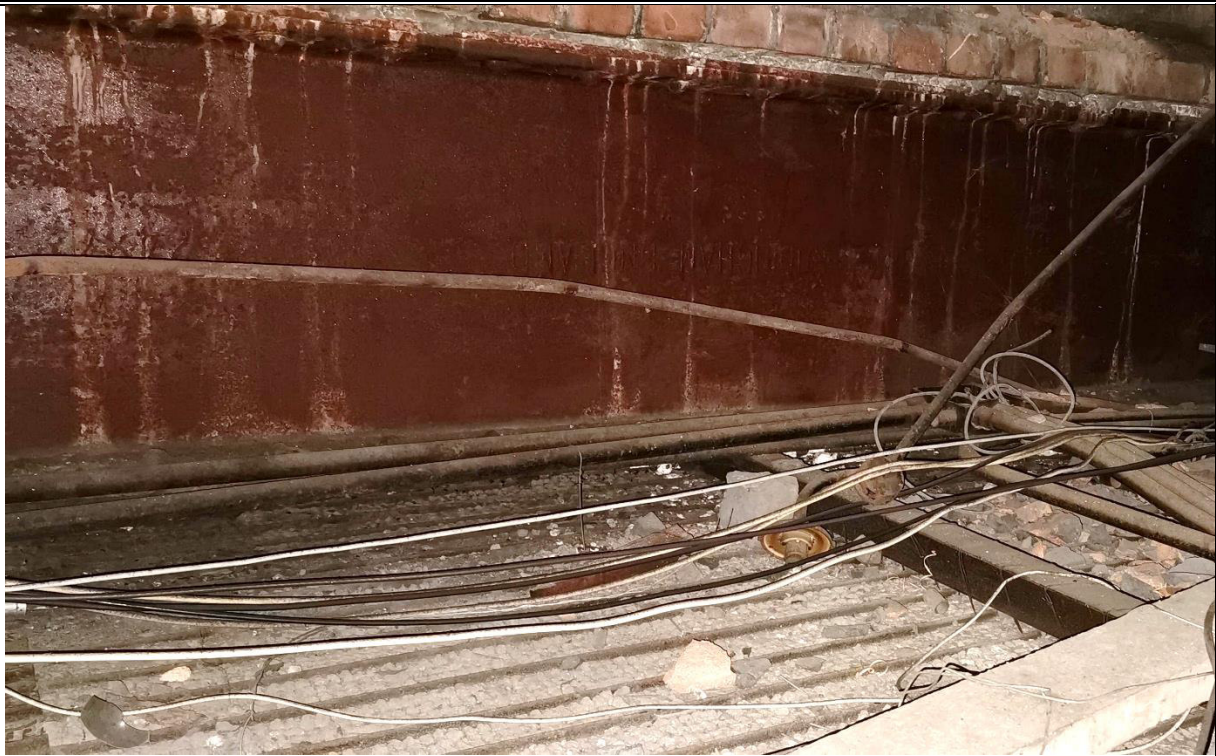
PHOTO NO: 15

The Proscenium Arch is noted as being intact adjacent to the wall line along the ancillary areas to the East side. The screen curtain supports from cinema times are noted as being connected to the Proscenium Arch steel beam. The Proscenium Arch is major element of structure of the original cinema building and is vital to the continued stability of the original building. (See photograph no 15)

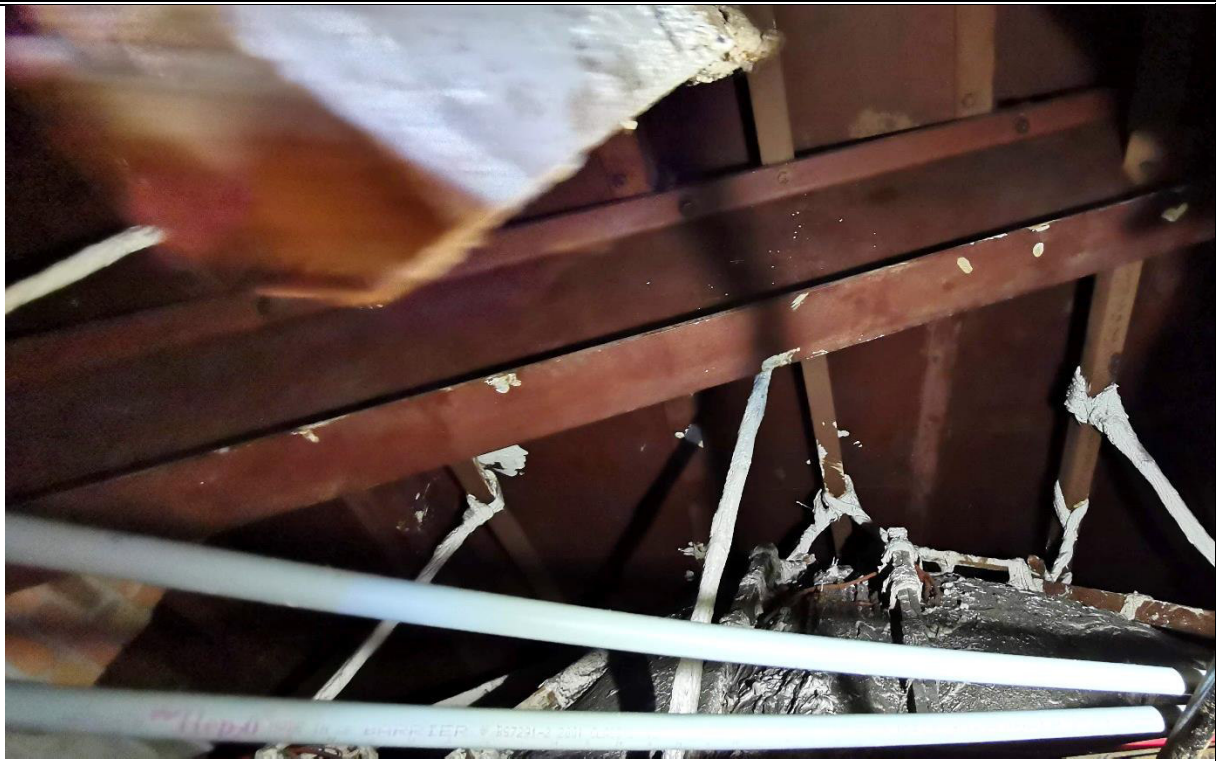
PHOTO NO: 17

Raking steel members are present below what appears to be the tiered aged timber decking which will have formed the upper circle. Different types of timber decking are noted below carpet tiles with screeding to disguise the joint in the decking surface. The line of the joint forms a curve across the entire floor surface interrupted by the more recent lift shaft suggesting that at least some of the upper circle structure remains below staging where some of the structure may have been cut out, although it was not proven that any steelwork structure has been removed. (See photograph no 17)

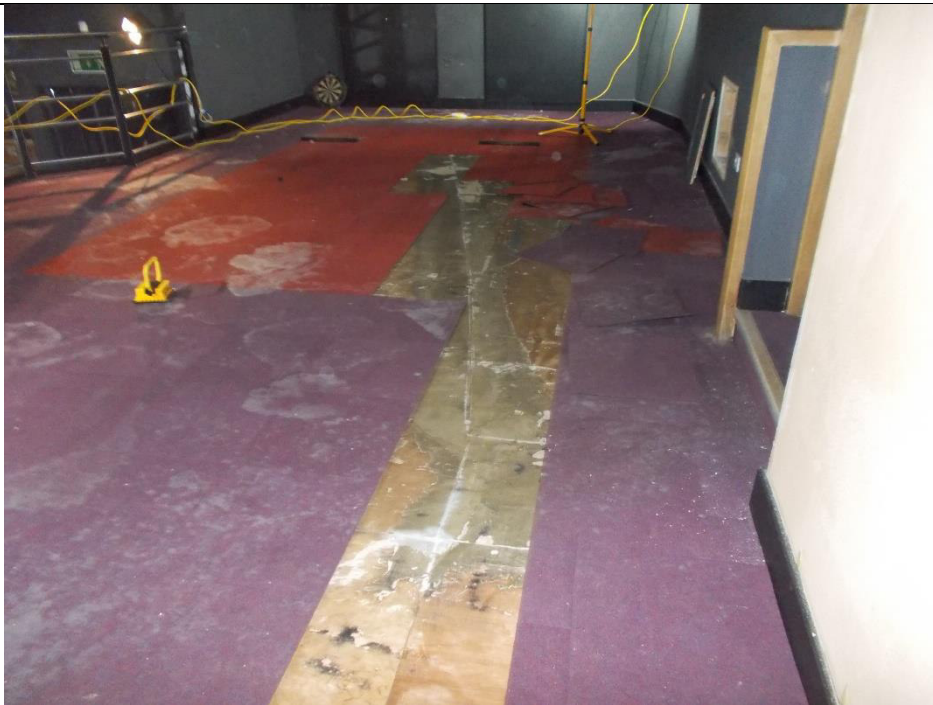
PHOTO NO: 18

This area was not investigated however a similar curved screeded joint in the differing types of floor decking was noted below the carpet tiles. This suggests the original circle structure is hidden within the staging. (See photograph no 18)

Line of screed above presumed upper balcony

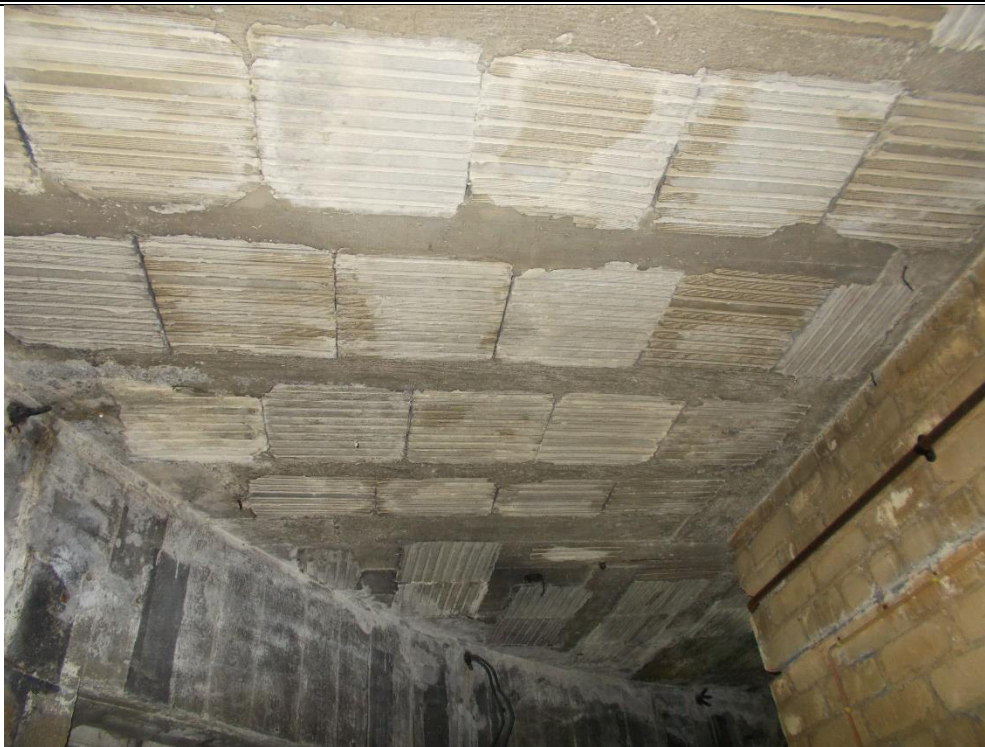
PHOTO NO: 19

The first floor is above the ground floor to the main building area only. This floor is on a number of levels comprising the substantial concrete as described above, beam and "pot" structure to the ancillary areas and substantial tiered timber staging areas elsewhere. Within the ancillary areas the feature window reinforced concrete structure in the NW corner could be seen to exhibit substantial spalling of concrete and exposed corroding steel reinforcing bars. (See photograph no 19)

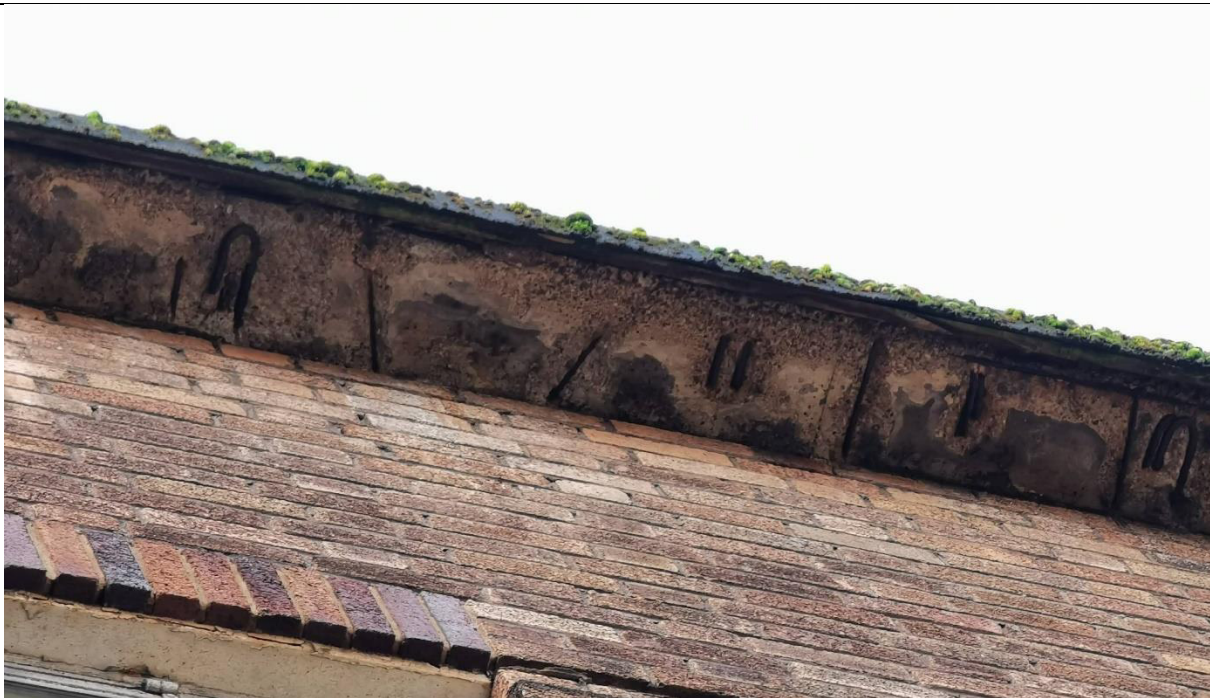
PHOTO NO: 20

The ancillary area roofs are flat. The roof protection to the flat roofs is not accessible. There is some risk that the upper surface of the reinforced concrete roof beams could have been affected by moisture and corrosion over time if any water leakage has occurred which is a concern due to the signs of moisture penetration through the building fabric elsewhere. Corroding reinforcement is a serious concern. (See photograph no 20)

Flat roof edge cantilevers – sign of corroding within reinforcement
