Former MTL Site - Pop-Up Studio

Tree Survey Report

Morgan Sindall

Project number: 60539643

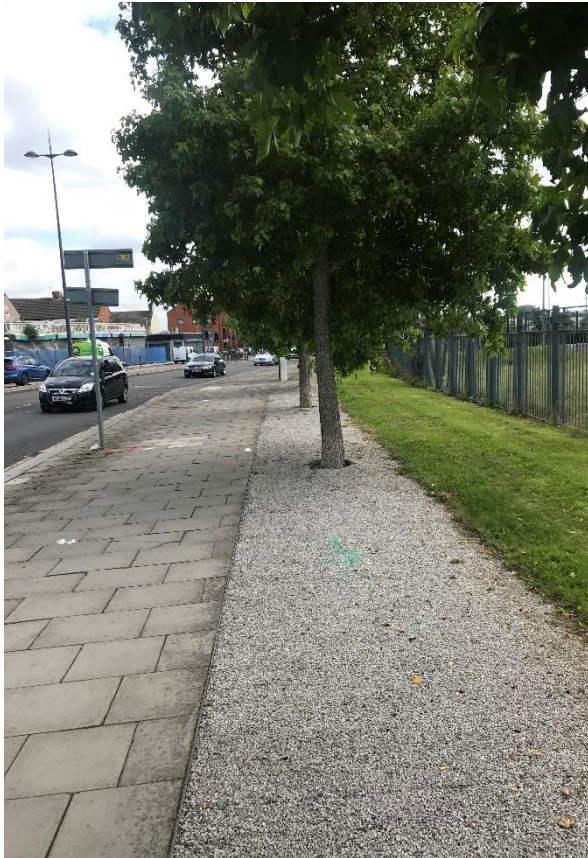
Figure 2. Showing third party tree avenue.

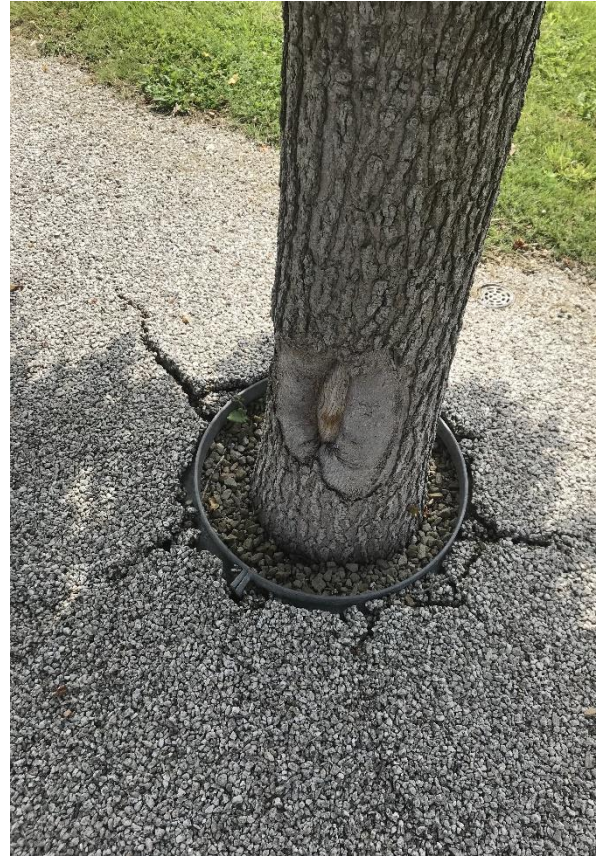
T3*	Sweet Gum (<i>Liquidambar styraciflua</i>)	12	215	3	2	3	2.5	2.0/NE	1	Good	SM	Good	- Within likely made for purpose planting pit. - Within slightly raised planting area, metal pit edge with stone infill. Cracking of gravel/bonded surface. - Normal crown form and leaf density. - Third party tree. - Minor leaf scorch with minor volumes of leaf curl. - High contribution and future potential.		20+	B2
T4*	Sweet Gum (<i>Liquidambar styraciflua</i>)	12	205	3	3	3	3	3.0/S	1	Good	SM	Good	-Within likely made for purpose planting pit. - Within slightly raised planting area, metal pit edge with stone infill. Cracking to gravel/bonded surface. - Normal crown form and leaf density. - Third party tree. - Minor leaf scorch with minor volumes of leaf curl.		20+	B2

Figure 3. Third party tree avenue with damage to surfacing.

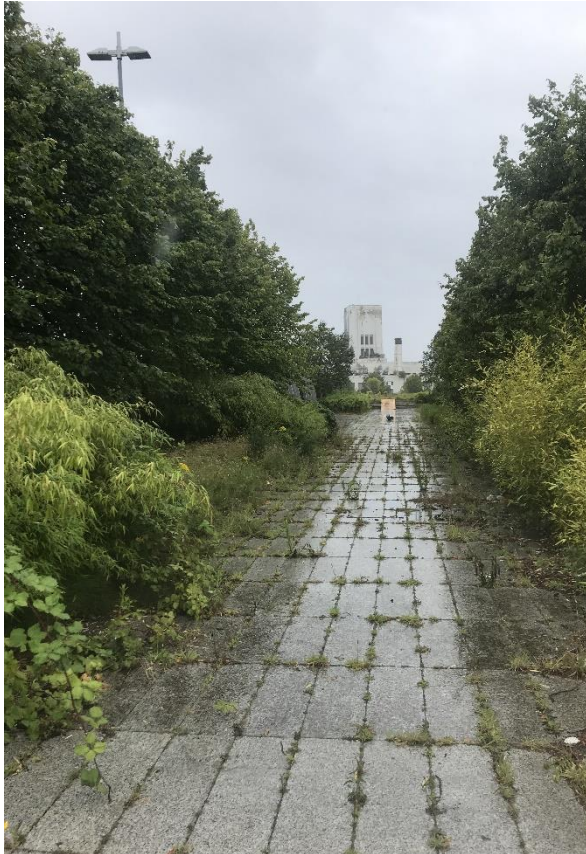
Central to the Site, numerous individual trees from the genus *Tilia*, form several single line avenue rows, underplanted with various ornamental low lying plants and shrubs, constituting as a formal landscaped walkway leading from Innovation Boulevard to a large facility within Innovation Park. Despite a high contribution to landscape character and forming a formal feature to the central Site, it is considered that due to each individual tree's overall size and relative age, each tree is likely easily replaceable and should therefore pose lesser constraint to any proposed development due to their overall replaceability within the landscape.

Figure 6. Looking west central to the lime avenue on Site.

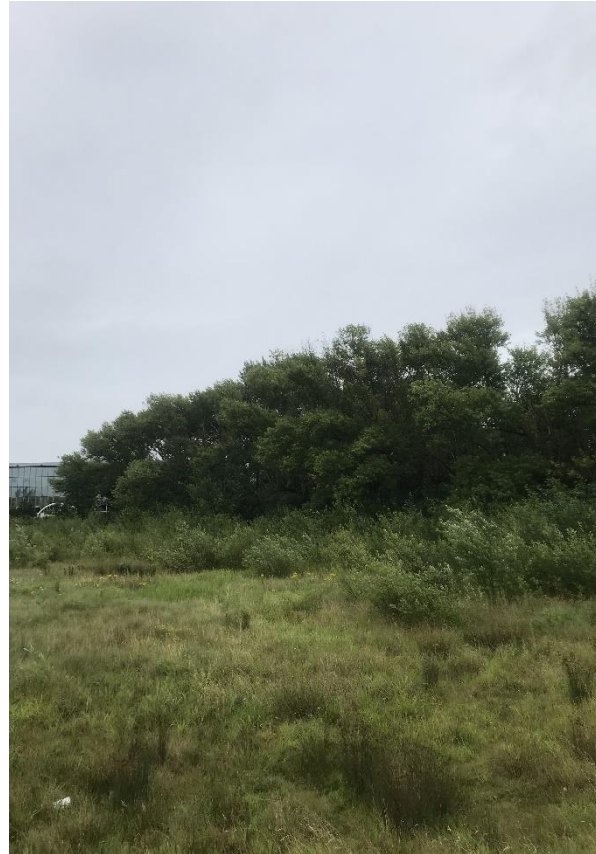
Previously pollarded at an approximate height of 5m, the management regime has likely lapsed due to the estimated diameter of the pollard poles (circa 200mm and over). Further to this, the majority of the trees within G125 showed signs of natural pruning of the pollard poles, including dieback of individual poles, prolific deadwood within the canopy, individual branch failures and hung up branches.

It is considered that the likelihood of pollard pole failure is high under normal weather conditions however, under the current land use (a suspected flood-prone grassland area) the trees pose little risk with no clear target. If development is to be undertaken resulting in a change in land use adjacent to these trees it is recommended that the tree owner is contacted prior to the commencement of any development in order to undertake essential safety tree works.

G125, a third party boundary tree group has been identified as posing an elevated risk to any proposed development located within or near to the tree group's impact zone. This tree group requires immediate attention and it is not recommended that any development works are undertaken near to this tree group until: a safety survey is undertaken, any deadwood which may affect the Site is removed, and tree works to structurally improve the lapsed pollards, likely through the application of a staged crown reduction are actioned. Further details on G125 can be found in the Tree Survey Schedule, included as Appendix B.

Figure 7. Looking south at G125.

One third party tree group, G125, large group of lapsed pollards of moderate quality on the Sites' southern boundary, have been identified as requiring safety tree works prior to any development being undertaken within or near to the tree group's target area. It is considered that the likelihood of failure from G125 is high under normal weather conditions. Further information regarding G125 is included within Section 2.9 and the Tree Survey Schedule, included as Appendix B.
