Document Title:	Arboricultural Implications Assessment									
Document Author:	Matthew Harmsworth, tech.arbor.a, DipRS, RPQ-s									
Project Manager:	Matthew Harmsworth									
Project Title	Norfolk Street / St James Street, Liverpool									
Revision History										
Date:		Version No.		Summa	ary of Changes:					
21st April 2015			1.0	First dra	aft					
22nd April 2015			1.0	Final issue						
Approvals										
Approved by:	Signa	ture	Date:		Version:					
Matthew Harmsworth		larmsworth	22.04.2015			1.0				
Distribution										
Name:	Title:		Date:		Version:					
Richard Gee Project		ct Manager	22.04.2015			1.0				
Re-Survey Date										
Survey Type:		Lifecycle:		Re-surv	vey Date:					
BS5837: 2012		Planning only		Not applicable

Report no: 15_5837_04_06

Arboricultural implications assessment to BS 5837 of trees at: Norfolk St / St James St, Liverpool.

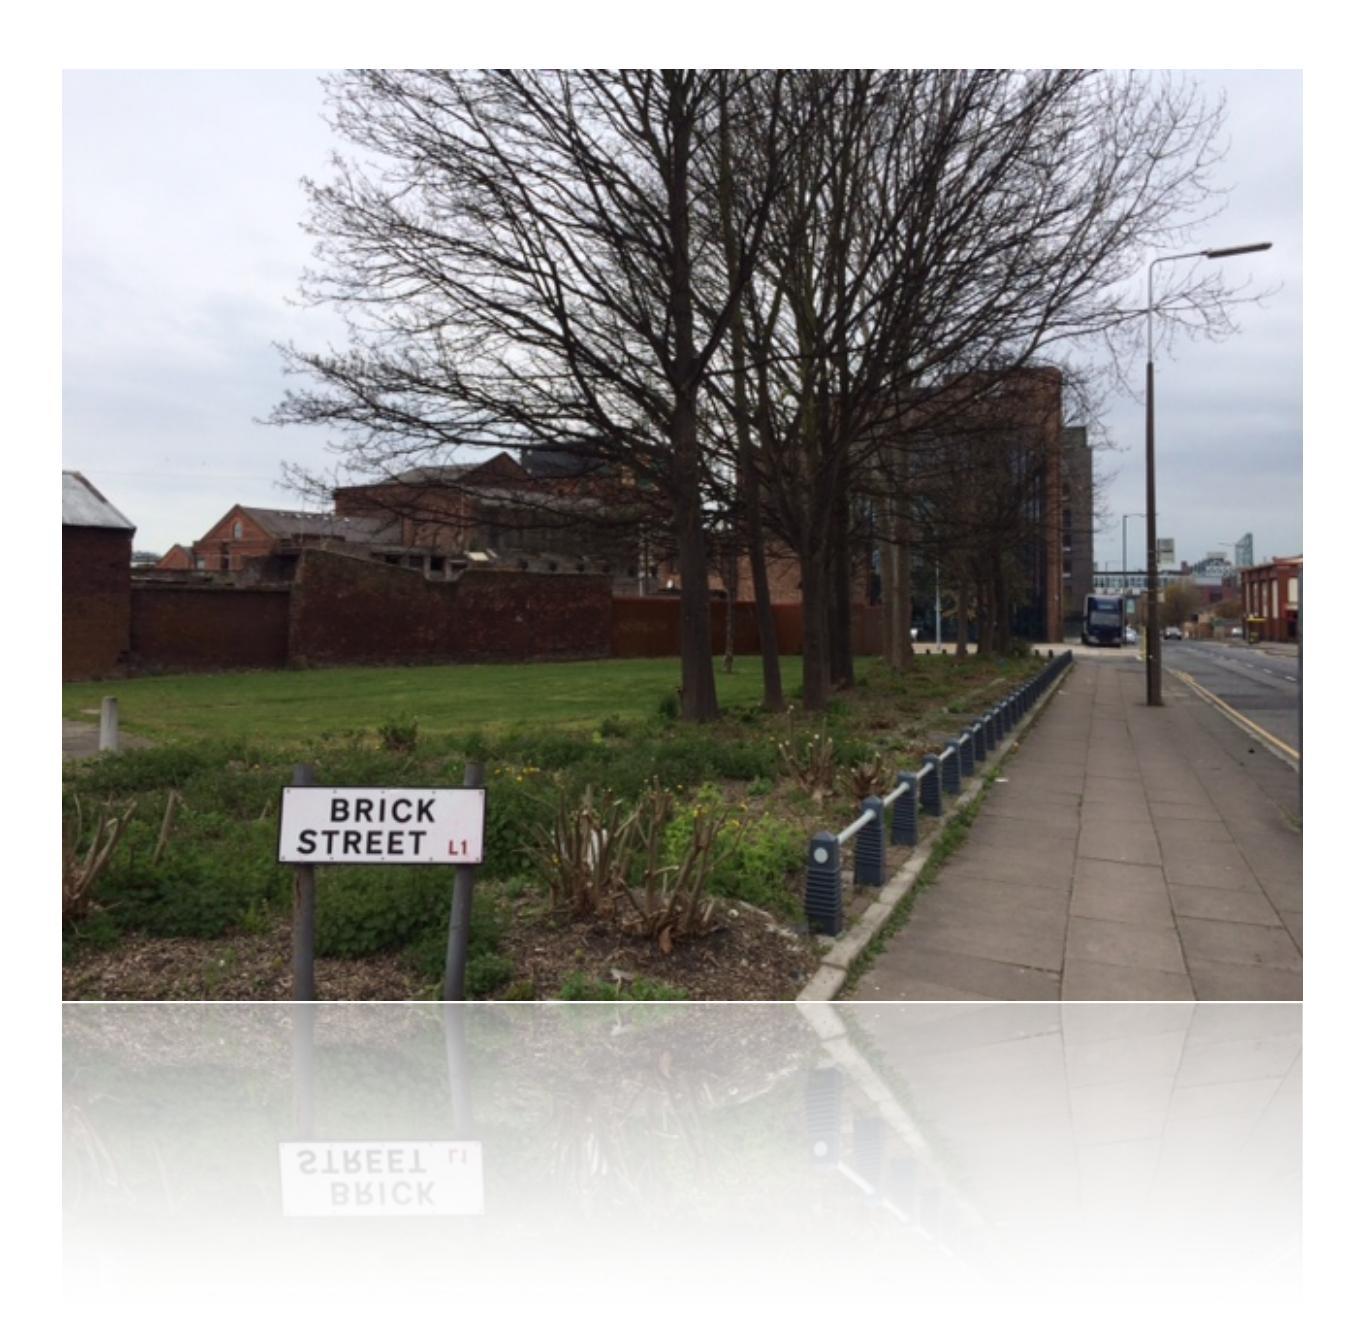
Photograph showing surveyed plot looking northwest.

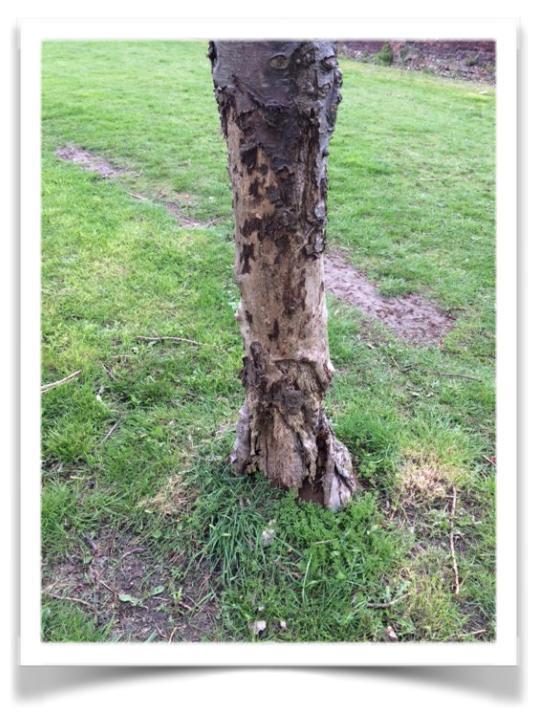
Photograph showing the heavily damaged stem - T6

- 3.6 The low crowns are also encroaching on various pieces of built infrastructure. This includes the adjacent lamp posts and a building on the northwestern corner of the plot.
- 3.7 A single young white beam is located toward the centre of the survey area. It is in very poor condition having been strimmed at the base with grass cutting equipment. This mechanical damage will ultimately lead to its death. This tree has been marked for removal.

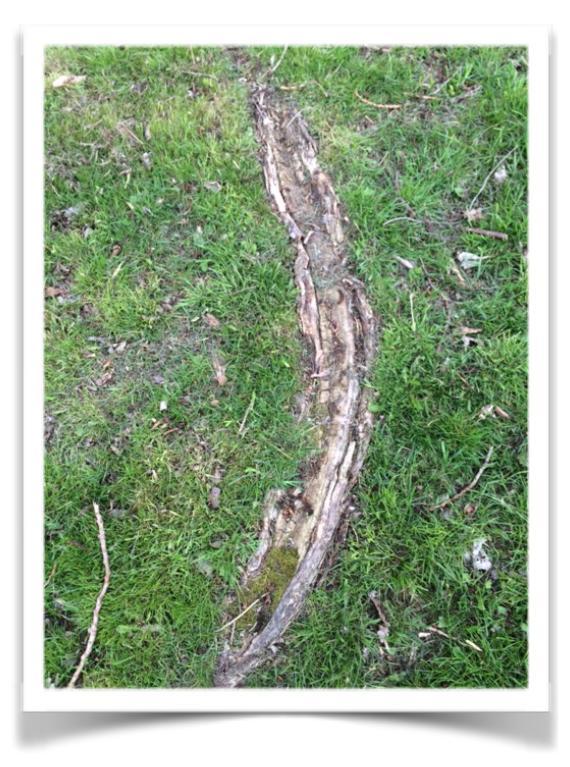
Photograph showing damaged surface roots, typical of trees located within a grass matrix

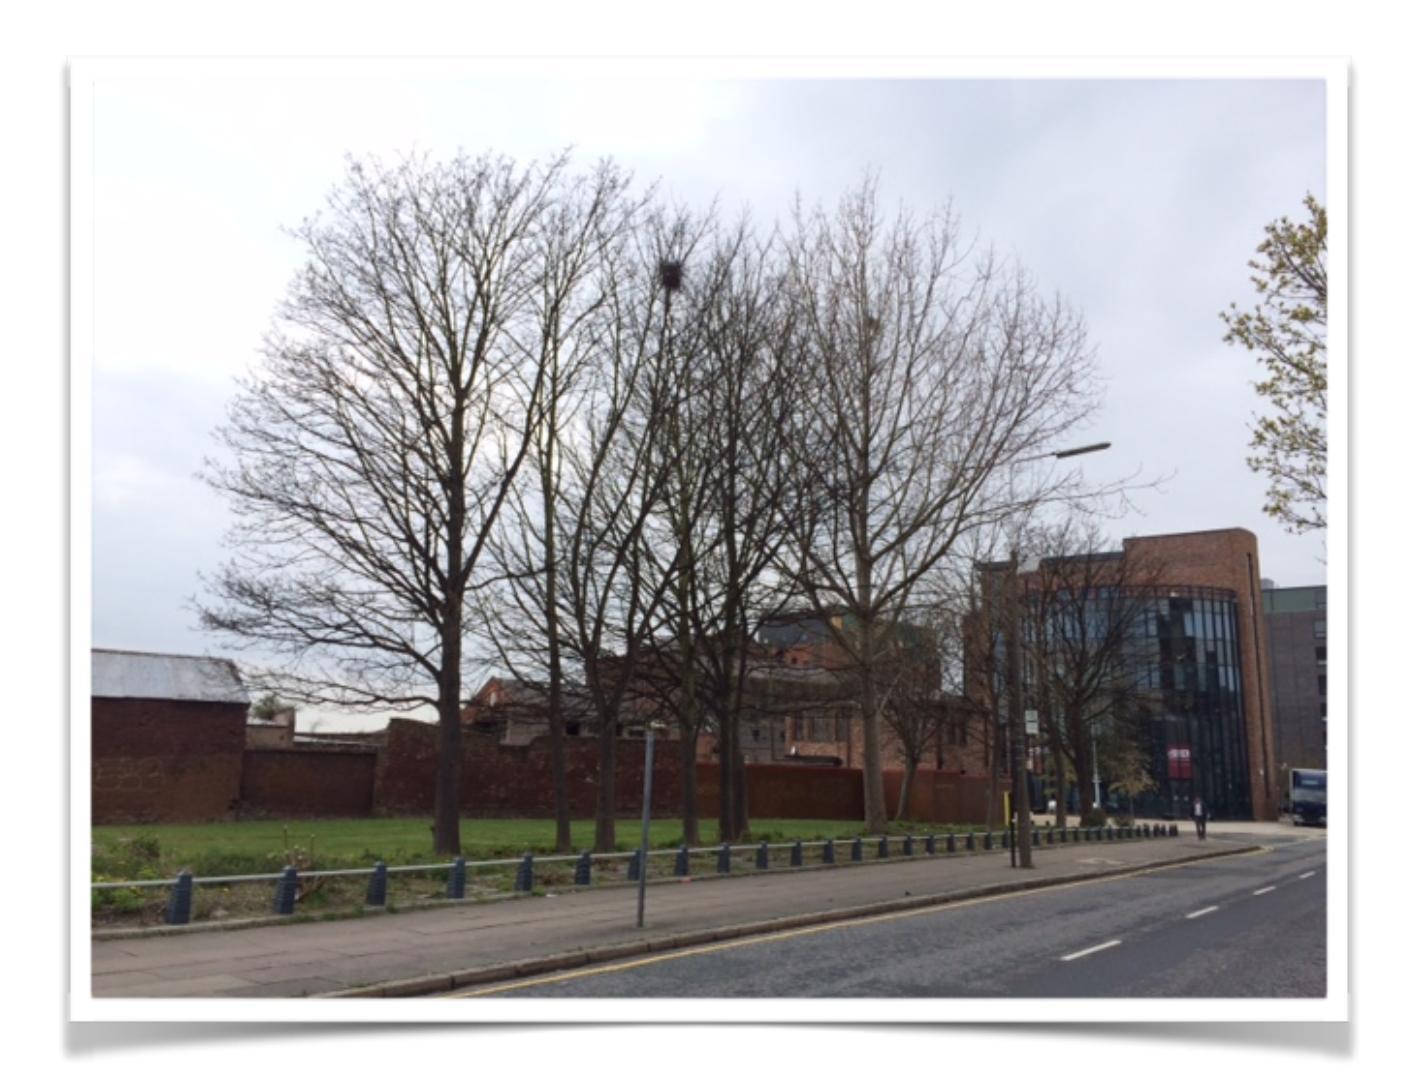
Photograph showing the surveyed trees viewed from the street, a dominant feature within the local area
