Knolle Park -AIA

Report no: 15\_5837\_05\_03-1.1

#### Arboricultural implications assessment to BS 5837 of trees at: St. Gabriel's Convent, Liverpool.

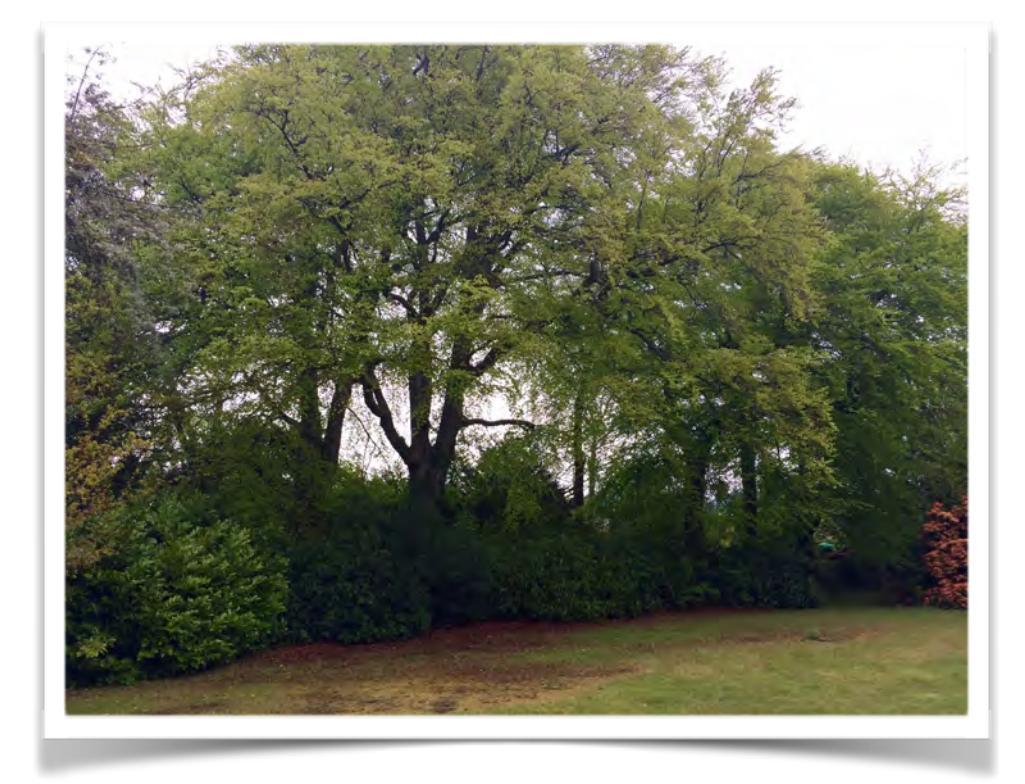
Photograph showing mature tree cover and dense non-native understory within group G25

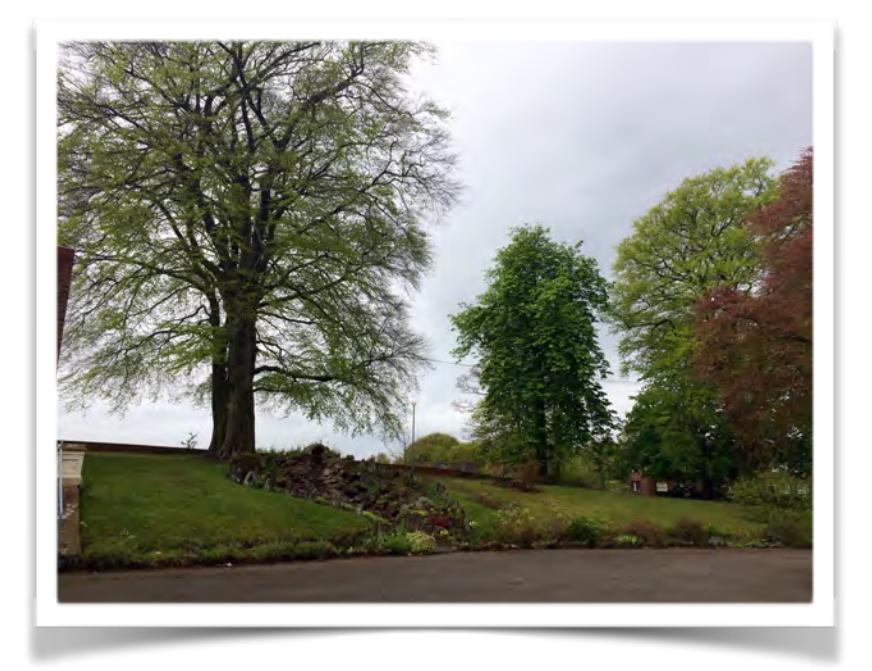
Photograph showing the outstanding mature beech trees located to the north of the Villa.

- 3.4 The mature tree cover located within the grass areas north of the house are of high value and have predominantly been graded A1. These trees should be retained and protected and opportunities exist to prolong their safe useful life expectancy by reducing compaction beneath the crowns.
