## STRUCTURAL ASSESSMENT

TARA HOUSE, OLDHAM STREET, LIVERPOOL

Rev: 3 Date: 25/05/2015 Project No: 4124 Client: Unite Students Ref: P:\Projects\4124\Documents\Reports\1.Existing Structure RPT\4124-RPT-141216-MO-ks-Rev3.docx

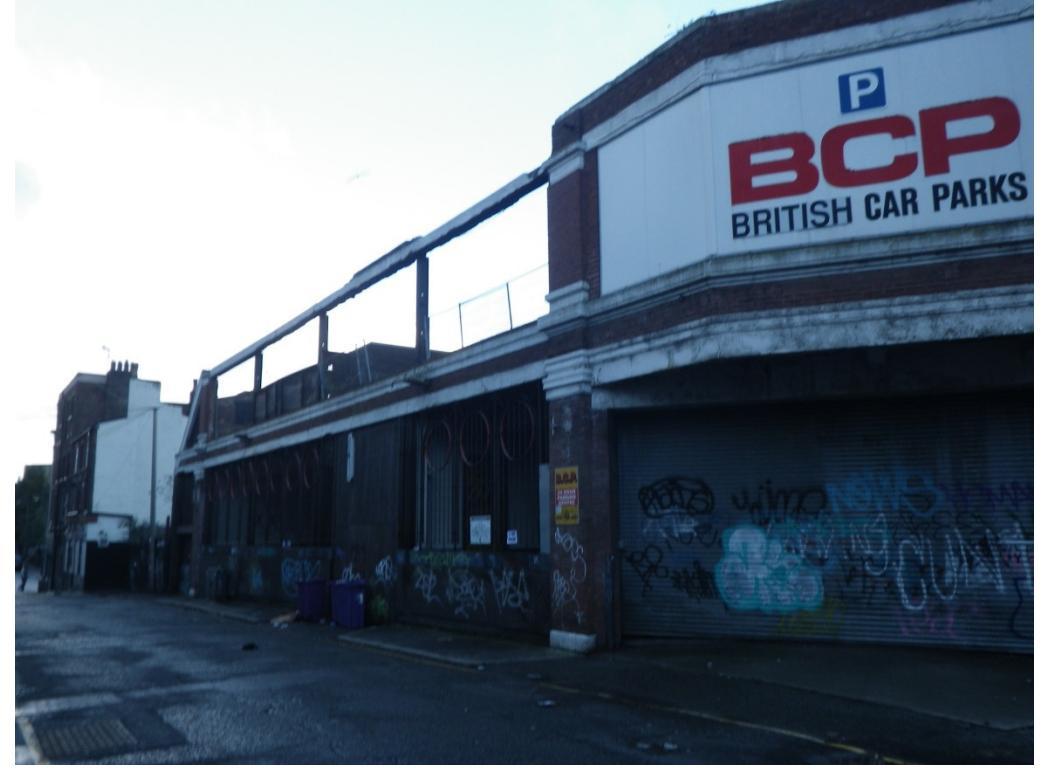
#### Photo 1 – Roscoe Street Elevation

No brickwork cladding to the beam was observed to the Roscoe Street elevation and concrete encasement to the steel beam was missing in more than one location.

In the central bay of the Roscoe Street elevation it could be seen that a previous structural arrangement had been cut back at the perimeter beam face. Where the concrete encasement has fallen away no rebar could be observed.

The perimeter structure to this elevation has been previously modified, the removal of the lateral retraints to be beam suggests that it will have limited laterally load carrying capacity. It has also deteriorated significantly and now has a very limited residual life. Whilst we would suggest that the risk of collapse in the near future is low to medium, the consequences of such a collapse are clearly serious and for this reason we suggest action is taken.

In the knowledge that the building is intended to be completely demolished in the future it is recommended that demolition of this element is advanced. The beam can be removed from the face of the brickwork at both ends. The steel intermediate column supports could be left in place if this is preferred, unless removal of the beam shows a loss of strength.

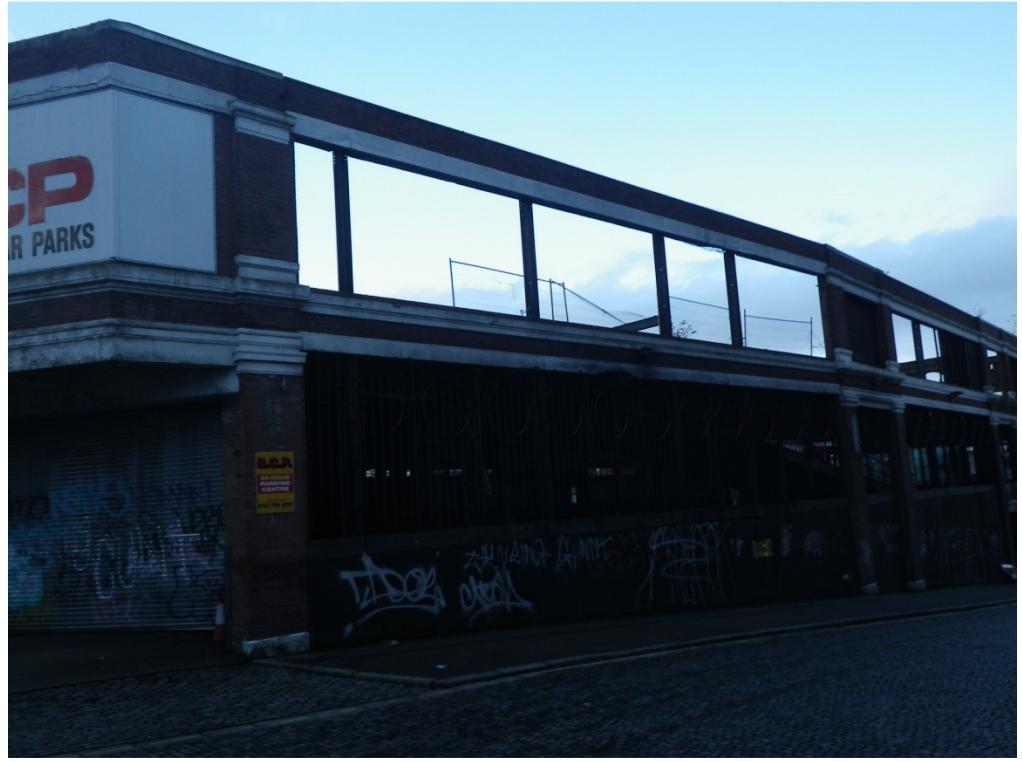
#### Photo 3 – Oldham Street Elevation

The concrete encasement and brickwork was still present to the Oldham Street elevation however fine cracks could be seen in both materials. These cracks can be generally considered as aesthetic but there are serviceability concerns related to the larger cracks within the concrete as there is potential for the concrete encasement to seperate and drop off from the steelwork.

There were no obvious signs of structural distress to the Oldham Street elevation however cracking that was observed externally could also be seen internally. Closer inspection allowed confirmation that the brickwork cladding on the whole remained intact.

This section is in a comparatively better condition with concrete encasement and brick cladding still present. However deterioration is still observed in the form of cracking to both the concrete and brickwork. Also lateral supports to the beam have been removed which suggests that the lateral strength of this element has also been reduced.

Due to the better condition of the this element and also because the structure is more extensive than the shorter section on Roscoe Street it is recommended that temporary structure is installed to improve its lateral stability between now and future demolition. It is expected that an arrangement of anchored raking props and strapping would be sufficient.
