TREE REMOVALS

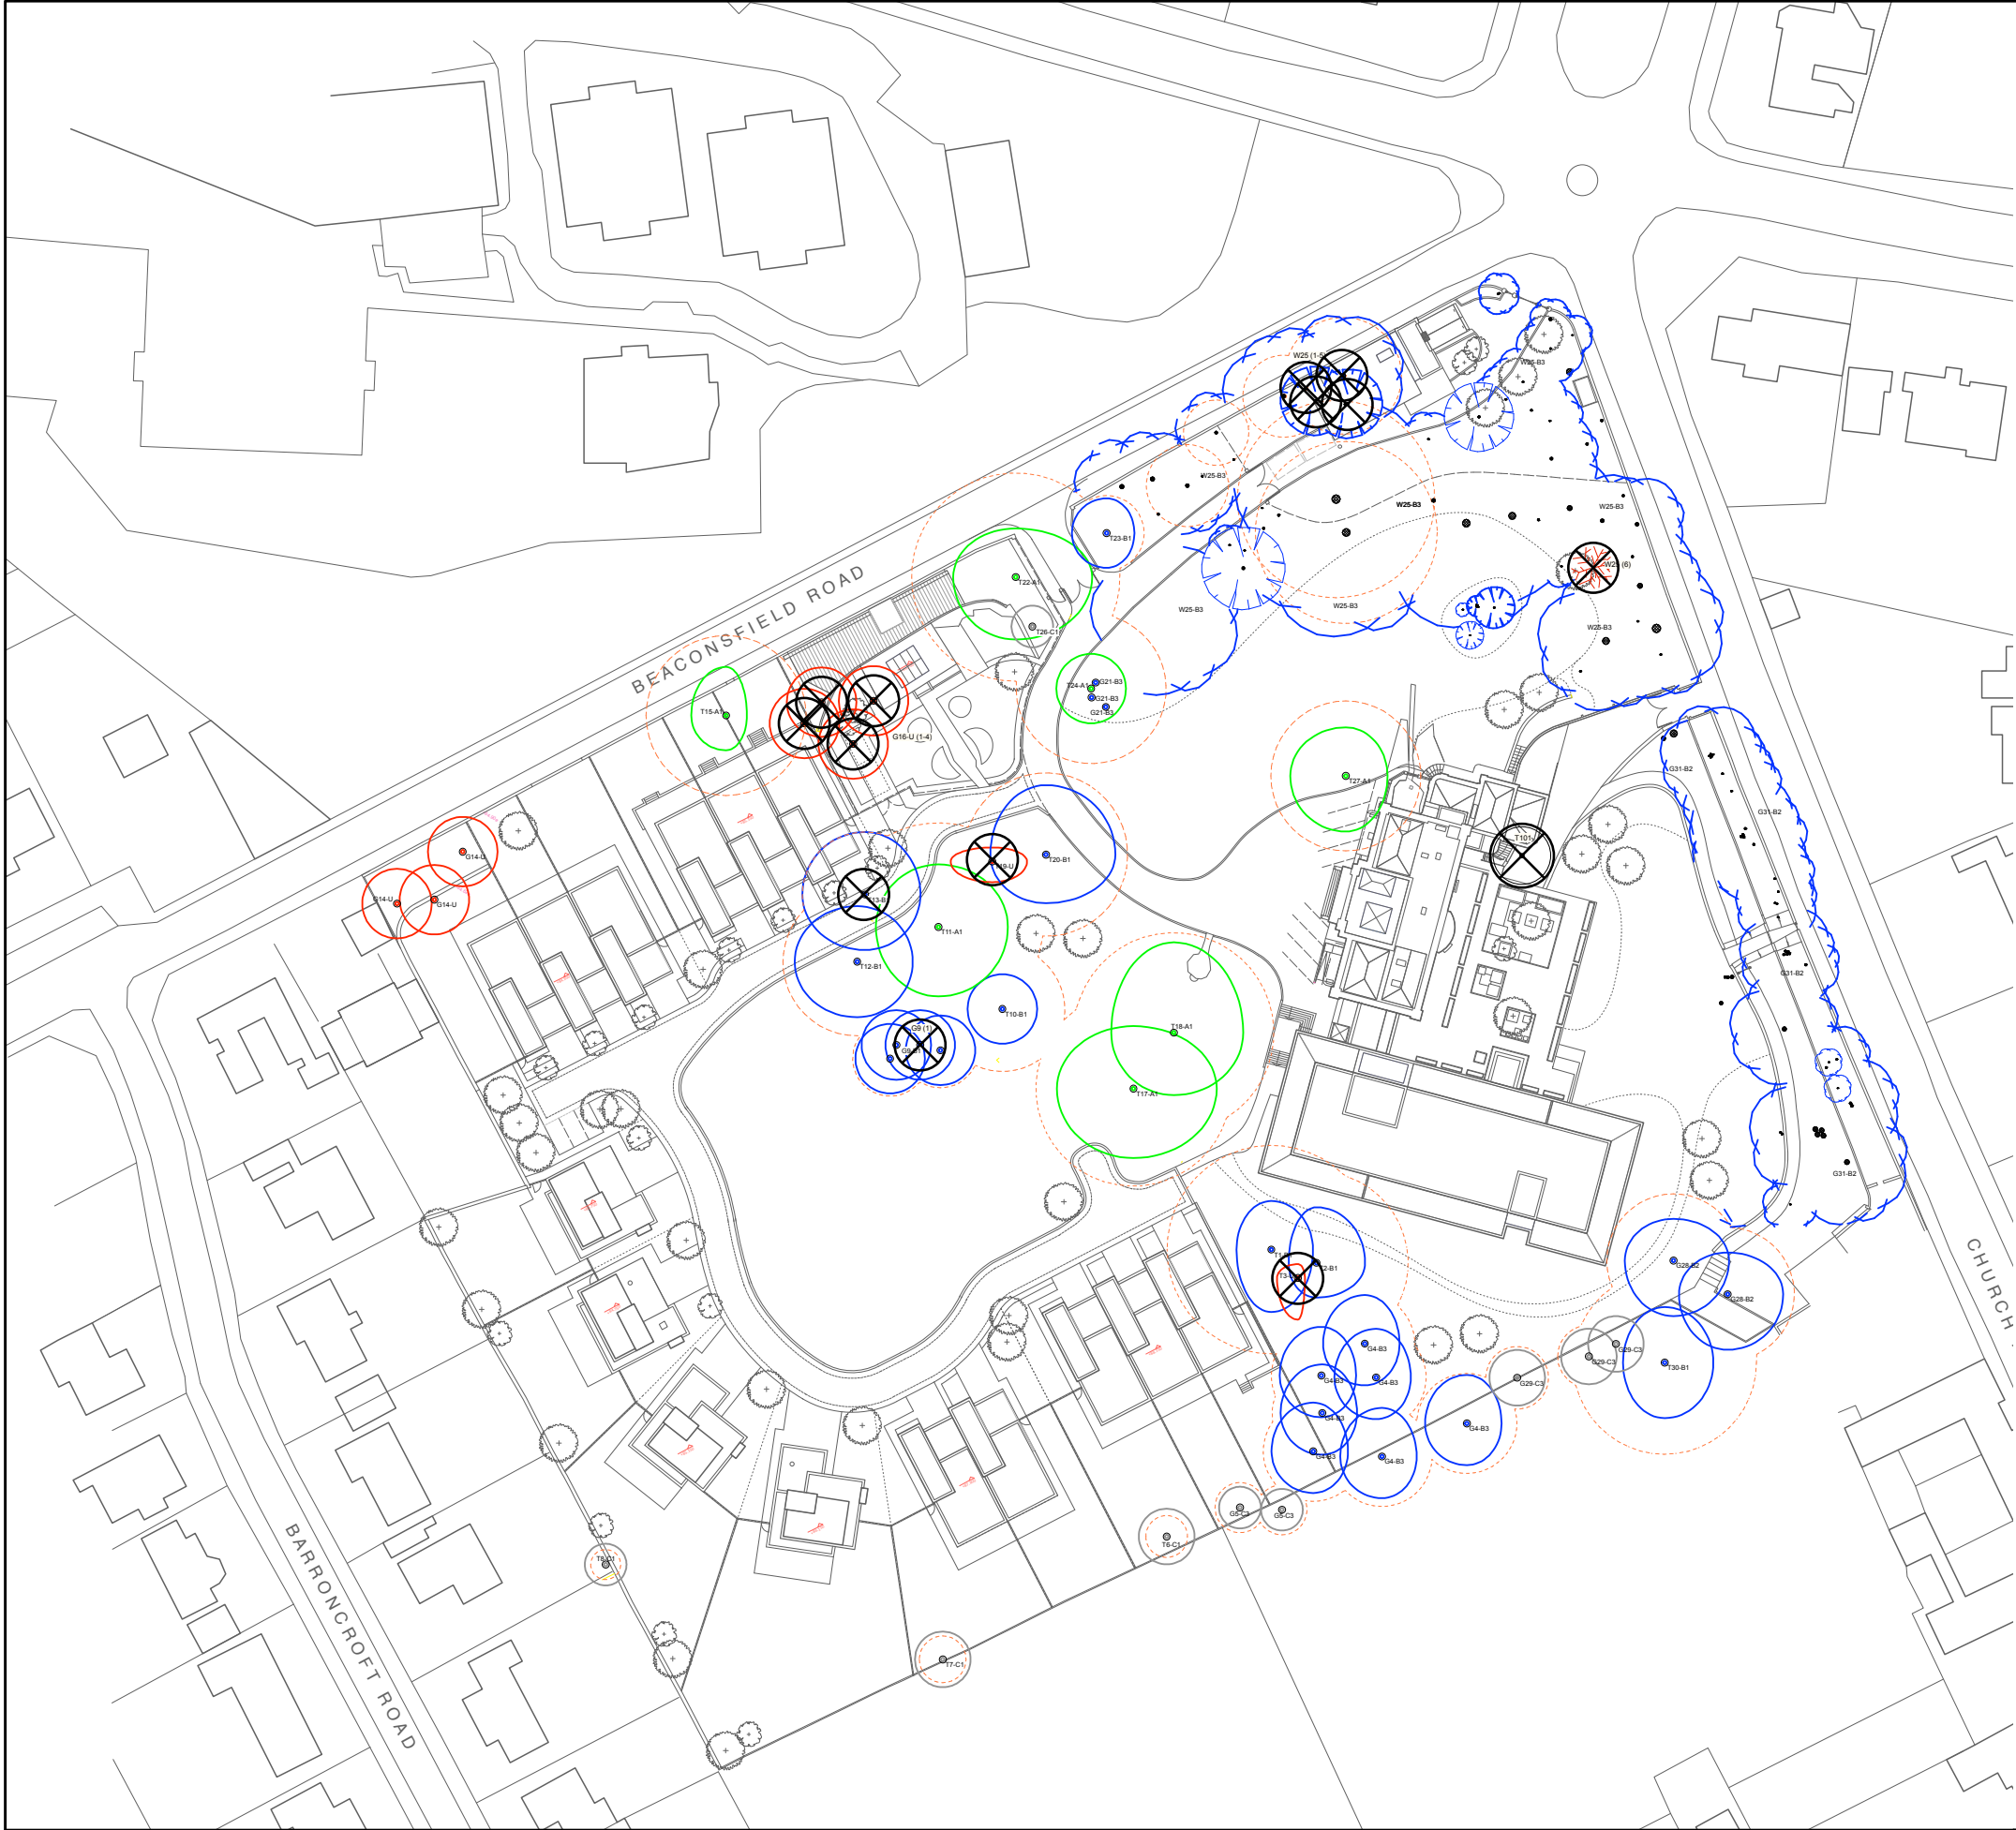
Ref	Species	Value	Notes	Reason for removal
T3	Sycamore	U	Limited long term prospects, low vitality, declining, leaning south, dieback in crown, low bud/ leaf density, major deadwood in crown, crown distorted due to group pressure	Arbor survey/ condition
T13	Horse Chestnut	B1	Tree located within hard surface area, major bark wounding on stem, low branches over road/ footpath, branches restricting highway light, cavity present in old pruning wound	To facilitate proposal
T19	Sycamore	U	Dieback in crown, low bud/ leaf density, unbalanced crown shape, crown distorted due to group pressure, in heavy decline suspect kretschmaria present	Arbor survey/ condition
T101	Taxus baccata	-	-	To facilitate proposal
G9 (1)	Sycamore	B1	Tree located in hard surface area, epicormics on stem, crown distorted due to group pressure, low branches over road/ footpath, group of three limes and one sycamore, sycamore in very poor condition	Arbor survey/ condition

G16 (1)	Sycamore	U	Limited long term prospects, low vitality, declining, unable to inspect stem due to ivy, dieback in crown, low bud/ leaf density, unbalanced crown shape, crown distorted due to group pressure, poor annual extension	Arbor survey/ condition
G16 (2)	Sycamore	U		Arbor survey/ condition
G16 (3)	Sycamore	U		Arbor survey/ condition
G16 (4)	Sycamore	U		Arbor survey/ condition
W25 (1)	Holly/ Field Maple/ Sweet Chestnut/ Beech	B3	Area of woodland dominated by tall beech and lime, understorey of laurel and holly, large collapsed dead horse chestnut within, many stems require tree safety works adjacent to road	To facilitate proposal
W25 (2)	Holly/ Field Maple/ Sweet Chestnut/ Beech	B3		To facilitate proposal
W25 (3)	Holly/ Field Maple/ Sweet Chestnut/ Beech	B3		To facilitate proposal
W25 (4)	Holly/ Field Maple/ Sweet Chestnut/ Beech	B3		To facilitate proposal
W25 (5)	Holly/ Field Maple/ Sweet Chestnut/ Beech	B3		To facilitate proposal

W25 (6)	Holly/ Field Maple/ Sweet Chestnut/ Beech	B3		Arbor survey/ condition
