Trees and Construction

BS5837 Arboricultural Report

Site: Land at Garston Park Church (Garston Old Road Liverpool L19 1QL)
Ref: GPC/ChCou/RB/13

Client:
The Church Council of Garston Park Church

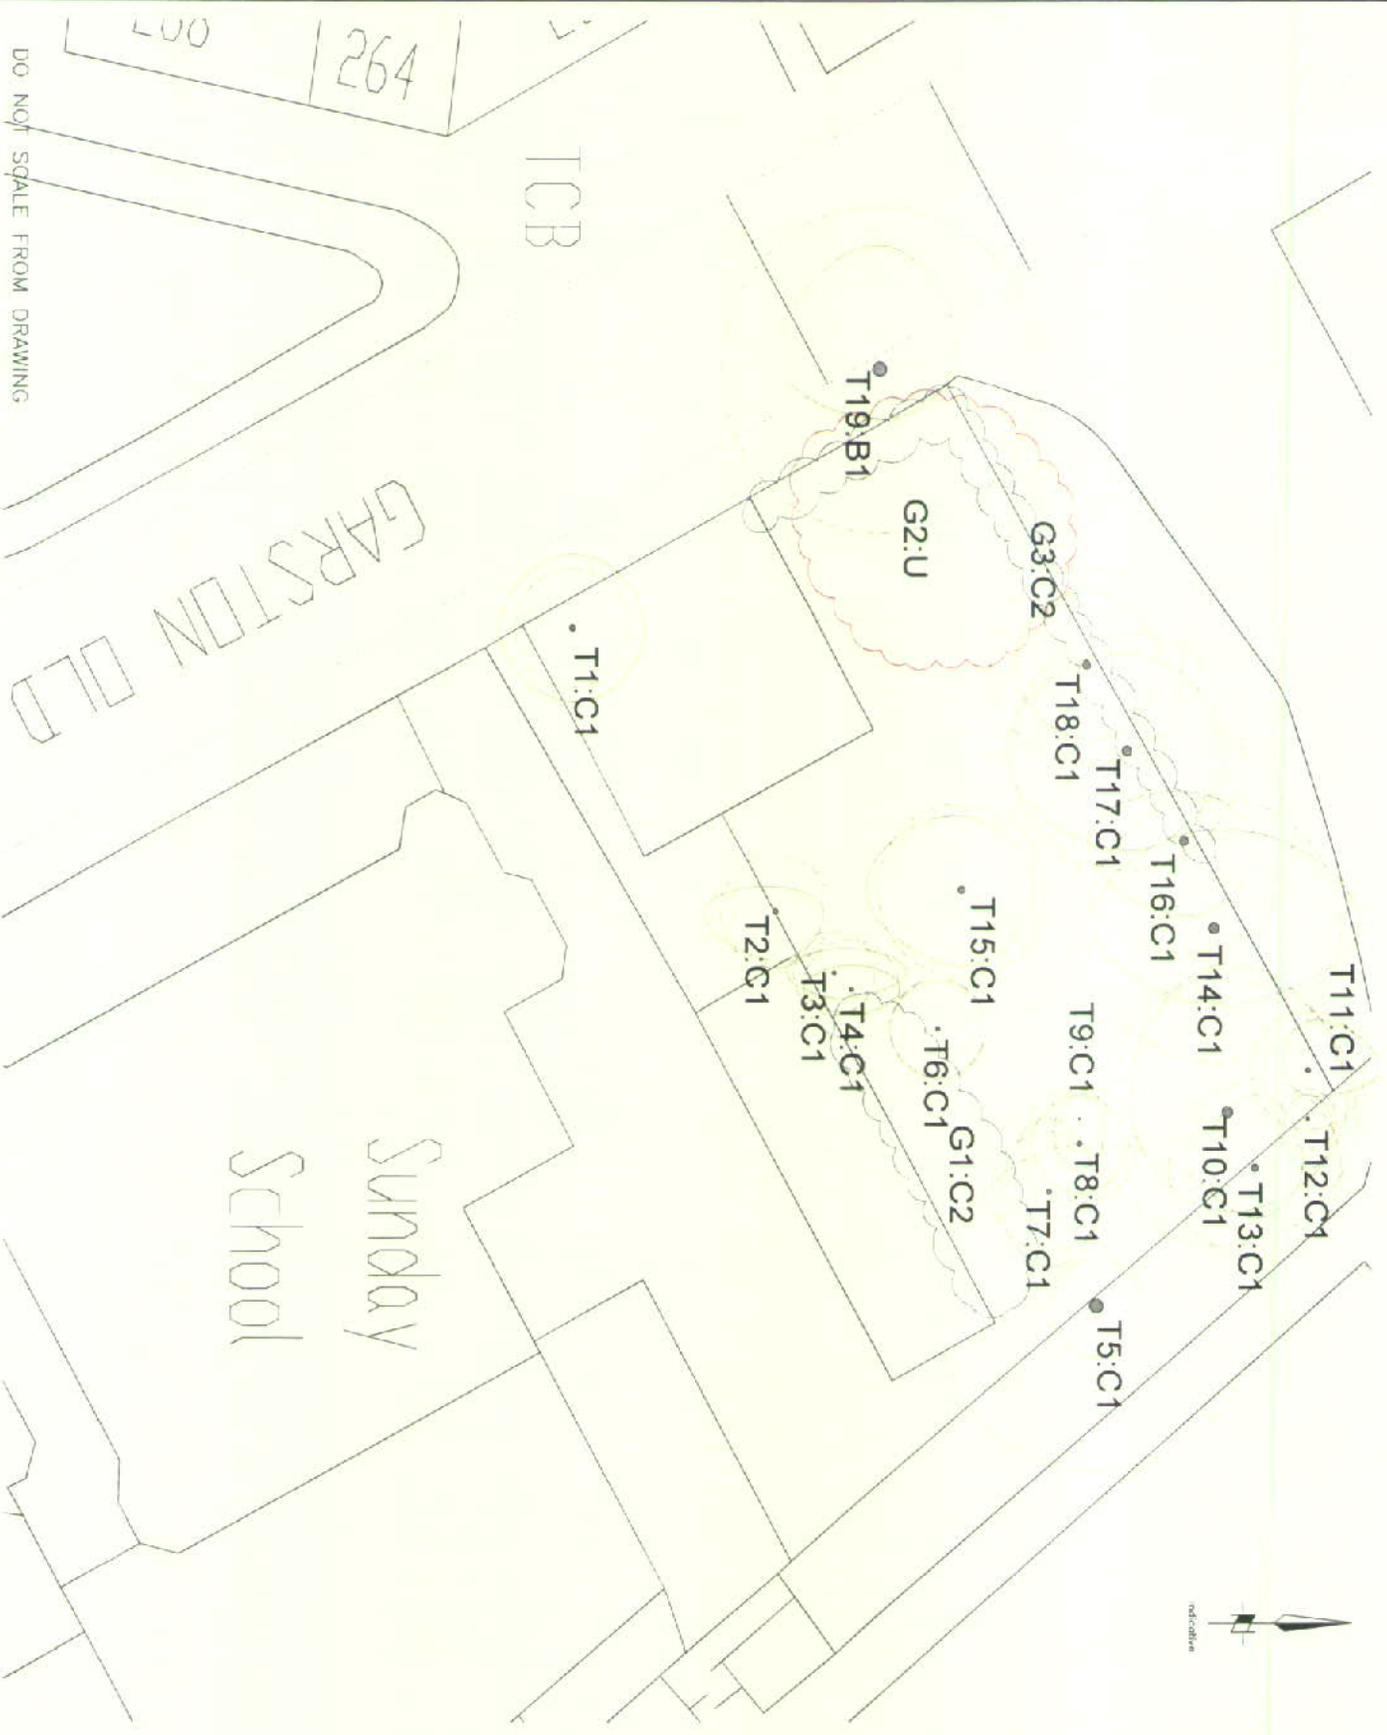
Drawing Number
TCP-01

2.4.2 The surveyed trees appear to be mostly self sown trees on the actual site itself. Off site there is a Red Horsechestnut. A group of trees G2 has been extensively damaged by fire in the past

2.4.4 The most significant trees are classed as 'B' (T19).

2.4.6 Trees with 'U' rating should be removed for Arboricultural or safety reasons these are: G2

The currently structural and physiological condition of some trees may benefit from a degree of tree pruning [depending on the increased use of close proximity surrounds], e.g. T1 removal of deadwood. Any trees which are to be removed should be well indicated to ensure that the retained trees are suitably protected. Hence, all trees being removed are too marked by a suitably qualified person [spraying the stems with a cross].

Consideration for the retained tree's RPAs should avoid any works from said areas in order to ensure the protection of existing growing conditions. Specific attention must be paid to tree protection measures, i.e. Heras barrier fencing.

In this instance, and in taking advantage of the grouped nature of the trees and the existing hard surfaced access routes, fencing could be installed to prohibit access to RPAs for the duration of construction which would provide adequate protection. It is sometimes possible to undertake construction activities within the rooting areas of retained trees which will require greater attention to the tree protection measures, foundation designs, phasing of works and construction processes etc. If it is proposed to undertake works within these areas, more specific advice should be sought from a qualified arboriculturalist with a view to forming a judgment on suitability and a method statement.
