St. Gabriel's Convent, Liverpool

Protected Species Survey Report (Bats).

Compiled by Ecology Services Ltd.

June 2015

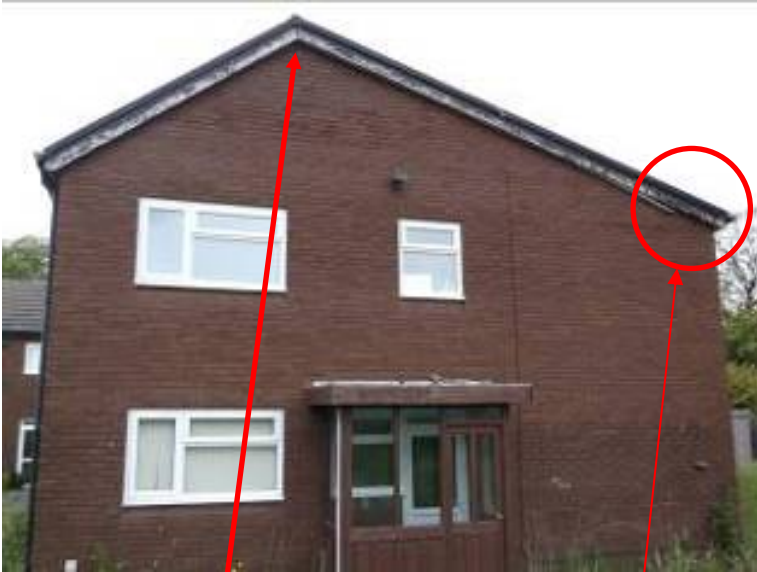
The previous survey on the building in 2011 discovered multiple bat droppings in the roof void of B1b at the southern gable end. Therefore this building contains **a confirmed bat roost**.

Southern elevation of Building 1b location of confirmed roost

- 6.3 For building 1a&b, containing the confirmed roost, three dusk emergence and/or pre-dawn re-entry surveys are required to be undertaken during May to September. The optimum time period is May to August. This level of survey should be sufficient to advise upon mitigation and follows Natural England's guidance for survey levels.

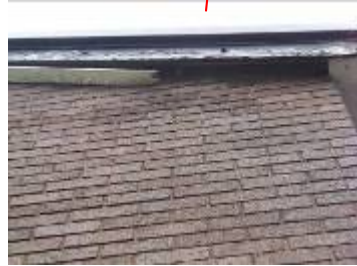
Rotted wooden soffit

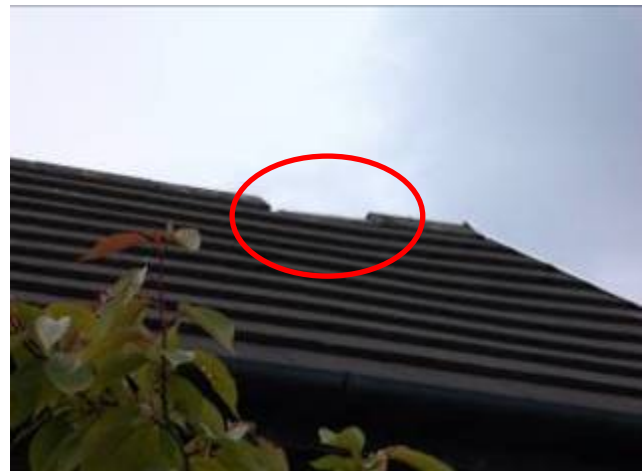
Missing ridge tile on 1b

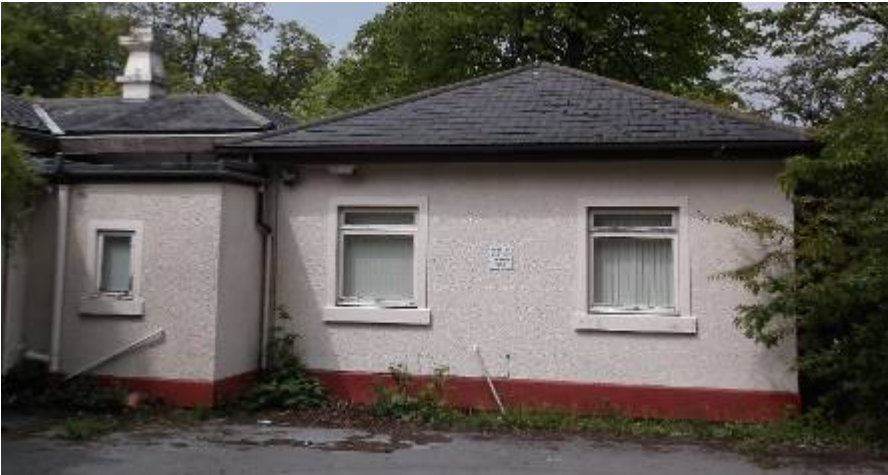
Building 2

It was difficult to see the roof of the building due to the height of the vegetation and the gentle slope of the roof. On the western elevation, there is a gap at the roofline directly below the roofing slates but above the wooden fascia board and there is a gap underneath the fascia which is approximately 30cm long.

The building is considered to have **low to moderate** potential for roosting bats.

- 6.4 For buildings with low to moderate roost potential, two dusk emergence and/or pre-dawn re-entry surveys are recommended during May to September. The optimum time period is May to August. This level of survey is deemed sufficient to prove presence or absence.

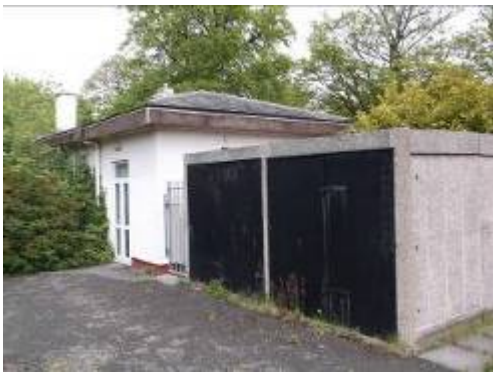
There are gaps present at the fascia boards on the southern elevation of the garages and a gap at the north-west corner.

Building 2 with garages

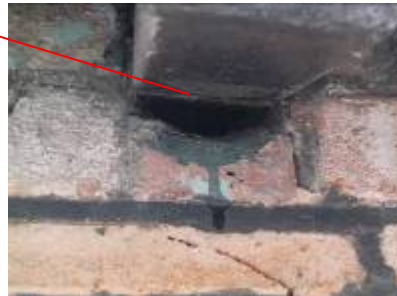
Gaps at the roofline

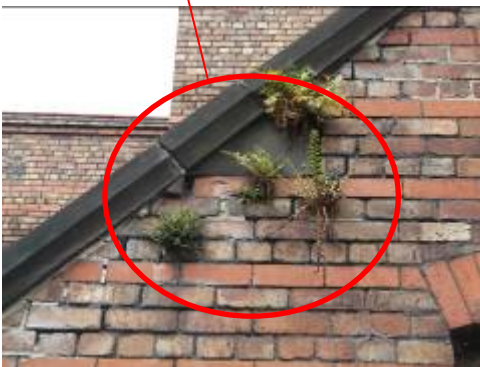
Gaps in the brickwork

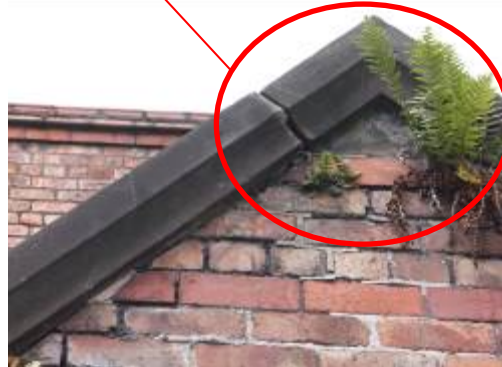
Gaps at the capping stones

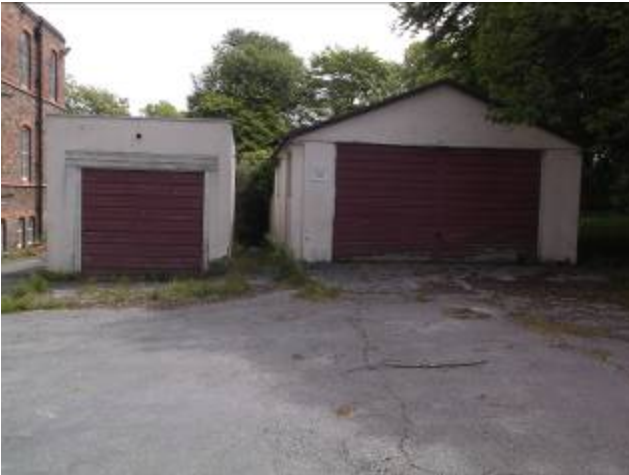
Buildings 4a and 4b

No access was gained internally.
The building is considered to have low to moderate potential for roosting bats.
Building 4a and 4b
Description:
<p>Building 4a is a single storey, flat roofed, single garage with rendered walls and a metal door. There is a bricked up window located on the eastern elevation.</p> <p>Building 4b is a single storey, pitched roof workshop located next to Building 4a. The roof is covered in felt, the walls are constructed of concrete panels and there is a metal garage door in the western elevation. The doors and window frames are composed of wood.</p>
Roost potential signs:
<p>Building 4a has a pipe leading inside the wall on the western elevation.</p> <p>There are gaps at the roof line of Building 4b but they did not recede and were heavily cobwebbed.</p> <p>There was debris on the ground showing the area had not been cleaned prior to arrival. No droppings or any other evidence of the presence of bats was identified which suggested present or historic use.</p> <p>No internal access was gained in to either building 4a or 4b.</p> <p>The building is considered to have negligible to low potential for roosting bats.</p>

- 6.12 For buildings 4a & 4b with negligible to low potential, not further surveys are considered to be required, due to the very low level of potential. As a precautionary approach, it is advised that if at any time a bat/s or evidence of bat/s is/are suspected or found, all works must cease immediately and advice should be sought from either Natural England or the acting Consultant.

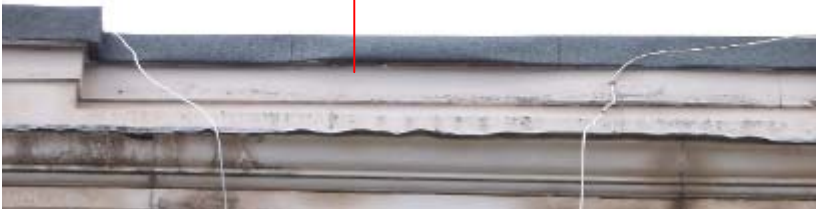
Gaps under felt

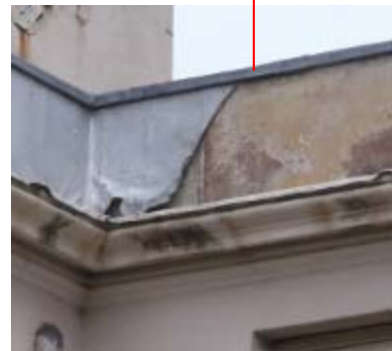
Gaps under lead flashing

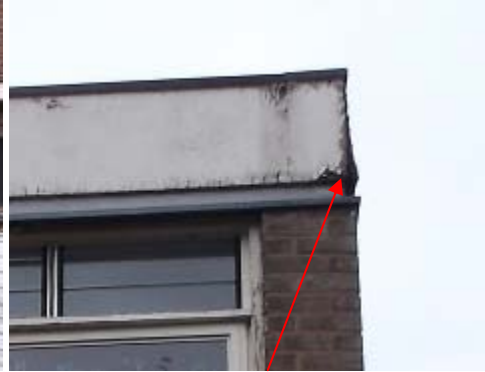
Lifted fascias on eastern elevation

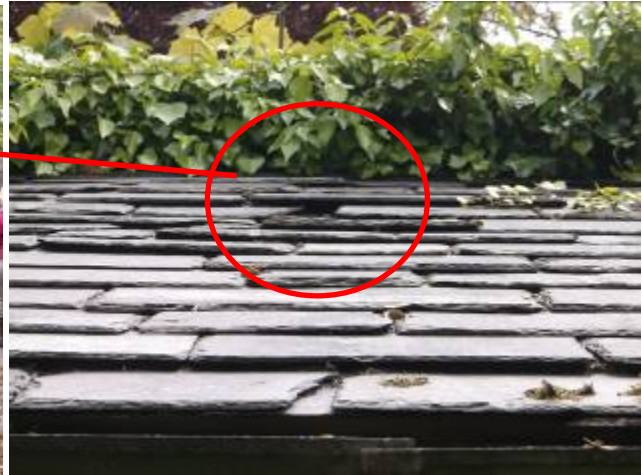
Gaps at lifted & slipped roof slates

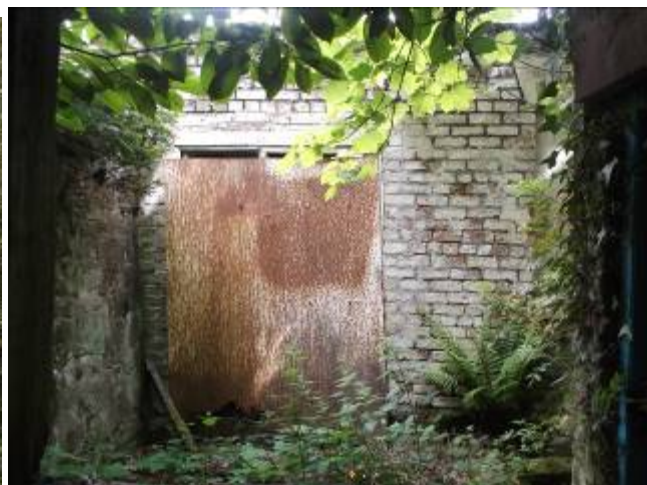
Eastern elevation 8 with slipped metal sheeting
