Former Holly Lodge Girls' College, Queens Drive

Protected Species Survey Report (Bats).

February 2015

Updated May 2016

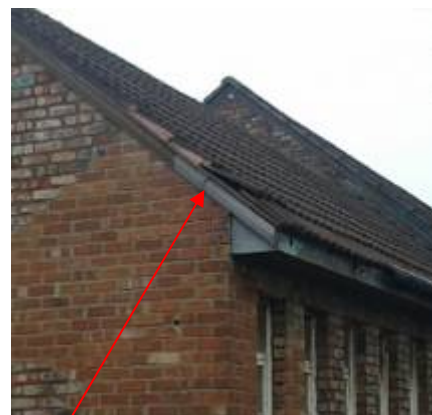
Lifted roof tiles on Building B

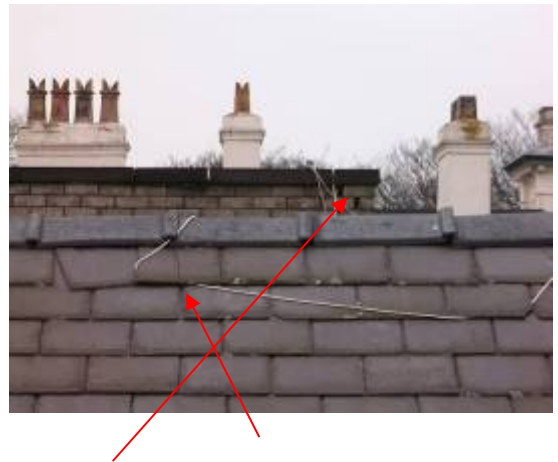
Gaps in brickwork and roofing tiles

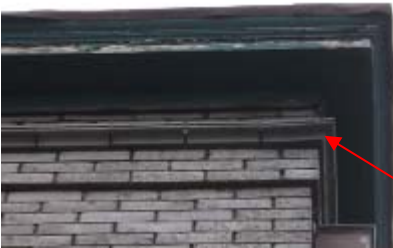
Building D – Gaps under soffits

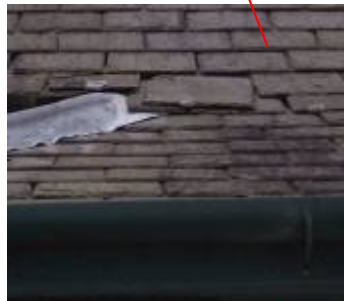
Gaps in the tiles

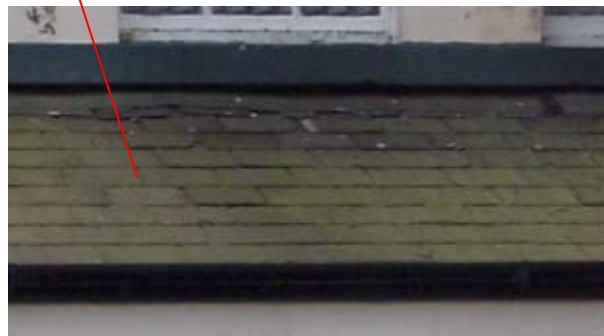
Gaps where the tiles have slipped

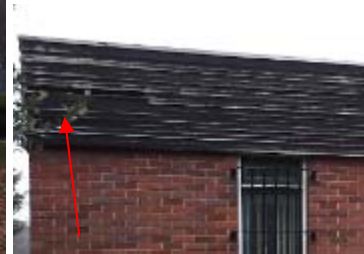
Gaps in the panelling

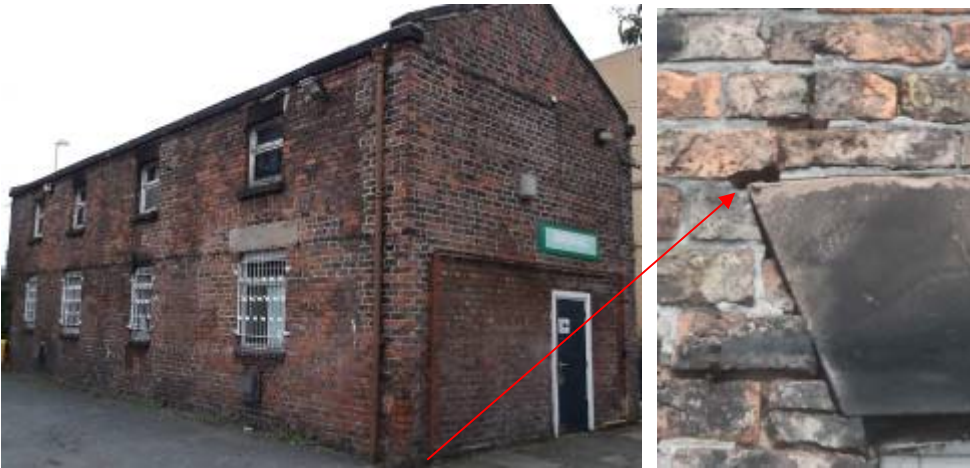
Building J – Viewed from south-west, gaps in brickwork

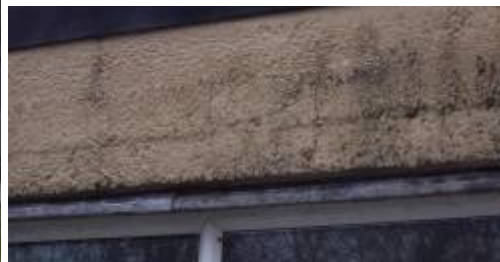
Building K - Viewed from south-west, gaps between concrete roof and flashing

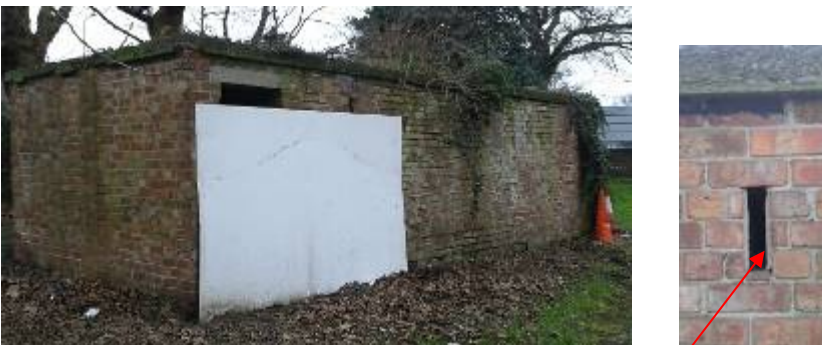
Building M - Gaps in brickwork on north-east and south-west elevations
