Ref: DMS603-LETREP01-A

## RE : Hardman House, Hardman Street, Liverpool, L1 9AS

- 1.0 Introduction and Limitations
- 1.0.1 Muir Associates UK Ltd were appointed by Carpenter Investments to undertake an initial Structural Condition Appraisal of the building referred to as Hardman House, located on Hardman Street, Liverpool L1 9AS.

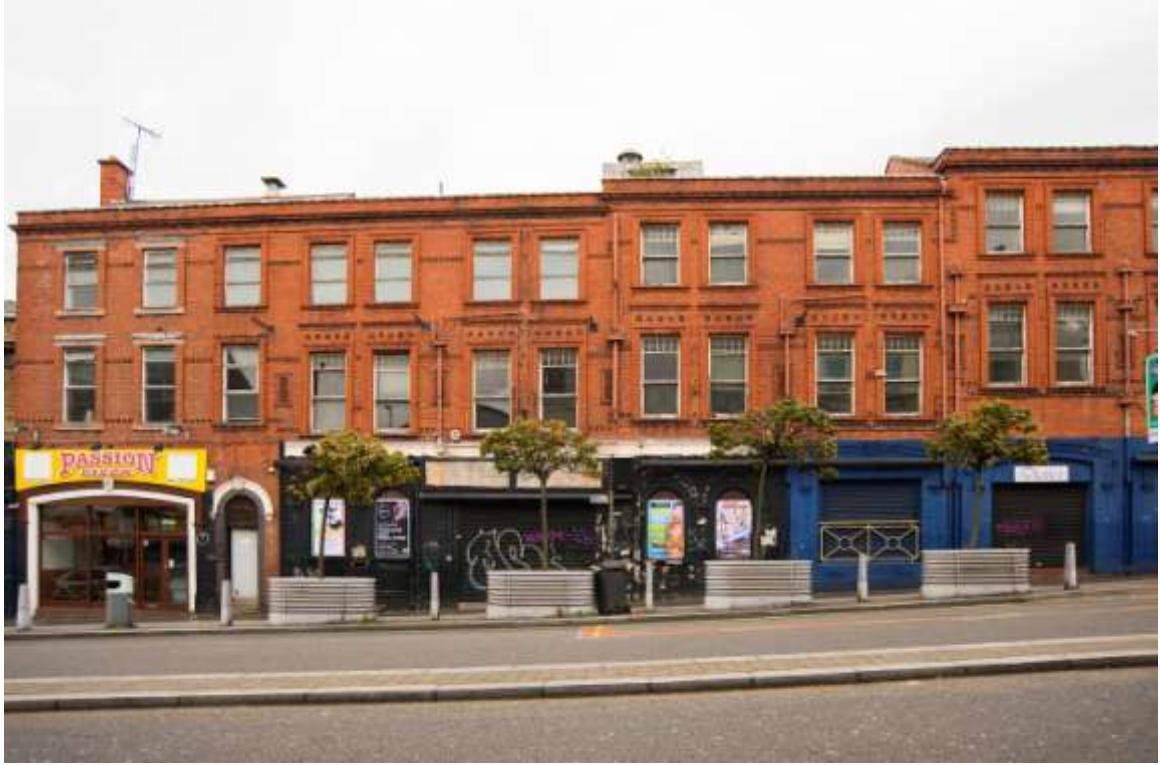
- 2.0.3 The majority of the building is built over 3 floors above ground level with part of the building having a varying basement which extends below the footpath level in line with the main Hardman Street façade.
- 2.0.4 The buildings are not listed structures.
- 3.0 External Envelope
- 3.0.1 An initial inspection of the building was undertaken from ground level by way of a walk around the perimeter to review any obvious defects which may be present. A high level visual inspection of the external elevations to assess any defects has not currently been undertaken.
- 3.0.2 It is apparent that a number of unsympathetic elevational alterations have been undertaken during the previous year's predominantly to the ground floor main frontage on Hardman Street, which is likely to have been following changes in retail occupiers.

Image 1 - Hardman Street Elevation

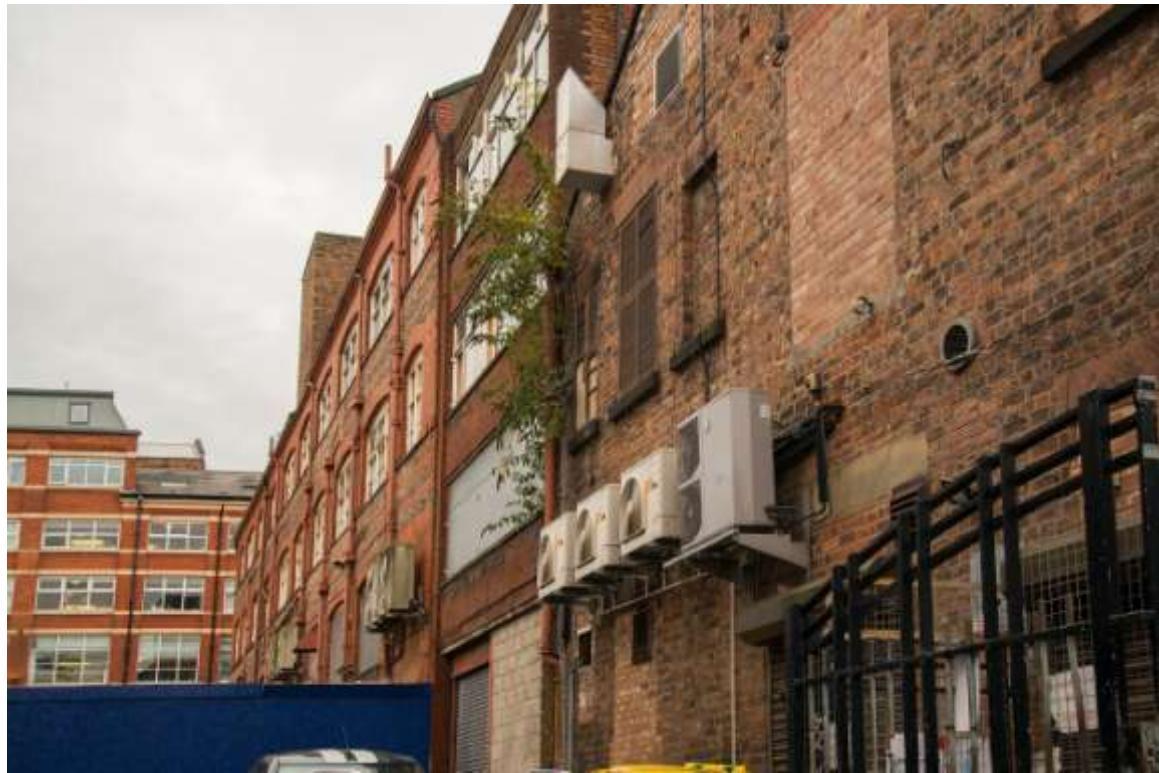
Image of Back Maryland Street

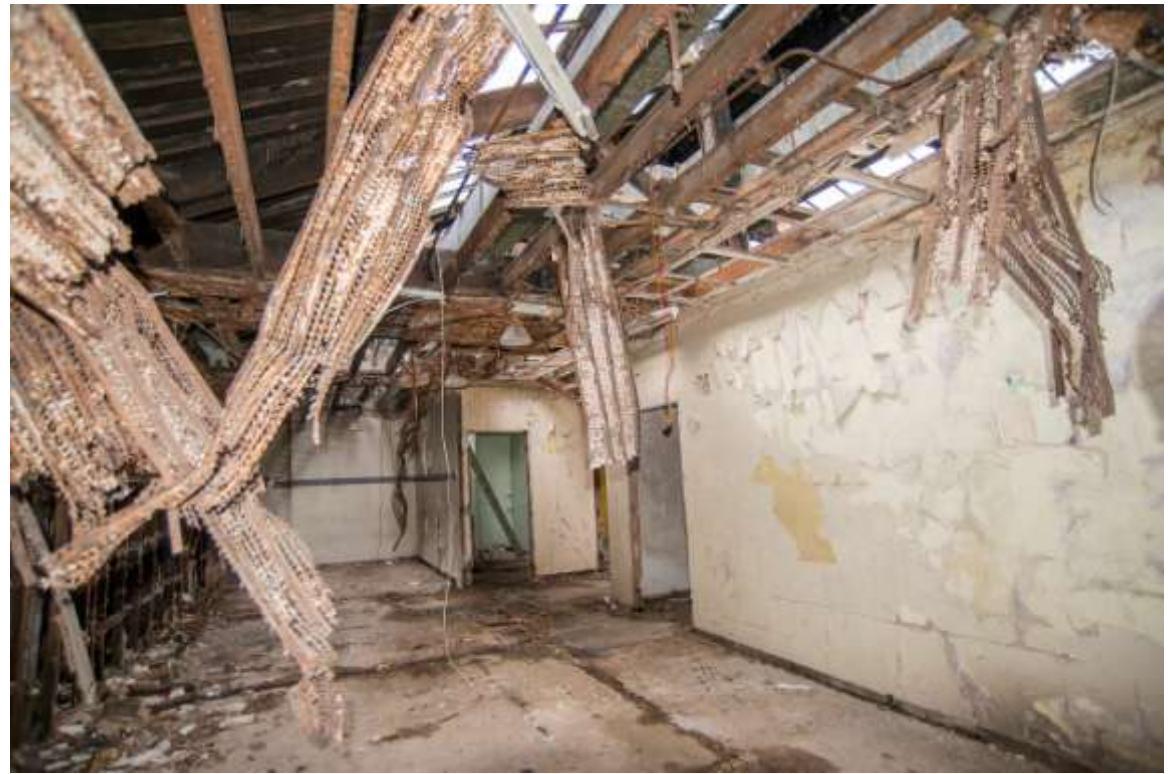
- 4.0.3 A significant number of ceilings have collapsed due to water ingress exposing the existing roof structure above, with upper floors being unsafe and deflecting significantly. The floors are generally out of level across the building, which is likely to be due to rotting timber and or settlement of the structure.

Image of Ceiling at 3rd floor level

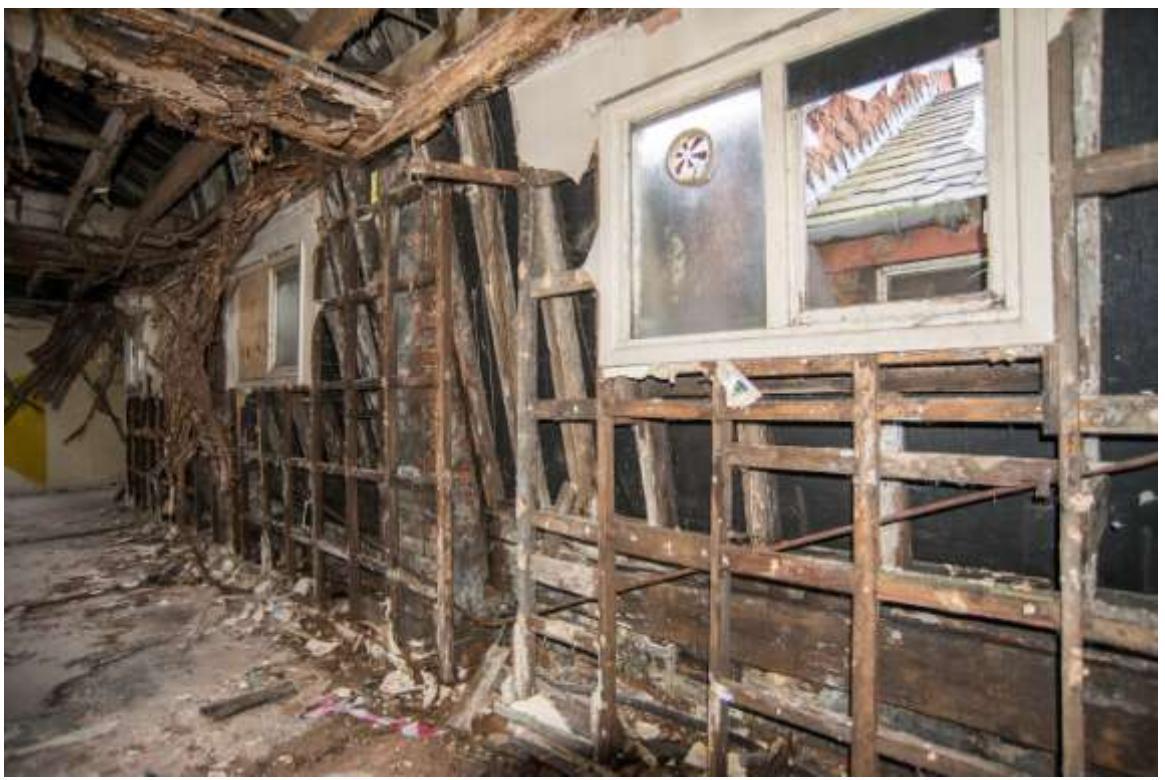
Image at 3rd Floor Level

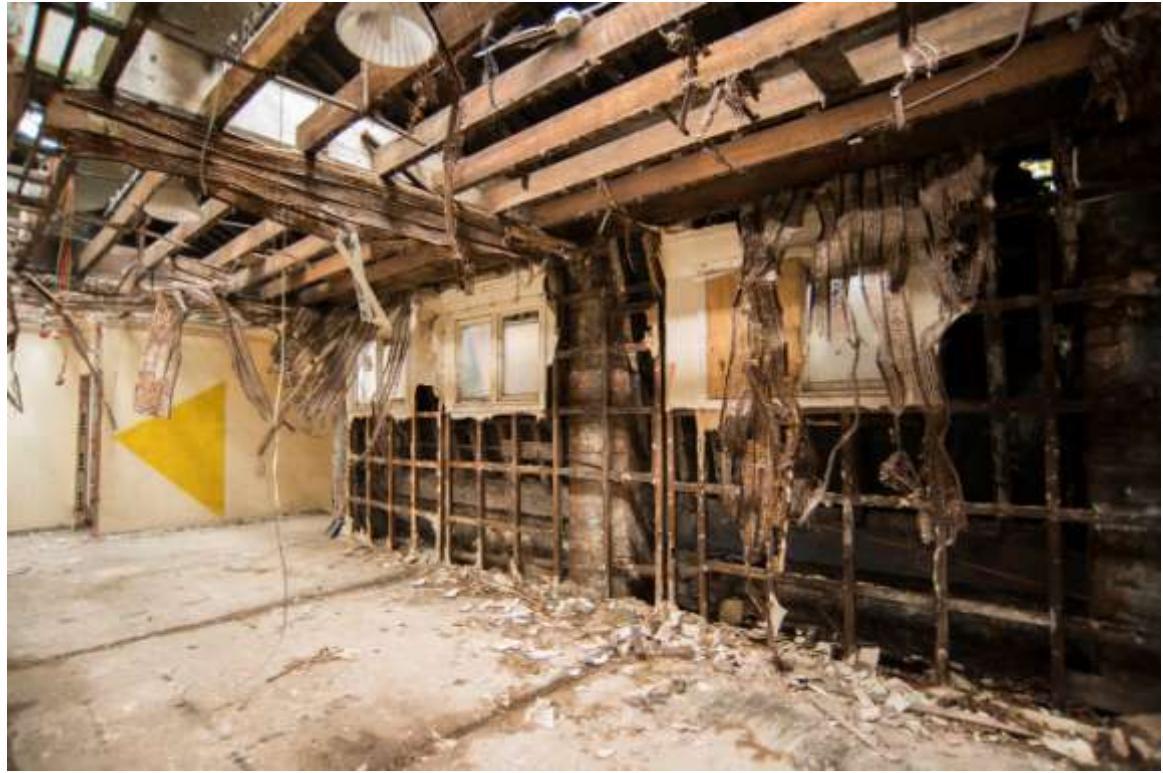
Image at 3rd Floor Level

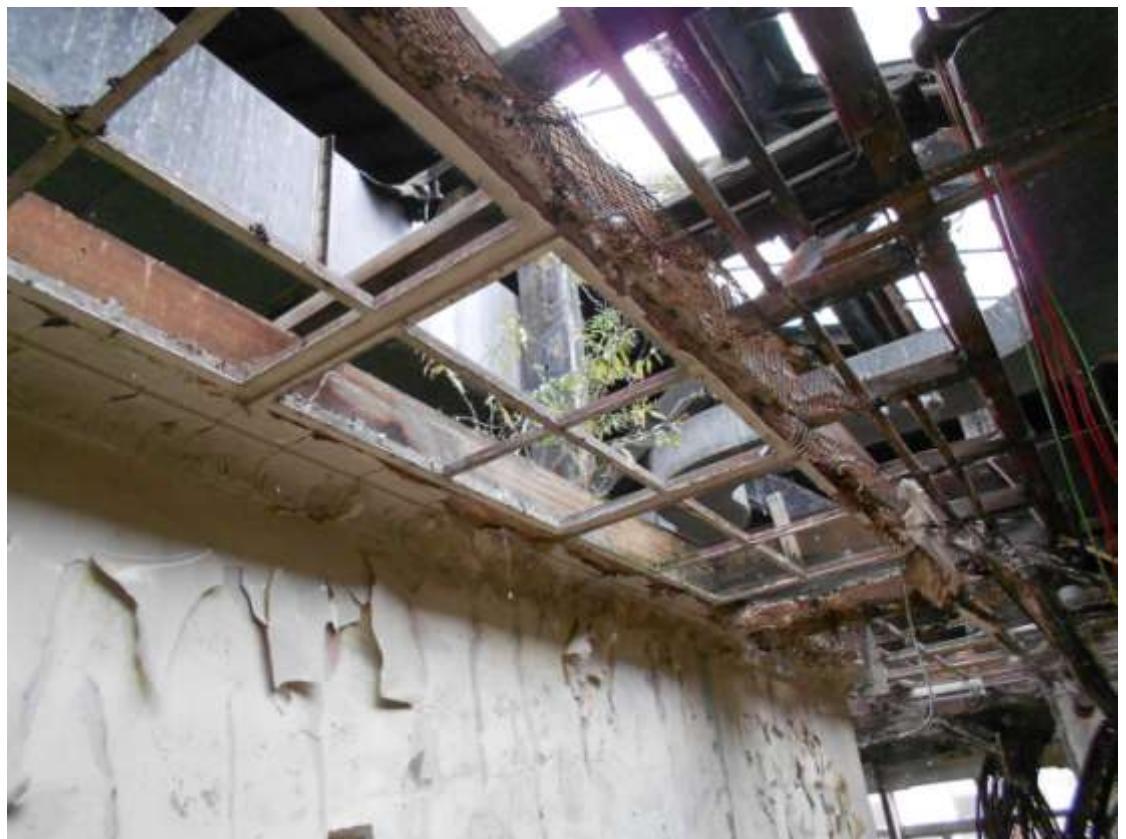
Image of collapsed ceiling at 3rd floor level

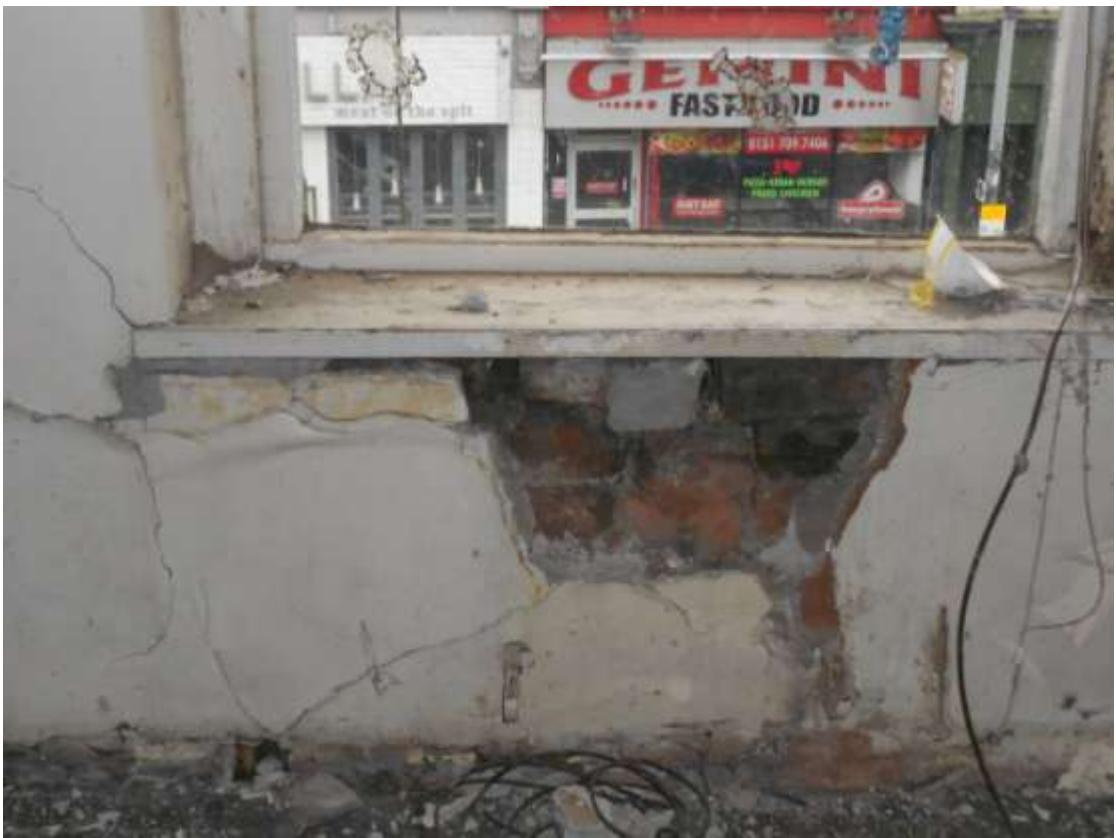
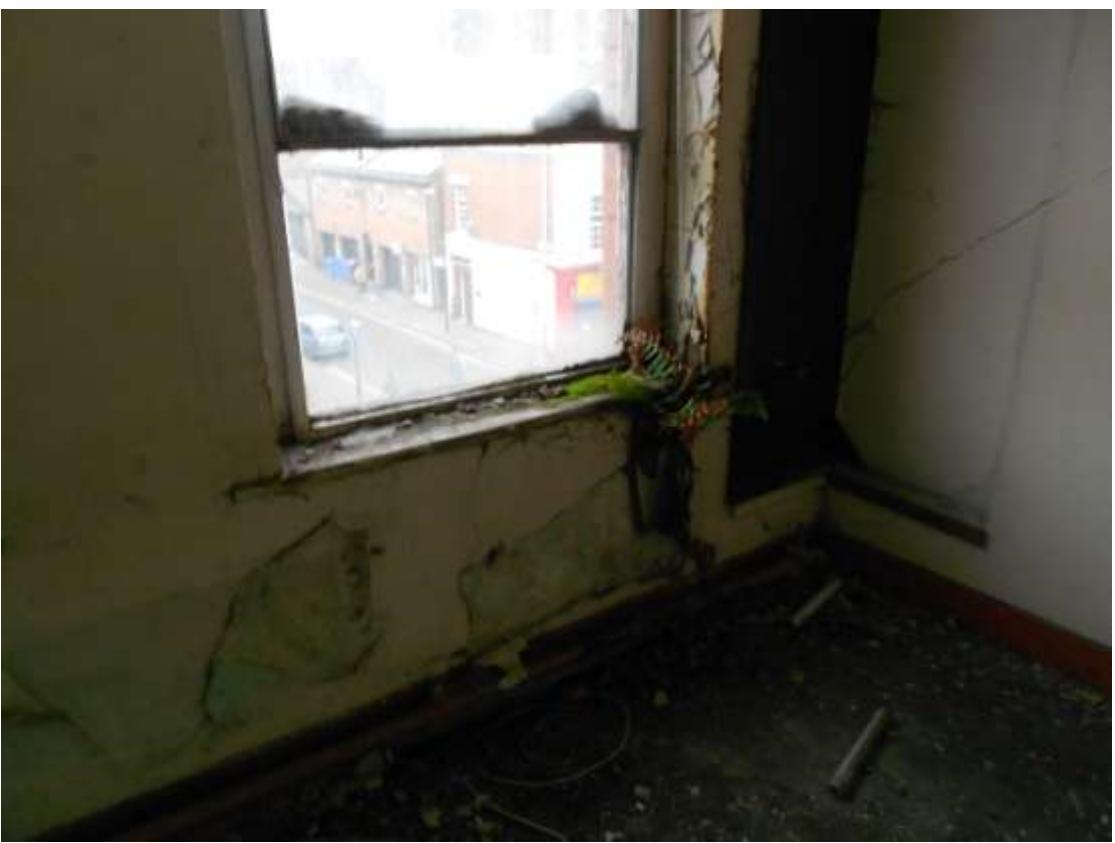
Image of 3rd Floor Window Cill Hardman Street Elevation

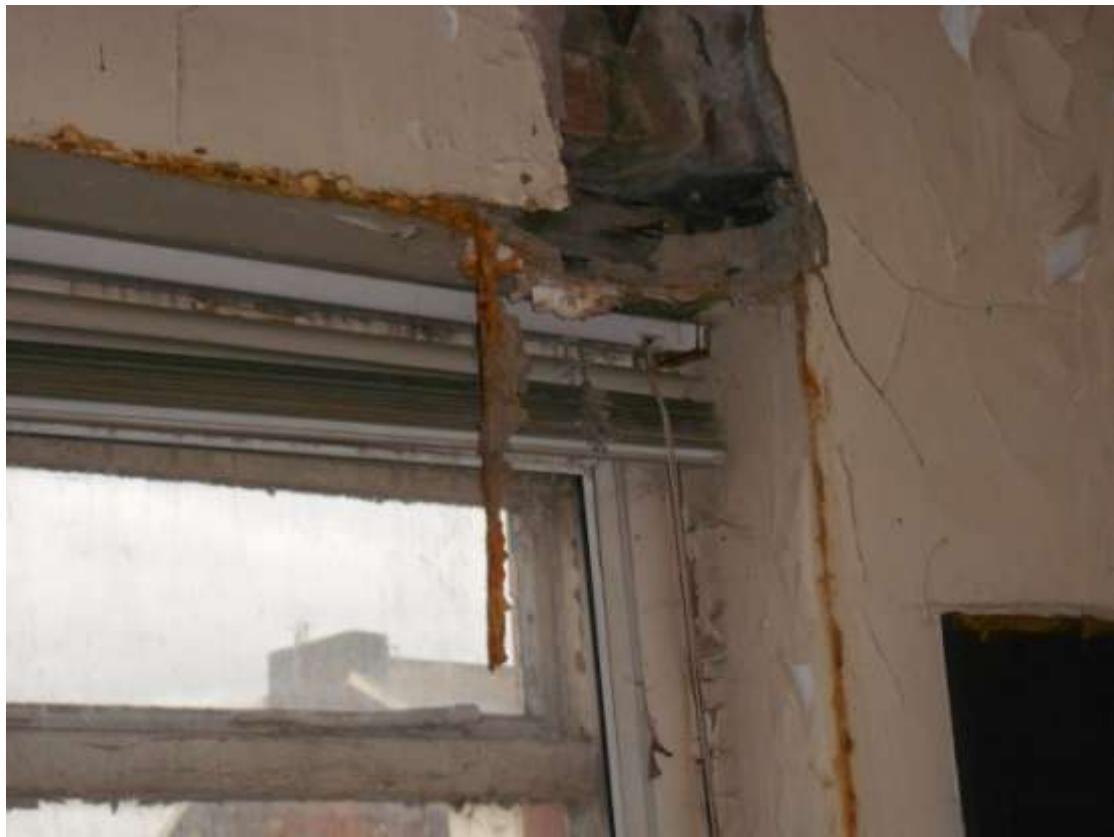
Image of window head structural problems

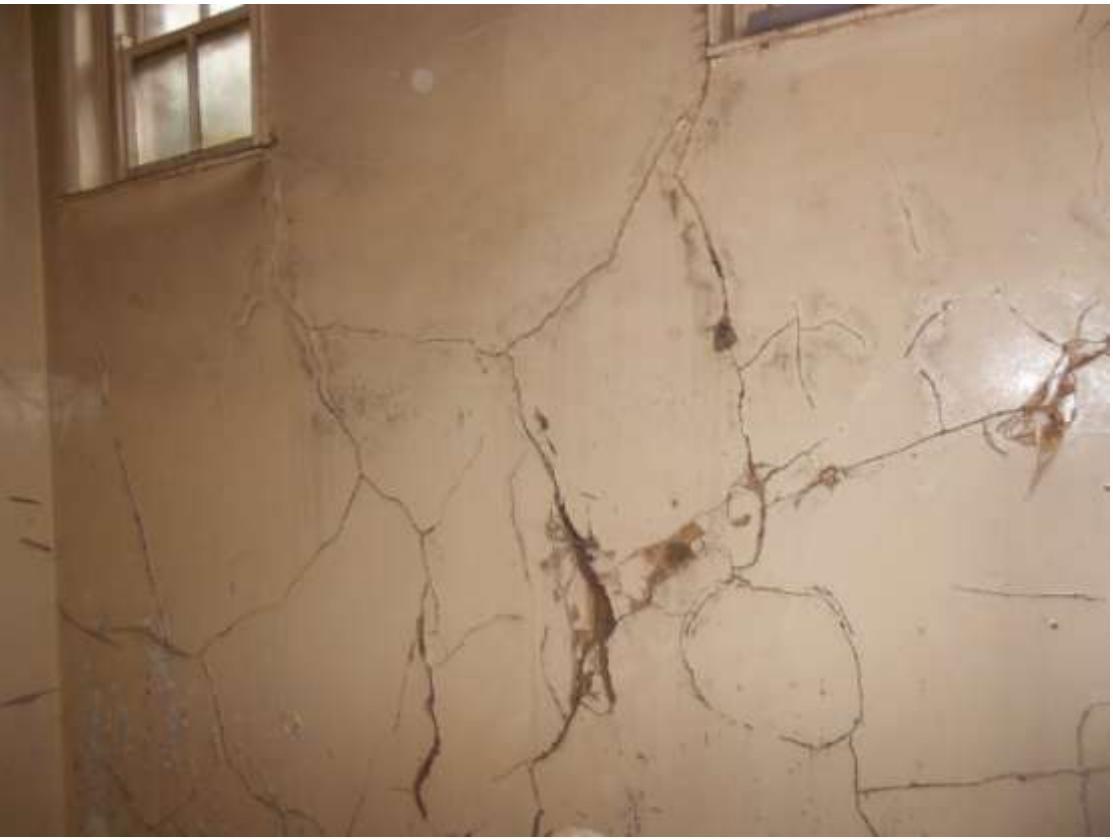
Image of Internal wall cracking

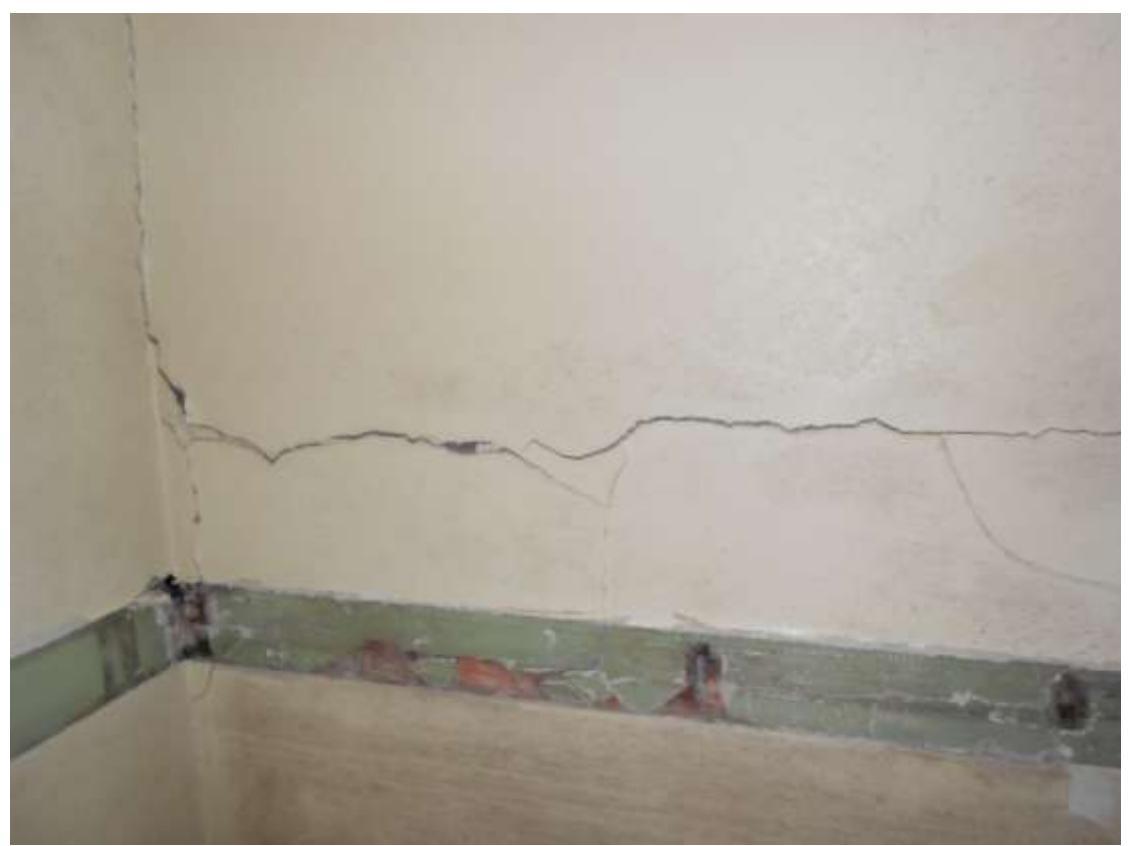
Image of structural cracking of internal loadbearing walls

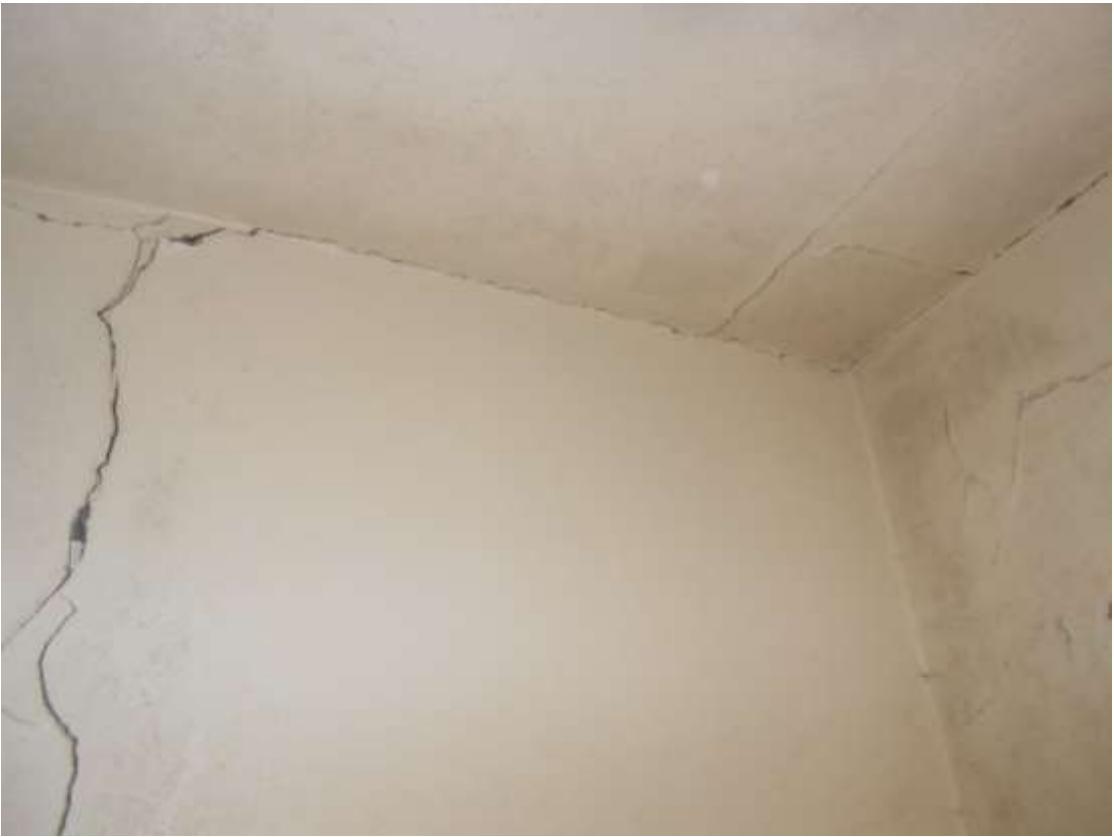
Image of structural cracking of loadbearing walls

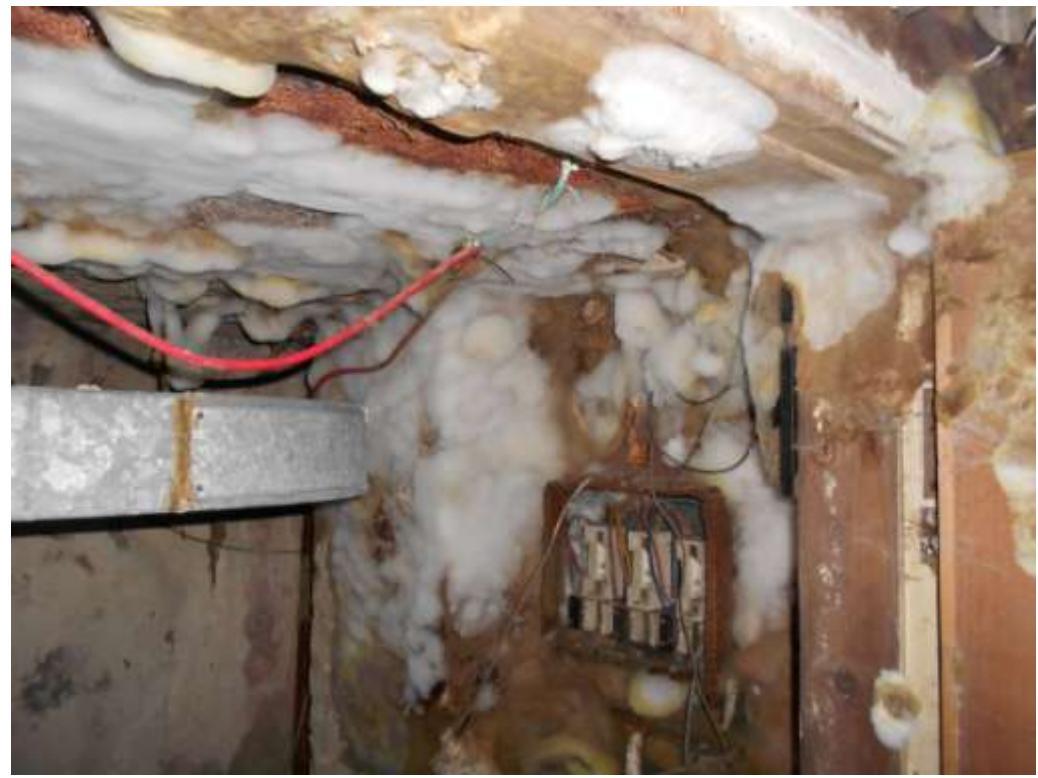
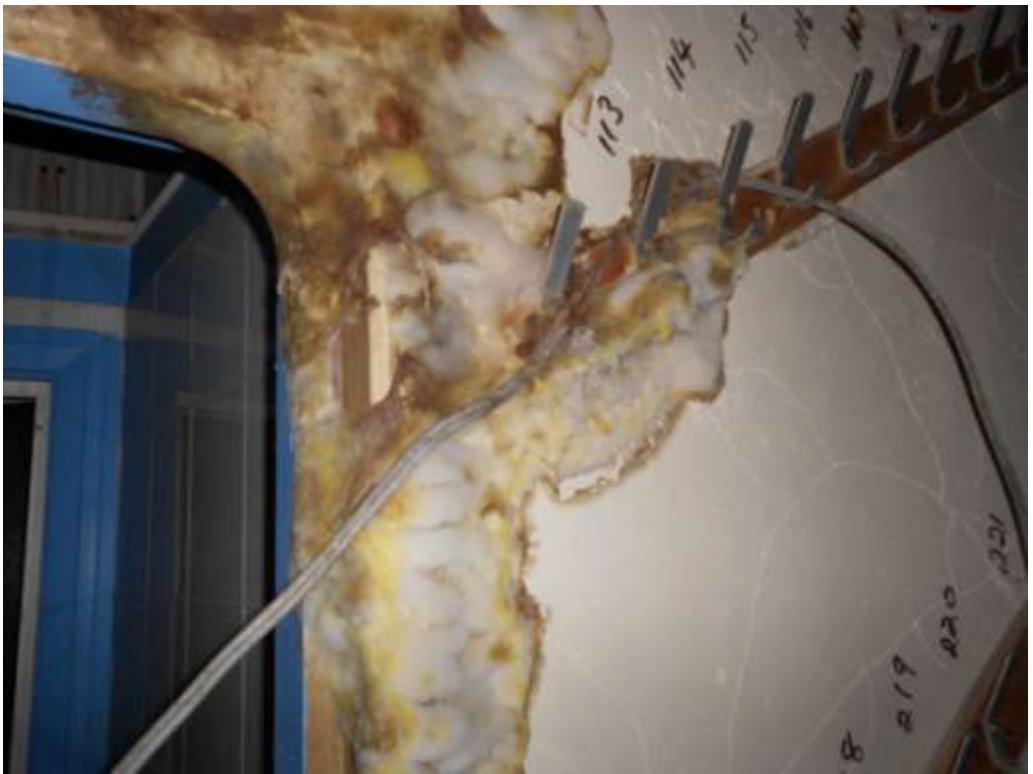
- 4.0.4 The basement area of the building has a serious damp problem and has some structural propping evident showing longstanding structural issues with the ground floor.

- 4.0.5 The ground floor construction is mainly suspended timber with a basement storey beneath. As the photographs indicate excessive damp issues with the basement and the ground floor structure is generally unsuitable for reuse.

Image of Basement Damp Issues

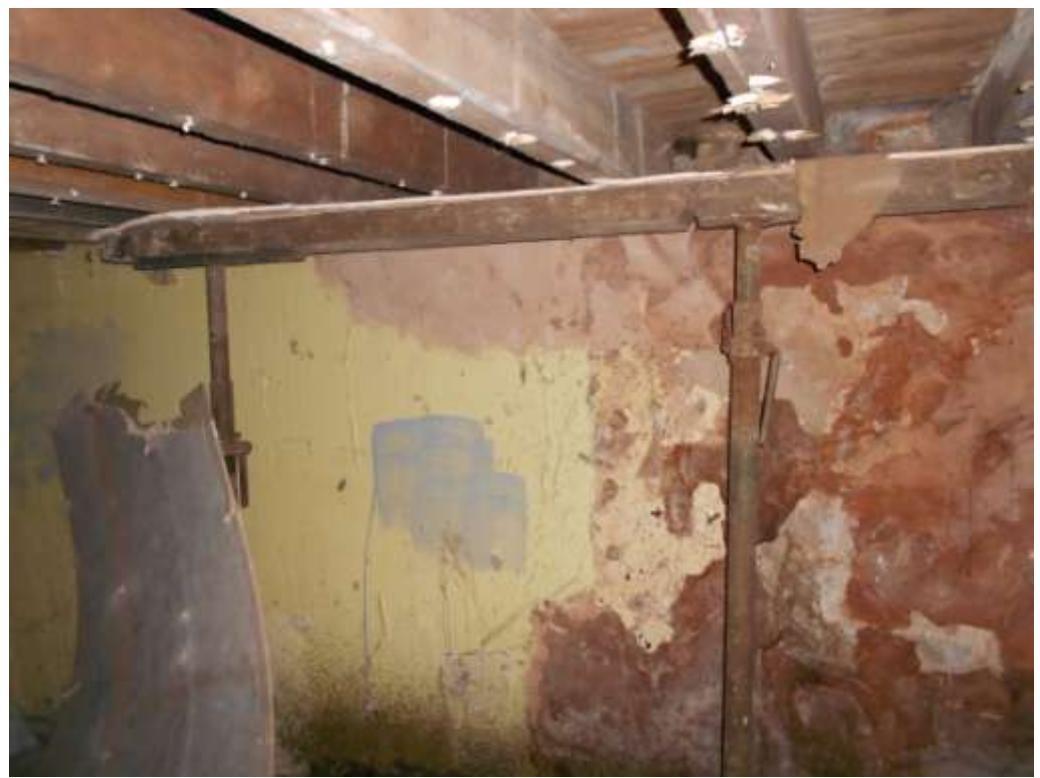
Image of Existing Propping

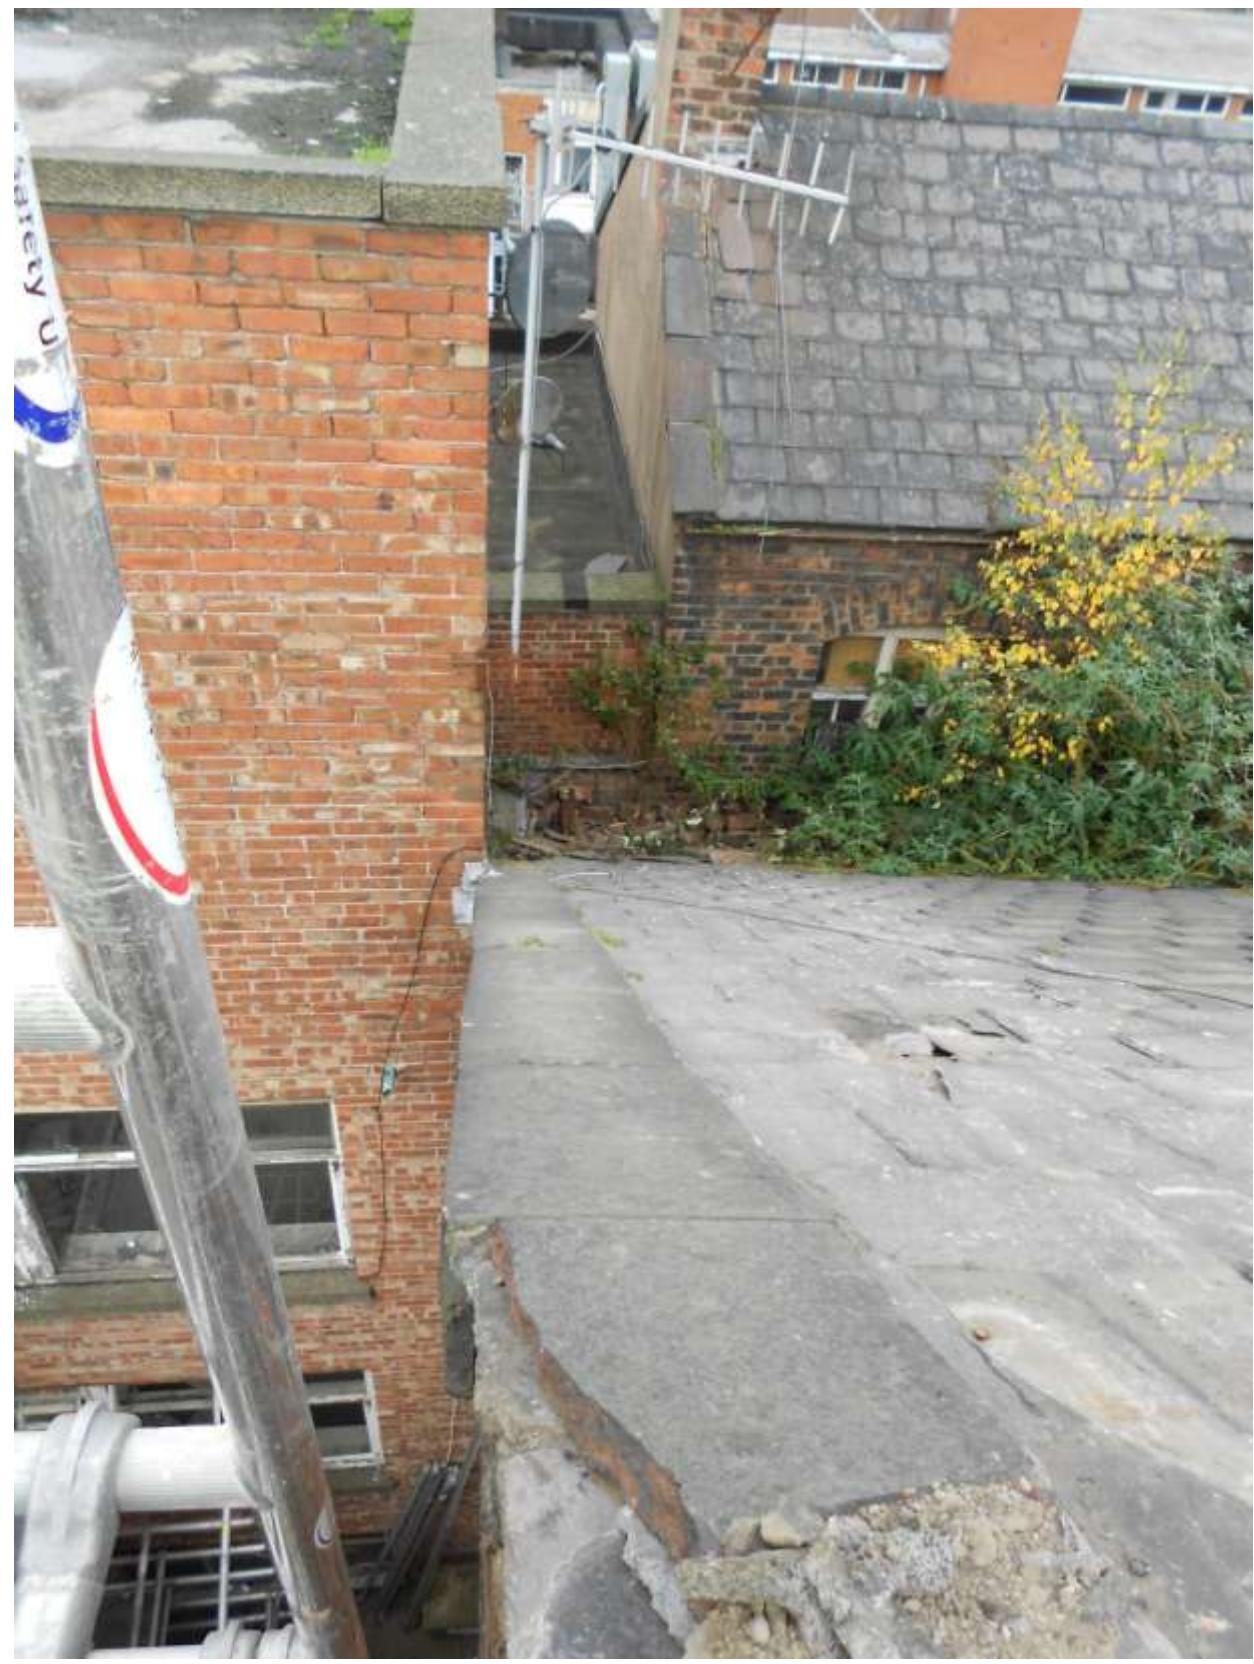
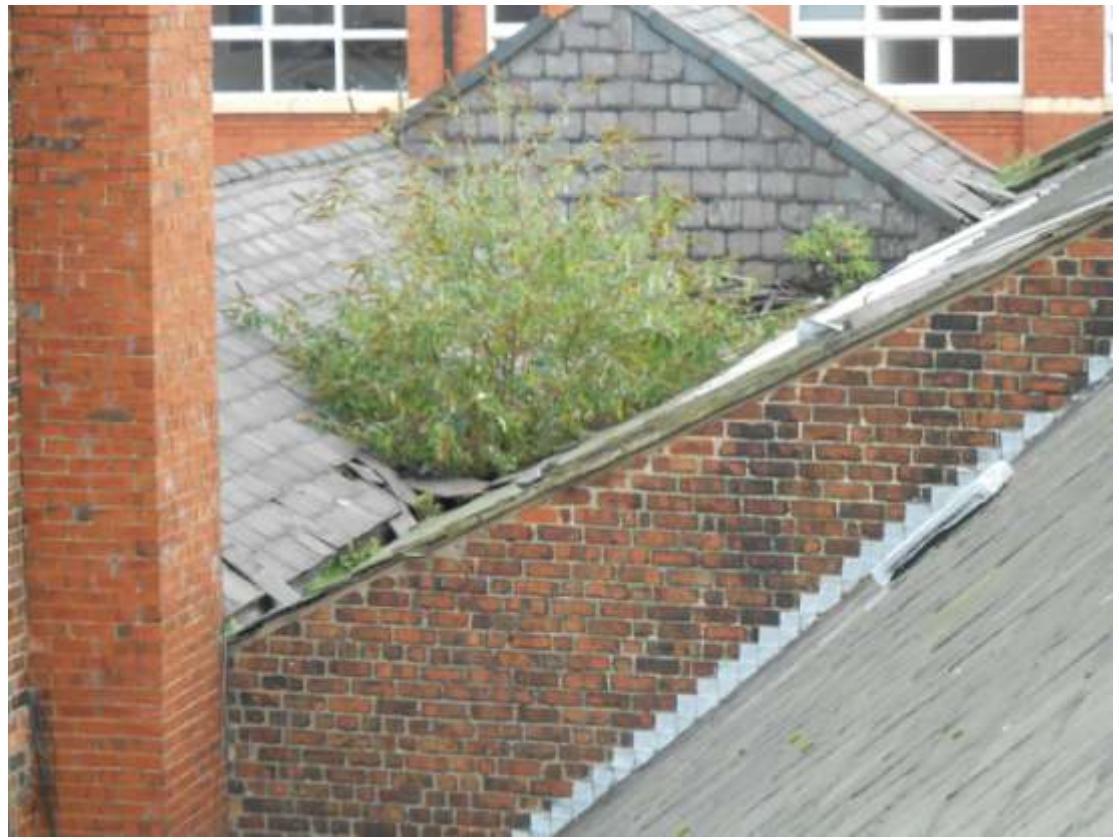
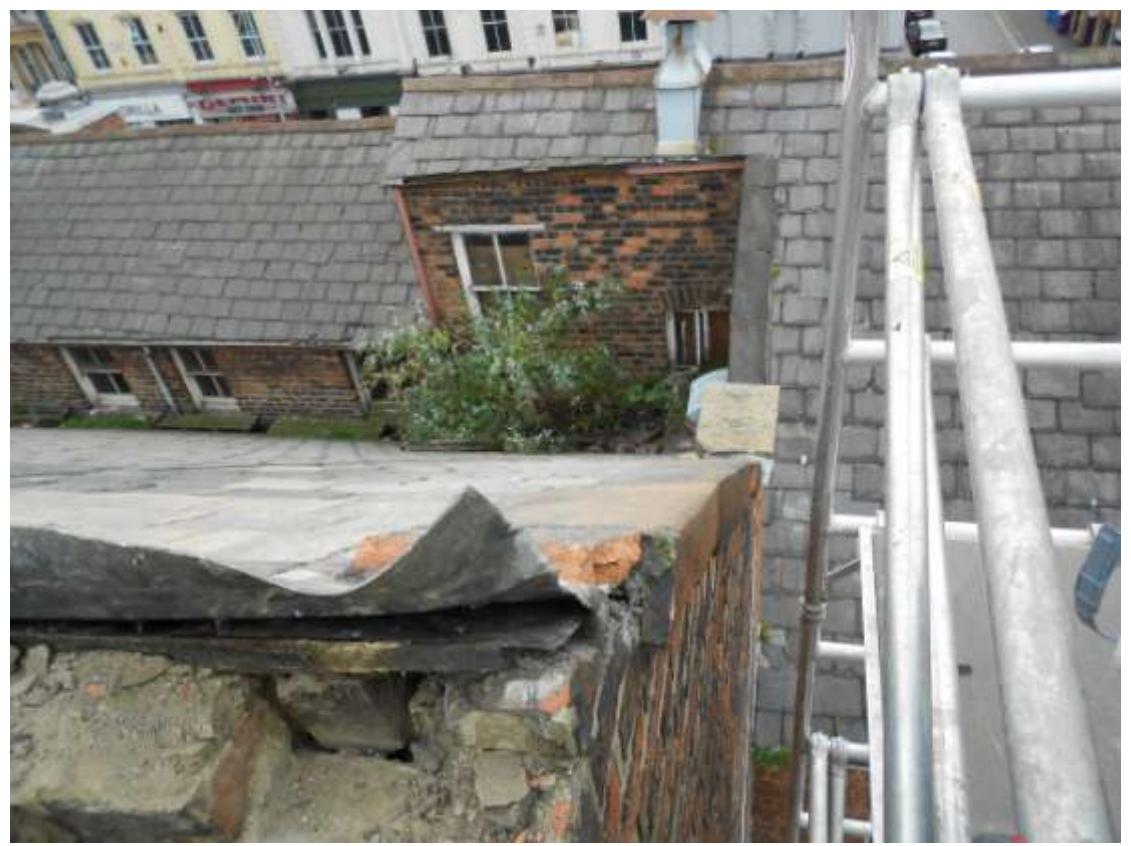
- 5.0.3 The roof coverings show signs of disrepair in a number of areas with missing roof slates, and significant vegetation growth coming from within the building which appears longstanding, with patch repairs being evident throughout.

- 5.0.4 The area of skylights within the roof are seriously damaged, which is not only dangerous, with the resulting ingress of water causing significant damage throughout the building for a number of years in addition to the number of missing and or damaged rainwater goods which have exacerbated the problems.

Image showing roof issues

Image showing existing roof issues
