Tobacco Warehouse

Proposed Residential Redevelopment

Bat Mitigation Strategy

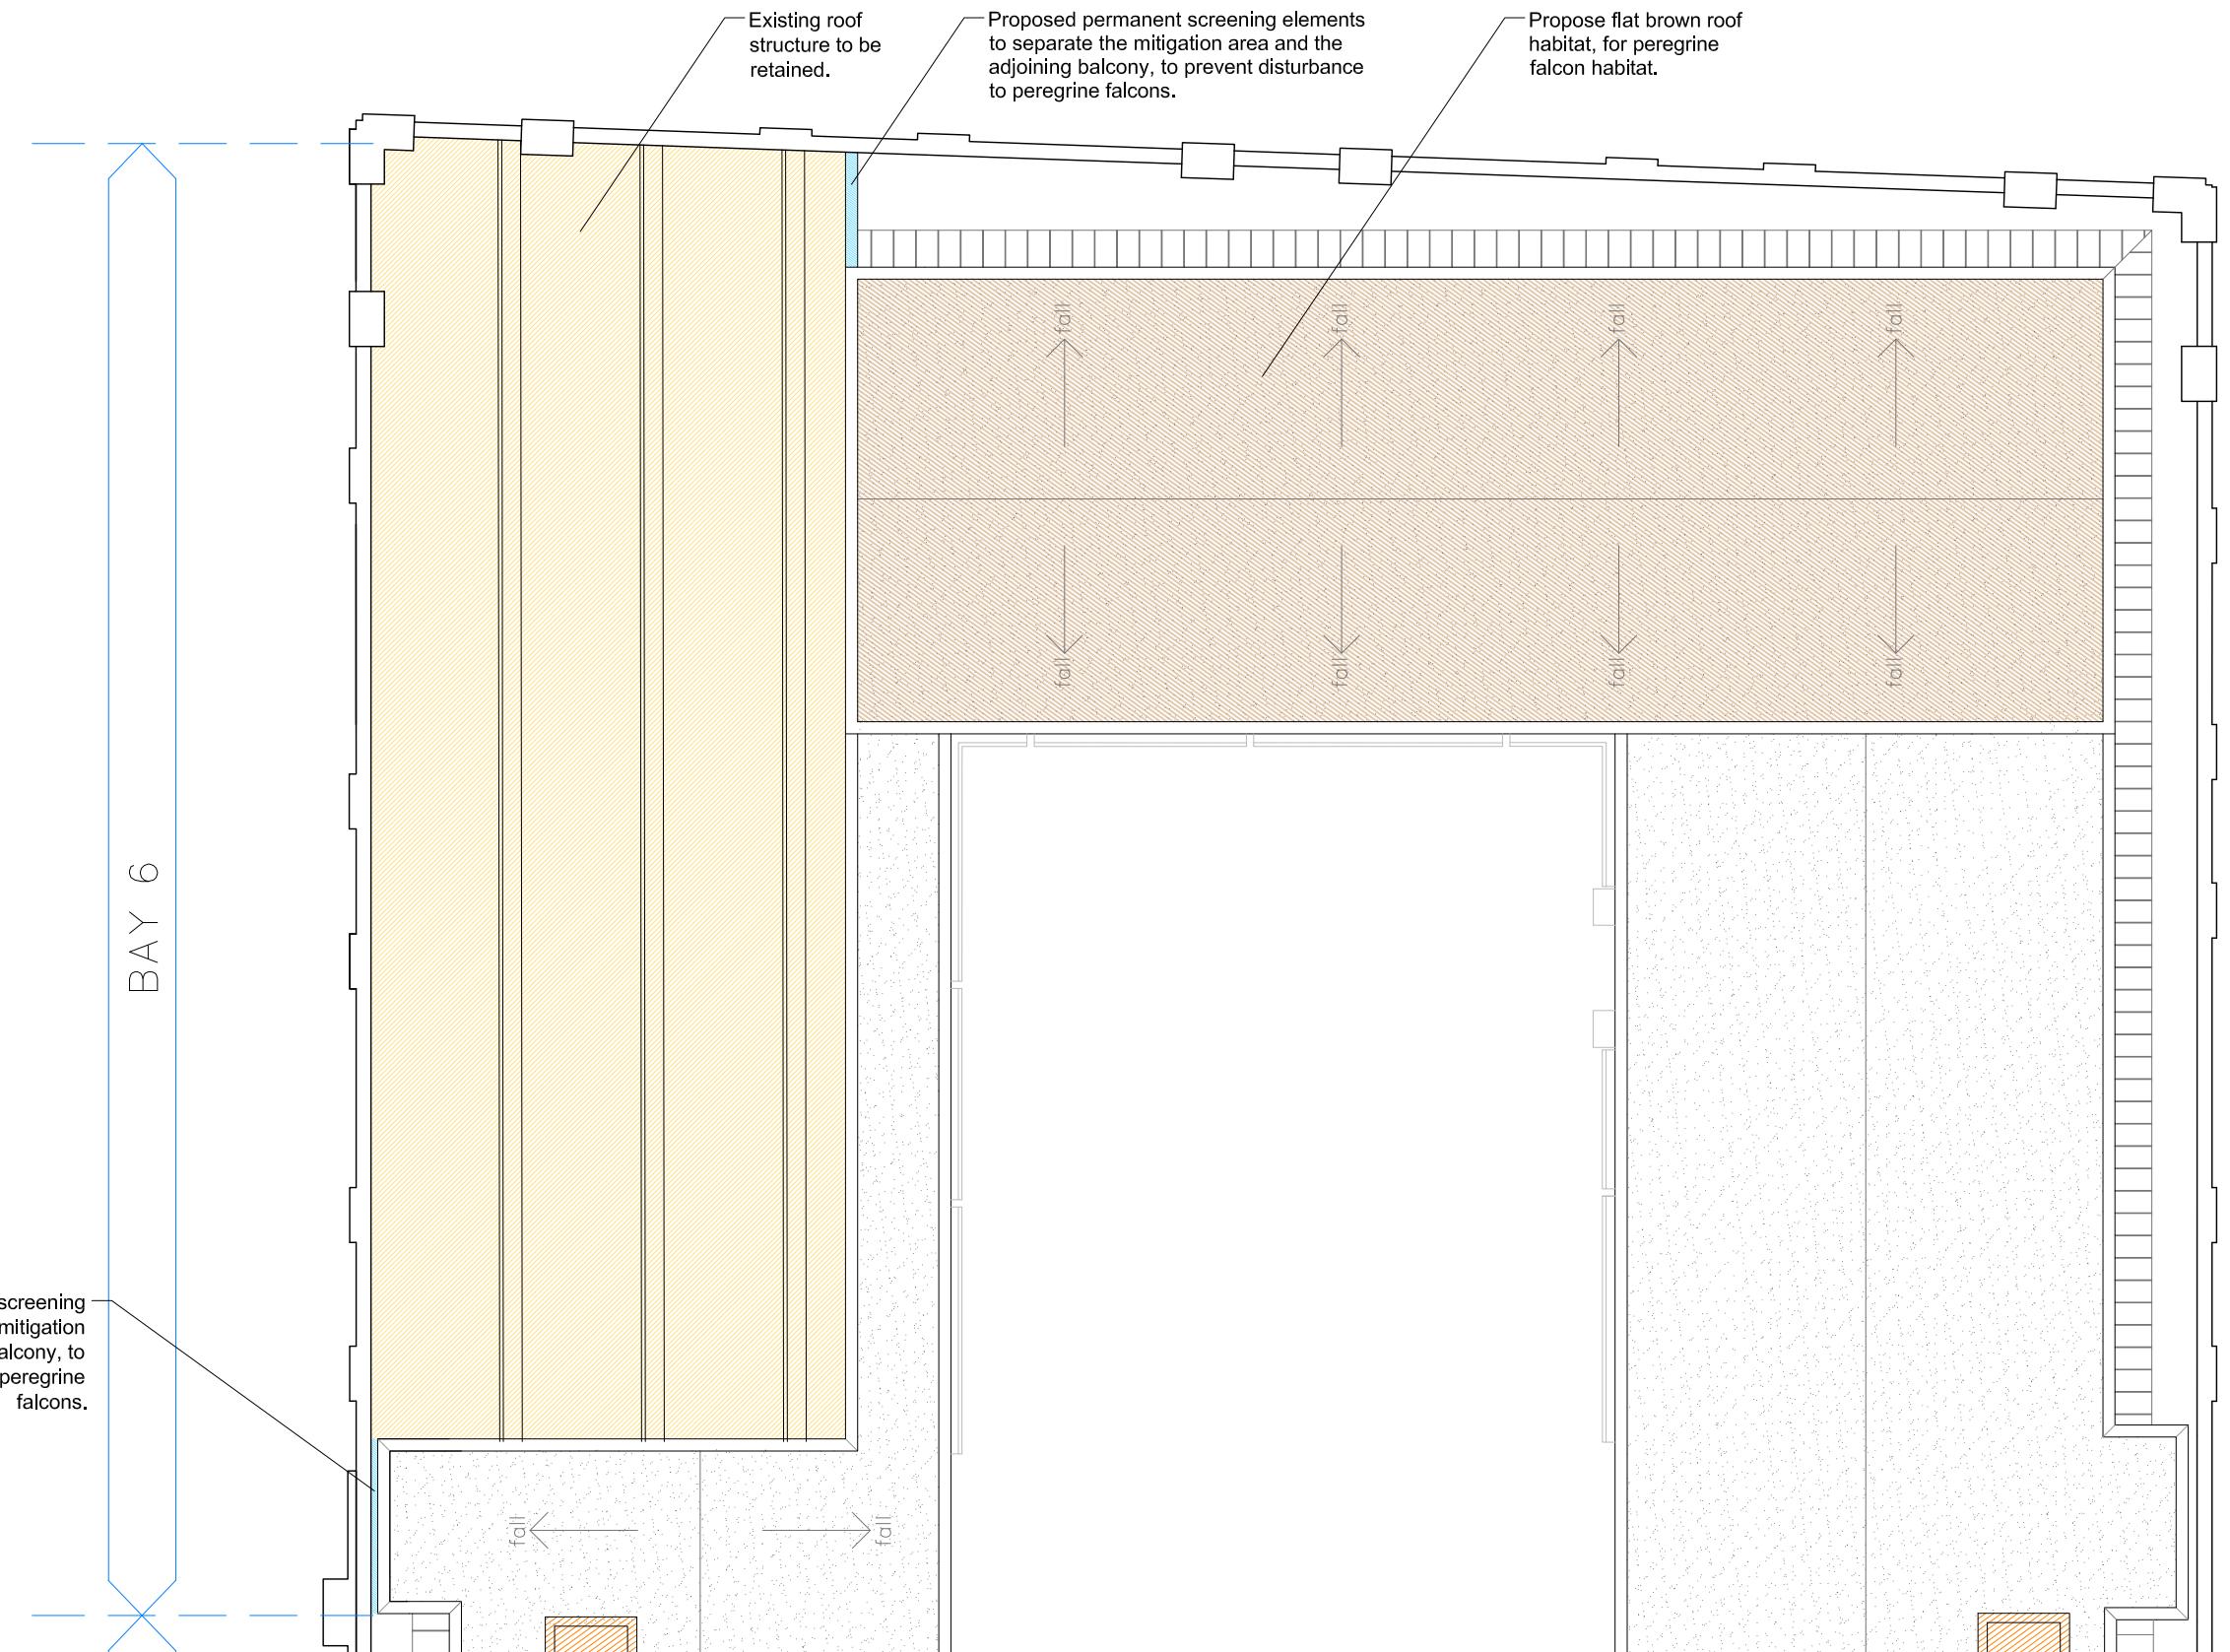
1
SK-100

Proposed Roof Plan - Existing Area of Roof to be retained for Peregrine falcon and Bat habitat
1:100

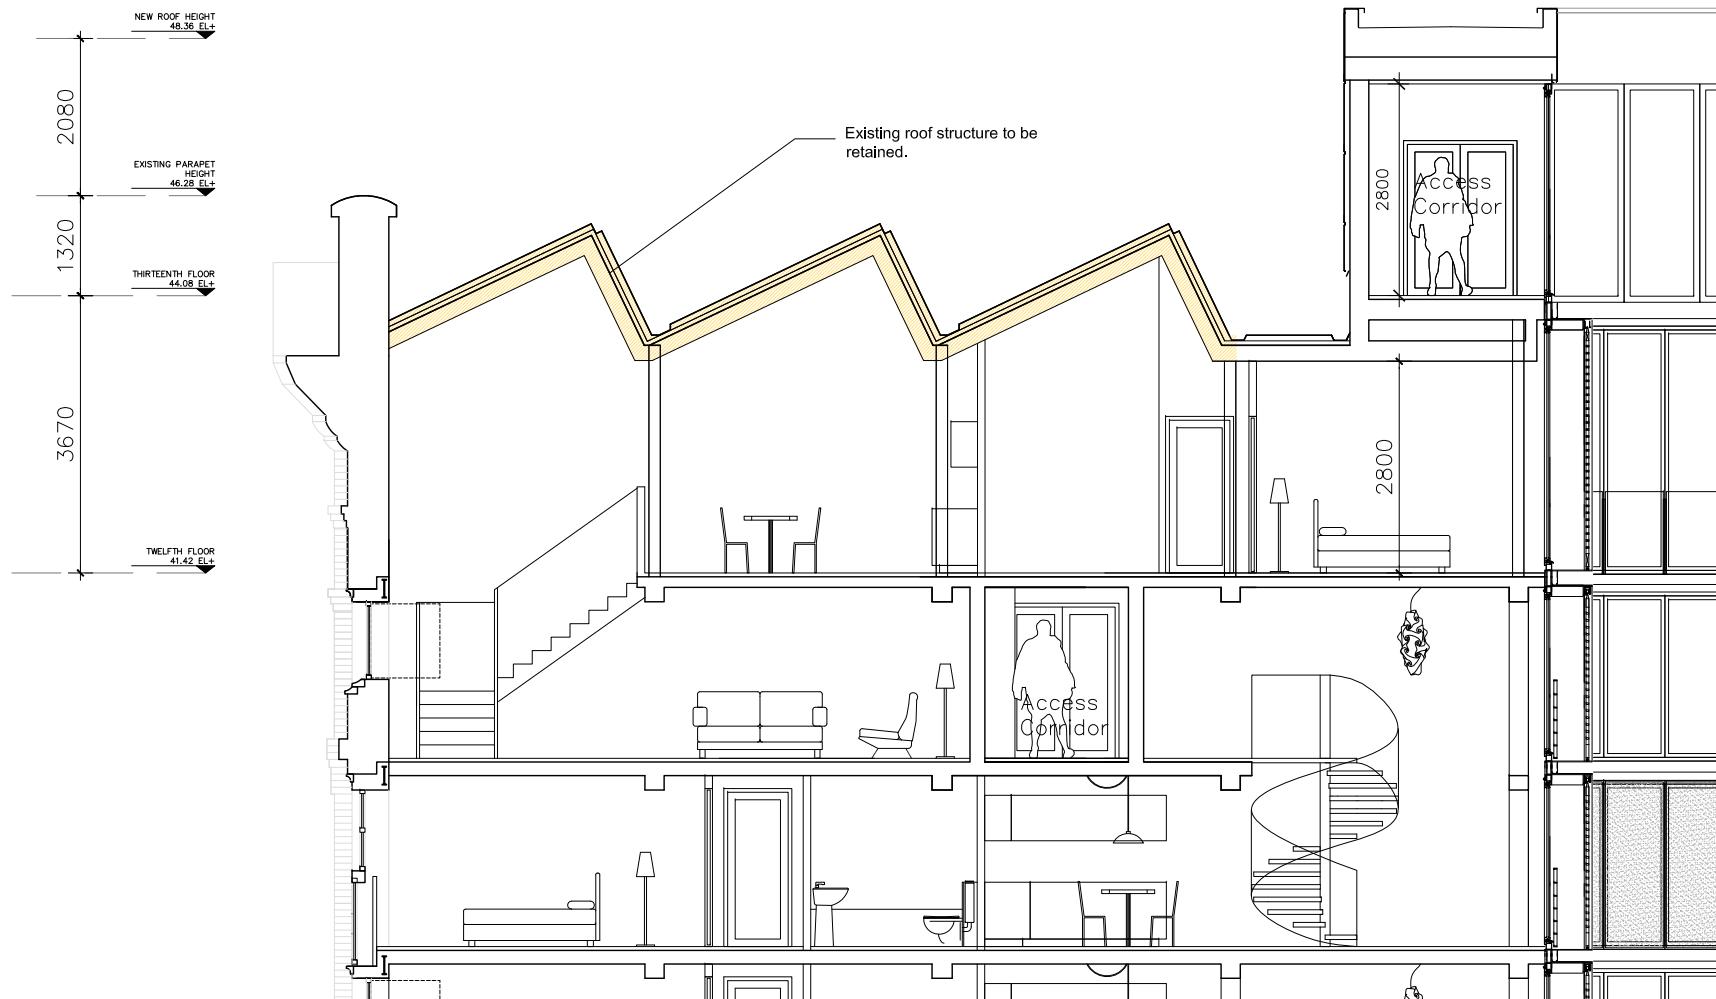
1
SK-200

Proposed Section - Existing Area of Roof to be retained for Peregrine falcon and Bat habitat
1:100

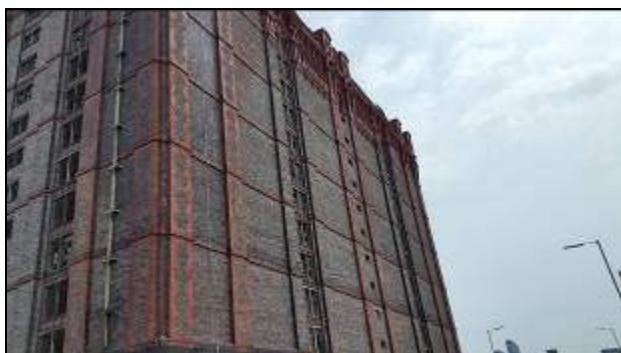
Photograph 1. Western aspect of building

The Warehouse is a brick building comprising 13 floors and a basement. Over 600 windows are present on the northern and southern aspects containing many smashed or partially smashed glass panes. The building is adjoined to the South Warehouse by three bridge walkways (Photographs 1-4).

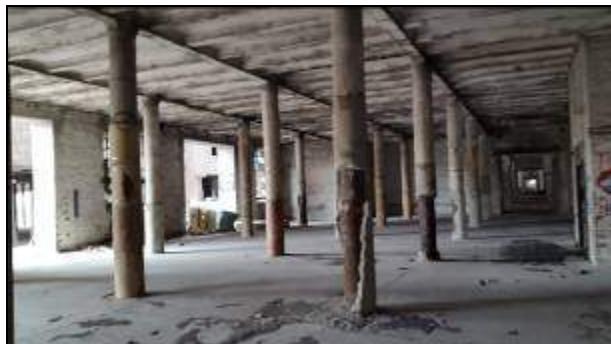
Photograph 5. Ground floor

The ground floor comprises mainly open plan loading bays with a grid arrangement of vertical supporting pillars (Photograph 5) and several brick dividing walls with open doors. Internal brick walls along the eastern end of the building suggest that internal offices may have once existed. The ground and ceilings comprise hard standing concrete and several man-made holes were recorded between floors (Photograph 6).

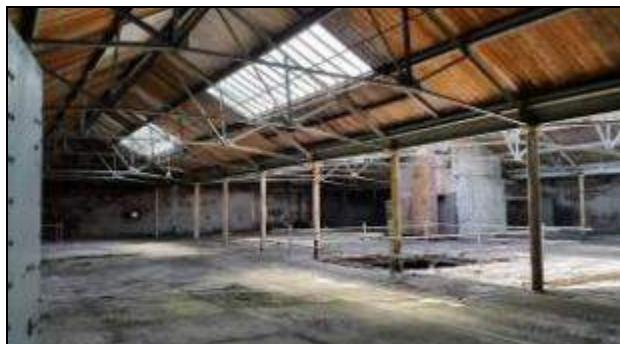
Photograph 7. Hip style roof section

The roof consists of two series of hip style roofs (Photograph 7) running north-south and two series of open gabled roof structures running west-east (Photograph 8). The two aspects of the hip roofs have tiled surfaces underlain by wooden planks and intermittent skylights. Wooden turret boxes are present along the ridges of the hip roofs. The northern aspects of the open gabled roofs consist of intact, partially intact and broken window panes whereas the southern aspects have a tiled surface underlain by wooden planks. The roof can be accessed via three brick stairwells by climbing a vertical ladder (Photograph 10).

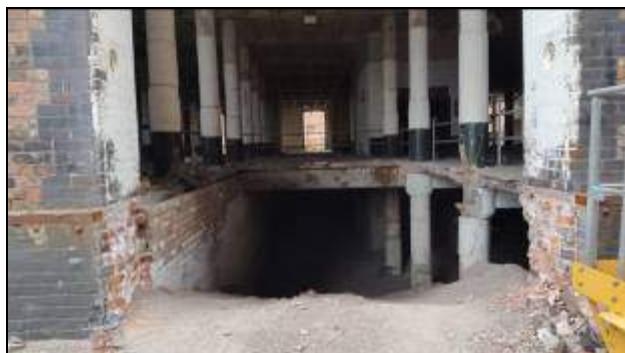
Photograph 11. Entrance to basement

The basement consists mainly of open plan spaces divided by bricked walls with open doors (Photograph 11). Multiple alcoves are present along the northern aspect of the basement considered to have formally functioned as loading bays although these are now filled in (Photograph 12).

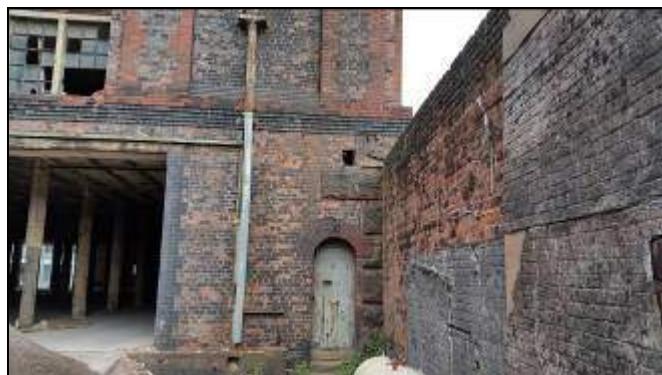
In general the brickwork was considered to be in fair condition. Holes in the brick walls exist where bricks have been removed or fallen out and where mortar has fallen away, especially around pipes and other features such as where gullies appear to have been / are attached (Photographs 13 and 14). These holes potentially provide access to crawl and roost spaces within the wall cavities.

Photograph 13. Hole in brickwork where bricks have been removed.

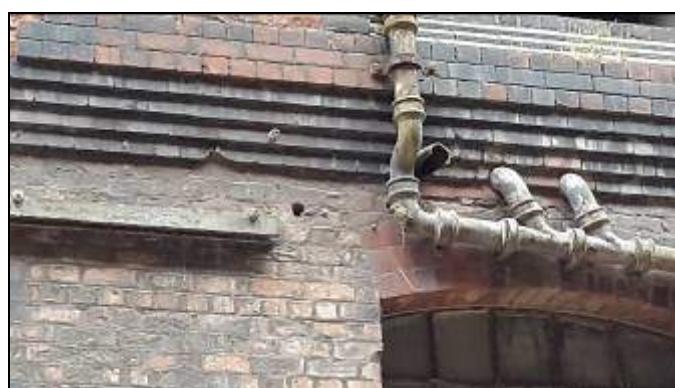
Photograph 14. Hole in brickwork where utility cable / pipe once entered wall cavity.

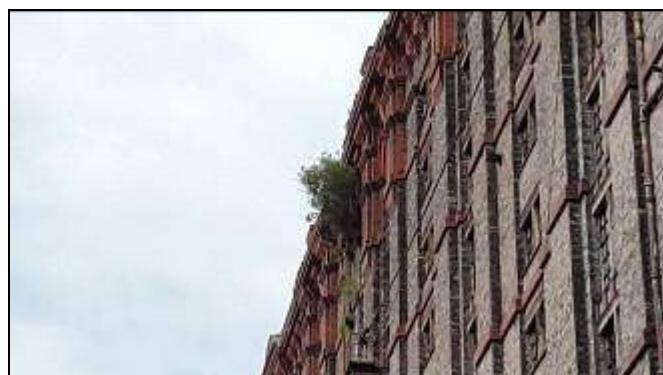
Butterfly bush *Buddleja davidii* shrubs have also rooted and grown out from ledges including the window sills towards the top of the building (9th floor upwards) and are considered likely to have pulled apart adjacent bricks and caused mortar to have disintegrated (Photograph 15).

Photograph 15. Butterfly bush rooted in ledge on southern aspect of building.

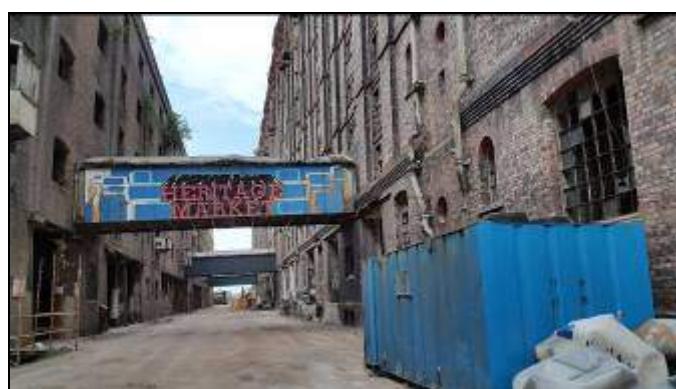
Photograph 16. Overpass between South Warehouse and the building.

A doorway, presumably providing former access to internal office spaces, is present at the southeast corner of the building. Gaps around the doorway are smoother and devoid of cobwebs and, therefore, are potential entry points used by bats into the building. Lifted lead flashing was also recorded where the pedestrian overpasses from South Warehouse attach to the building (Photograph 16). Many of the window frames were damaged, in-filled or missing. Gaps exist around these frames and around areas of infilling work. Many of the decorative tiles around the edge of the building were either missing or lifted. Mortar in these areas may have also disintegrated; however, due to the height of these features this could not be confirmed.

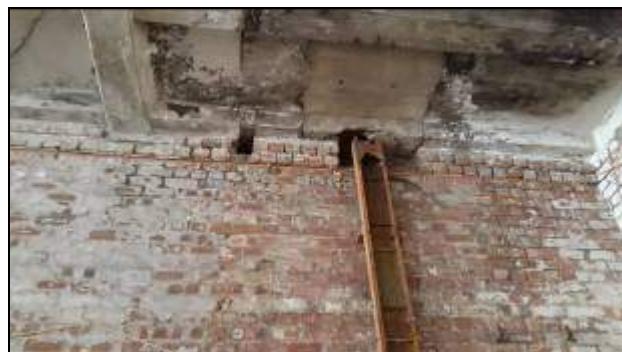
During the internal inspection, it was noted that all floors could potentially be accessed by bats via smashed / missing window panes. The ground floor could also be accessed via the permanently open loading bays and the basement via the permanently open access slope. Multiple crevices and holes were recorded along the internal brick walls especially on the ground and 13th floors providing potential access to crawl and roost spaces within wall cavities (Photographs 17 and 18).

Photograph 17. Hole in brick wall on ground floor

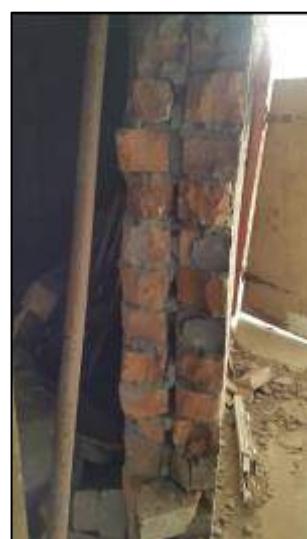
Photograph 18. Exposed wall cavity in brick wall on ground floor

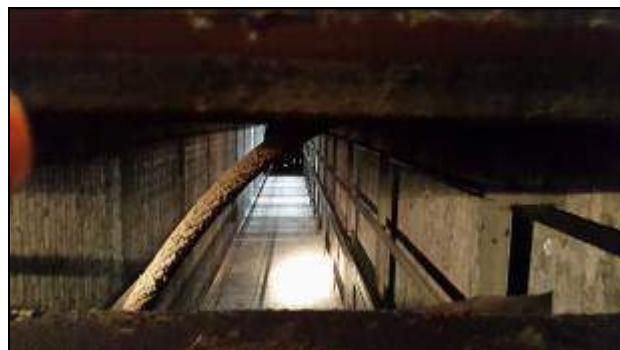
Photograph 19. Lift shaft

Bats could also potentially access the lift shafts because the lift doors were fixed open (Photograph 19) allowing bats to fly down / up to areas of missing / damaged brickwork.

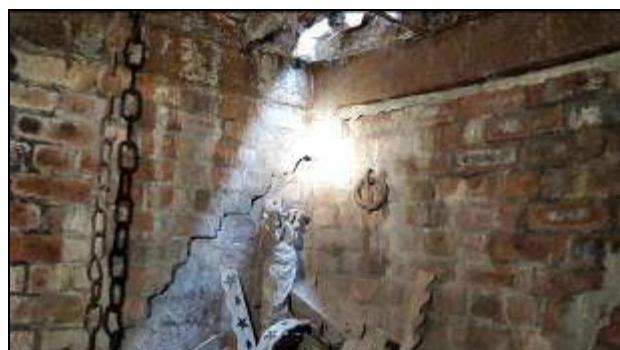
Within the basement, multiple cracks were recorded within the brick walls around the alcoves and in many cases lacking cobwebs across the gaps (Photograph 20). Two areas of crushed brick / debris were recorded, one on the fourth floor and the second on the ceiling of the basement (Photographs 21 and 22). These two areas may provide bats with access to crawl and cavity spaces suitable for a range of roosting needs.

Photograph 20. Crack along brick wall within alcove in basement

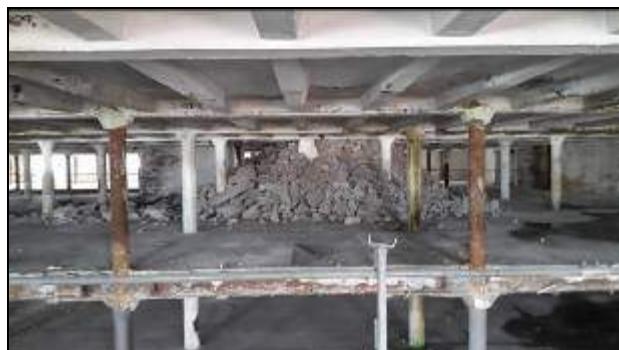
Photograph 21. Pile of bricks / debris on fourth floor

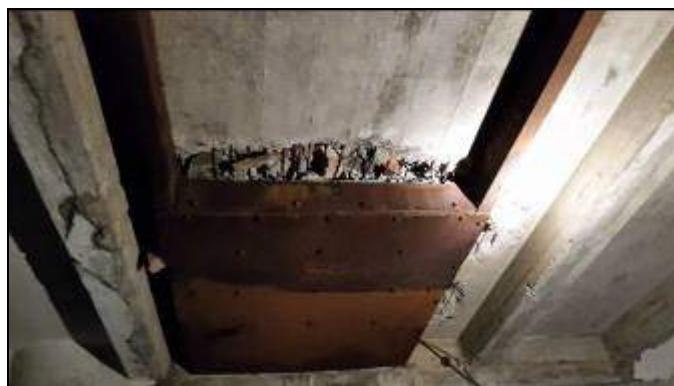
Photograph 22. Bricks / debris used to repair / fill hole in ceiling of basement.

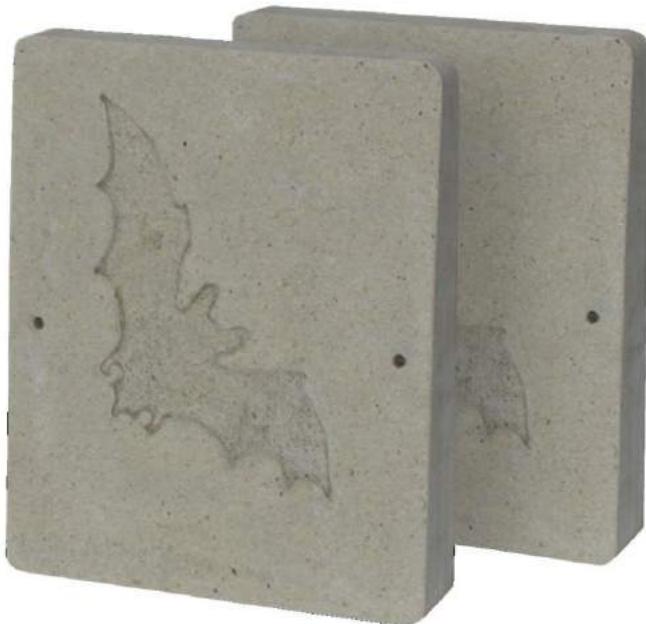
2FE Schwegler Wall-Mounted Bat Shelter

The Schwegler Wall-Mounted Bat Shelter 2FE has two applications: it can either be fixed to outside walls to provide a summer hideaway for bats, or it can be installed inside buildings to provide winter hibernation quarters. For winter use, damp cellars, bunkers, bridges or caves protected from ice and frost are examples of ideal locations. During the summer months the common pipistrelle, whiskered bat and barbastelle are among the species which will roost in the Schwegler 2FE as a daytime hideaway. Daubenton's bat, Natterer's bat and the common long-eared bat will also use it, often sleeping huddled together in small groups. A partition inside the Schwegler 2FE also suits the habits of the greater mouse-eared bat. In the winter, all species that hibernate in caves will use the 2FE. The interior has shaped cavities in various sizes where the animals can roost giving optimum body contact, and offering a home to a very wide range of species. The outside surface has an attractive logo in the shape of a bat, making it easy for the amateur to recognise that this is a bat home. Each purchase includes two 2FE bat shelters.

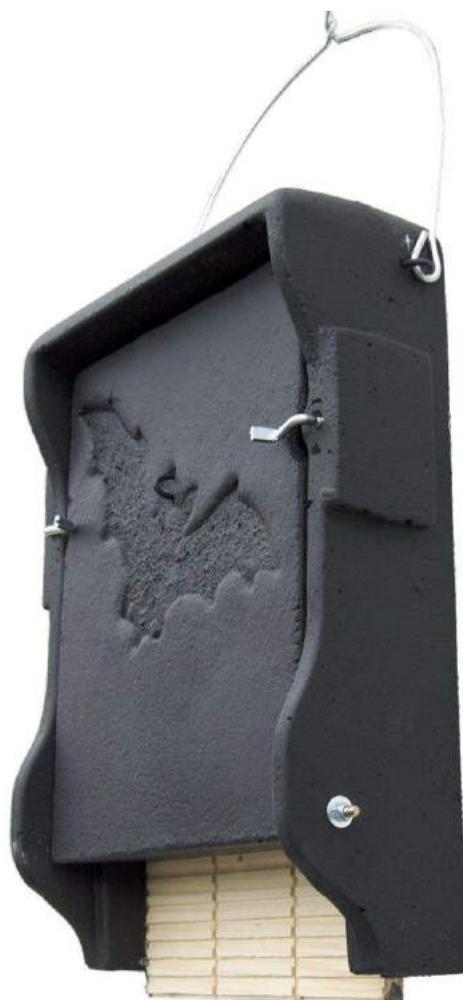
1FF Schwegler Bat Box With Built-in Wooden Rear Panel

The Schwegler 1FF bat box is spacious enough for bats to use as a summer roost or nursery site and is open at the bottom, allowing droppings to fall out so it does not need cleaning. The 1FF is, therefore, especially suitable for hanging in inaccessible places such as high in trees, or on steep slopes and house walls. The 1FF is manufactured from long-lasting Woodcrete, which is a blend of wood, concrete and clay which will not rot, leak, crack or warp, and will last for at least 20 - 25 years, making it suitable for long-term mitigation projects. Woodcrete is breathable and maintains a stable temperature inside the box and the 1FF is painted black to absorb warmth. It also provides a good rough surface for bats to cling on to and climb. To compensate for fluctuations in temperature in spring and autumn, the 1FF is provided with a roughened rear panel made of hard-wearing wood. Depending on their individual temperature requirements, the bats can choose between the cooler Woodcrete surface or the warmer wooden panel.

Height 43cm x width 27cm x depth 14cm. Entrance hole 12cm x 24cm. Weight 9.5kg. Aluminium nail and hanger included.

The 1FF is manufactured from long-lasting Woodcrete, which is a blend of wood, concrete and clay which will not rot, leak, crack or warp, and will last for at least 20 - 25 years. Boxes will be installed on the **ground floor level**. Roughened rear panel made of hard-wearing wood. Bats can choose between the cooler wood-concrete or the warmer wood. Front can be swung open for inspection purposes.
