## Phase 1 GeoEnvironmental Assessment

Hardman House

Liverpool

**Report No. A1530/16**

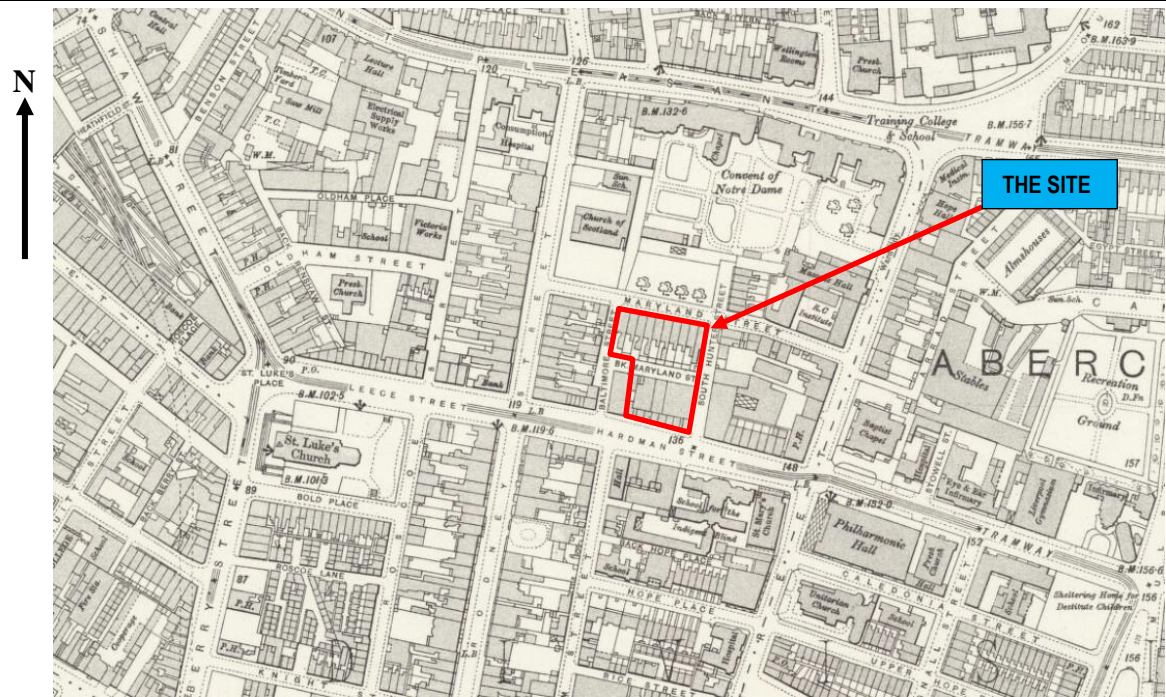
Figure 2: OS Map Extract 1908

1908, 1910, 1927, 1928	<p>Entire site is covered in two blocks of buildings in a similar layout to today.</p> <p>Church marked on site 1927.</p>	<p>Warehouses ~300m SW of the site.</p> <p>Tunnel 250m SE of the site, oriented NE-SW.</p> <p>Tunnel 250m SW of the site oriented N-S.</p> <p>Stables ~130m E of the site.</p>
1954, 1954-1957, 1955, 1956-1958, 1959-1968, 1969, 1973-1982, 1983-1987, 1983-1991	<p>1 large building on site along Hardman Street labelled Atlantic House.</p>	<p>Large garage 25m E of the site.</p> <p>Warehouse ~100m SE of the site.</p> <p>Hospital ~160m NE of the site.</p> <p>Laboratories ~210m NE of the site.</p> <p>4 garages ~110m NW of the site.</p> <p>Foundry ~160m NW of the site.</p>

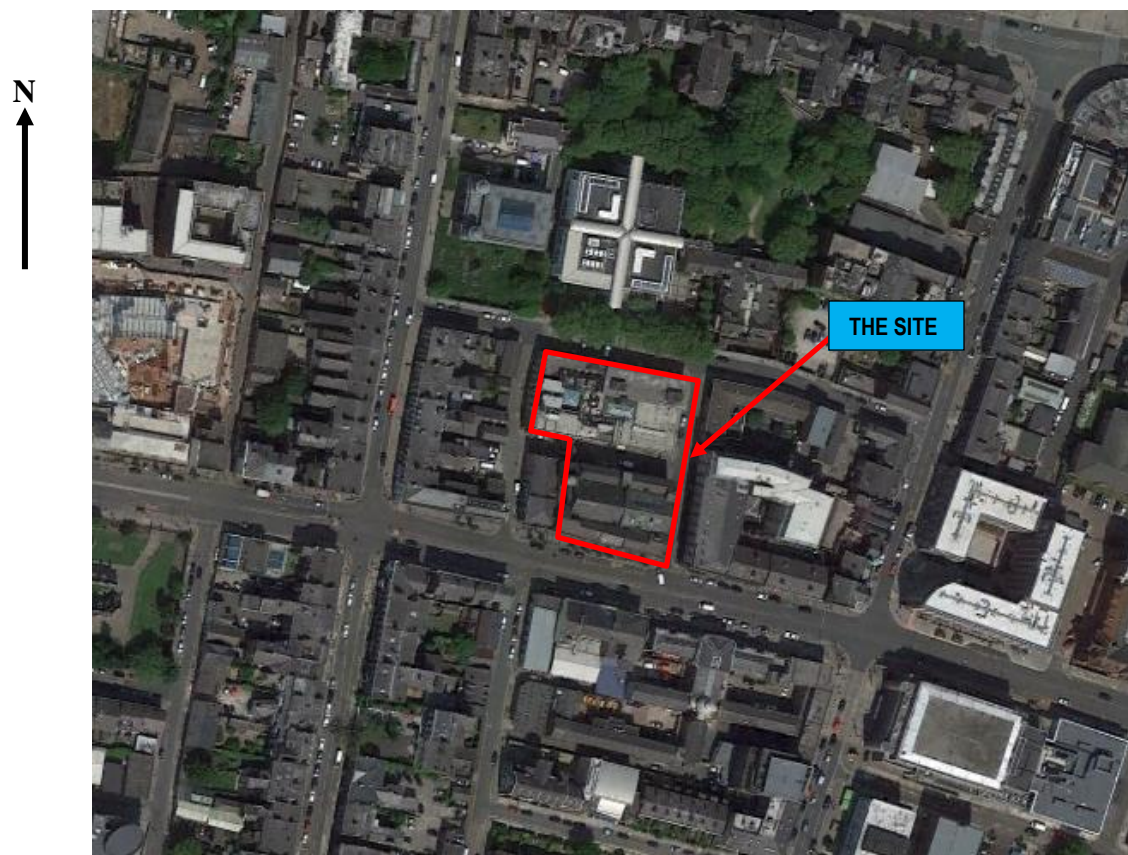
Figure 3: Google Earth Extract 2016

- 2.1 The site is currently fully occupied by two large blocks of terraced buildings separated by Back Maryland Street through the centre of the site.
