Bramley-Moore Dock, Regent Road, Liverpool

Building Survey and Evaluation Report

September 2020

Client: Laing O'Rourke

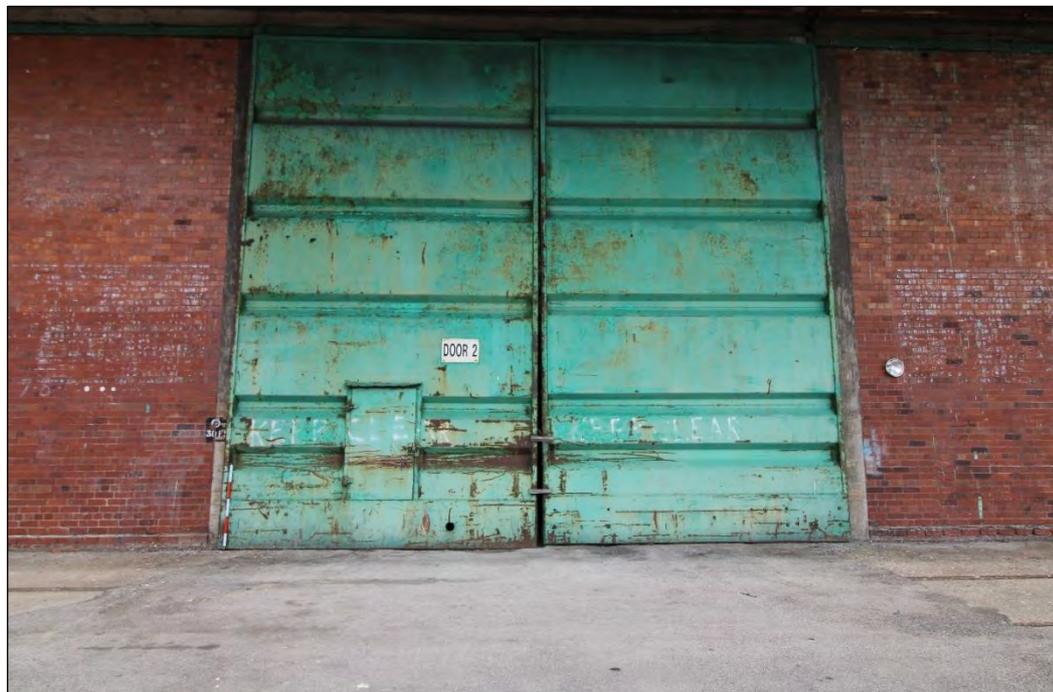
Plate 2: Sliding steel doors, with pedestrian hatch in the left door. 1m scale

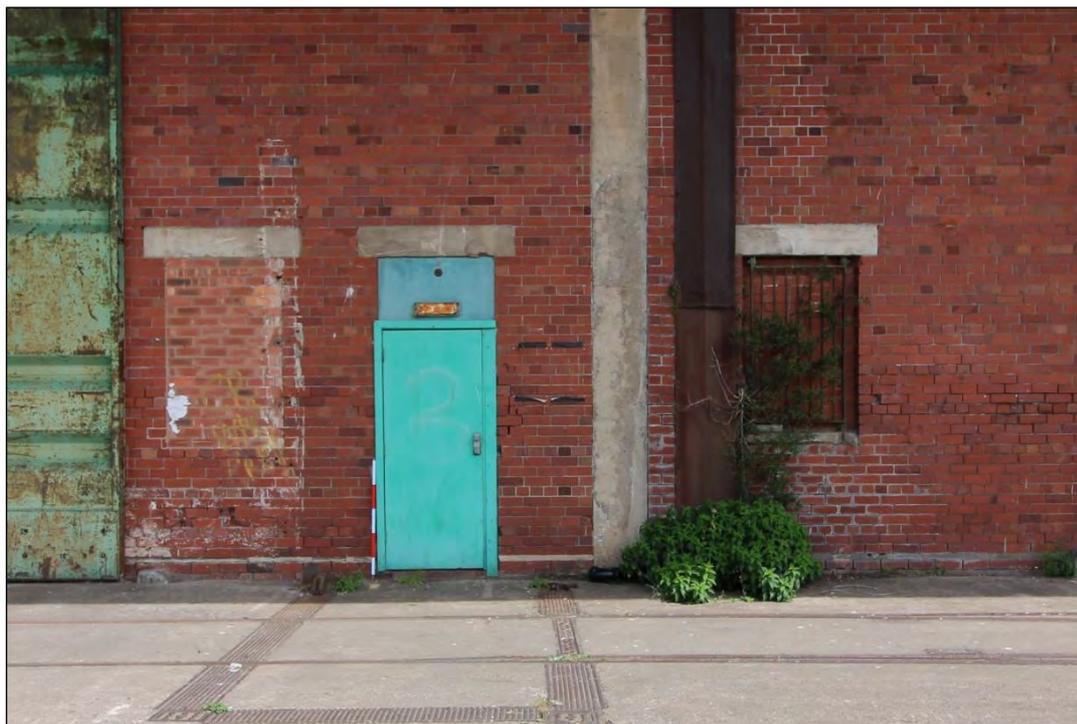
Plate 4: Pedestrian doorway in bay 18, flanked by two blocked windows, with 1m scale

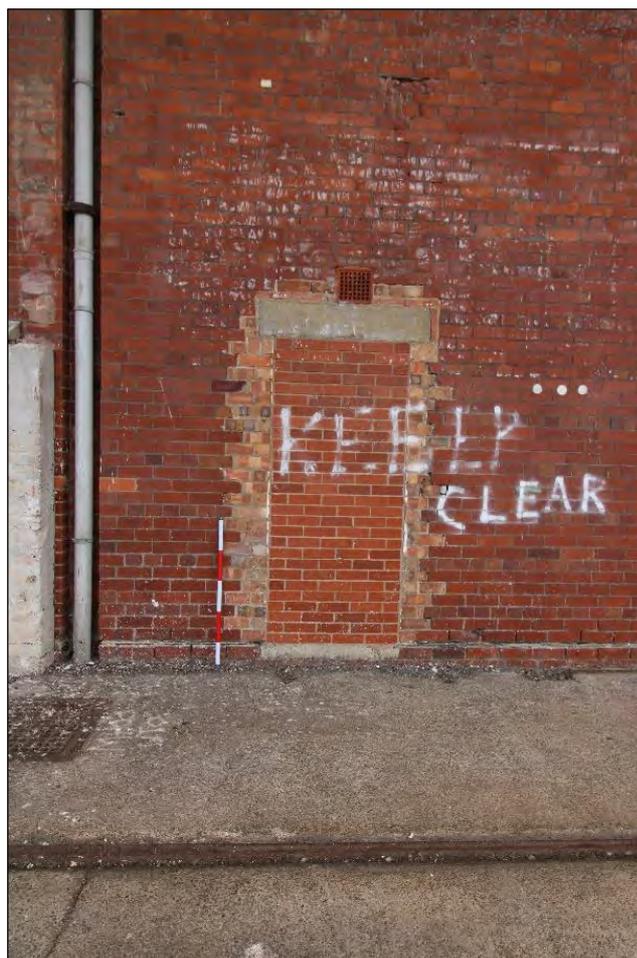
Plate 5: Blocked doorway in bay 9, with 1m scale

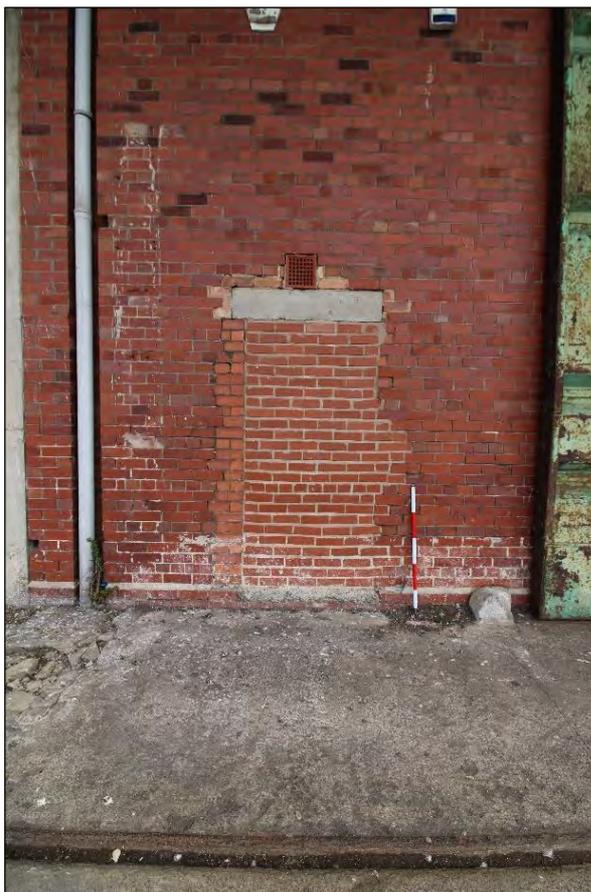
Plate 6: Blocked doorway in bay 20, with 1m scale

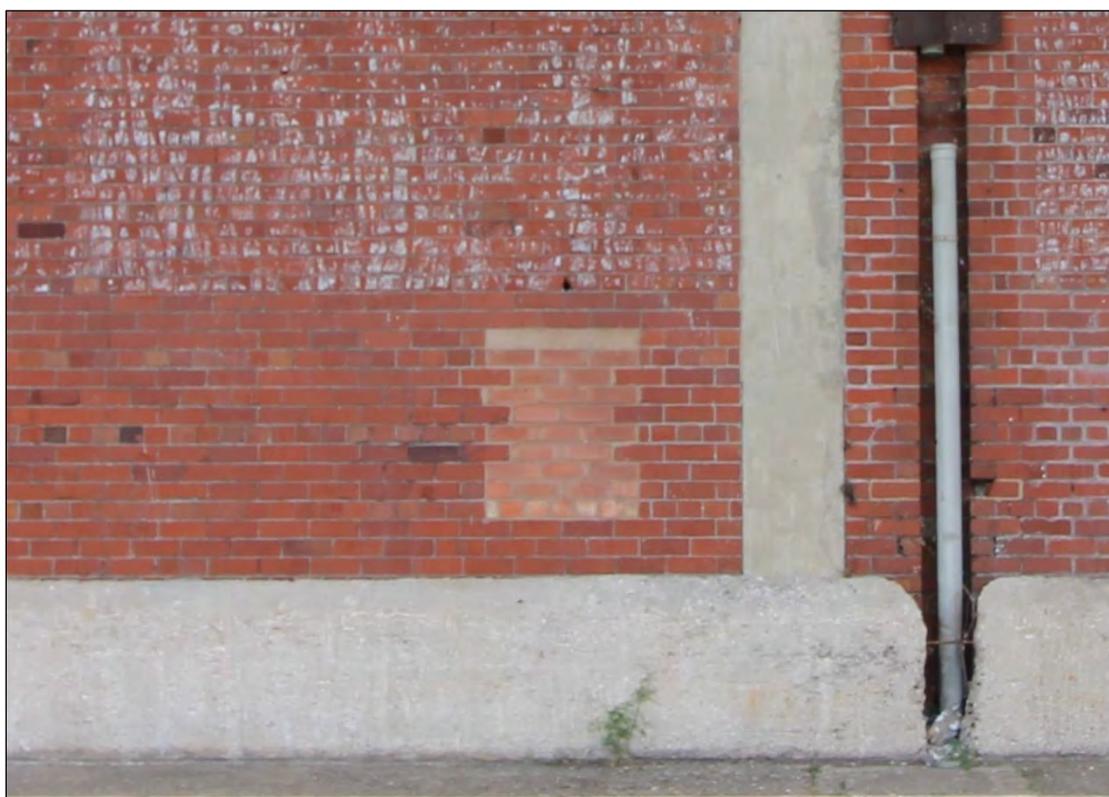
Plate 7: Blocked aperture in bay 15

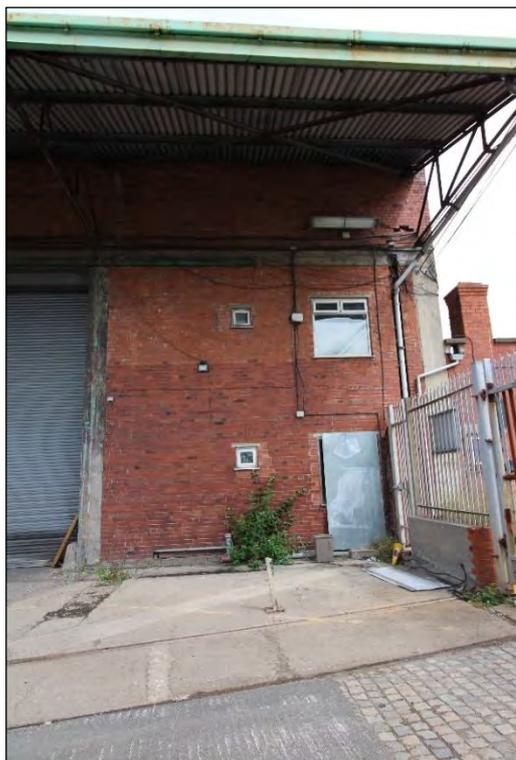
Plate 8: Ground and first floor windows in Bay 1, facing north

window flanked to the west by a tiny square window fitted into what had evidently once been a larger opening (Plate 8). These two windows were matched by two of identical character beneath, but all had been replaced with modern double-glazed units.

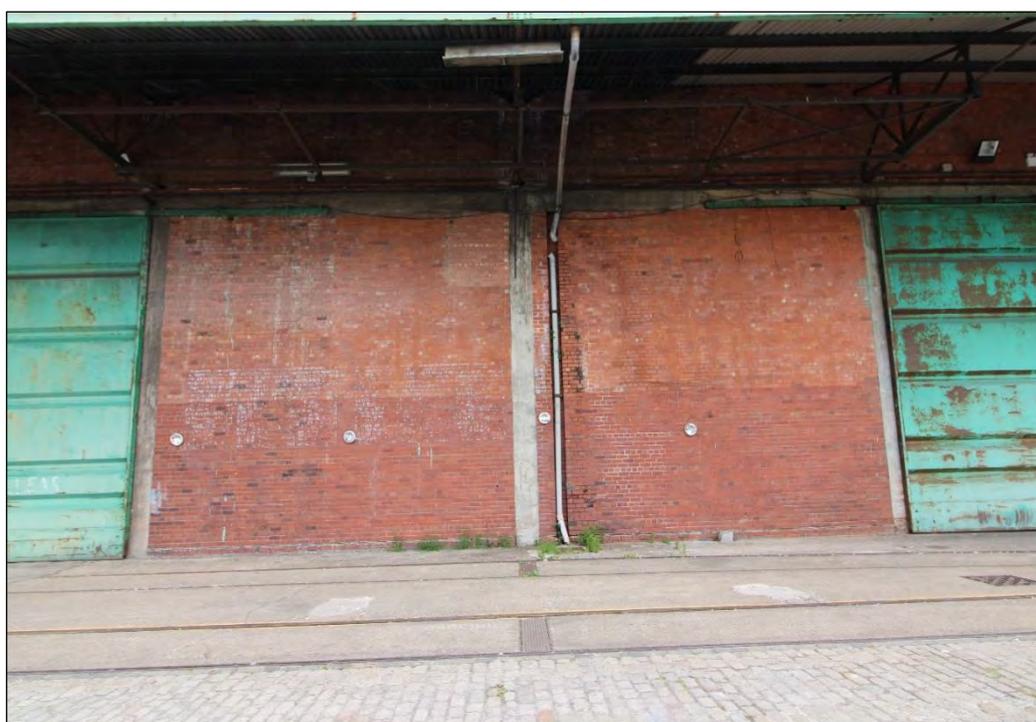
- 3.1.3 Within the eastern nine bays there was a slight change in the character of the brick work above mid-height, suggesting a possible rebuilding or perhaps more likely a contemporary construction break (Plate 9). A corrugated steel awning resting upon half trusses projected south along the full width of all three sheds, extending the pitch of the roof to cover the loading bays on this side of the structure (Plate 10).

Plate 9: Two bays, facing north. Note the change in the character of the brickwork

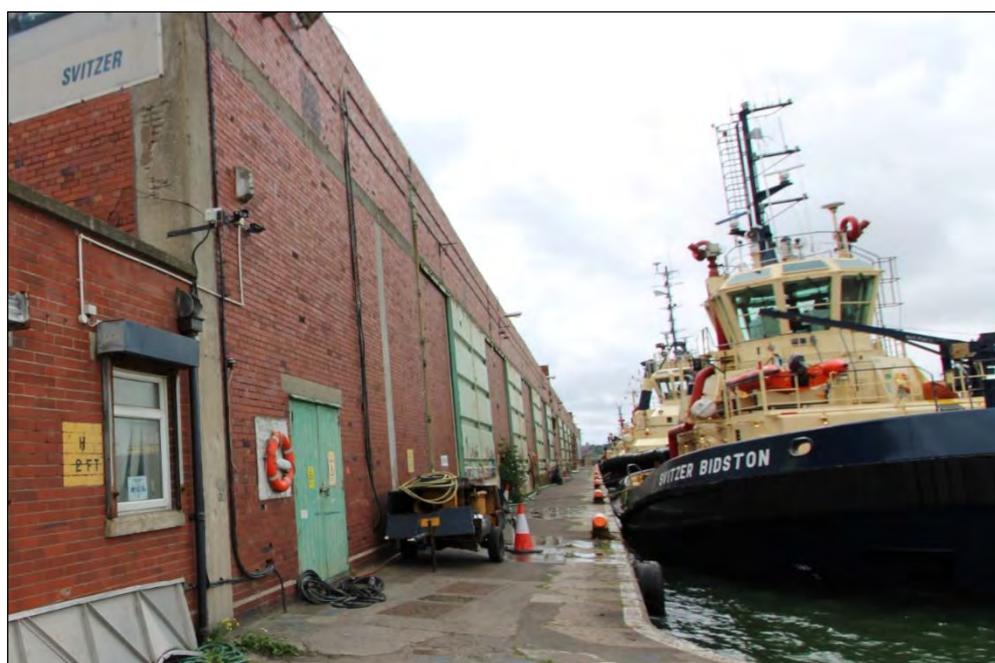
3.1.4 The northern elevation of the eastern shed had a double width door located within every second bay. Each opening comprised a sliding, top-mounted double door of the type described on the southern elevation, except within Bay 1, where a smaller double doorway better suited to pedestrian access had been fitted (Plate 11). The northern elevation of the Western shed was similarly arranged in reverse but lacked the pedestrian entrance and the two northernmost bays were left blind (Plate 1). The same pattern was used on the Central shed too, although where the buildings adjoined there were a pair of blind bays.

Plate 11: Northern elevation, facing west, with double pedestrian doors to the left of frame

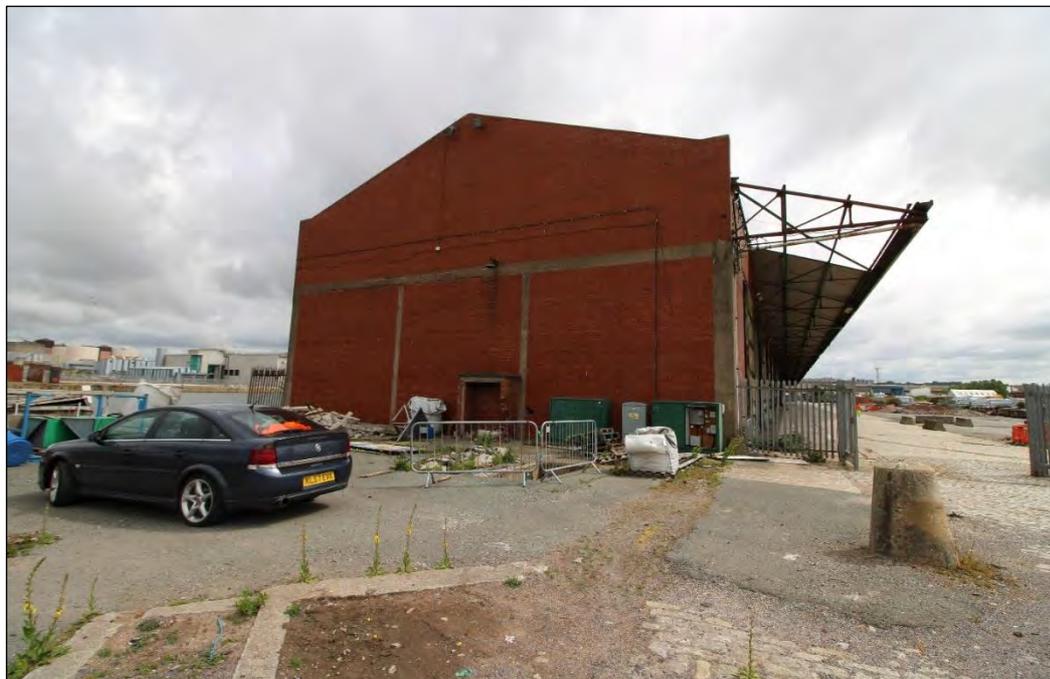
3.1.5 The western gable elevation employed the same construction techniques as the remainder of the building, being divided into three bays by a pair of concrete piers topped by a lintel of the same, but it revealed no openings or evidence that there had been any (Plate 12). The only feature of note was a small rectangular brick structure with a flat concrete roof that abutted the wall to the south of centre and must formerly have been fitted with a door on its western side (Plate 18).

Plate 12: Western elevation, facing east

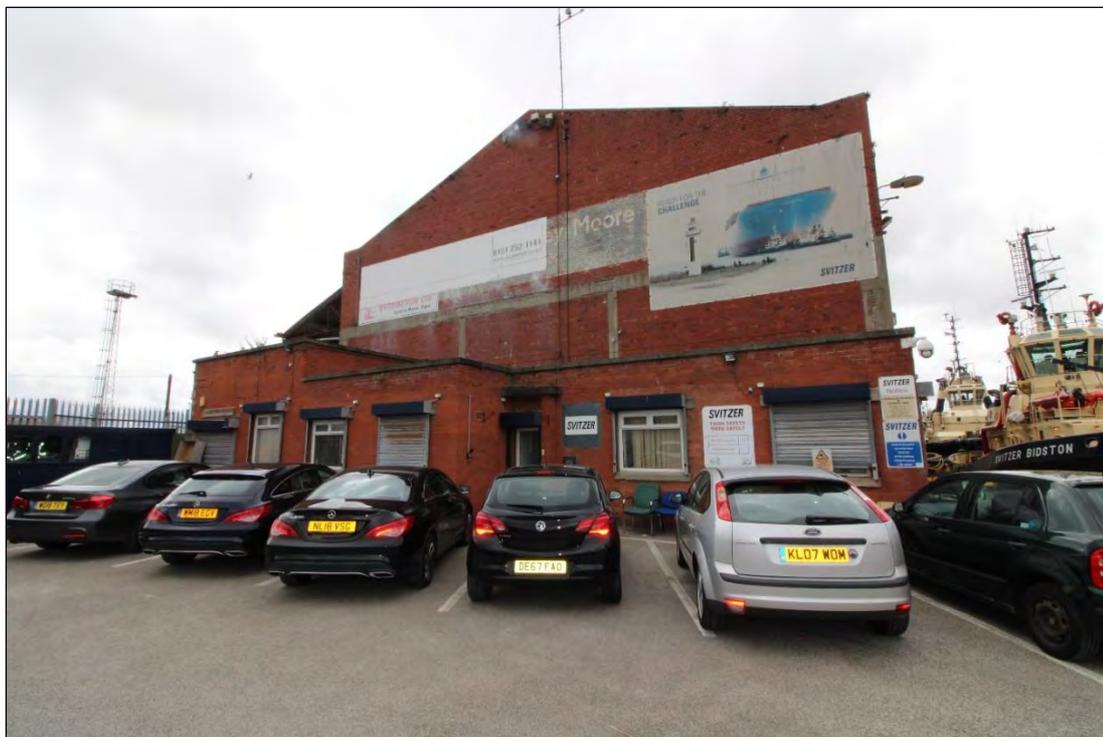
3.1.6 The eastern gable appeared similar to the western one, but its lower portions were masked by the presence of the single-storey office building (Plate 14). Although much obscured by modern signage in the upper gable, there were traces of white painted lettering on a light blue background that spelt out the docks name. At the south end, a single, small first-floor window represented the elevation’s only aperture.

Plate 14: Eastern gable, facing west, with office at the base of the elevation

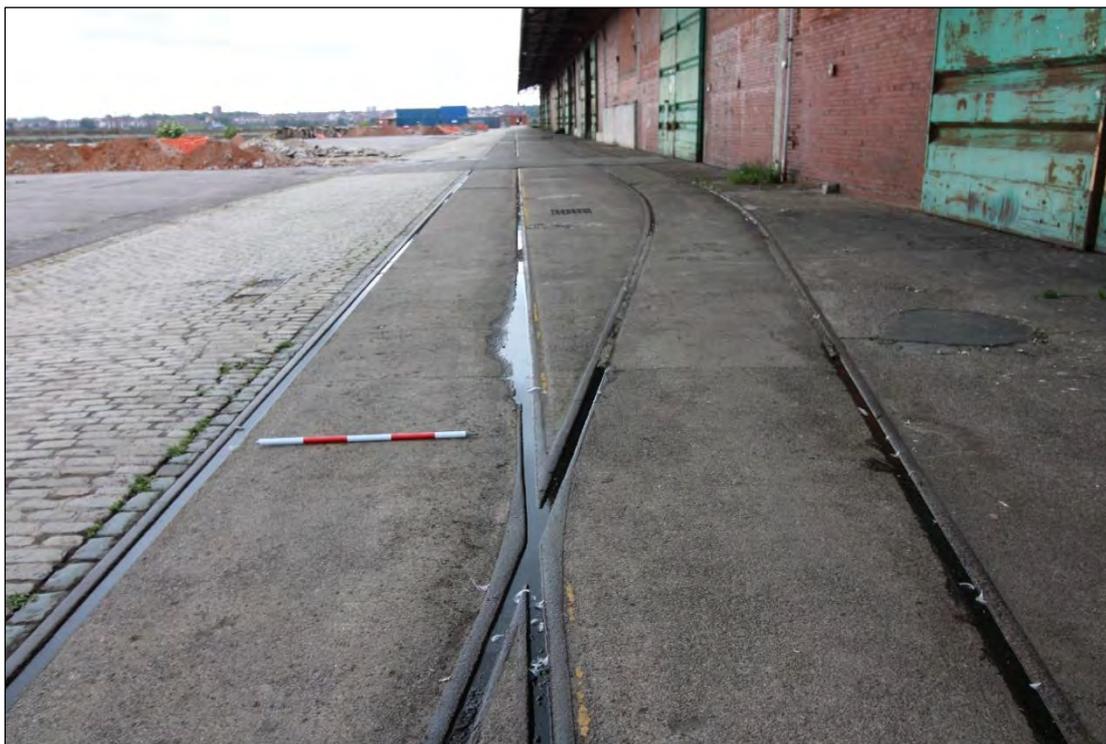
3.1.7 A grooved railway line passed in close proximity to the southern side of the shed, approaching from the east and immediately dividing into two before crossing each other at the centre of the shed and reforming into one line at the western end (Plate 15). The tracks were of standard gauge, flush with the ground surface and preserved the remnants of a series of switching points along its length (Plate 16). The points were hand operated by an iron lever to one side of the track and carried the manufacturers name “Hadfields Ltd Sheffield”, a name in use between 1913 and 1951. To the south, the rails were flanked by a surface of durable stone setts, that extended the full length of the shed but had only a width of approximately 5m.

Plate 15: Grooved rails, passing the southern side of the Transit Shed, facing west with 1m scale

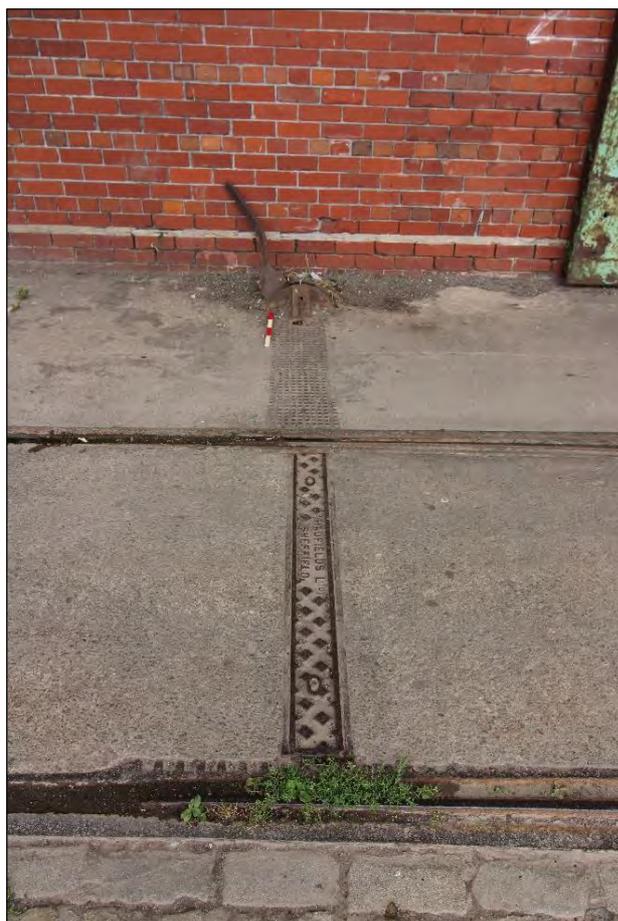
Plate 16: Switch points, manufactured by Hadfields Ltd, Sheffield

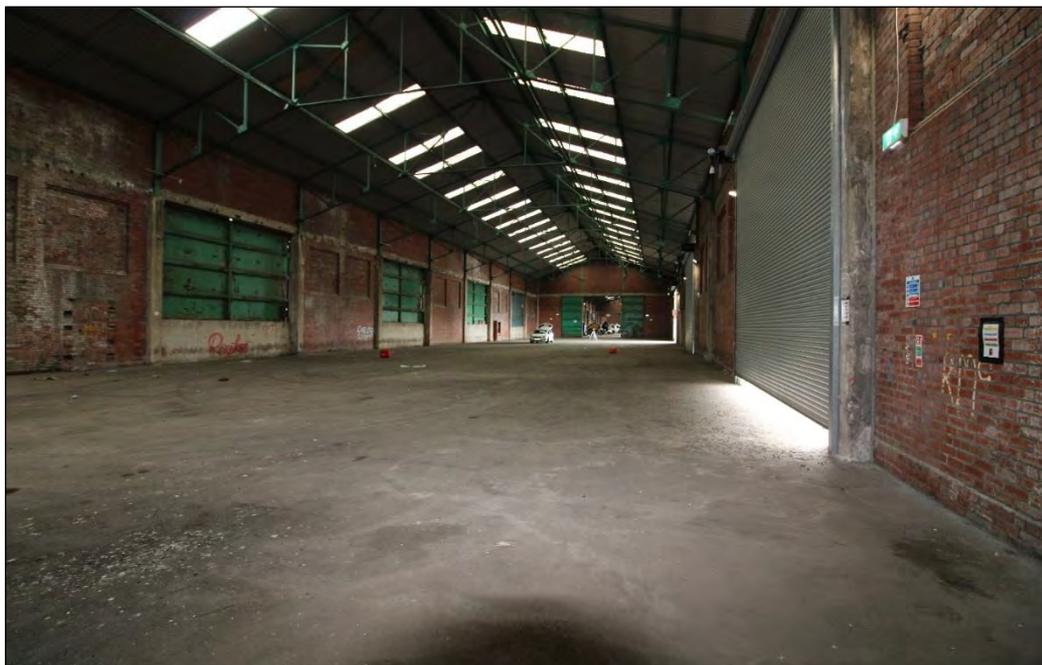
Plate 17: Western Shed, facing east

- 3.1.8 The interior of each shed provided a largely uninterrupted open space from floor to ceiling (Plate 17) and each of the three sheds was connected via a pair of sliding steel doors at the centre of the shared cross-wall (Plate 18). On their internal elevations the blind bays incorporated pairs of rectangular panels at mid-height, chamfered along their bottom edges and stepped along the top. At the gable ends, additional panels were incorporated into the upper gables (Plate 19).

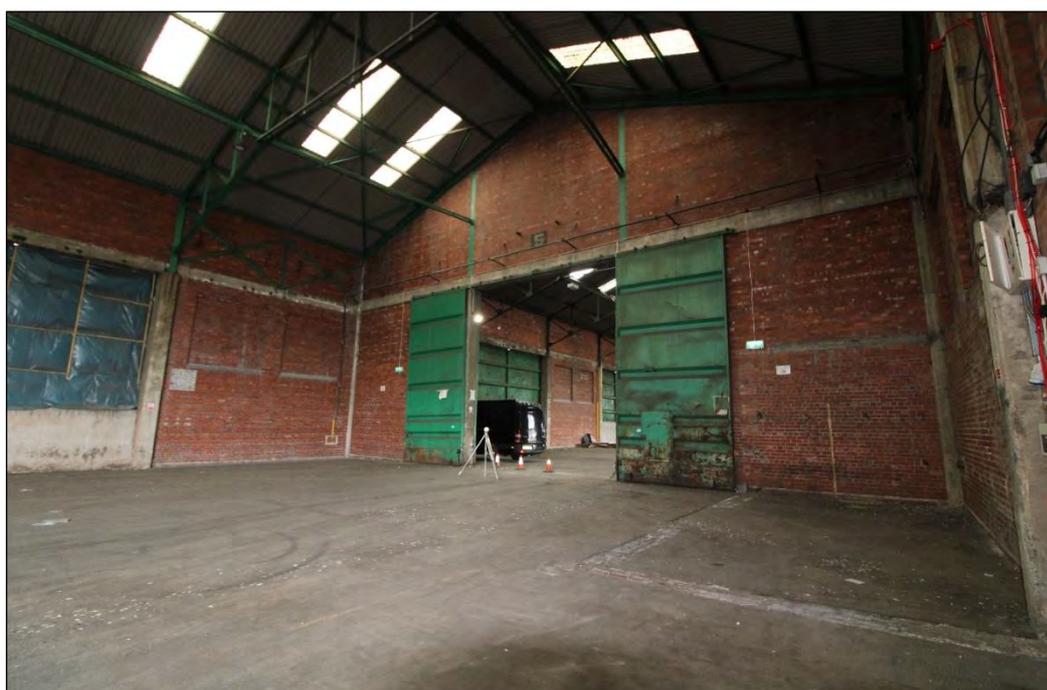
Plate 18: Cross-wall entrance between Western and Central Sheds. Note footing of a demolished single-storey structure to the right of the frame

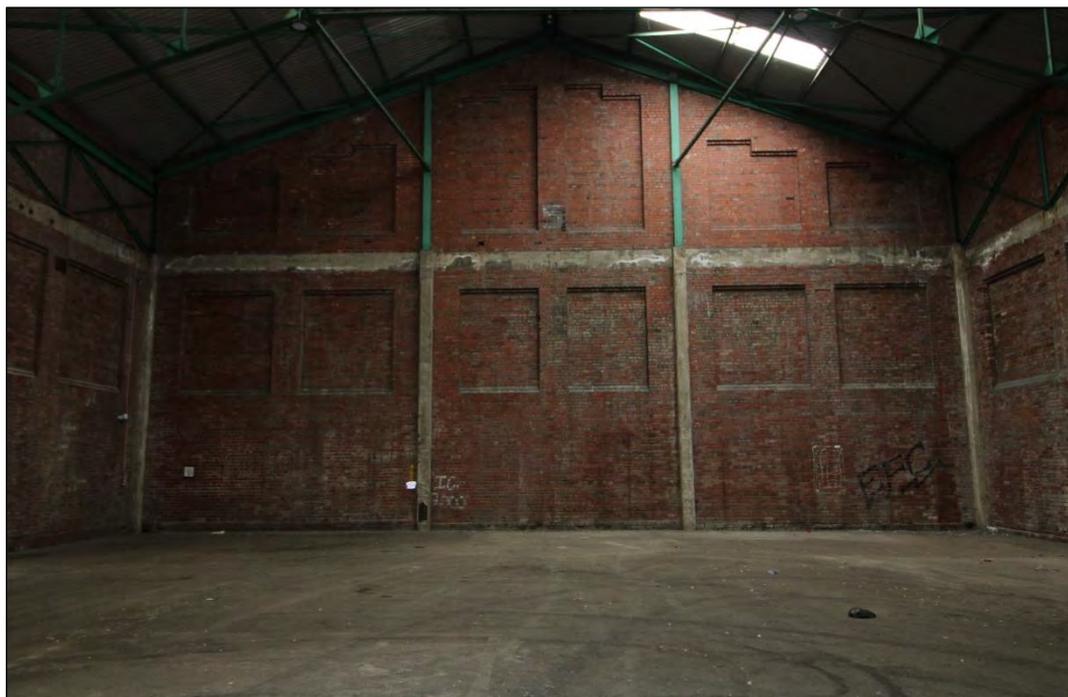
Plate 19: Recessed panels on interior of western gable, facing west

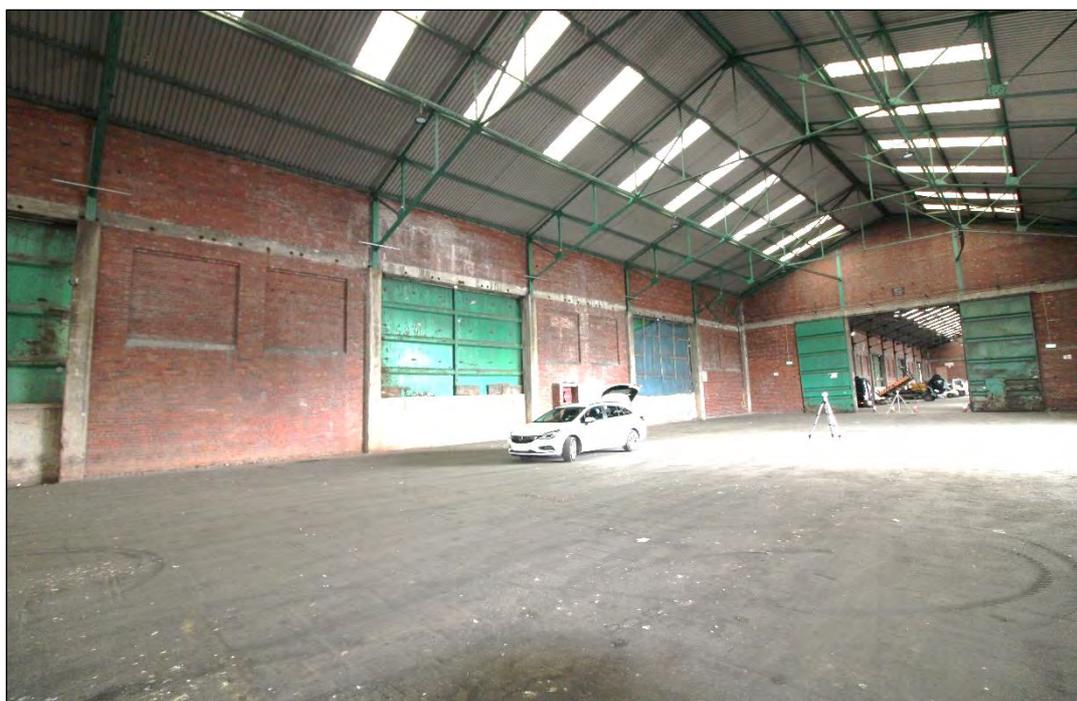
3.1.9 The roof had been re-covered, at some point, with modern corrugated sheet and featured a series of roof lights to provide additional internal illumination. It was supported upon a framework of triangular steel roof trusses, that incorporated a raised bottom chord to provide additional working height within the building (Plate 20). The ends of each truss rested upon the tops of the concrete piers that defined each bay and were tied together by a central ridge purlin, four purlins on each pitch and another two that connected the bottom chords.

Plate 20: Steel triangular roof trusses

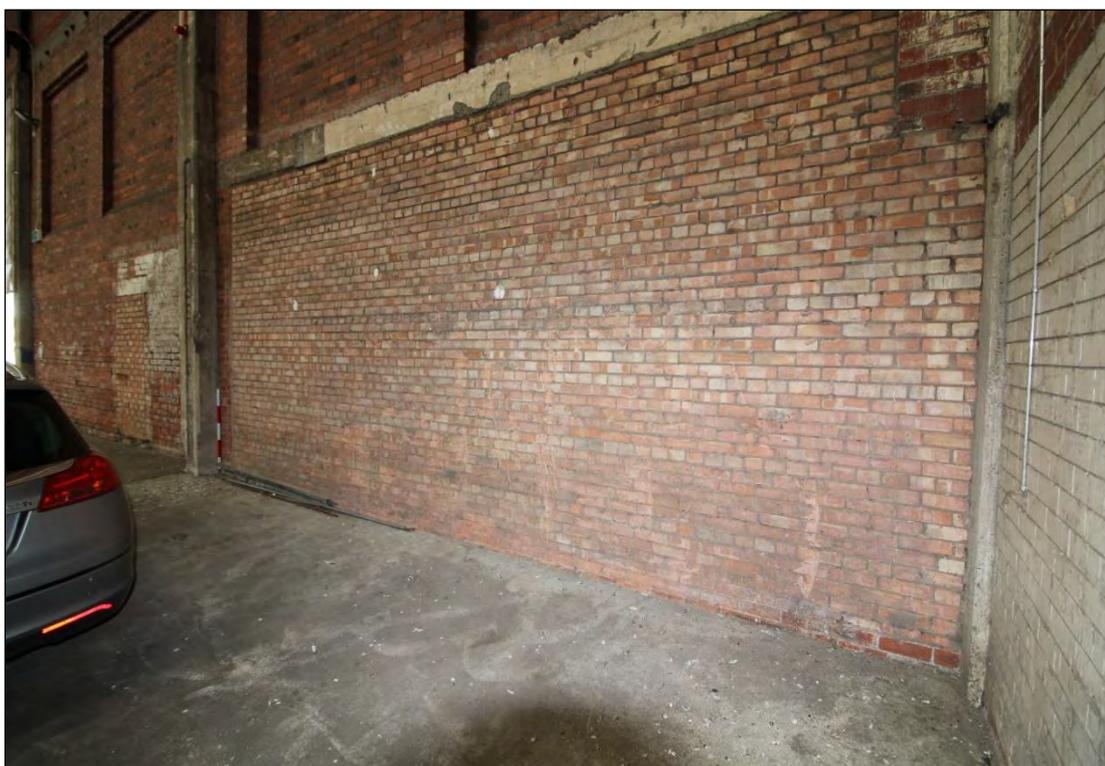
- 3.1.12 The remnants of a second structure was recorded in the adjacent bay, in the south-western corner of the central shed, where a vertical wall scar on the cross-wall and the use of glazed brickwork to its south suggested the former location of a toilet or some other sanitary provision (Plate 21). It was apparent from the differing character of the brick that the adjacent southern wall of the shed had been rebuilt at this point, below a mid-height concrete lintel and in the adjoining bay to the east lay the infilled pedestrian doorway identified externally. In addition, traces of a cream paint had been applied to the surface of the brickwork above the glazed tiles and around the blocked doorway, suggesting a subdivision from the remainder of the shed.

Plate 21: Former structure in south-western corner of the central shed, with 1m scale

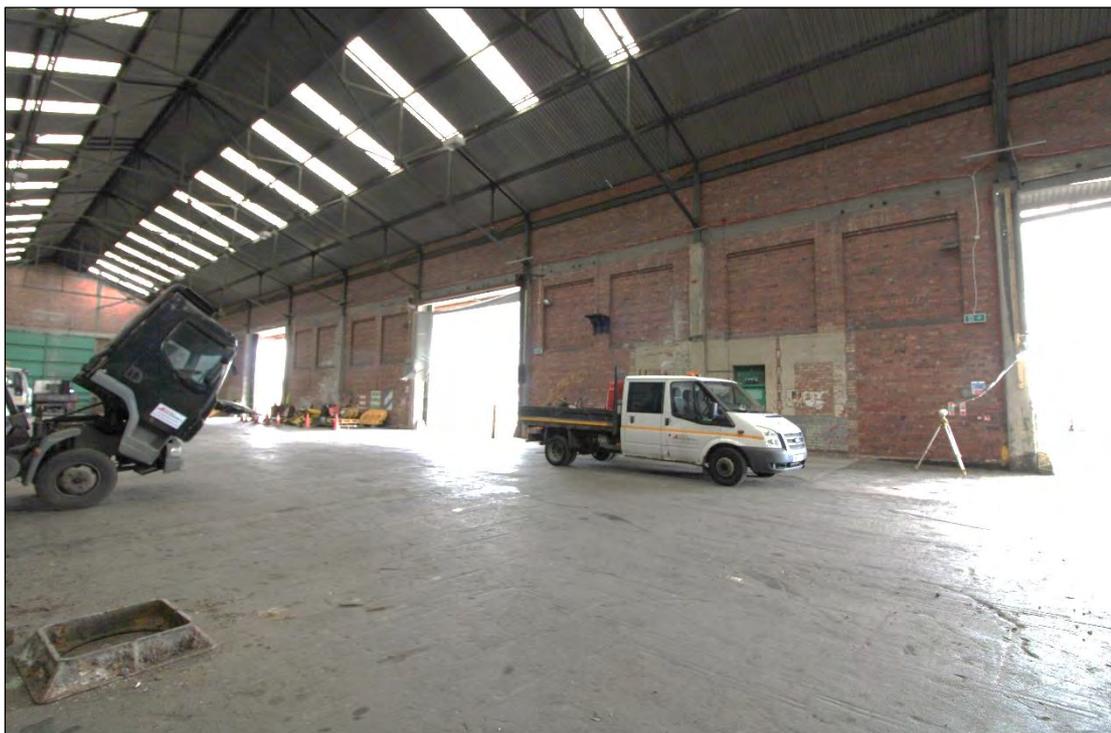
- 3.1.13 A third structure was observed on the south wall of the central shed, spanning bays 17 and 18 and coinciding with one of the surviving pedestrian entrances and the location of its two flanking blocked windows (Plate 22). The former extents of this structure were again defined by the application of paint to the wall, the vertical scars of two end walls and at least one cross-wall that suggested a structure of at least two cells.

Plate 22: Former single-storey structure in bays 17 and 18, facing south

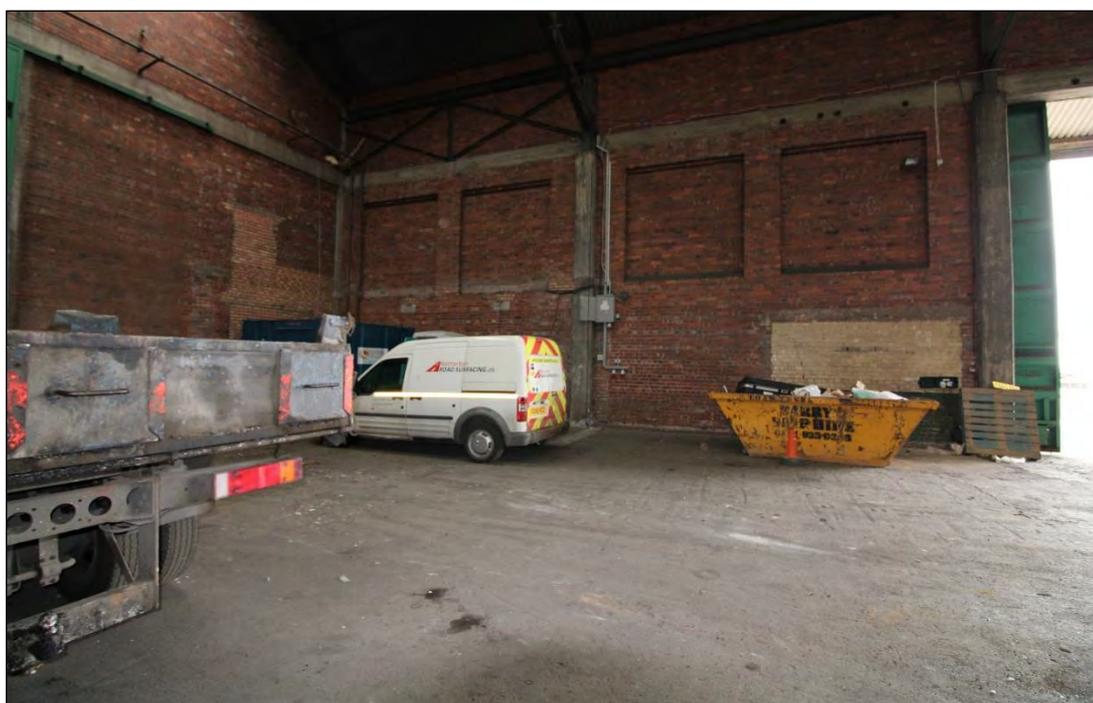
3.1.14 Within bay 12, towards the eastern end of the central shed, the outline of another single-storey structure was recorded against the building's southern wall (Plate 23). Here, two vertical wall scars and a horizontal roof scar defined an area of wall to which a cream paint had been applied above a dark green base at the foot of the wall. At approximately 3.5m in length this structure was the smallest of those identified and could only have been accessed from the interior of the shed.

Plate 23: Evidence of structures in the south-eastern corner of the central shed, facing south

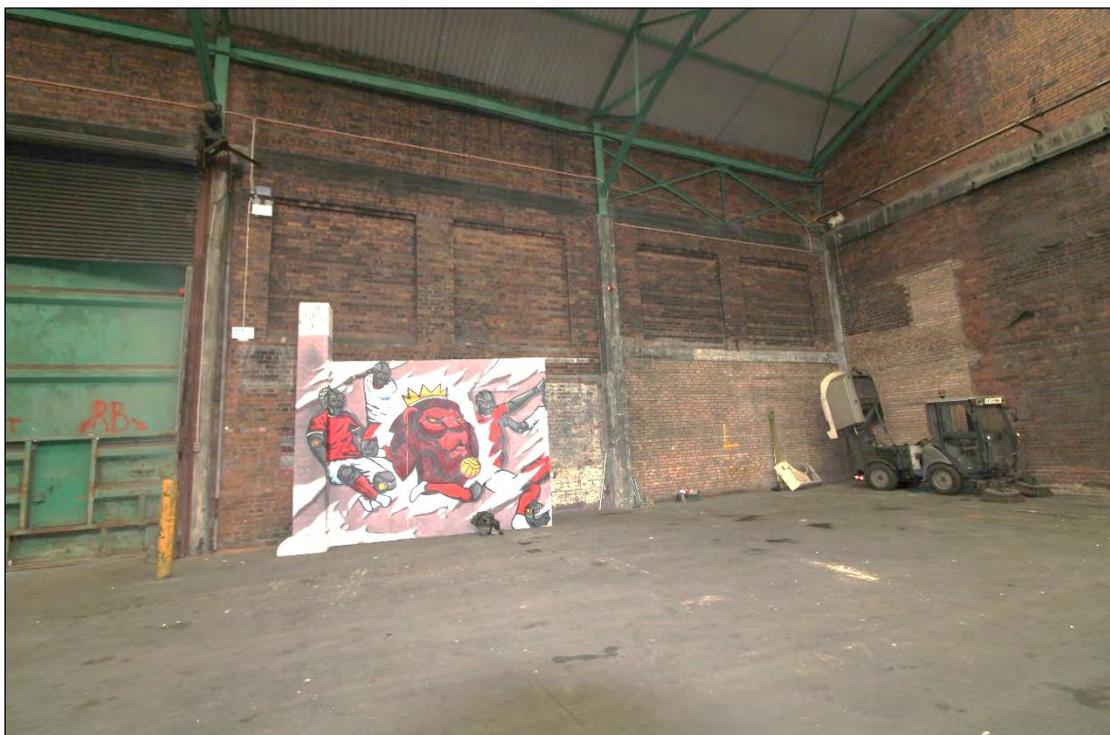
3.1.15 In the adjacent bay, to the east, further vertical wall scars against the cross-wall and the southern wall of the central shed preserved evidence for a fifth structure (Plate 23). A wall footing extending north from the southern wall defined the western end of this building and its roof line was again visible as a horizontal scar. From the brick work of the cross-wall at the eastern end of this building, there had evidently been a substantial rebuild and perhaps the blocking of a rectangular aperture at first-floor level. This reconstruction was also visible within the adjacent bay in the south-western corner of the eastern shed, where in a manner similar to bay 21, the southern wall of the shed had been rebuilt to the level of a mid-height concrete lintel (Plate 24). As with bay 21, there was also a blocked pedestrian doorway in the adjoining bay to the east, surrounded by a coat of white paint.

Plate 24: Remains of a probable structure in south-western corner of the eastern shed

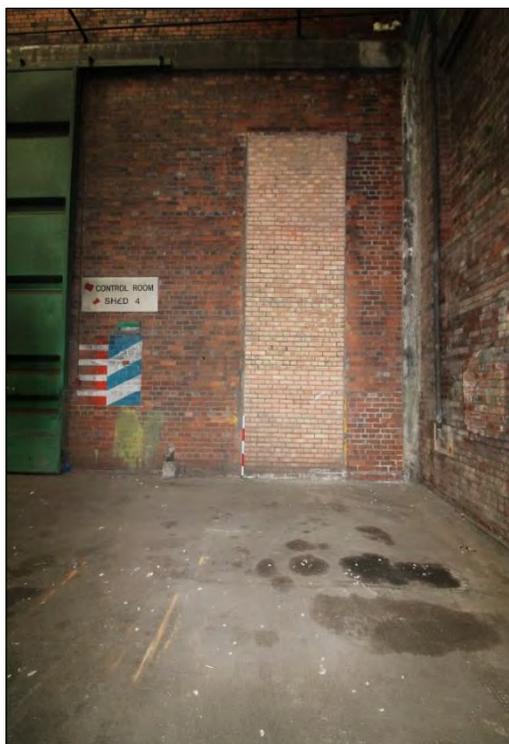
Plate 28: Blocked opening in cross-wall between Eastern and Central Sheds, with 1m scale

3.1.18 On the cross-wall between the eastern and central sheds there were several other features of note. The largest was a very tall and narrow aperture at the northern end that had been subsequently infilled with brick (Plate 28). Immediately to its south a

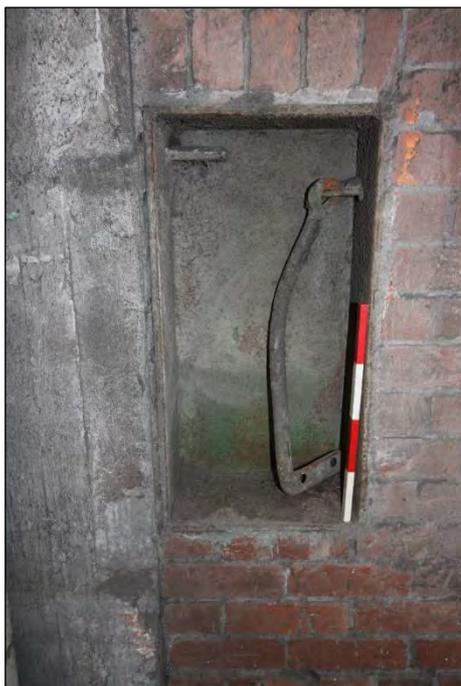
Plate 30: Steel box housing door retaining hook, with 0.4m scale

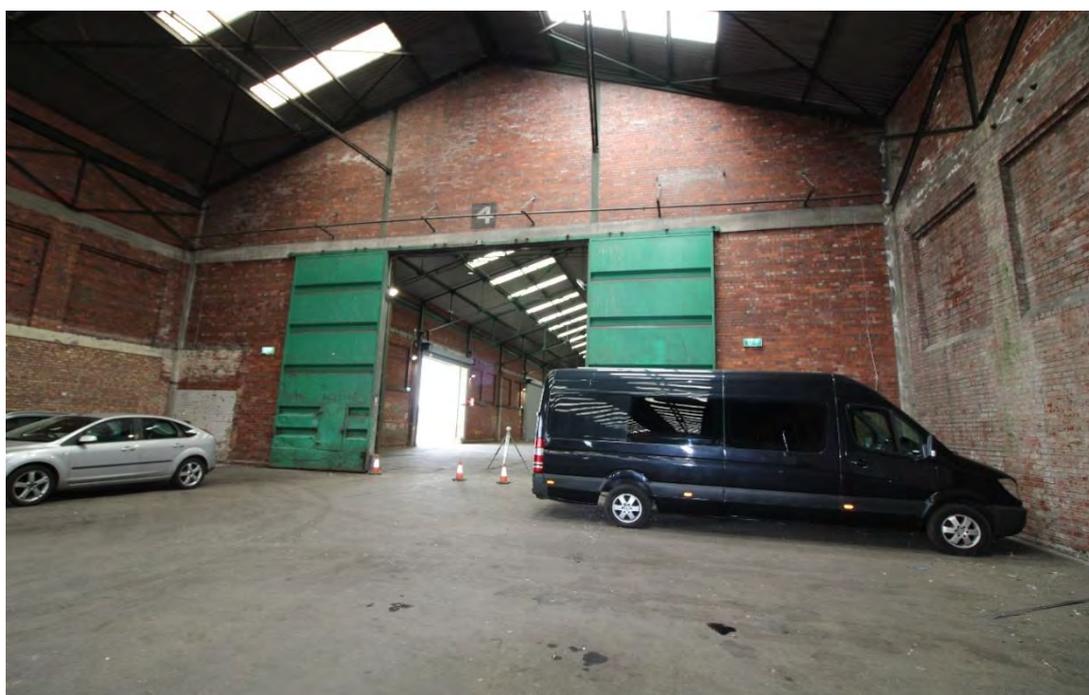
3.1.19 Evidence for the organisation of the sheds was preserved in the upper gables of the cross-walls, where a number was recorded in white letter on a black background. In this manner the western shed was evidently known as number 5 (Plate 18), the central shed 4 (Plate 31) and the eastern shed 3 (Plate 32). Furthermore, in the eastern shed several of the bays had been attributed a number, painted in red onto a white background (Plate 33). It was also noted that the walls of this shed were dirtier than the other two, with a coating of black soot or grime.

Plate 31: Cross-wall between Central and Western Shed, facing west. Note the number 4 painted above the door

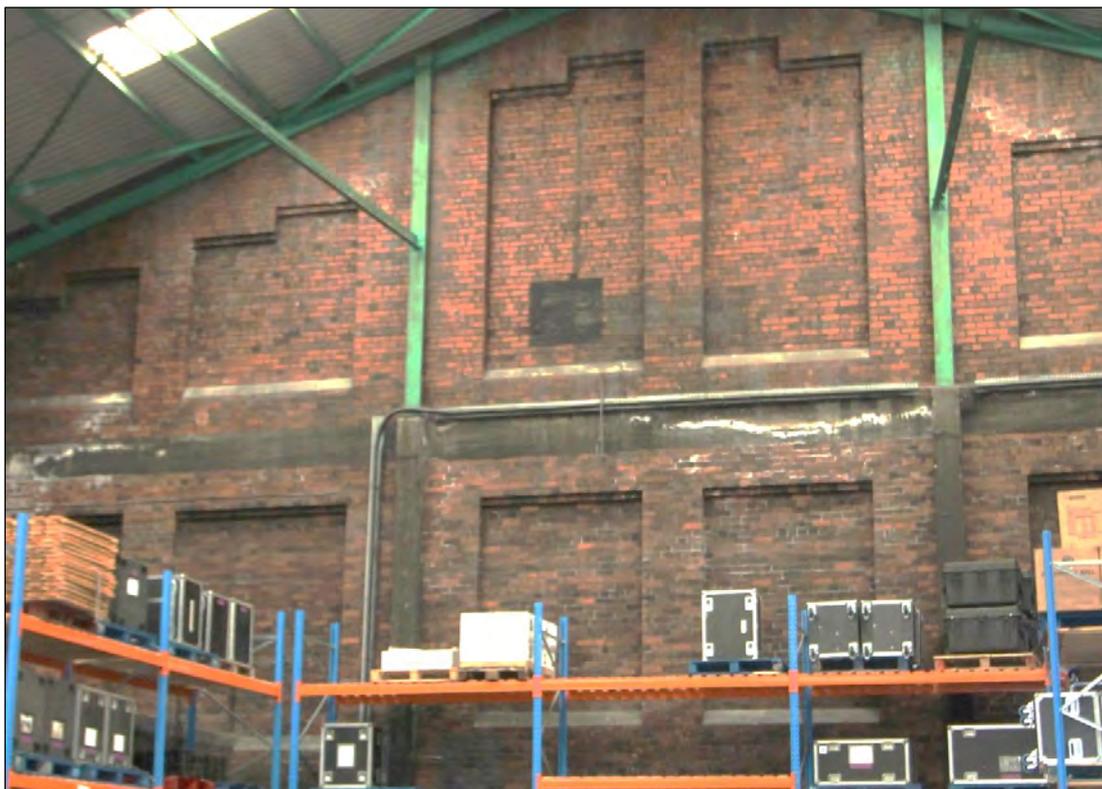
Plate 32: Faded number 3 painted on the eastern internal gable wall of the eastern shed

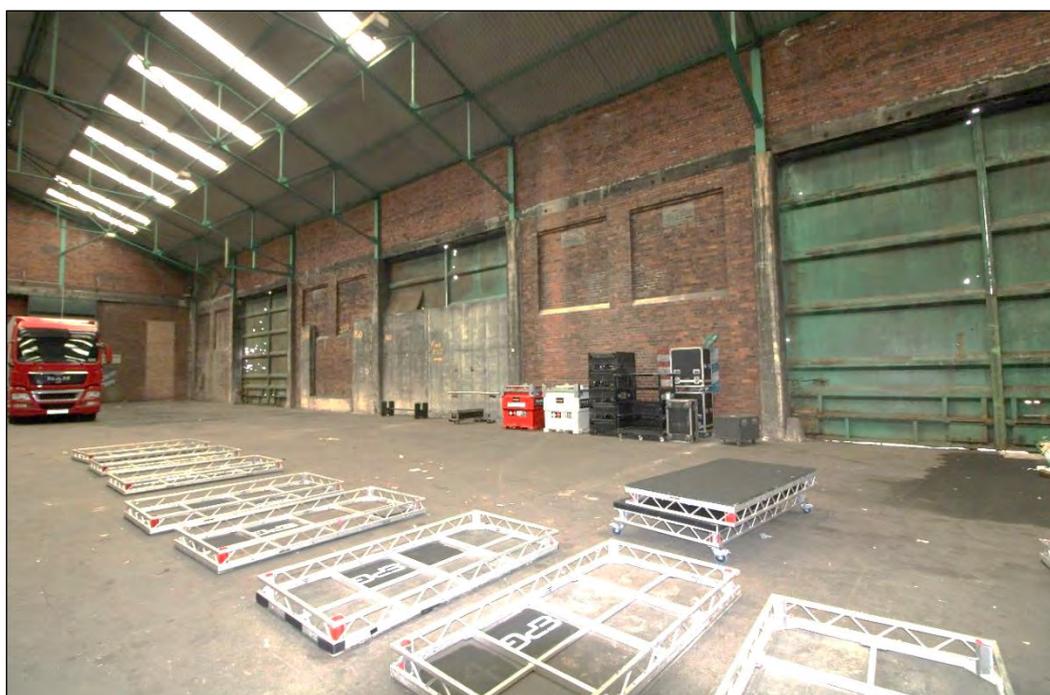
3.1.21 In the western and central sheds the lower thirds of each of the large loading doors had been fitted with a reinforced concrete barrier, but in the easternmost shed only one of the entrances had been modified in this way, blocking the loading door in bay 7 to two-thirds height (Plate 35).

Plate 35: Northern wall of eastern shed, showing partially blocked loading door in bay 7

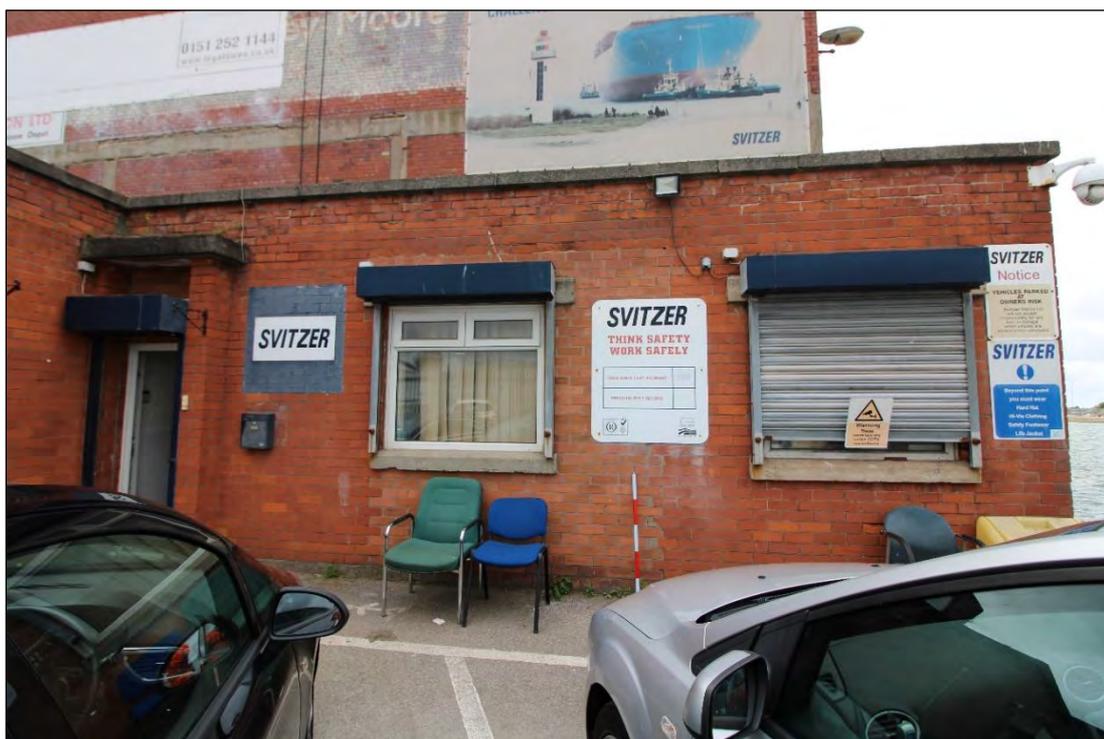
3.2.1 Attached to the eastern end of the transit shed was a small L-shaped red brick structure with a two-stage flat roof surrounded by a concrete coping (Plate 14). The building was of two parts, with the northern end of the eastern elevation set back from the remainder. The entrance lay at the southern end of the northern half, with a pair of large rectangular windows to its north, both fitted with modern double-glazed units and steel roller shutters. The brickwork surrounding the southern of these windows was of a lighter colour than the surrounding bricks and appeared to indicate the former presence of a wide doorway into which the present window had been inserted (Plate 36). The southern half of the elevation incorporated three regularly-spaced rectangular windows, each modified in the same manner as the previous two, but in each case an original sandstone lintel was just visible behind the roller shutter housing (Plate 37). A second and slightly larger doorway was recorded at the southern end of the elevation, which, from the position of the original lintel, had once been an opening of slightly narrower proportions.

Plate 36: Northern half of the eastern elevation, showing infilled doorway behind the left-hand window, with 1m scale

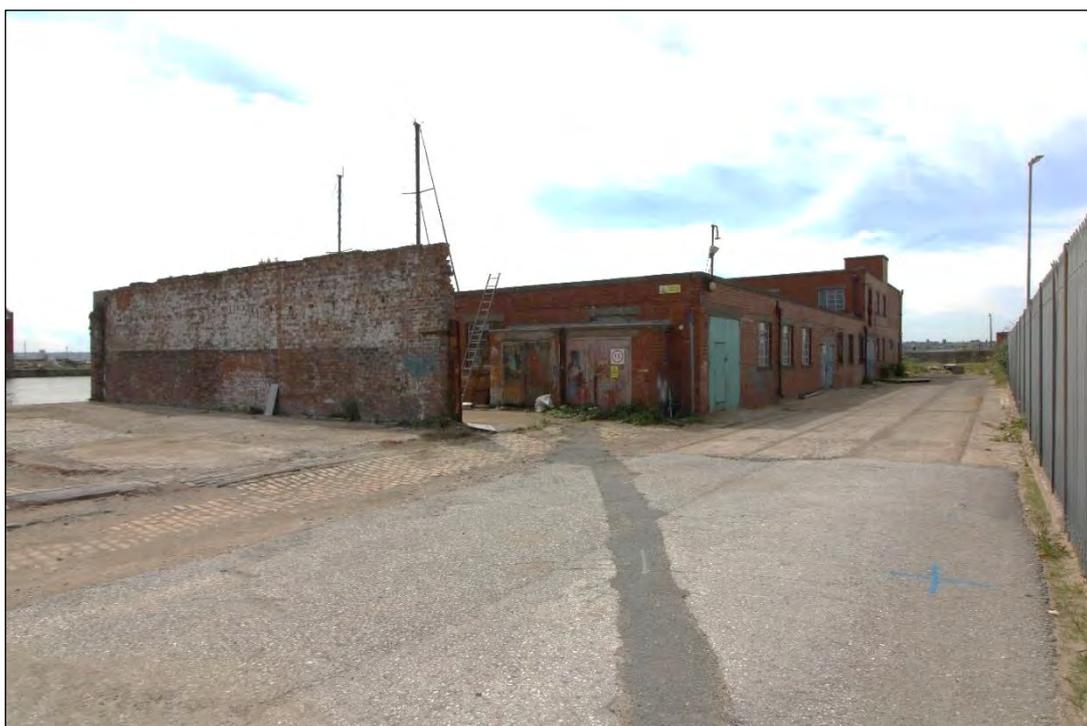
Plate 47: Maintenance Shed facing south-west

- 3.3.1 The Maintenance Building was a rectangular red brick structure with a flat roof located at the western end of the North Quay. It was primarily of a single-storey but incorporated a second-storey at the western end. It was constructed of hard-fired impermeable red brick laid in a cementitious mortar and employed concrete sills and lintels to its openings fitted with Crittal-style windows and timber doors. The building was disused but in reasonable structural condition, although there was no access to the first floor and several rooms on the eastern side of the building.

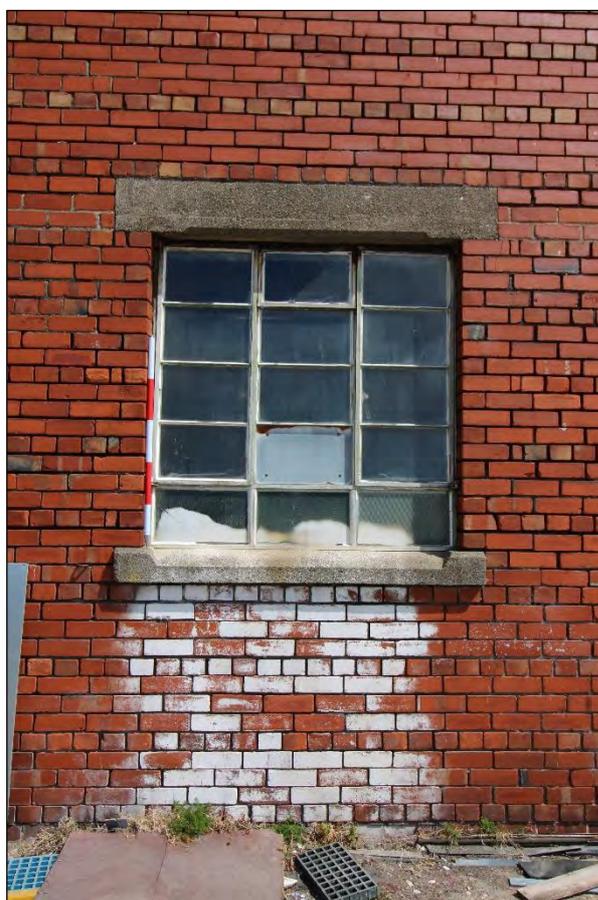
Plate 51: Typical Crittall-style window, on western elevation, with 1m scale
