Bramley-Moore Dock, Regent Road, Liverpool

Building Survey and Evaluation Report

September 2020

Client: Laing O'Rourke

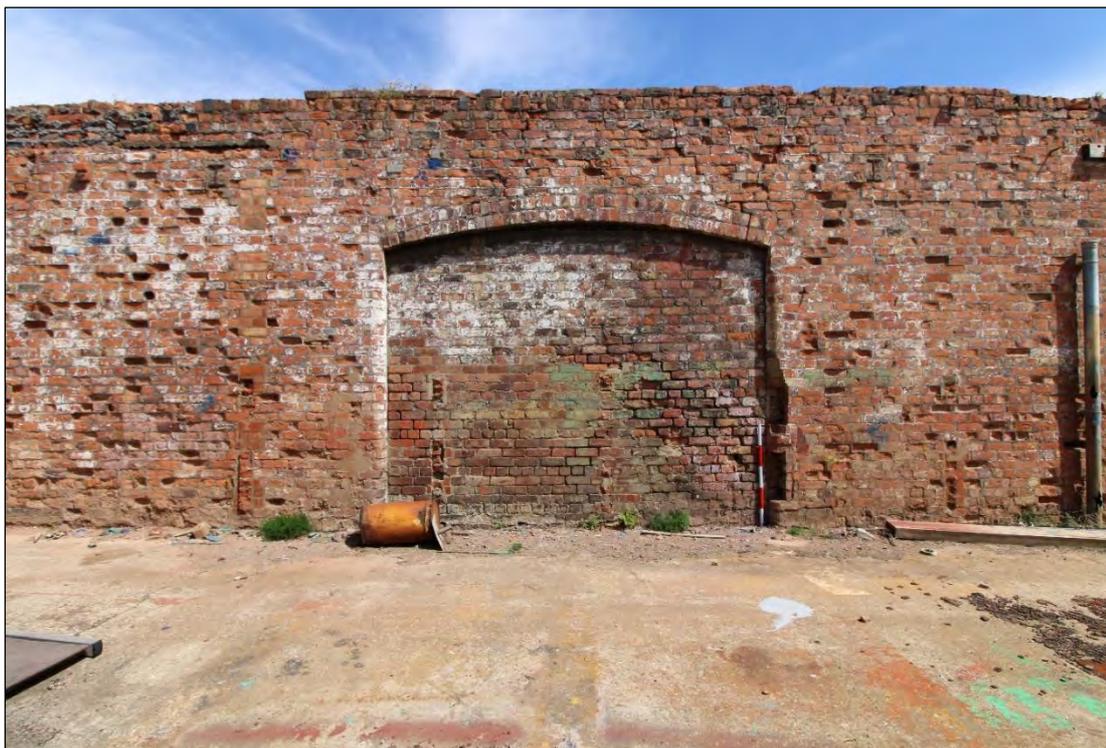
- 3.3.2 To the east of the building there was a detached linear section of brick wall with a wide blocked opening at its centre beneath a shallow cambered brick arch. The brickwork was in poor condition with the loss of fire skins across much of its face and was clearly of nineteenth century character, but a stone-topped pier at the southern end had been built of Staffordshire blue engineering brick and had survived in much better condition.

Plate 60: Blocked opening at the centre of the detached brick wall, facing east, with 1m scale

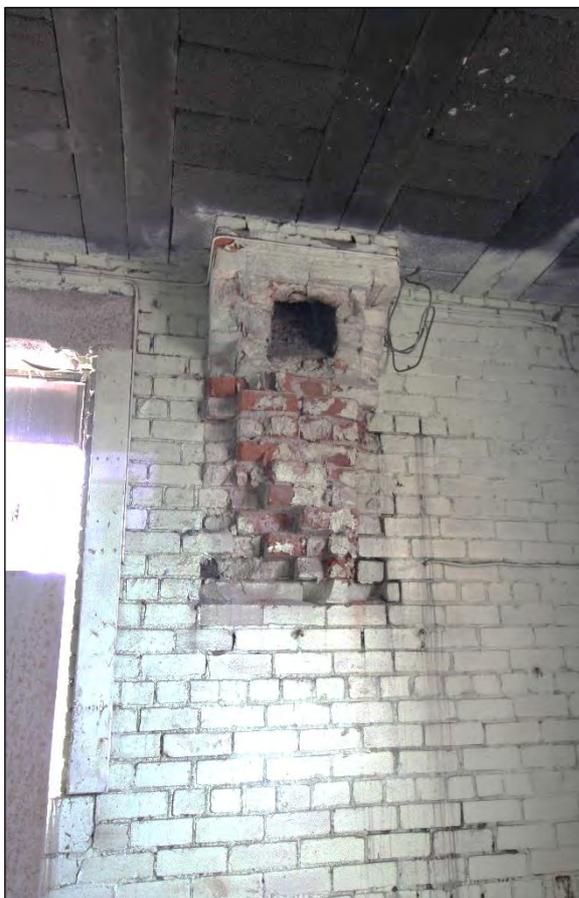
Plate 75: Remains of flue on southern wall of Workshop D

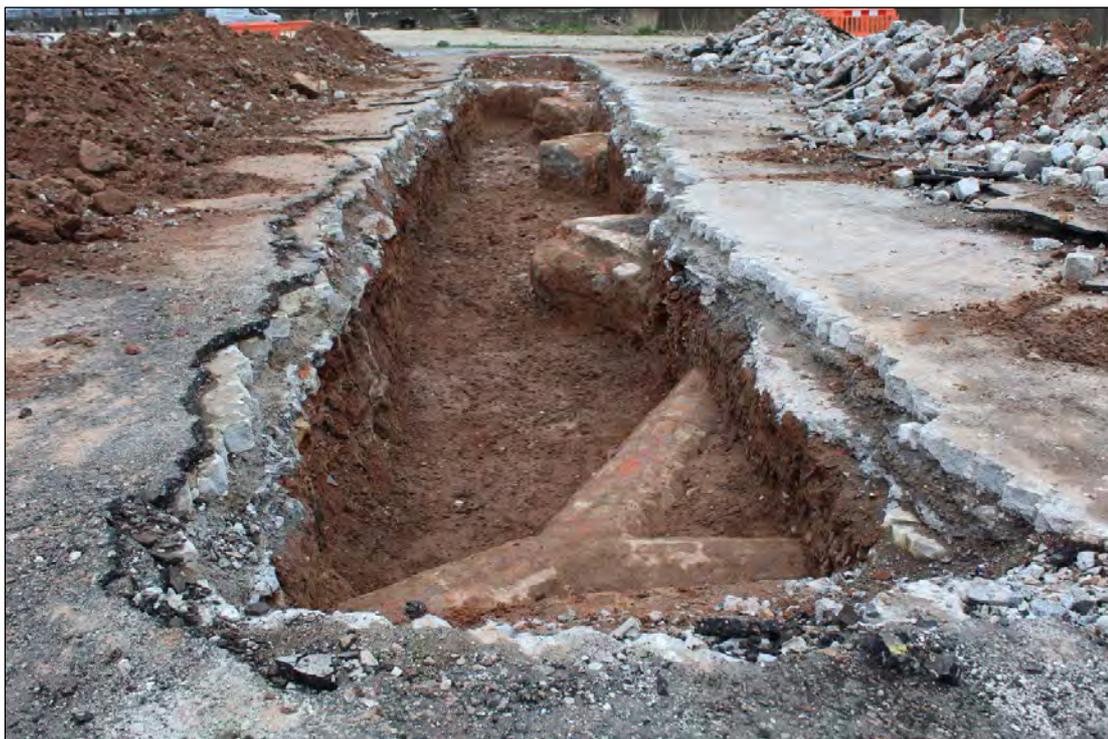
Plate 86: Trench 81 looking south-west, scale 2m

- 4.2.3 Working from the north-eastern end of the trench, a brick culvert (**8108**; Plate 86) was identified comprising two drains forming a Y-shaped structure, both constructed from machine-made bricks, laid as stretchers and bonded with portland cement. The main part of the feature was aligned north-west/south-east, parallel with the north-eastern end of the trench, whilst the arm of the feature was aligned east/west and extended beyond the limits of the trench to the west.

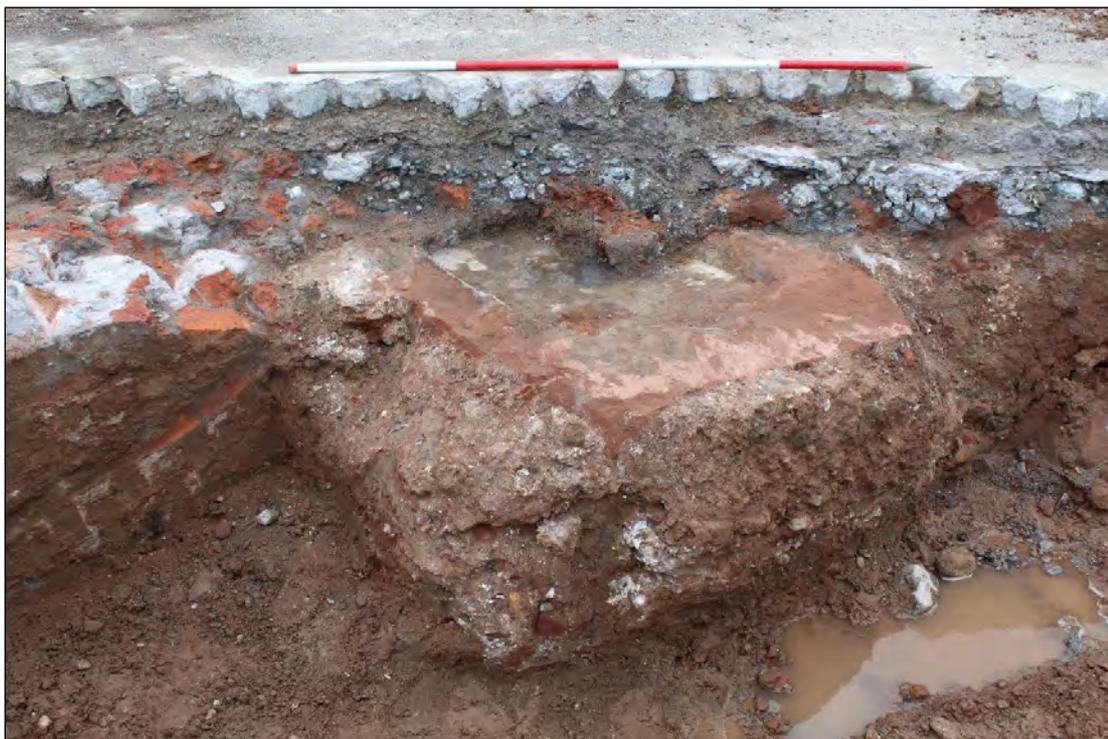
- 4.2.4 To the south-west of brick culvert **8108**, were three sandstone column bases (**8104**, **8105**, and **8106**), regularly spaced along the western edge of the trench and on a north-west/south-east alignment, reflecting the angled northern end of the shed, as depicted on the historic mapping (Fig 12). All three column bases were only partially exposed, approximately 2m long by 1.5m wide was exposed (Plate 87). There was no visible coursing, however, the central part of each column base had a slight depression, most likely for seating the column.

*Plate 87: Column base **8104** looking north-west, scale 2m*

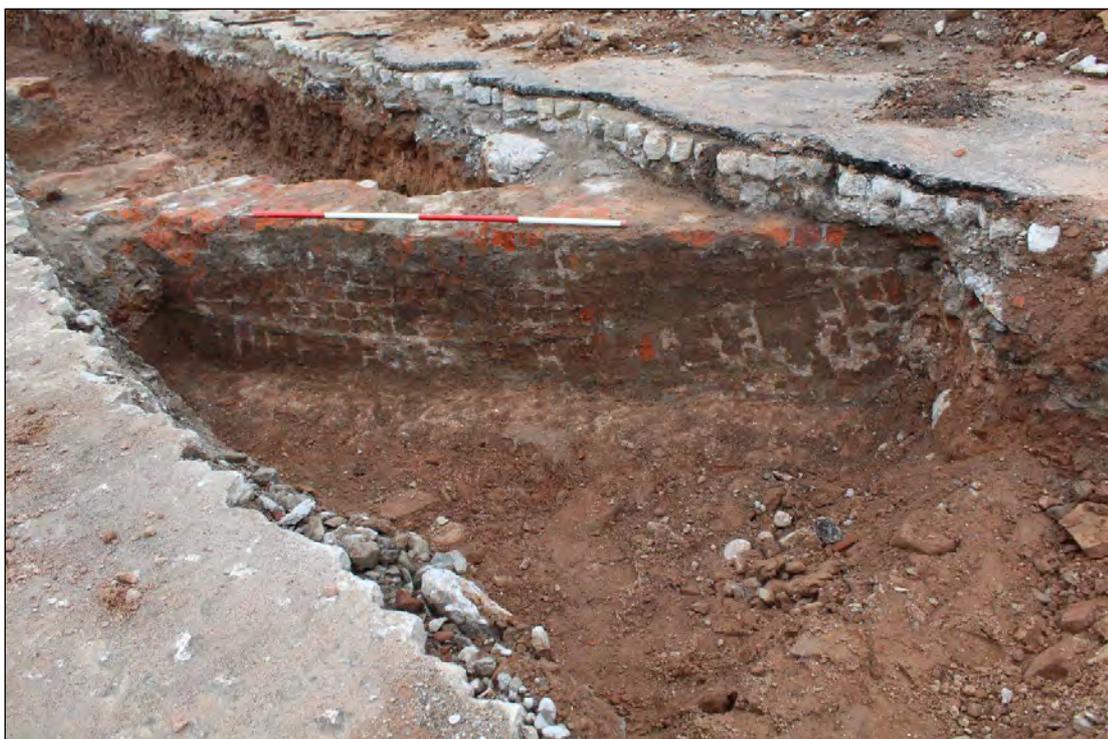
- 4.2.5 Abutting the south-westernmost column base **8104**, was north/south aligned wall **8103**, measuring 3.42m long, 0.75m wide and 0.88m in high (Plate 88). Wall **8103** was constructed from red brick and bonded with a firm grey mortar, likely relating to the western wall of the mid-nineteenth century shed.

*Plate 88: Wall **8103** looking east, scale 2m*

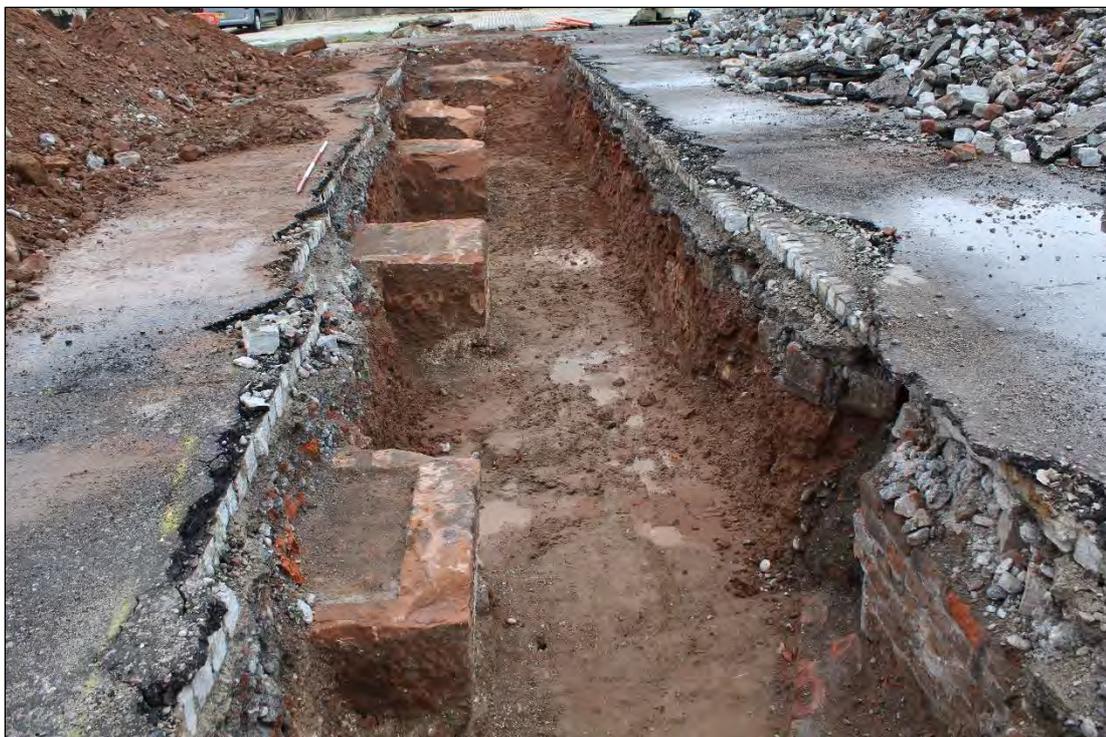
Plate 89: Trench 82 looking west, scale 2m

- 4.2.6 **Trench 82**: the middle of the three trenches on the western quay, was aligned east/west and measured 18m long by 2.8m wide (Fig 10; Plate 89). The structures identified within the trench appeared to cut a mid-orange brown silty sand with frequent sandstone cobble inclusions, layer **8205**, which was, in turn, overlain by two make-up layers **8204** and **8203**.

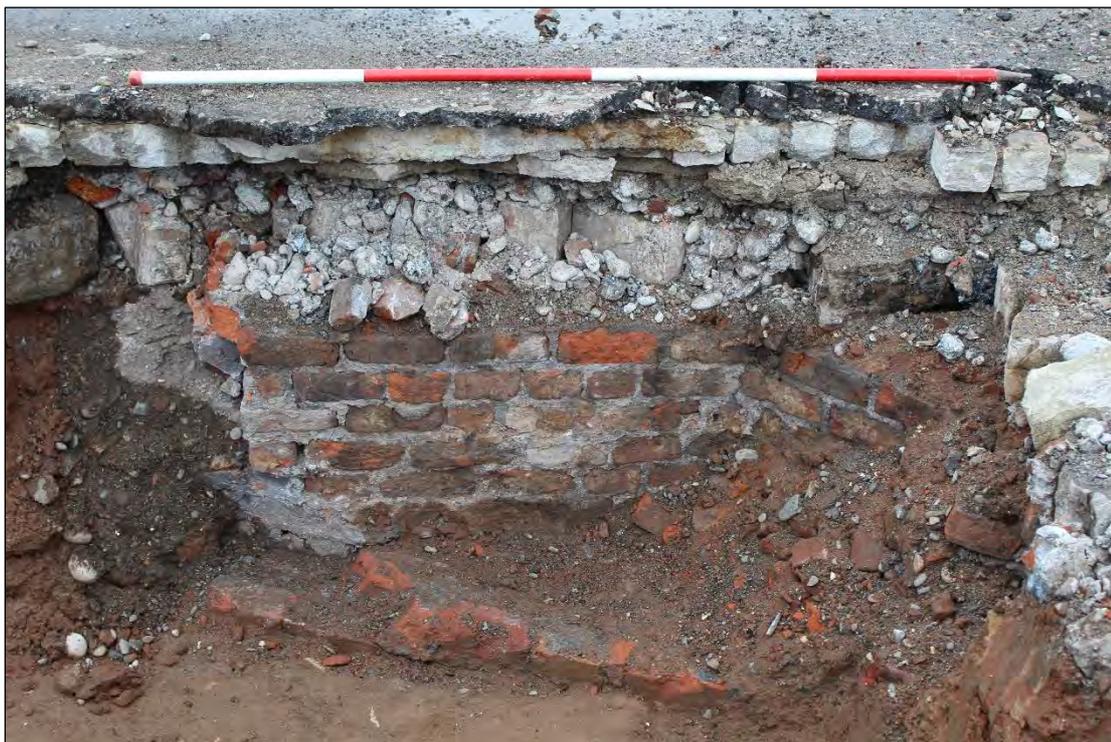
- 4.2.7 Working from the eastern end of the trench, a north-west/south-east-aligned foundation **8213** was identified at the very eastern end of the trench, two courses high, constructed from machine-made bricks, bonded with Portland cement and laid as stretchers (Plate 90). Constructed immediately on wall foundation **8212**, was wall **8213**, which survived to a height of six courses and was constructed from machine-made bricks, bonded with Portland cement. The wall was exposed within the trench for 1.6m, was 0.55m wide and survived to a height of 0.77m.

Plate 90: Wall **8212** overlying foundation **8213**, facing north-east, with 2m scale

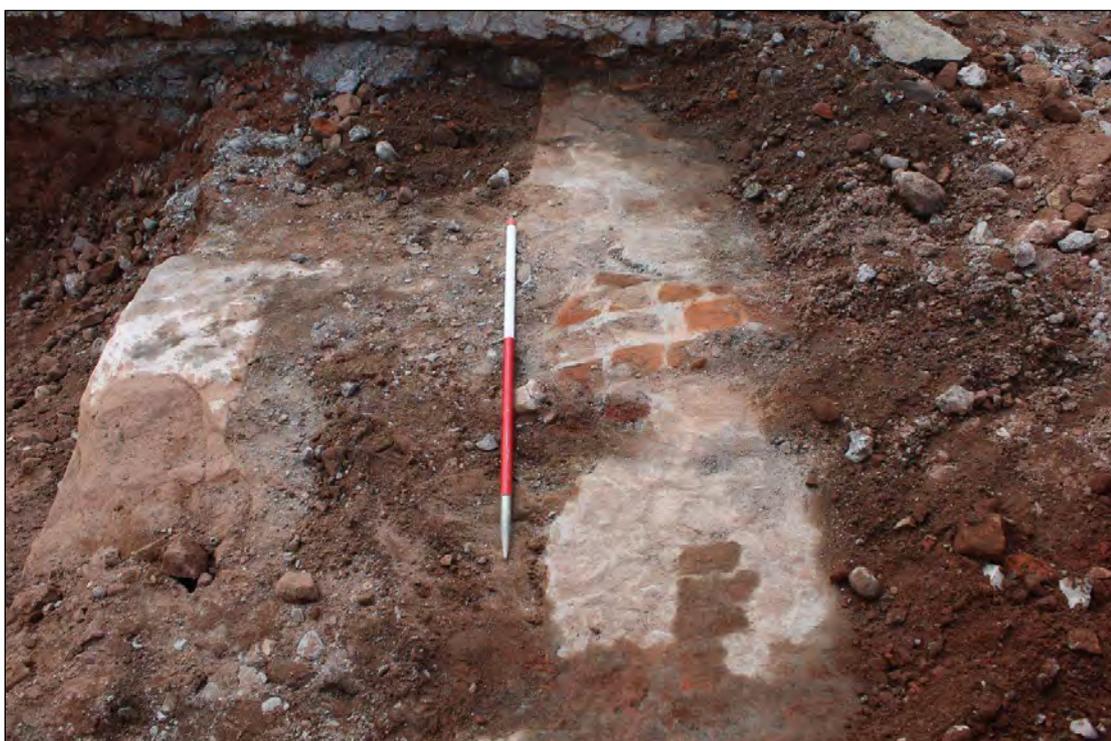
- 4.2.8 Along the southern extent of the trench were four sandstone column bases (**8208**, **8209**, **8210** and **8211**), the same construction as those identified in Trench 81. The column bases measured 1.1m by 1m and survived to a height of 0.82m, within the trench. There was evidence of iron staining encased within a slight square depression on the top of the bases, measuring up to 0.7m by 0.7m. An additional column base, **8207**, was identified at the western end of the trench on a slightly different alignment, and also, with no evidence of a square depression in the top (Plate 91). The column bases were all approximately 2.5m apart.

Plate 91: Large sandstone wall **8206** and base **8207** to left of frame, looking south, scale 1m

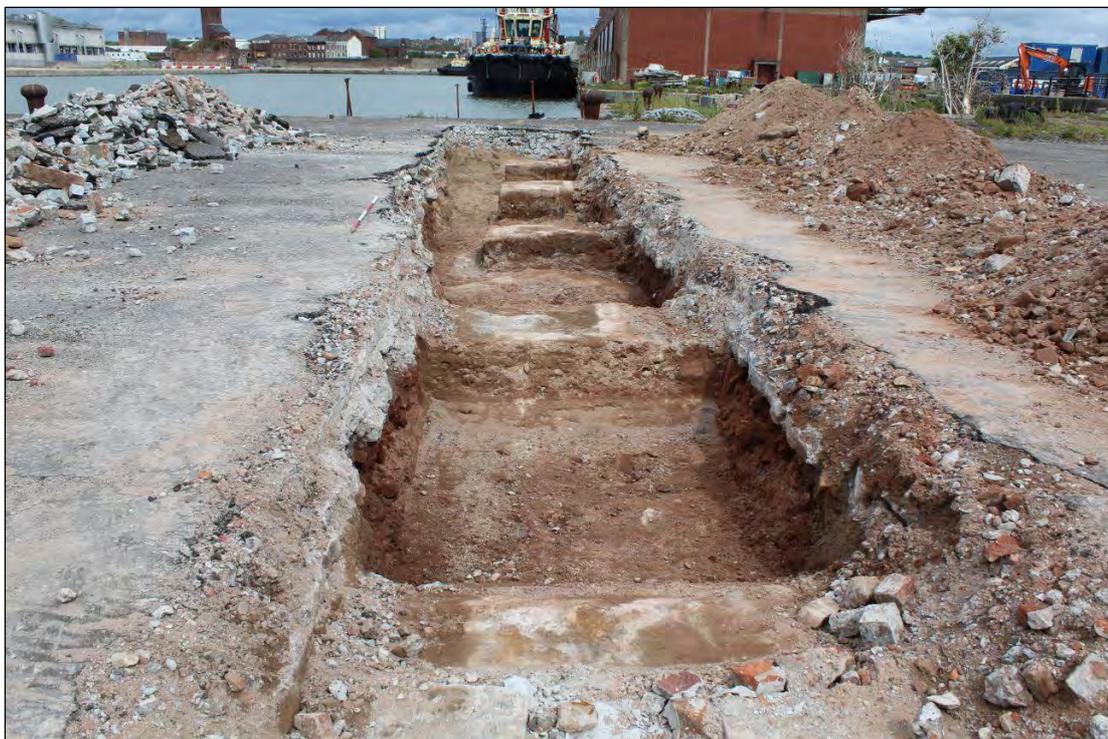
Plate 92: Trench 83 looking east, scale 2m

4.2.10 **Trench 83**: the southernmost of the three trenches on the western quay of BMD, was aligned east/west and measured 18m long by 2.8m wide (Fig 10; Plate 92). The structures identified within the trench appeared to cut a mid-brownish-red silty sand layer **8304**, approximately 0.55m thick, which was, in turn, overlain by a layer of brick rubble, **8303**, approximately 0.12m thick.

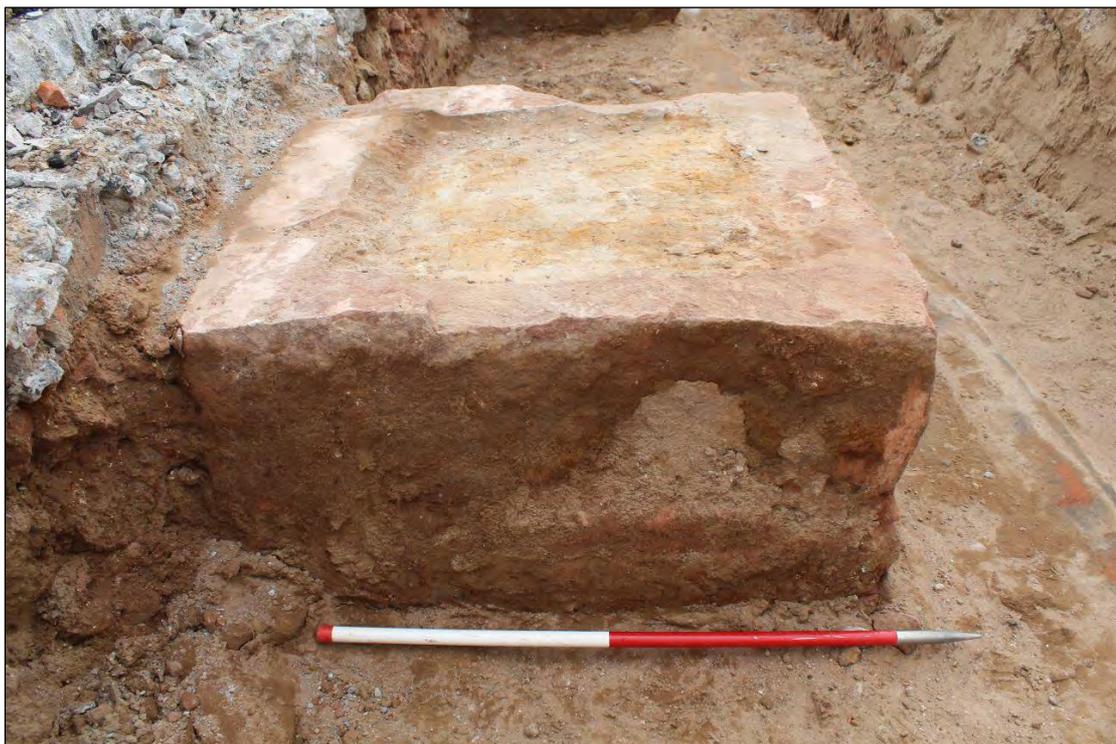
- 4.2.11 The earliest feature identified within this trench appeared to be brick-built drain **8311**, aligned east/west, prior to splitting into a Y-shape at the feature's western end; it was constructed from machine-made bricks and bonded with a cream sandy mortar. The feature appeared to be cut by two of the sandstone column bases (**8306** and **8307**).
- 4.2.12 Trench 83 contained five sandstone column bases (**8305**, **8306**, **8307**, **8308** and **8309**; Plate 93), of the same construction as seen in Trench 81 and 82, constructed from red sandstone blocks with evidence of iron staining within a slight depression in the top of the column base. The column bases all measured approximately 1.1m by 1m and survived to a height of 0.82m.

Plate 93: Sandstone column base **8305** looking west, scale 1m
