Project The People's Project
Subject Regent Road – Factual Report on Ground Investigation
Project no 0045753
Date 20 April 2020
Doc # BMD01-BHE-XX-XX-SU-C-129017

Bramley Moore Dock Wall

Factual Report on Ground Investigation

Project No: 764954

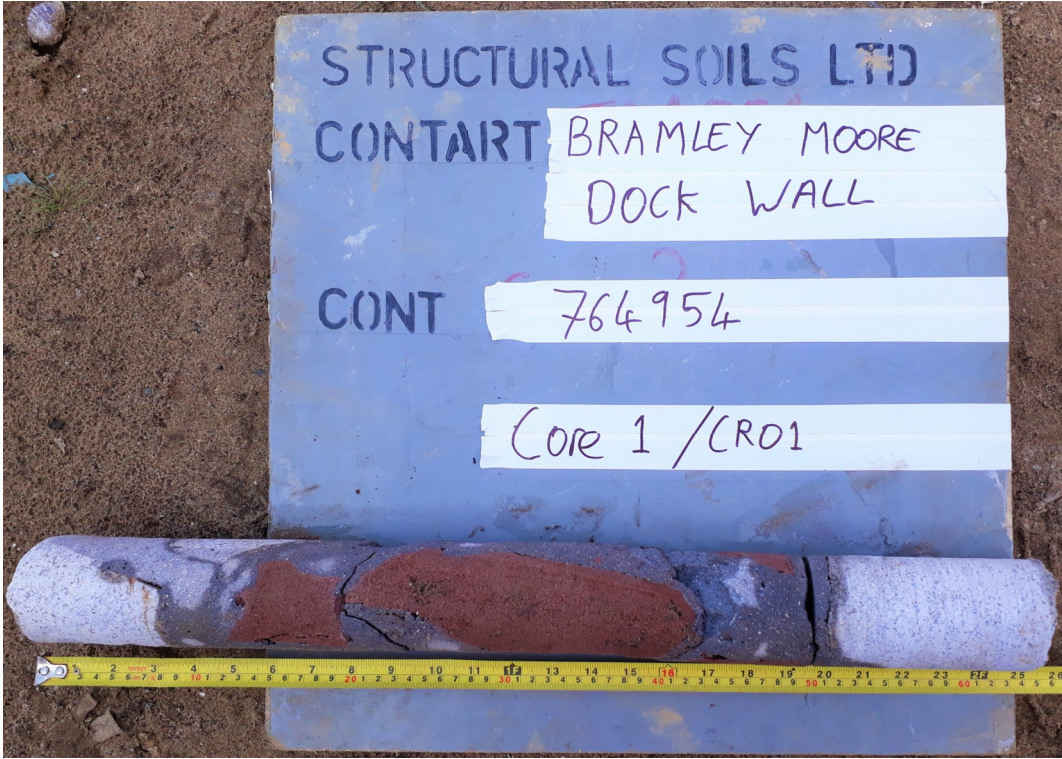
Core 01

Depth	Water	Backfill	Description of Strata	Depth (Thickness)	Material Graphic Legend
0.00-0.10			Very strong non-jointed non-fractured yellowish grey with frequent black specks GRANITE. (MADE GROUND)	(0.10)	
0.10-0.50			Strong occasionally jointed grey to dark grey gravelly HYDRAULIC CEMENT with medium cobble content, angular 60-120mm of sandstone. Gravel is angular to rounded 1-3mm of mixed lithologies including sandstone, quartzite & augite. 15% voids, 2-40mm size. (MADE GROUND)	(0.40)	
0.50-0.64			Very strong non-jointed non-fractured yellowish grey with frequent black specks GRANITE. (MADE GROUND)	(0.15)	
			Core terminated at 0.64m distance (thickness of wall).	0.64

1. Hole backfilled with concrete and re-faced with existing granite facings upon completion.
2. Dockside wall 4.0m high, granite facings with sandstone rubble and hydraulic cement fill. Topped with flush rounded coping stones of granite.
3. Horizontal concrete core through wall at 0 degrees from horizontal.
