Preliminary Ecological Appraisal

Land at Eldon Grove, Liverpool

Report reference: R-2474-01
January 2016

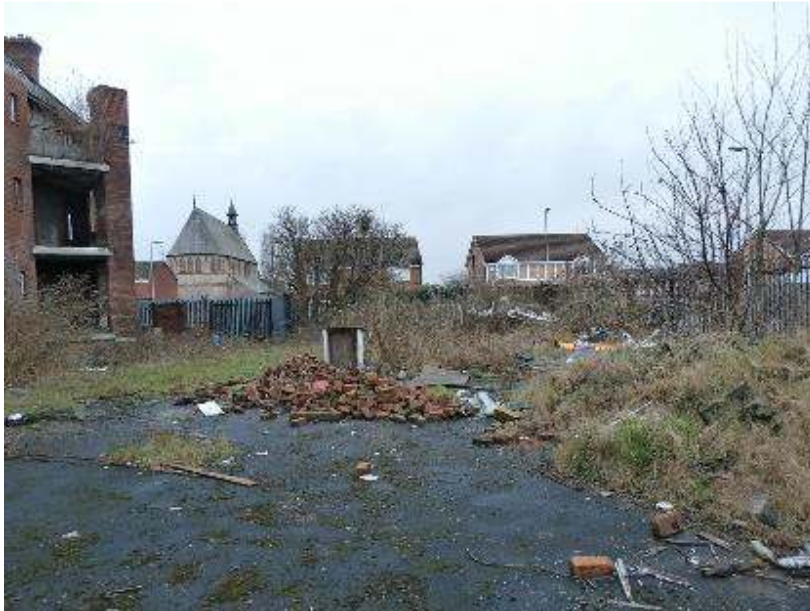
Figure 6

29. Hardstanding comprises the former access road off Bevington Street and areas around the buildings. Secondary vegetation, described above, has established where deeper pockets of soil are evident and where rubble piles created through previous attempts of renovation have been left. Large expanses of flytipping are also evident throughout.

Hardstanding to the north west of the Site showing fairly new rubble piles and now established vegetation rubble piles.

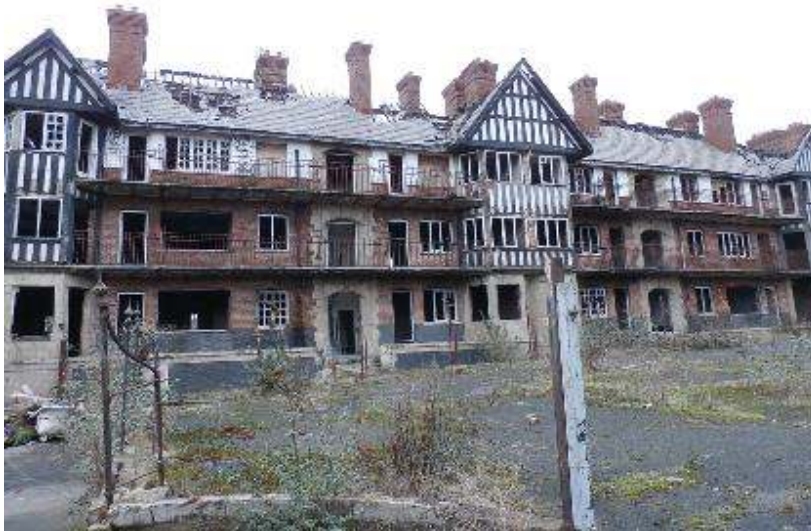
Figure 7

30. There are three former residential listed buildings on Site; these were subject to lead theft and subsequent fire damage approximately eight years ago and as a result, are now in a poor state of repair.
31. All buildings are of similar nature; being three storeys high of brick built construction, with decorative concrete and timber façades on the southern building elevations and brick built alcoves on the northern elevation. The timber facades surround bay windows which extend up from the second storey to a dormer style roof feature with a gable end. Timber fascia boards and soffit boxes are present on these gable ends.
32. The brick work is in largely good condition with rendering present over the third storey; this has evidently come off exposing the brickwork beneath in parts. Windows and some of their frames are largely absent across all buildings.

The southern elevation of building 3 showing the poor state of repair of the roof structure and general nature of the buildings.

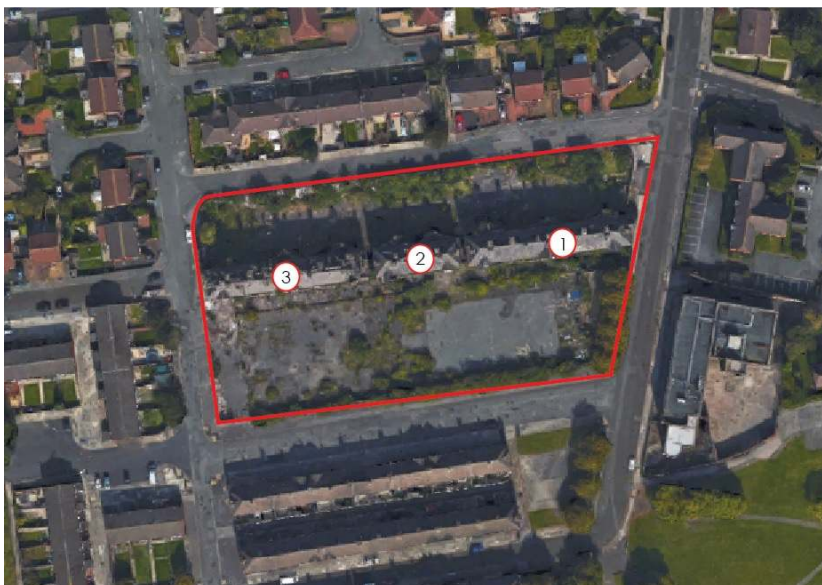
Figure 8

Building location and corresponding number.

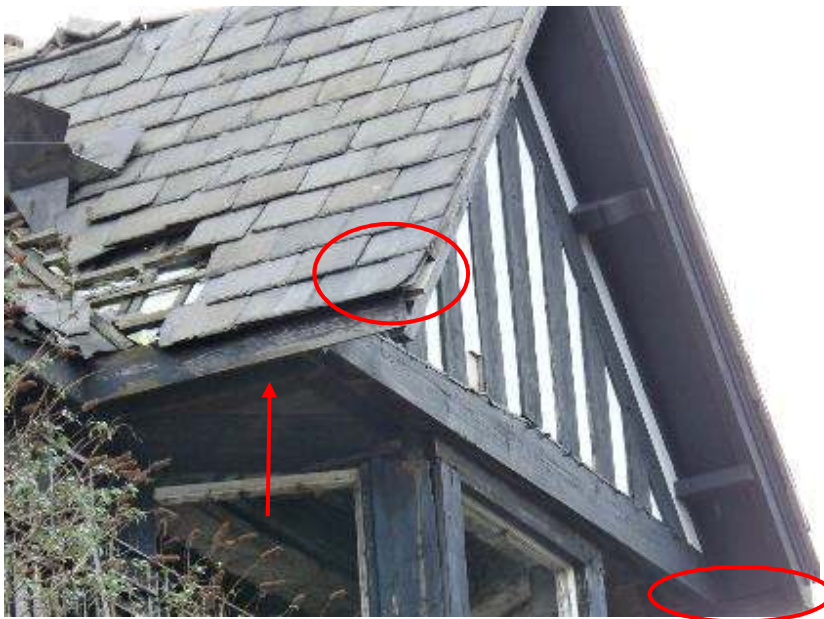
Figure 9

35. No internal inspections of Building 1 were carried out given health and safety restrictions.
36. External inspections identified several features considered suitable to support roosting bats; largely on the timber facades and the dormer style roofs which remain mostly intact. Notable features include; missing mortar at the gable ends providing potential access / egress into suitable roosting locations between the roof tile and internal roofing membrane on the southern and eastern elevations, gaps between the wooden panels on the soffit boxes and under timber panels adjacent to the bay windows.

Building 1; gaps in the far eastern dormer style roof providing potential access / egress into suitable roosting locations.

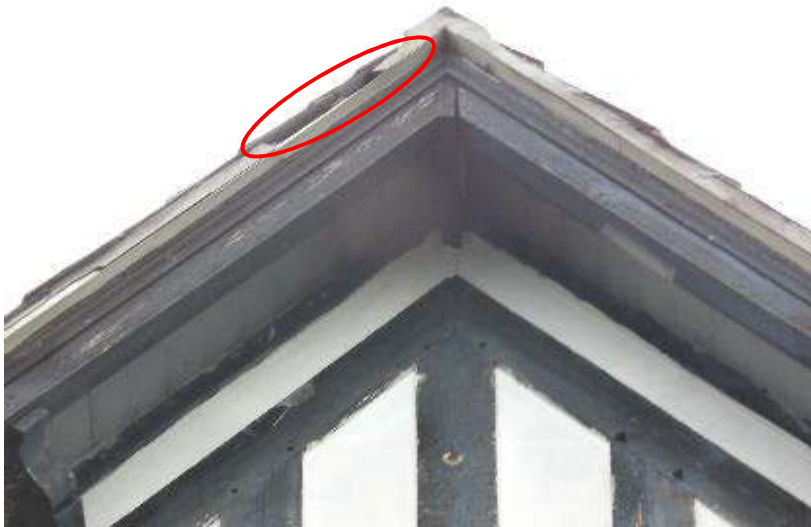
Figure 10

Gap present where mortar is missing on the central dormer roof providing potential access / egress into possible roosting locations.

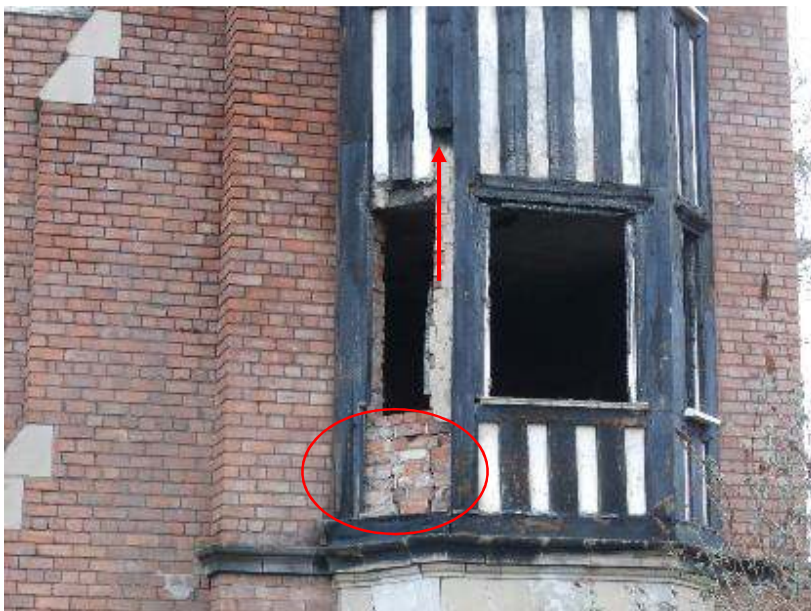
Figure 11

39. With the exception of a large crack on the north western building elevation and where part of the timber façade is absent on the eastern, the brickwork on the building is in good condition. The buildings appear to have a cavity, which could be accessed through the missing mortar at these locations.

Gaps in missing mortar where part of the timber façade has come off on the eastern elevation. Potential access / egress is also available under the panels.

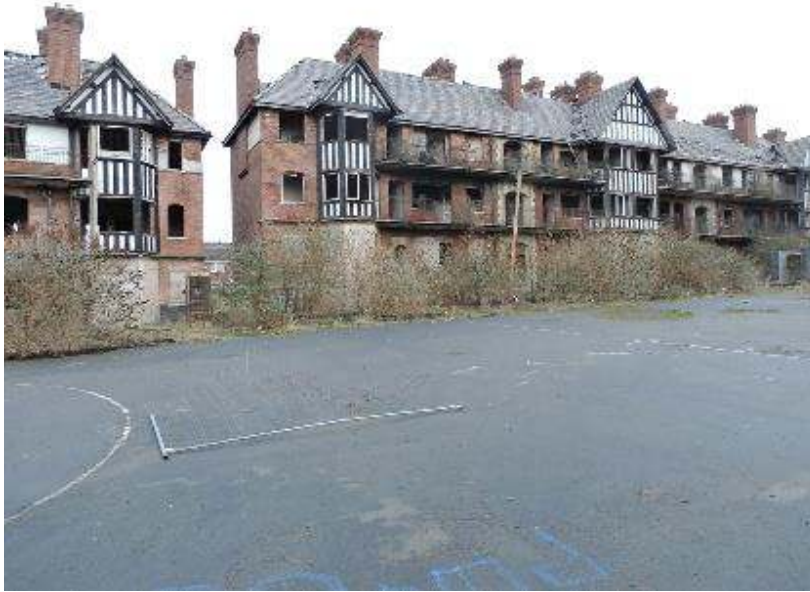
Figure 12

40. The roof structure is largely intact across this building; being only absent where lead flashing has been removed causing external tiles to slip, exposing the internal roof membrane beneath. Gaps are evident beneath the slate roof tiles in these areas leading to potential roosting locations.

Building 1 from the southern elevation showing the largely intact roof structure.

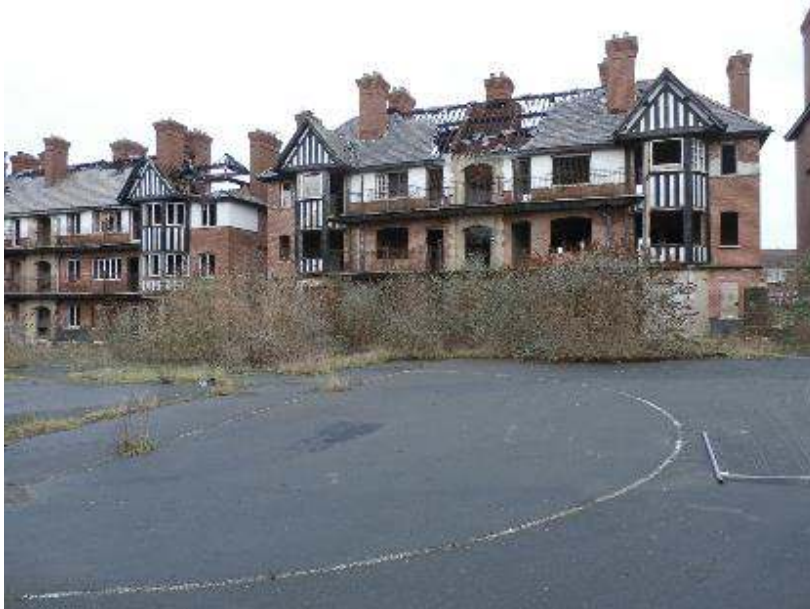
Figure 13

41. The central area of roof and across the ridge line is in poor state of repair, leaving the areas around the chimney and hipped and dormer style roofs intact. Despite this, the building has a number of features considered suitable for roosting bats.

Building 2 from the southern elevation showing the roof structure in a poor state of repair.

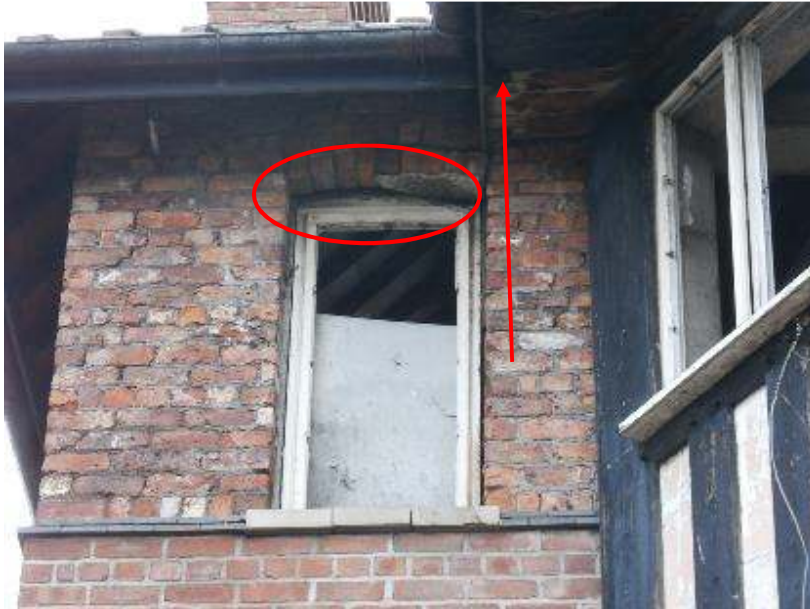
Figure 14

42. Absent rendering on the south western building elevation has exposed brick mortar and gaps around the third storey window; providing potential access / egress points to internal cavities within.
43. Timber panels located beneath the dormer style roofs adjacent to the third storey bay windows appear loose and considered suitable for roosting bats where internal cavities are present.

Absent rendering on south western building elevation provides access/egress for roosting bats; with loose timber panels around the bay window.

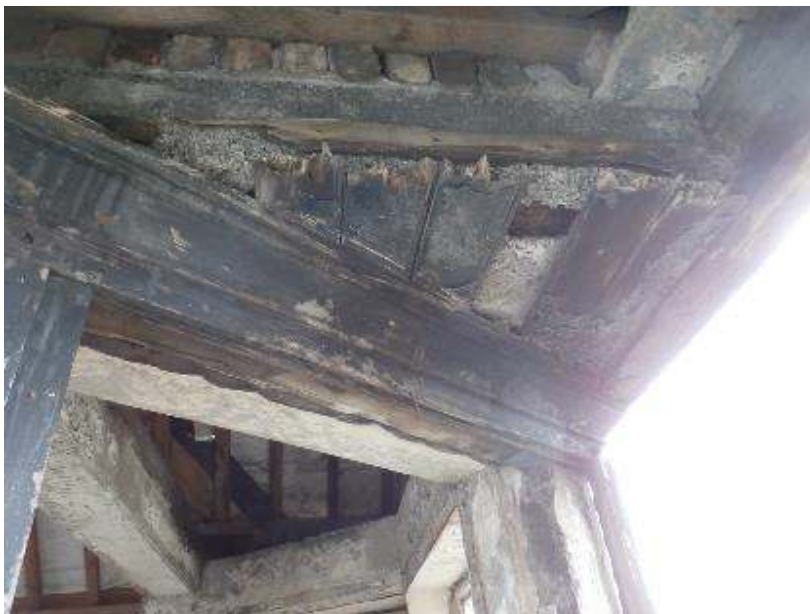
Figure 15

Absent timber panels and missing mortar beneath the dormer style roof provides potential access/egress to suitable cavities.

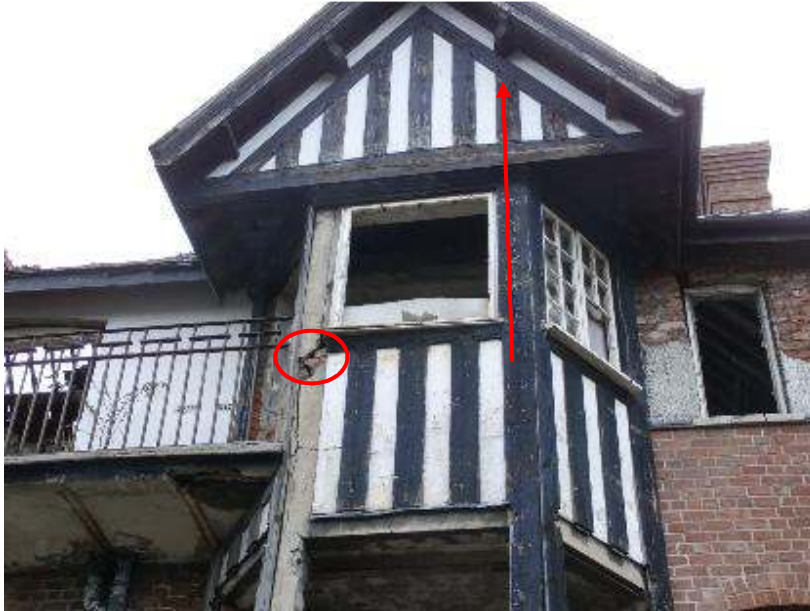
Figure 16

44. Gaps in the brick mortar are evident where the timber façade has come loose; this feature could provide potential access / egress into suitable roosting locations within the cavity wall, or surrounding window frames.

Gap in brick mortar exposed where timber façade is now absent.

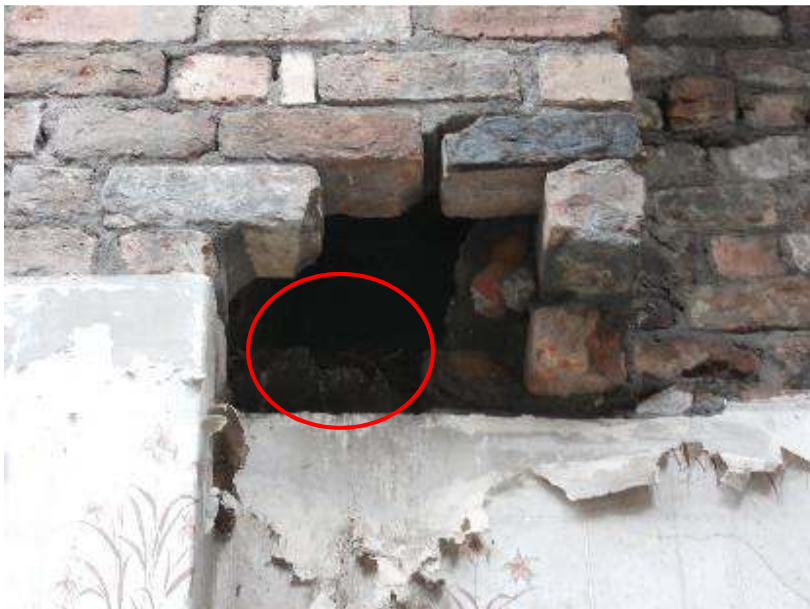
Figure 17

45. Internal observations were made in rooms where considered safe to do so. The roof structures are all open to the apex with significant damage across the main ridge line and central area; the dormer style roofs are largely intact with roofing membrane evident throughout. Birds evidently use the more sheltered areas of the building, as shown by evidence of nests and a large amount of faeces on the floor.

Birds nest on a ledge within an internal chimney stack.

68. The buildings are considered suitable to support common garden birds during the nesting period (March-August). To prevent the proposed works impacting on nesting birds, any building renovation where nesting birds were identified will need to be undertaken outside of the breeding bird season which is 1st March – 31st August inclusive. Any works required during the breeding bird season should be preceded by a nesting bird survey to ensure that the Wildlife and Countryside Act (1981) is not contravened through the destruction of nests and that any active nests are identified and adequately protected during the renovation works.

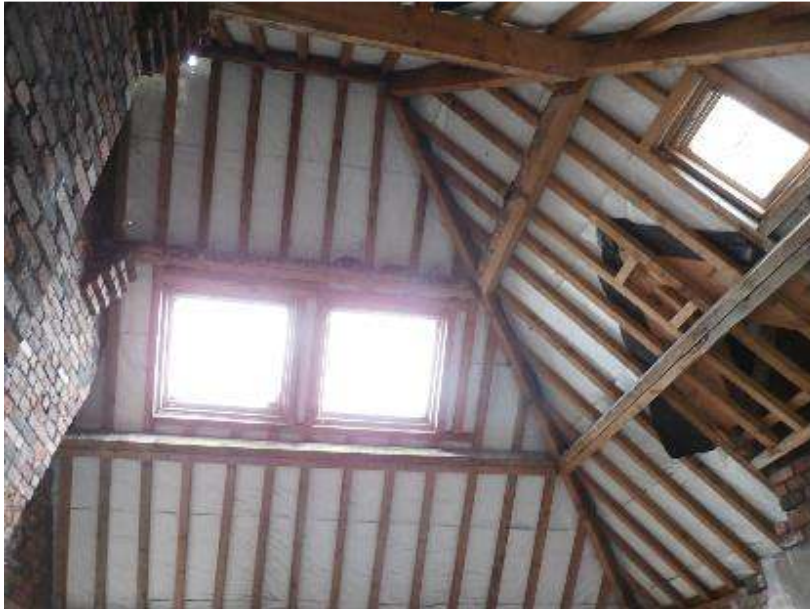
Figure 18

The internal roof structure of the dormer style section of building showing its intact nature.

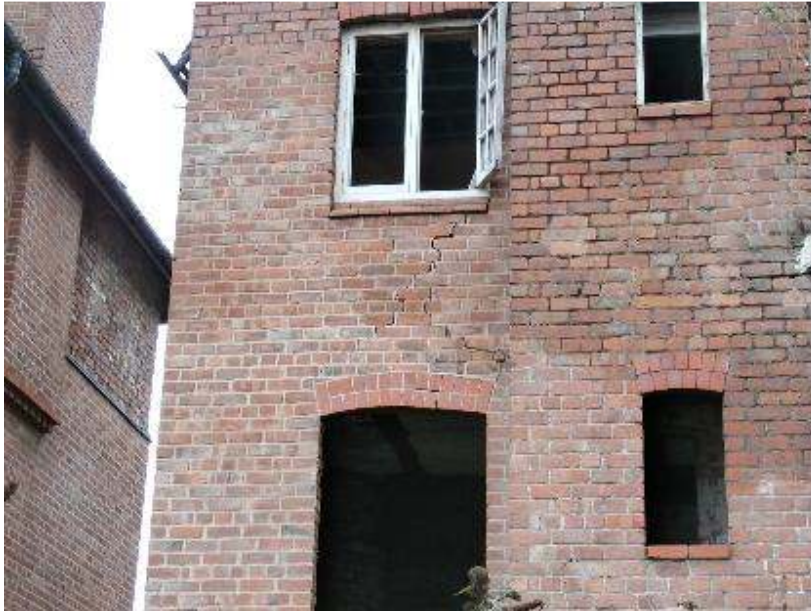
Figure 19

47. From ground level, there appears to be access / egress into the buildings cavity walls where there is missing mortar beneath the third storey window on the north eastern elevation, and in a gap under the window frames on the western building elevation.

Missing mortar beneath the third storey window on the north eastern building elevation.

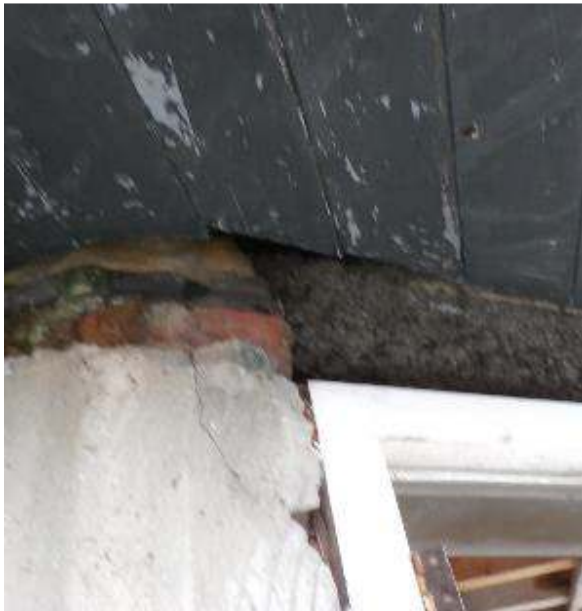
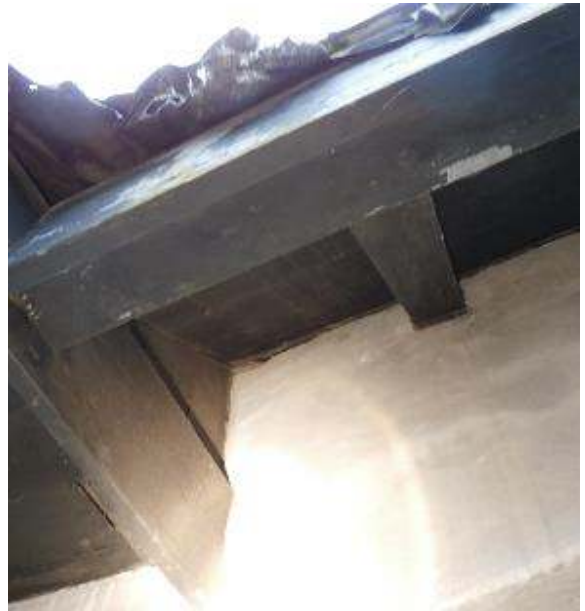
48. As per the previous two buildings, there are gaps beneath the timber panels adjacent to the bay windows and at the building eaves that have the potential to lead to suitable roosting locations.

Figure 20 Gaps beneath the timber panels on the dormer style roof adjacent to the bay window and at the building eaves providing potential access / egress to further suitable cavities.

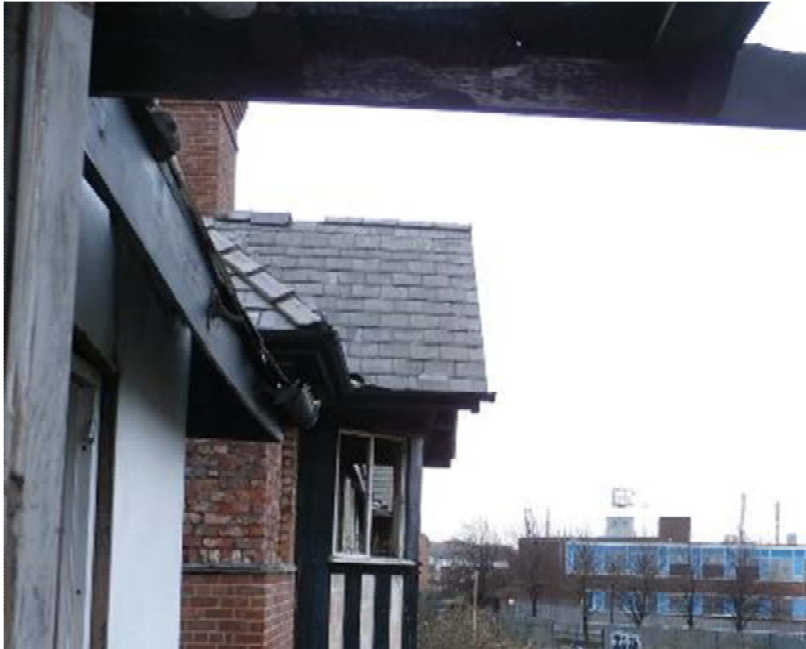
Figure 21

50. In addition, where the roof is intact, missing roof and ridge tiles provide access to suitable roosting locations between the roof tiles and internal roofing felt.

Missing ridge tile and roof tile close to the eaves of the southeast facing dormer style roof.

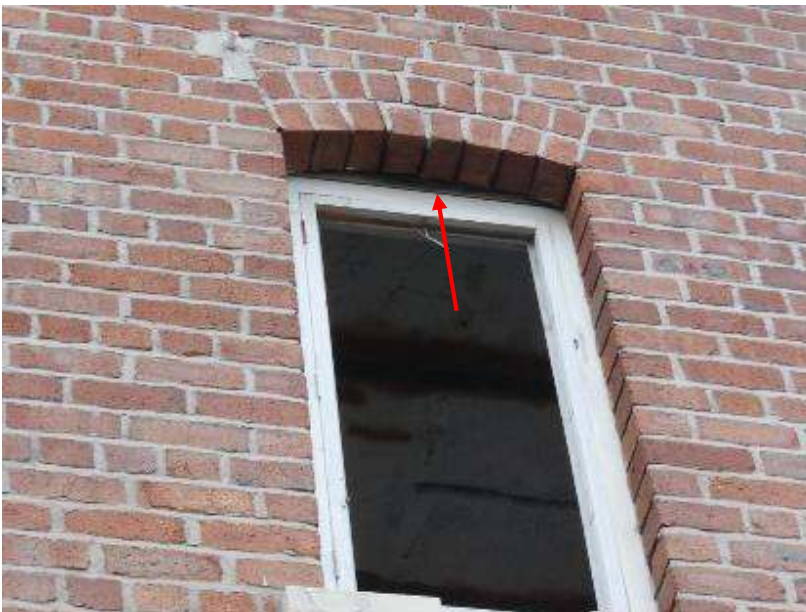
Figure 22

Gap behind the brickwork above the window on the western building elevation.

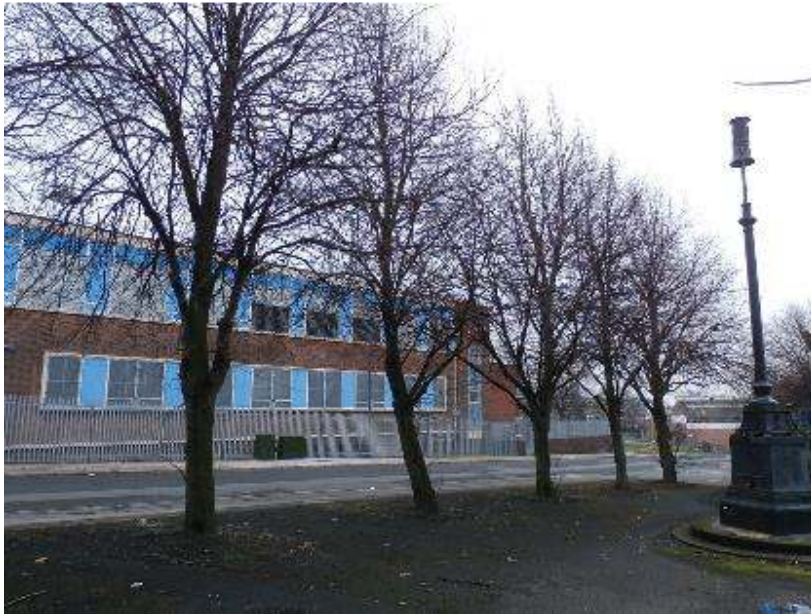
Figure 23

52. There are six semi-mature lime (*Tilia* sp.) set amongst hard paved areas immediately adjacent to the eastern site boundary off Limekiln Street. These trees have no features considered suitable to support roosting bats, but are tagged suggesting they afford some level of protection.

Semi-mature lime trees adjacent to the eastern Site boundary.

64. Measures should be put in place to safeguard the row of semi-mature lime trees adjacent to the eastern Site boundary to BS 5837, ensuring the absence of impacts on root protection zones.
